NBSIR 74-468

Examination of Failed Aircraft Rudder Torque Tube Assembly

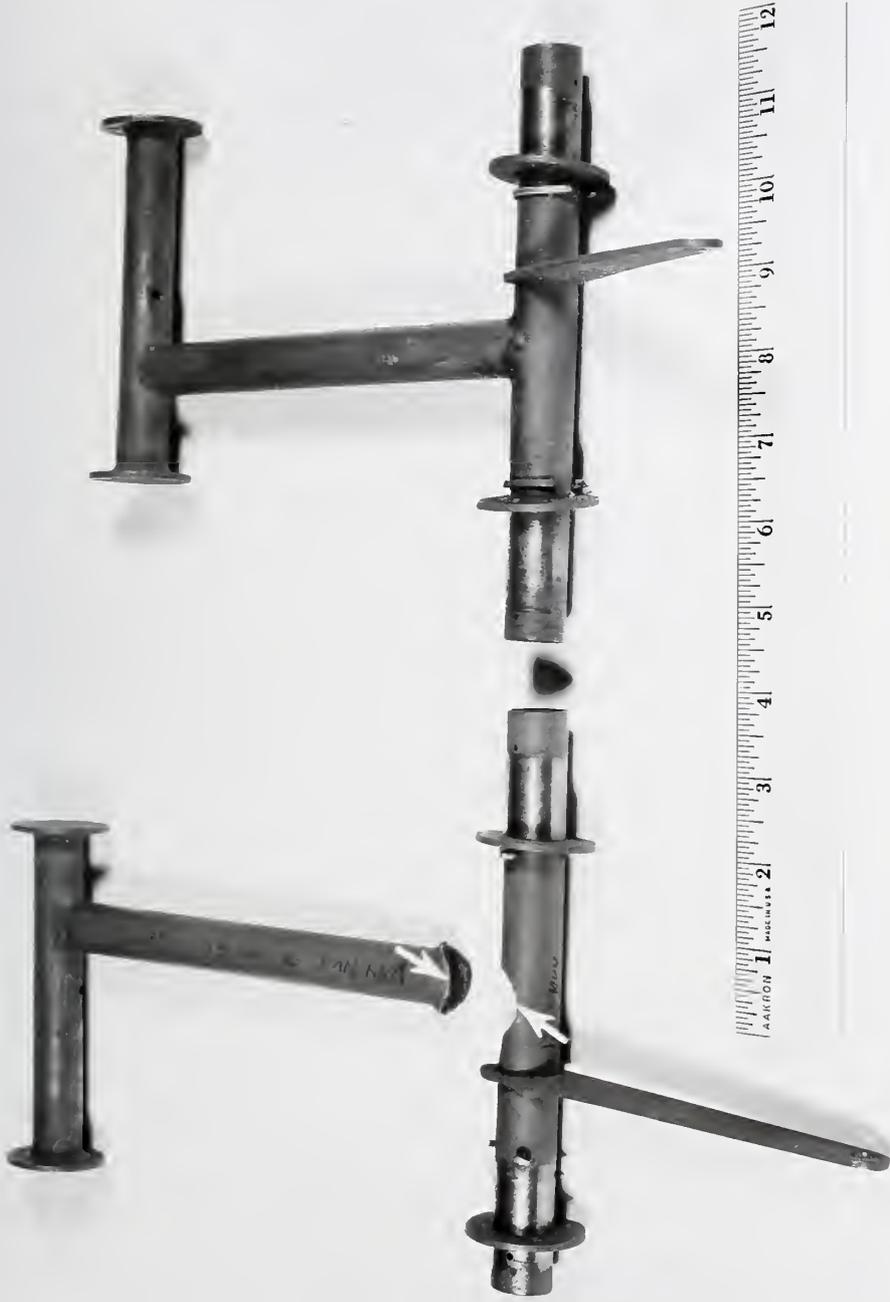
Figure 1. Failed left and intact right rudder torque tube assemblies as received. The apparent origin of the fracture of the left assembly is indicated by the arrows.

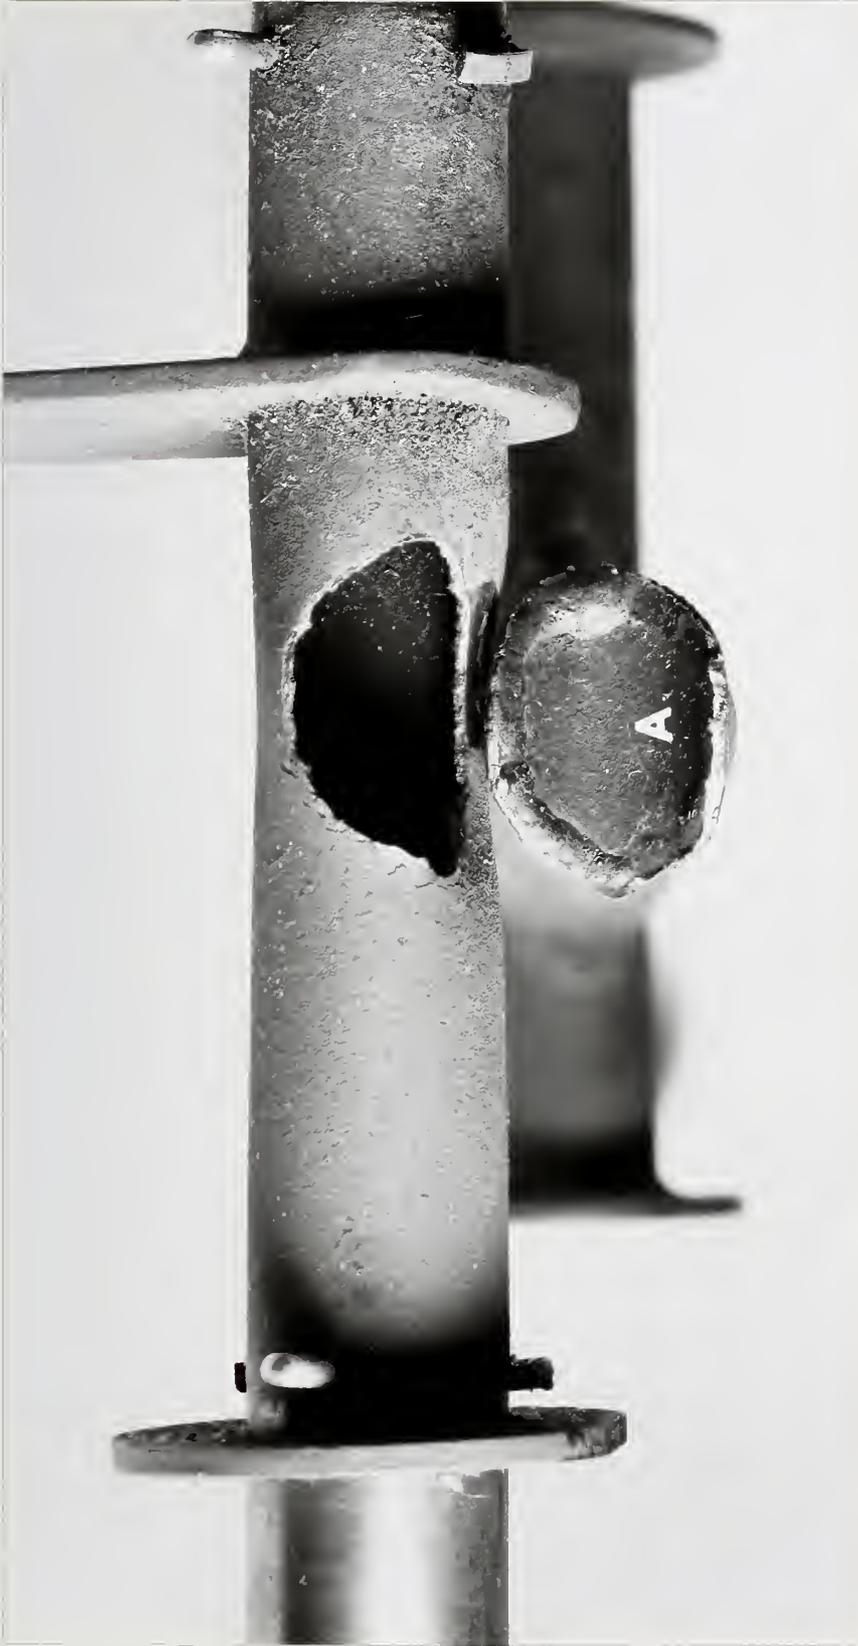
Figure 2. Opposing fracture surfaces of the left torque tube (top) and the left pedal connecting tube (bottom). A curved disk portion from the torque tube which remained joined to the pedal connecting tube is designated by the letter A. X 2

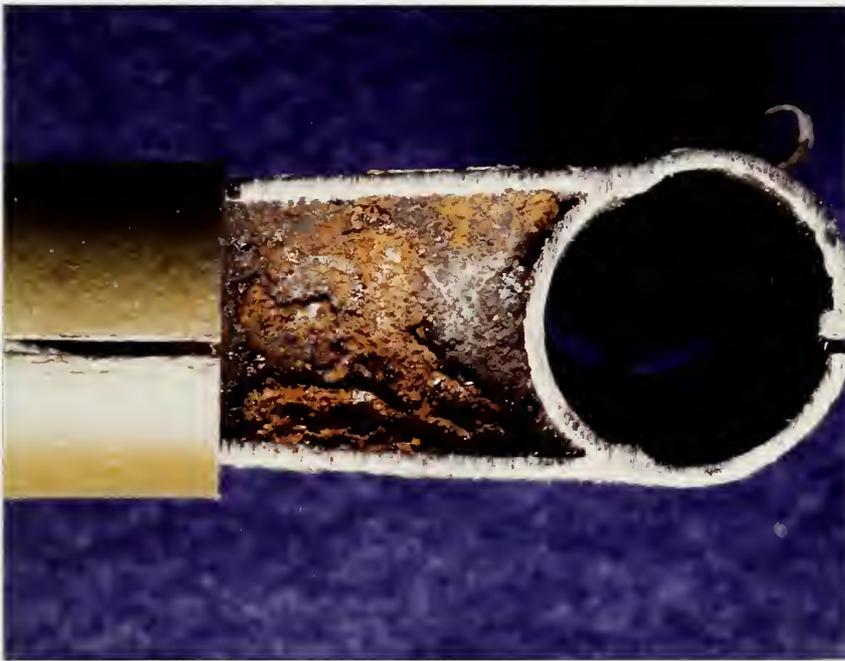
Figure 3. Corrosion product in the right pedal connecting tube adjacent to the welded joint between the connecting tube and the torque tube. X 2

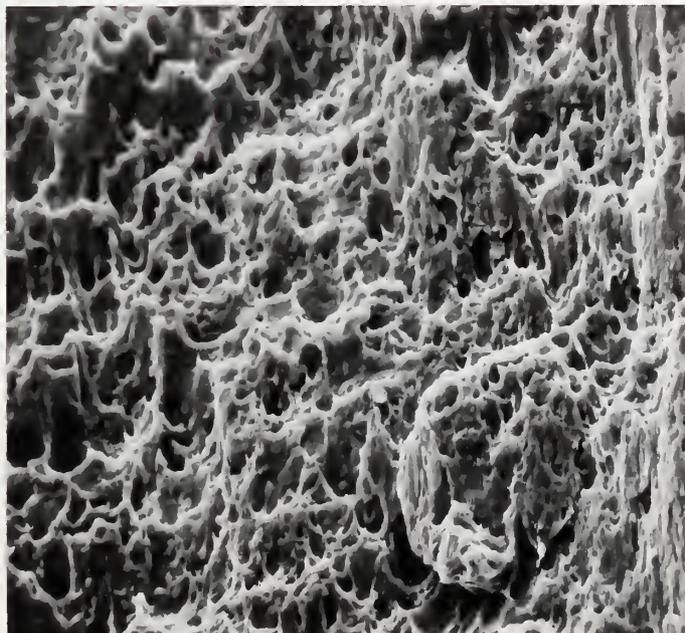
Figure 4. SEM fractograph from the back part of the fracture showing dimpled rupture. X 1190

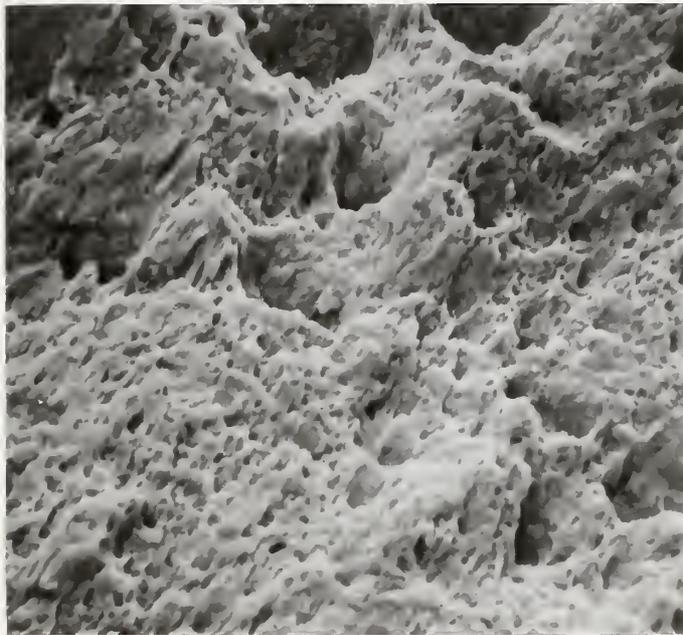
Figure 5. SEM fractograph from the front part of the fracture showing dimpled rupture. X 1150

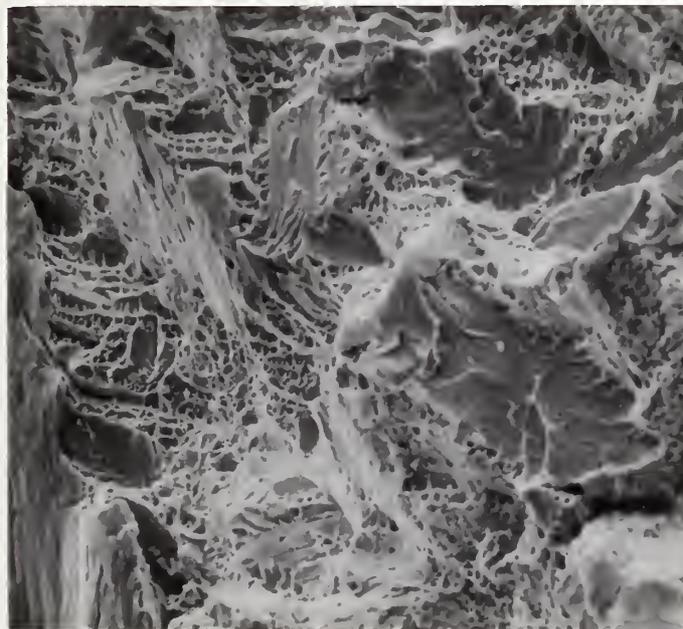
Figure 6. SEM fractograph from the side of the fracture surface showing a mixture of dimpled rupture and quasi-cleavage. Some porosity is evident. X 510

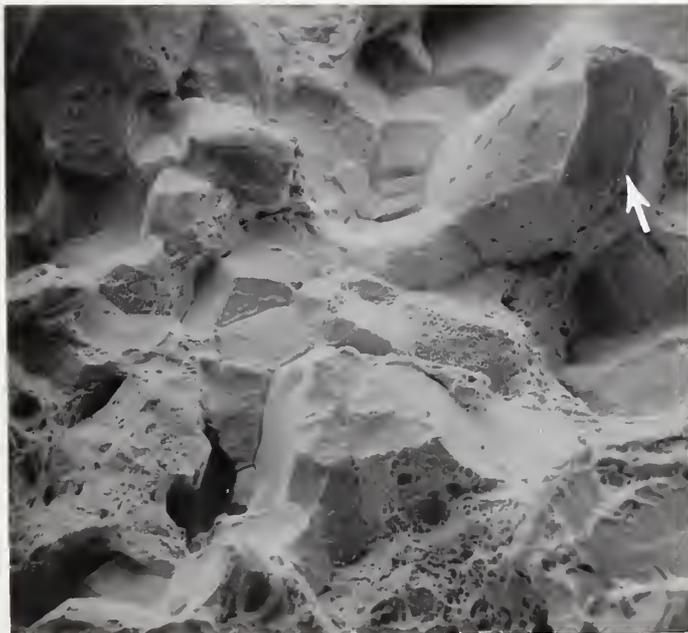
Figure 7. SEM fractograph from the back part of the fracture showing an intergranular appearance. Dimpled rupture can be seen on the sides of several of the grains. The arrow indicates an area of mechanical damage. Some porosity is evident. X 260

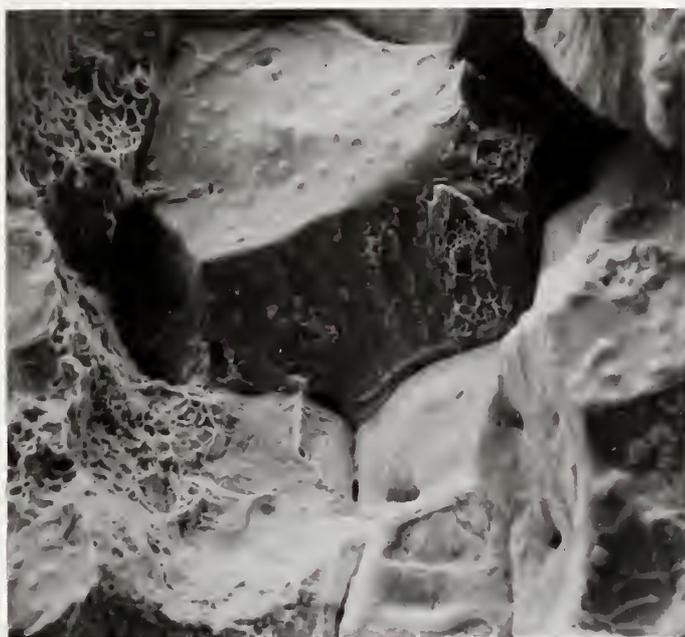
Figure 8. SEM fractograph from the front part of the fracture showing an intergranular appearance. Some dimpled rupture is evident and there is some porosity. X 650

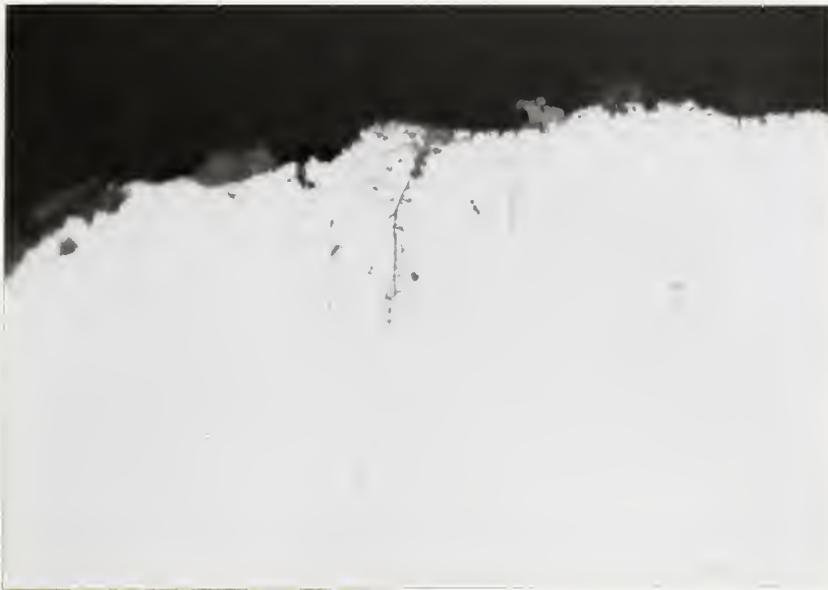
Figure 13. Longitudinal cross section through right torque tube assembly showing crack in heat affected zone at location of arrow B in figure 12b. As polished. X 500

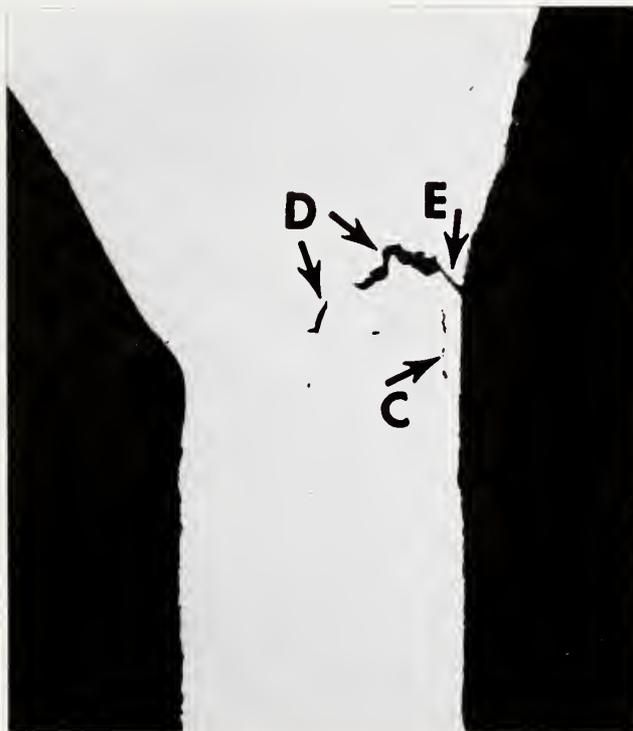
Figure 14. Longitudinal cross section through right torque tube assembly showing large stringer type inclusion at arrow C, area of gas porosity-slag inclusion in heat affected zone at arrows D, and apparent crack at arrow E. Same arrow designations indicate these features in figure 12b. As polished. X 40

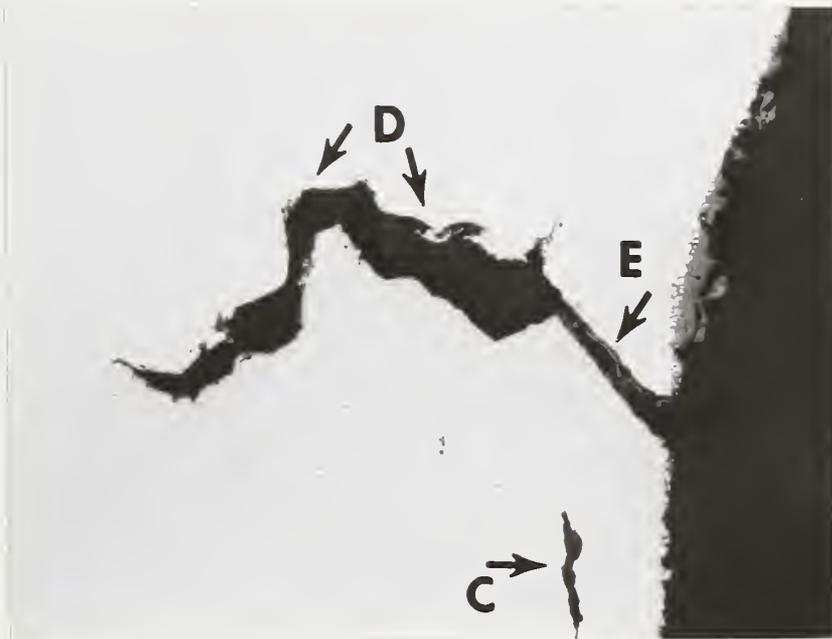
Figure 15. Longitudinal cross section through right torque tube assembly showing gas porosity-slag inclusion area (arrows D), apparent crack in heat affected zone between inclusion and surface (arrow E), and part of stringer inclusion in tube (arrow C) shown in figure 14. As polished.
X 200

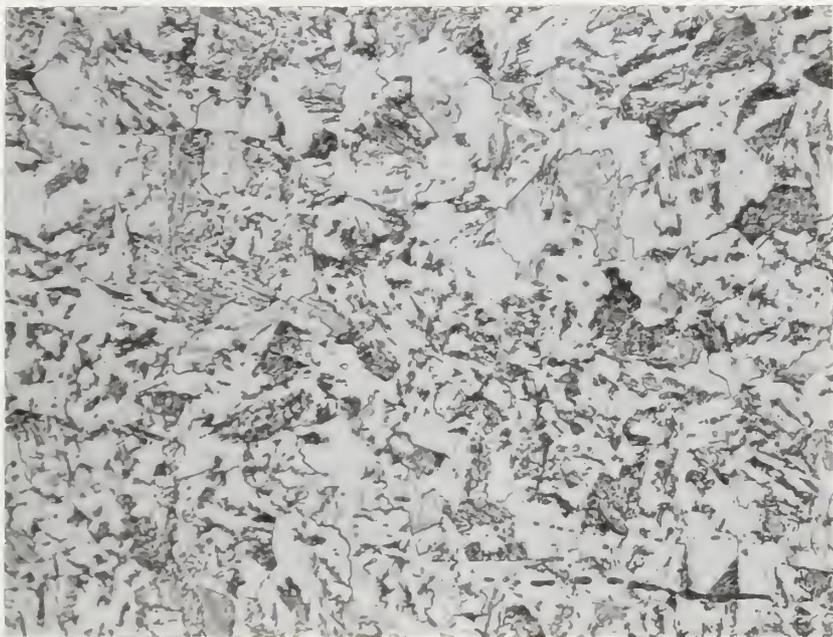
Figure 17. Etched longitudinal cross section showing microstructure of the tube material. Microstructure consists of pearlite (dark) and ferrite (light) and some spheroidized cementite. Etch: 1% nital. X 1000

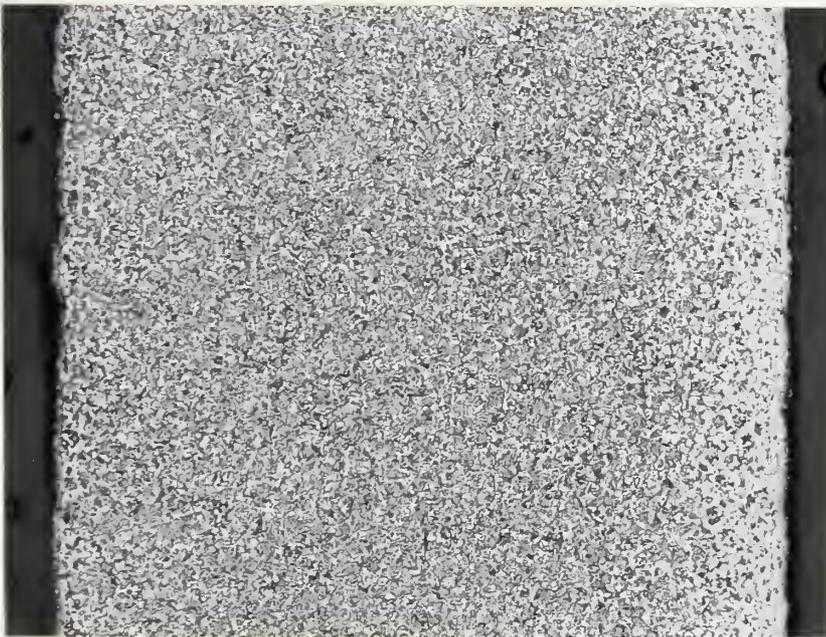
Figure 18. Etched longitudinal cross section showing decarburized layer adjacent to the outside surface of the tube. The entire thickness of the tube is shown. The decarburized layer is at the right. Etch: 1% nital. X 100

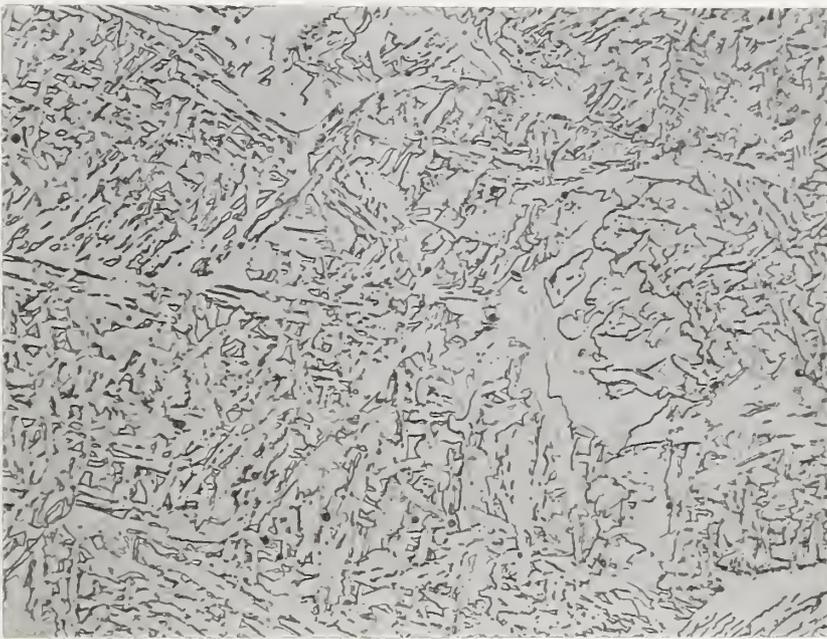
Figure 19. Etched longitudinal cross section showing microstructure of the weld metal which consists of coarse, tempered martensite. Etch: 1% nital. X 1000

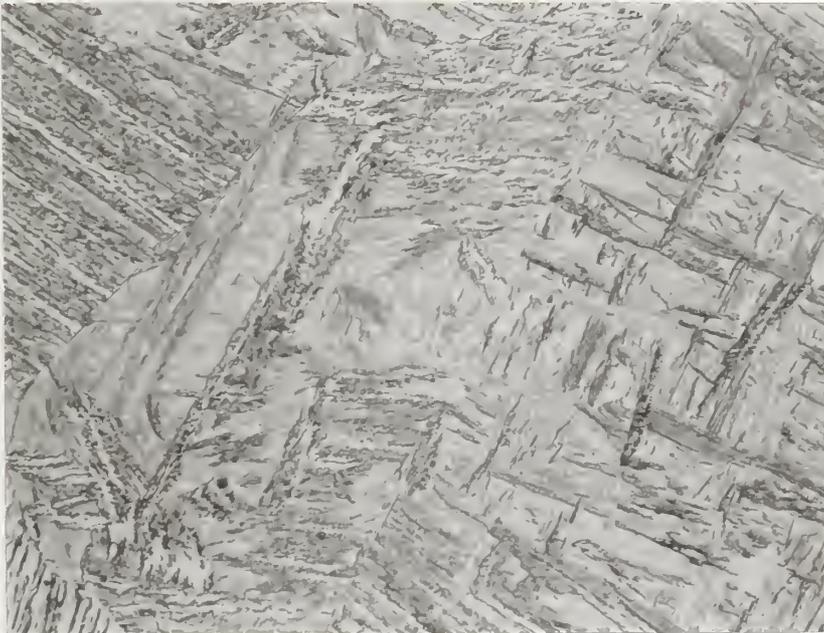
Figure 20. Etched longitudinal cross section showing the microstructure of the heat affected zone adjacent to the weld. Microstructure consists of coarse grained martensite outlined by grain boundaries of prior austenite grains. Etch: 1% nital. X 1000

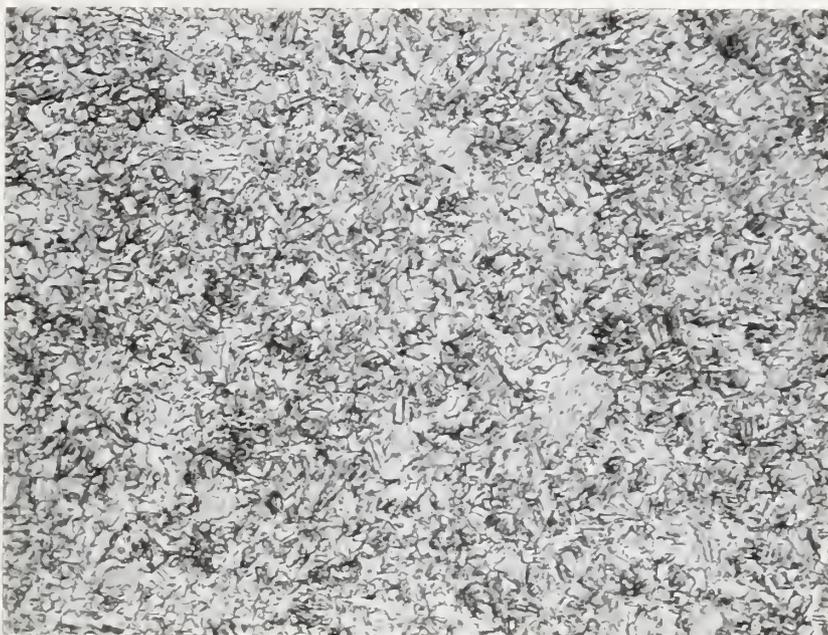
Figure 21. Etched longitudinal cross section showing the microstructure of the heat affected zone adjacent to the parent tube material. Microstructure consists primarily of martensite with some ferrite. Etch: 4% picral. X 1000

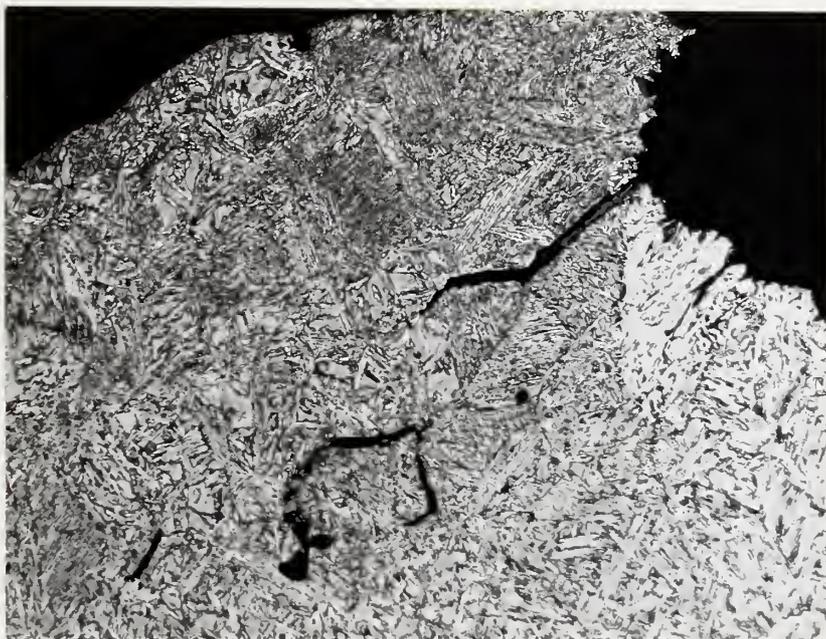
Figure 22. Etched longitudinal cross section through left torque tube assembly showing part of fracture profile (upper left) and some secondary cracking. Etch: 1% nital. X 200

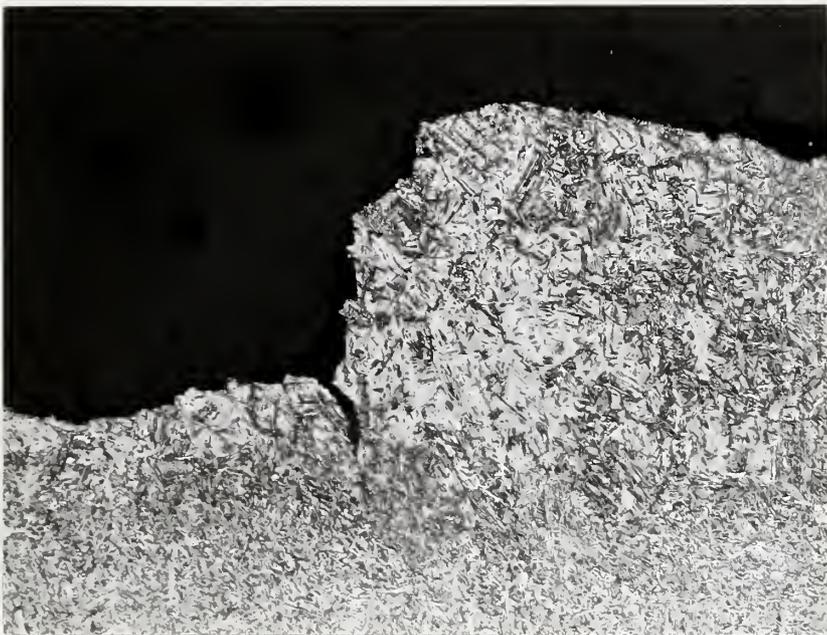
Figure 23. Etched longitudinal cross section through left torque tube assembly showing part of fracture profile. Etch: 1% nital. X 200

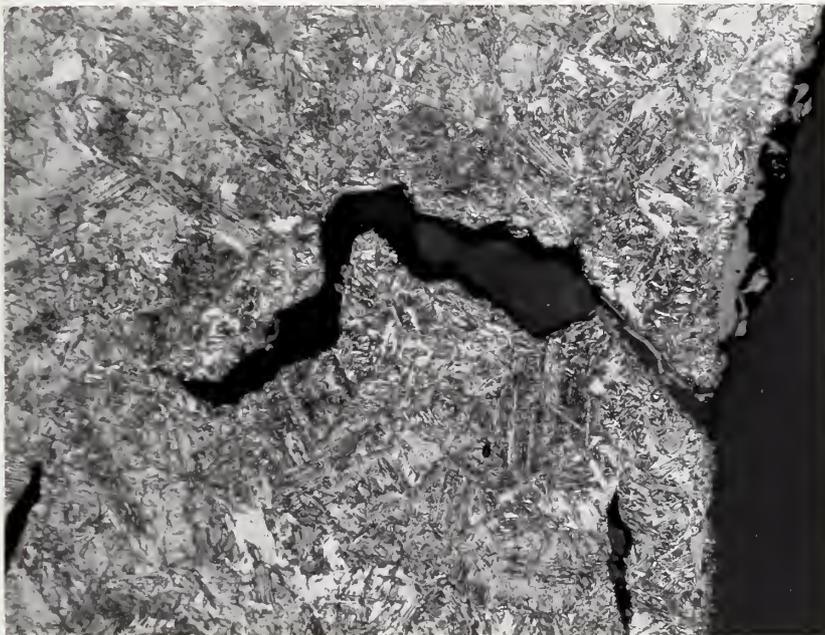
Figure 24. Etched longitudinal cross section through right torque tube assembly showing location of gas porosity, welding slag inclusion, and crack in the heat affected zone. Etch: 1% nital. X 200
