NBSIR 76-981(R)

# **Examination of Steel Components from the Yadkin River Bridge, Siloam, North Carolina**

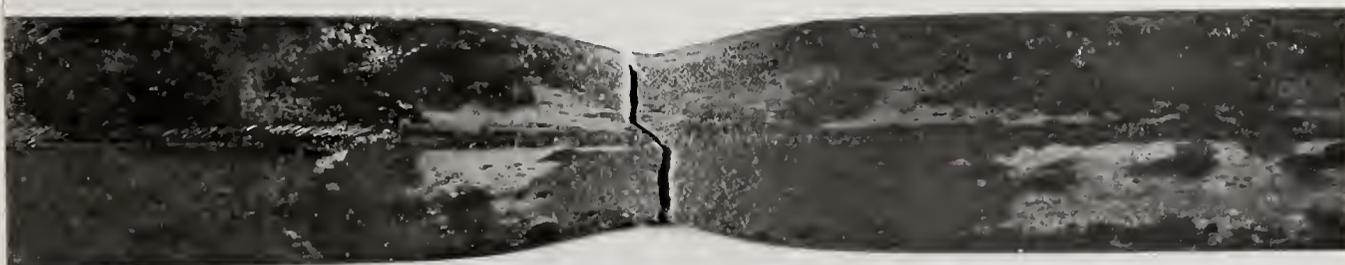
Figure 5. Fracture profile of bar B6 showing necking which occurred during the laboratory tensile test. X 1

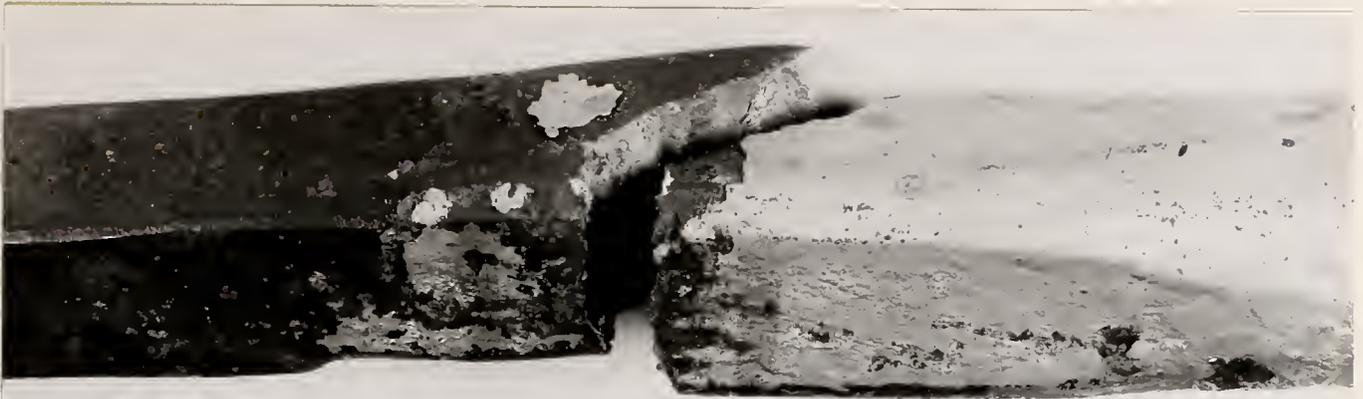
Figure 6. Fracture profile of bar X1A. X 1

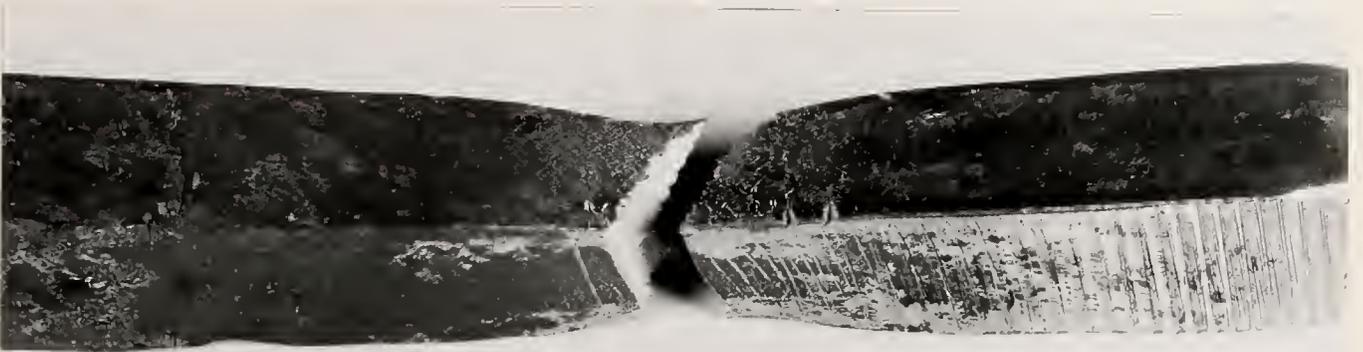
Figure 7. Fracture profile of bar Y1. X 1

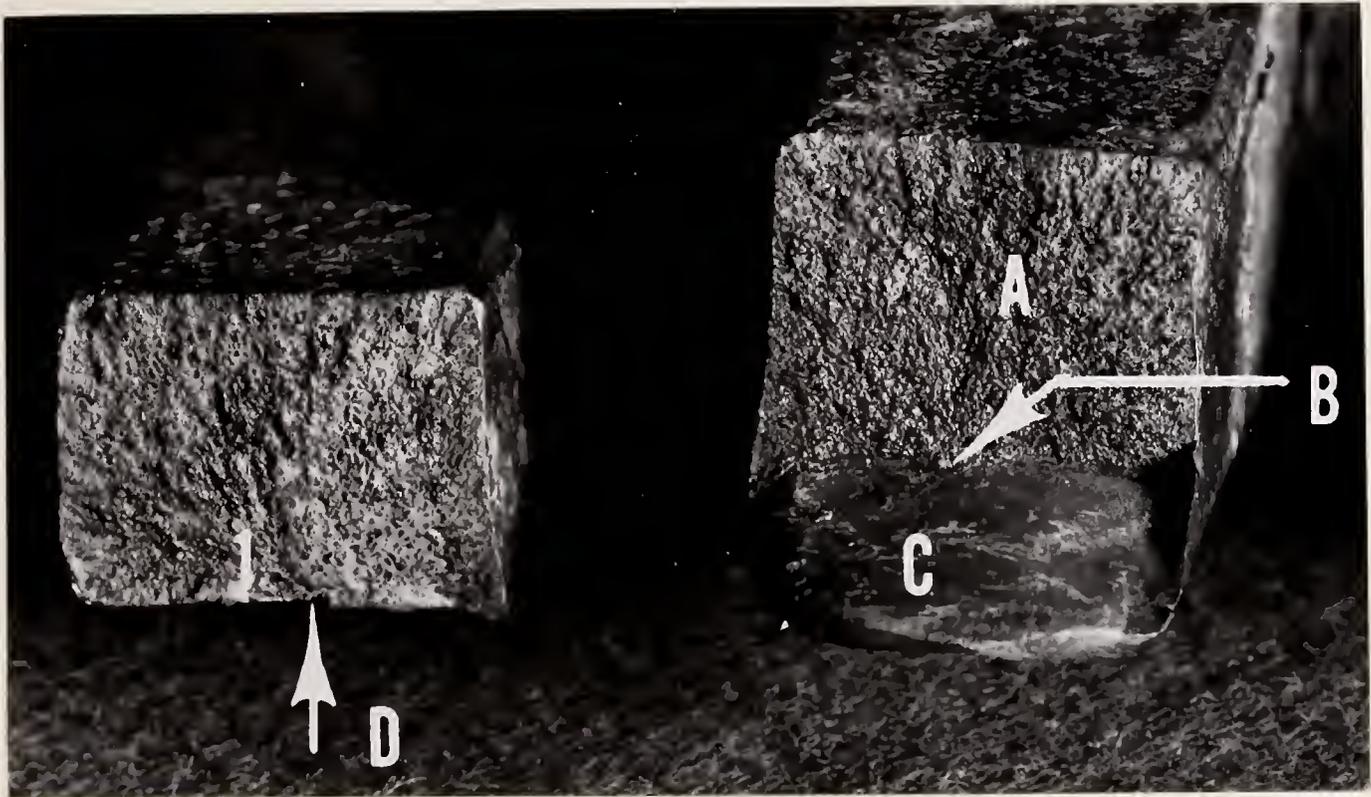
Figure 9. Opposing fracture surfaces of Bar B1. X 2  
 A is region of fracture perpendicular to the longitudinal axis of the bar.  
 Arrow B indicates apparent fracture origin and location of change in direction of fracture path.  
 C is region of fracture following junction.  
 Arrow D indicates apparent fracture origin.  
 Region 1 is small area where the fracture mode appears to be dimpled rupture.

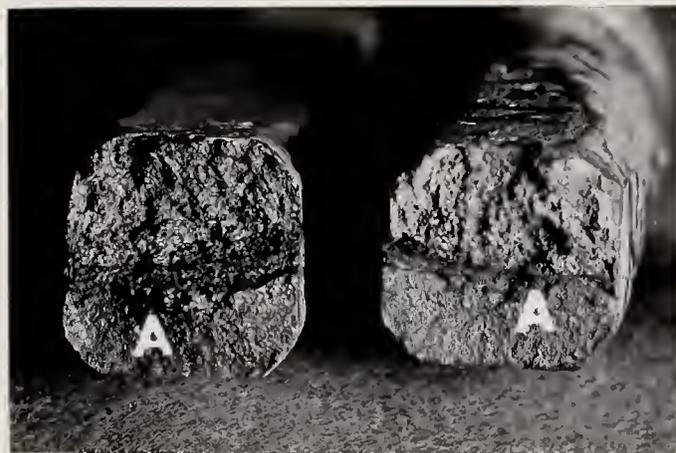
Figure 10. Opposing fracture surfaces of bar B5. X 1  
 The fracture features appear to be finer in region A than on the rest of the fracture surface.

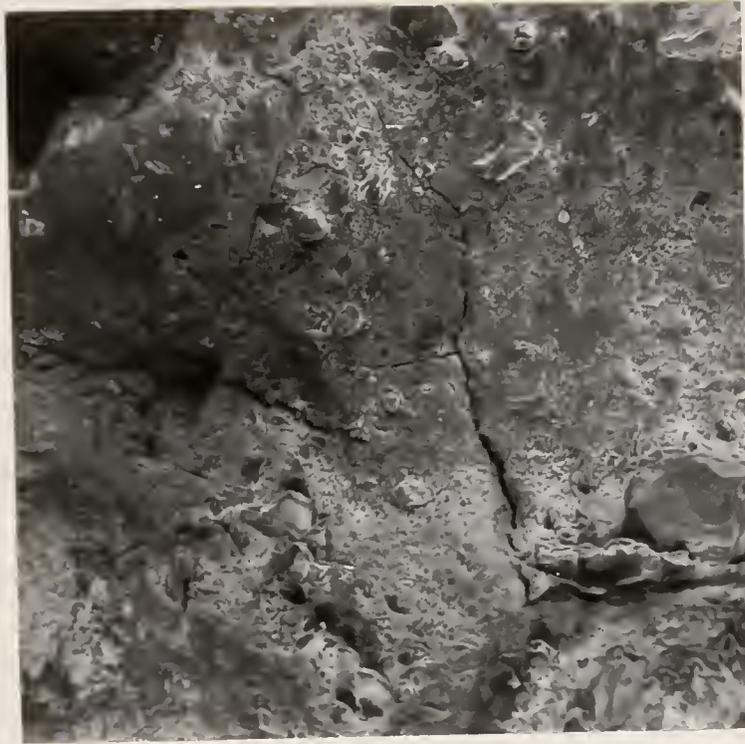
Figure 11. SEM fractograph of area adjacent to the apparent fracture origin in bar B1. What appears to be corrosion product is masking the fracture features. X 370

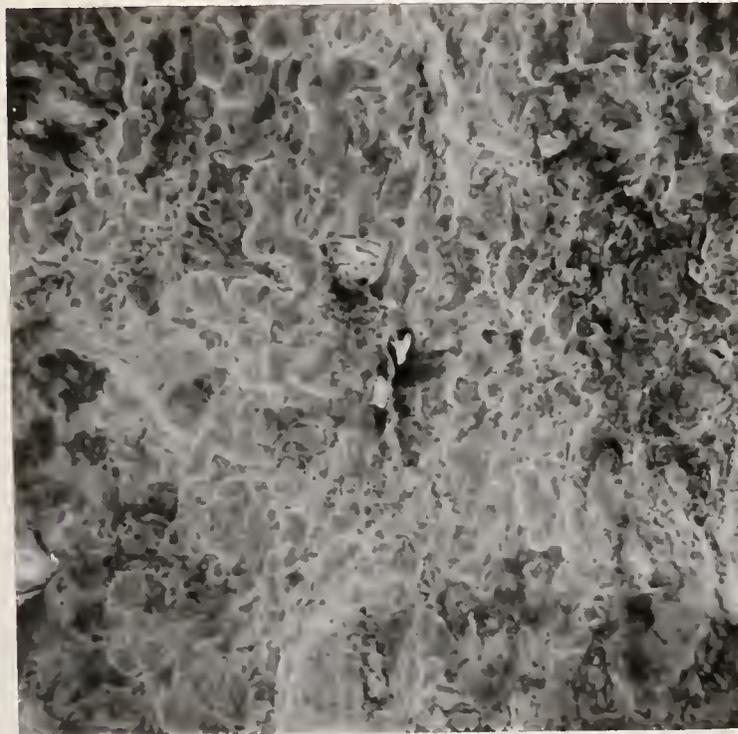
Figure 12. SEM fractograph of area near the apparent fracture origin in bar B1. Mode of fracture appears to be dimpled rupture. X 380

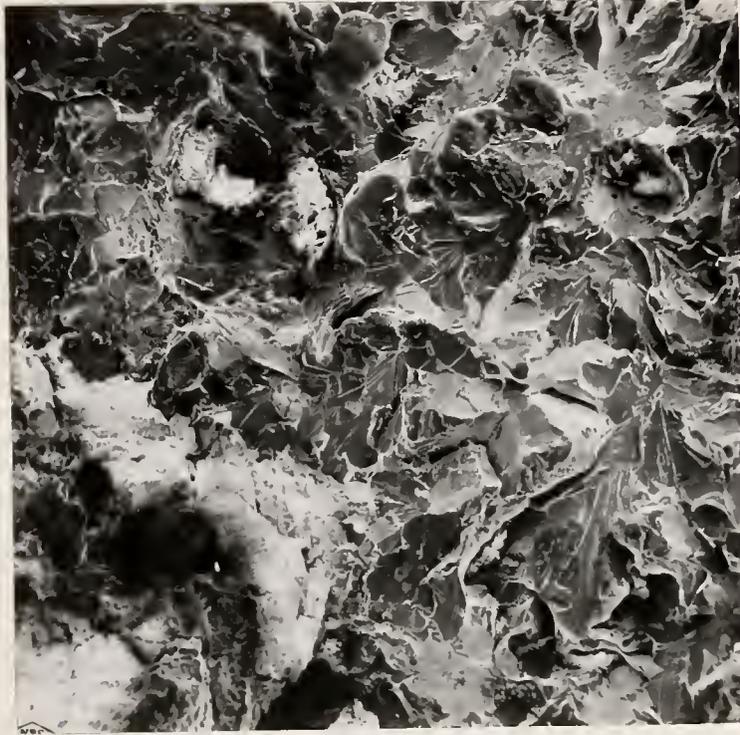
Figure 13. SEM fractograph from bar B1 showing the fracture surface away from the apparent origin. The predominant fracture mode is cleavage. X 175

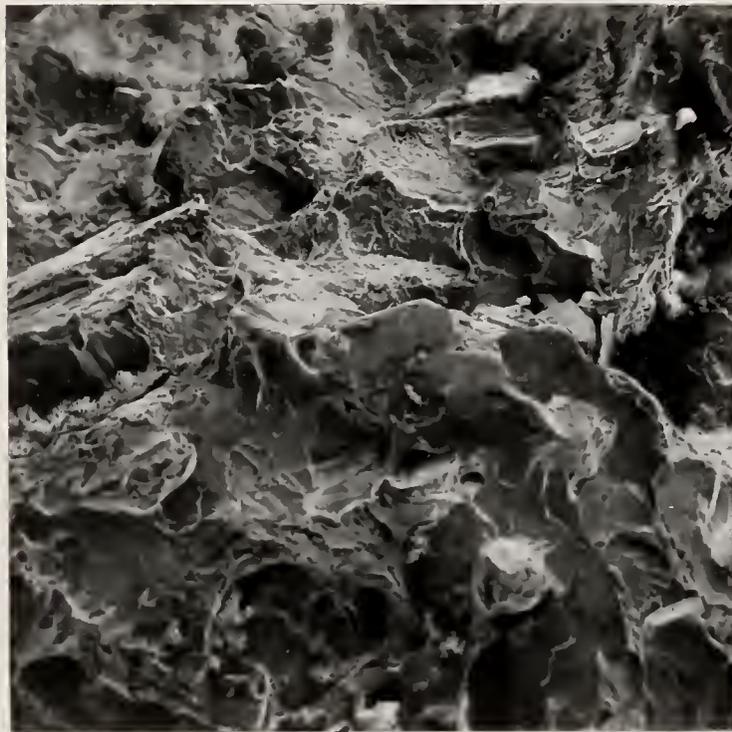
Figure 14. SEM fractograph from bar B5 (region A, figure 10) showing mostly cleavage and some dimpled rupture. X 210

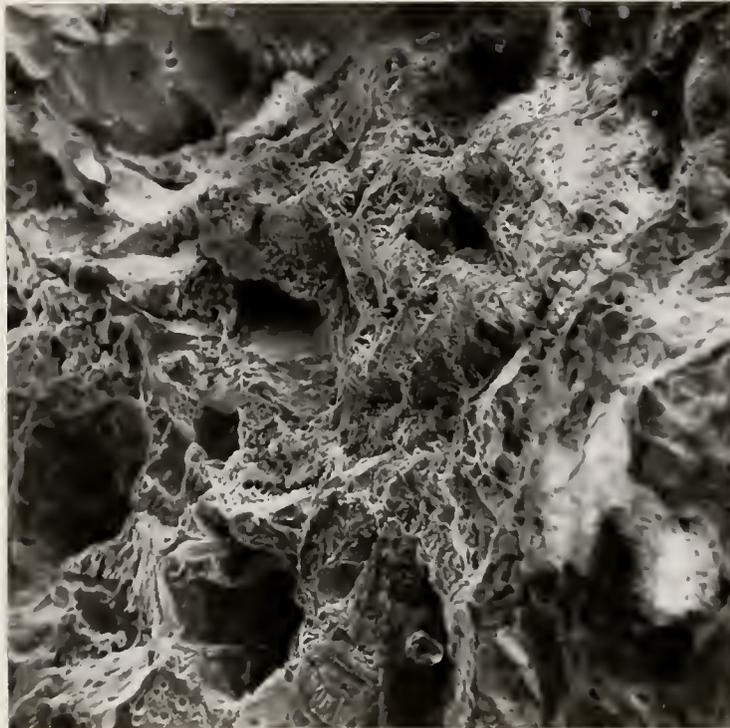
Figure 15. SEM fractograph from bar B5 (region A, figure 10) exhibiting mostly dimpled rupture and some cleavage. There are several large holes or pores. X 540

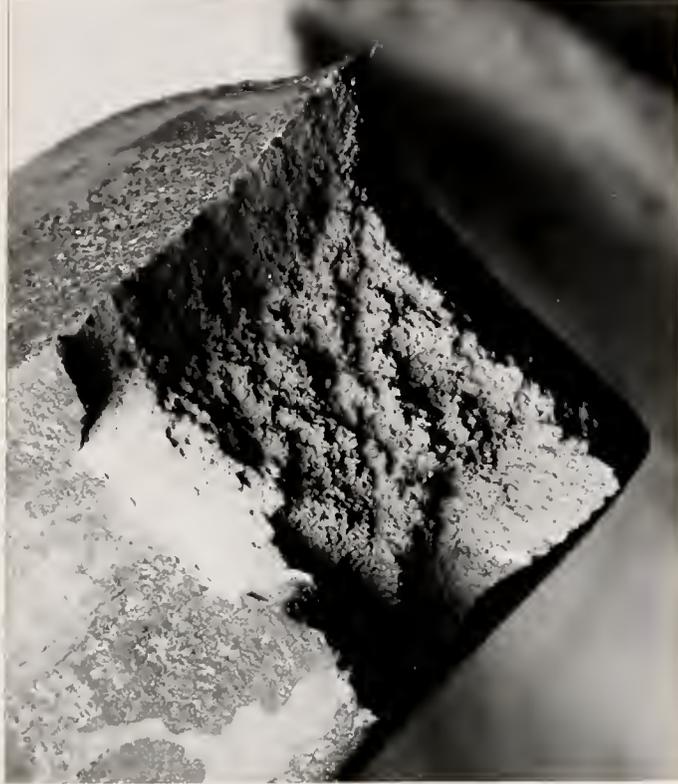
- a. Bar Y1, X 1.
- b. Bar X1A, X 1.
- c. Bar X1B (fracture at junction), X 1.
- d. Bar B6, X 4.

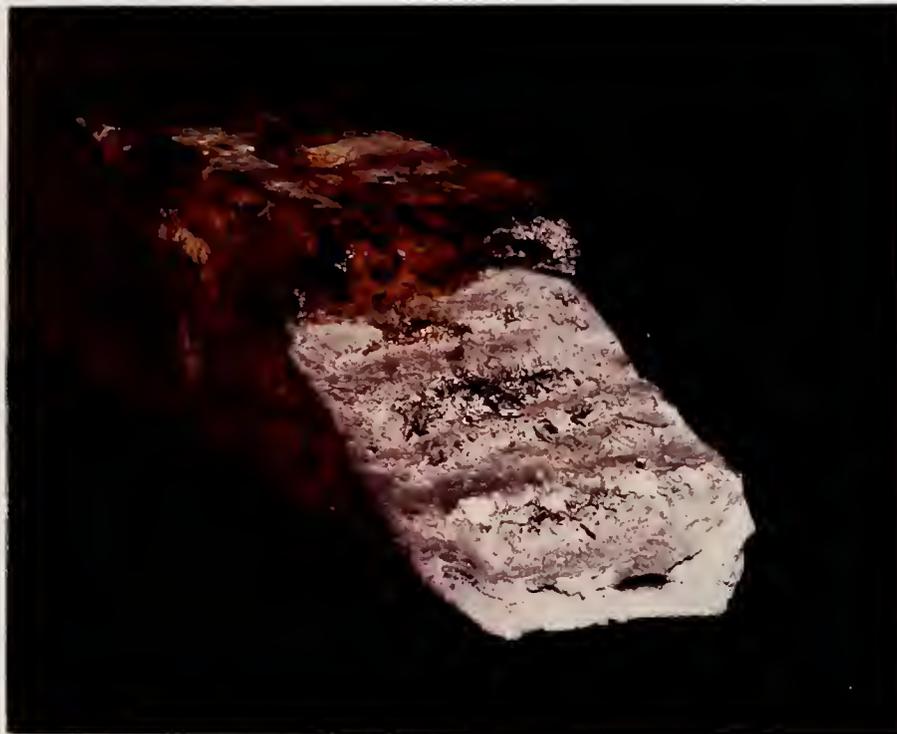
Figure 17. Surface of the laboratory produced fracture through bar X1A. The heavily corroded portion near the top of the fracture surface is the pre-existing crack. The center portion of the fracture (about 35° to the longitudinal axis of the bar) is essentially along the junction of the two parts of the bar. X 1

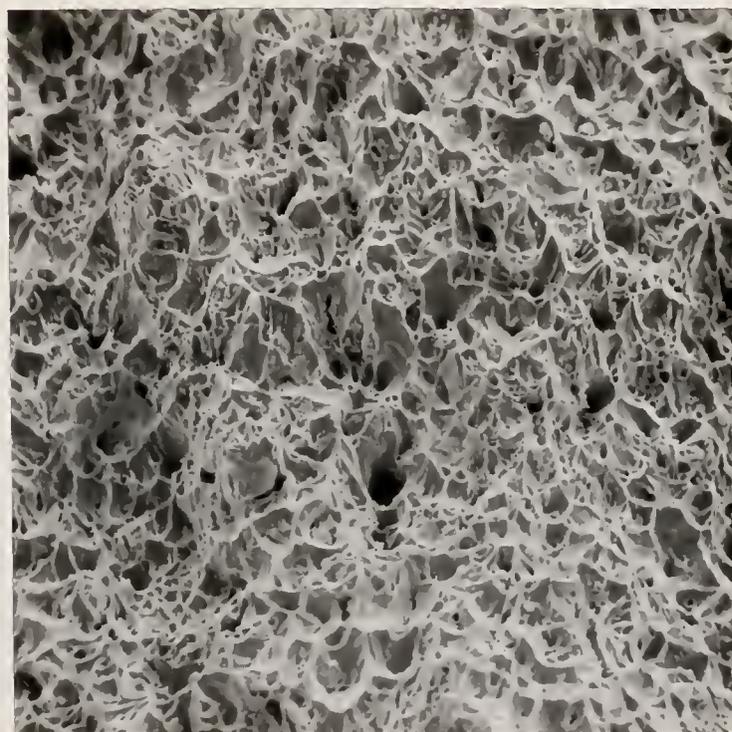
Figure 18. SEM fractograph from laboratory produced tensile fracture in bar B6. Dimpled rupture is the primary fracture mode. X 490

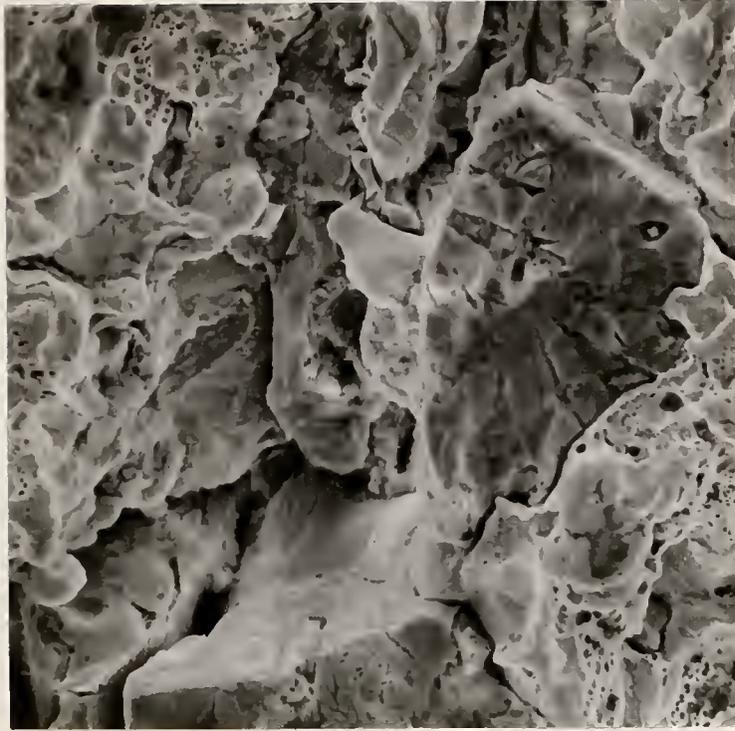
Figure 19. SEM fractograph of bar X1A in the region containing the pre-existing crack. The mode of fracture is mixed, consisting of cleavage, apparent intergranular cracking, and some dimpled rupture. X 525

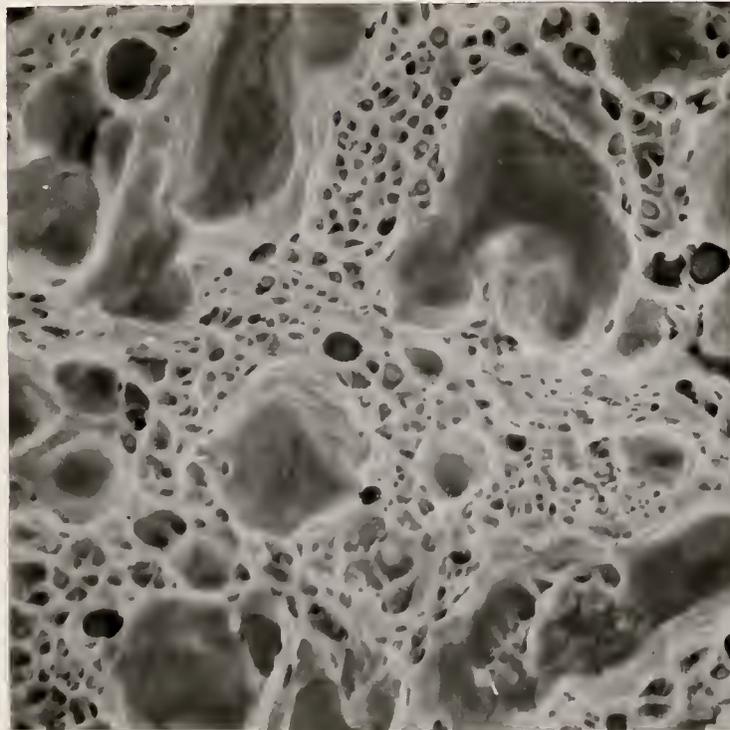
Figure 20. SEM fractograph of bar X1A in the remaining ligament in the plane of the pre-existing crack (see figure 17). Dimpled rupture is the primary fracture mode. X 2000

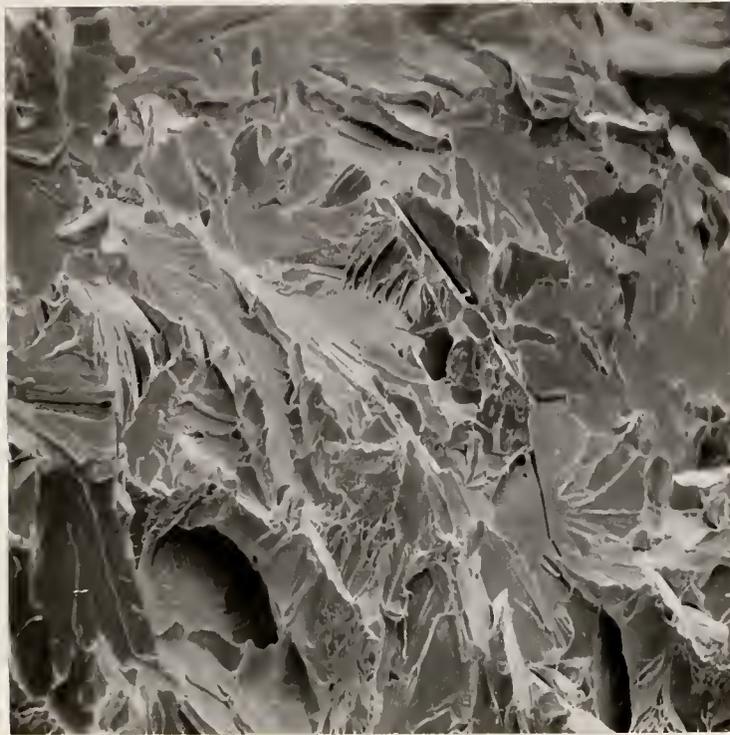
Figure 21. SEM fractograph of the part of the fracture of bar X1B that exhibited cleavage as the primary fracture mode. X 200

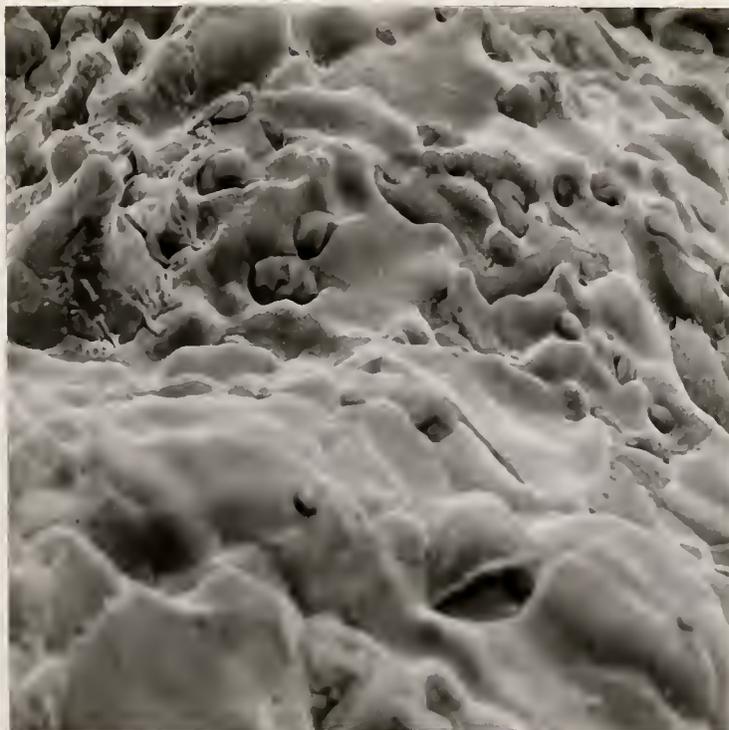
Figure 22. SEM fractograph of bar X1B where the fracture was following a flaw in the junction between two bars that had been forge welded together. X 550

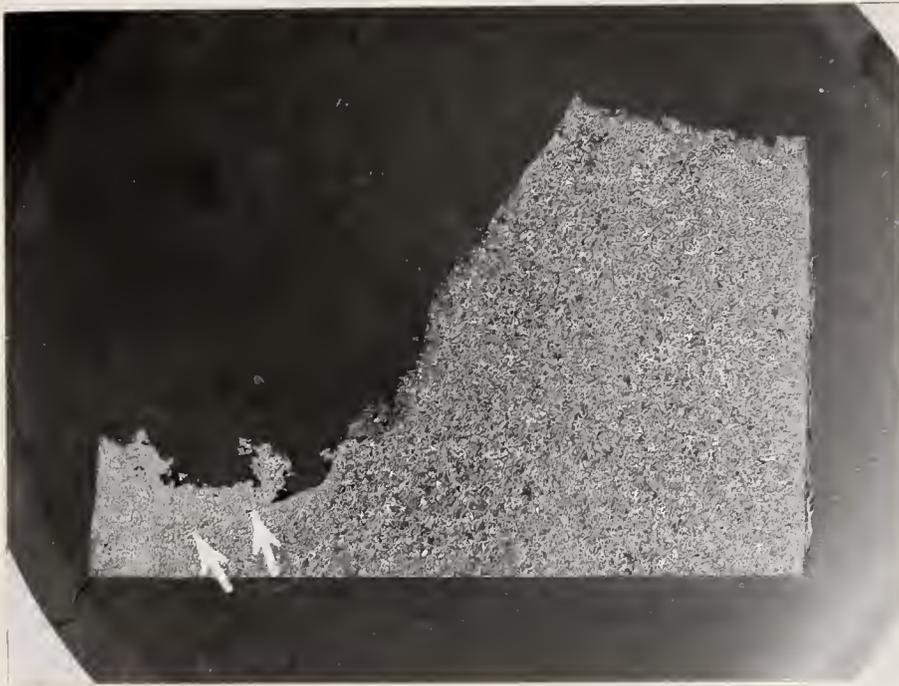
Figure 23. Etched longitudinal section through bar B6 showing the fracture profile. The longitudinal axis of the bar is vertical. The fracture followed the junction between the two components of the bar where the fracture is about  $35^{\circ}$  from the longitudinal axis of the bar. Where the fracture deviates from the junction at the lower left, the junction can be seen (arrows).  
Etchant: 10% nitric acid X 3

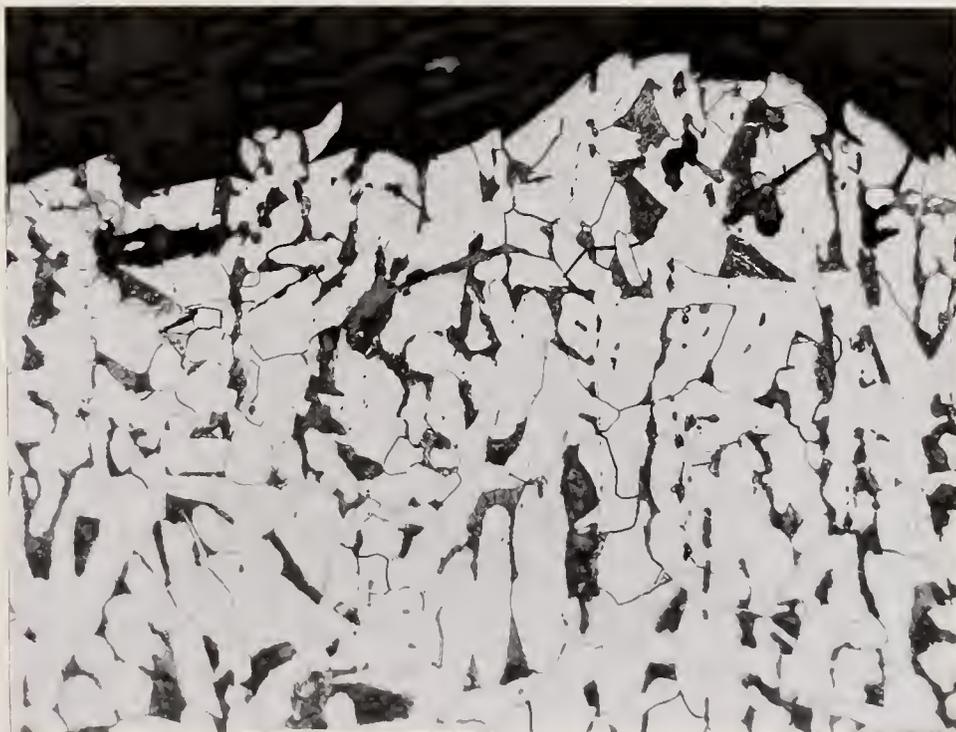
Figure 24. Profile of the fracture through bar B1. The longitudinal axis of the bar is essentially vertical.  
Etchant: 1% nital X 200

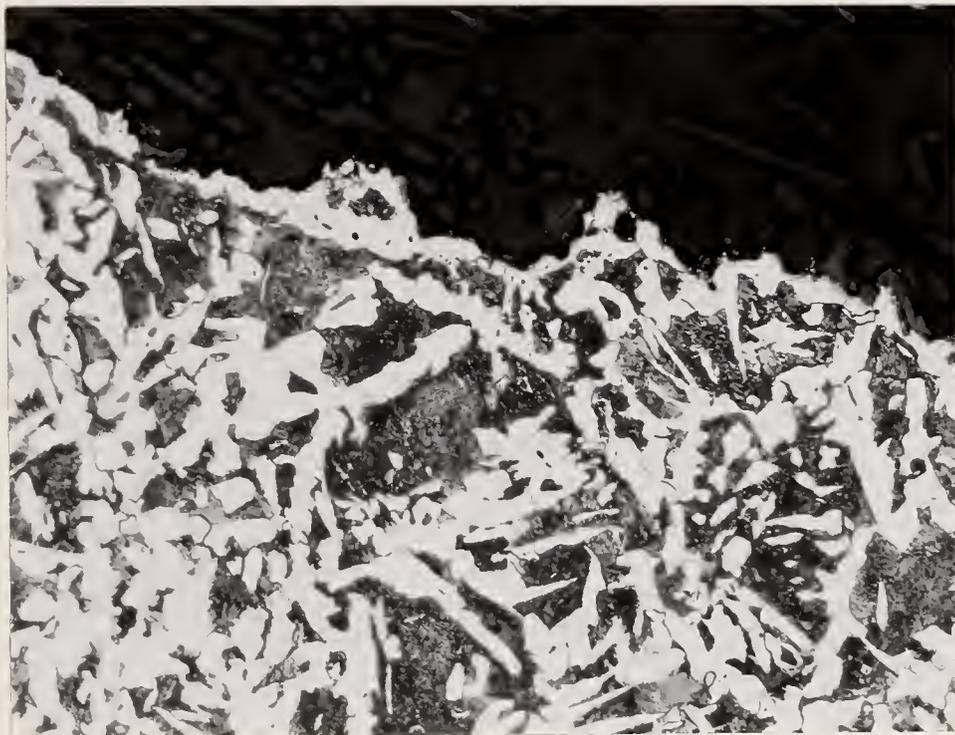
Figure 25. Profile of the fracture in the pre-existing crack portion of the fracture through bar X1A. The longitudinal axis of the bar is essentially vertical.  
Etchant: 1% nital X 200

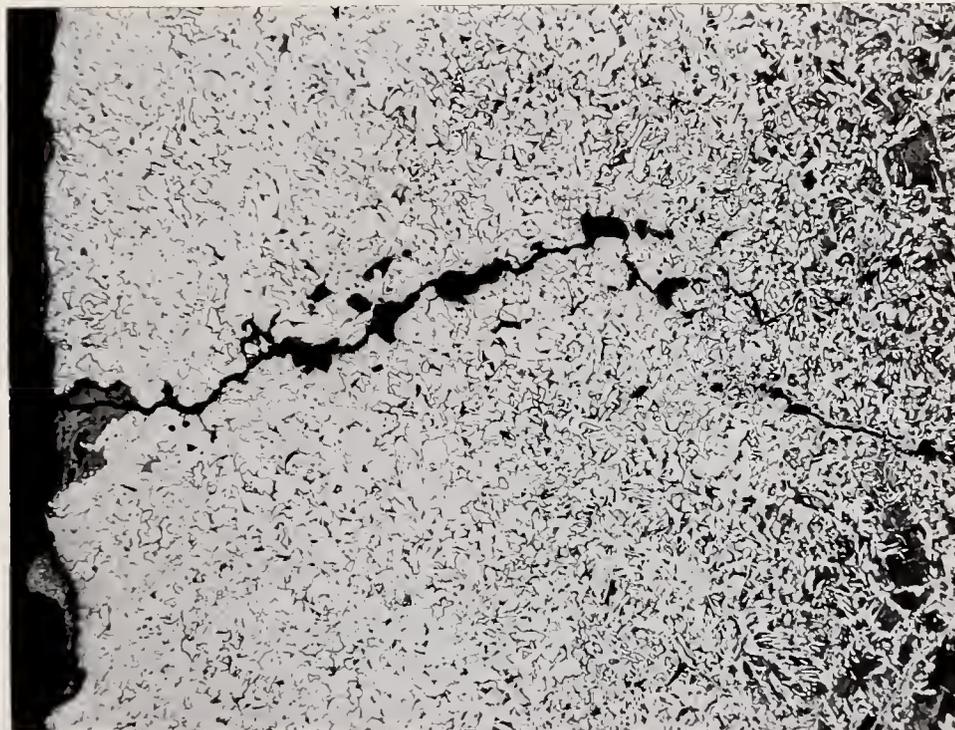
Figure 26. Longitudinal section through bar X1A showing secondary crack parallel to the fracture. The longitudinal axis of the bar is vertical.  
Etchant: 1% nital X 40

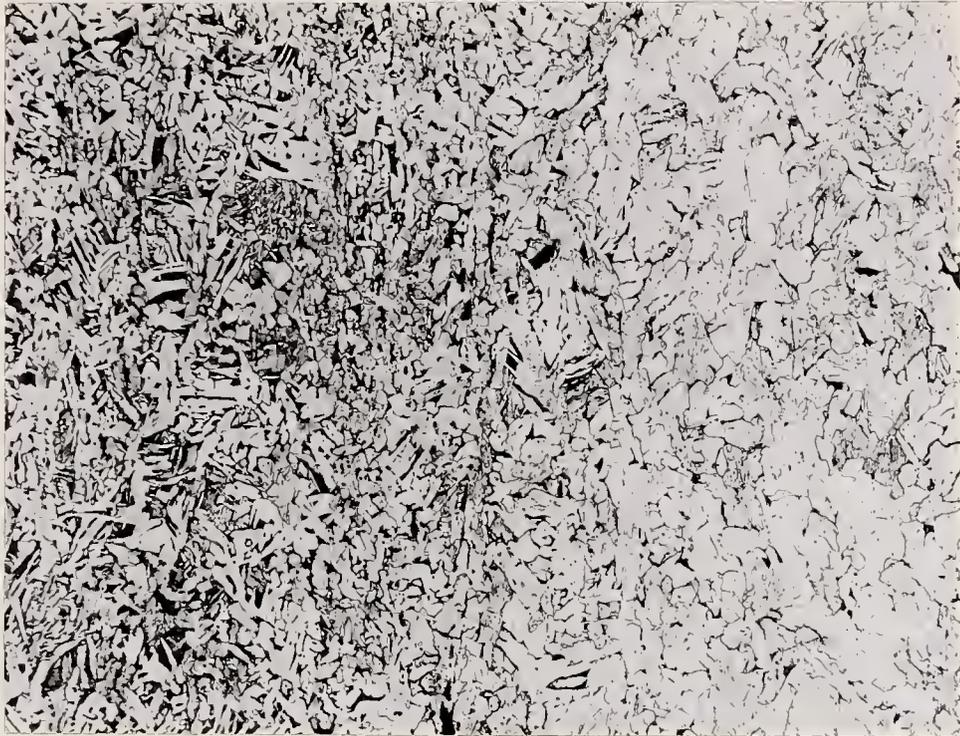
Figure 27. Part of the longitudinal section shown in figure 4 at a higher magnification and at a different orientation. The junction between the two components is vertical in the center of the photomicrograph. The microstructure is different on either side of the junction.  
Etchant: 1% nital X 50

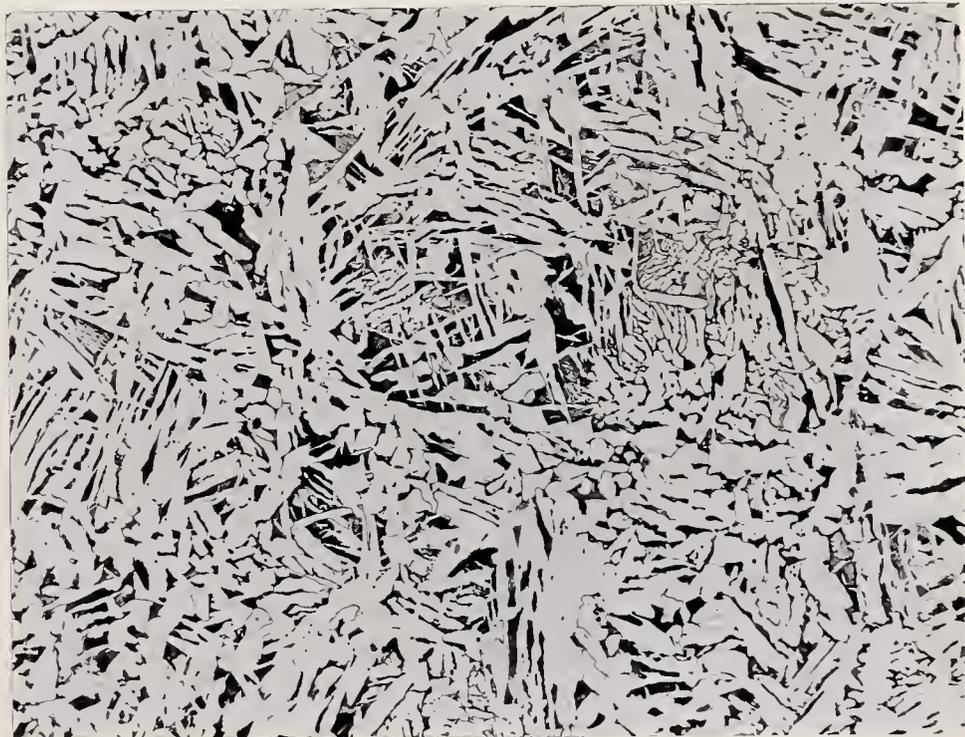
Figure 28. Transverse section through one of the components of bar B6 exhibiting a Widmanstaaten structure.  
Etchant: 1% nital X 100
