NBS CIRCULAR 550

Mechanical Failures of Metals in Service

**UNITED STATES DEPARTMENT OF COMMERCE
NATIONAL BUREAU OF STANDARDS**

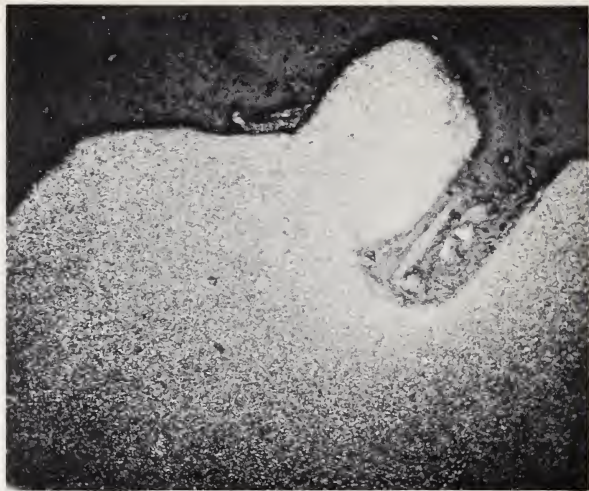
Case 1: Aircraft bolts (steel). The threads stripped before the recommended torque values were reached. The surface of the bolts was decarburized, that is, there had been a loss of carbon from the surface during fabrication or heat treatment. This decreased the strength of the threads to such an extent that they deformed in shear under the normal applied loads. There was some indication of excessive play between the bolt and the nut. This may have been a factor in the failure.

FIGURE 1.2. *Soft decarburized tip of thread that deformed when loaded below the recommended torque.*
Etched with nitric acid in alcohol. $\times 100$.

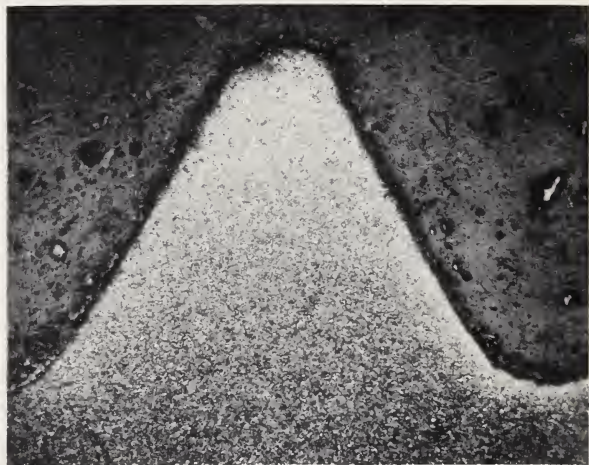
FIGURE 1.3. *Photomicrograph of unused thread, showing depth of decarburization at the tip.*
Etched with nitric acid in alcohol. $\times 100$.

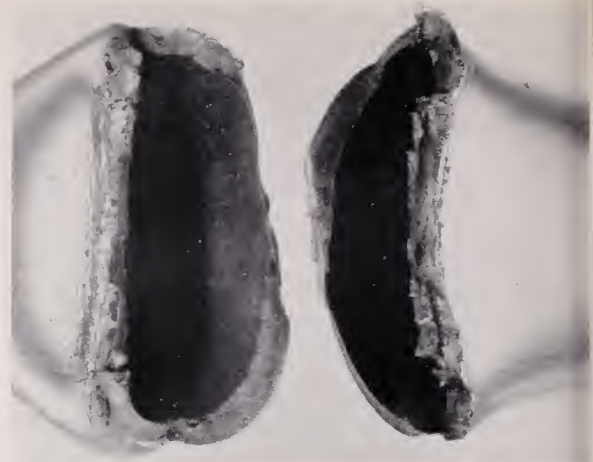
FIGURE 2.2. *Fractured surfaces of the tube viewed from the compression side of the bend.*

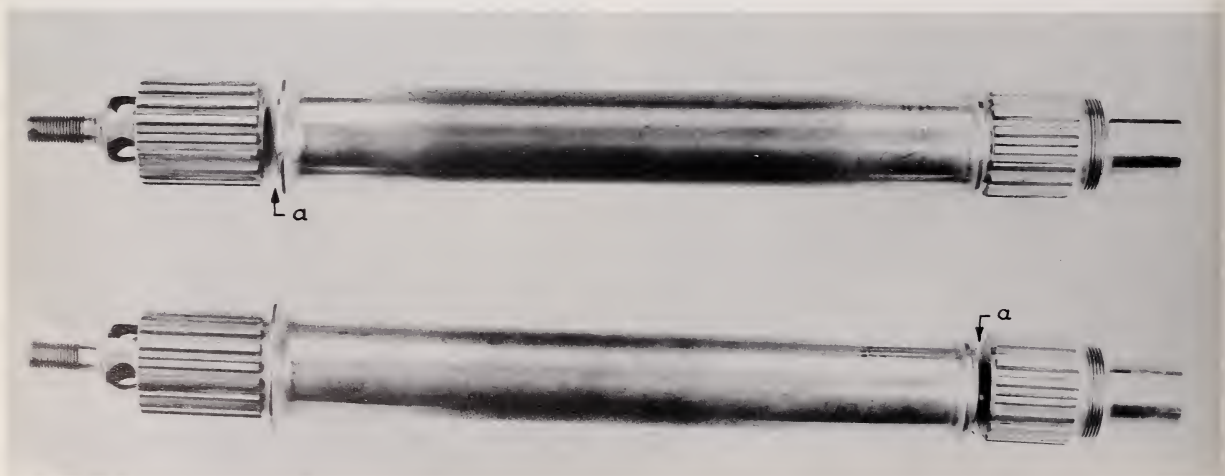
sudden stopping of the engines. The shafts apparently failed owing to the excessive torque applied to them when the propellers were stopped by impact with the ground. This example is included to show the type of fracture found in ductile materials subjected to torsion. The absence of deformation remote from the fracture is due to the stress concentrating effect of the grooves and the high rate of loading. This fracture might easily have been mistaken for fatigue, but on close examination of the fracture surfaces it was evident that the metal had been extensively deformed in shear.

FIGURE 3.1. *Accessory drive shafts fractured at arrows a*

The geometry of the parts and the high rate of loading localized the deformation in the grooved portions of the shafts, which were nearly identical at the two ends. The torsion load caused no dimensional change in the shaft before fracture such as a tension load would have caused. $\times \frac{1}{2}$.

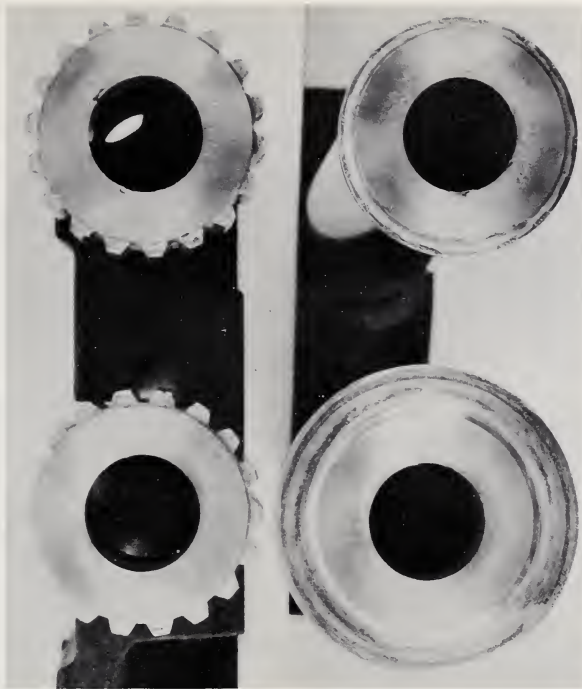
FIGURE 3.2. *Surfaces of the fractures.*

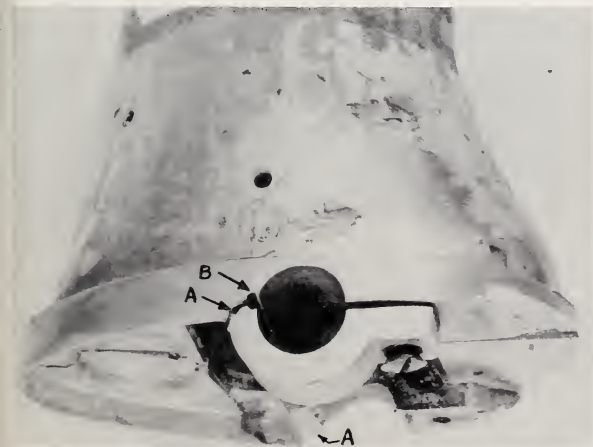
at the back of the clamp acted as points of stress concentration that would reduce the strength of the relatively brittle casting. In addition, the casting was of poor quality, containing numerous voids.

FIGURE 4.1. *Aluminum-alloy ankle casting.*

The fractures, A, occurred at the back of the clamp where the key grooves, B, reduced the cross section. $\times 1$.

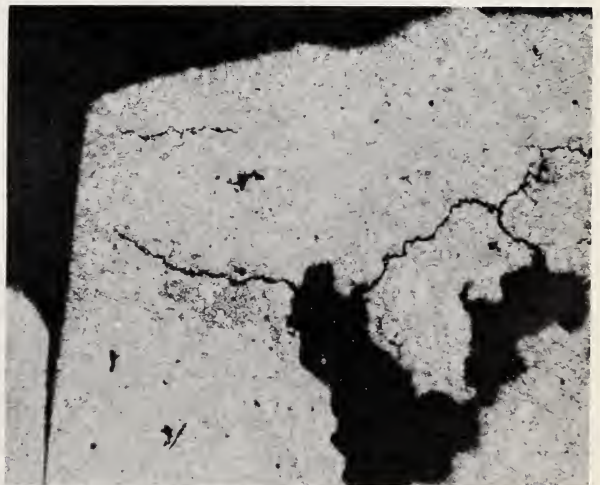
FIGURE 4.2. *Section perpendicular to the fracture (top) showing porosity, which greatly reduced the strength of the casting.*

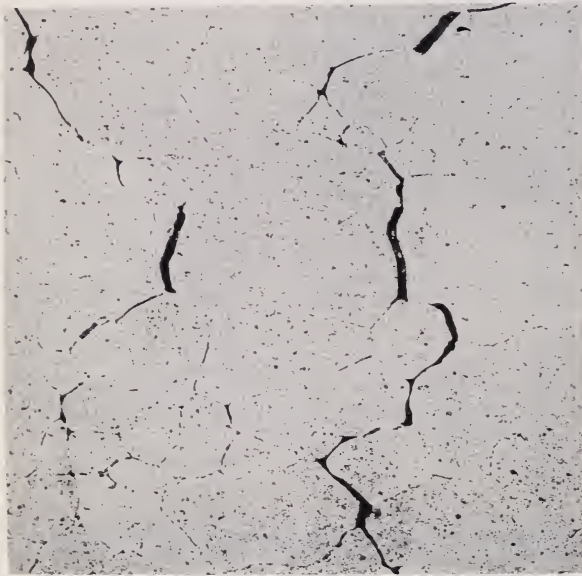
FIGURE 5.2. Microstructure on a longitudinal section of the tube near the fracture shows numerous intergranular cracks that are typical of material that has been subjected to stress at high temperature.

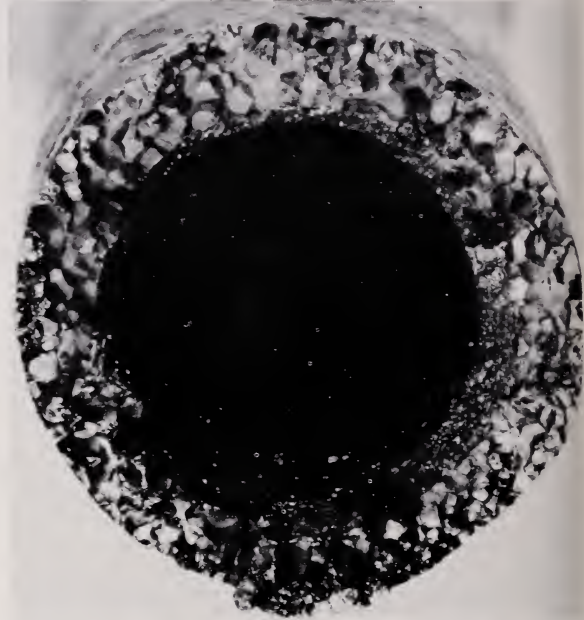
FIGURE 6.2. Fracture surface showing extremely coarse grains due to elevated temperature. $\times 8$.

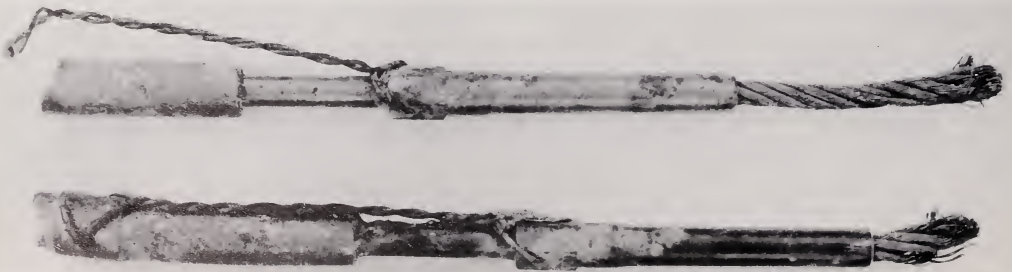
Case 6: Turnbuckle from aircraft control system (brass). Removed from an airplane that had been involved in an accident. It was evidently not the primary failure. The part had broken while heated to a very high temperature. The fracture surface shows extremely coarse grains and little ductility. The temperature at the time of failure was sufficiently high to reduce the strength of the grain boundaries in the metal, which resulted in fracture, with little or no ductility.

FIGURE 6.1. Parts of two broken turnbuckles removed from a crashed airplane. $\times 1$.

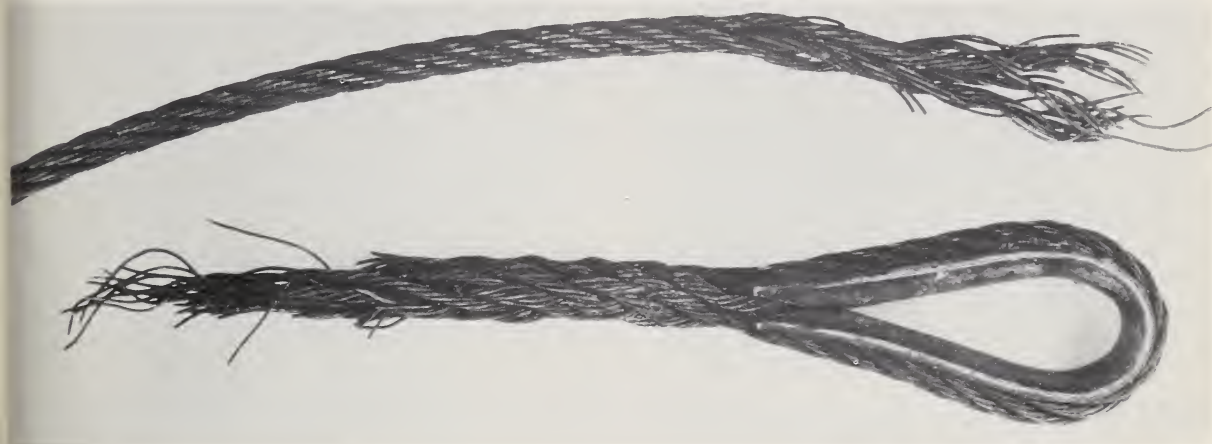
completely alter the microstructure, resulting in much lower strength. This weakened portion of the wire was unable to withstand the normal applied loads and failed in a ductile manner.

FIGURE 7.1. *Broken rudder cable.* $\times 3$.

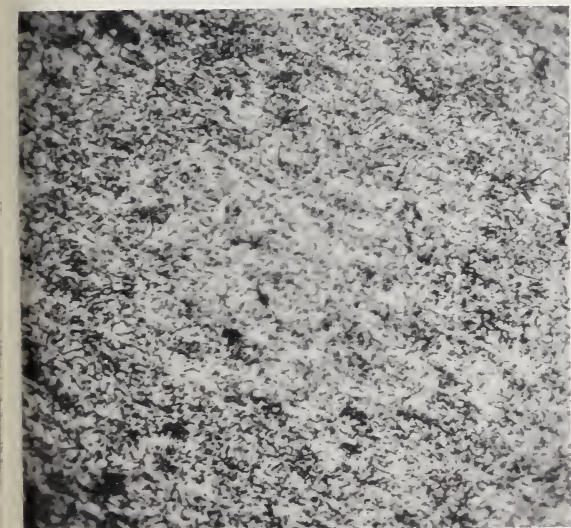
FIGURE 7.2. *Microstructure of a longitudinal section of a wire near the fracture indicates that this portion of the cable had been heated sufficiently to spheroidize the carbides and reduce the strength of the cable.*

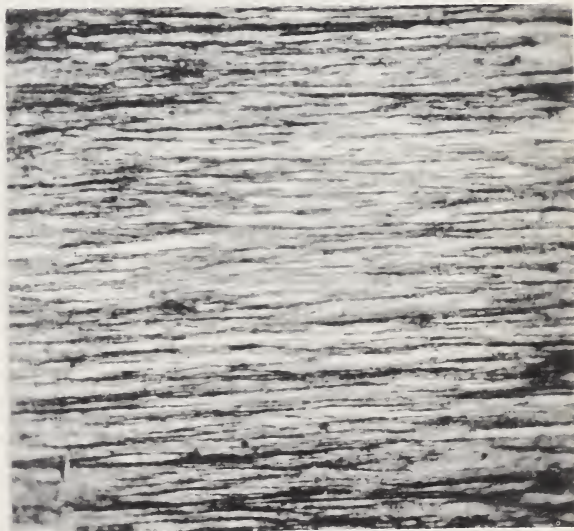
FIGURE 7.3. *Microstructure of a longitudinal section of a wire 2 feet from the fracture shows the normal structure of severely cold-drawn steel wire.*

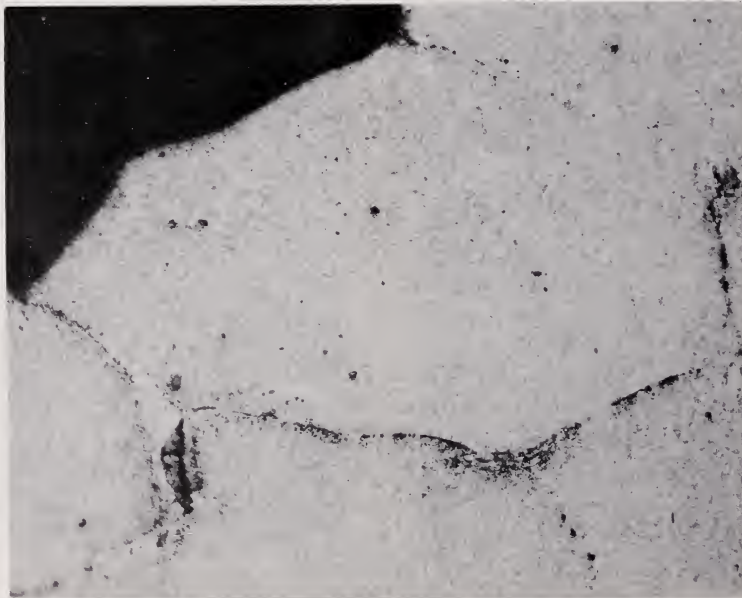
FIGURE 8.3. *Microstructure of steel adjacent to the fracture.*

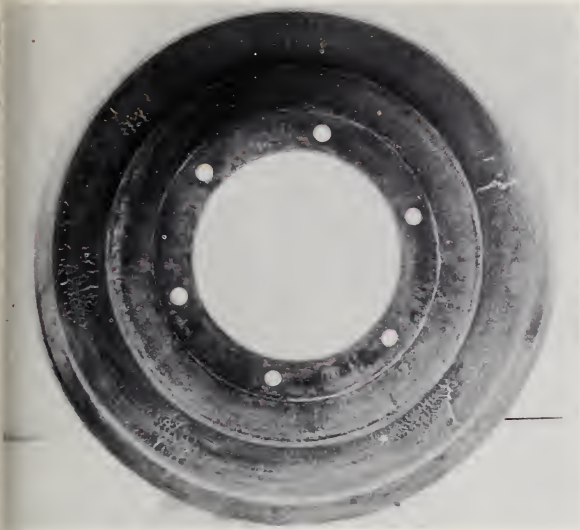
iron to martensite in some spots. As martensite occupies more volume than pearlite, the transformation set up high internal stresses in the metal, which, combined with the applied stress, were sufficient to cause cracking adjacent to the transformed areas. This type of cracking is often referred to as heat checking.

FIGURE 9.1. *Cracked brake drum, as received.*

The cracks are easily visible because of the brake lining material that had been scraped off and forced into them. $\times 1/6$.

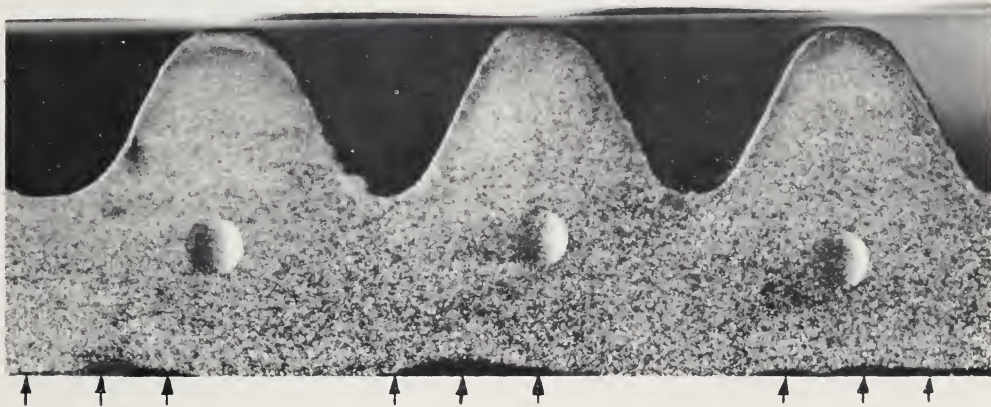
FIGURE 9.2. *Etched section of drum showing numerous transformed areas (dark) indicated by arrows along the inner surface at bottom.*

The hardness of the original material was 265 Vickers, whereas that in the dark areas was as high as 450 Vickers. $\times 2$.

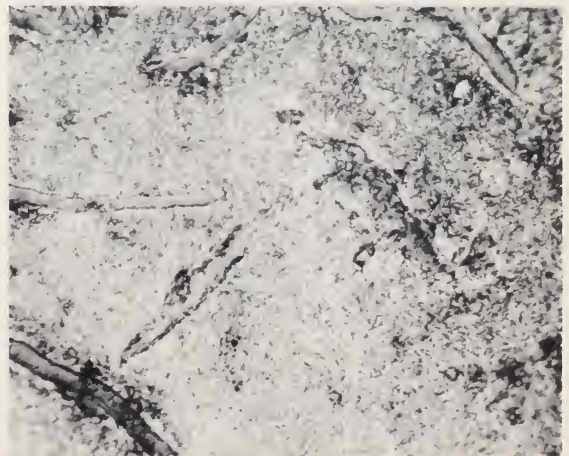
FIGURE 9.4. *Microstructure in the dark-etching areas along the inner surface of the drum.*

The pearlite has transformed to hard, brittle martensite. Etched with nitric acid in alcohol. $\times 500$.

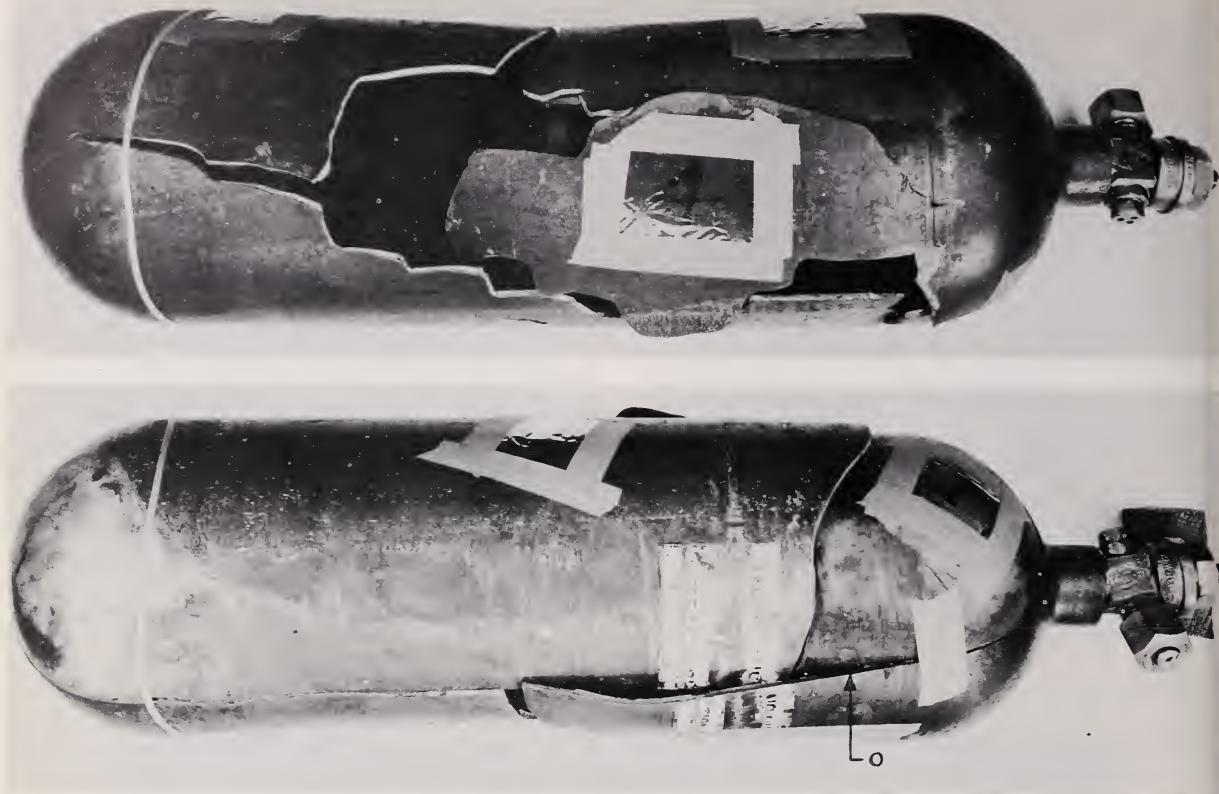
FIGURE 10.1. *Appearance of exploded cylinder with pieces fitted approximately in their original positions.*
By following the indications of the markings on the fracture surfaces, the origin of the fracture was located at arrow O. $\times \frac{1}{4}$.

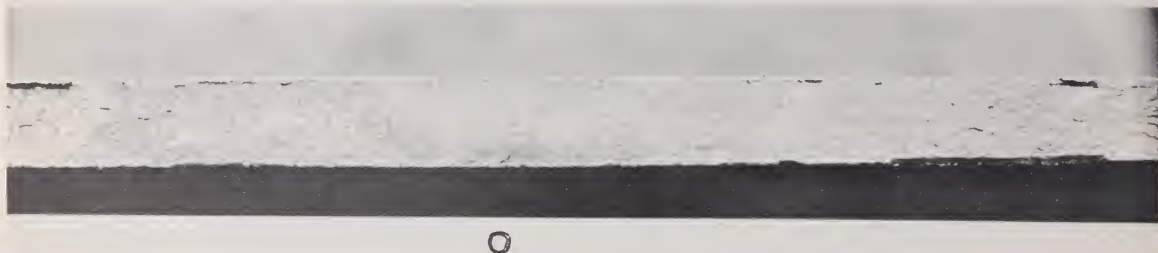
FIGURE 10.2. *Surface of the fracture, in the region of the origin.*

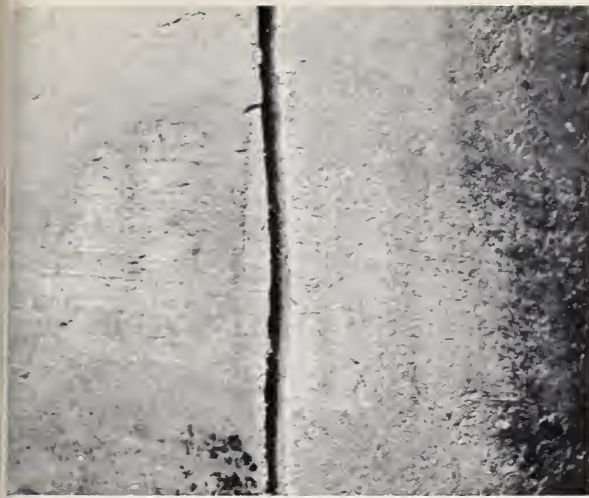
The fracture started in an area that had been abraded on the surface of the cylinder. It is probable that scratches in this area caused sufficient concentration of stress to result in the formation of a small fatigue crack under the fluctuating load when the cylinder was filled and emptied. However, this crack did not grow to sufficient size to be observed because the material was so brittle that a very small crack produced sufficient stress concentration to initiate a brittle fracture.

FIGURE 10.3. Surface of the cylinder near the origin of the fracture, showing the abrasions apparently caused by a clamping tool. $\times 3$.

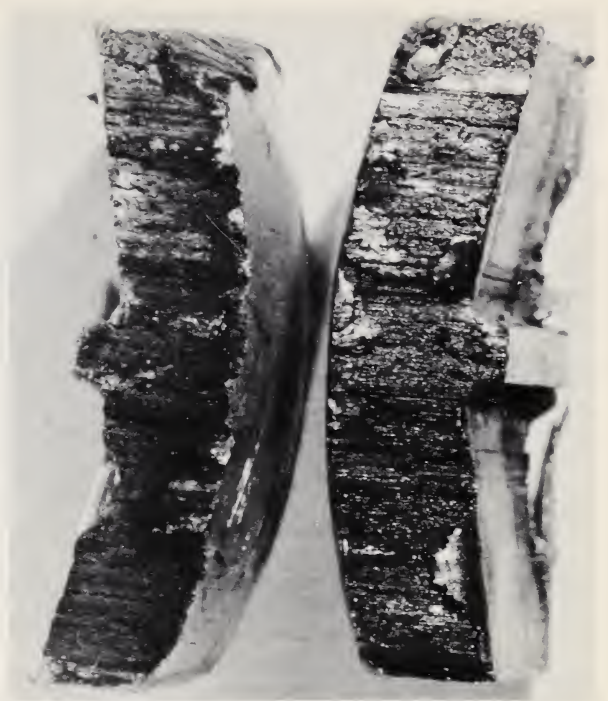
FIGURE 11.2. Surfaces of the fracture; note the "woody" appearance caused by the large number of inclusions in the steel. $\times 5$.

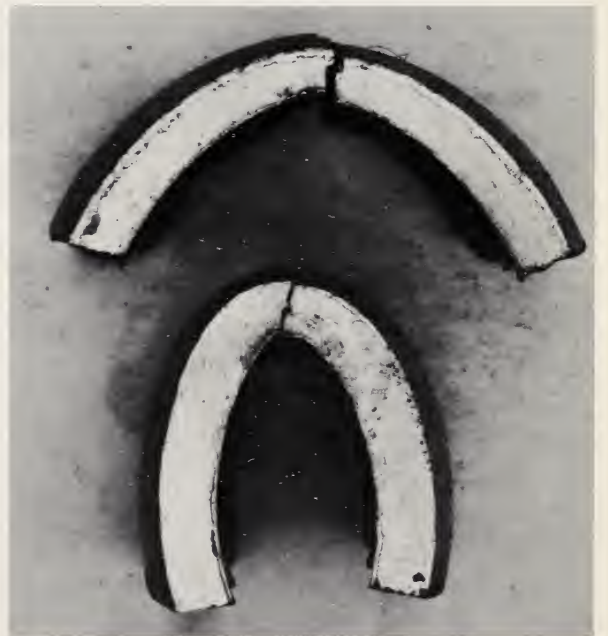
FIGURE 11.3. Bend tests on sections cut from the eye of unused bearings, showing the difference in ductility in different directions.

Top, section cut from top of eye so the bending stress was transverse to the direction of rolling. Bottom section from side of eye. $\times 2$.

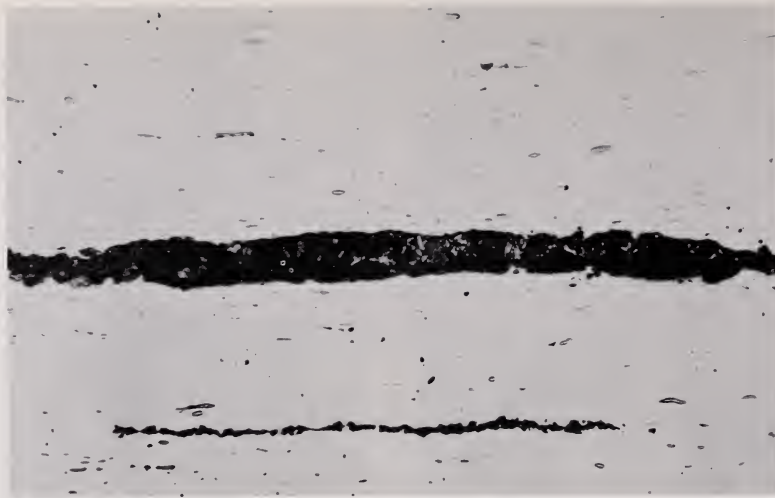
FIGURE 11.4. *Large inclusions observed on a longitudinal section of the steel*
The numerous small inclusions shown in this micrograph are typical of those found on all sections examined. No etch. $\times 100$.

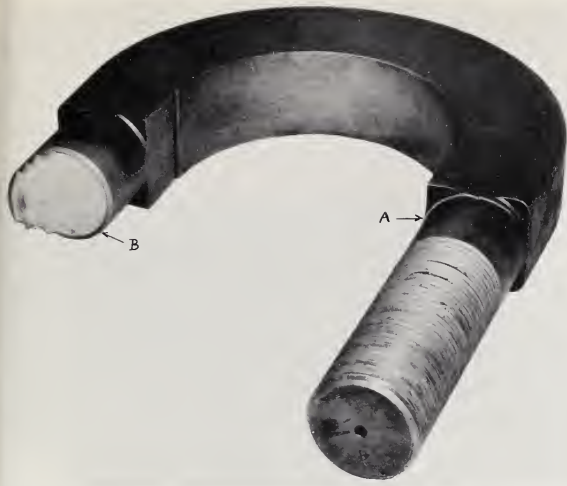
stress at fracture was only 30,000 lb/in.² It was found that the piece contained numerous intergranular cracks, probably due to improper forging practice or heat treatment. In addition, the hardness and strength of the steel were much higher than that specified, (45 Rockwell C compared to a specified value of 34) with consequent greater brittleness. The combination of these factors reduced the strength of the part much below that of sound material of lower hardness.

FIGURE 13.1. *Fractured yoke with the initial fracture, A fitted together.*

The fracture at B resulted from the eccentric loading after the initial fracture. $\times \frac{1}{8}$.

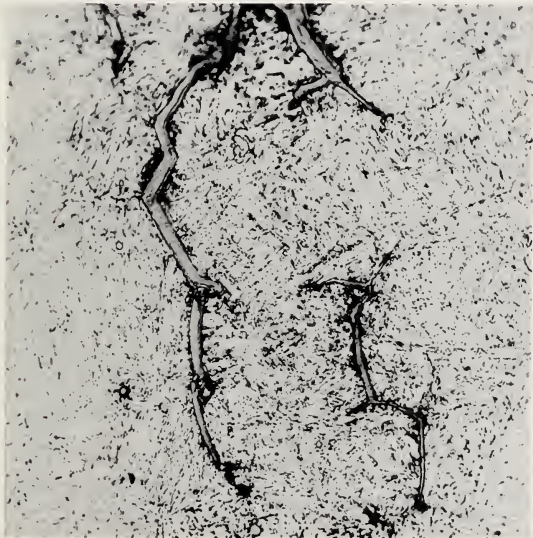
FIGURE 13.3. *Inner end of a crack similar to those which caused the fracture.*

The path of the crack appears to be along the boundaries of prior austenitic grains, which is typical of cracks due to improper forging or quenching. Etched with nitric acid in alcohol. $\times 500$.

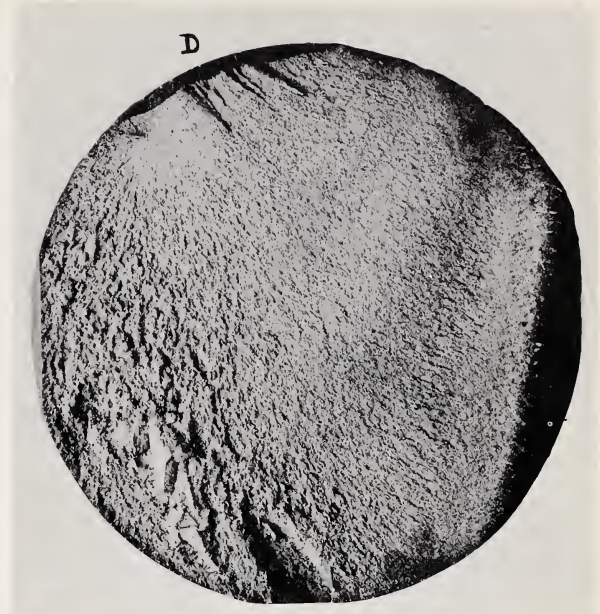
FIGURE 13.2. *Surface of the initial fracture.*

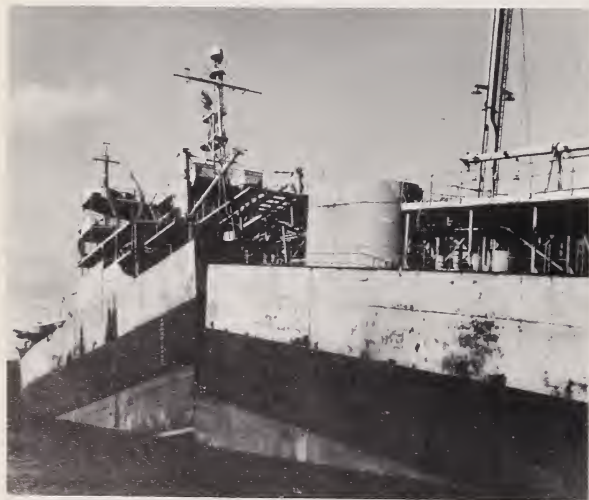
FIGURE 14.1. Tanker that broke in two at dock, viewed from port side.

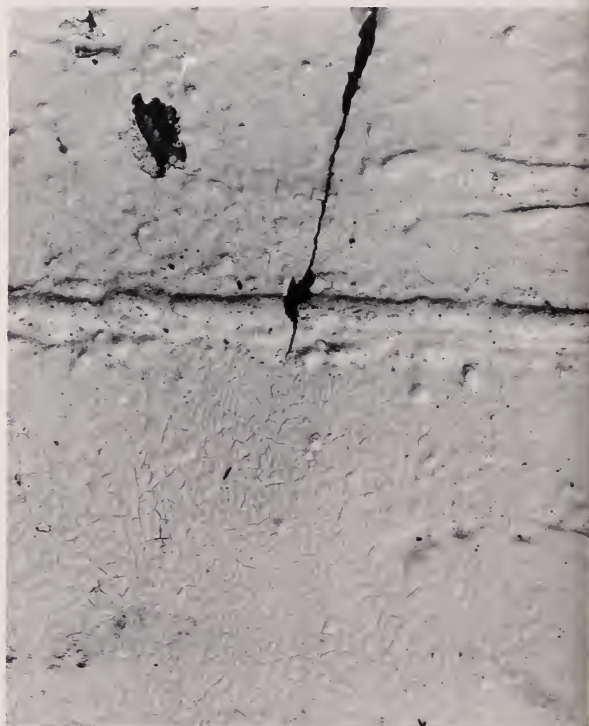
FIGURE 14.3. Area near the end of a fracture.

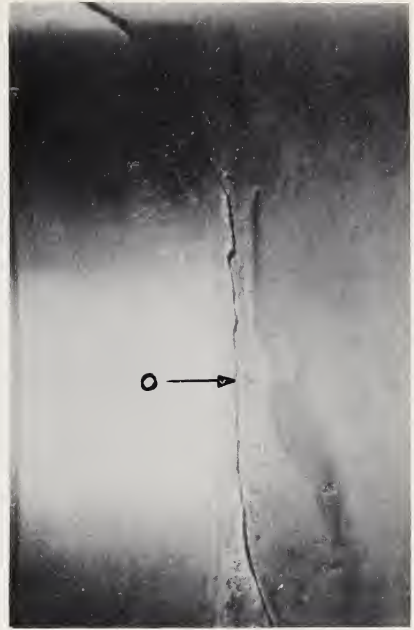
FIGURE 15.2. Appearance of the surface near the origin.

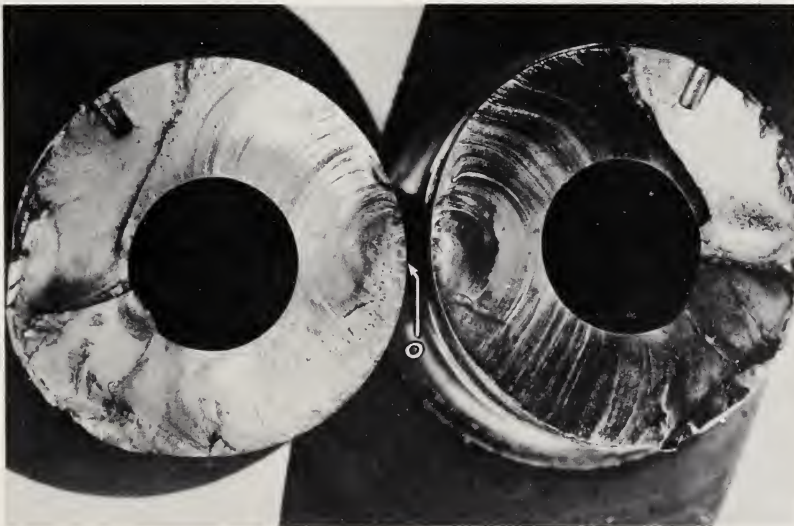
FIGURE 15.3. Surfaces of the fracture.

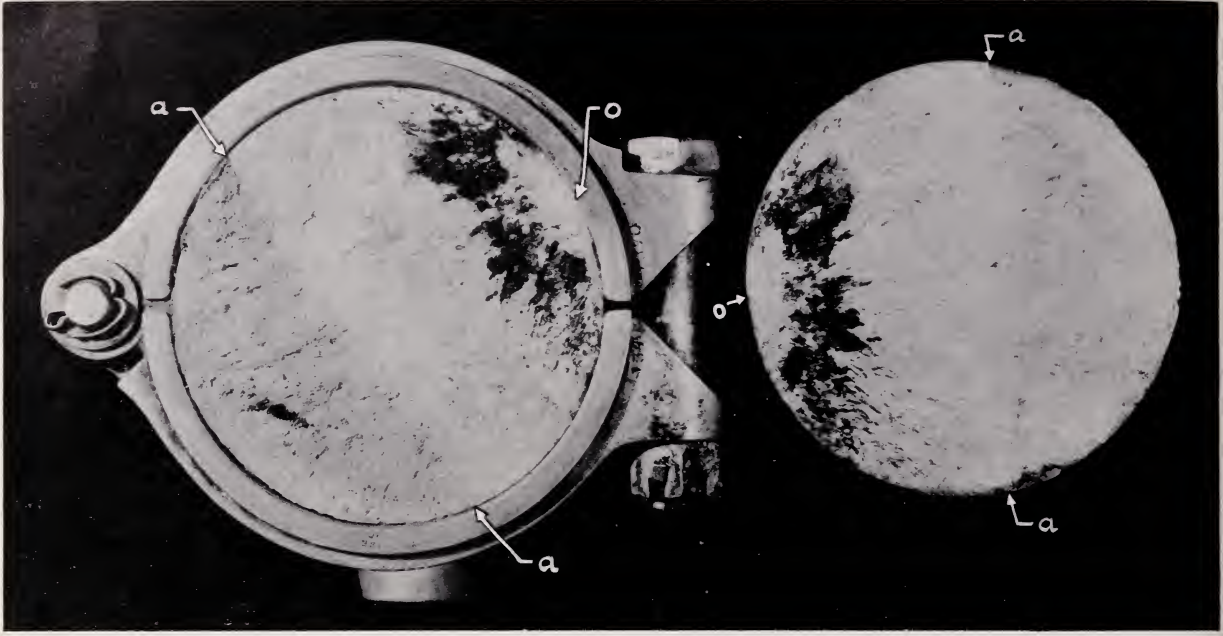
FIGURE 16.1. Surfaces of the fracture which originated under the hub ring clamp at arrow O.

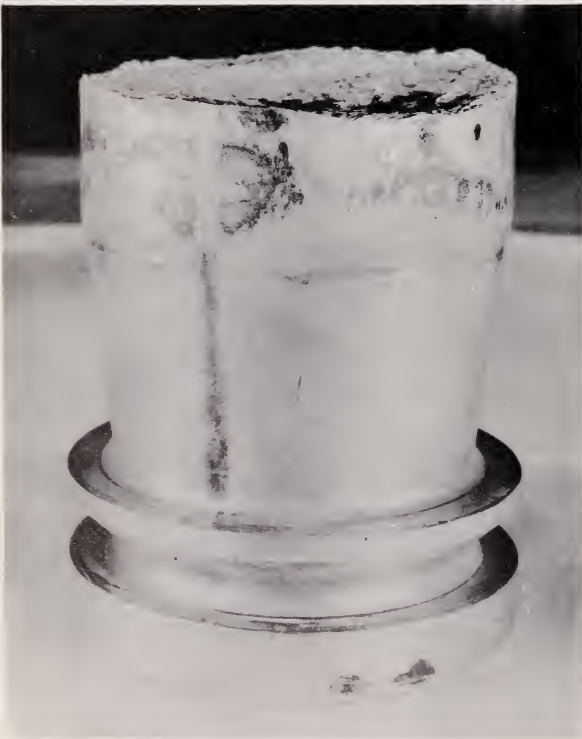
FIGURE 16.2. Surface of the blade near the origin of the fatigue crack.

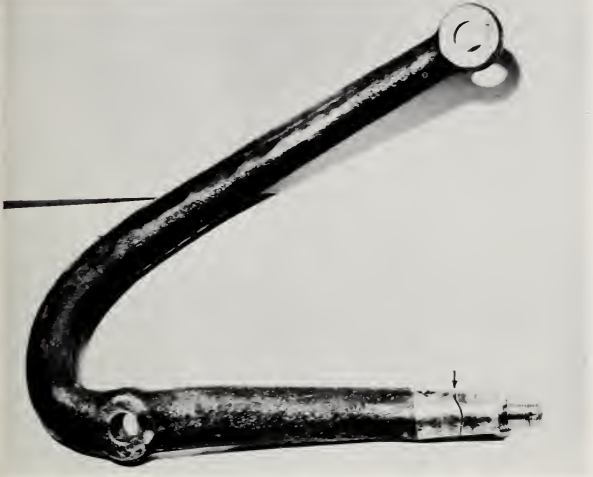
FIGURE 17.1. Broken steering arm from a highway truck. The origin of the primary fatigue crack is indicated by the arrow. $\times 1/4$.

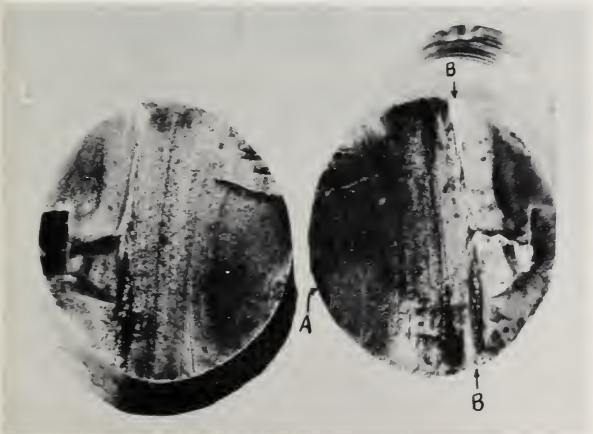
FIGURE 17.2. Surfaces of the fracture shown in figure 17.1. The first fatigue crack started at A, and other cracks started on the opposite side of the piece. These progressed across most of the section before the final overload fracture broke the remaining metal along line BB. The small portion of the section involved in the overload fracture indicates that the working stresses were relatively small. $\times 1$.

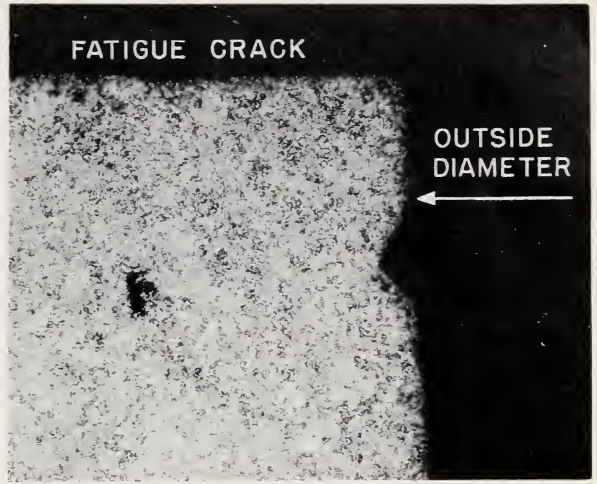
FIGURE 17.3. Longitudinal section of the arm near the origin of the fatigue crack.

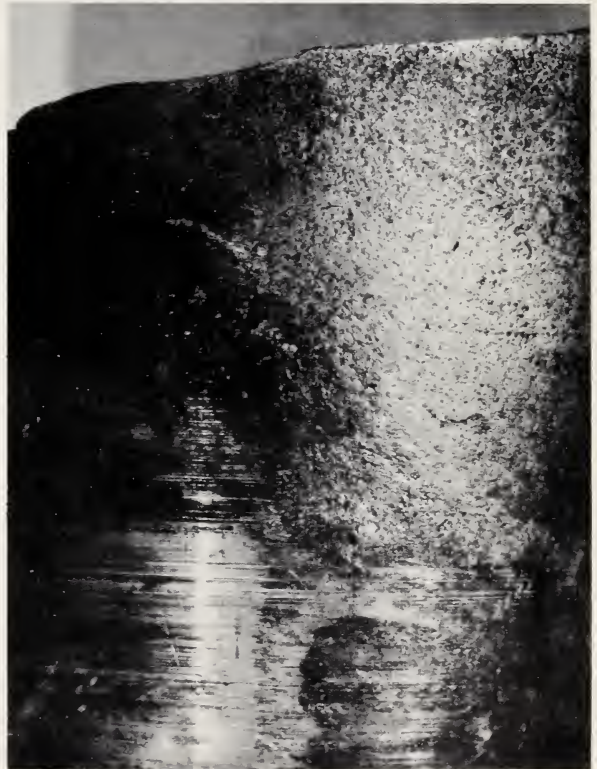
FIGURE 17.4. Surface of the arm near the origin of the fatigue crack.

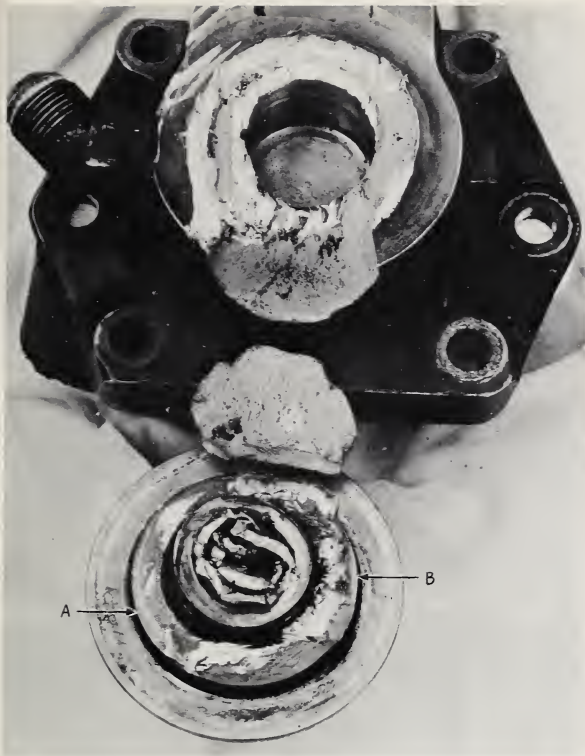
FIGURE 20.1. *Fractured fitting as received.*

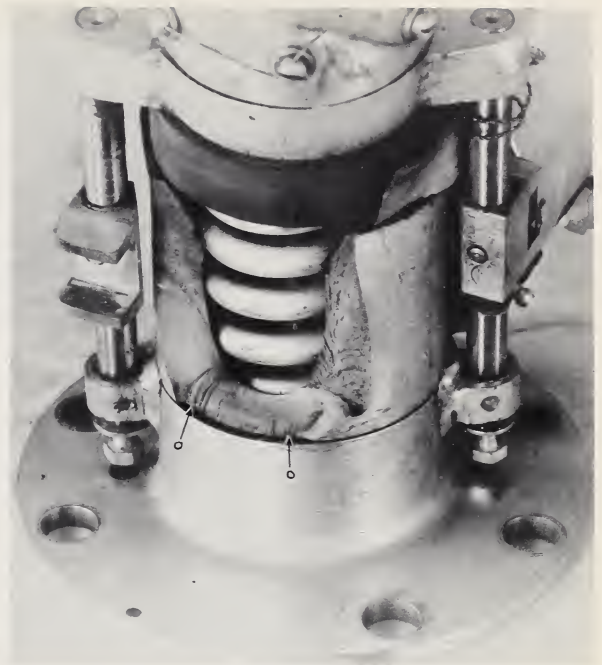
FIGURE 21.1. *Surface of the fracture in the propeller hub where the arm holding one blade broke completely out of the hub.*

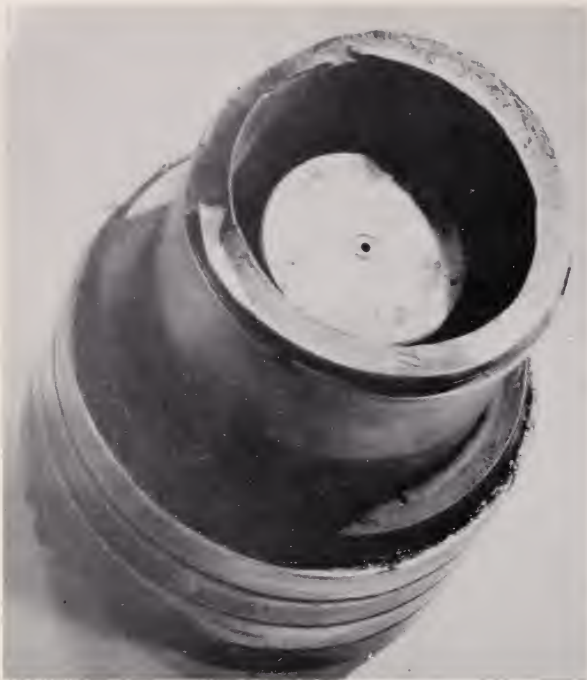
FIGURE 22.1. Hub end of the fractured blade. $\times \frac{1}{4}$.

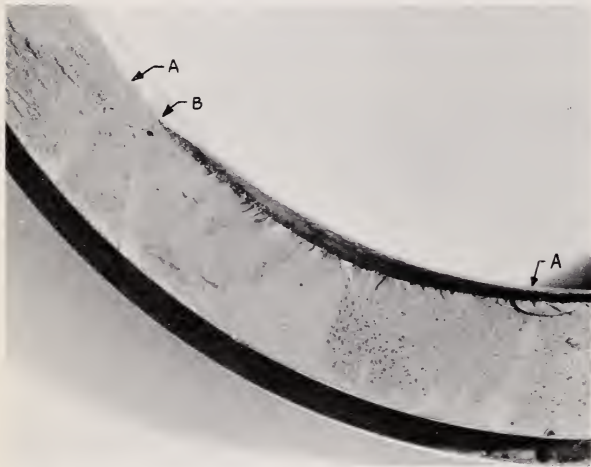
FIGURE 22.2. Fracture surface near the origin of the fatigue crack.

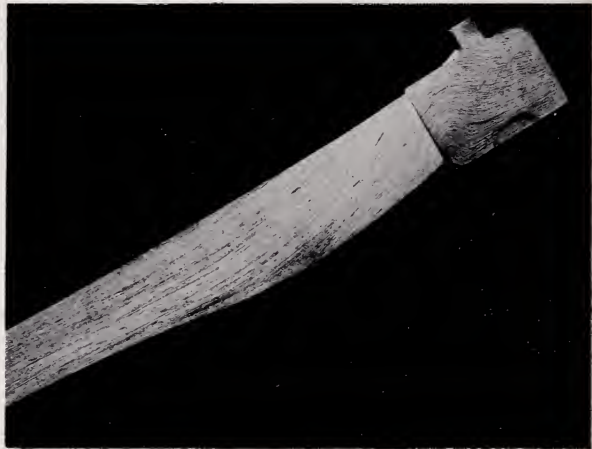
FIGURE 22.4. Longitudinal section of the blade intersecting the fatigue crack.

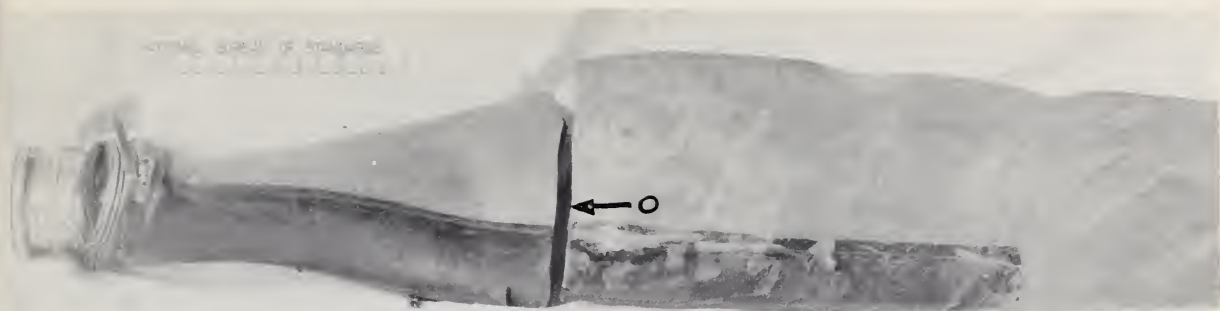
FIGURE 23.1 *Flat side of the broken propeller blade.*
The fatigue crack started on the inside surface near arrow O.

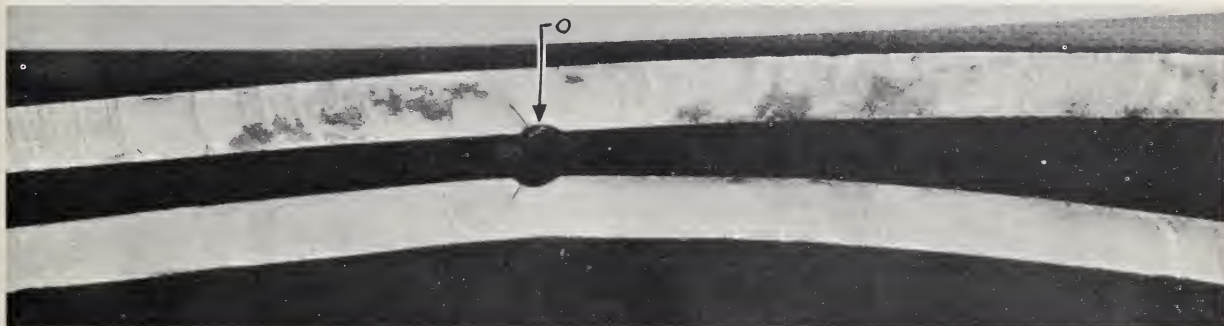
FIGURE 23.2. *Fracture surfaces near the origin of the fatigue crack, arrow O.* $\times 3$.

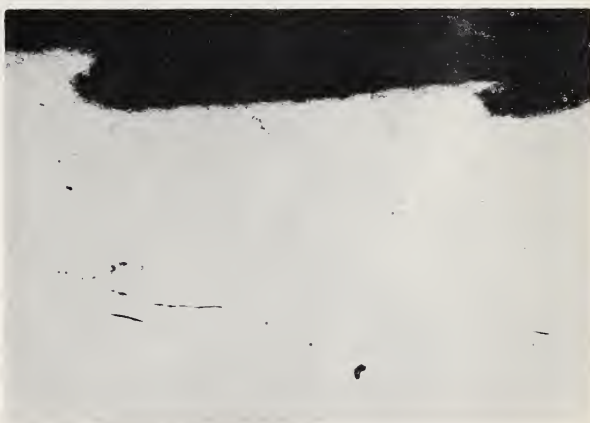
FIGURE 23.4. *Longitudinal section through the defect shown in figure 23.3.*

Arrows beside the fracture indicate the directions of growth of the fatigue crack. $\times 4$.

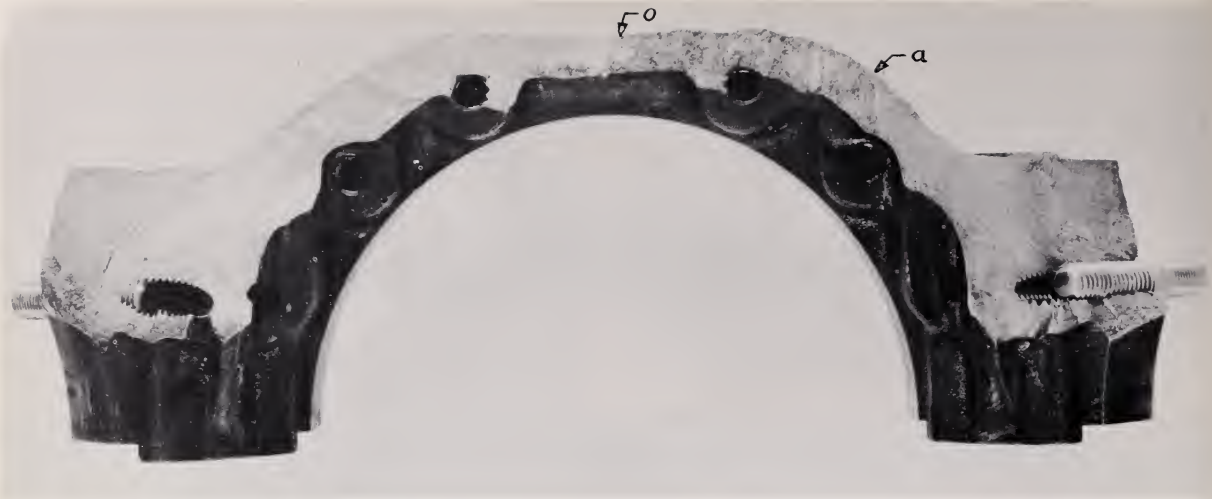
FIGURE 24.1. *Surface of the fracture in the cylinder pad.*

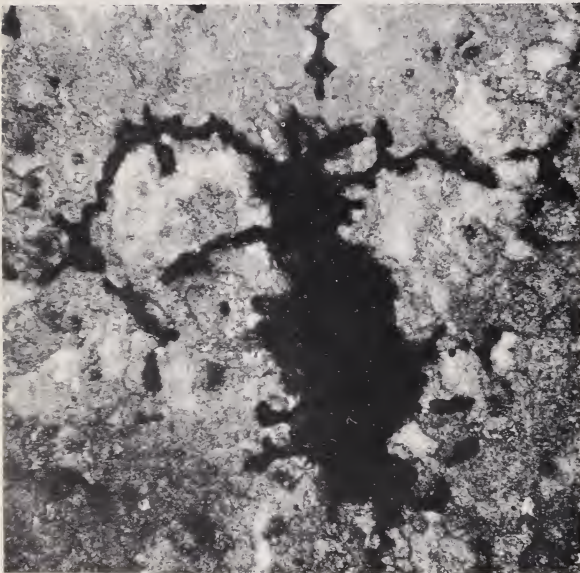
FIGURE 24.2. *Microstructure of the metal in the porous zone near the origin.*

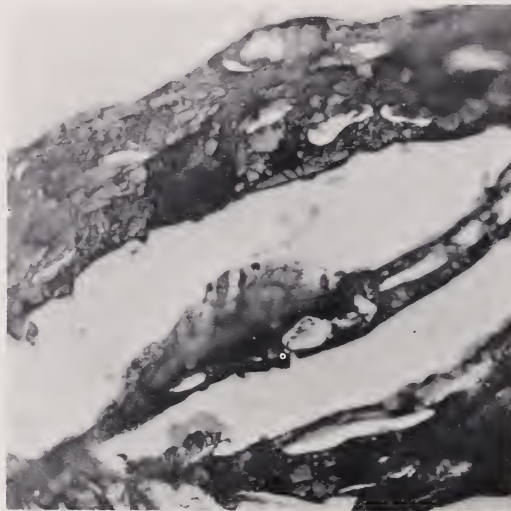
FIGURE 27.3. *Micrograph showing large nonmetallic inclusions found at several locations on a section through the rod.*

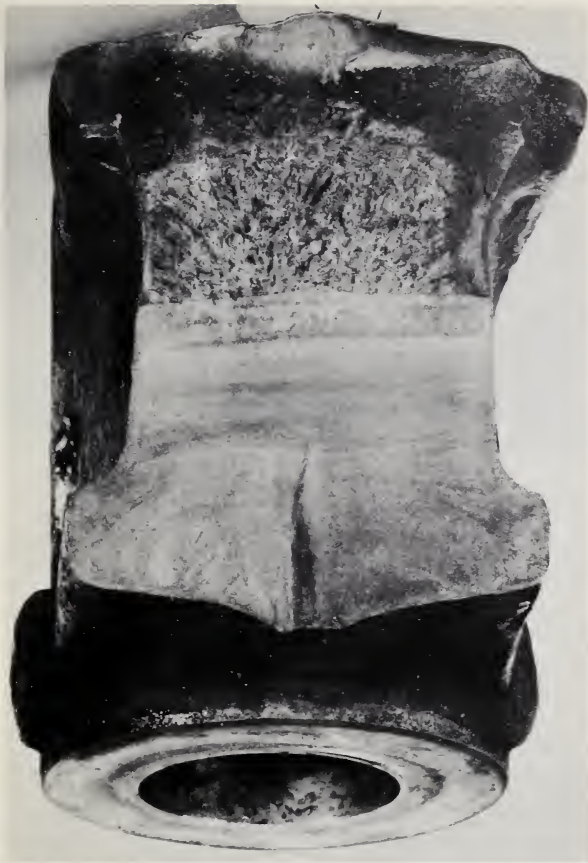
FIGURE 28.1. *Surface of fracture in front axle.*

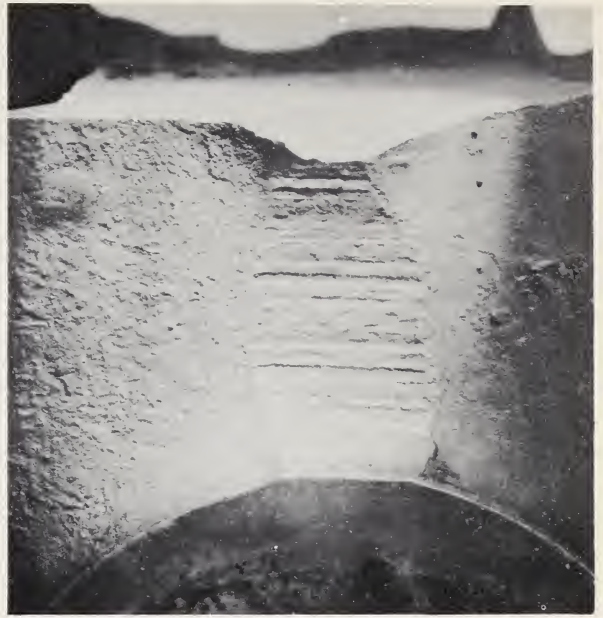
FIGURE 28.2. *Bottom surface of the axle adjacent to the fracture, showing the transverse grooves apparently due to shearing off the forging flash.*

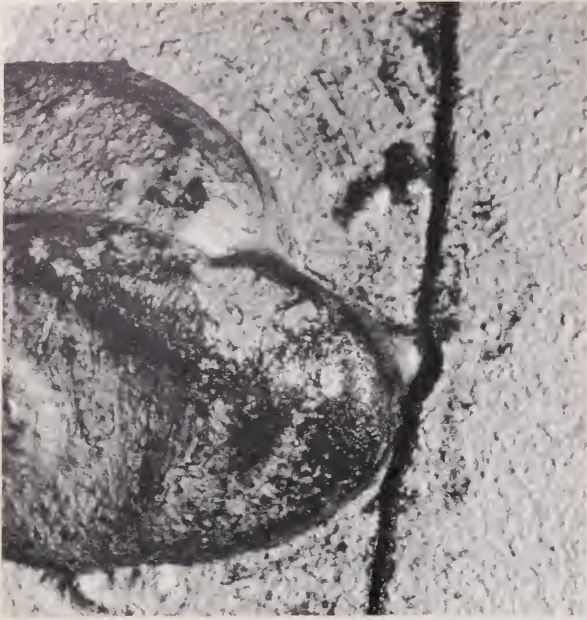
FIGURE 29.1. Surface of the fractured spar tube showing the origin of the fatigue crack at the toe of a weld. $\times 5$.

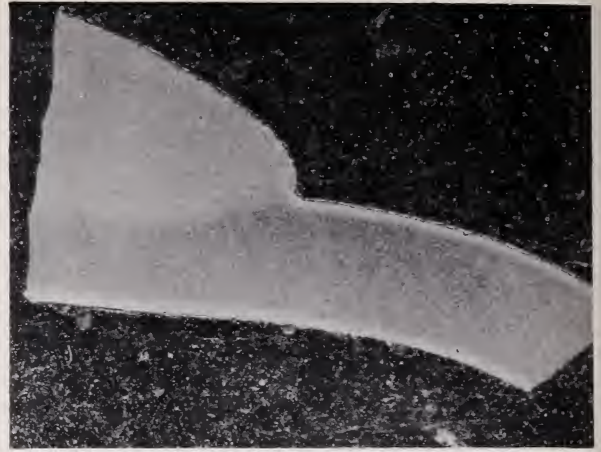
FIGURE 29.2. Transverse section of the tube and weld inboard of the fracture.

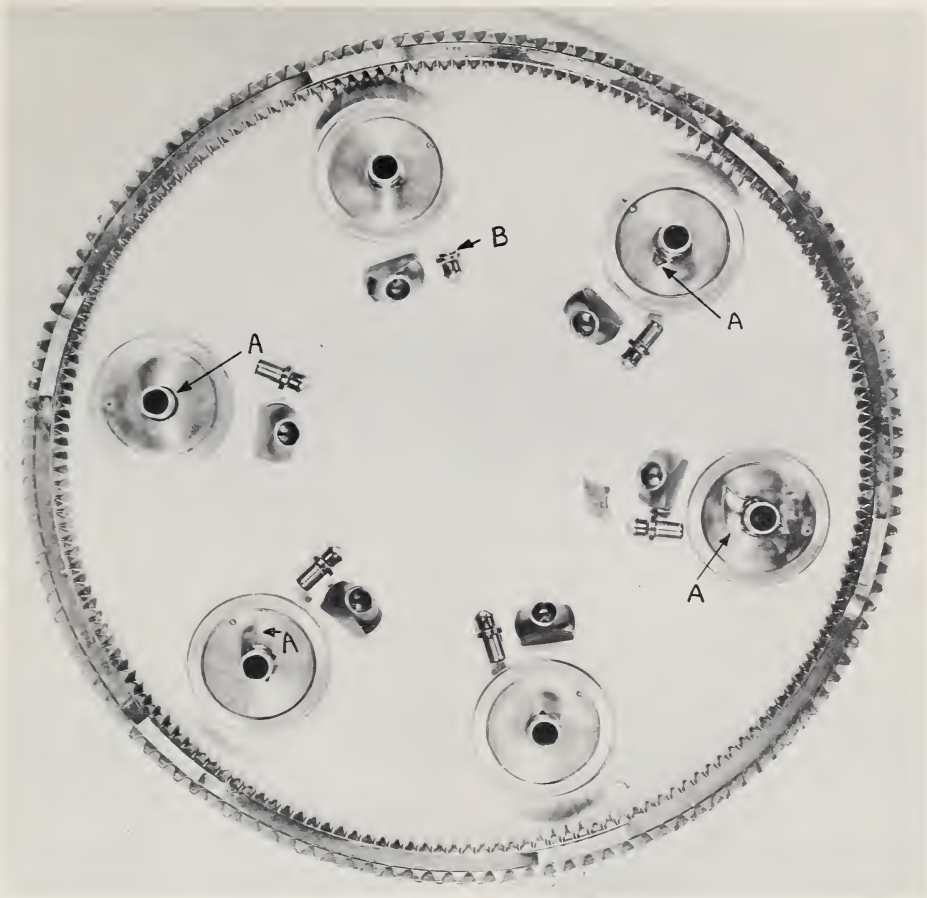
FIGURE 30.1. *Failed torque meter parts.*

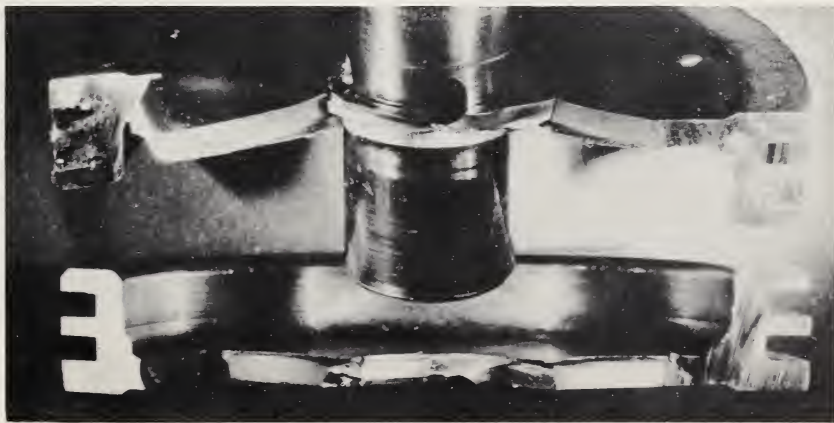
FIGURE 30.2. *Fatigue cracks in one of the pistons.*
