NBS CIRCULAR 550

Mechanical Failures of Metals in Service

**UNITED STATES DEPARTMENT OF COMMERCE
NATIONAL BUREAU OF STANDARDS**

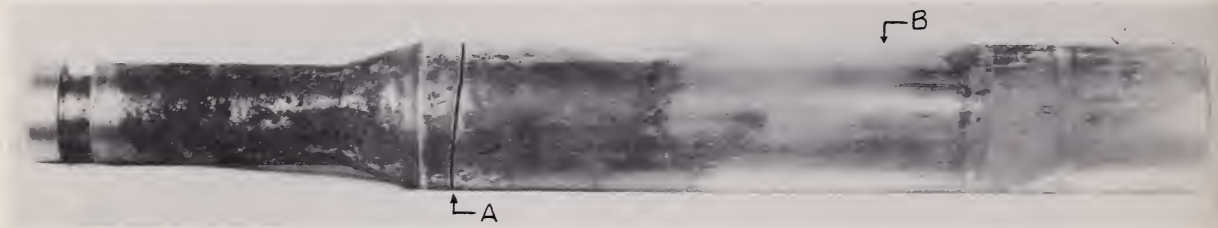
FIGURE 31.1. Pump plunger broken at A, where a crack had been found.

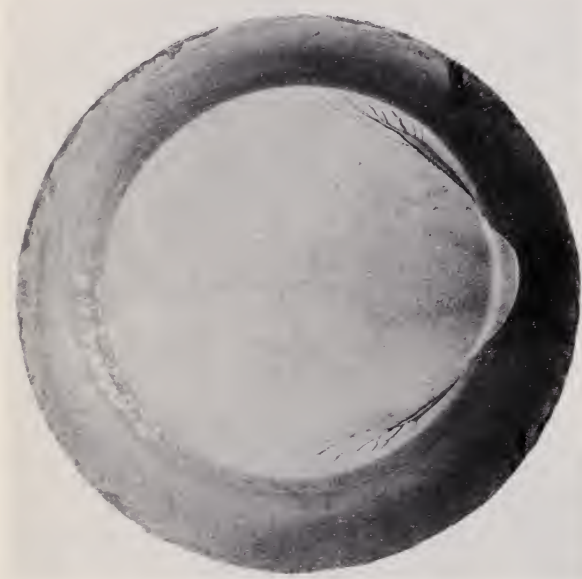
FIGURE 31.2. Surface of the fracture.

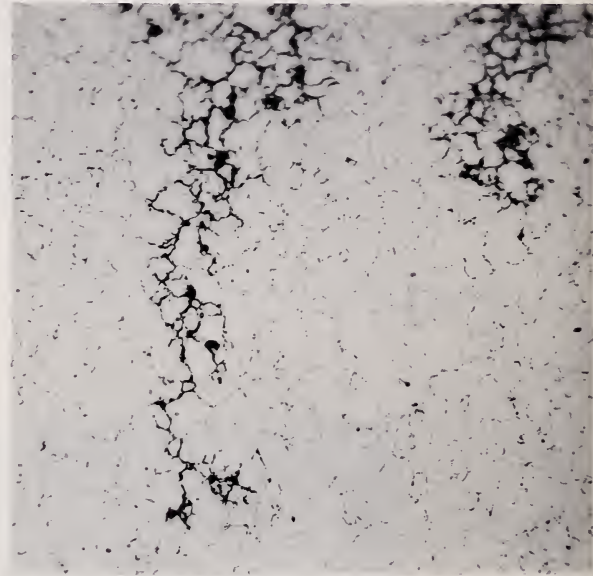
FIGURE 31.3. Transverse section of the plunger near the fatigue fracture.

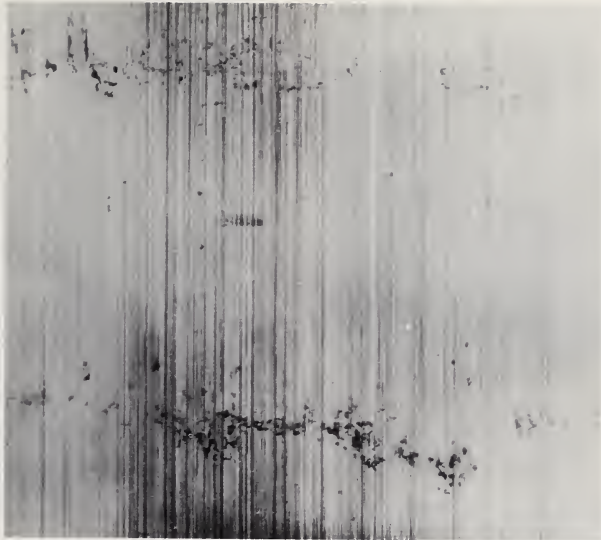
FIGURE 31.4. Corrosion on the surface of the plunger remote from the fatigue crack.

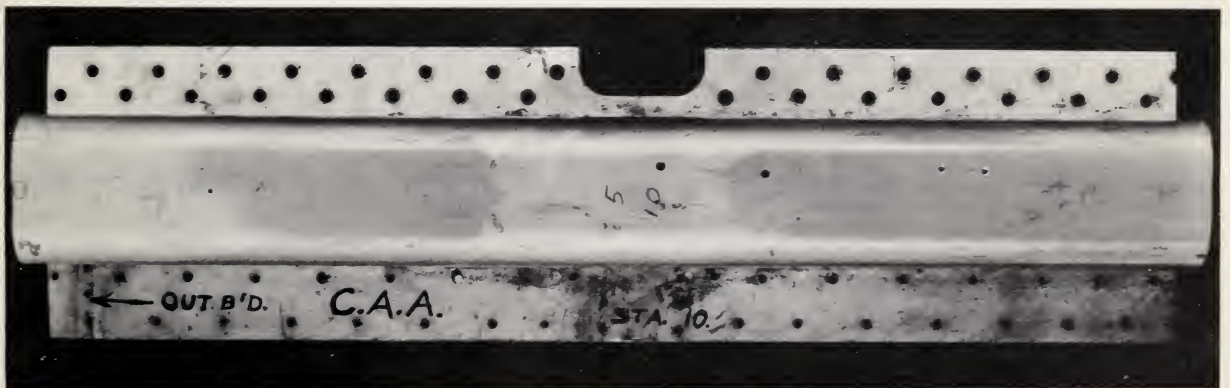
FIGURE 32.1. One of the pieces of cracked spar cap removed from a plane which had been in transoceanic service.

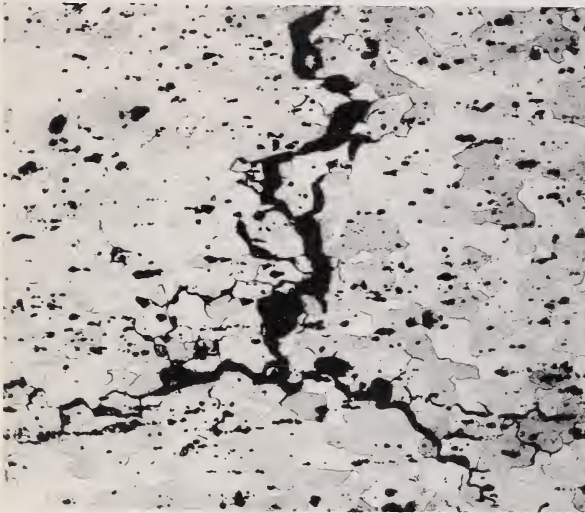
FIGURE 32.4. Photomicrograph showing the intercrystalline path of a crack.

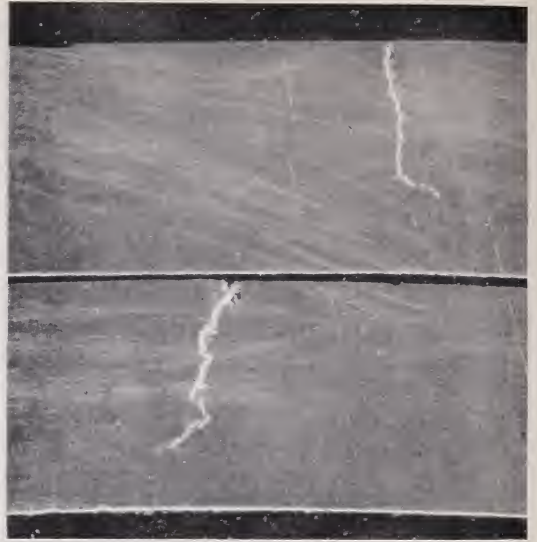
FIGURE 32.3. Cross sections of the tube wall, showing the depth of penetration of the cracks. $\times 7$.

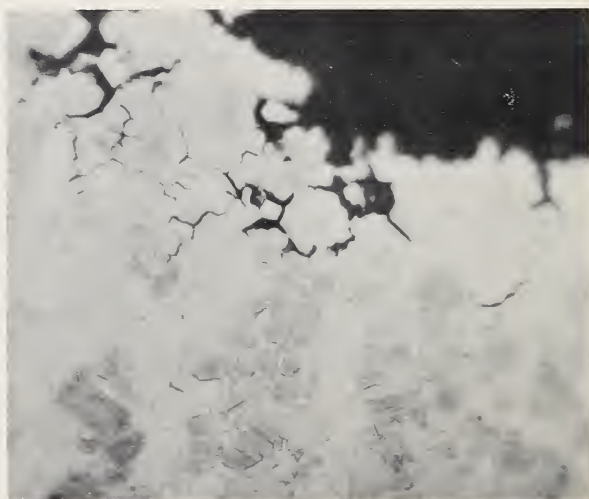
FIGURE 34.2. *Longitudinal section near the fracture, showing the intercrystalline cracks typical of stress-corrosion failures.*

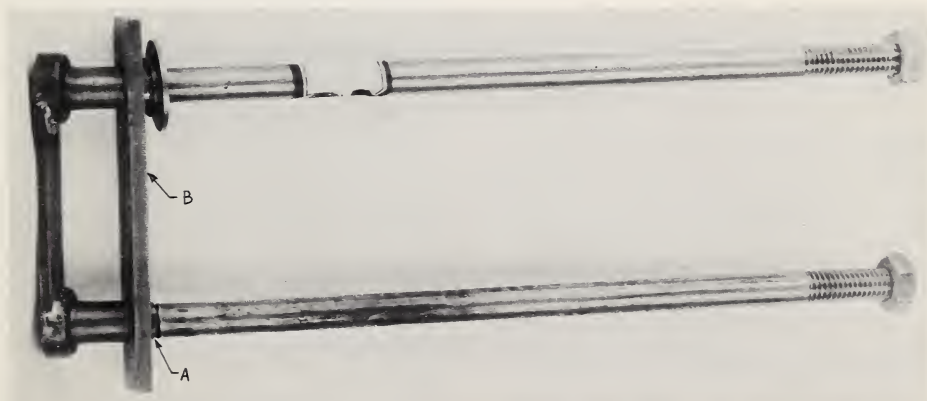
FIGURE 34.1. *Window washer's anchor with one bolt broken at arrow A.*

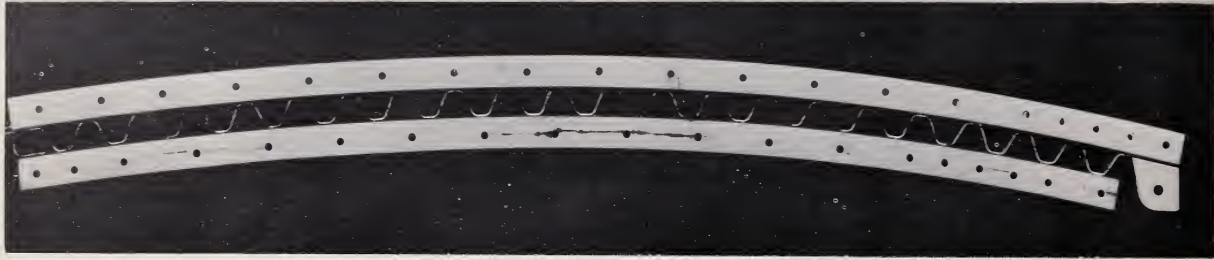
FIGURE 35.1. Cracks in the lower angle as revealed by a dye penetrant inspection method.

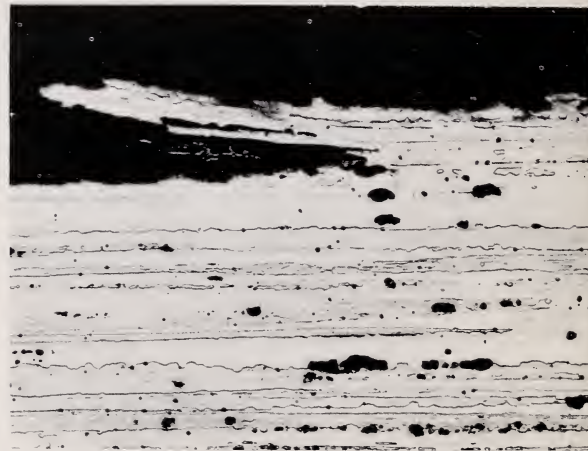
FIGURE 35.3. Longitudinal section perpendicular to the fracture shown in figure 35.2.
