# Technical Investigation

of the May 22, 2011,  
**Tornado** in  
**Joplin, Missouri**

NIST NCSTAR 3

## **Technical Investigation of the May 22, 2011, Tornado in Joplin, Missouri**

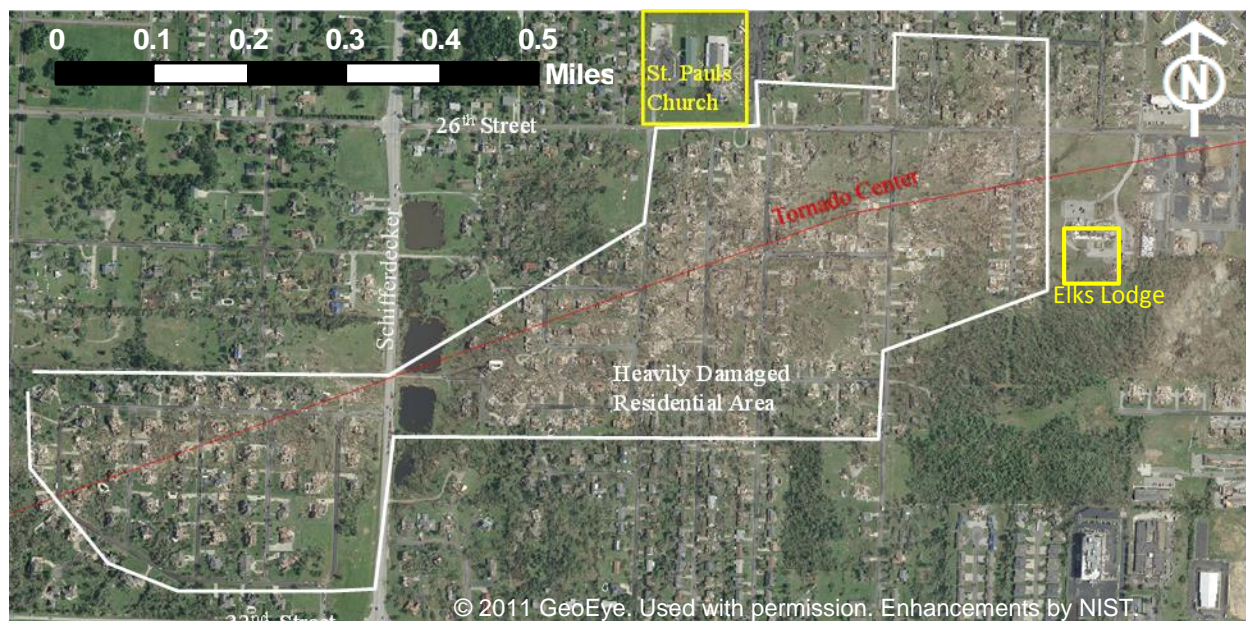
**Figure 1–5. Damage on the west side of Joplin.**

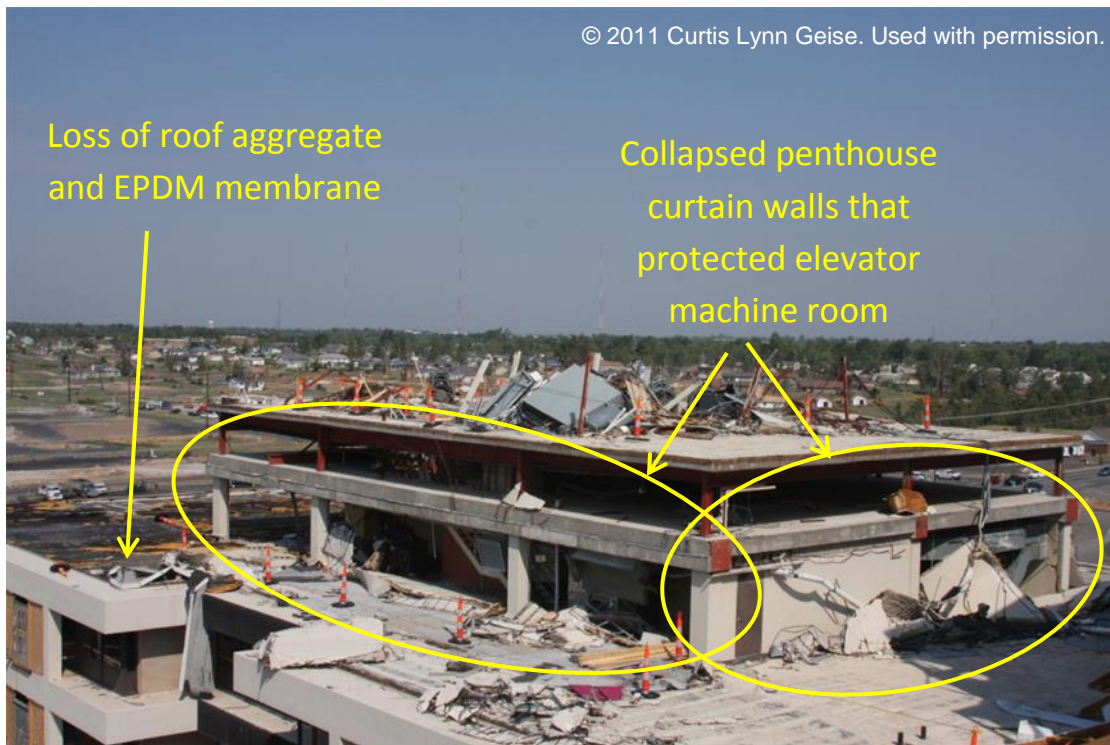
**Figure 3–12. Damage to roof and penthouse walls of SJRMC's West Tower.**

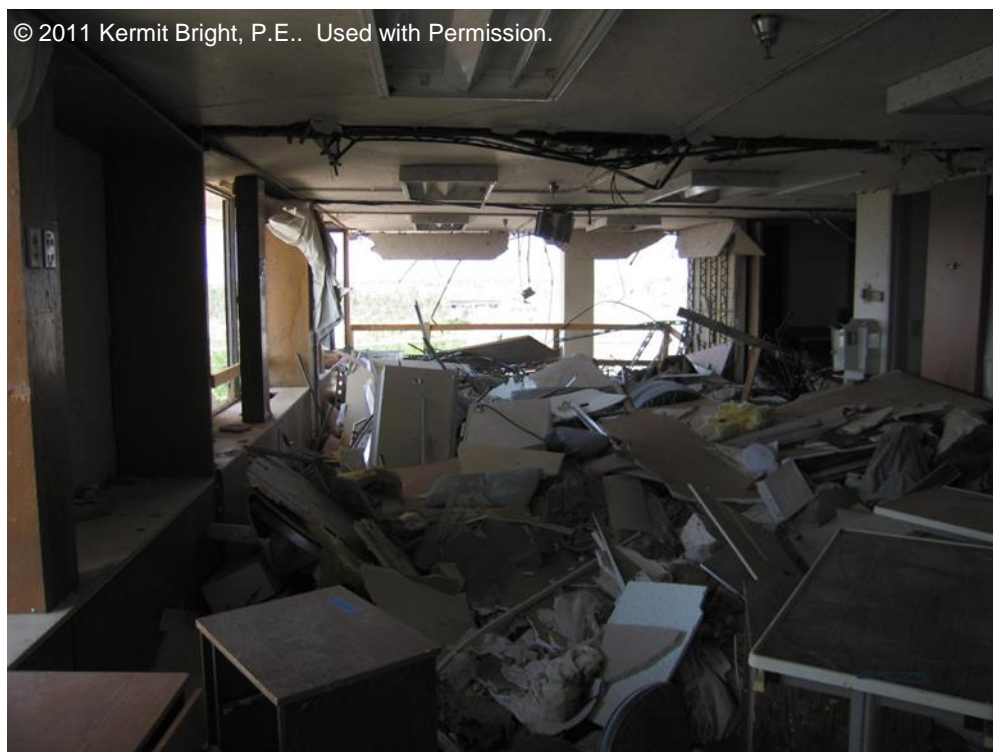
**Figure 3–13. Typical damage to the interior of SJRMC's West Tower.**

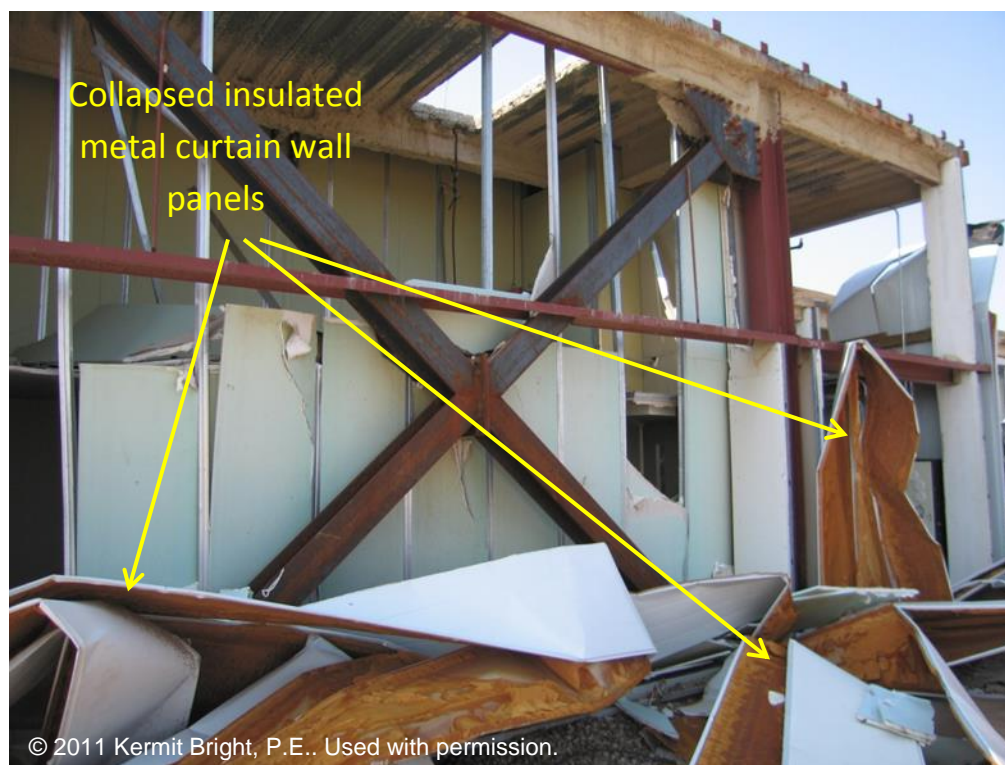
**Figure 3–17. Missing/collapsed vertical insulated metal curtain wall panels of SJRMC's East Tower penthouse.**

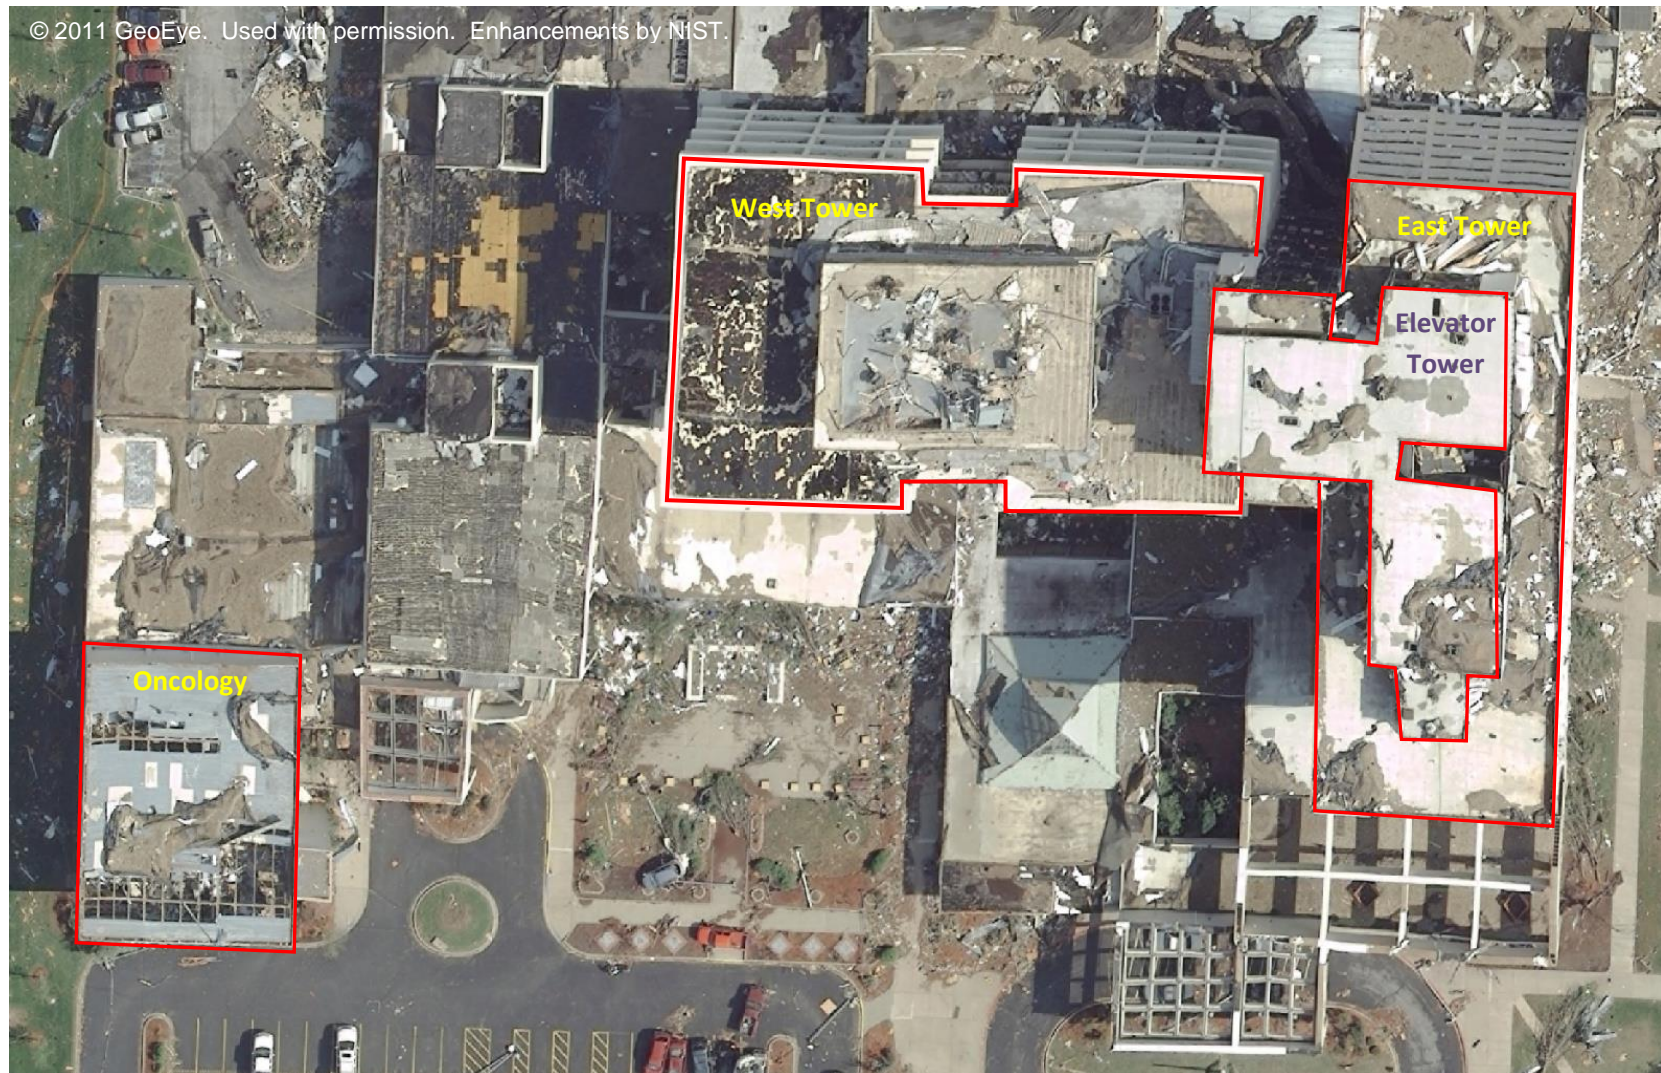
**Figure 3–19. Overview of West, East, and Elevator Towers and Oncology Clinic Building showing that most of the aggregates that were used as roof ballast on these buildings are missing.**

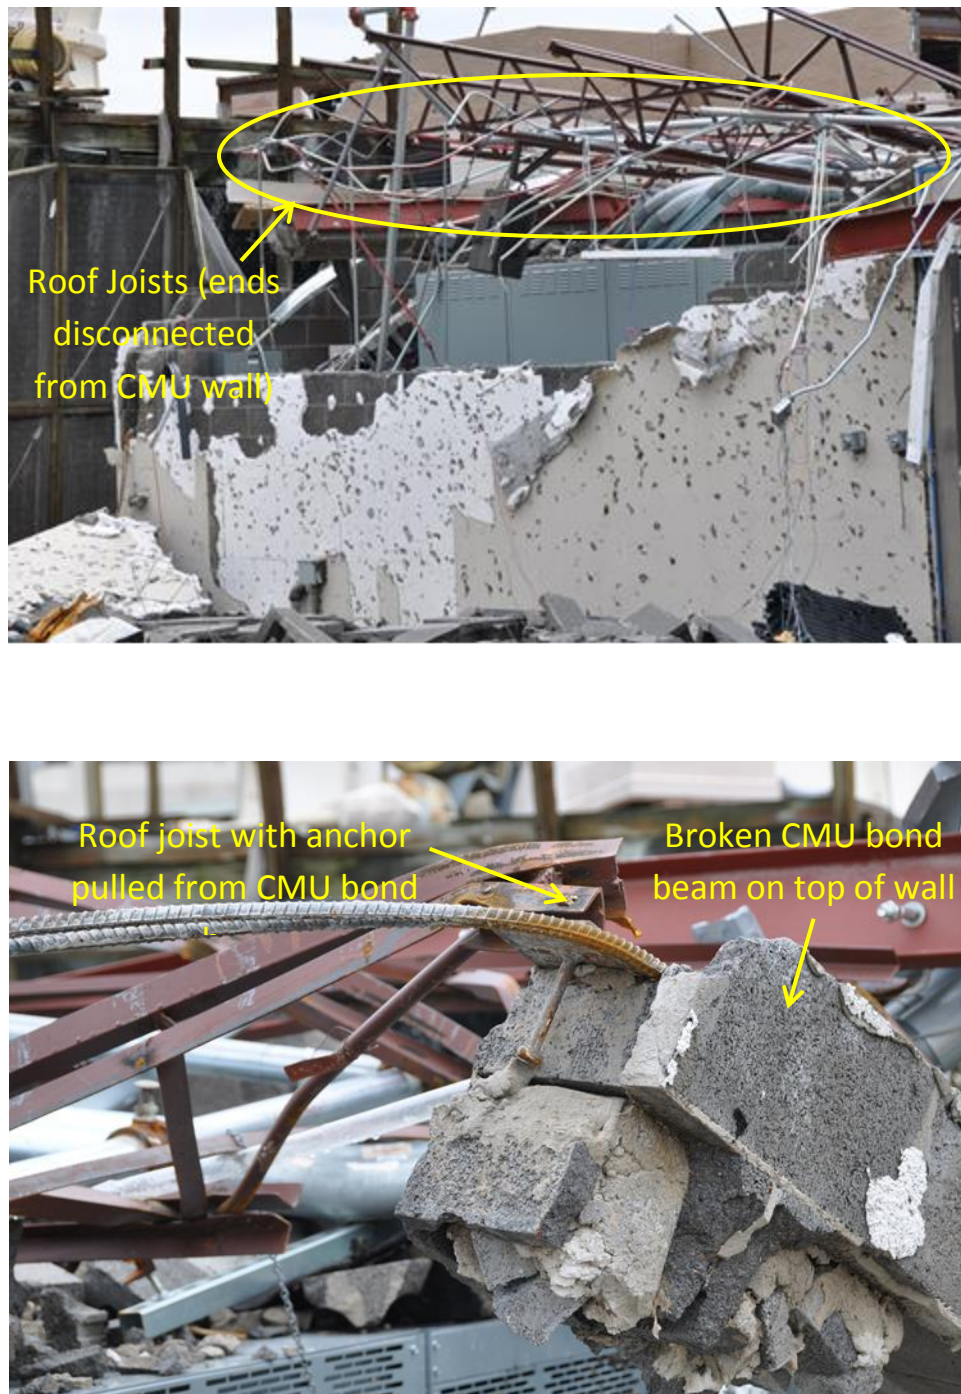
**Figure 3–22. Failure details at Emergency Generator Building.**

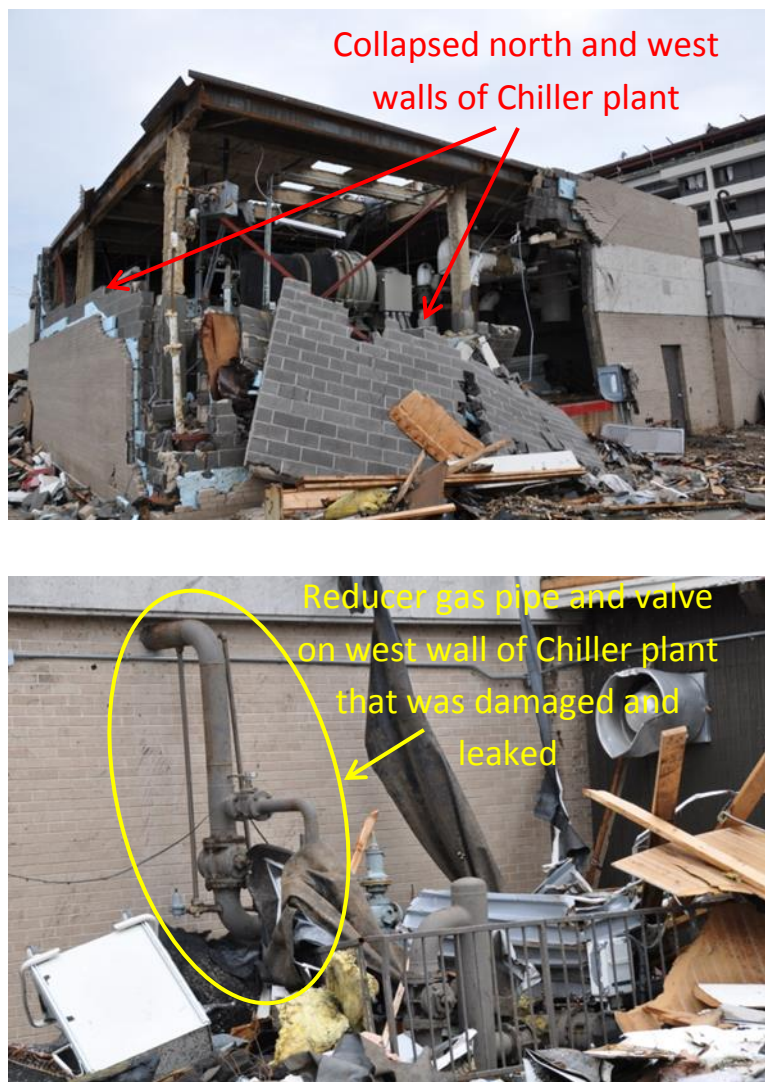
**Figure 3–23. Views of damage sustained at the Chiller Plant.**

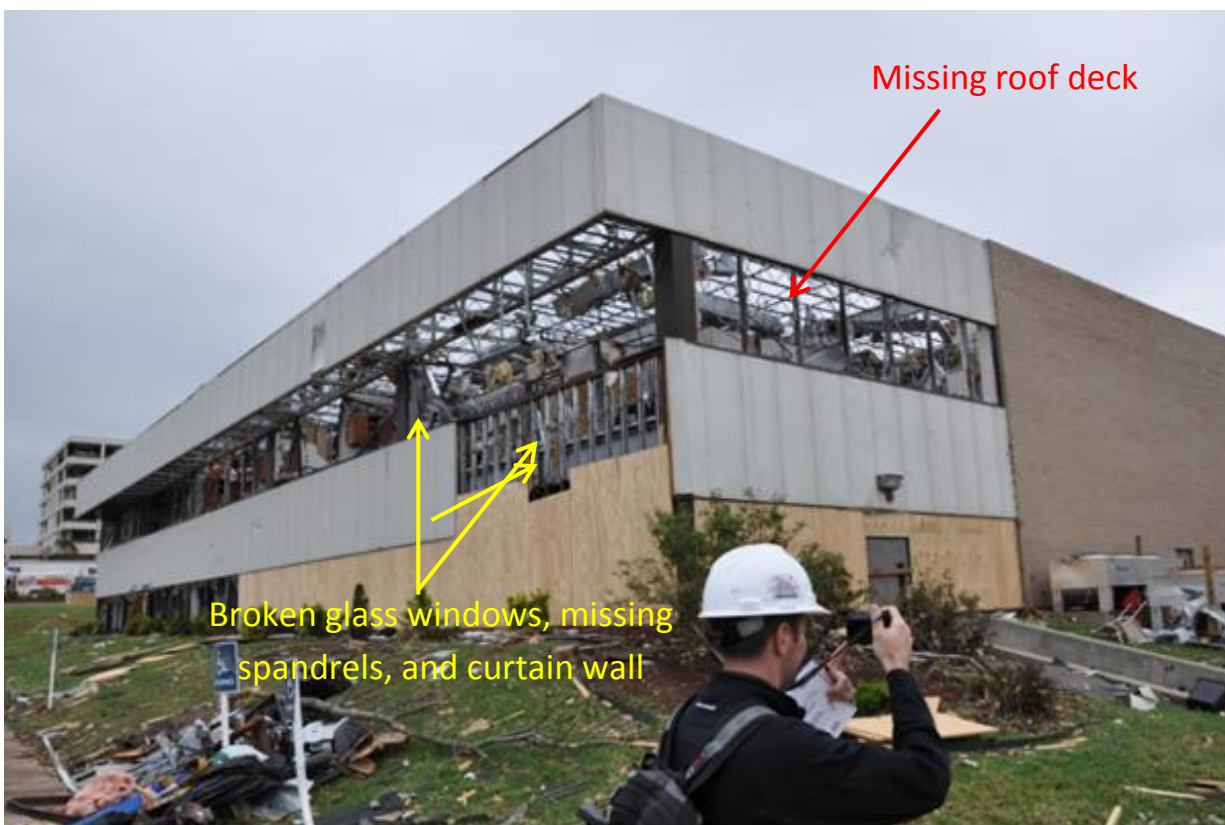
**Figure 3–28. View of damage to envelope of Medical Office Building 1.**

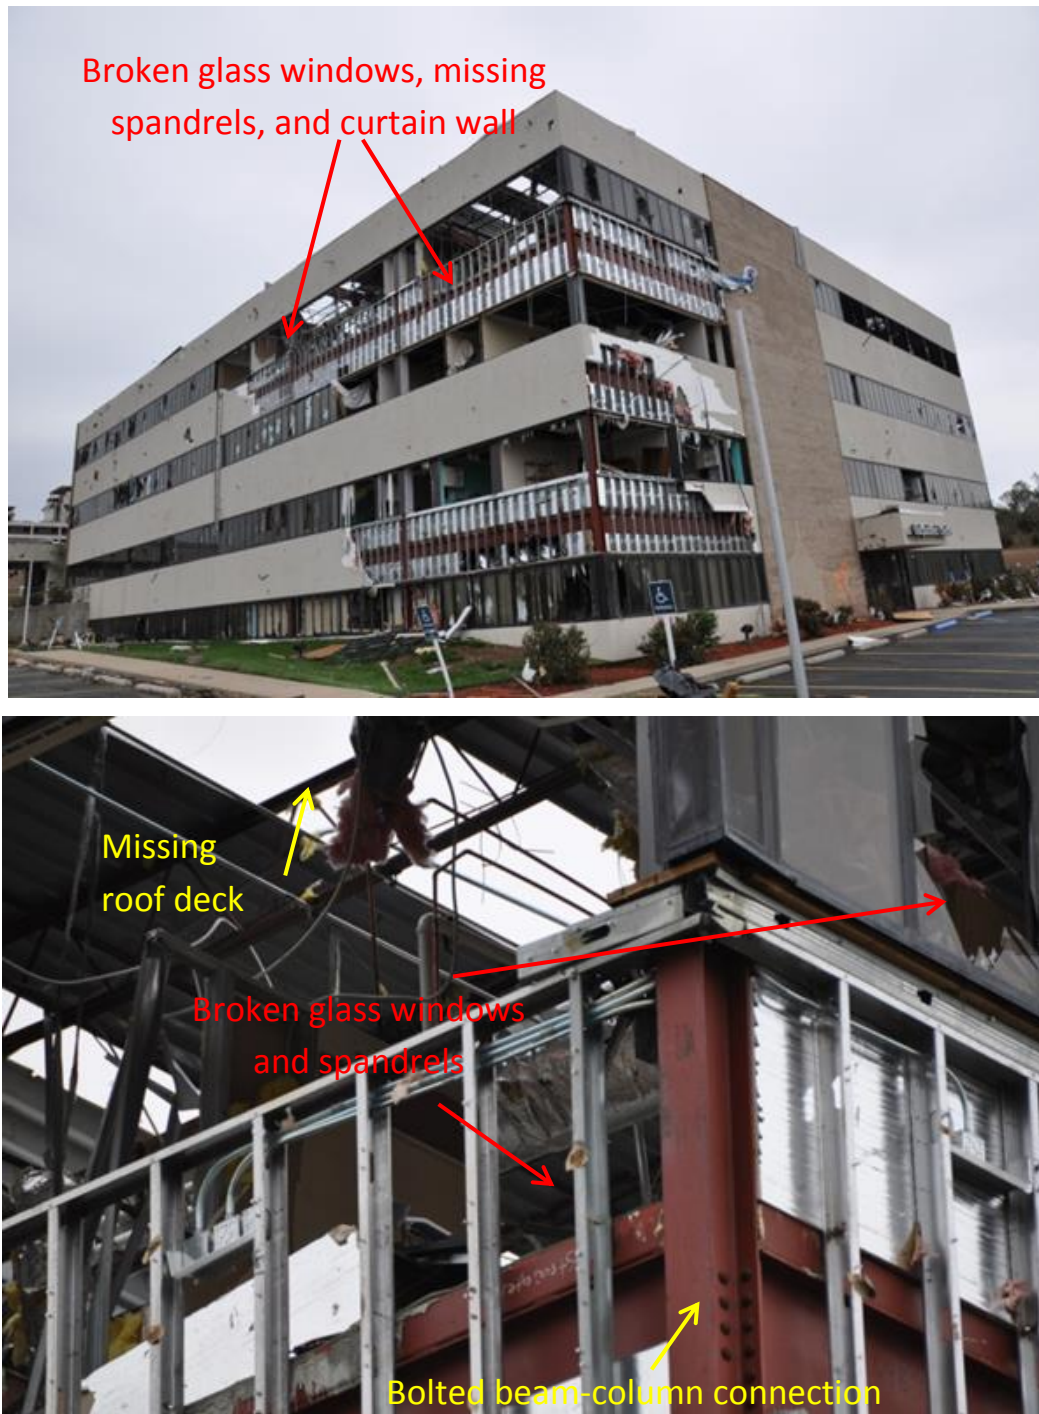
**Figure 3–29. Views of (top) damage to envelope of Medical Office Building 2 and (bottom) portion of the steel frame system (bolted beam–column connection).**

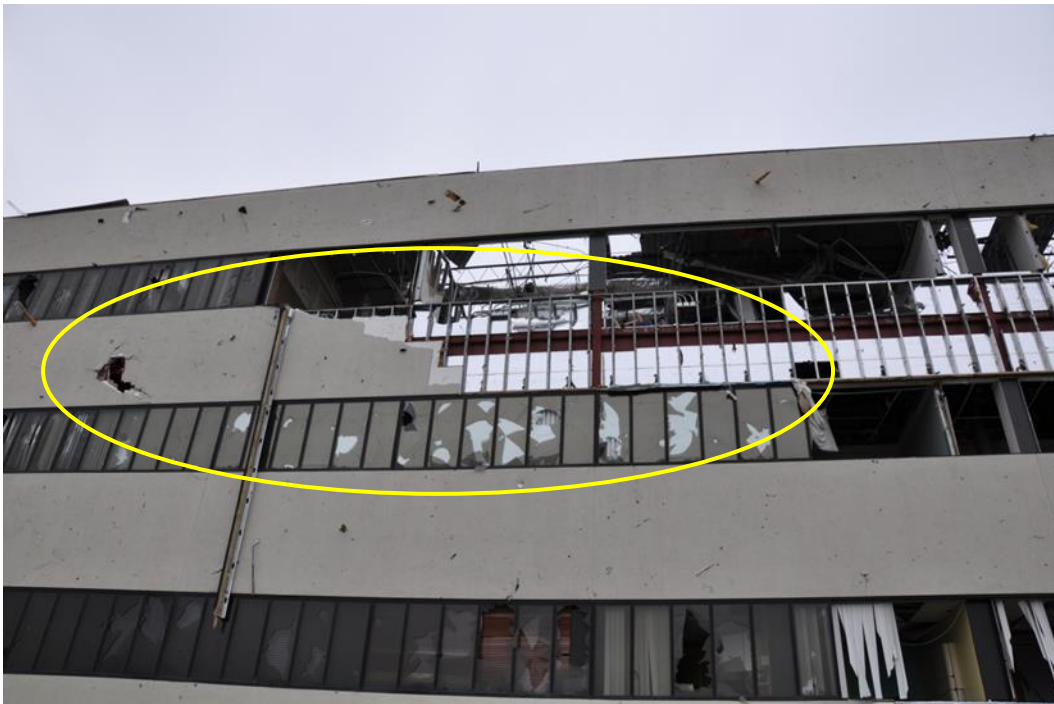
**Figure 3–30. Evidence of debris impact causing breakage of windows at Medical Office Building 2.**

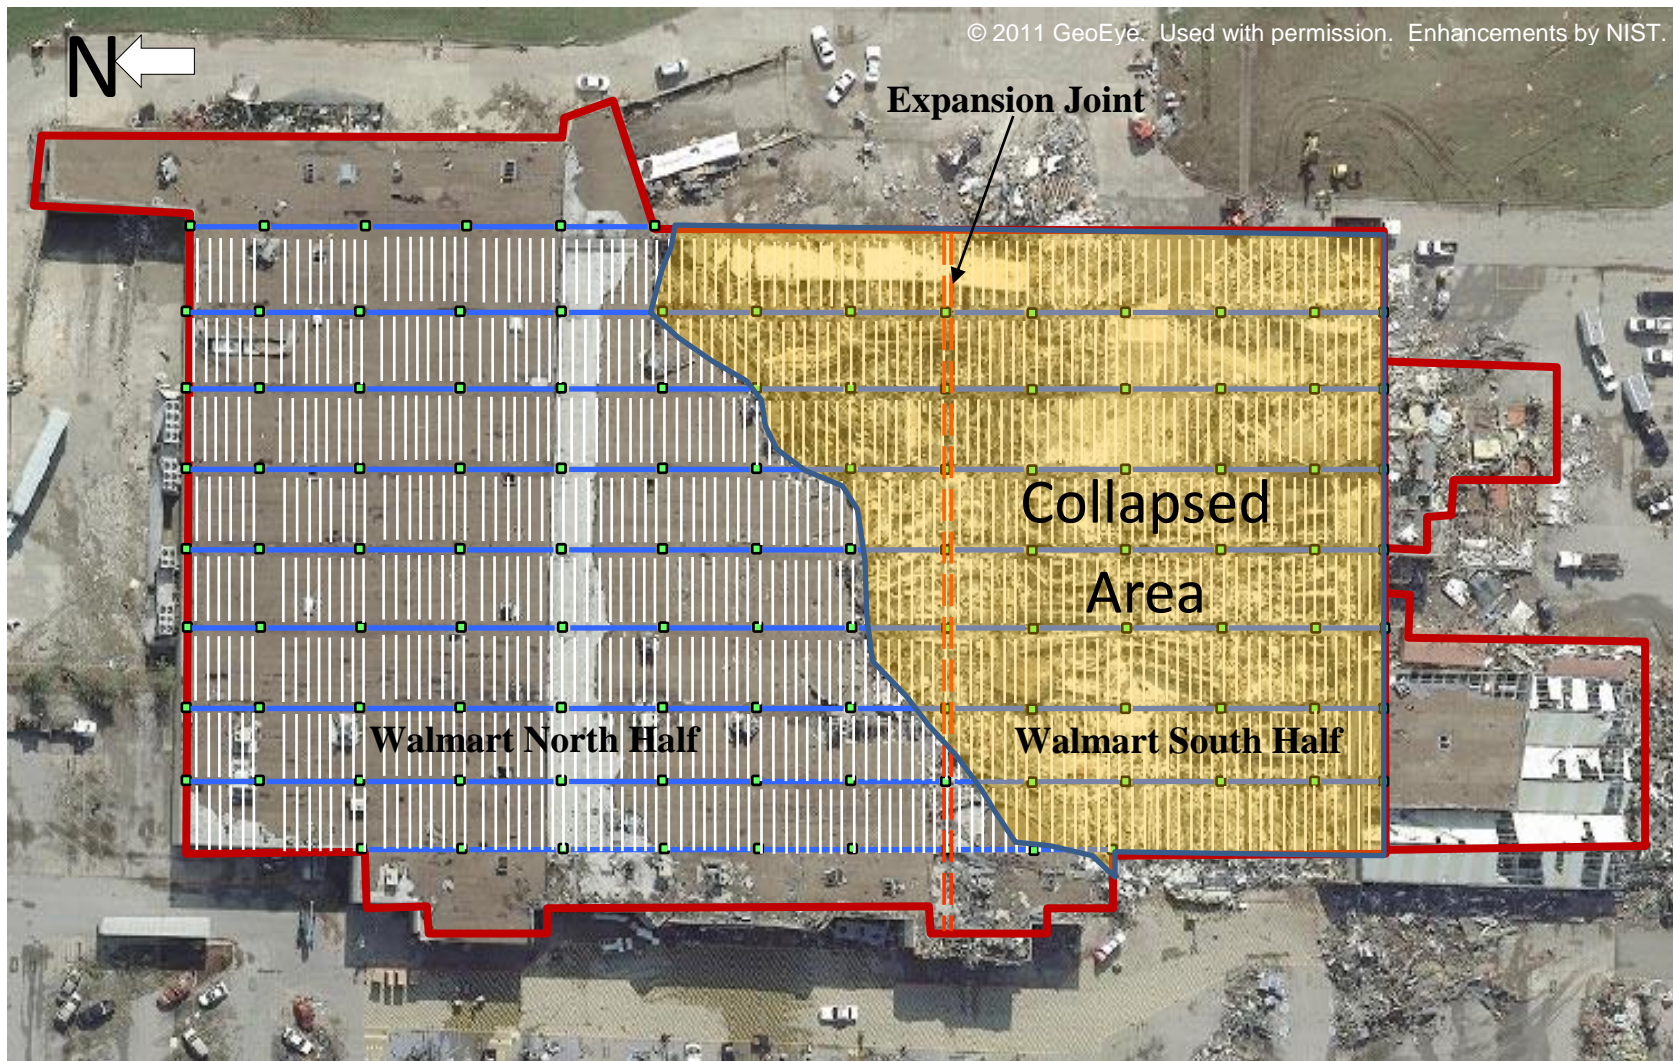
Figure 3–34. Aerial view of Walmart outlining southern half of building collapsed by the tornado.

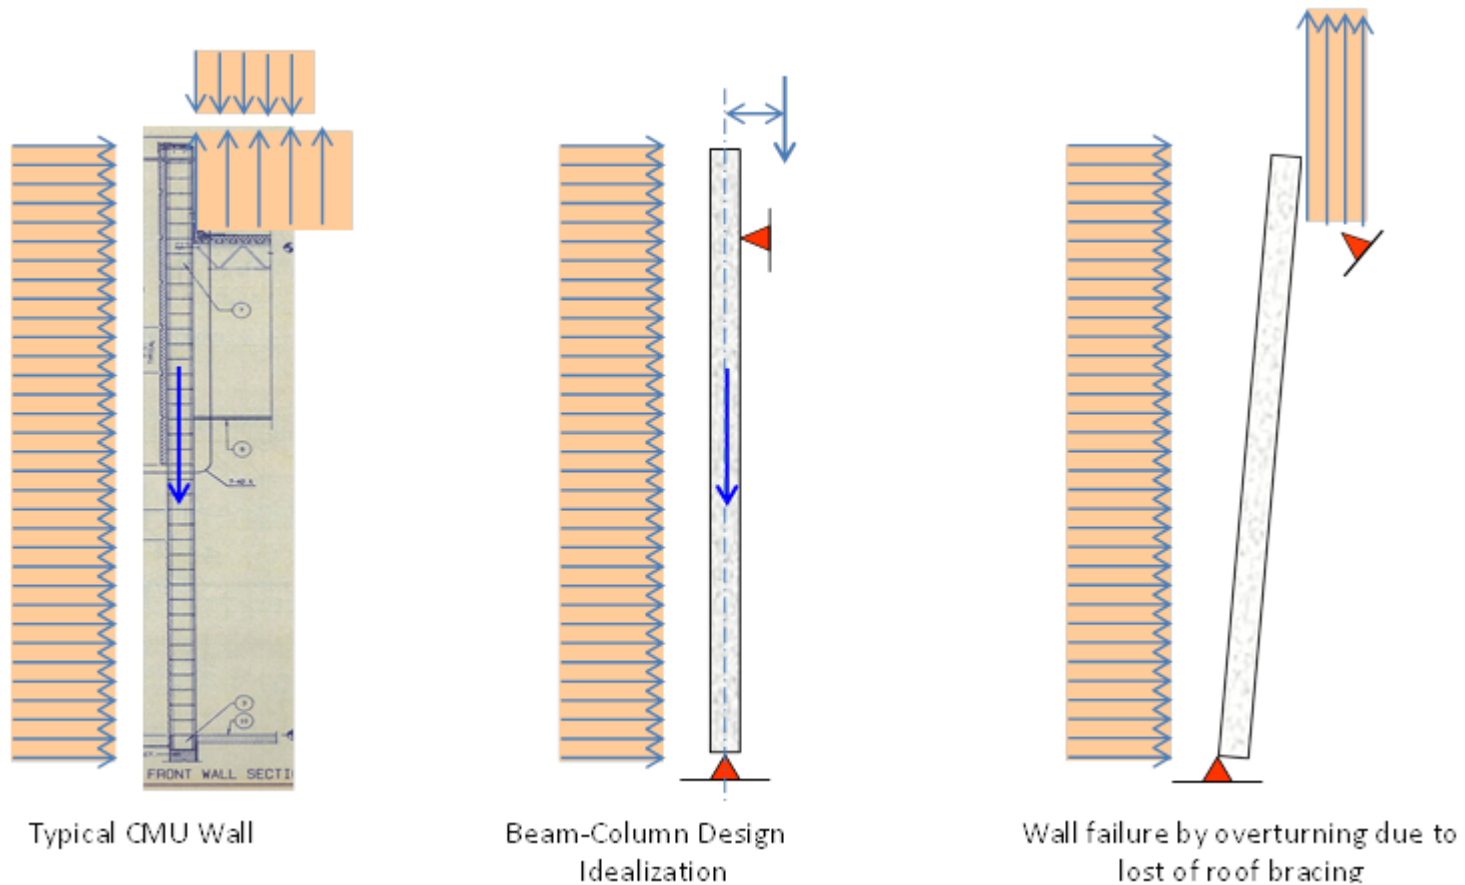
**Figure 3–41. Typical loading and design conditions for BTS building and possible failure mode.**

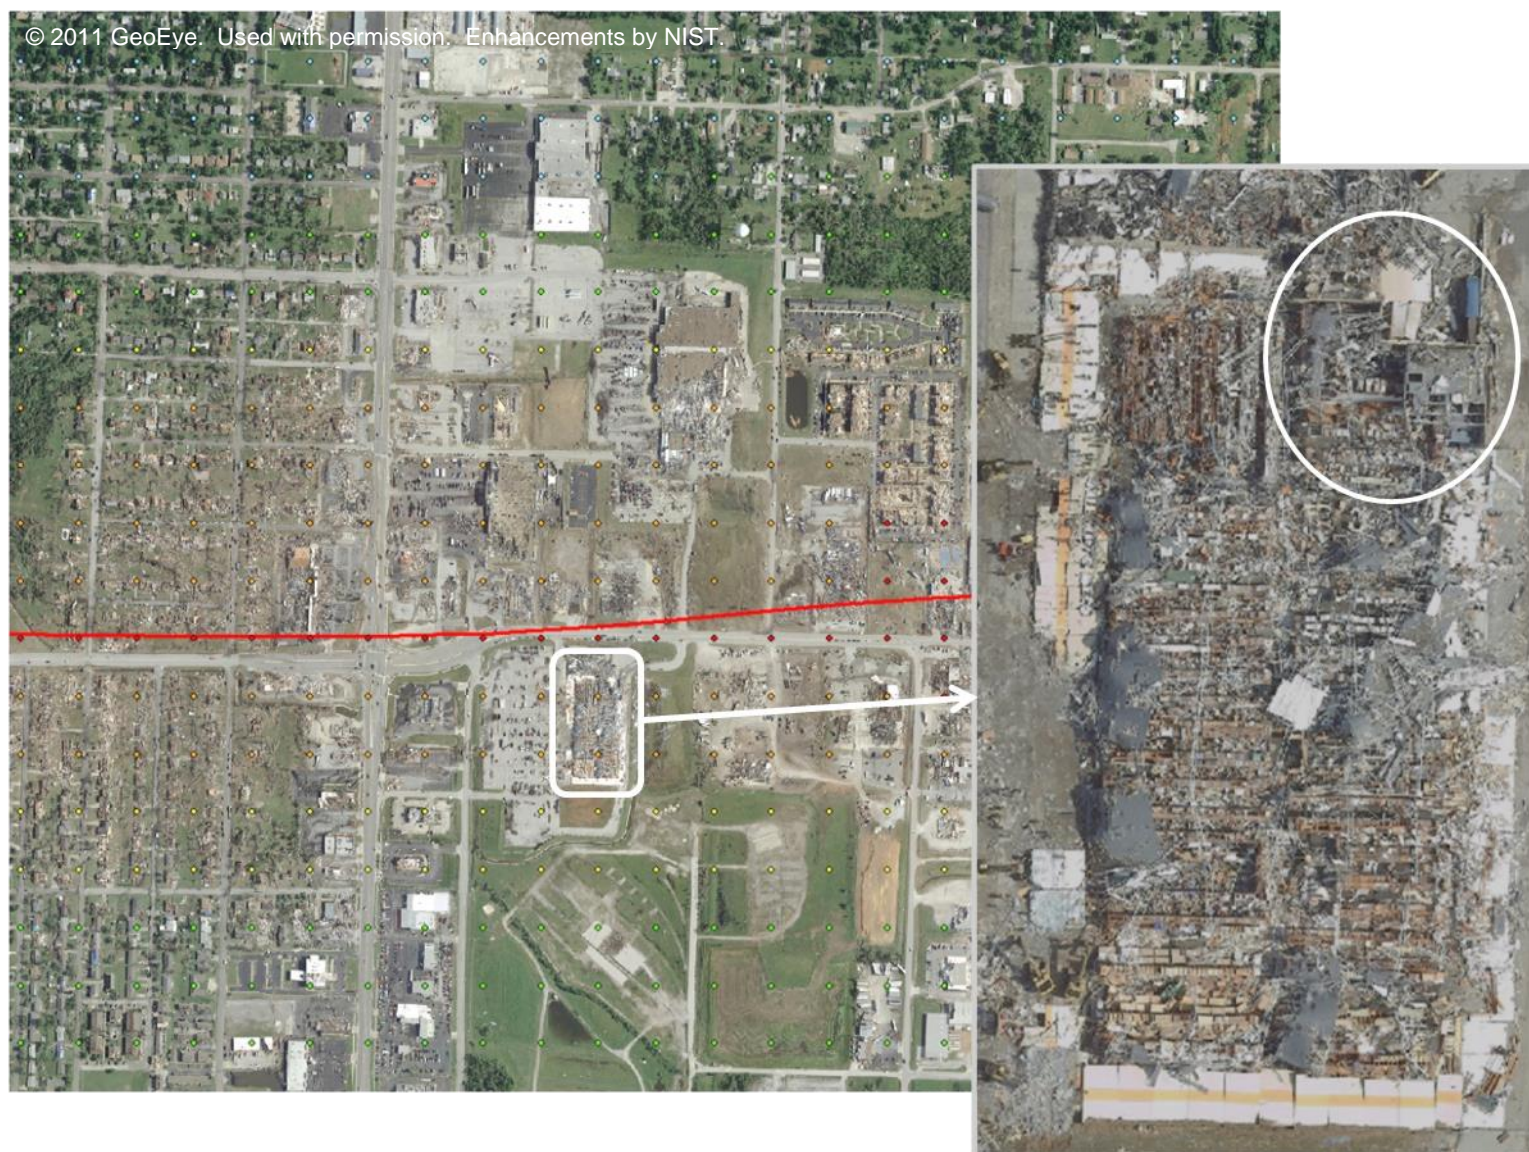
**Figure 3–42. Aerial views of Home Depot in relation to the tornado damage path (red line denotes center of damage path). Note the loss of all roof decks due to wind uplift.**

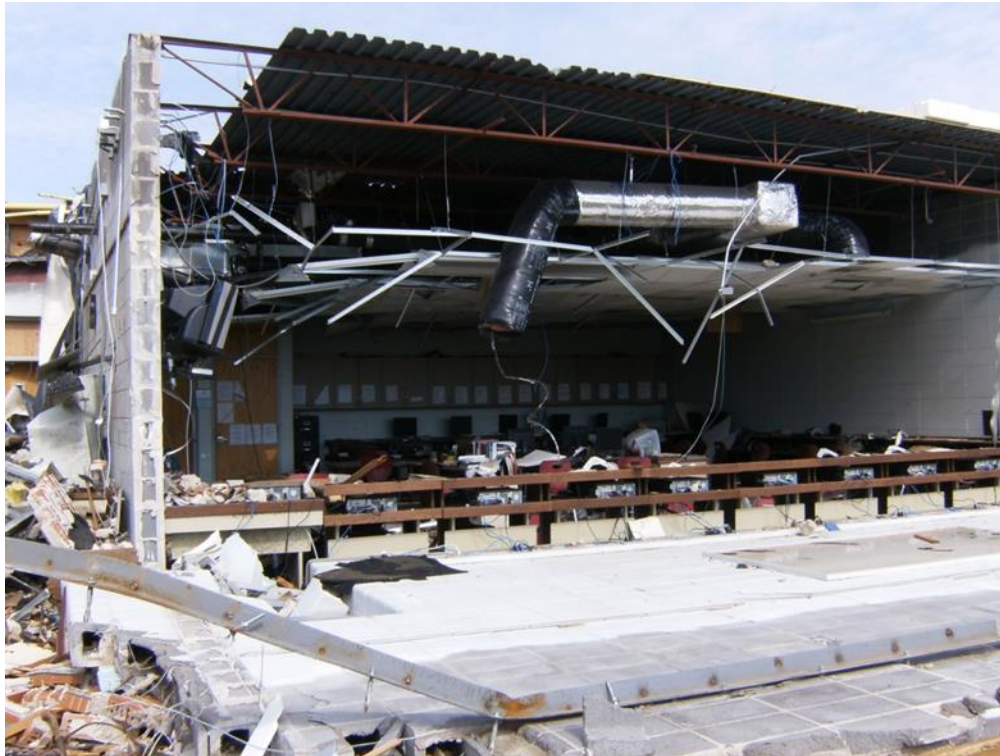
**Figure 3–72. Collapse of CMU wall due to loss of lateral roof bracing at Joplin High School.**

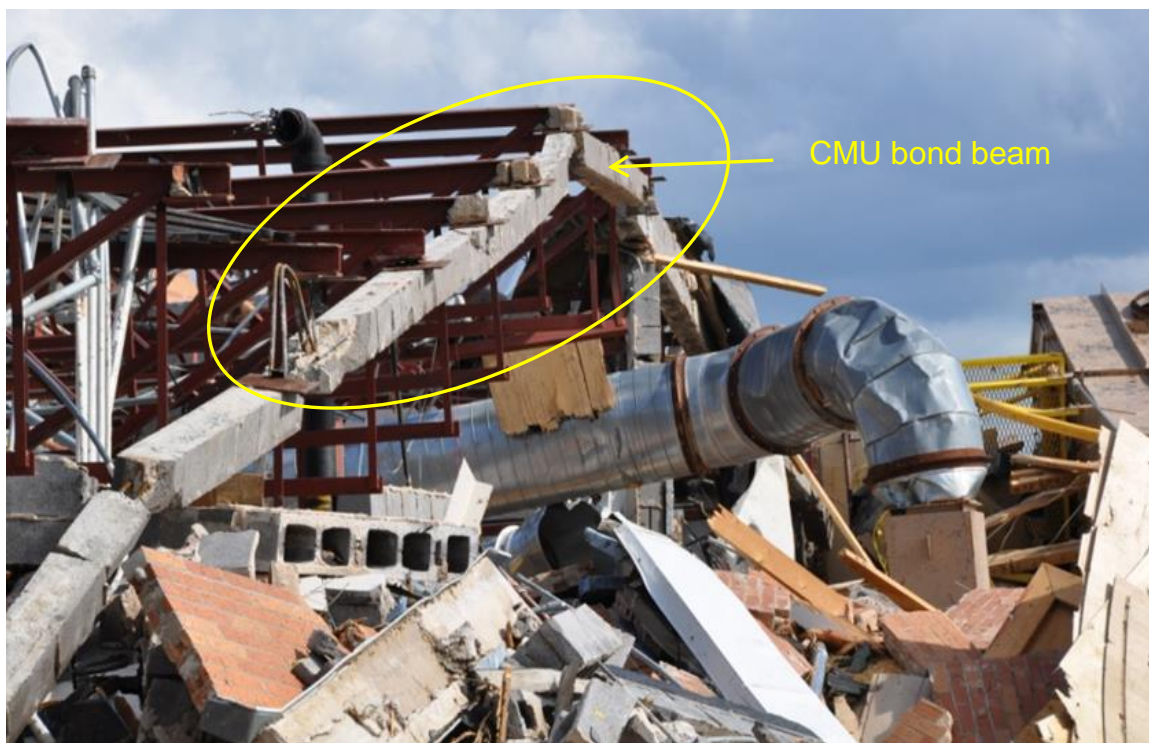
**Figure 3–77. Steel roof joists, with missing roof decks, remained connected to CMU bond beam. Bond beam remained continuous, but was disconnected from the CMU walls along the bond line between the two CMU courses at the top of the Franklin Technology Center wall.**

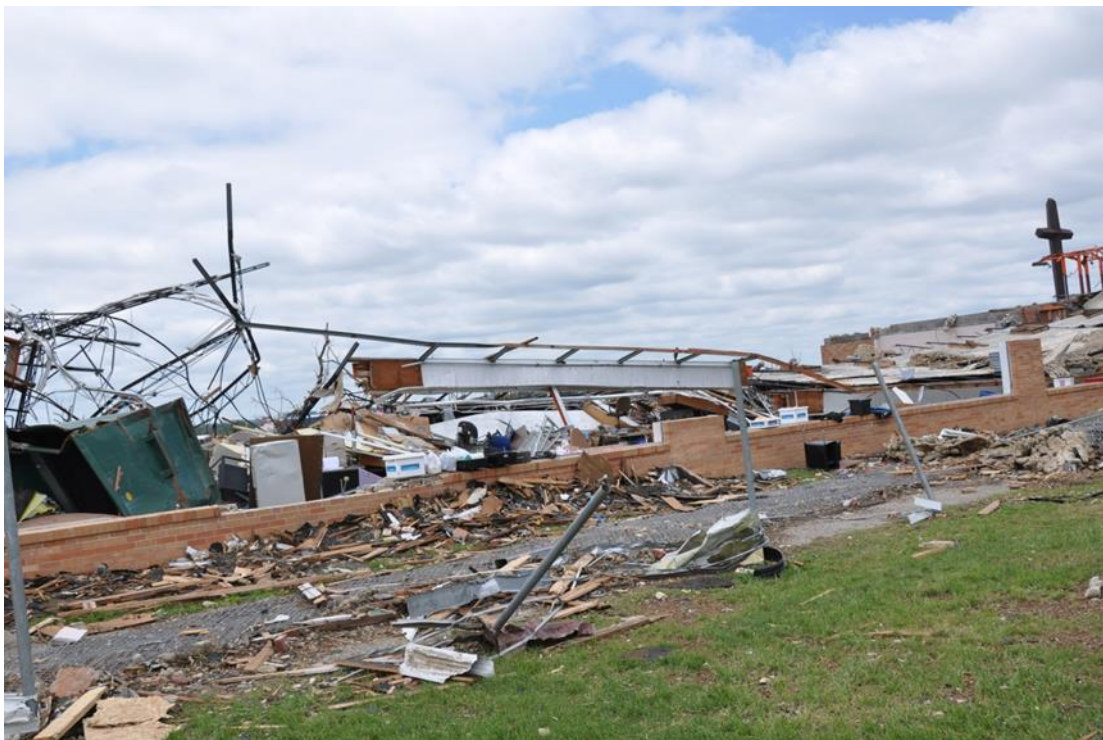
**Figure 3–83. Section of building at St. Mary’s Catholic Elementary school with collapsed perimeter CMU walls.**

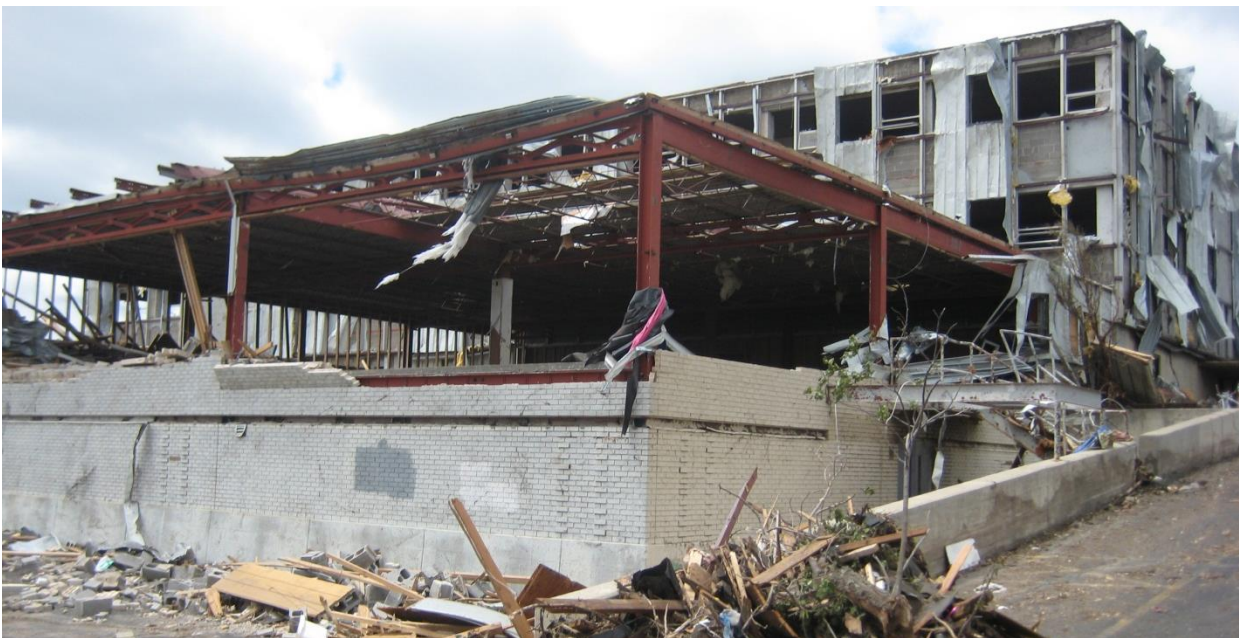
**Figure 3–88. Significant damage to the envelope and minor damage to the MWFRS of the physical education section of the Ozark Center building, including (1) loss of part of steel roof decks, (2) loss of all insulating windows and steel frames on all wind-exposed sides, and (3) deformation of steel beam (likely due to debris impact).**

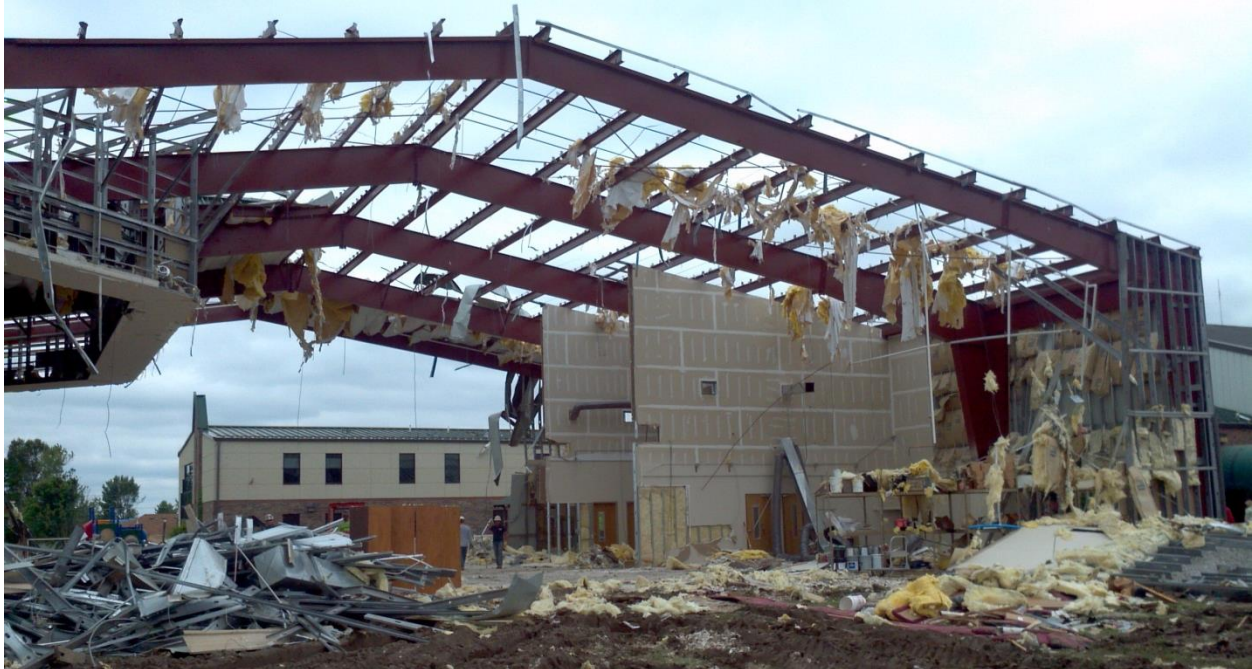
**Figure 3–92. View from east of the damaged, MBS Mass Hall building of St. Paul’s United Methodist Church.**

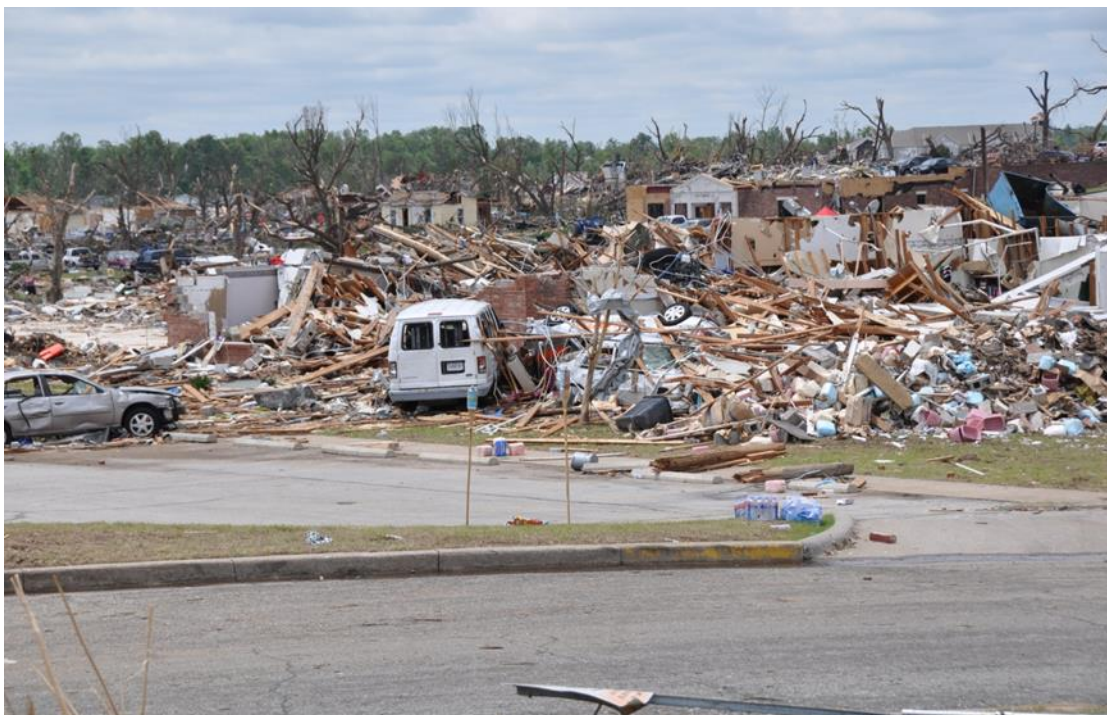
**Figure 3–104. Collapsed Greenbriar Nursing Home (viewed from the east) with missing roof system and collapsed exterior CMU walls. Note debris from building materials as well as other sources (automobiles) in all interior areas of the facility.**

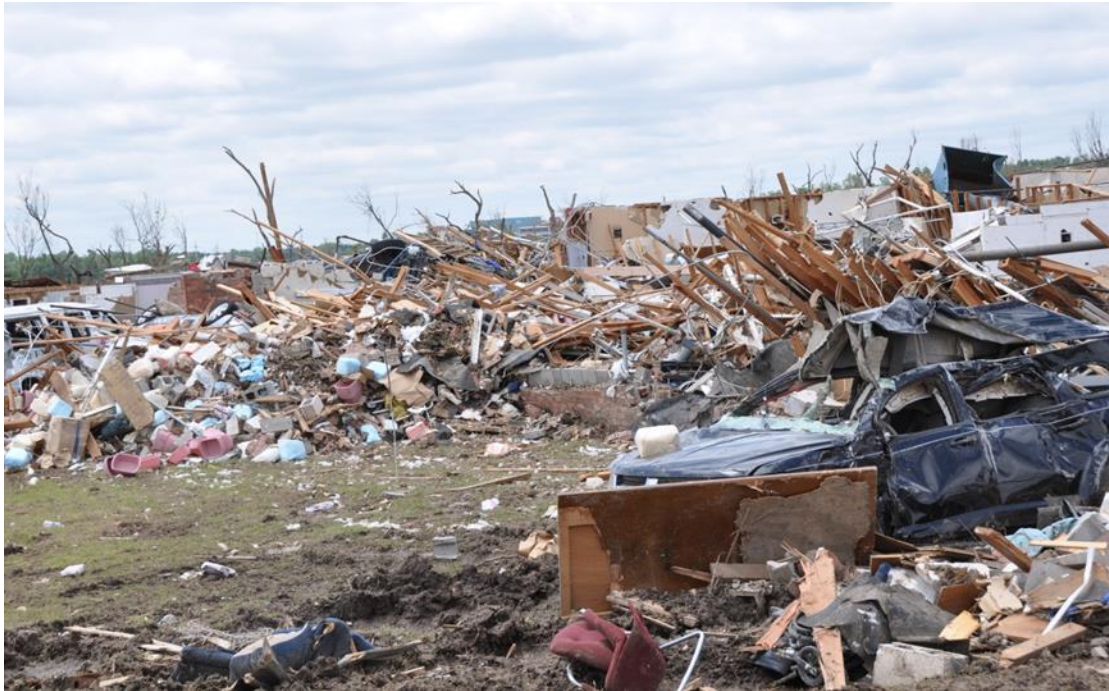
**Figure 3–105. Collapsed Greenbriar Nursing Home.**

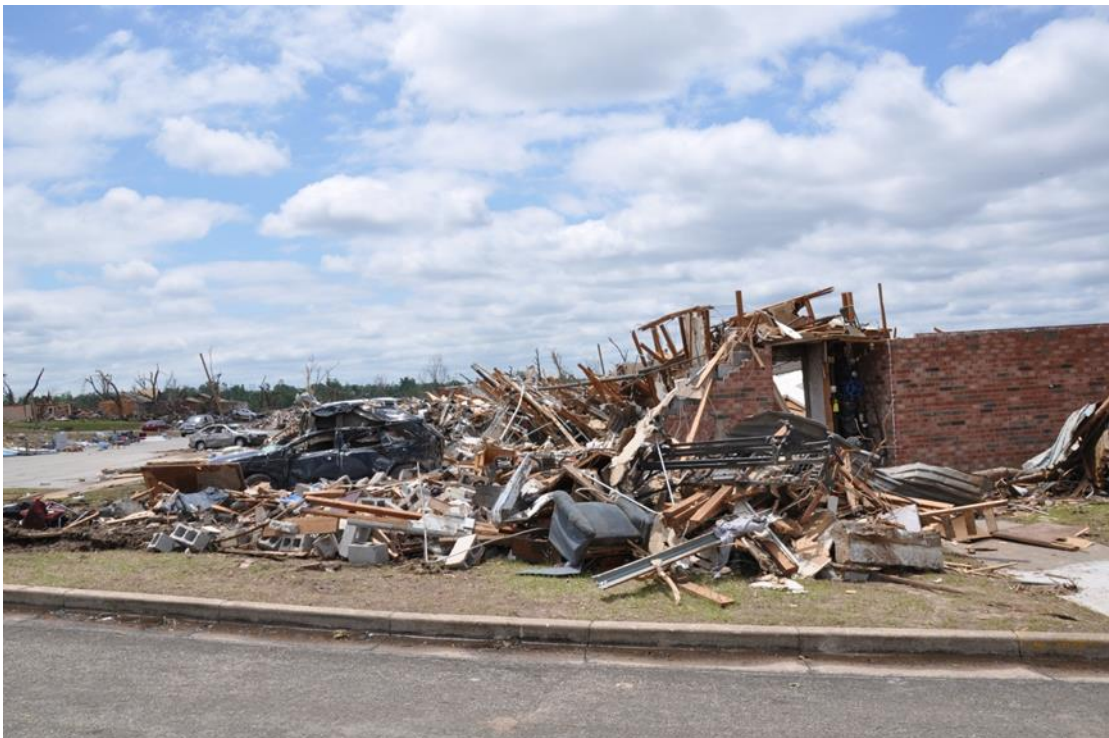
**Figure 3–106. Collapsed Greenbriar Nursing Home (viewed from the north) showing the portion of the north wing's exterior wall that did not collapse.**

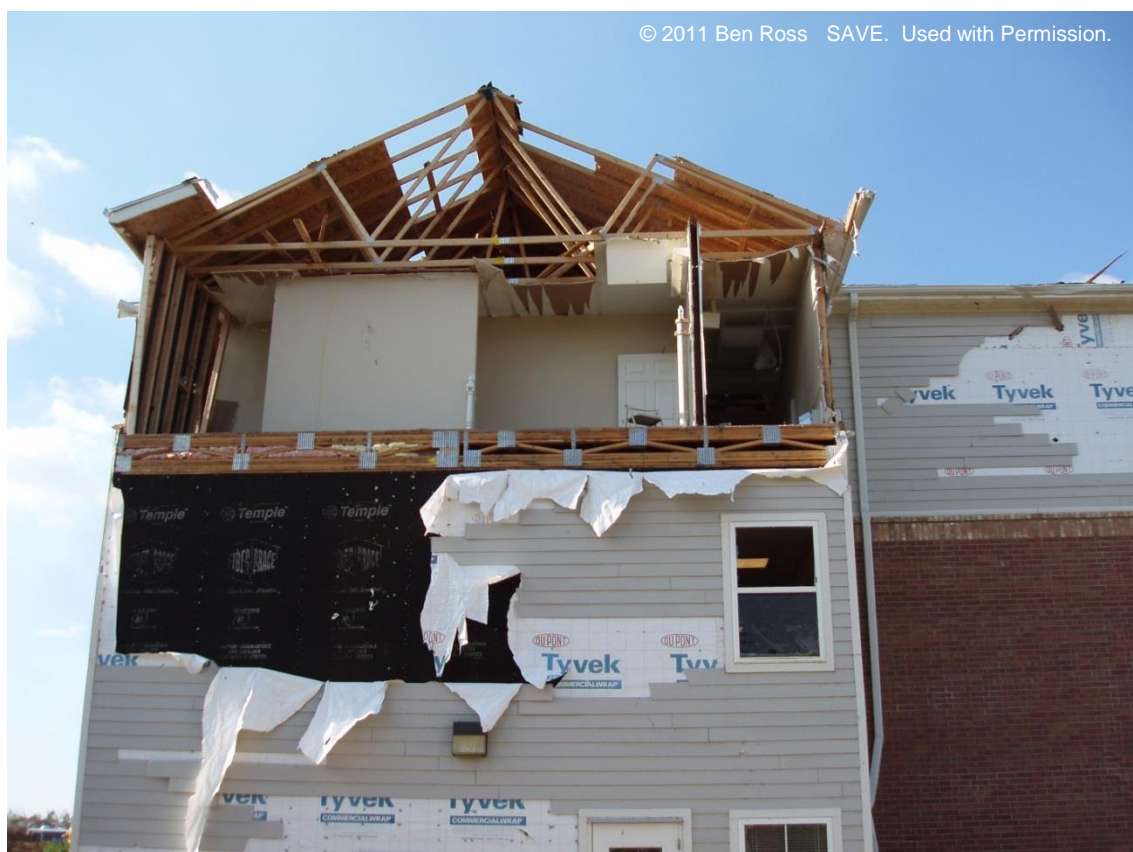
**Figure 3-112. Damage to the building envelope and structural systems (loss of wall section, roof framing and sheathing) of the Mercy Village Apartments.**
