# Technical Investigation

of the May 22, 2011,  
**Tornado** in  
**Joplin, Missouri**

NIST NCSTAR 3

## **Technical Investigation of the May 22, 2011, Tornado in Joplin, Missouri**

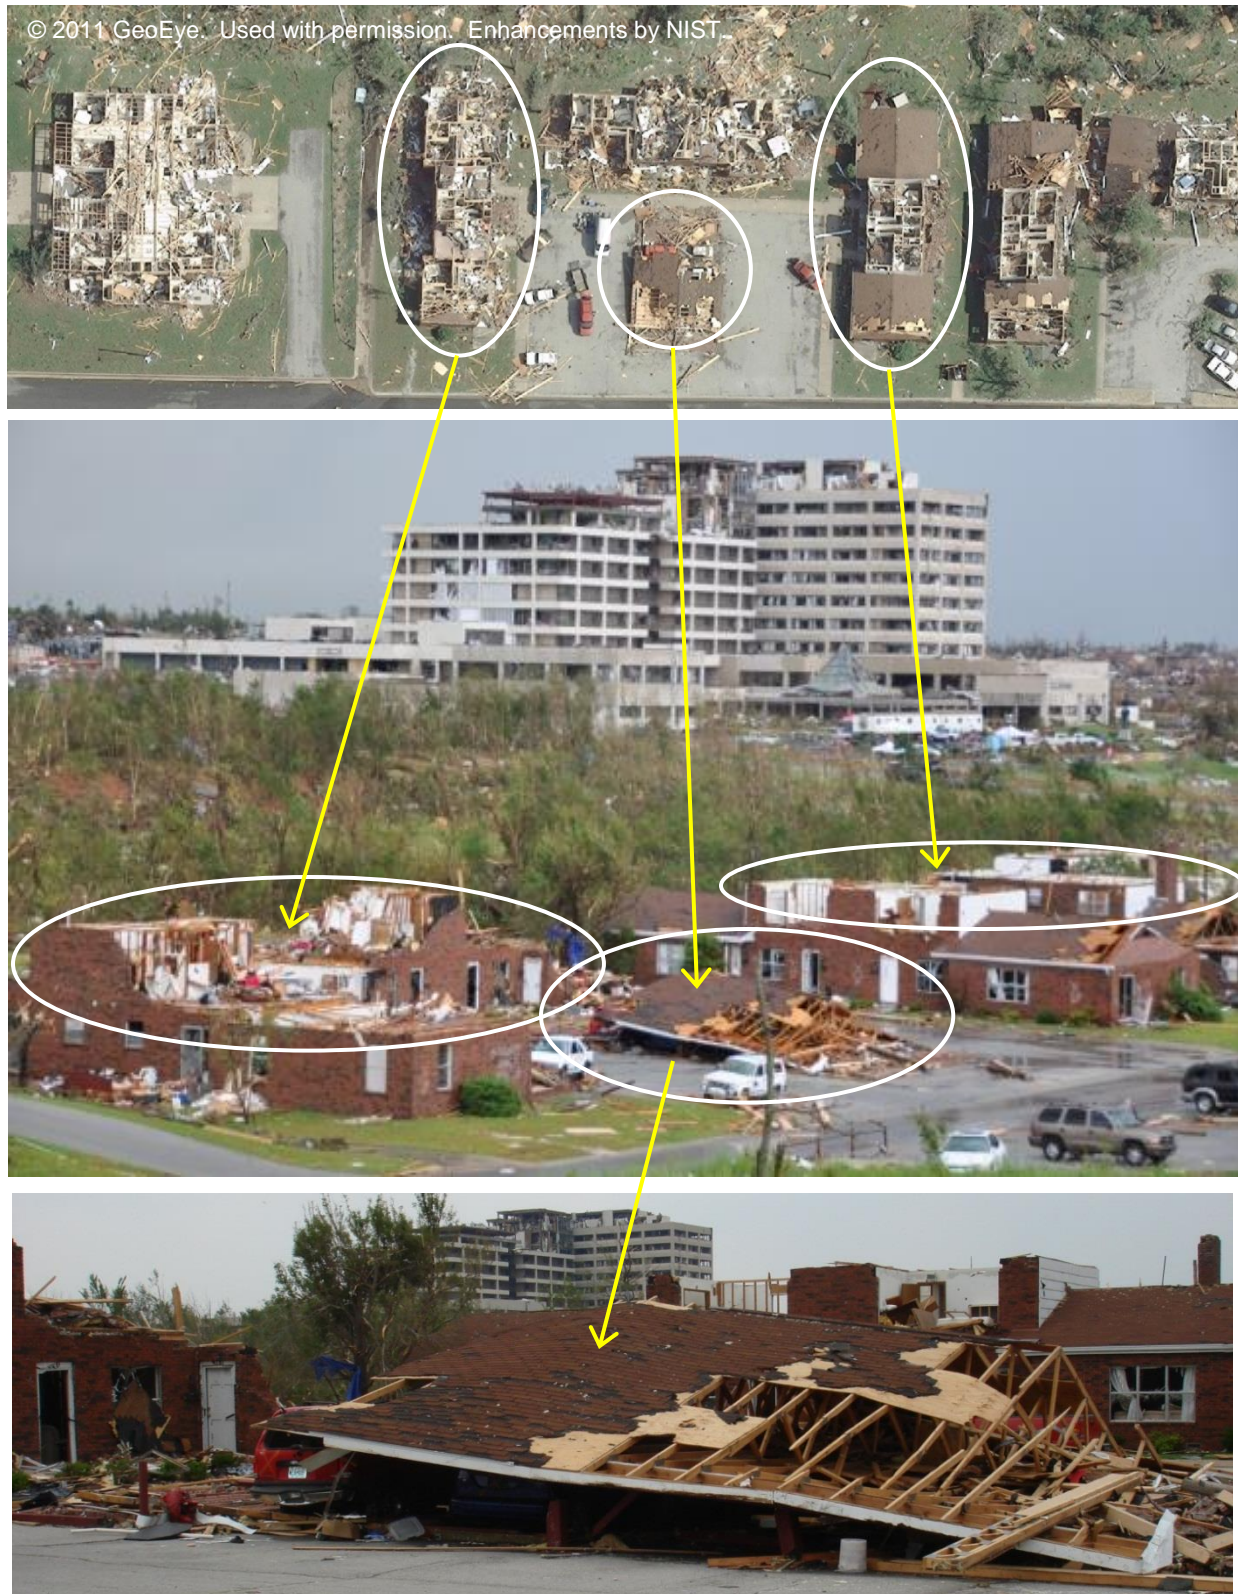
**Figure 3–113. Residential failure due to disconnection of entire roof system (roof-to-wall connection failure due to wind uplift).**

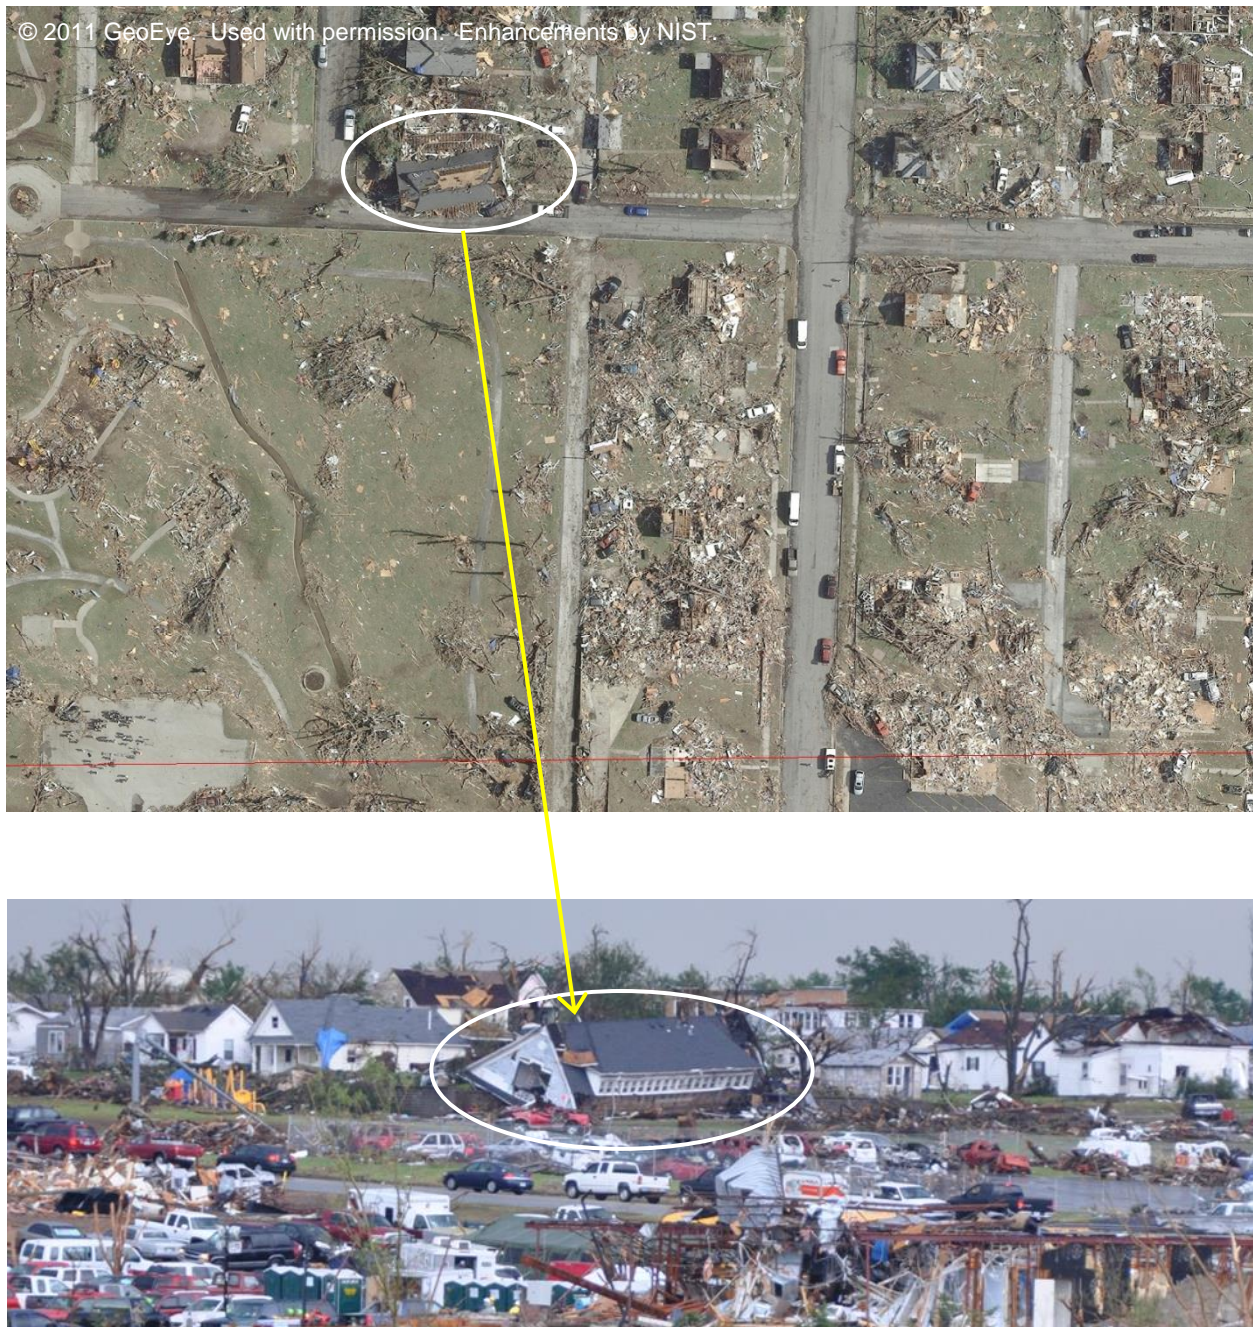
**Figure 3–114. Failure of first-story-to-foundation wall connection. Entire roof and first floor shifted off of lower story (directly north of SJRMC).**

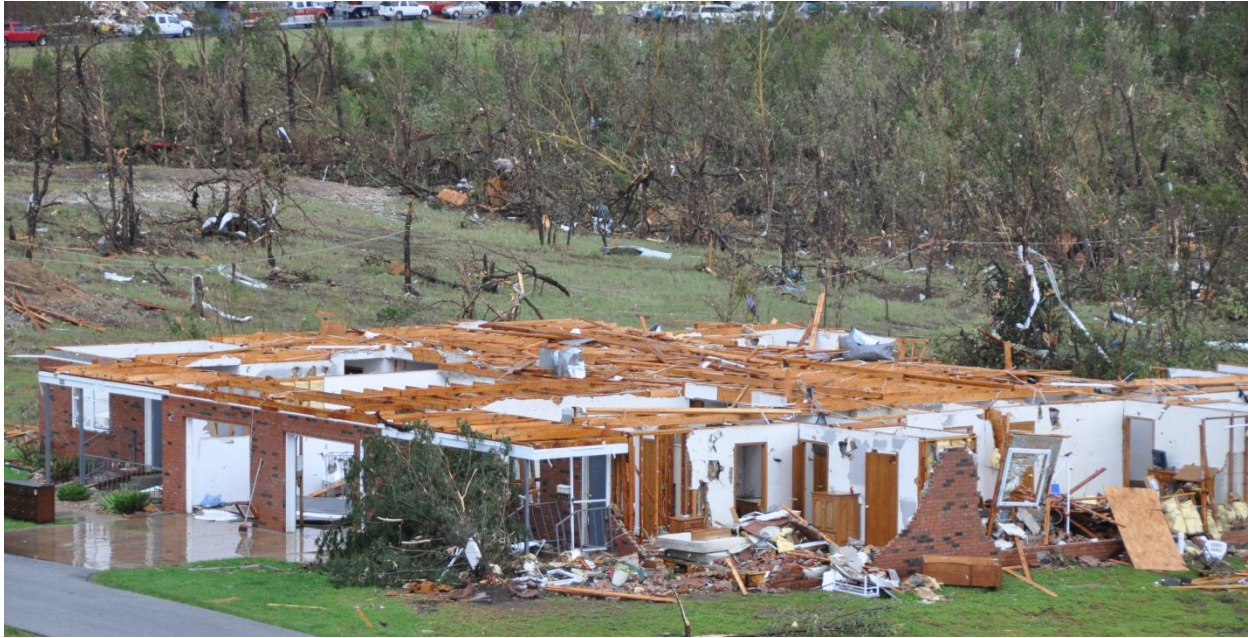
**Figure 3-115. Disconnection and loss of entire roof system.**

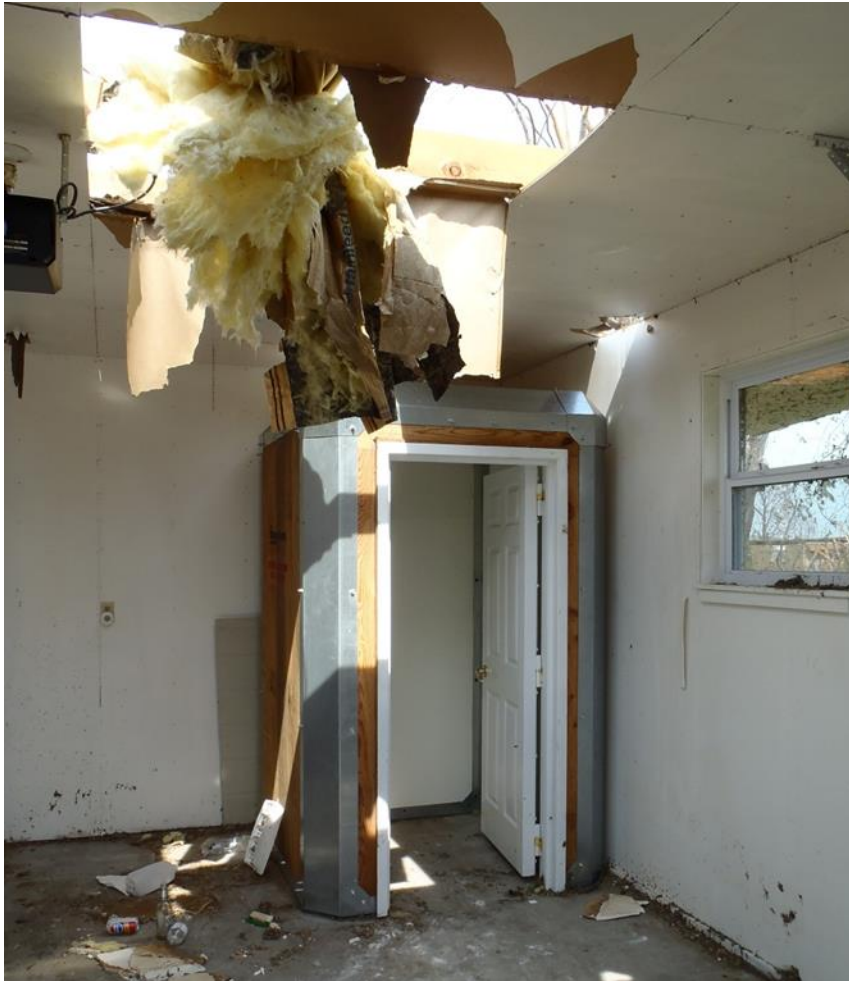
**Figure 3–129. Above-ground Kevlar® storm shelter bolted to concrete garage floor in residence that was damaged during the tornado.**

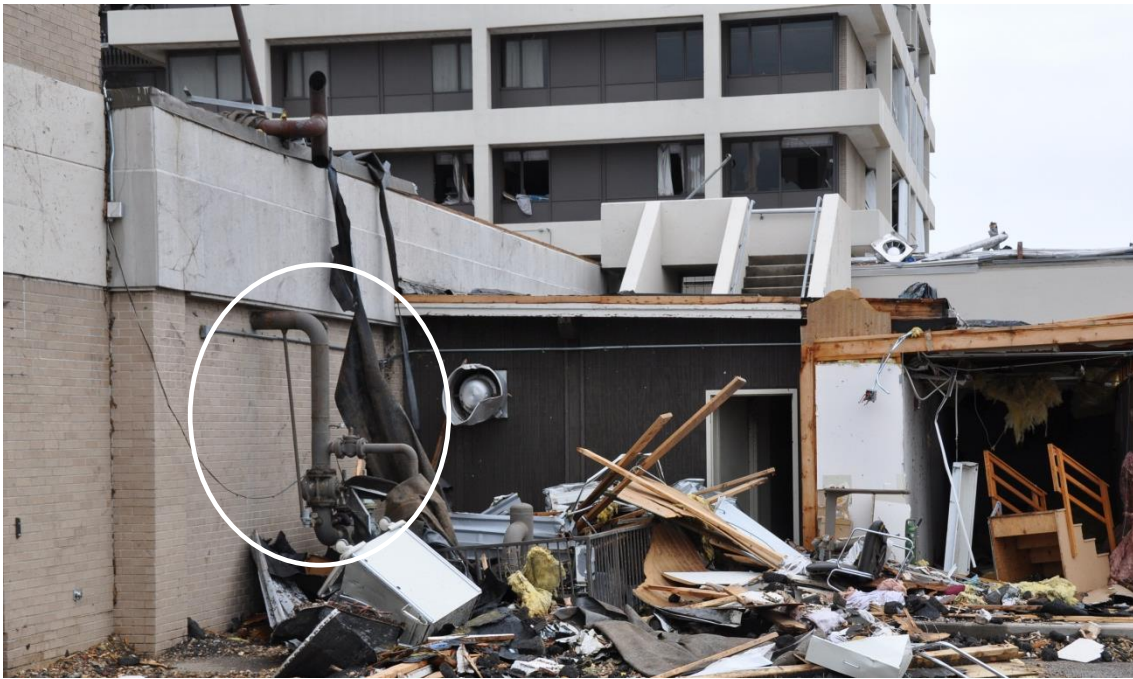
**Figure 3-132. High-pressure gas reducer valve at SJRMC that was damaged and leaked.**
