2011 Wildland Urban Interface Amarillo Fires Report #2 – Assessment of Fire Behavior and WUI Measurement Science

NIST Technical Note 1909

February 2016

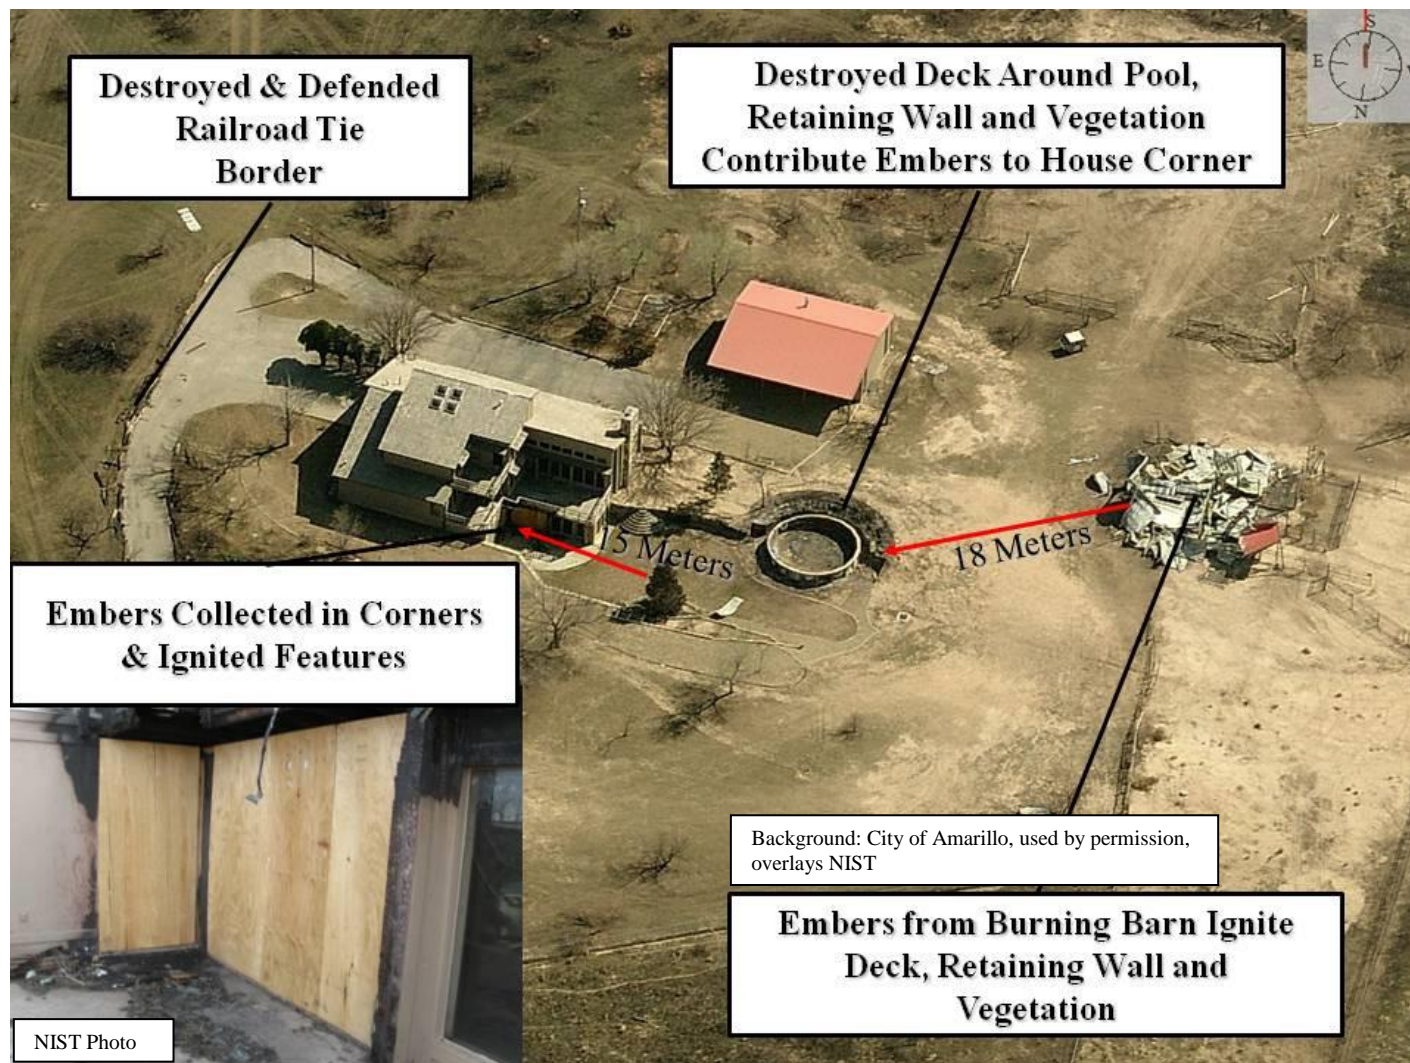
Figure 11 shows destroyed combustibles around 411 Roberts Drive.

Figure 11 Ignition mechanisms in and around 411 Roberts Drive, close to the fire origin. Structure was defended.

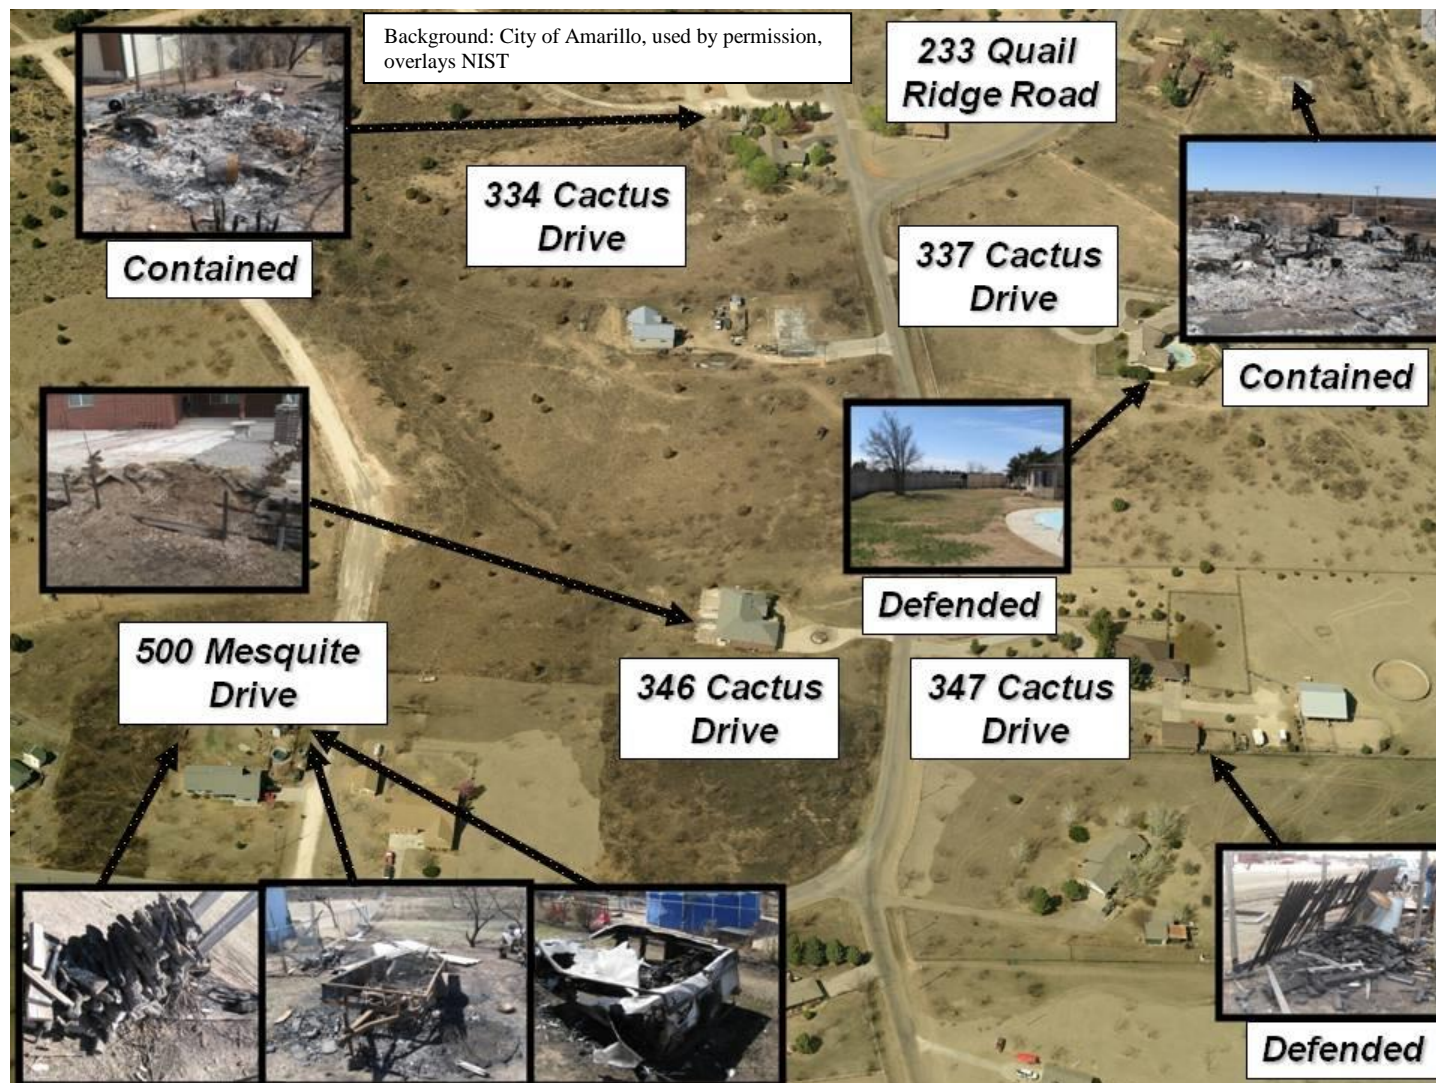
Figure 12 Ignition mechanisms around non-damaged or non-destroyed residential structures in Timber Creek Canyon, NIST photos.

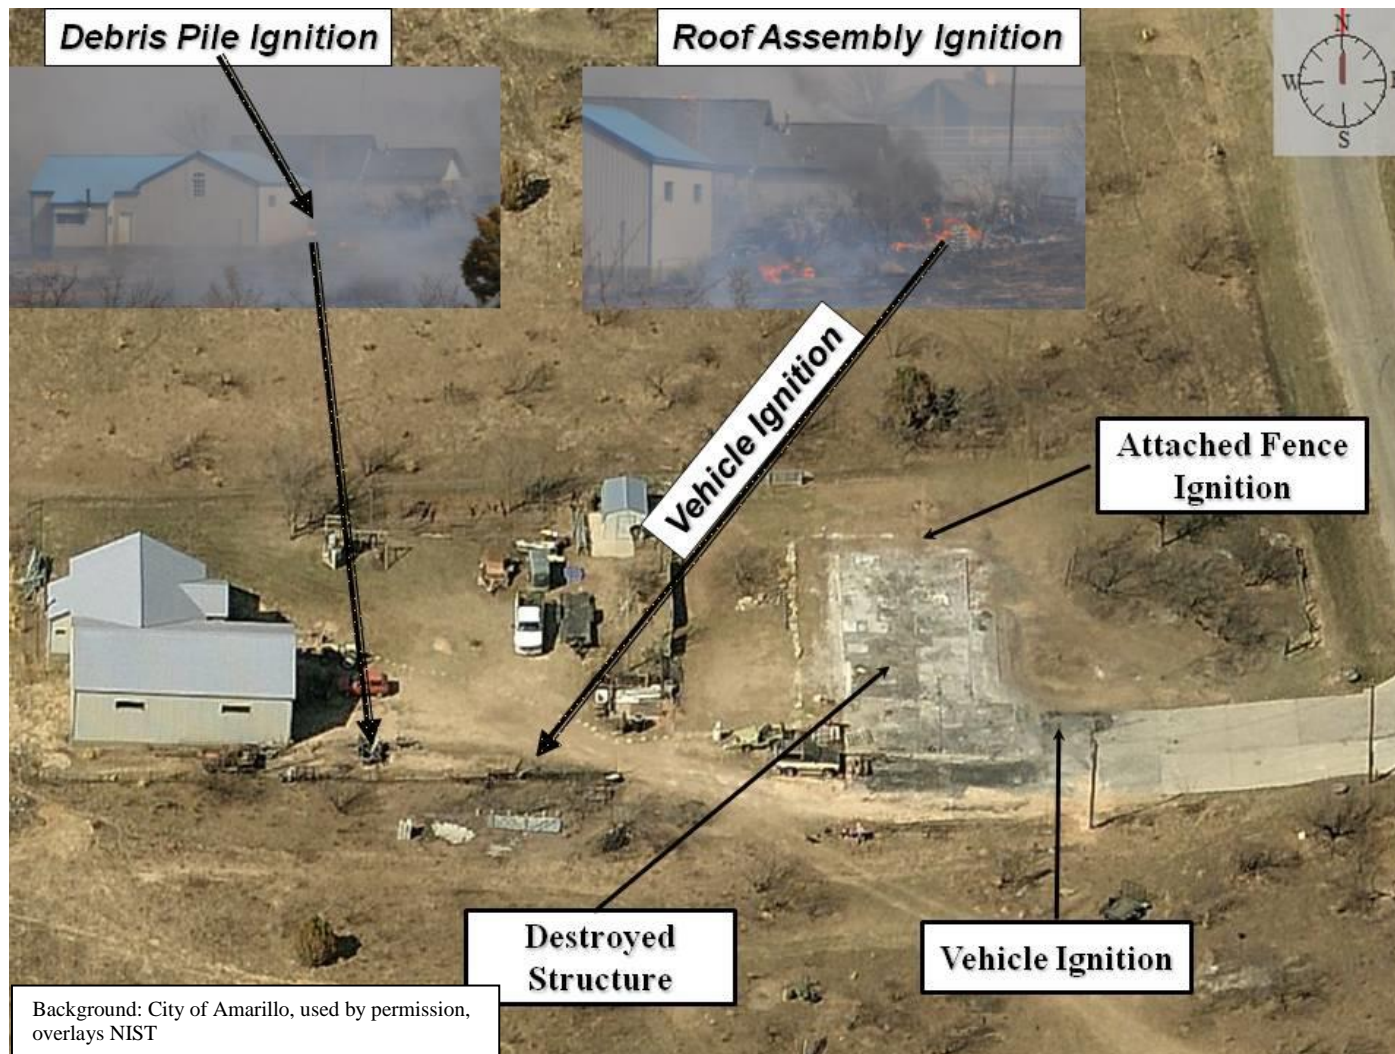
Figure 13 Structural element ignition mechanisms at 338 Cactus Drive. Structural elements portrayed are known or suspected to be ignited prior to residential structure ignition. Fire direction was from southeast to northwest and the attached fence was on the north of the destroyed home, NIST photos.

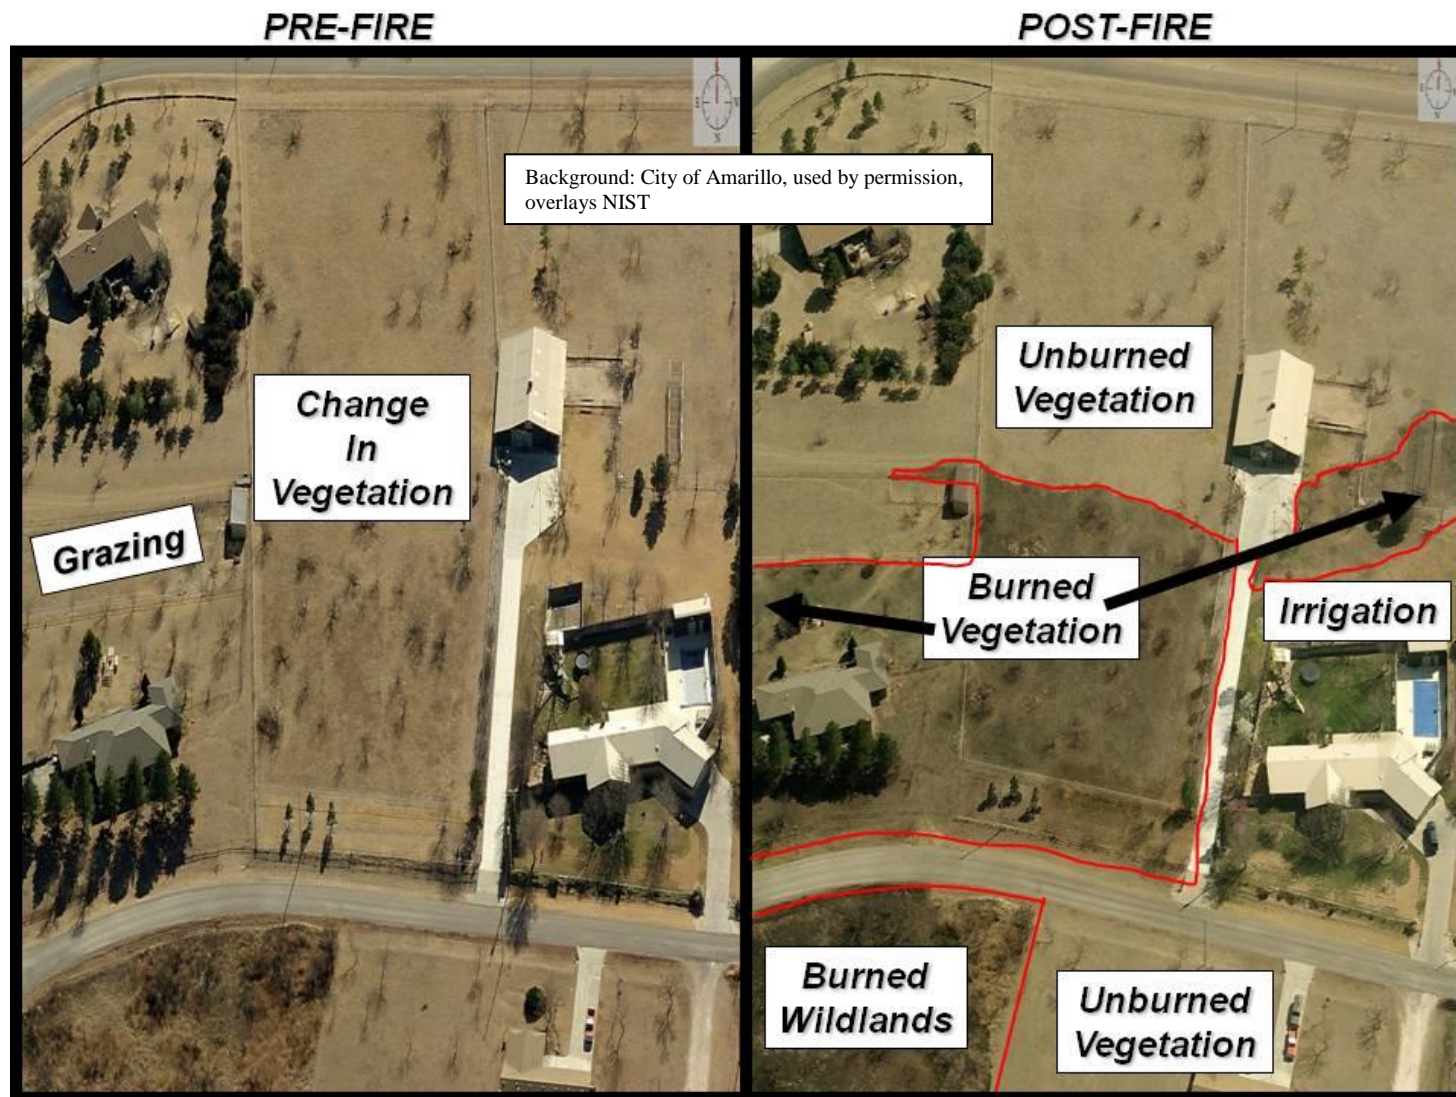
Figure 14 Pre-fire and post-fire imagery showing how vegetation treatments or landuse might have effected fire behavior. Approximate fire line is shown in red on image to the right.

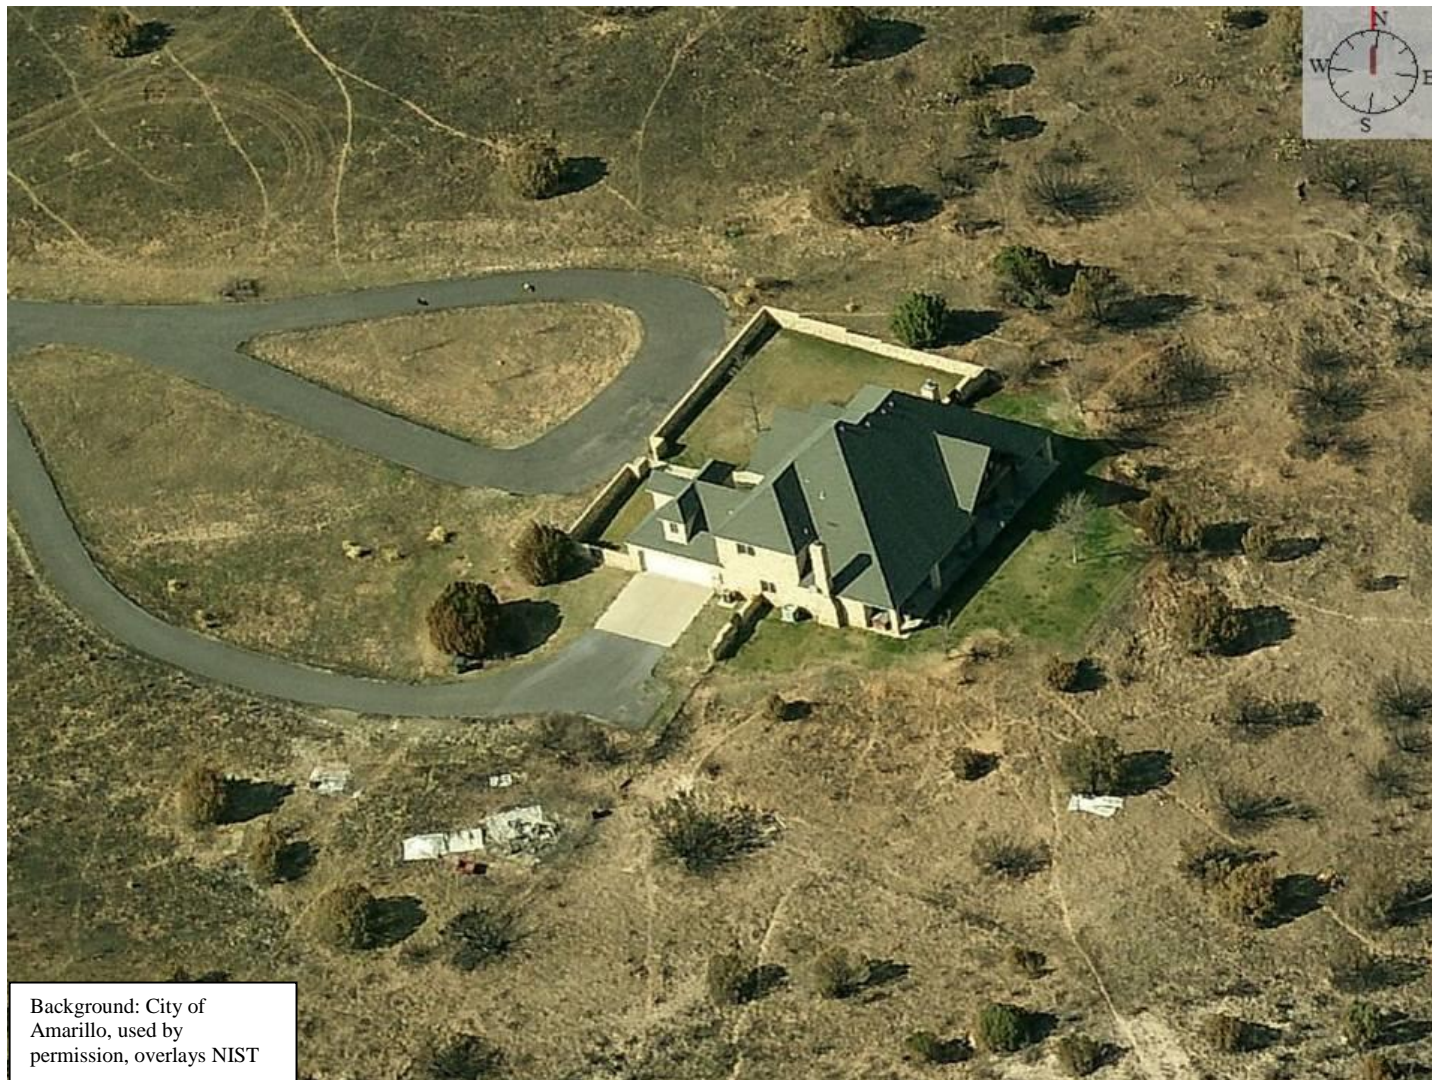
Figure 20 Treated vegetation around 209 Quail Ridge Road that might have helped to stop fire from contacting house. Exact contributions of defensive actions are unknown.

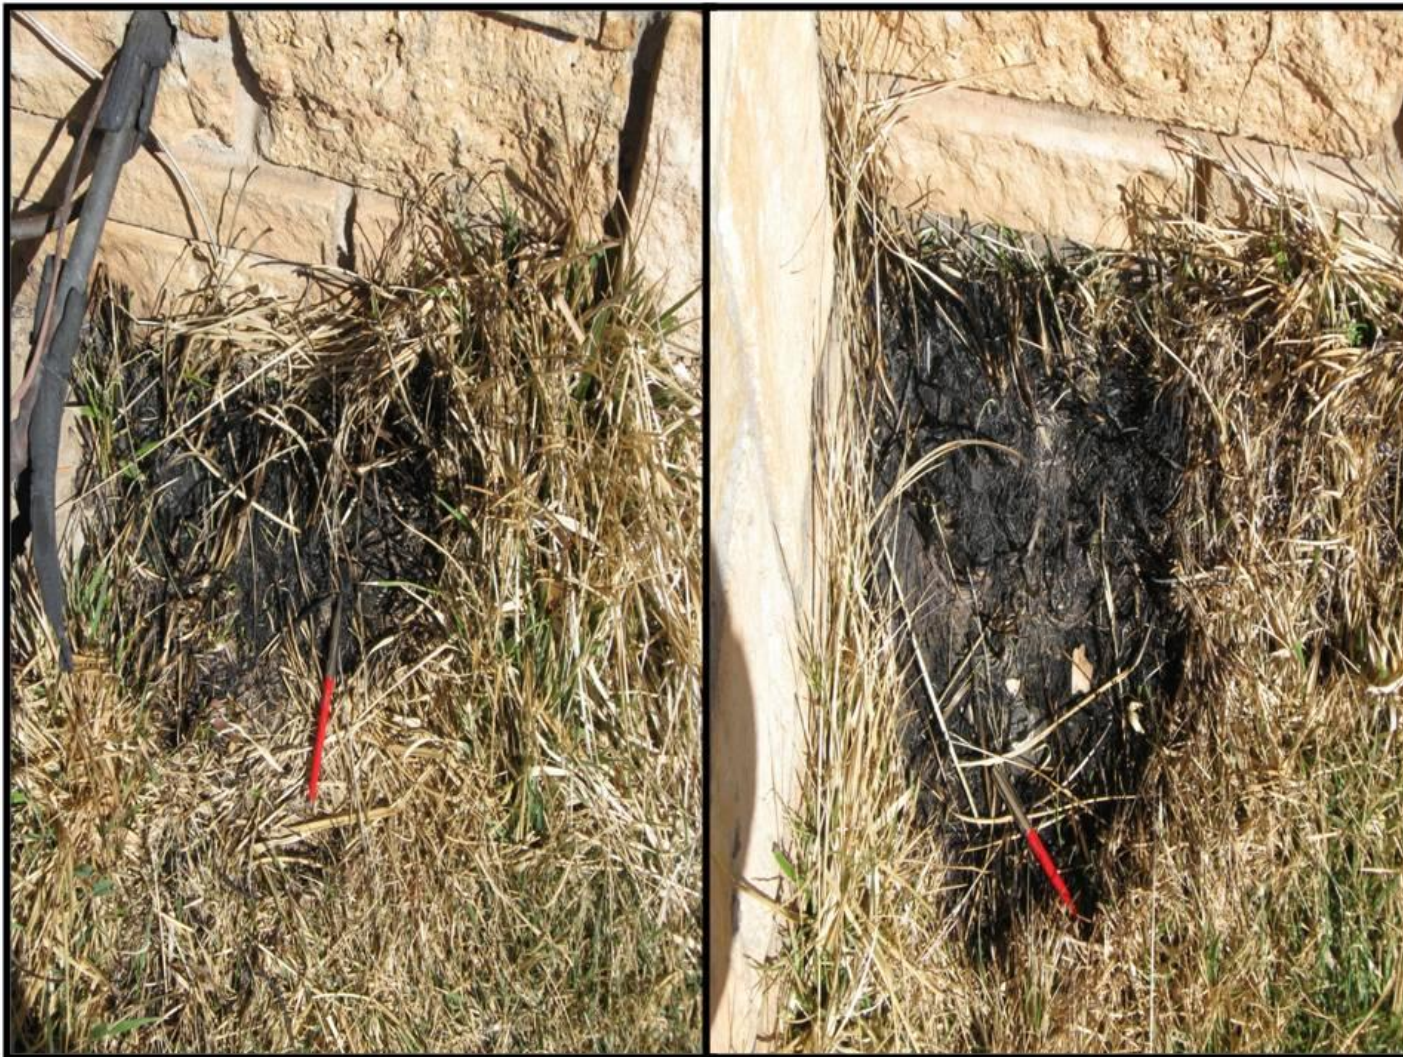
However, field assessments at 209 Quail Ridge Road identified small areas of vegetation burning adjacent to noncombustible sections of the house as shown in Figure 21. It is not known if these areas were extinguished through manual intervention or if they extinguished independently. These burned areas were in the direction of the fire front and might have ignited due to ember accumulation against the wall possibly combined with the non-mowed grass directly adjacent to the house.

Figure 21 Two distinct vegetation ignitions adjacent to structure at 209 Quail Ridge Road. Red feature is 15 cm (6 in) long ballpoint pen, NIST photos.

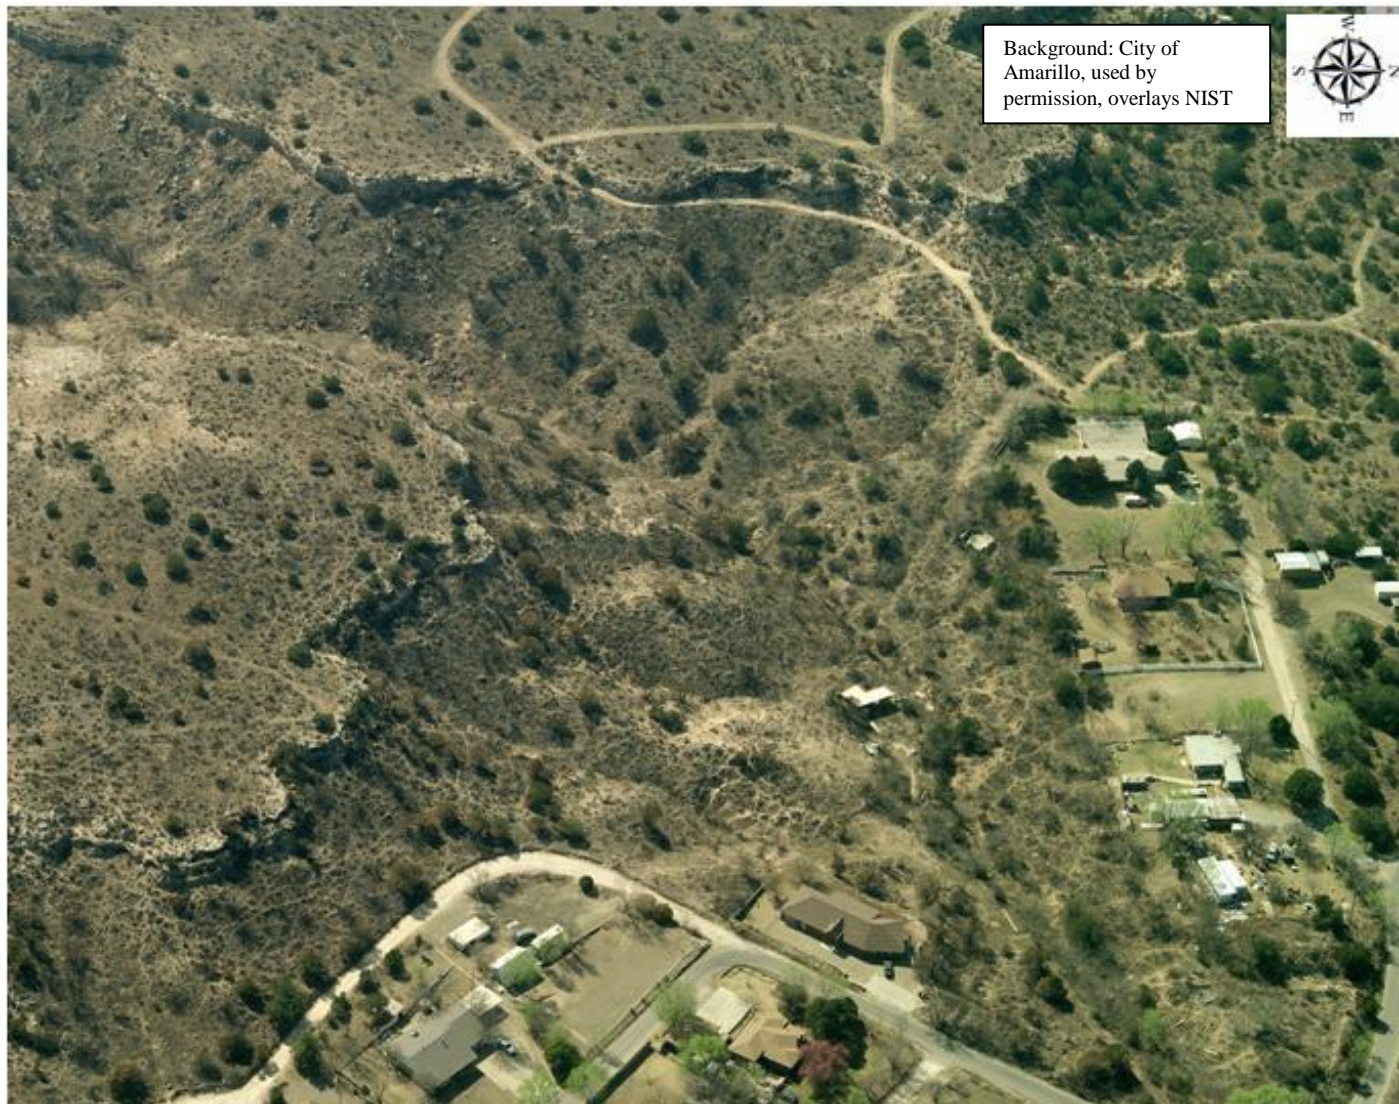
Figure 26 Post-fire south facing oblique imagery showing results of higher intensity fire on the southeastern side (northeast facing) of the canyon compared to the northwestern side.

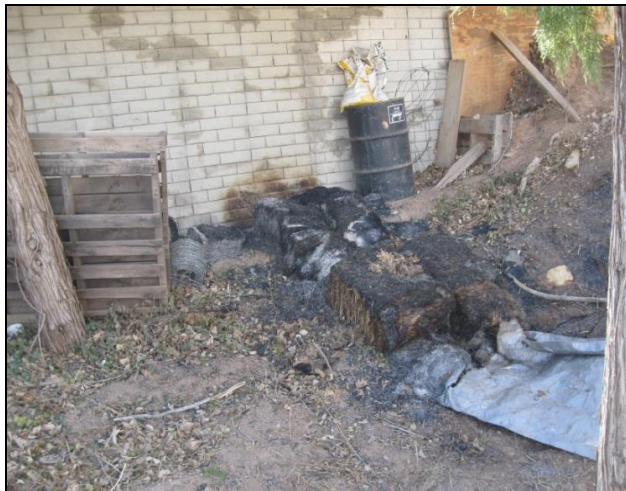
Figure 33 Burned hay bales leading from destroyed secondary structure to primary structure causing scorching on the brick siding. Categorization of defensive actions is unknown, NIST photo.

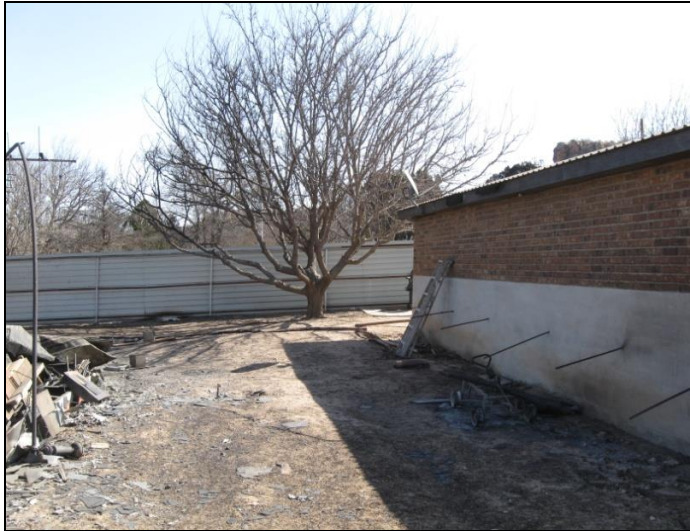
Figure 34 Unidentified burned features adjacent to the northern side of the residential structure at 102 Gary Drive. These features are believed to be ignited by the burning mobile home to the north of the brick residential structure, NIST photo.

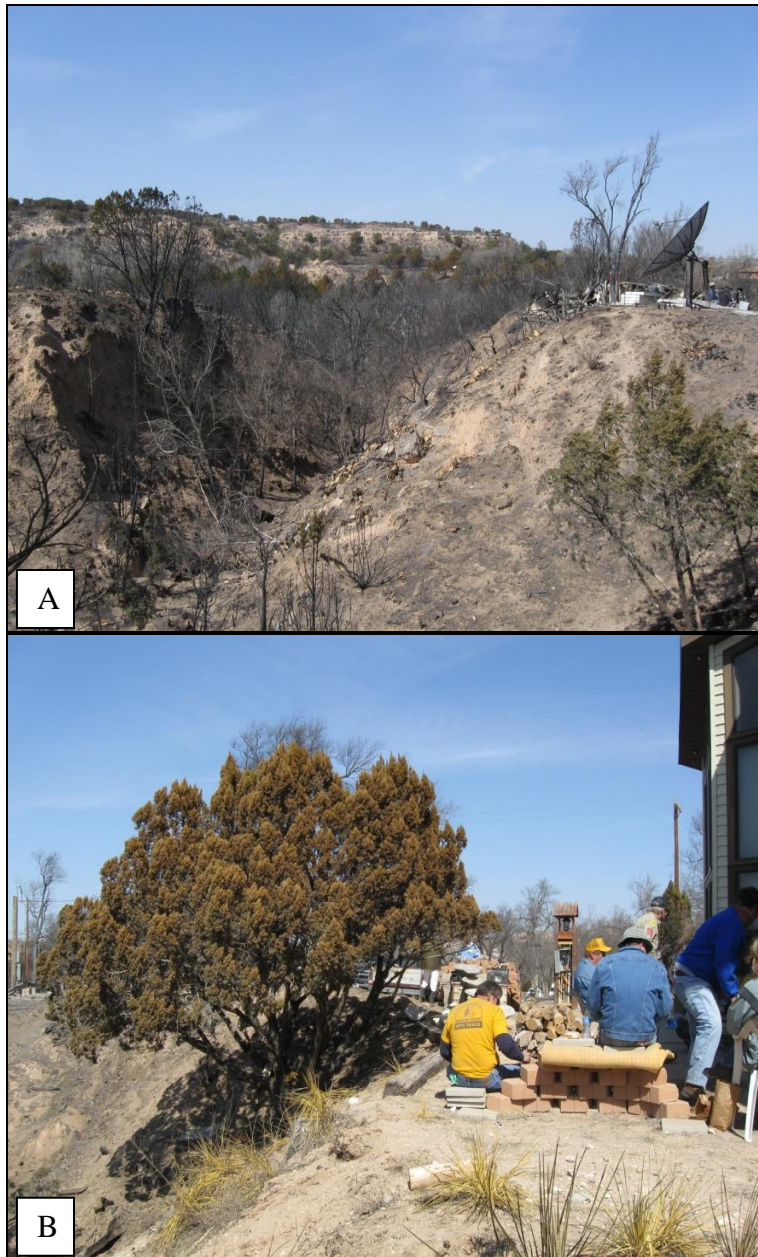
Figure 35 A: Stand replacing fire in the canyon to the west of 102 Gary Drive. B: Vegetation and building features with minimal damage at the top of the canyon, indicating topographically influenced fire behavior. Image taken from the south side of 102 Gary Drive looking north, NIST photos.

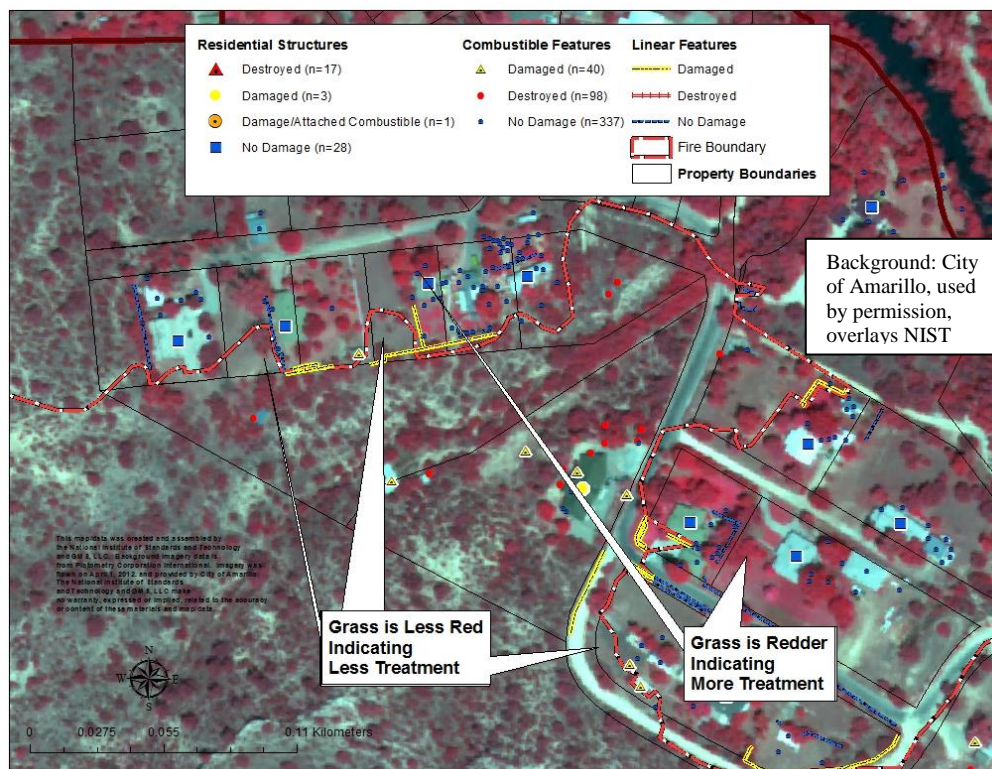
the fire and treatments, either those present or lack thereof, on the yards did not affect fire behavior. Also, the properties on Hill Drive appeared to be located on a less exposed area due to topography and wind. Other areas along Janet Drive and Gary Drive also showed burn patterns that corresponded to possible vegetation treatment in pre-fire imagery.

Figure 36 Portions of the fire perimeter overlaid on pre-fire (2009) color-infrared imagery. Fire did not travel into redder residential grass areas. This could be due to exposure conditions, defensive actions, pre-fire vegetation treatment or a combination of these factors.

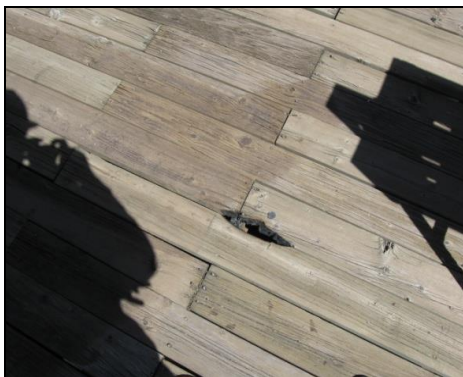
Figure 44 Ignited deck, which was extinguished by homeowners, NIST photo.

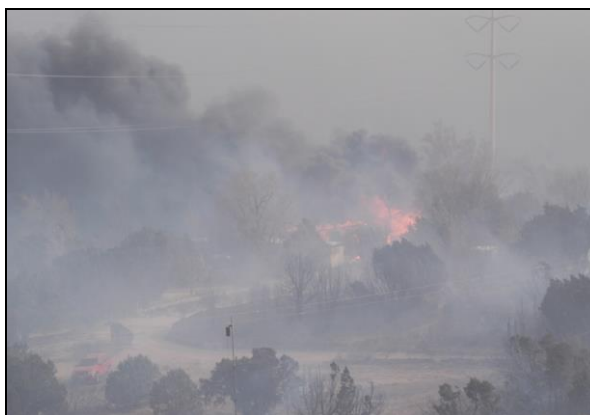
Figure 45 Fully involved residential structure at 128 Exmoor Road igniting residential structure at 130 Exmoor Road, Photo Gordon Ivy, used by permission.

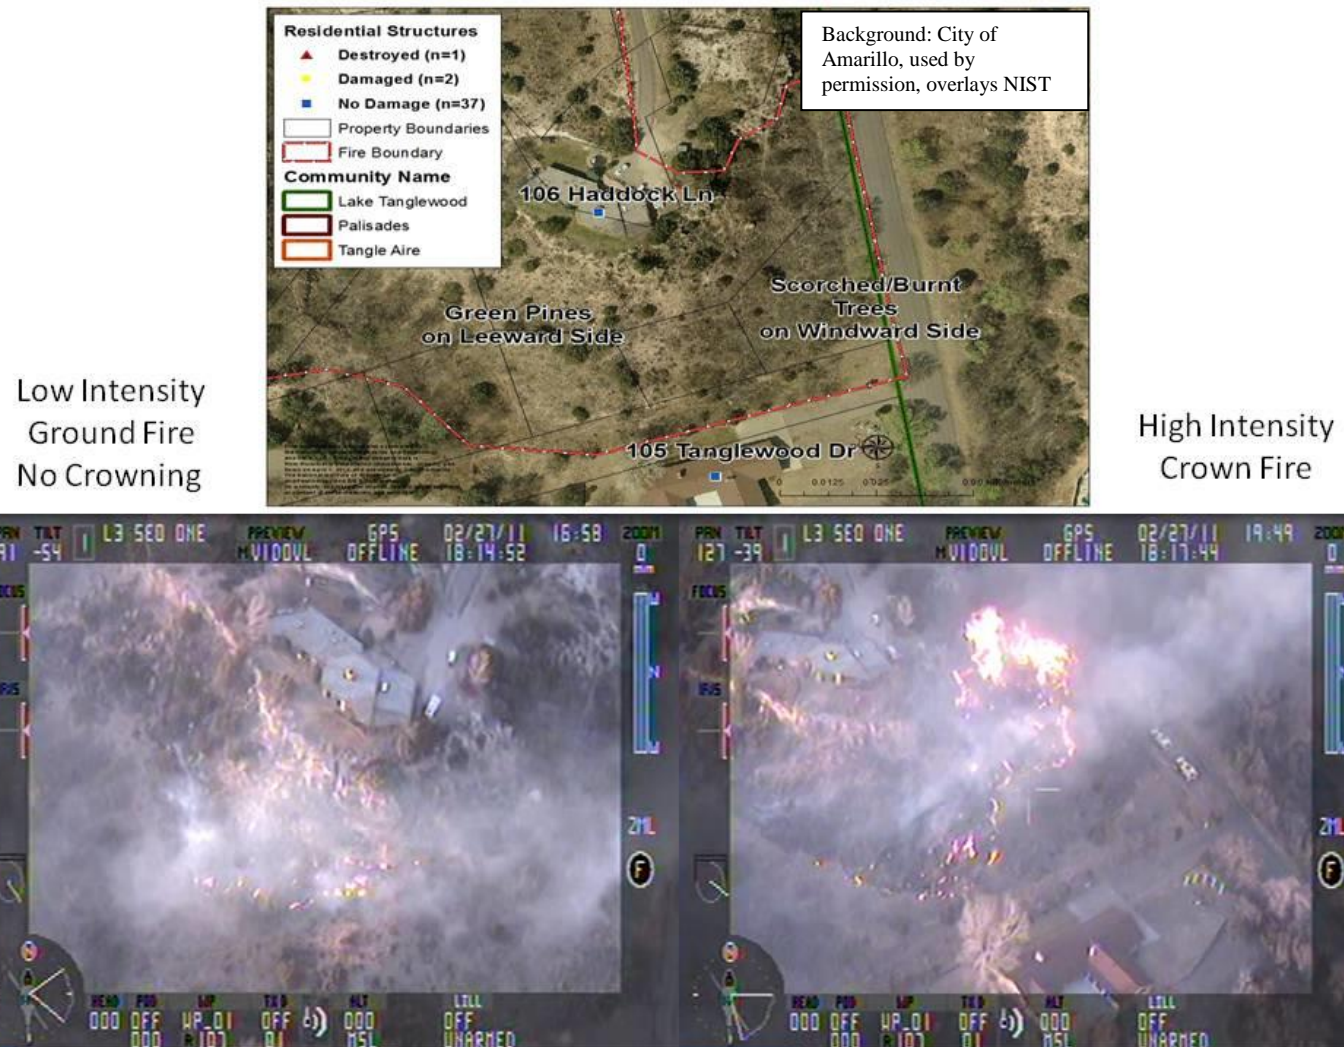
Figure 50 Fire behavior changes coincident with topography. Side directly exposed to wind (left) saw limited scorching and no torching of trees in post-fire imagery, and a low intensity ground fire during Amarillo Sheriff Helicopter flight. Side not facing wind (right) exhibited scorching and torching of trees in post-fire imagery, and a high intensity crown fire during helicopter flight was observed.

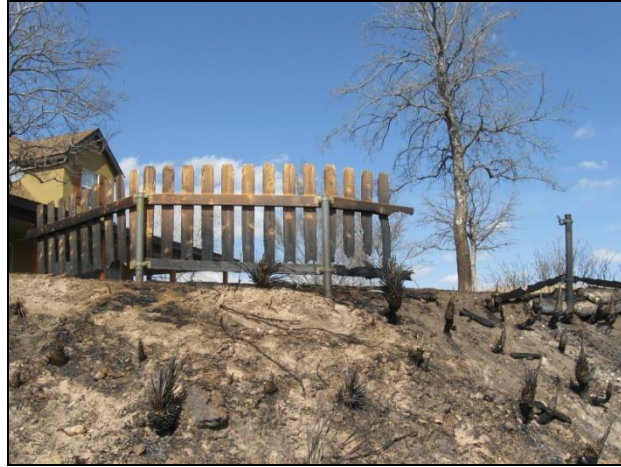
Figure 54 Partially destroyed fence at 100 Camino Alto, NIST photo.

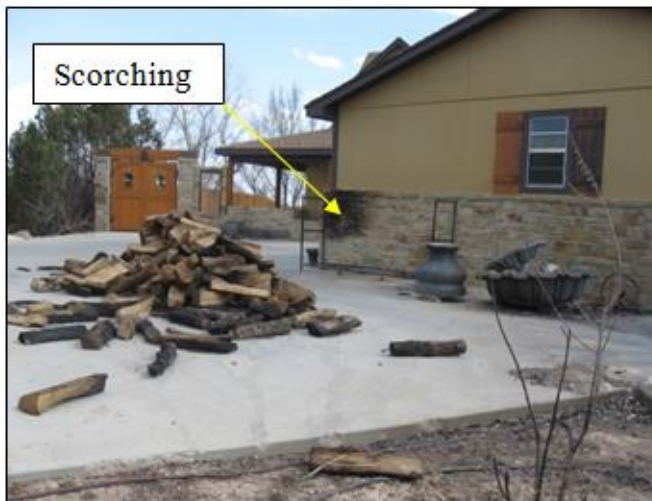
Figure 55 Defended firewood pile at 100 Camino Alto, NIST photo.

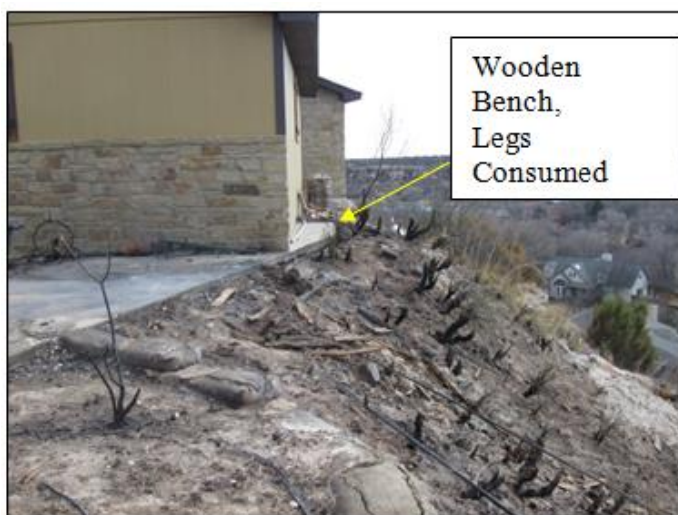
Figure 56 Damaged wooden bench and burned and unburned vegetation on west side of 100 Camino Alto, NIST photo.

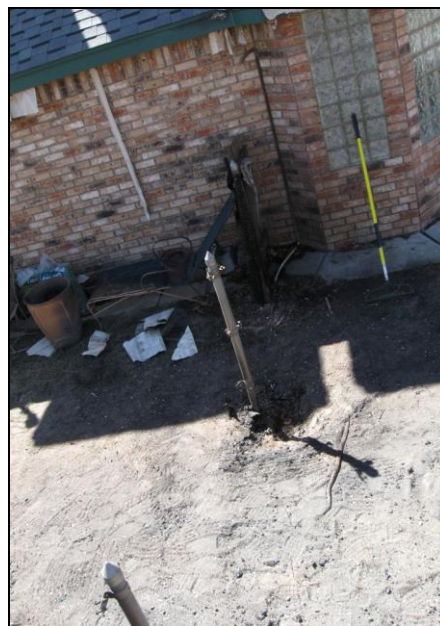
Figure 57 Partially destroyed wood fence, which caused scorching to brick siding and melting of vinyl soffit, NIST photo.

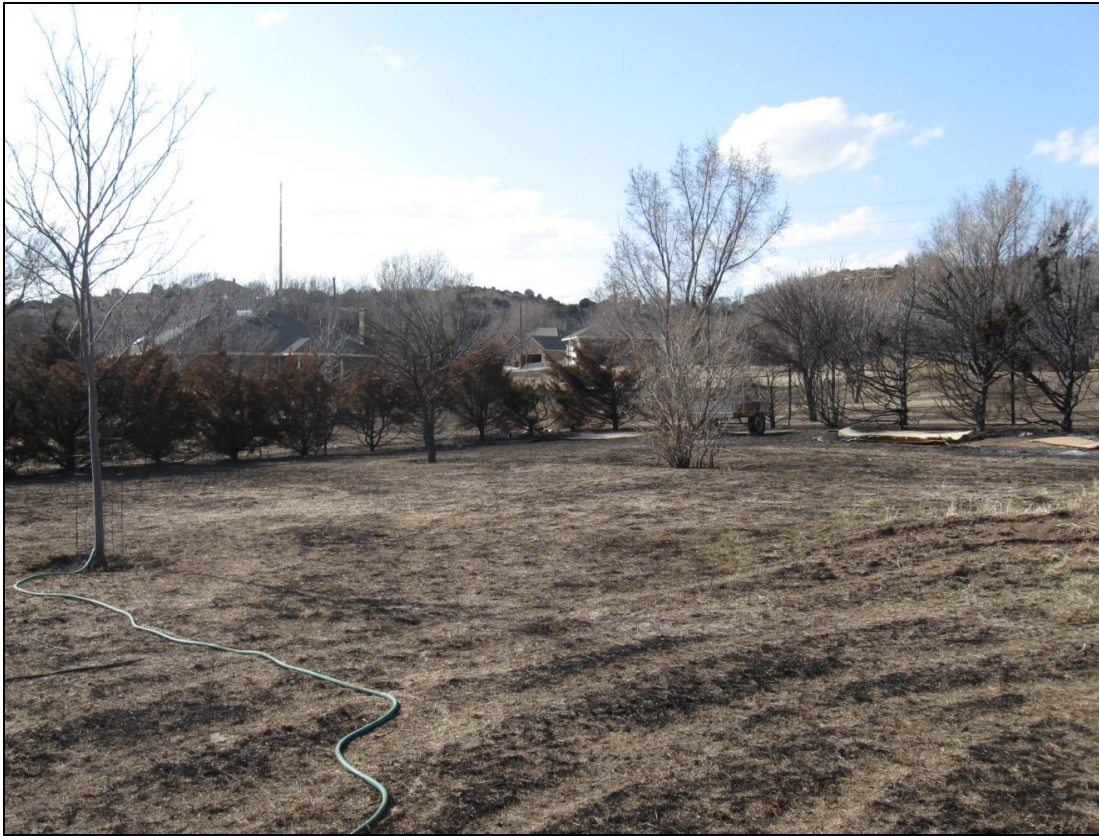
Figure 58 Burnt hedgerow and Buffalo grass that facilitated fire spread to destroyed secondary structure at 105 Port-O-Call Drive, NIST photo.

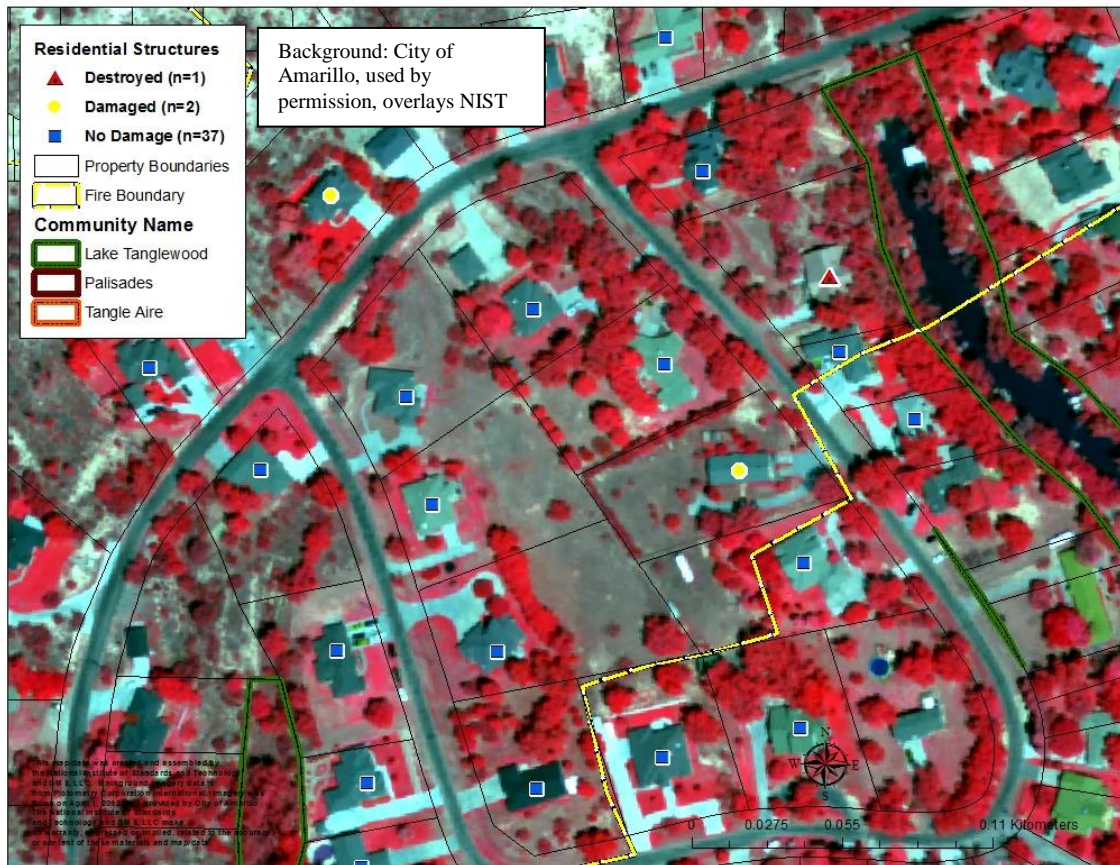
Figure 59 Pre-fire false color imagery showing redder areas that did not burn along with brown to black areas that did burn. In some locations the fire perimeter ended where these red, photosynthetically active, areas began and interior, red, photosynthetically active areas did not burn.

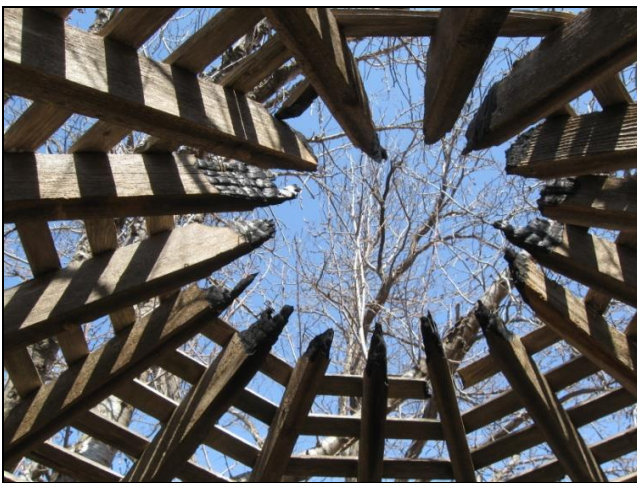
Figure 60 Damaged pergola roof ignited by embers, NIST photo.

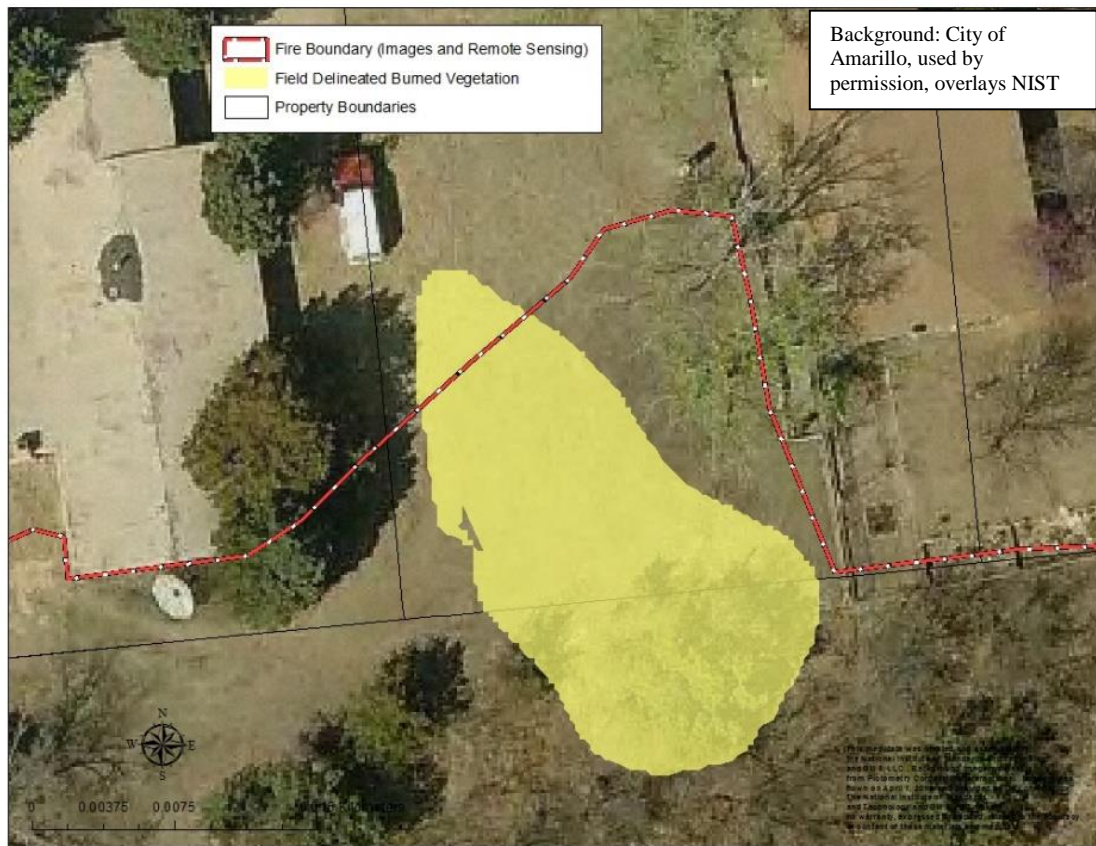
Figure 74 Erroneous field collected burn vegetation boundary
