RELIABILITY OF FUSIBLE TIN BOILER PLUGS IN SERVICE

By John R. Freeman, Jr., J. A. Scherrer, and S. J. Rosenberg

In cooperation with the Steamboat Inspection Service a study has been made of the reliability of fusible boiler plugs of the type installed in ships boilers under the jurisdiction of the Inspection Service. It has been found that under certain conditions fusible plugs would not operate due to the formation in service of a refractory oxide replacing the tin in the fire end of the plug. Apparatus is described in which plugs may be tested under simulated service conditions. The results of examination and tests of 184 plugs returned from service indicated that 10 per cent of all plugs in service would not operate when and if required. Recommendations regarding specifications and design of plugs to eliminate this dangerous condition are made.

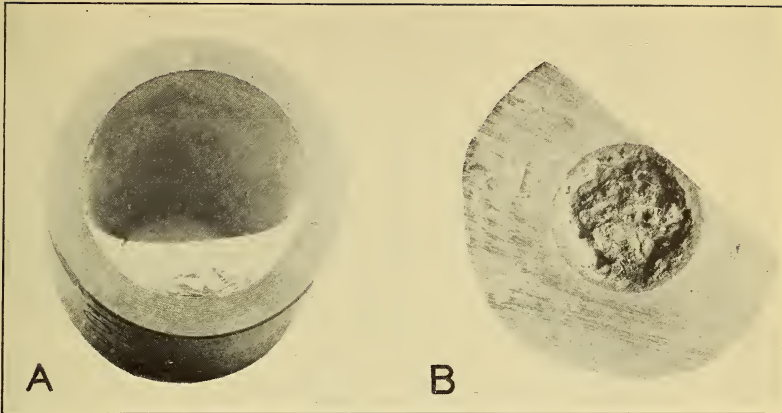
FIGURE 4.—*Plug No. 91 after test*

The cause of the failure to function was evident in every case. It was always due to the presence of a hard "infusible crust" packed tightly in the fire end of the plug replacing some of the tin filling. In general, this deposit was apparent upon inspection, but in many cases, especially when the tin in the fire end had been melted out for an appreciable distance back into the plug, it was difficult to determine its presence, and in some instances a plug which was apparently in good condition failed to function in test because of it.

The appearance of this so-called infusible crust is shown in Figure 4 (plug No. 91). Figure 4 (b) shows the water end of plug No. 91 after test. It is evident that the tin melted during test and the plug would have functioned except for the obstruction which had formed in the fire end during service. This is typical of all plugs that failed to blow out in test.

A, Appearance of water end filling melted during test but "infusible crust" in fire end prevented blowing; B, appearance of fire end showing "infusible crust" which had replaced filling during service.

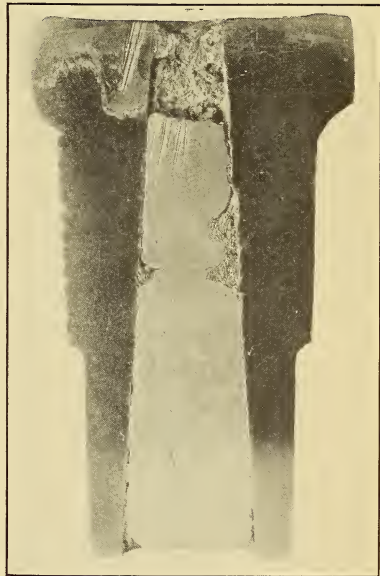
FIGURE 6.—*Section of plug No. 3*

Deposit in fire end would probably have prevented functioning.

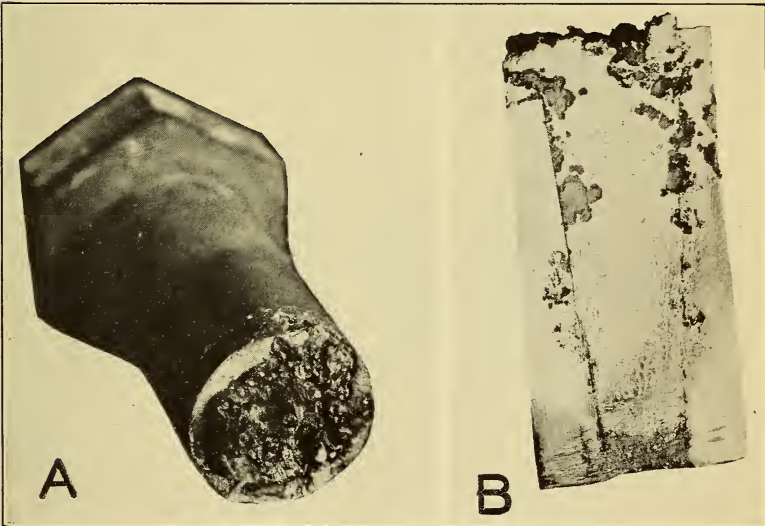
If the tin should not run out but remain in the plug in a molten condition, it probably would rapidly pick up copper from the casing and also might readily oxidize and finally fill up the fire end with the "infusible crust" noted. In order to determine the validity of this hypothesis, one end of a fusible plug was closed with a copper plug. A heating coil was wound around the casing and the entire plug heated to a temperature above the melting point of tin for approximately three months. The tin filling was left open to the air and was stirred about once a day with a glass rod. It was apparent that the tin was oxidizing and a hard infusible crust similar in appearance to that found in used plugs eventually formed. The appearance of the crust formed is shown in Figure 7 (a). A longitudinal section of the plug is shown in Figure 7 (b). It is evident that particles of the oxide had been stirred into the molten tin, and in time the oxide would have completely replaced the pure tin at least at this end of the plug.

FIGURE 7.—*Infusible crust produced in plug in laboratory*
A, Shows oxide crust in end of filling; B, longitudinal section through filling.

It will be noted that the copper content of the tin has attained a very high value with a consequent raising of the melting point of the filling to approximately 650° C., considerably above that of pure tin. This, of course, is a very extreme condition, but emphasizes the importance of preventing molten tin from remaining in the plug.
