Corrosion of Steel Piling in Soils¹

Melvin Romanoff

(April 18, 1962)

Results of inspections made on steel pilings which have been in service in various underground structures under a wide variety of soil conditions for periods of exposure up to 40 years are presented.

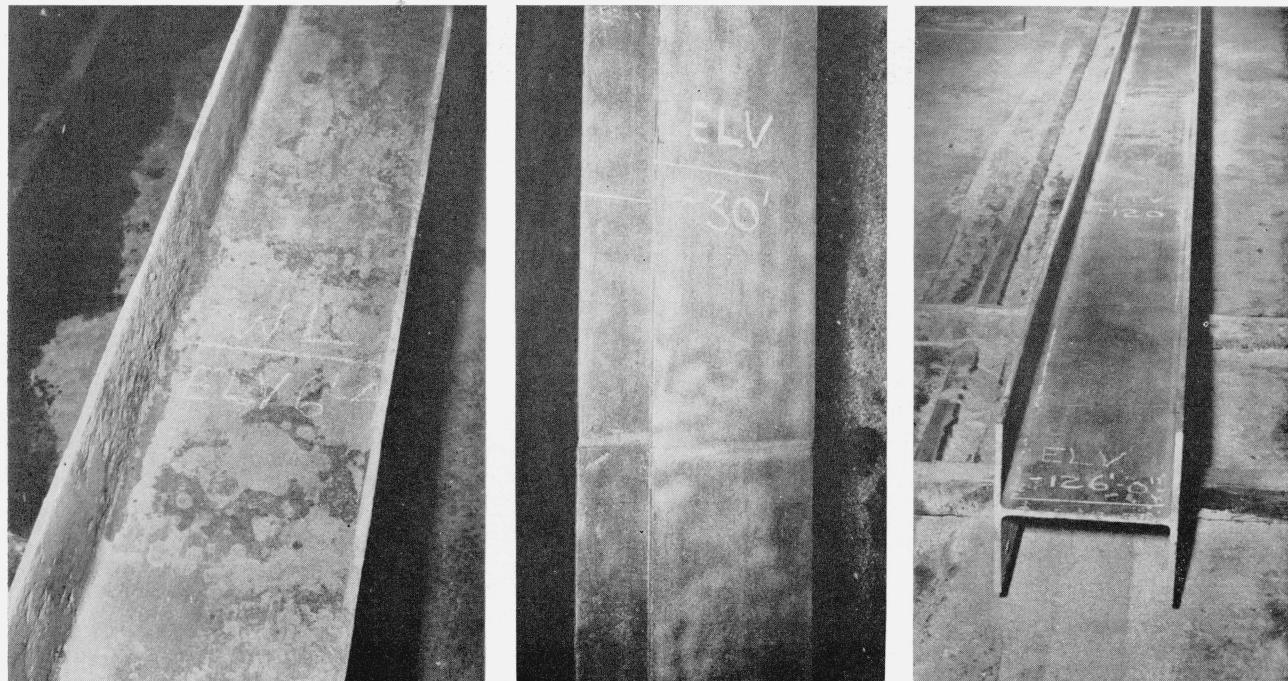
FIGURE 1. Sections of the 139-ft H-piles pulled from Sparrows Point, Maryland, after exposure for 18 years.

The pattern and amount of corrosion on the two piles were about the same. Corrosion was confined to two areas. One area extended from the top of the piles, which was above ground level, and extended through the zone exposed to the cinder and slag fill in the water table zone. The other corroded area occurred between elevations -115 to -118 ft where the piles passed through a sand and gravel bed.

-115 to -118: At this depth the piles passed through a sand and gravel stratum. The steel surfaces were uniformly corroded and contained many localized pits which generally ranged in depth up to 50 mils; 12 pits measured between 50 and 65 mils and 2 pits had depths of 80 and 95 mils. The average reduction in flange thickness measured 9 and 4 percent, respectively, for pile I-S and for pile II-S.

Figure 1 shows the condition of pile II-S at three different levels.

Left, water table zone consisting of fill material; center, clay soil stratum at about elevation -30 ft; and right, coarse sand and gravel stratum underlain by clay between elevations -110 and -126 ft. The pile was cleaned by sandblasting. Note the excellent condition of the butt weld at the splice in the center photograph.

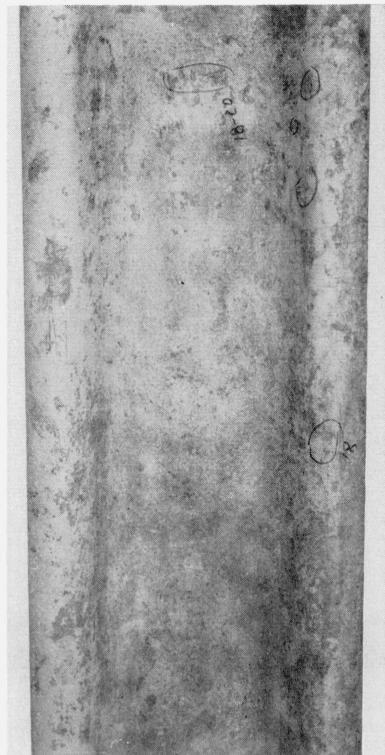
FIGURE 2. Sandblasted 3-ft section from the 40-year-old piling extracted from an abutment wall in the Corps of Engineers Dam and Lock No. 8 on the Ouachita River near El Dorado, Arkansas.

The entire length of the pile was driven below the water table. Corrosion was confined to a 2-ft section on the river side of the pile between elevation 59.8 to 61.8 ft. Pitting occurred in 11 places, each about 1 in.² in area, along the fingers of the pile. The maximum pit depth was 26 mils and others ranged up to 22 mils. Several pits having a maximum depth of 20 mils were found in a 3-in.² area in the center of the web. Ninety percent of the mill scale was intact in this moderately corroded zone. At least 95 percent of the original mill scale was found to be intact on the remaining areas of the pile, and no measurable pits or corrosion beyond the mill scale was observed. Based on the maximum pit depth, the total loss of pile thickness in the corroded zone could not exceed 5 percent of the original pile thickness.

The section was exposed about 18 ft below the ground line and it is the only portion of the pile which contained pits of measurable depth. The maximum pit was 26 mils in depth.

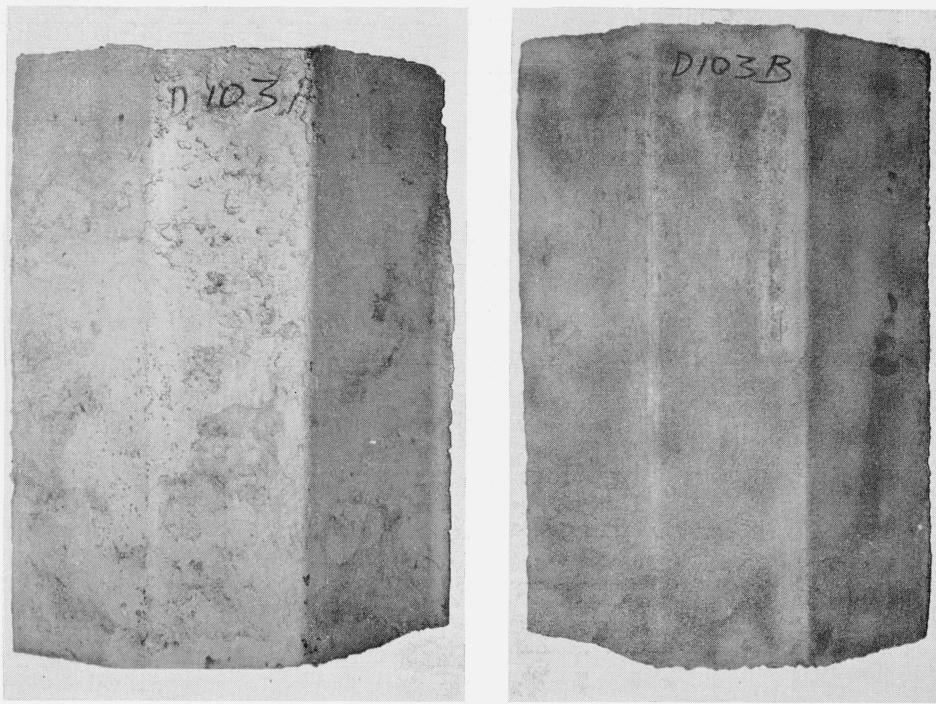
FIGURE 3. Sections (1.5 ft by 1 ft) cut from a piling which was pulled from the north upstream wingwall of the Grenada Dam Spillway at Grenada, Mississippi, after exposure for 12 years.

Sections were cleaned by sandblasting.
D103A, section of pile exposed to fill soil.
D103B, section of pile exposed to natural soil.

251.5 to 246.0 ft: Many scattered pits up to 50 mils in depth. Seven pits measured between 68 and 80 mils, and two pits 88 and 122 mils in depth. Pits were of similar depth on both sides of the pile, but much less numerous on the side facing the spillway. About 50 percent of the mill scale was intact on the spillway side and 10 percent on the other side. The reduction in cross section of the three most corroded areas measured between 6 to 8 percent of the original wall thickness.

244.0 to 237.5: About 75 percent of the mill scale was present over the surfaces in this zone. No measurable pits were found except two at elevation 241.0 ft which were 13 mils in depth. The average wall thickness of a 17 × 22 in. section removed from this zone was 0.37 in. after cleaning by sandblasting.

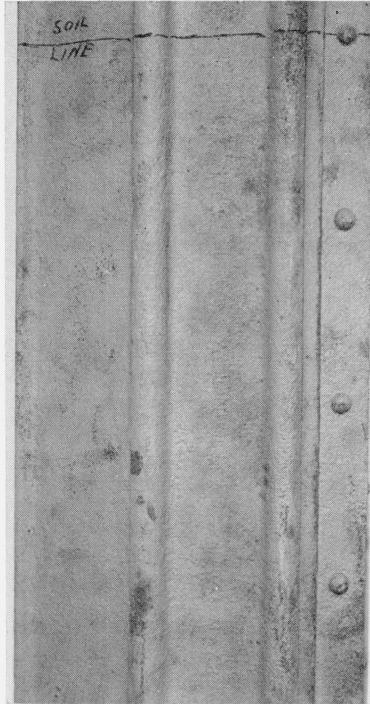
FIGURE 4. A 3-ft section of steel sheet piling exposed below the soil line in a cofferdam structure in the Lumber River near Boardman, North Carolina.

+2.5 to 0 ft: Section exposed to total or partial water immersion, or atmosphere. Uniform corrosion of surface. Measurements of the cross section in the top 6 in. of the piles (elevation +2.5 to +2.0) showed a minimum thickness of 0.06 in. in places. This represents a loss of 76 percent in the original pile thickness. The maximum thickness measured on uncorroded surfaces near the bottom of the piles was 0.26 in. Piles in the zone between +2.0 ft to the ground line showed a maximum reduction in thickness of 60 percent.

-3 to -17.5: In this zone the condition of the surface was similar to that described above, but was less severely corroded. Many isolated pits measured up to 30 mils in depth, and relatively few up to 60

mils. A maximum reduction in pile cross section of 12 percent was noted in this zone.

Exposure, 37 years.

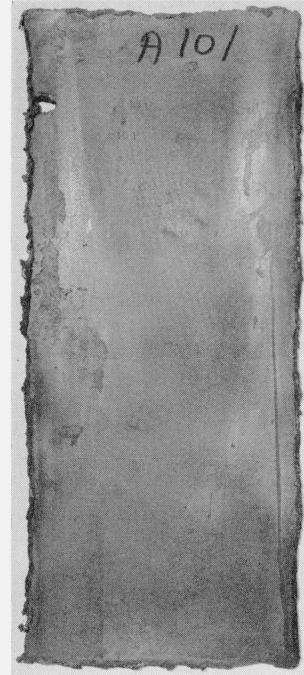
FIGURE 5. Steel sheet piling sections (2 ft by 1 ft) cut from two locations on the Memphis Floodwall after exposure for 6.3 years.

The entire surface of the pilings was in excellent condition. More than 90 percent of the mill scale was intact. There was very slight uniform metal attack in small localized areas. No measurable pits were found on the entire surface. From elevation 218 to the bottom of the excavated pit, the clay adhered very tightly to the piling. On removal, the soil peeled off in layers leaving free water on the steel surface.

A 2 ft by 1 ft section removed from the pile is shown in figure 5.

The sections were cleaned by sandblasting.

A101, section of coated piling showing pits up to 35 mils in depth, occurring in area of damaged coating.

A102, section of uncoated piling exposed to a silty clay containing cinders showing no measurable corrosion.

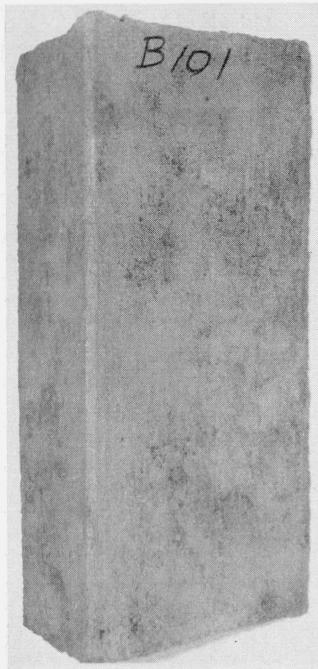
FIGURE 6. Sandblasted sections of Z-type sheet piling cut from two different locations in the Vicksburg Floodwall after exposure for 7 years.

Although cinders were present in the soil at both locations, no significant corrosion occurred.

Approximately 30 to 40 percent of the steel surfaces was covered with mill scale. Soil adhered in many areas of about 1-in.² like barnacles, beneath which appeared uniform metal attack or shallow pitting. Pitting up to 40 mils in depth was widely scattered and confined to areas of less than 1 in.² At elevation 83.5 to 81.5 ft, there were a few pits with depths between 40 and 45 mils. Measurements made on the three most corroded 1 in.² areas showed an average reduction in the cross section of the web of 4 to 6 percent. A section removed from the most corroded area of the pile is shown in figure 6.

Mill scale was intact on about 70 percent of the piling surfaces. There was no difference in the appearance of the surface at the different horizons. Where the mill scale had been removed, there was a film of red rust which was brushed off with ease. Under the rust, the steel surfaces were smooth. No measureable pits were found on the exposed pilings. Measurements fail to show a perceptible reduction in wall thickness (fig. 6).

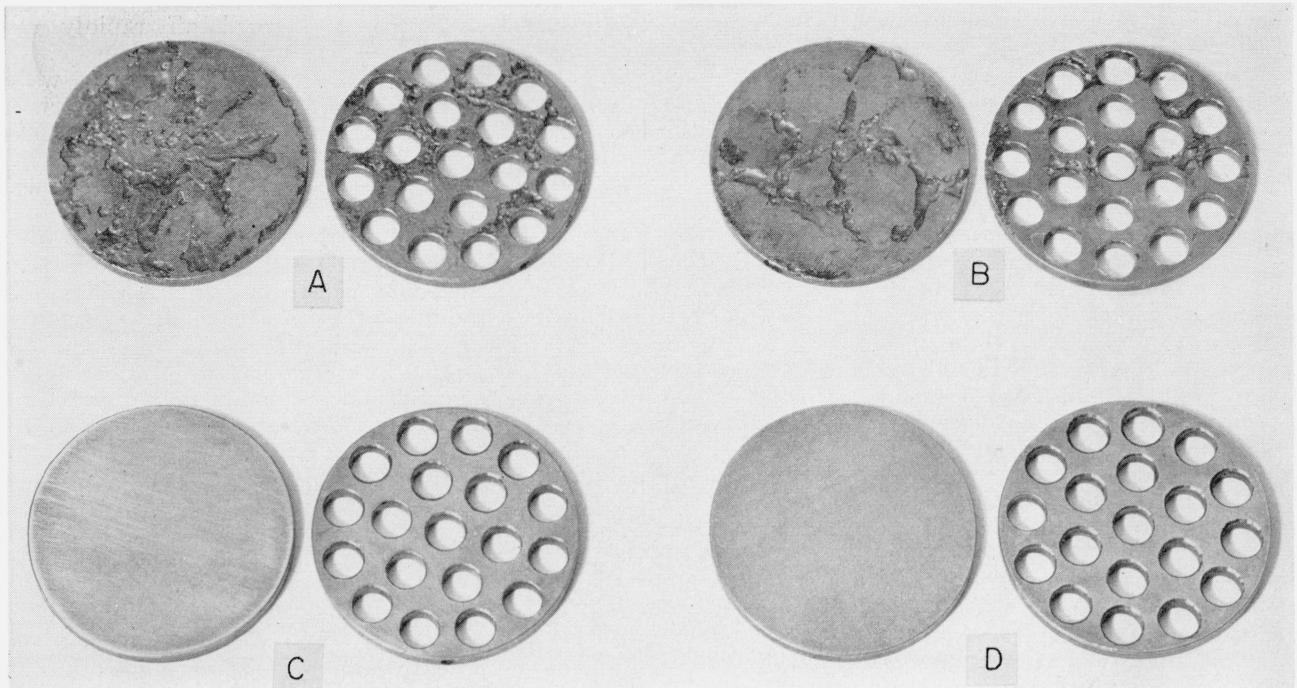
FIGURE 7. Corrosiveness of soil samples from Bonnet Carre Spillway as indicated by electrode weight losses after 6 months in modified Denison corrosion cells.

Electrode sets A and C set up under aerated and unaerated conditions, respectively, with soil samples obtained at 22 ft depth from surface of ground.
Electrode sets B and D set up under aerated and unaerated conditions, respectively, with soil samples obtained at 45 ft depth.
