ACCELERATED WEATHERING TESTS OF SOLDERED AND TINNED SHEET COPPER

By Peter R. Kosting¹

ABSTRACT

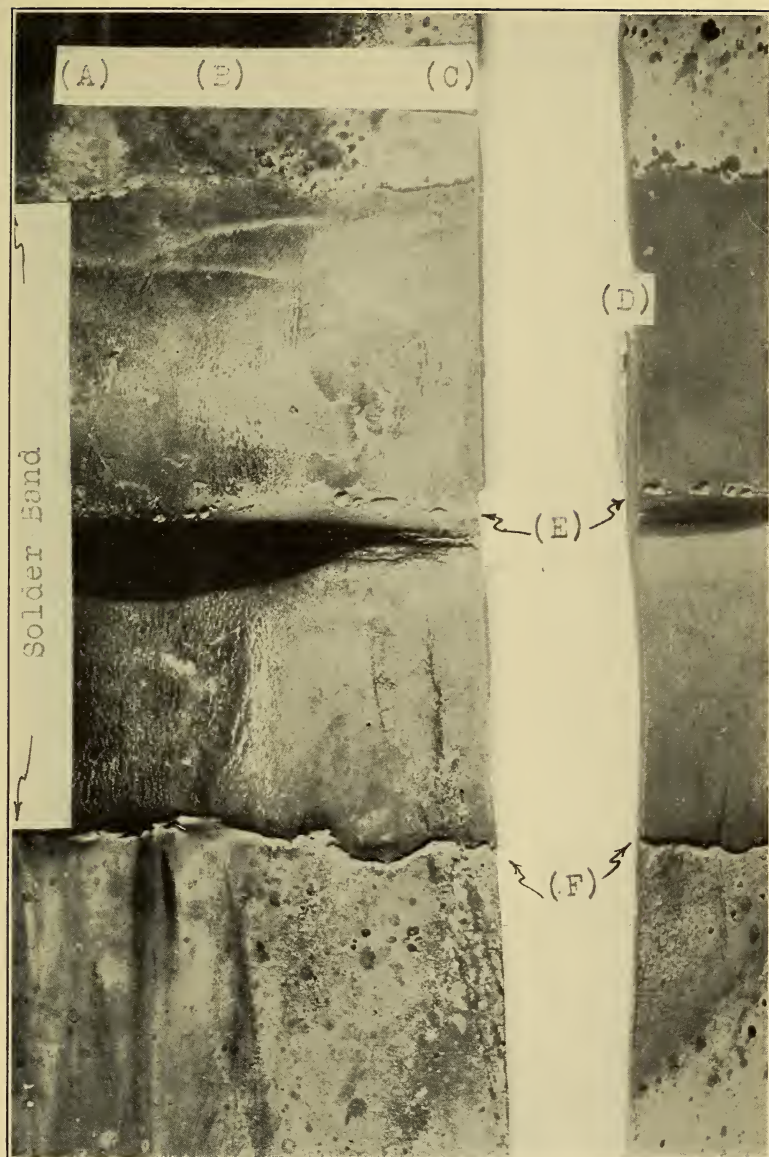
A typical case is illustrated by a sample of sheet copper which had been in service for 16 to 20 years as a valley (fig. 1) in the roof of a residence, and which was sent to the Bureau of Standards for examination. Marked furrowing was observed in the copper along the lower edge of the solder band at those portions not covered by the shingles. No localized corrosion of the copper had occurred along the upper edge, except in the areas where the flow of rain water was greatest. Pits extending through the solder into the copper had formed along the high ridge of the soldered lock seam. Evidence of included flux was obtained upon sectioning the seam. Cavity *D* was found to be filled with liquid, probably flux; likewise, the underside of the seam gave indications that flux had been left in place, although there was no evidence of any deep-seated corrosion having occurred.

FIGURE 1.—Seam corrosion on soldered copper valley. $\times 2$

A, Etched copper where flow of rain water was greatest; B, tarnished copper; C, patina covered copper where flow of rain water was least; D, hole of seam in which flux was trapped; E, pits extending through solder at high ridge of seam; F, furrow at copper-solder junction.

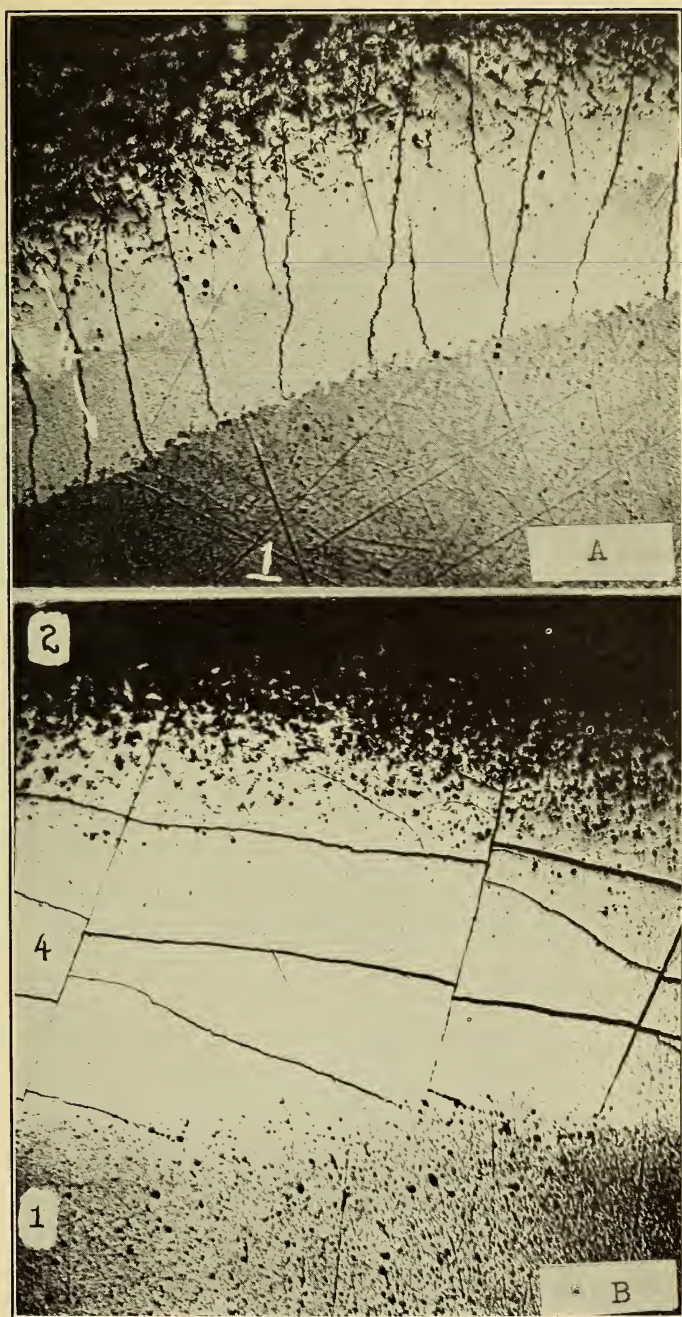
FIGURE 3.—Oblique sections of heat treated electroplated sheet copper showing cracks in coating. $\times 100$

A, Heated to 350°C .; B, heated to 500°C . 1, Sheet copper base; 2, unchanged tin; 4, copper-tin alloys. Both unetched.

The microstructure of the coatings on heat-treated electrotinned copper was rather complex. Electrotinned copper had but one phase present in the coating—the tin. Upon heating to 350° and 500° C., the copper and tin alloyed, copper dissolving quite rapidly in the tin. The alloy layers were brittle and slight bending caused them to crack, as shown in Figure 3. Many of these cracks extended through the alloy layer only. During polishing a slight relief effect was sometimes obtained, as shown in Figure 3(a), thus revealing the complex nature of the coating.

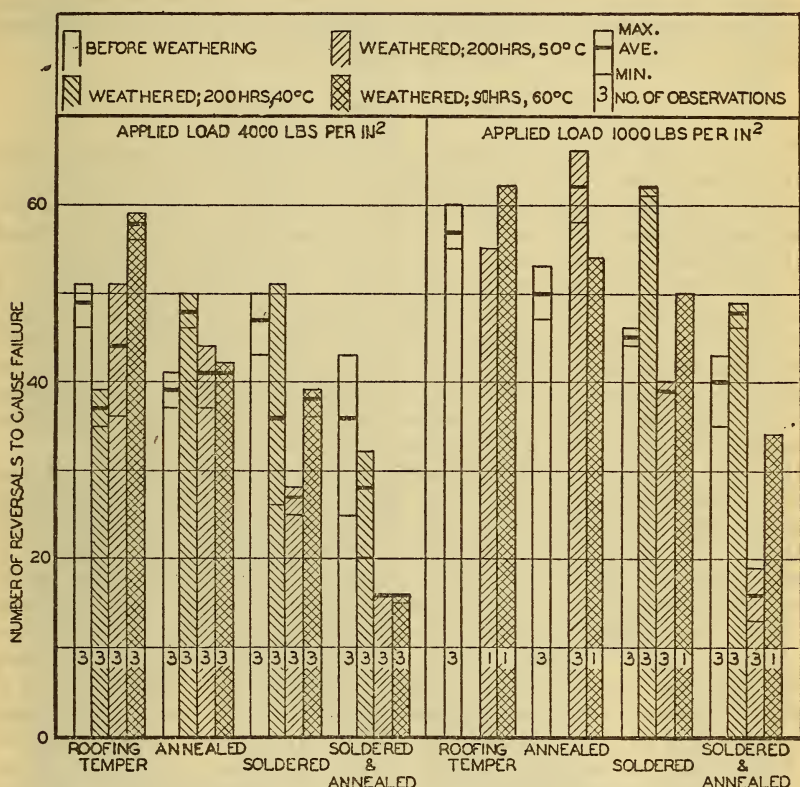
FIGURE 6.—Results of bend tests of plain and soldered sheet copper

The influence of the temperature of soldering on seam corrosion which is another example of detrimental galvanic corrosion of copper by copper-tin alloys is shown by the change in the physical properties upon weathering, especially of the soldered and annealed specimens weathered for 200 hours at 50° C. The tensile strength of one individual specimen was lowered as much as 3,000 lbs./in.² due to accelerated weathering. The greatest change was in the number of bends needed to produce failure.
