Investigation of Failures of White-Coat Plaster

United States Department of Commerce
National Bureau of Standards
Building Materials and Structures Report 121

Lansing S. Wells, Walter F. Clarke, Edwin S. Newman, and Dana L. Bishop

Issued February 1, 1951

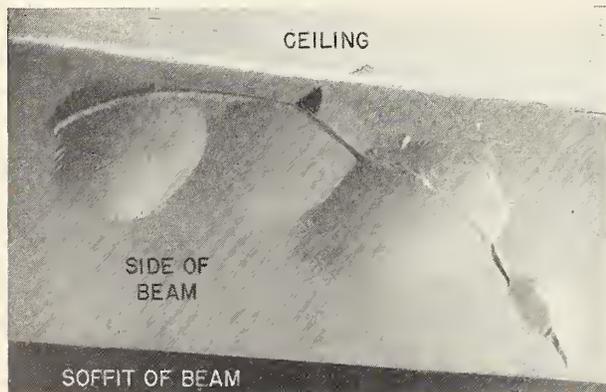
Failures in the white coat of plaster over concrete bases were of frequent occurrence. Figure 1 shows a series of bulges on the side of a concrete beam. In this case, the bulging was confined entirely to the white coat. On breaking these bulges it was found that the underlying coat of gypsum bond plaster (which had been applied directly over the concrete) had been well scratched, was hard, and still attached firmly to the beams.

FIGURE 1. A series of bulges in white coat along the side of a concrete beam, caused by the expansion attending the slow hydration of free MgO in the hydrated lime used in preparing the white coat.

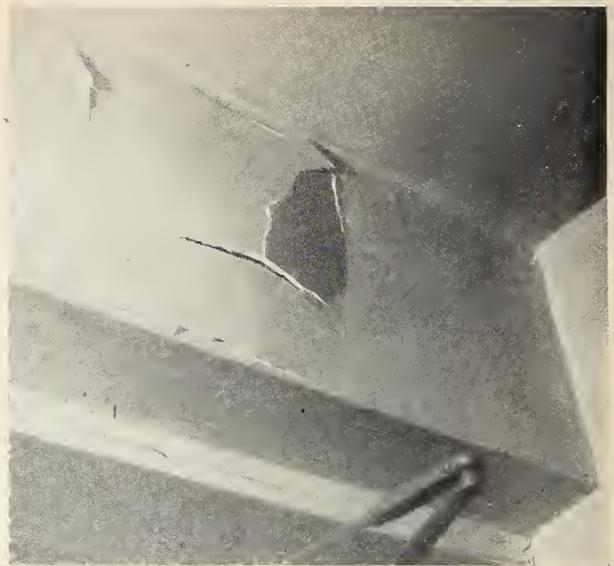
Figure 2 shows bulging white coat along the side of a concrete beam located above a door in an inside stairway of an eight-story fireproofed apartment house built in 1924. Here, again, the failure was confined to the white coat; the underlying gypsum bond plaster was still adhering tightly to the concrete base. Failures are also taking place in the white coat on the ceilings and side walls. There has been no trouble with the underlying base coats of sanded gypsum plaster. Failures started in this building about 7 years after the building was erected.

FIGURE 2. Bulging white coat along the side of a concrete beam located above the door of an inside stairway in an eight-story fireproofed apartment house.

The underlying gypsum bond plaster was still adhering tightly to the concrete base.

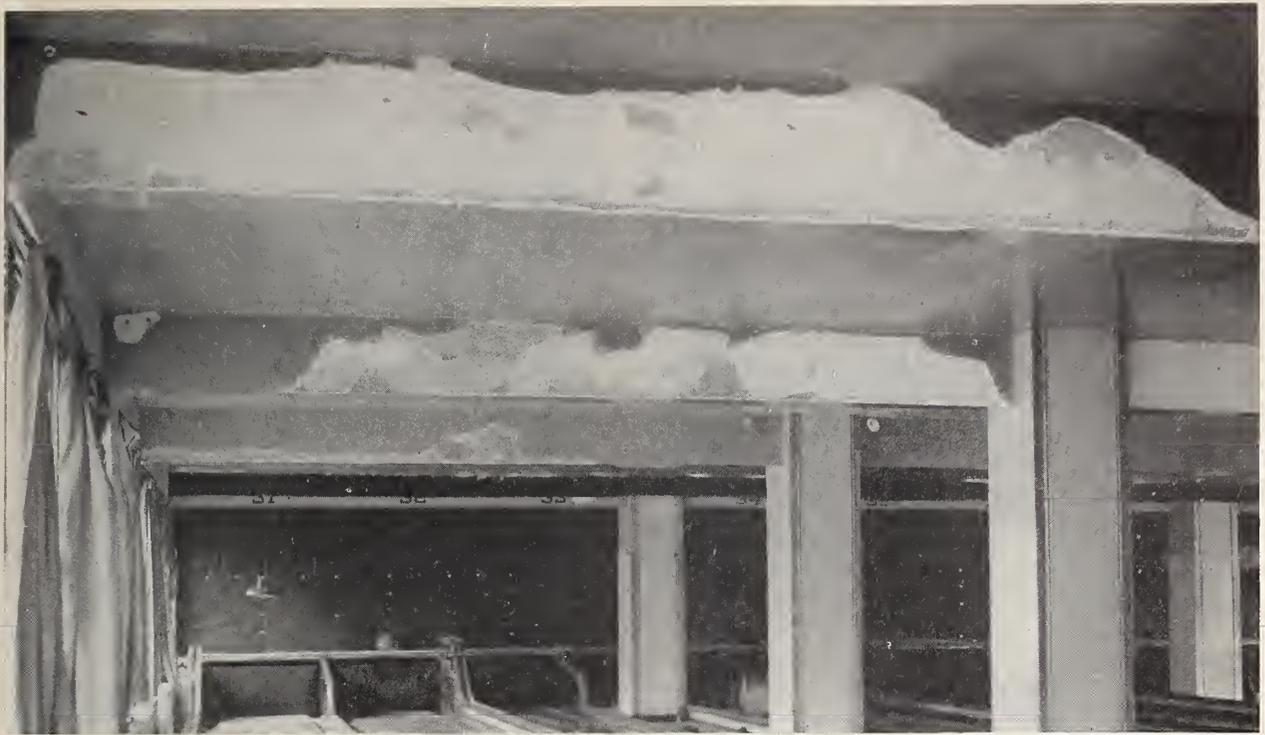
was being made to keep in repair the white-coat finish. In fact, the failures had occurred so frequently that the owner of the bowling alleys found it cheaper and more advantageous to hang velvet drapes in front of the concrete beams to hide their unsightly appearance rather than to replaster the beams repeatedly. Inasmuch as the bulged and loose plaster had been removed before the concrete beams were photographed, the picture reveals where the failures had occurred. For the most part they were at the bond between the successive layers of white coat, applied to straighten up the beam, rather than between the white coat and scratch coat of neat gypsum bond plaster. Only in very limited areas was there any separation of the bond plaster from the concrete.

FIGURE 3. Failures in white coat along sides of concrete beams over bowling alleys.

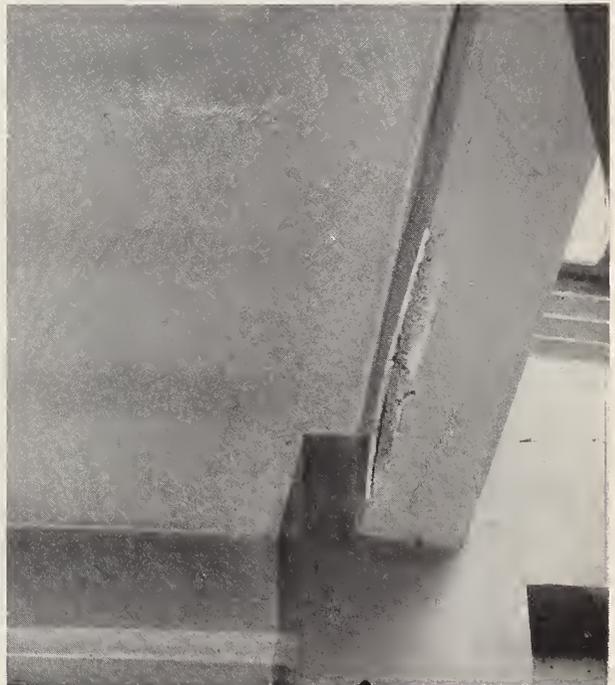
FIGURE 4. Bulging white coat along the edge of the soffit and side of a concrete beam in an office building.

Note the old patch in the white coat in the ceiling.

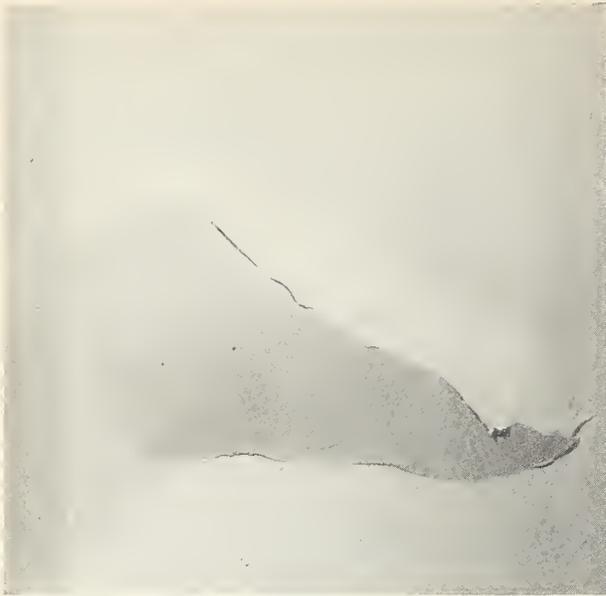
FIGURE 5. *Large bulge of white coat on a concrete pilaster in a school building.*

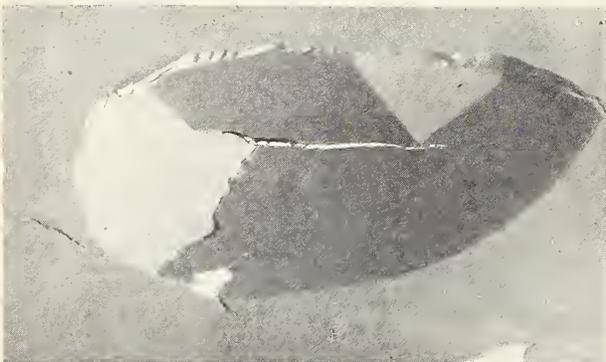
Figure 6 shows a white-coat blister, cracked and bulging from an underlying sanded gypsum brown coat on a plastered ceiling, but still held

FIGURE 6. *Cracked bulge of white coat on a ceiling, still held suspended by a film of paint.*

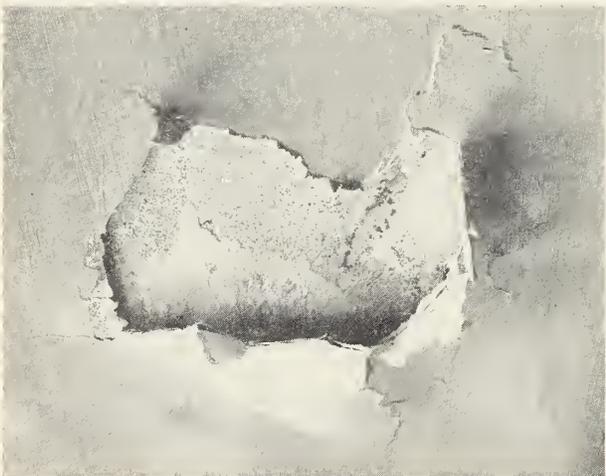
FIGURE 7. *All that remained after a bulge of white coat fell from a ceiling of an office building.*

Note the firm underlying brown coat of sanded gypsum plaster and a thin layer of white coat still intact.

Figure 7 shows the loosely held remains of a shattered blister after the missing portion had fallen from the ceiling, thus revealing the firm underlying brown coat of sanded gypsum plaster and a thin layer of adhering white coat still intact. The plaster base of the ceiling was composed of concrete joists with hollow-ceramic-tile fillers.

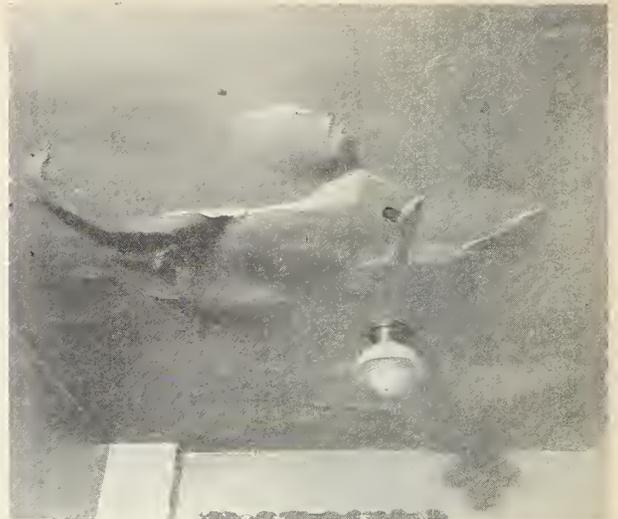
FIGURE 8. *A kitchen ceiling in an apartment house; revealing pronounced bulging in the white coat, caused by expansion.*

Note the small patches previously applied.

An example of pronounced bulging of white coat is illustrated in the photograph of a kitchen ceiling in an apartment house (fig. 8). Figure 9

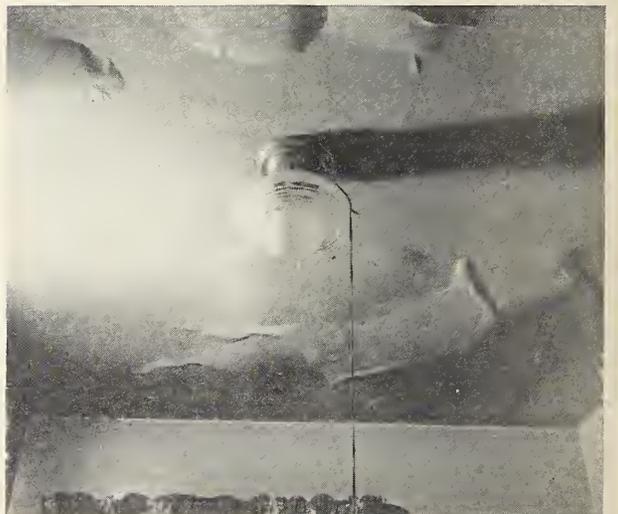
FIGURE 9. *A more detailed photograph of the bulges shown in the background of figure 8.*

presents in greater detail the bulge in the background of figure 8. Trouble had started about 7 years after the building was erected and had continued for 18 years up to the time of the inspection. White-coat-plaster failures had occurred on the side walls also. There had been very little trouble with the sanded gypsum base coats on ceilings and side walls.

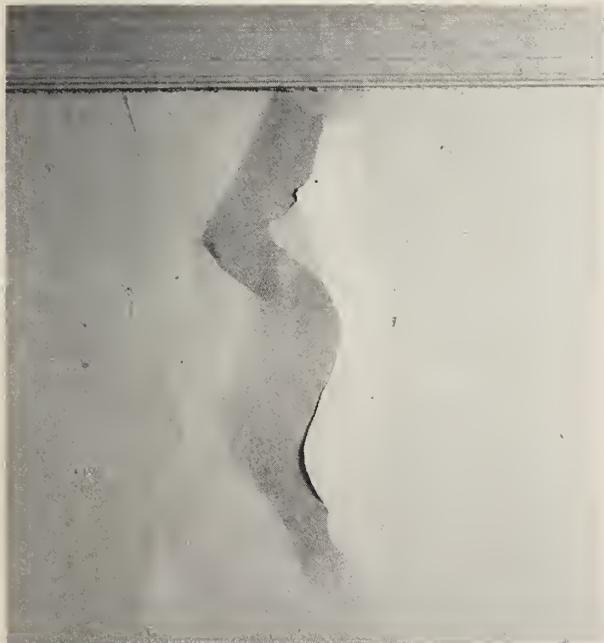
Figure 10 shows a large bulge of white coat protruding from a sanded base coat on a side wall and extending downward from the plaster moulding for about 2½ feet. There was no evidence of poor workmanship in the plastering. The 12-story building was of reinforced-concrete construction with hollow-ceramic-tile partitions. No details were obtained as to when failures began nor as to their extent each year, but at the time of the inspection, 27 or 28 years after the building was completed, a great deal of trouble was being experienced with the white-coat plaster throughout the building. White-coat-plaster failures were as extensive on the ceilings as on the side walls. The gypsum sanded base coats on the side walls were in good condition.

FIGURE 10. A large bulge of white coat extending about 2½ feet downward from a cast gypsum plaster moulding.

The photograph was taken in a corridor of a 12-story building of reinforced-concrete construction with ceramic-tile partitions. The building, originally designed and occupied as a hotel, was later converted to an office building. No expense had been spared in the plastering work.

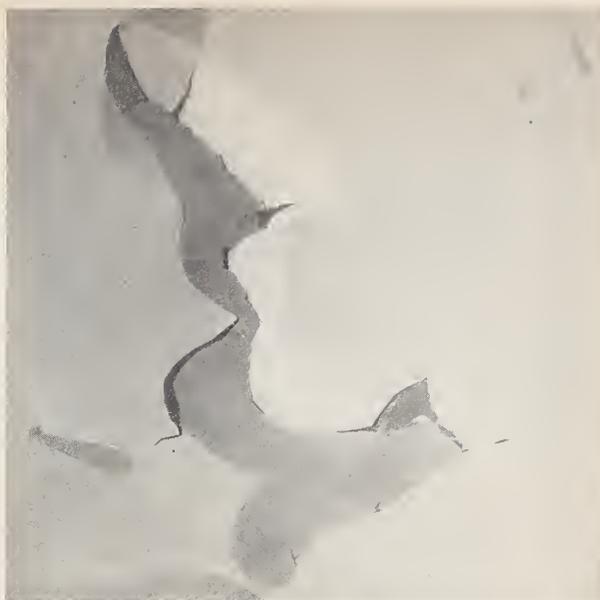
Figure 11 shows the bulging of white coat, involving separation of this coat from the gypsum sanded base coat within an area of about 1 square yard. This is a photograph of the side wall of an inside stairway of an apartment house where there were several similar failures in the white coat.

FIGURE 11. Bulging of white coat on a side wall, involving separation from the sanded gypsum base coat within an area of about 1 square yard.

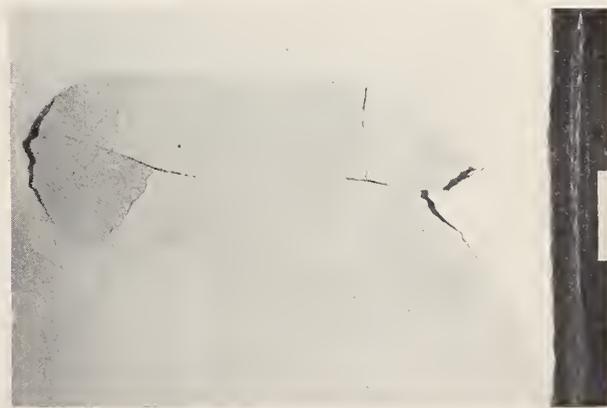
Figure 12 shows a bulge of white coat on the side wall of another building. In this case the backing was wood lath.

FIGURE 12. Bulge of white coat on the side wall next to a door jamb.

The firm base coat of sanded gypsum plaster was applied over wood lath.

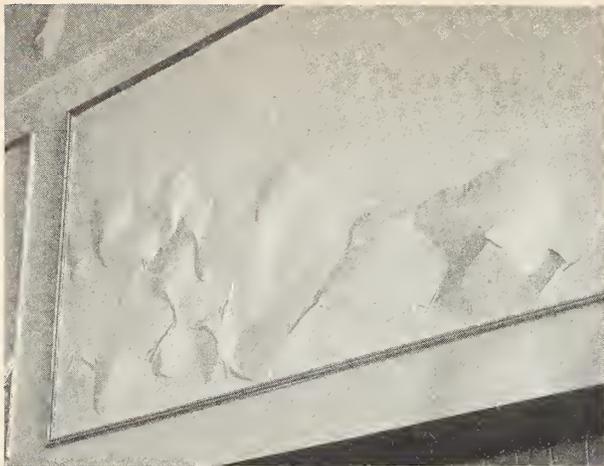
An example of extensive white-coat failure is shown in figure 13. This is a side-wall panel in a shop of a store and office building. The gypsum brown coat underneath this white coat was firm and well bonded. The white coat in an adjoining panel had been replaced, and the members of the inspection committee were told that the bulges in this panel were even more pronounced than those shown in figure 13.

FIGURE 13. Series of white-coat bulges along the side wall of a plastered panel in a shop of a store and office building.

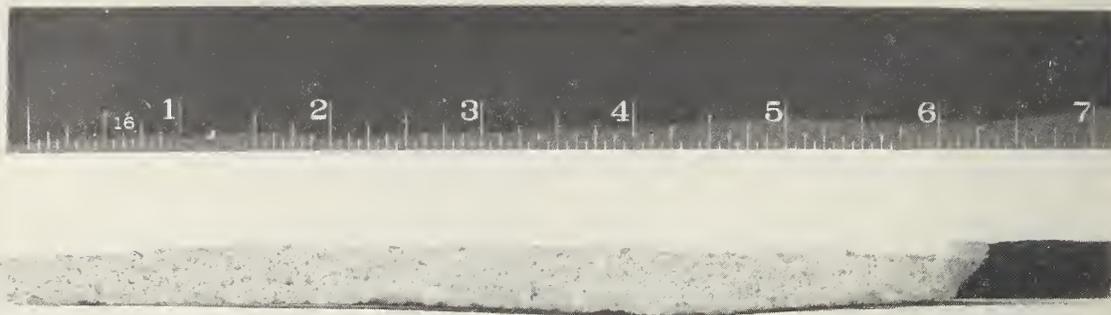
FIGURE 22. A cross section of white coat adhering to a sanded gypsum plaster base coat that had been applied over a concrete beam.

Photograph made prior to autoclaving.

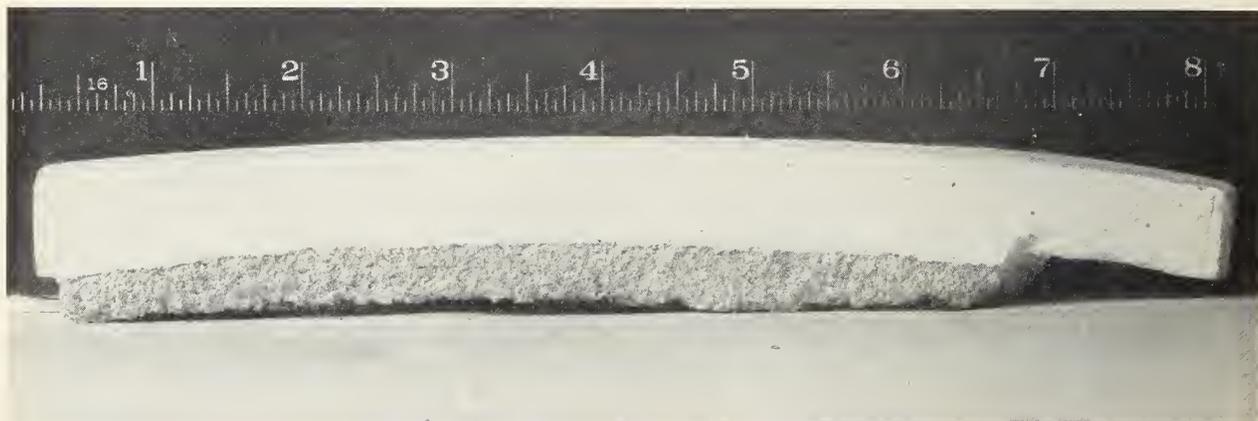
FIGURE 23. The specimen shown in figure 22, after autoclaving.

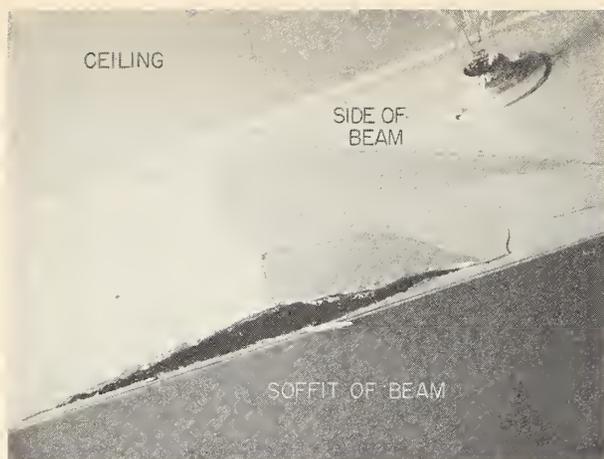
FIGURE 24. Plaster failure involving an expansion of about 0.5 percent in the white coat along the side of a concrete beam.

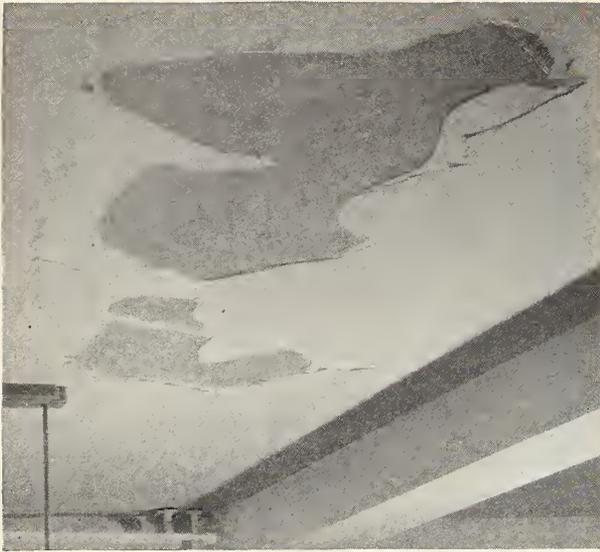
FIGURE 27. A ceiling in an office building where white-coat plaster failures are of frequent occurrence and where repatching has been going on for years.

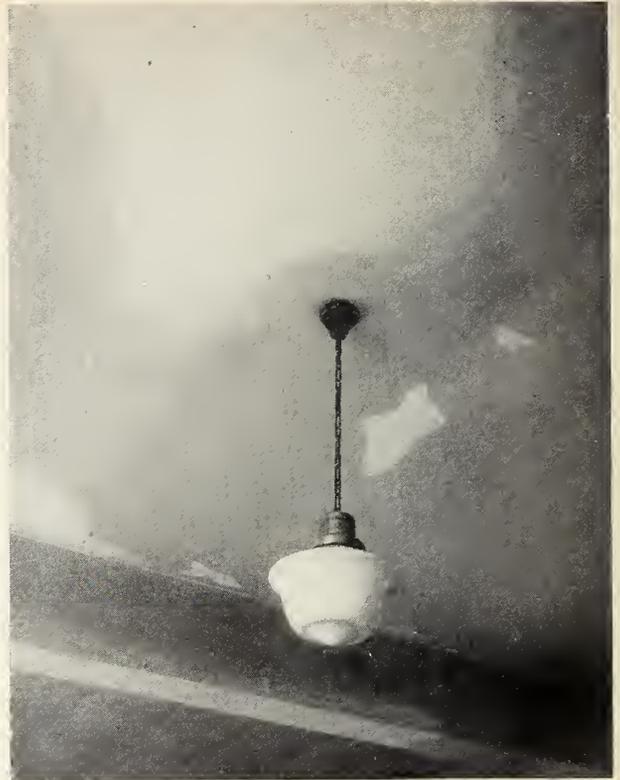
Figure 28 shows a plastered ceiling with an extensive area that had been patched because of the loosening of the white coat. But, more important, it shows additional white-coat-plaster failures that occurred subsequent to the patching but before the painter got around to redecorating the ceiling. Faced with the continuous reappearance of bulged and defective areas, it was finally decided that the

FIGURE 28. An extensive area of patched white coat and additional areas of delaminated white coat that occurred subsequent to patching.

best policy in this parochial school would be to cover the ceilings with some material that would not undergo excessive expansion with seasonal changes. Hence, the selection of pressed metal as a ceiling material. Note in figure 29, however, that bulges are still appearing in the white coat on the concrete beams.
