Atmospheric Exposure Tests of Nailed Sheet-Metal Building Materials

Building Materials and Structures Report 128

Theodore H. Orem

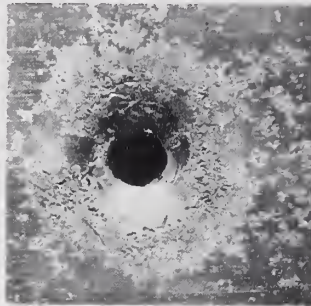
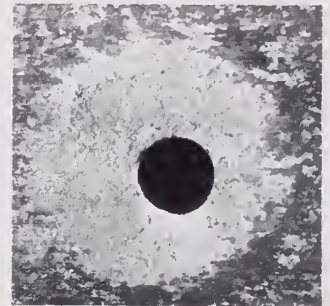
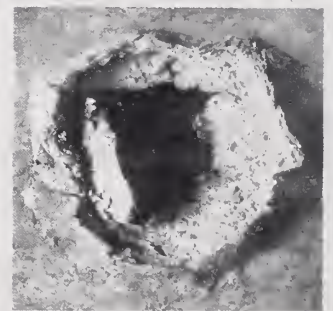
CORROSION FROM LEAD WASHER
MATERIAL 5A

CORROSION FROM LEAD WASHER
MATERIALS 1A, 2A, 3A, 4A, 6A, 7A, 8A & 10A

CORROSION FROM LEAD WASHER
MATERIAL 9A

FIGURE 5. *Lead-washer corrosion ratings for aluminum-base alloys; $\times 2\frac{1}{2}$.*

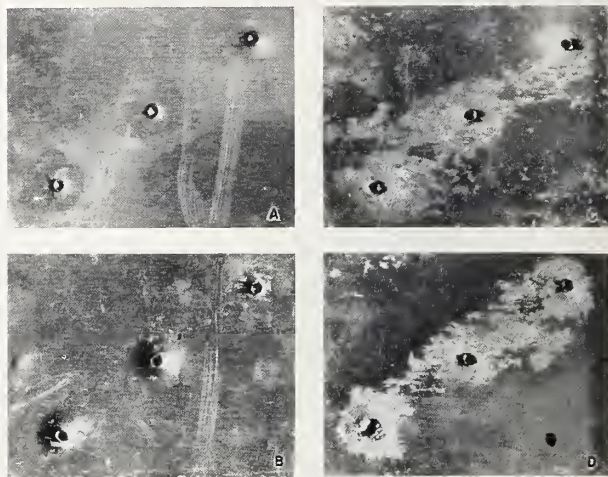
exposure sites when nailed to basswood. Material 9A, which showed unusual corrosion on the undersurface after only 6 months of exposure when nailed to basswood, did not corrode on the undersurface after 6 months when nailed to yellow pine, as illustrated in figure 11. Further evidence that

FIGURE 11. Effect of 6-month contact of material 9A with basswood and yellow pine, respectively.

Note abnormal corrosion of cladding (light areas) where contacted by basswood and absence of corrosion where contacted by yellow pine. A, Yellow pine, NBS site; B, yellow pine, Norfolk site; C, basswood, NBS site; D, basswood, Norfolk site.
