# Fire Resistance of Shutters for Moving-Stairway Openings

United States Department of Commerce  
National Bureau of Standards  
Building Materials and Structures Report 129

Issued March 1, 1952

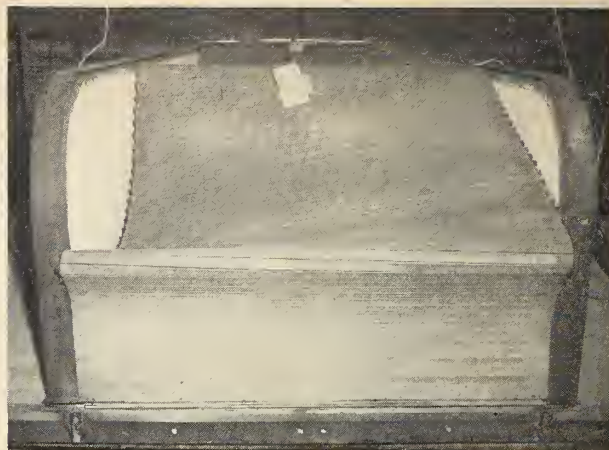
FIGURE 7. Shutter after test A.

The lubricants in the shutter started burning and smoke was observed at 5 min. At 7 min the shutter guide rails were observed to be spreading apart at the curved portion. At 20 min the curved portion of the rails had spread so much that the shutter rollers had come out of the guide slots. At 1 hr the shutter was out of the slot 1 in. on one side and  $\frac{1}{2}$  in. on the other. It had pulled clear of the slot for a length of 6 ft on one edge and 3 ft on the other and had sagged, causing the shutter to bow out beyond the front end about 6 in. The bottom chords of the balustrades had expanded over  $\frac{3}{8}$  in. longitudinally, notwithstanding the restraint of the floor slab. The test was ended at 3 hr 1 min, at which time a portion of the shutter had sagged 3 to  $3\frac{1}{2}$  in. at its center line, although the rollers were still held in the side-rail slots. The condition of the specimen after the test is shown in figure 7.

The primary source of trouble in test A was the spreading of the side rails, or balustrades. The shutter guide rail was rigidly attached as a part of the top chord of the truss, the inner portions being directly exposed to the furnace fire, whereas the outer portions were cooled by the air outside the furnace, a condition which resulted in a considerable difference in the thermal expansions along the inner and outer edges. This difference in expansion caused bowing of the chord members and consequent spreading of the guide rail, thus allowing the shutter rollers to drop out of the guide slots. The transverse members of the housing for the operating mechanism fixed the rear ends of the guides, and outside braces set at  $2\frac{1}{2}$  ft from the beginning point of curvature of the rail resulted in the spreading of the relatively free curved portion of the guides. In test B this effect was partly obviated by providing an expansion joint in the guide rail and placing the top chord of the balustrade framework below the guide rail, where it was somewhat protected from the fire by plaster. Another means of neutralizing unequal expansion was introduced by making saw cuts in the inner edges of the top chord and the guide rail. In spite of these provisions, some spreading of the guide rails was observed. This should be overcome by increased allowance for expansion. Any provisions that make adequate allowances for expansion effects might be substituted for those employed in test B.

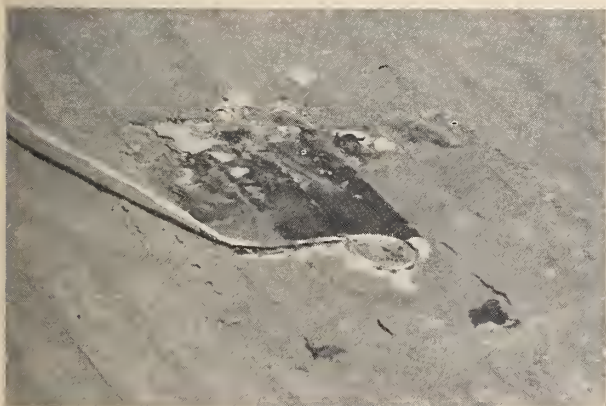
FIGURE 9. Surface of shutter under pad after test B.

Following the cooling of the furnace and test specimen, the shutter surface was found to be badly oxidized under the surface thermocouple pads (fig. 9). The shutter was out of the guide rail slot for a length of 3 or 4 ft on one edge and 12 or 14 ft on the other (fig. 10). The electric equipment was damaged in the test to the extent that it could no longer function. The shutter could not be retracted with the hand crank. Hence it was removed by use of a cutting torch.

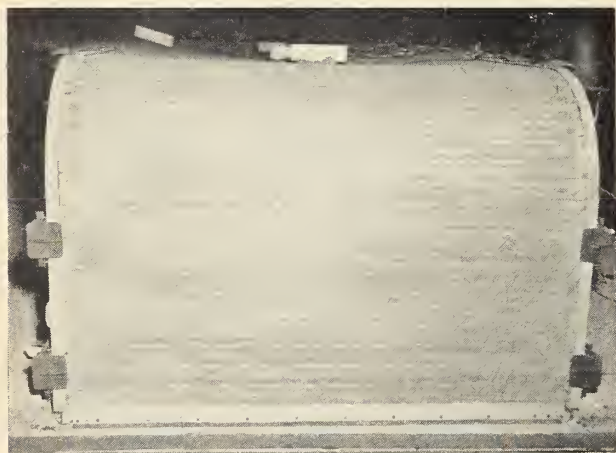
FIGURE 11. Specimen after test B.

The following day, after cooling, the shutter still sagged 4 in., but the ends of the slats were back in the guide slots (fig. 11). The unexposed surface of the shutter was coated with zinc oxide, except under the thermocouple pads where the

oxide had blistered and flaked off. However, the steel of the shutter was in good condition. The plaster was cracked extensively but remained in place. The guide rail was deformed to the extent that four men were needed to open the shutter.

Placing the top chord of the balustrade truss 7 in. below the guide rail in test B made its protection from the fire by plaster possible and imparted some flexibility to the structure. The expansion joint in the shutter guide rail appeared to be not quite long enough. For the temperature obtained in the test, the expansion of a guide rail of the length required would be about  $2\frac{3}{4}$  in. The number of saw cuts in the inner edge of each top chord should be increased to not less than one every 5 ft.
