REPORT BMS34

Performance Test of Floor
Coverings for Use in Low-
Cost Housing: Part 1

PERCY A. SIGLER *and*
ELMER A. KOERNER

NATIONAL
BUREAU OF STANDARDS

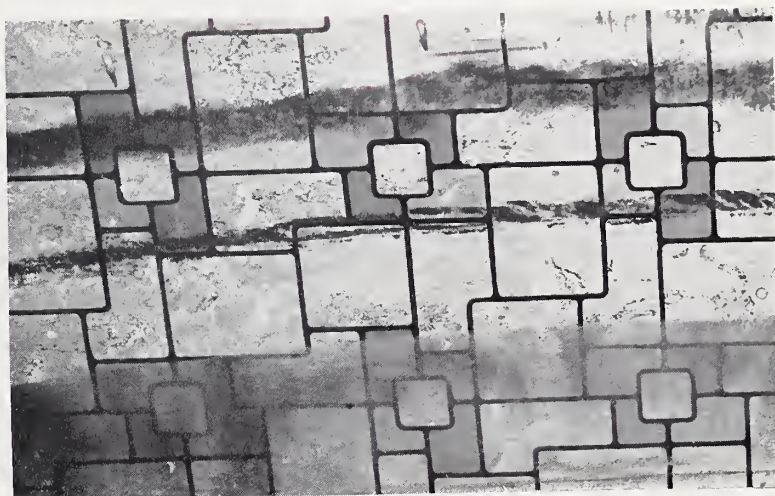
The standard gage inlaid linoleum, test panels 3 and 4 (see figs. 4 and 5), was in good condition at the end of the performance test. There was some failure in adhesion to the subfloors along the paths of the truck wheels, the worst failure occurring in panel 4-R as distinct ridges extending for the full length of this panel. On a wood subfloor with an asphalt-saturated lining felt, test panel 4-L, the linoleum was moderate-

FIGURE 4.—Standard-gage inlaid linoleum on concrete subfloor (test panel 3-L).

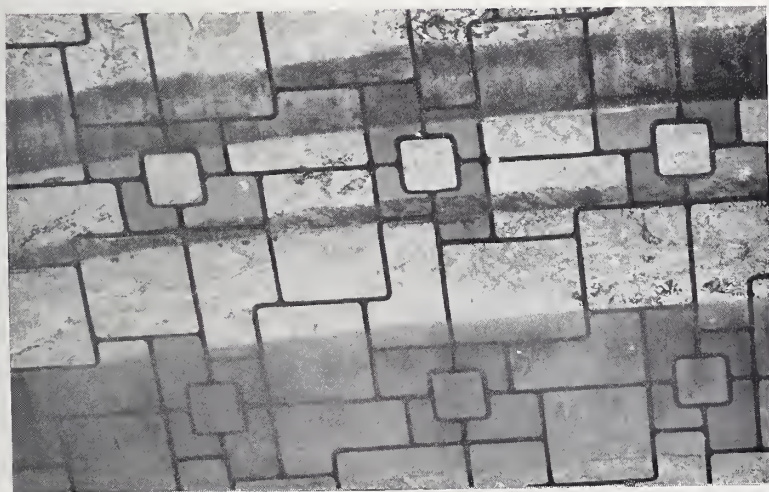
ly depressed by the metal truck wheels. With a dry lining felt, test panel 4-R, the linoleum was depressed by the metal truck wheels to a greater degree and was also depressed to a slight extent by the walking wheel. There was evidence of some separation in the dry lining felt. The linoleum was fractured to a slight extent by the metal truck wheels.

FIGURE 5.—Standard-gage inlaid linoleum on wood subfloor (test panel 4-L).

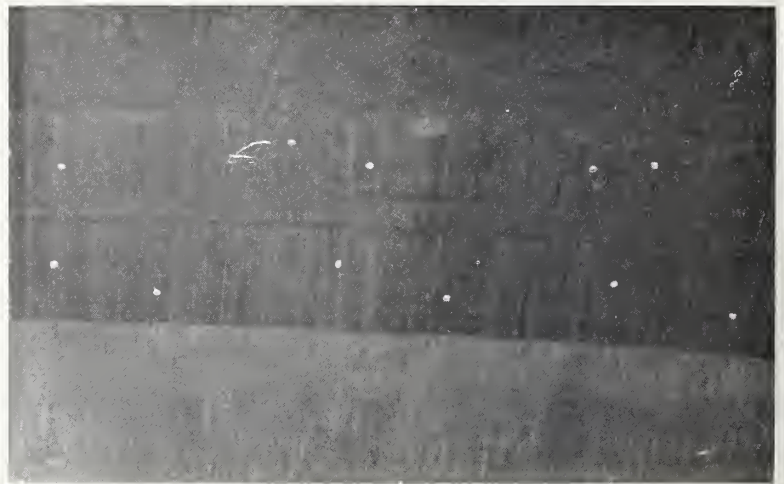
The medium-gage jaspe linoleum, test panels 5 and 6 (see figs. 6 and 7), was in unserviceable condition at the end of the performance test. Extensive failure in adhesion to the subfloors and buckled ridges in the linoleum perpendicular to the travel of the test truck occurred at an early stage of the test. The failures appeared first under the truck wheels and in panel 6-R at 4,000 cycles. On a wood subfloor with a dry lining felt the linoleum was appreciably depressed by the metal truck wheels and to a slight extent by the walking wheel. There was evidence of some separation in the dry lining felt. The linoleum was fractured to a considerable extent by the truck wheels and in panel 6-R was also fractured at one blister by the roller caster and walking wheel.

FIGURE 7.—*Medium-gage jaspe linoleum on wood subfloor (test panel 6-R).*

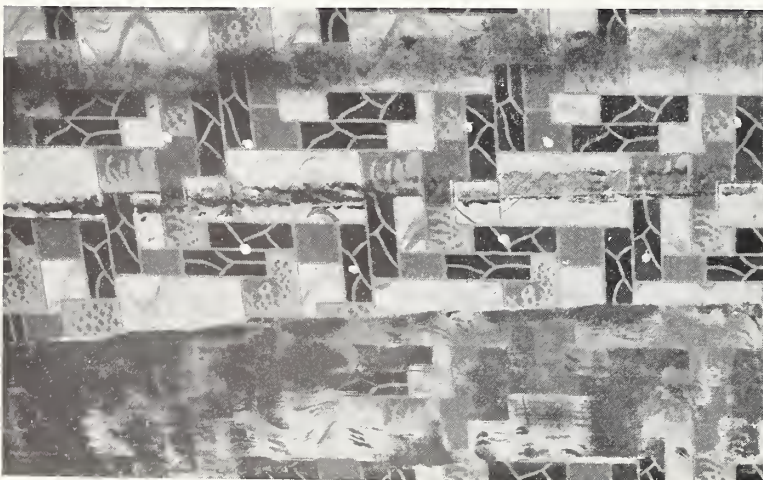
The printed linoleum, test panels 7 and 8 (see figs. 8 and 9), was in serviceable condition at the end of the performance test, although the enamel printed on the surface was worn through in spots by the abrasive action of the walking wheel in 6,000 cycles after the wheel had been covered with abrasive cloth. There was only slight failure in adhesion to the subfloors, the principal failures occurring as a few small blisters along the paths of the truck wheels

in panels 7-L and 8-L. On a wood subfloor with an asphalt-saturated lining felt the linoleum was moderately depressed by the metal truck wheels. There was evidence of slight fracture of the linoleum by the metal truck wheels in panels 7-L and 8-L.

FIGURE 8.—*Printed linoleum on concrete subfloor (test panel 7-L).*

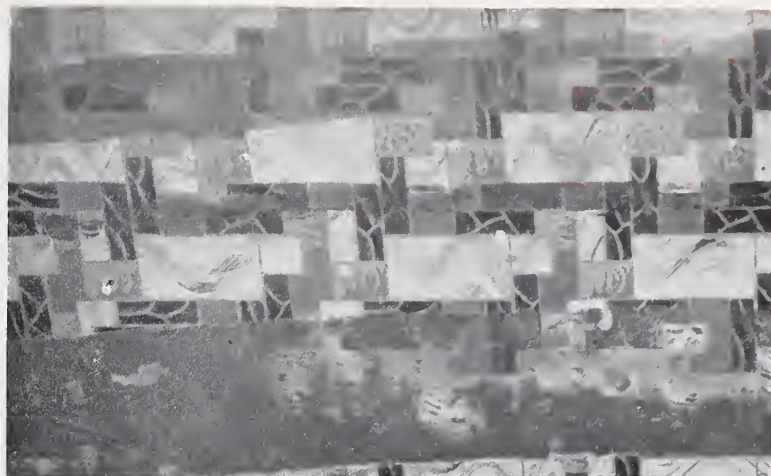
FIGURE 9.—*Printed linoleum on wood subfloor (test panel 8-L).*

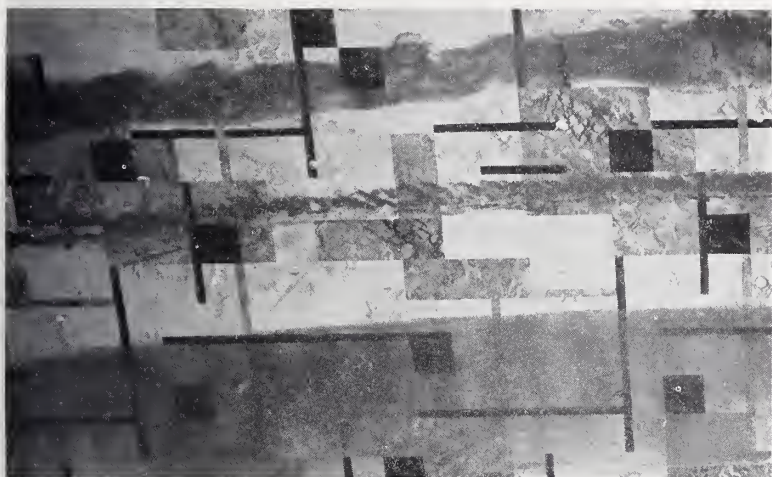
The inlaid felt-base floor coverings, test panels 9, 10, 11, and 12 (see figs. 10, 11, 12, and 13), were in unserviceable condition at the end of the performance test, with the possible exception of panel 9-L. Failures in adhesion to the subfloors and blisters in the floor coverings occurred along the paths of the truck wheels. The metal truck wheels depressed the floor coverings to a moderate degree on both a concrete subfloor and a wood subfloor. The floor coverings were fractured to a considerable extent by the metal truck wheels. There was evidence of some separation of the linoleum composition from the felt backing in panel 9-R.

FIGURE 10.—*Inlaid felt base on concrete subfloor (test panel 9-L).*

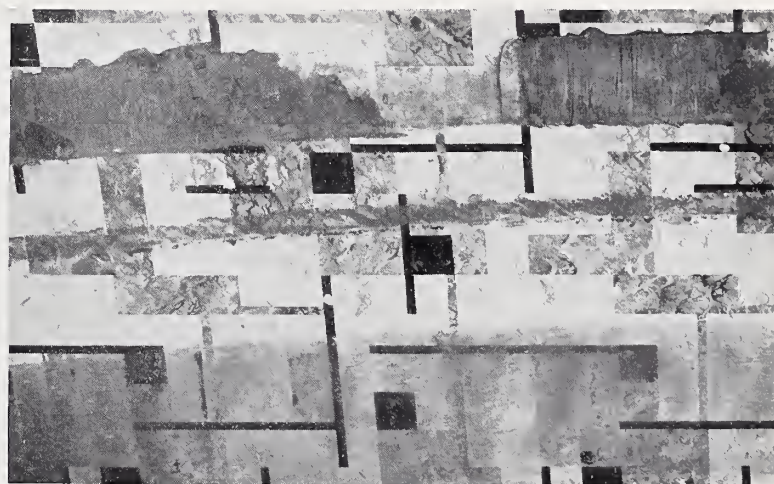
FIGURE 11.—*Inlaid felt base on wood subfloor (test panel 10-L).*

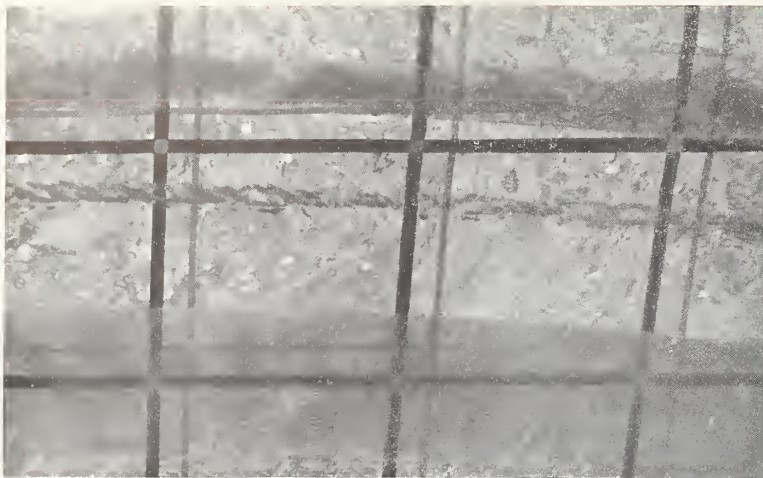
FIGURE 12.—*Inlaid felt base on concrete subfloor (test panel 11-R).*

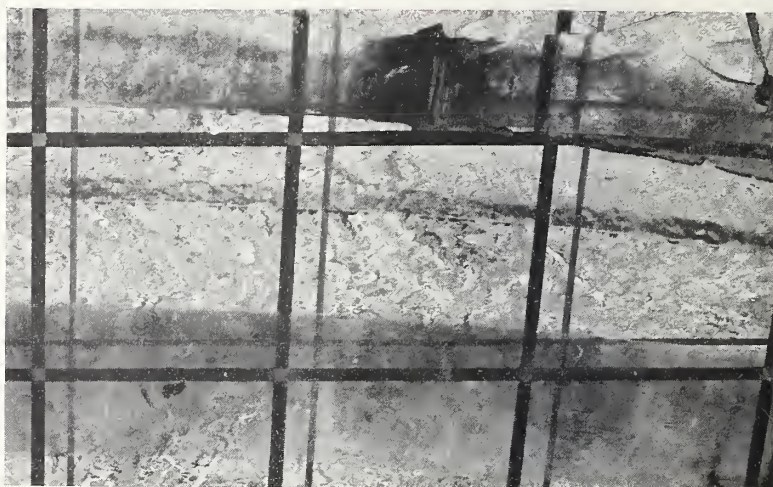
FIGURE 13.—*Inlaid felt base on wood subfloor (test panel 12-R).*

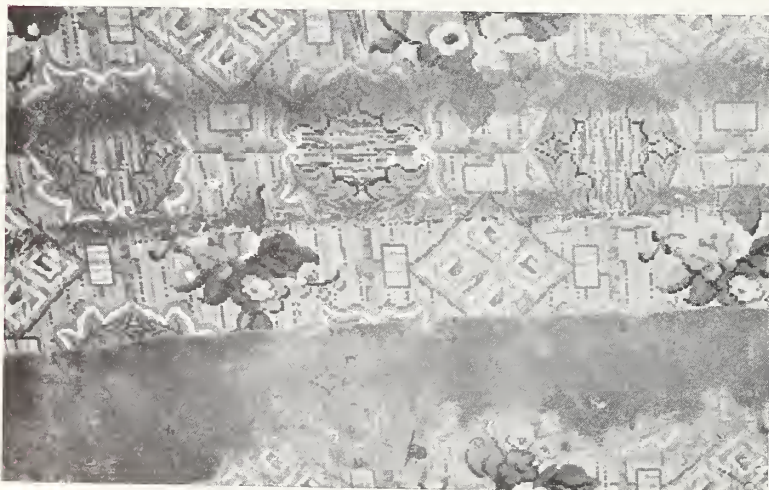
The printed felt-base floor covering, test panels 13 and 14 (see figs. 14 and 15), withstood the severe treatment of the test fairly well, although at the end of the performance test it was in unsatisfactory condition for additional service. The enamel printed surface was worn through in spots by the abrasive action of the walking wheel in 2,500 cycles after the wheel had been covered with abrasive cloth. Along the paths of the truck wheels there was evidence of some failure in adhesion to the subfloors and some fracture of the floor covering, the worst failure occurring in panel 13-R, where it was found necessary to cut and recement the floor covering in order to remove a blister formed by accumulation of vapor from the adhesive. The metal truck wheels depressed the floor covering to a moderate degree on a concrete subfloor and to a greater degree on a wood subfloor.

FIGURE 14.—*Printed felt base on concrete subfloor (test panel 13-L).*

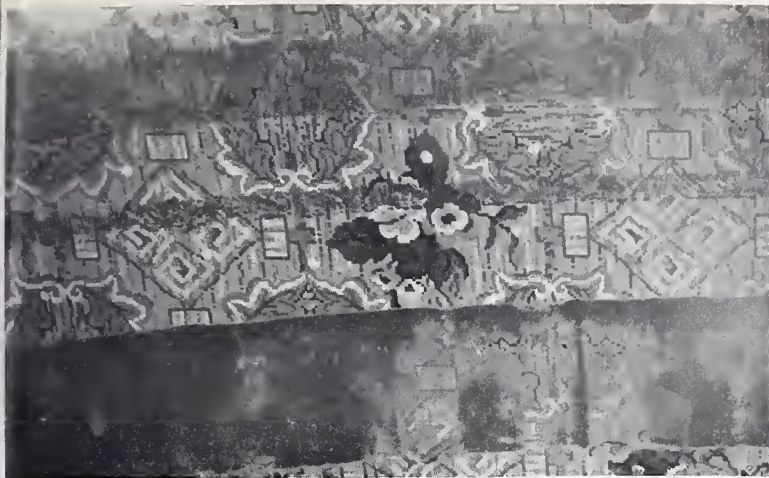
FIGURE 15.—*Printed felt base on wood subfloor (test panel 14-L).*

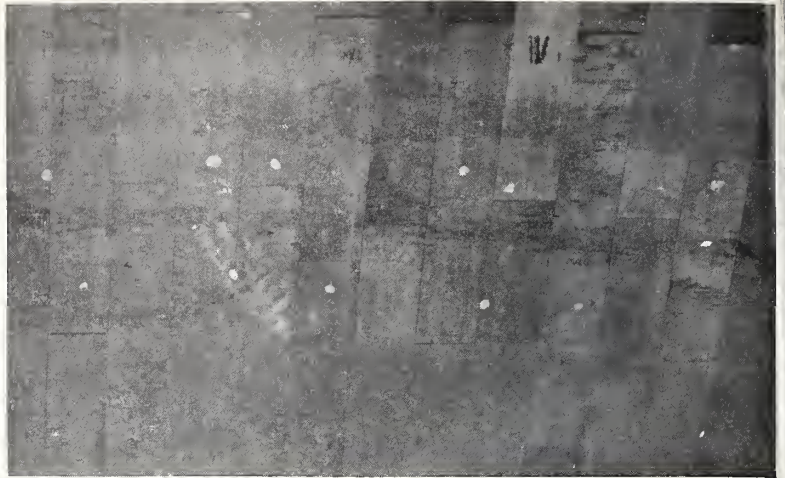
FIGURE 18.— $\frac{25}{32}$ -in. short-strip maple
on concrete subfloor (test panel 19-R).

The short-strip maple flooring, test panel 19 (see fig. 18), was in very good condition except for some failure in adhesion to the concrete subfloor. In panel 19-L the maple expanded across the grain and formed an arch approximately one-eighth of an in. above the concrete subfloor in the central portion of the track. In panel 19-R some of the maple strips shifted toward the inside of the track, leaving a slight separation in some of the end joints. The maple was moderately depressed by the metal truck wheels. There was no evidence of fracture or splintering of the maple.

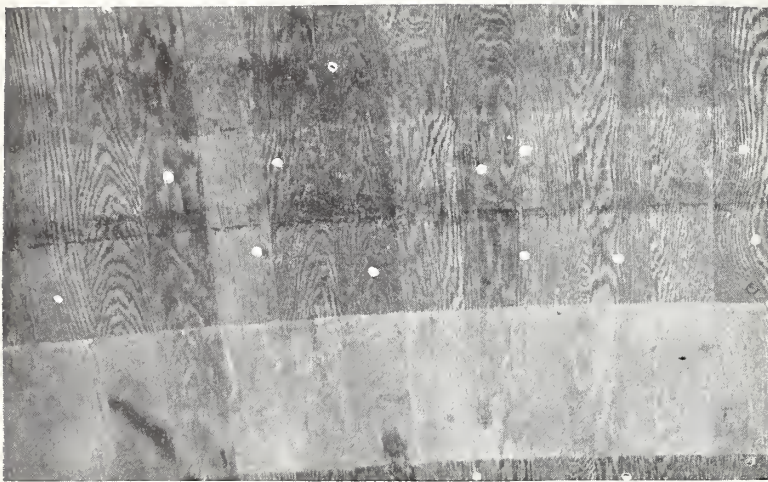
FIGURE 19.— $\frac{25}{32}$ -in. strip white oak
on wood sleepers (test panel 20-L).

The strip white-oak flooring, test panel 20-L (see fig. 19), was in good condition at the end of the performance test. The strips remained rigidly bonded to the sleepers. The white oak was moderately depressed, and fractured to a slight degree, by the metal truck wheels.

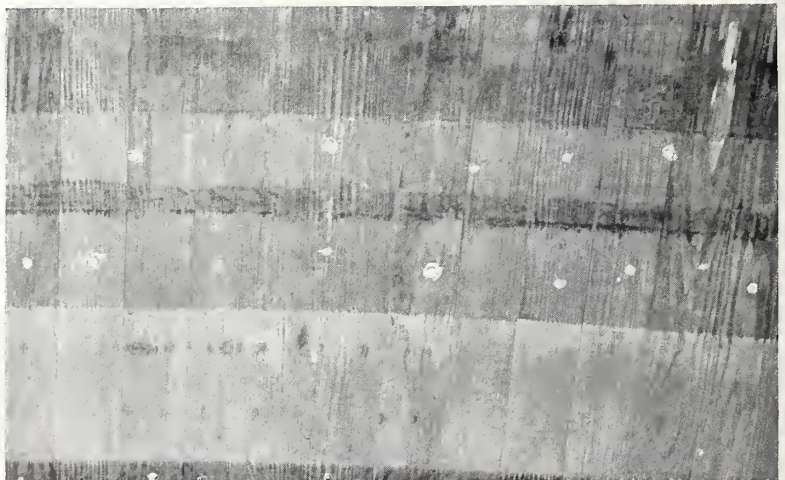
FIGURE 20.— $\frac{25}{32}$ -in. strip yellow pine
on wood sleepers (test panel 20-R).

The strip yellow-pine flooring, test panel 20-R (see fig. 20), was in fair condition at the end of the performance test. The strips remained rigidly bonded to the sleepers. The metal truck wheels depressed the yellow pine to an appreciable degree and caused some fracturing and splintering of the flooring.
