REPORT BMS76

Effect of Outdoor Exposure,
on the Water Permeability
of Masonry Walls

by CYRUS C. FISHBURN,
DOUGLAS E. PARSONS,
and PERRY H. PETERSEN

NATIONAL
BUREAU OF STANDARDS

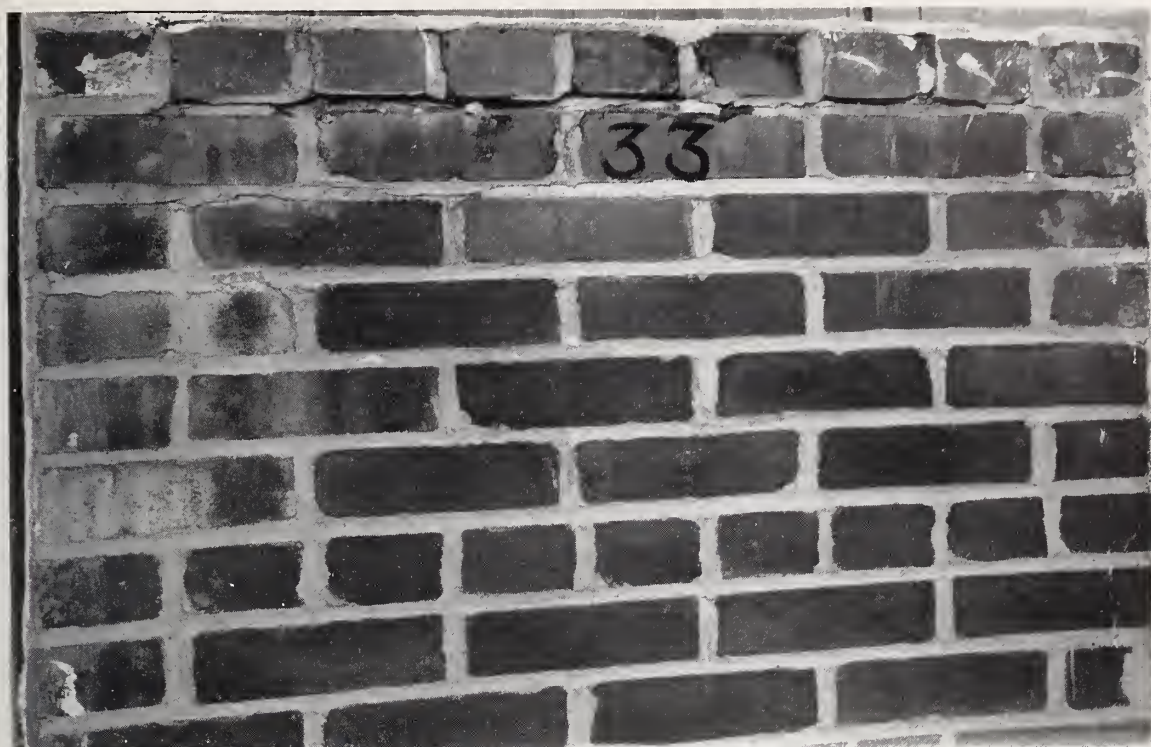
FIGURE 2.—Top portion of wall 33-cc12A3 after 3 years' outdoor exposure.

The upper facing portion of wall 33 (worse damaged) is shown in figure 2. The bed joints in both faces of the top three courses of this wall were badly cracked, and there were several spalled brick and head joints in the rear facing. The bed joint under the top course of wall 21 was severely cracked and spalled in both faces. Damage sustained by walls 20, 40, 43, and 94 was comparatively small. In walls 20 and 40 a few isolated brick were spalled with cracking or spalling in the adjacent mortar joints and in

Since the interior of the joints in five of the six walls rated *C* in table 5 were solidly filled with mortar (workmanship *A*) and since the brick were more absorptive than the mortars, it is probable that the primary cause of damage to the joints was the expansion of the brick produced by the freezing of absorbed water.

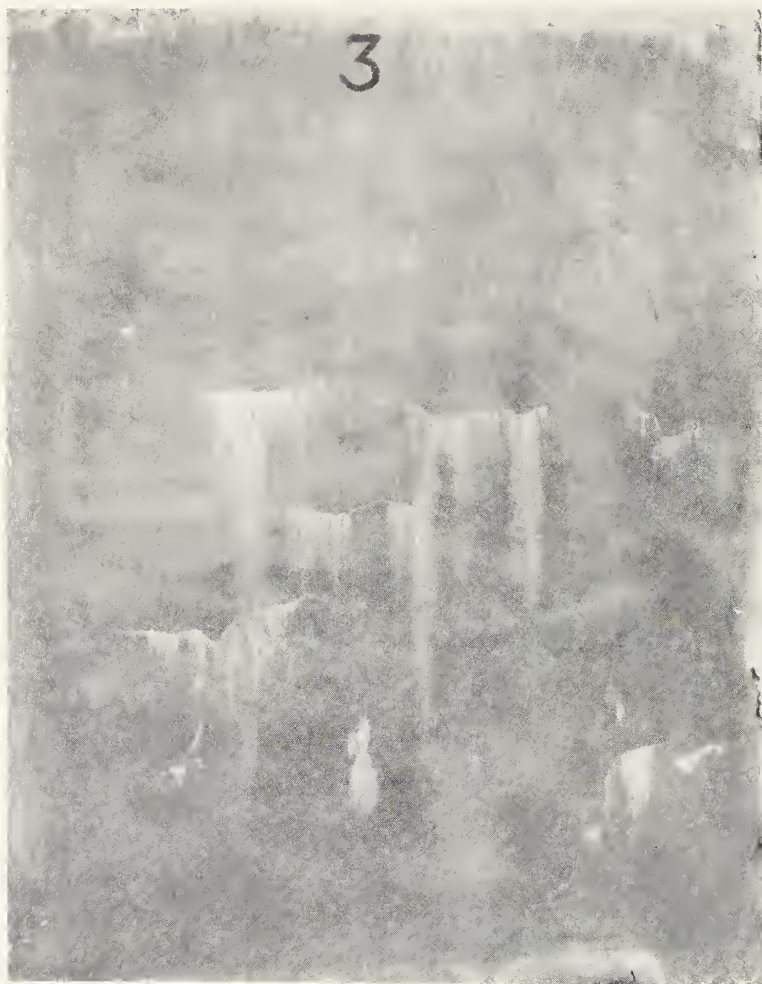
FIGURE 3.—Stucco-faced wall 3-sj9A2, with tile on end, after 2 years' outdoor exposure.

The stucco facings in all of the tile-backed stucco-faced walls were crazed and the facings in some of them were badly cracked, as can be seen from figures 3, 4, and 5. It was not determined if large cracks in the stucco facings coincided, in location, with mortar joints in the tile backing or if they were caused by possible differential movements in the backing. The tile appeared to be in good condition after exposure,

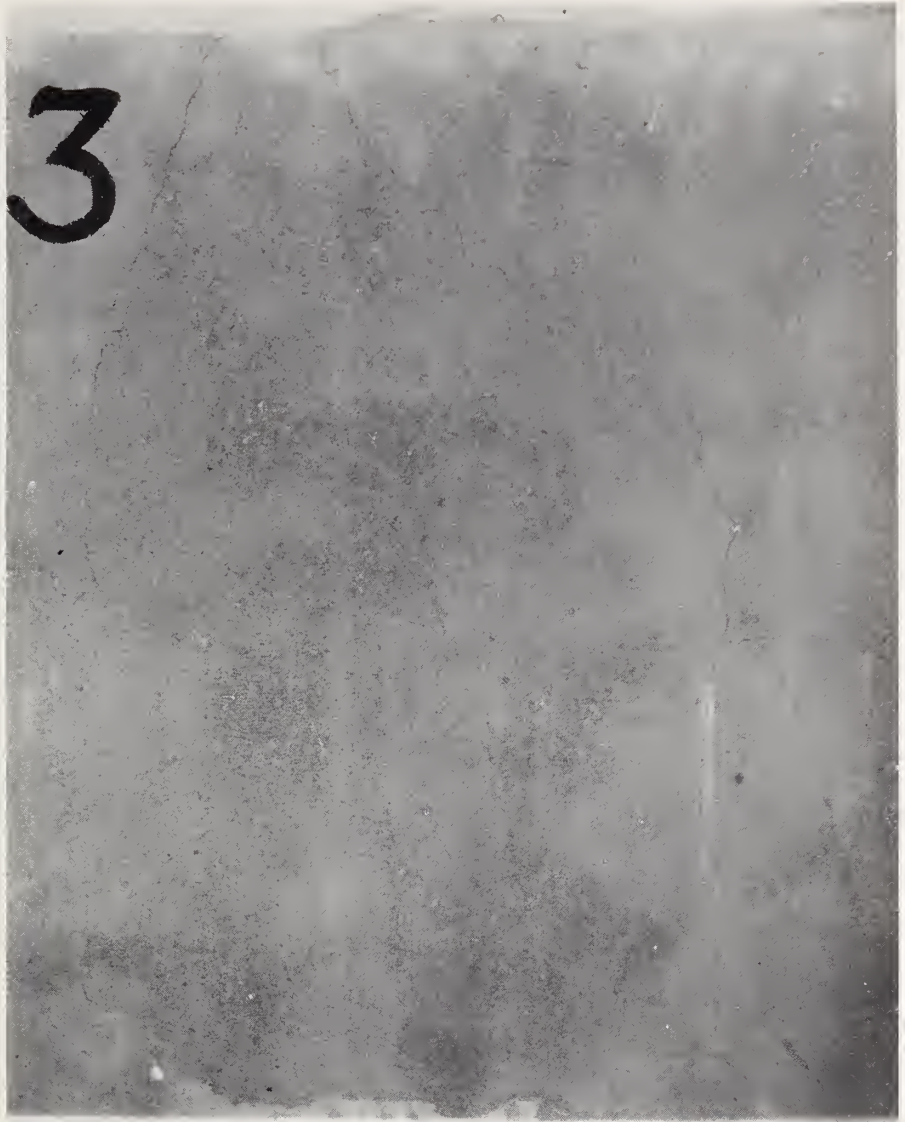
FIGURE 4.—Upper portion of wall 3 after 2 years' outdoor exposure.

Cracks about one-fourth actual size.

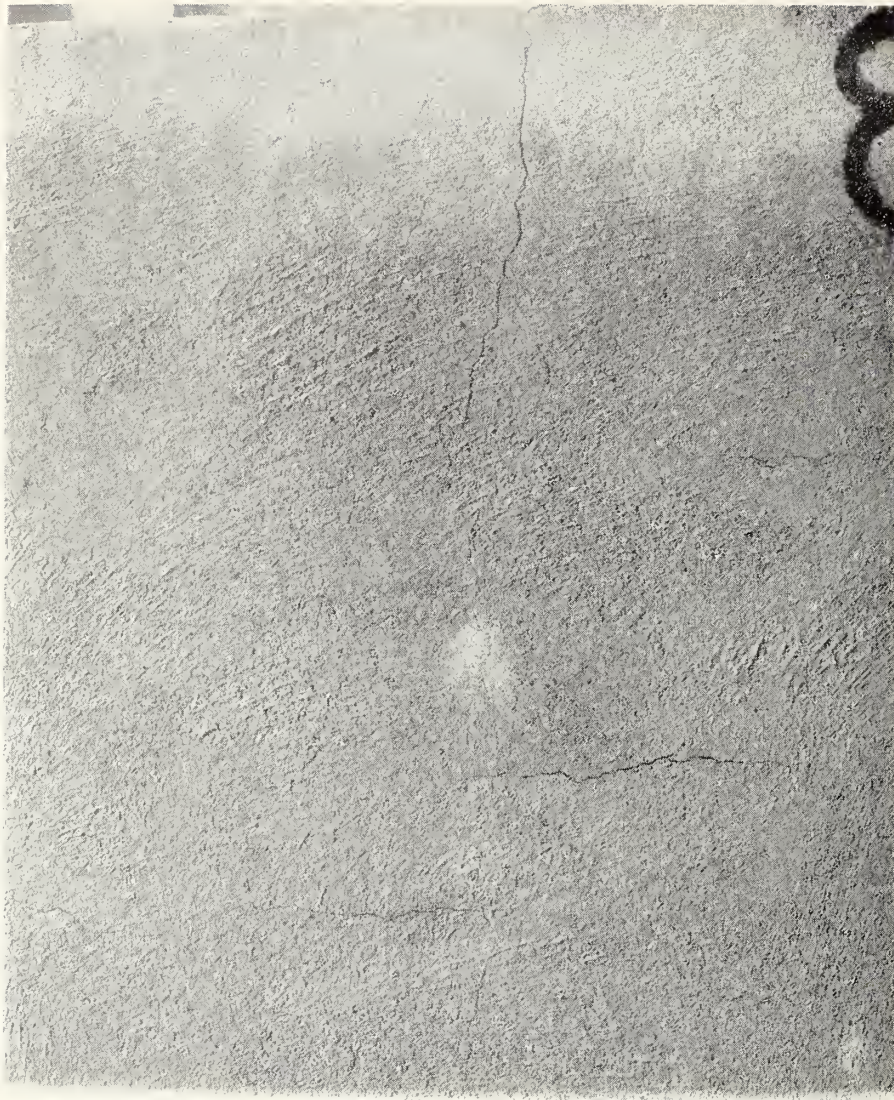
FIGURE 5.—*Upper portion of wall 8-sj9A2 after 3 years' outdoor exposure.*

Stucco-faced wall with tile on side. Cracks about one-fourth actual size.

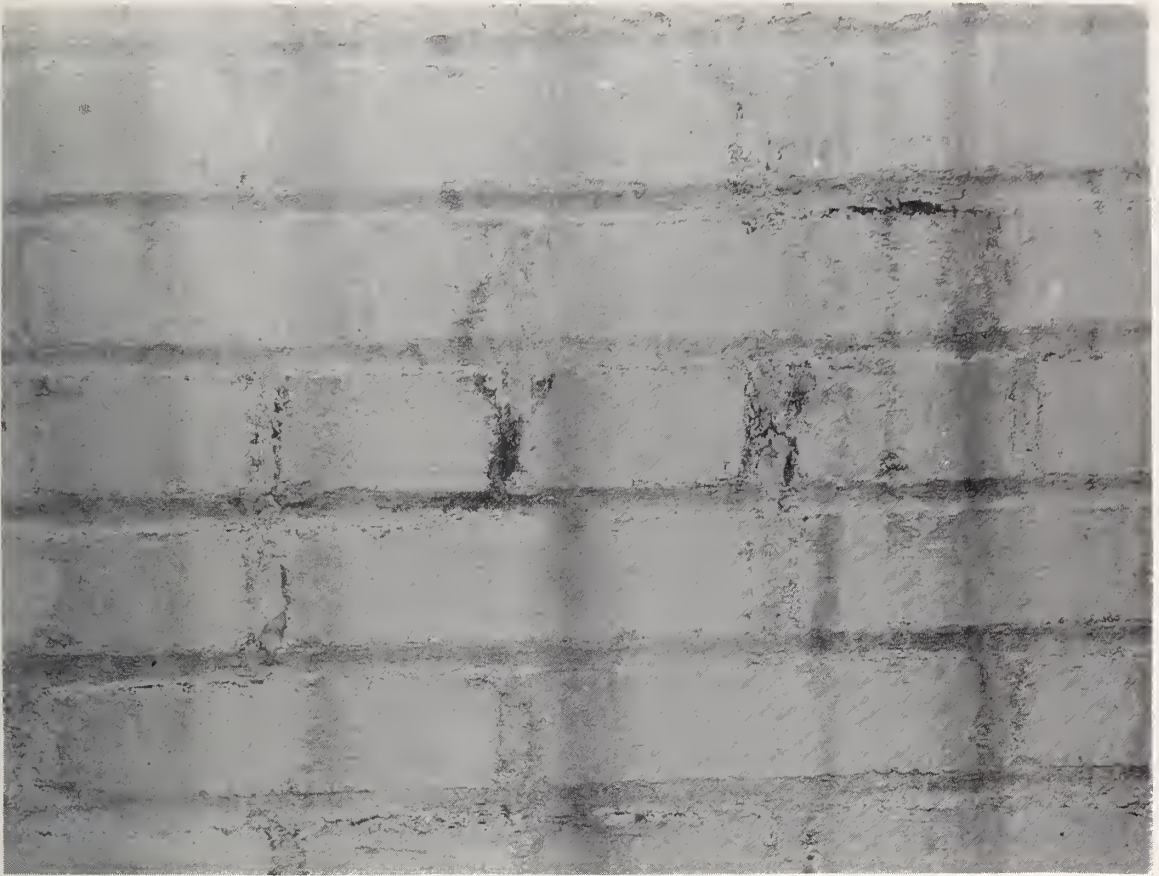
FIGURE 6.—Oil paint film on wall A10-bb8B2, after 3 years' outdoor exposure.

Wall was reported before painting.

The oil paint applied to wall A10-bb8B2 was in fair condition after 3 years' outdoor exposure. This wall had been repointed before painting, and the paint film over the joints was crazed and slightly peeled, as is shown in figure 6. This wall was tested once for permeability between the repointing and the painting treatments, and it is possible that the alkalinity of the repointed joints was not sufficiently neutralized before painting. There was considerable dusting in the paint film over the brick.

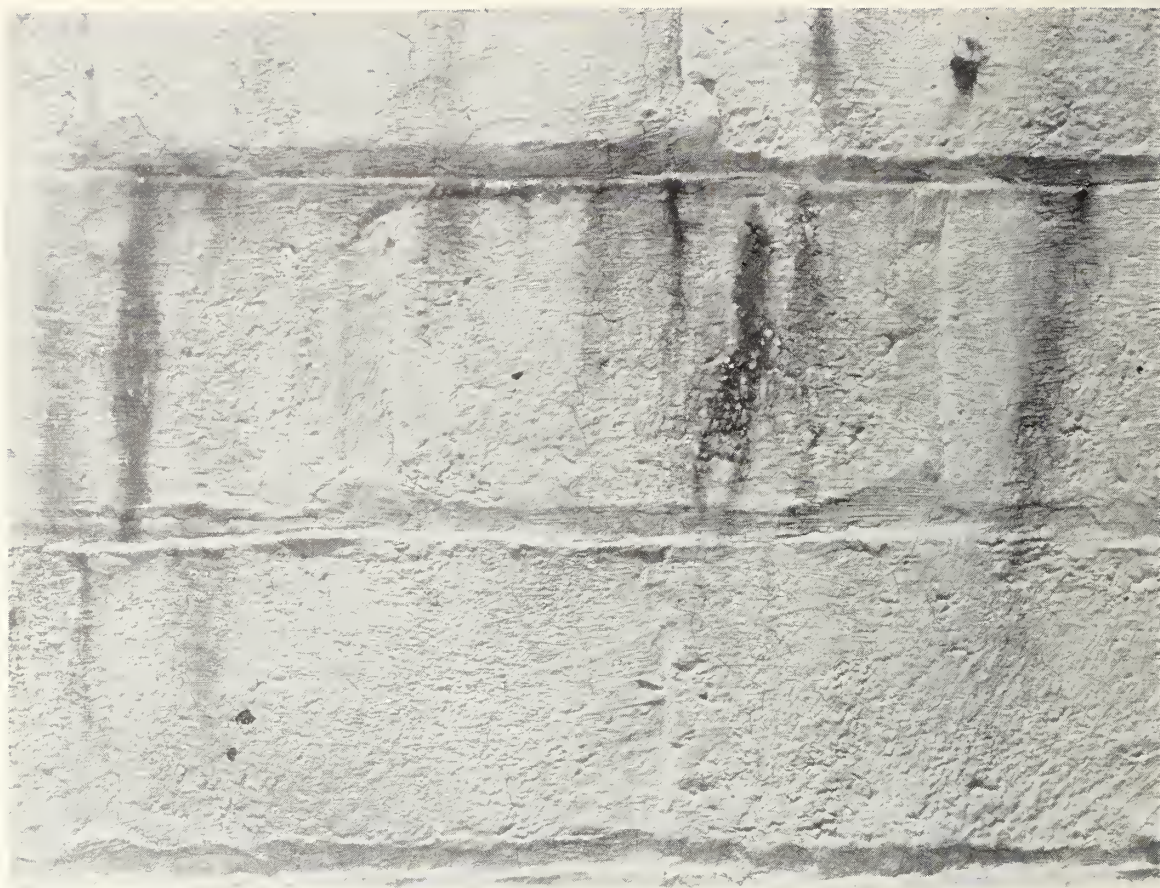
lower edges of the stretcher brick. Two brick were badly spalled to a depth of one-half inch. After 3 years' outdoor exposure, the paint films on the concrete-block walls were crazed and dusting. There was no scaling of the paint film except in wall A11 where the cinder block had popped or spalled (see fig. 7).

FIGURE 7.—Cement-water paint film on cinder block wall A11-n8B2 after 3 years' outdoor exposure.

Note crazing of paint film. Dark vertical stains are from dirt washed off metal covering at top of wall.
