Field Burnout Tests of Apartment Dwelling Units

D. Gross

Building Science Series 10

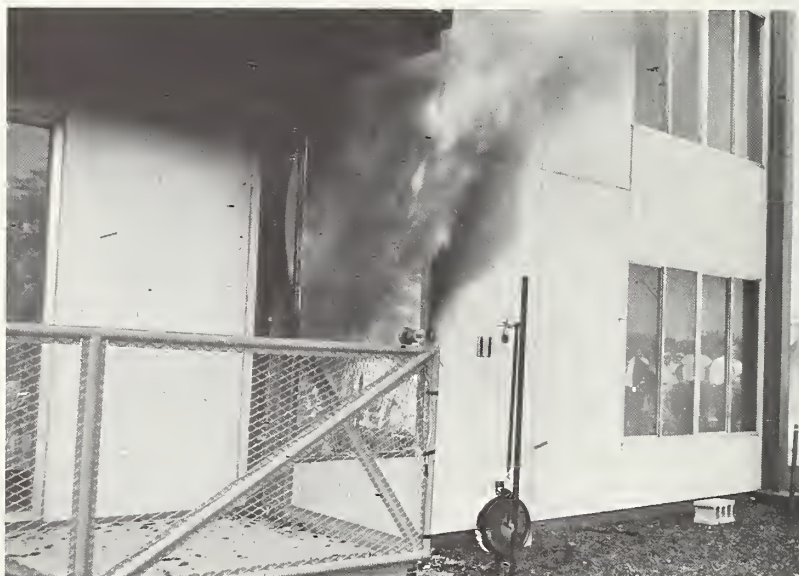
FIGURE 6. Active burning stage, Test No. 1, approximately 26 min after ignition.

Windows fell out at 15 min. Note radiometers in position.

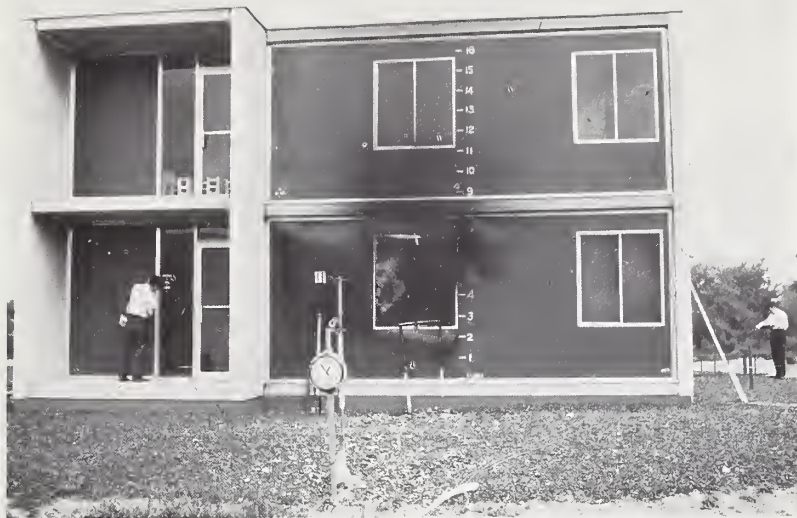
Figure 7. Active burning stage, Test No. 2, 53 min after ignition. Windows fell out at 41 min. Observer at left is making gas concentration measurement.

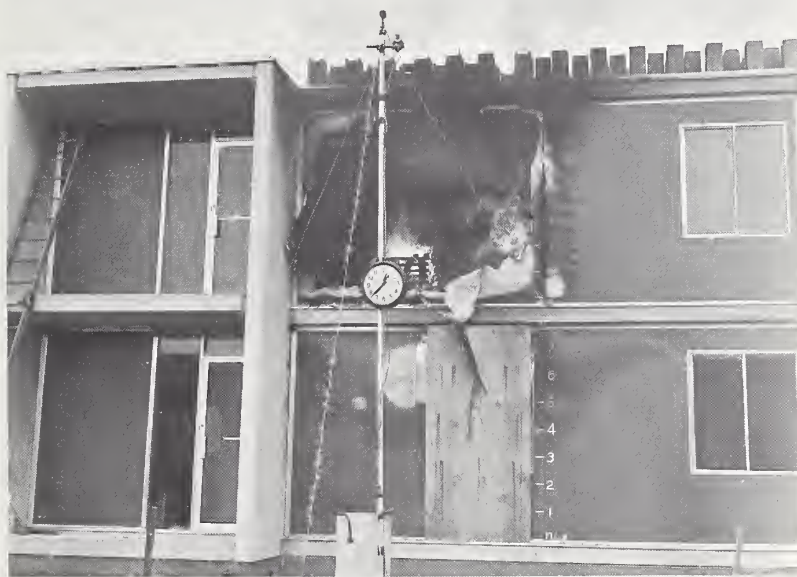
FIGURE 8. Active burning stage, Test No. 3, 38 min after ignition. Sandwich panel fell out at 33 min. Note concrete block load on roof.

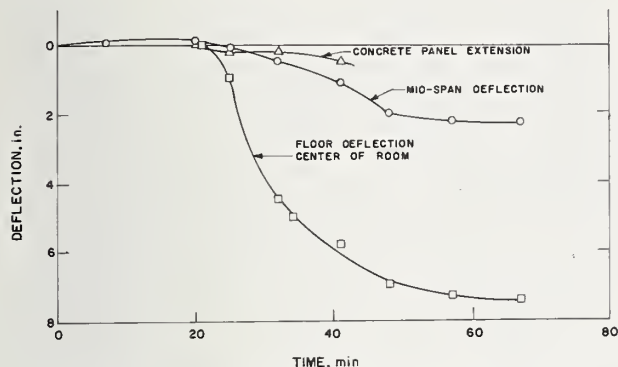
FIGURE 15. Deflections and extensions, Test No. 1.

Vertical and lateral deflection measurements are shown in figure 15. Rapid deflection of the floor at the center of the room above followed shortly after the ceiling of the fire room

dropped and all structural members became directly exposed to fire. The maximum deflection observed was 7.4 in, with a permanent sag of about 6 in after cooling. At the mid-span of the joists, the maximum deflection observed was $2\frac{1}{4}$ in.

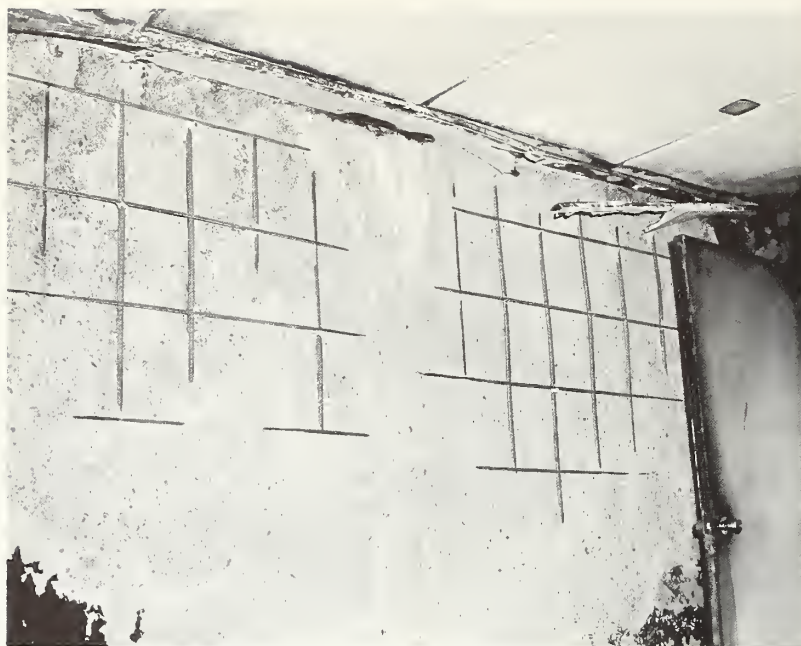
Prior to test, concern was expressed regarding the possible spalling of concrete if fire-tested while moist. Such spalling did actually occur, and in Test 2, was sufficient to expose a considerable number of reinforcing bars (see fig. 18). It is anticipated that, with adequate conditioning resulting in a close approach to moisture equilibrium, the tendency of concrete members to spall under fire exposure should decrease.

FIGURE 18. Reinforcing bars exposed by explosive spalling of concrete wall, Test No. 2.
