NBS BUILDING SCIENCE SERIES 143

Investigation of the Kansas City Hyatt Regency Walkways Collapse

DEPARTMENT OF COMMERCE • NATIONAL BUREAU OF STANDARDS

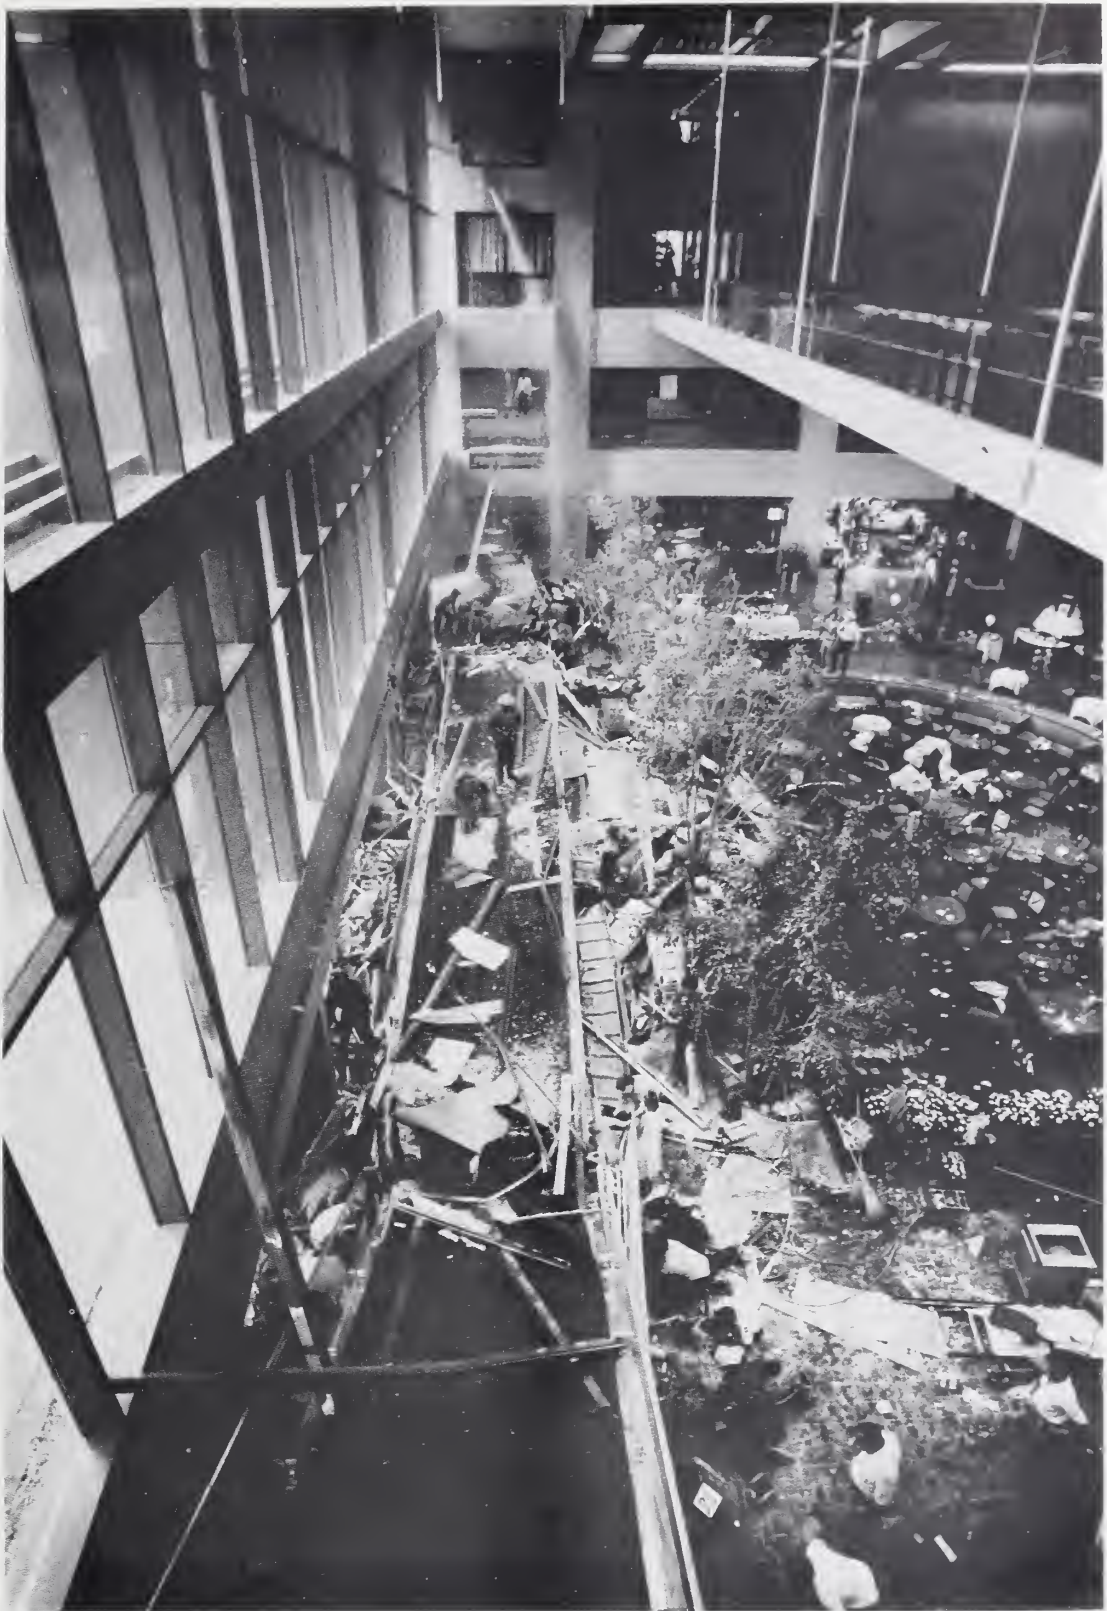
Figure 4.1 Walkways shortly after the collapse. View is to the west-northwest with span U7-8 sloping down and to the right. Spans U8-9 and U9-10 are visible behind the trees. Photo by Greg Smith, reprinted by permission of The Kansas City Times, © 1981, The Kansas City Star Company.

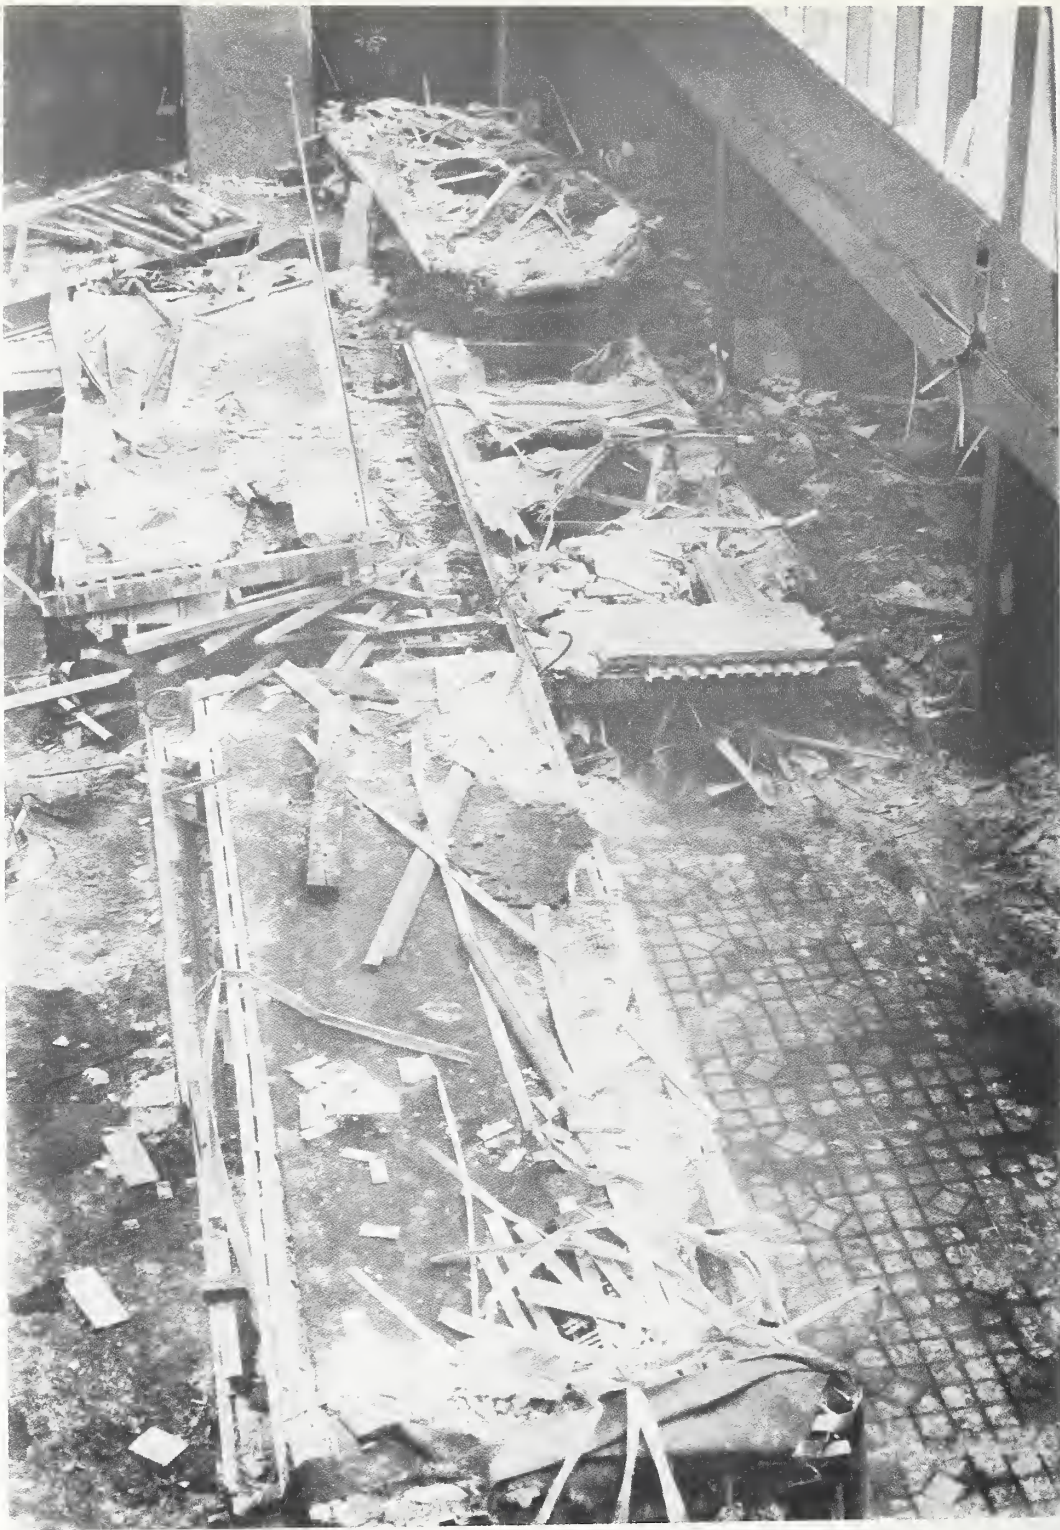
Figure 4.2 Walkways shortly after the collapse. View is directly to the north along the axis of the walkways. Span U7-8 is in foreground and third floor walkway is at upper right. Water is coming from broken sprinkler pipes. Photo by Greg Smith, reprinted by permission of The Kansas City Times, © 1981, The Kansas City Star Company.

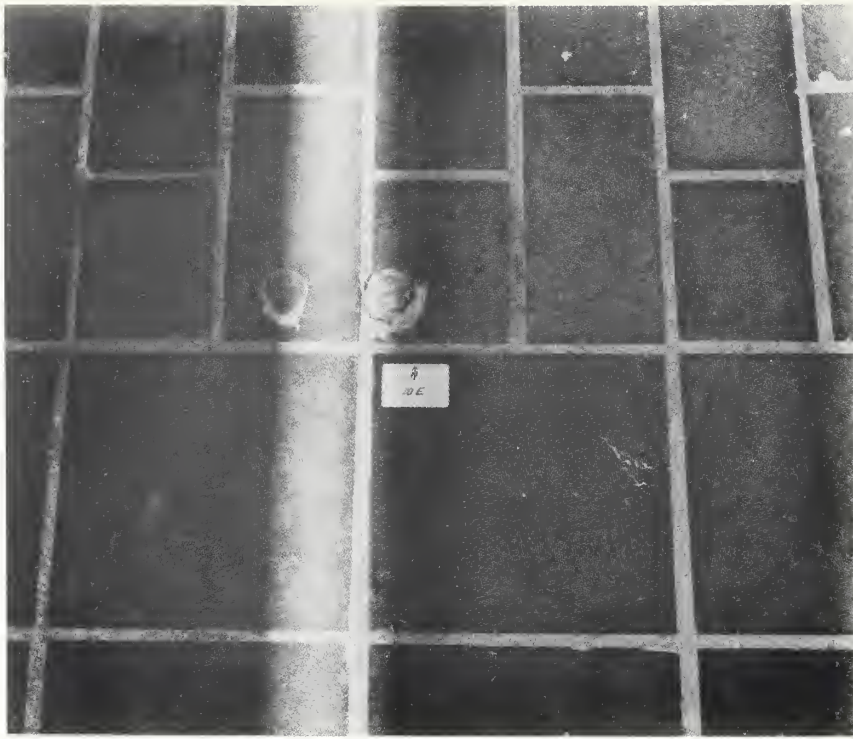
Figure 5.3 Tile damage caused by second floor hanger rod 10E.

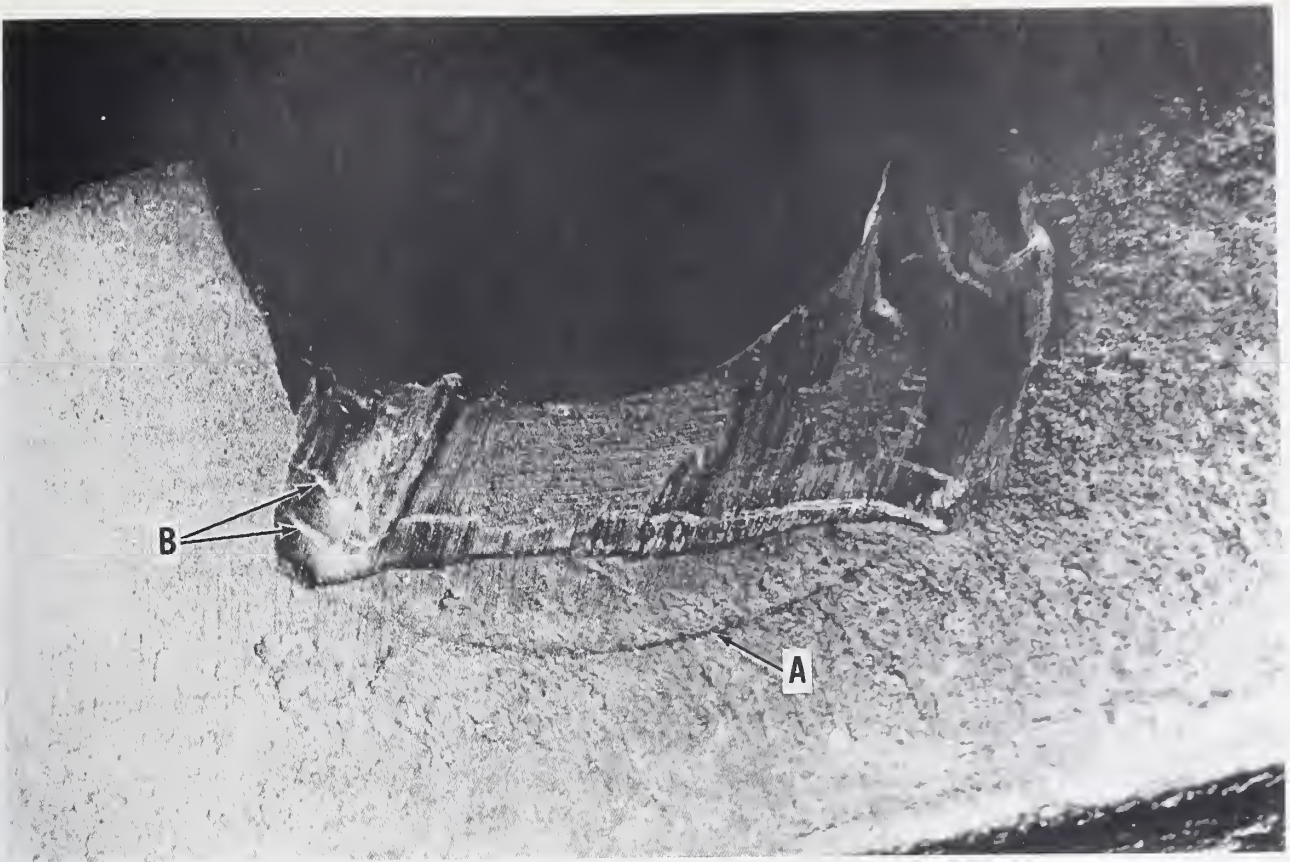
Figure 5.10 Deformation at underside, outer hole, location 9UE due to pull-through of washer/nut assembly. Note imprint of washer (A) and evidence of slip-stick progressive failure (B).

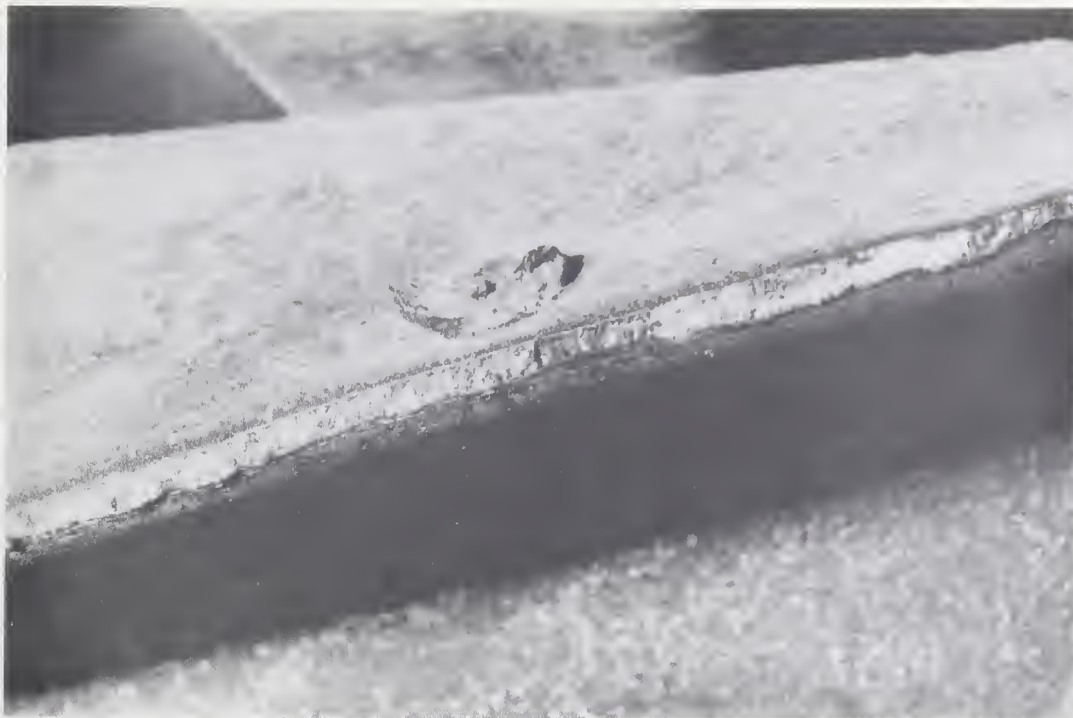
Figure 5.15 Weld penetration at location 8UW, upper flange.

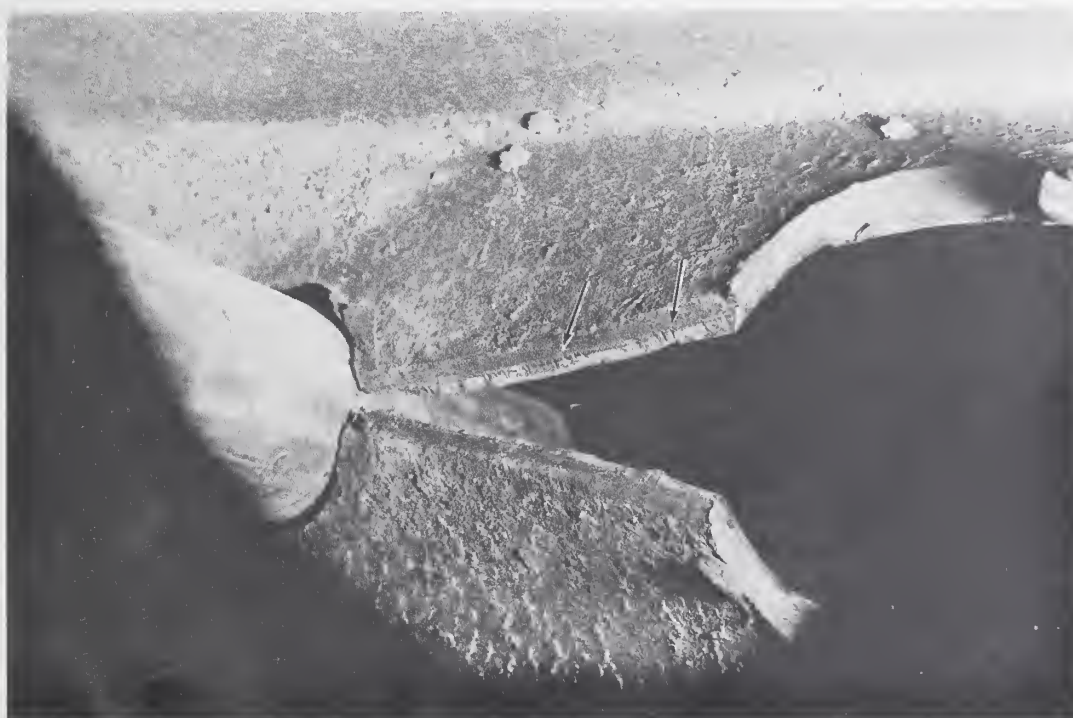
Figure 5.16 Fracture through the weld at location 9UE, lower flange. Weld porosity denoted by arrows.

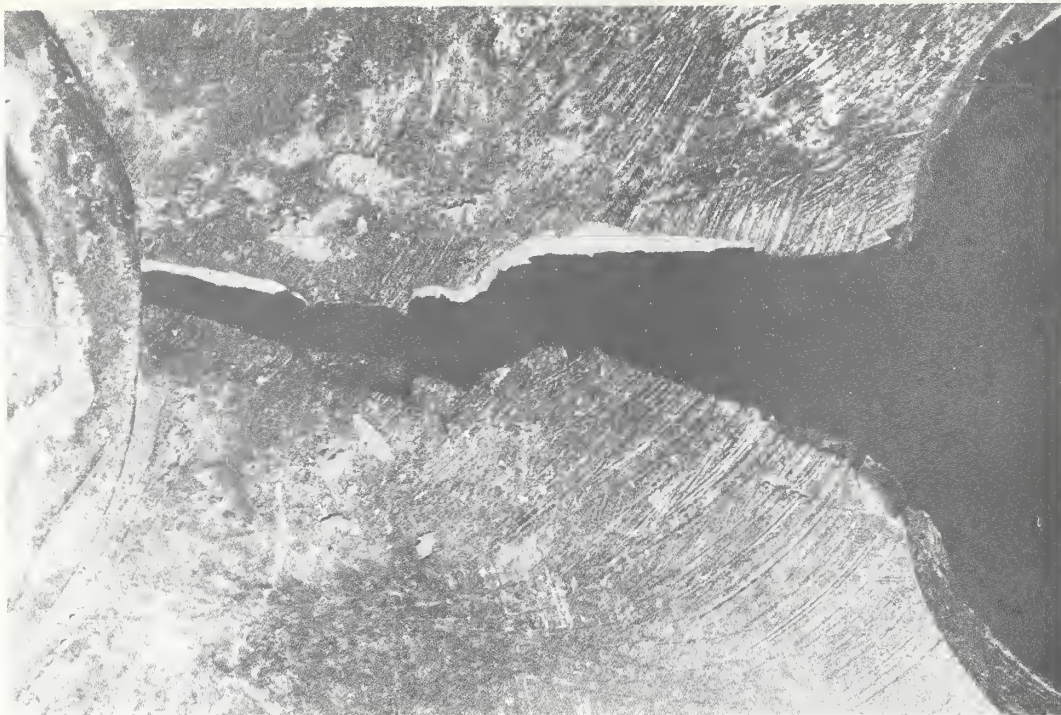
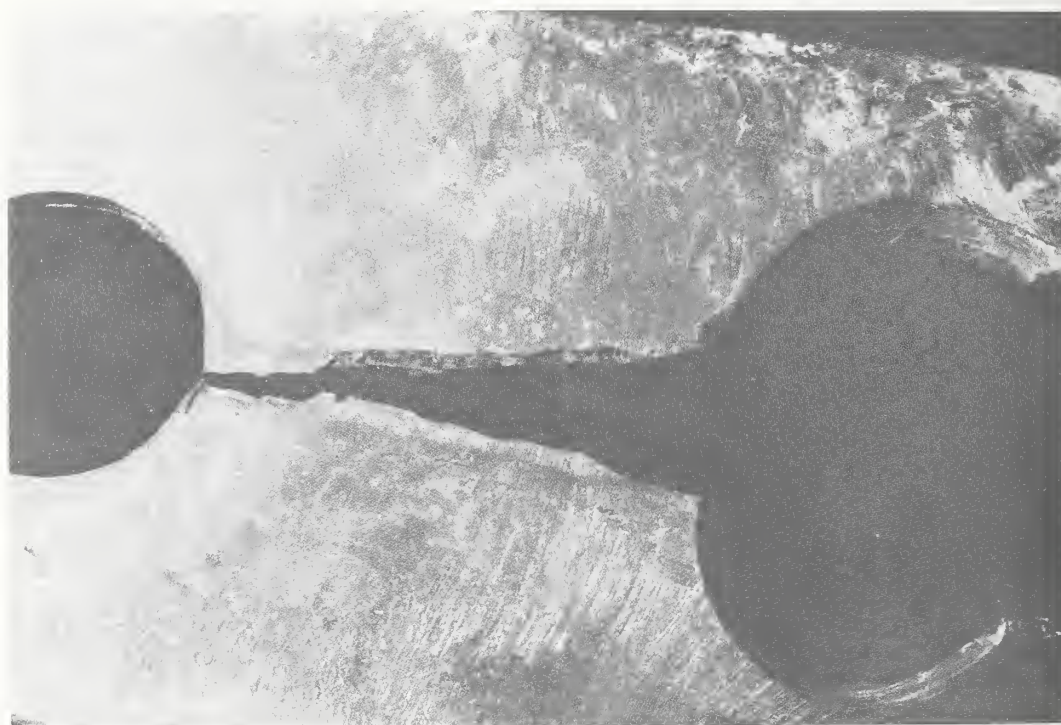
Figure 5.17 Fusion line weld fractures between hanger rod holes, upper flange weld, locations 9UE(a) and 8UE(b).

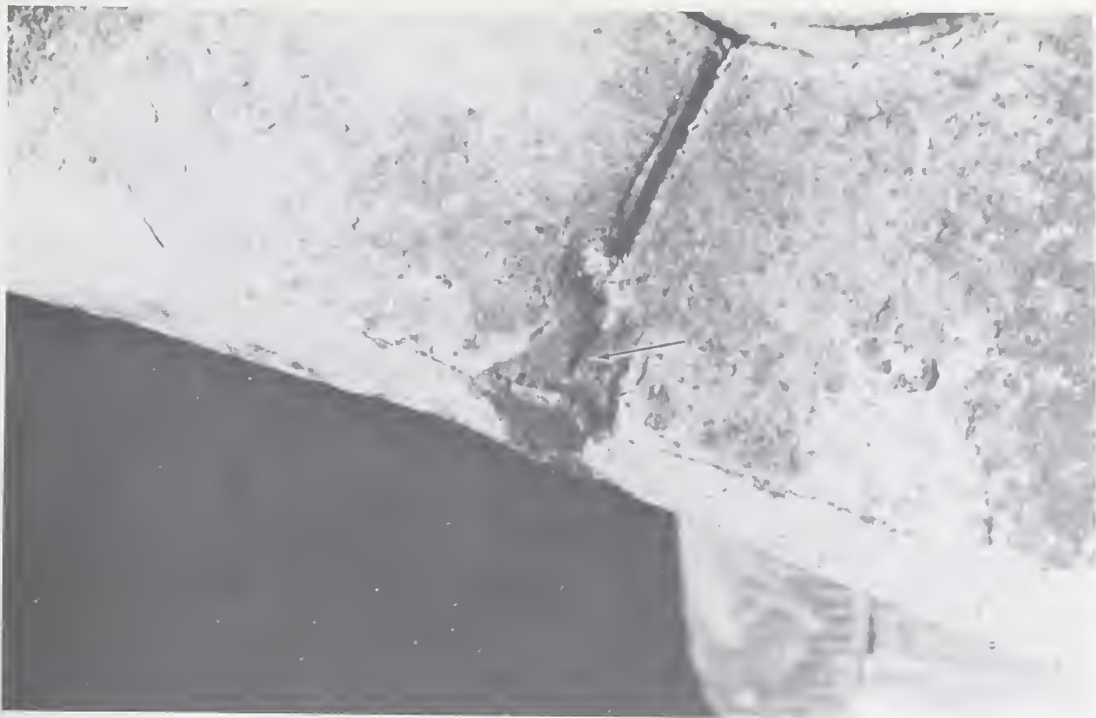
a) Location 8MW. Tack weld crack.

Figure 5.18 Apparent cracks (arrows) in lower welds of box beams in third floor walkway.

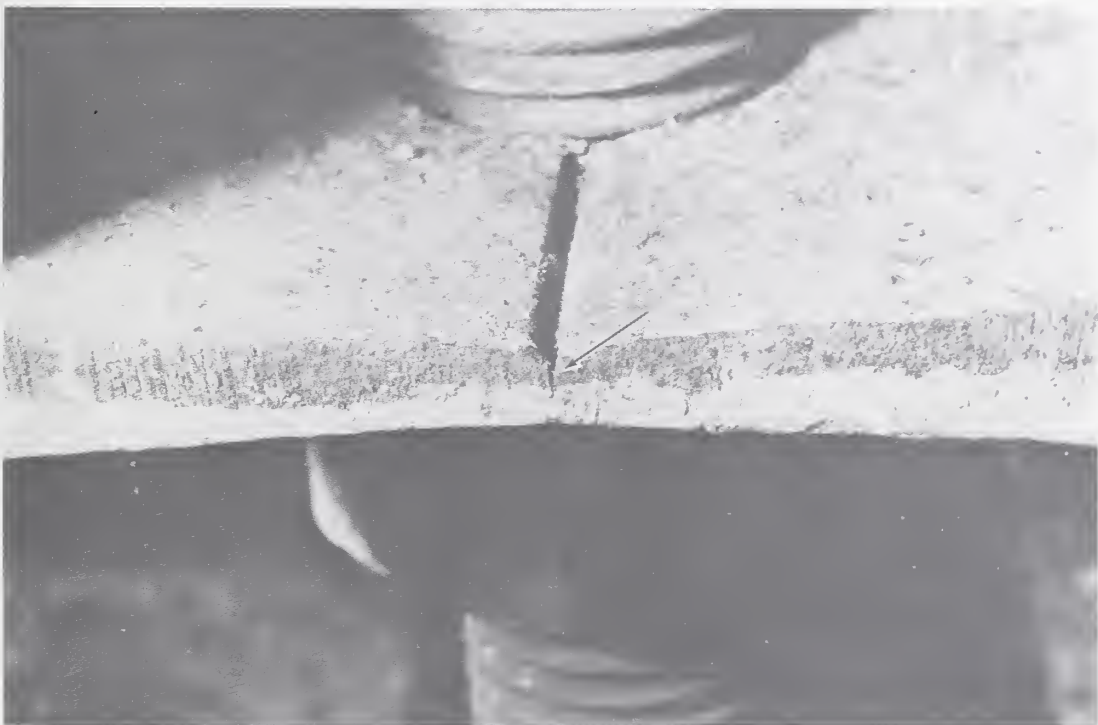
b) Location 8ME. End crack.

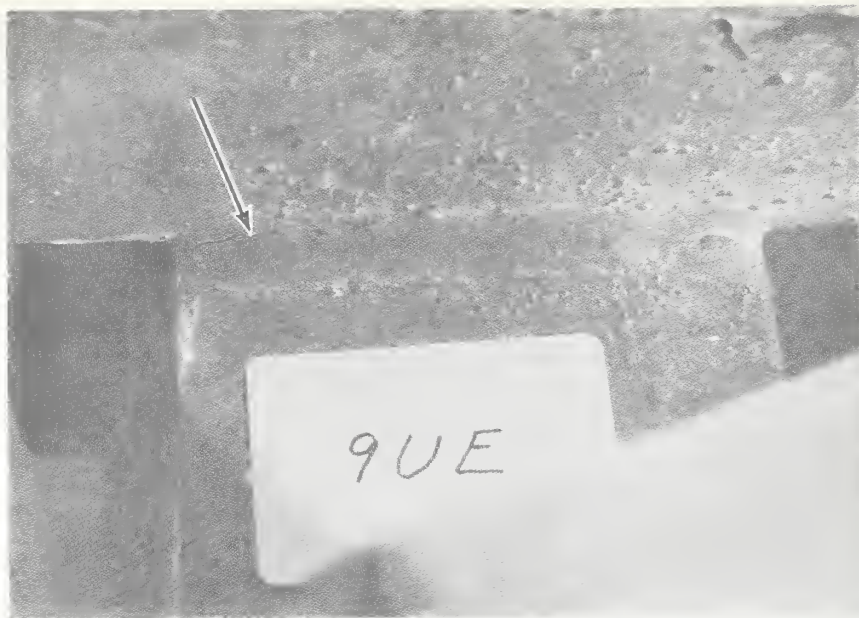
Figure 5.19 Incipient shear failure, bottom fillet weld of intact clip angle, location 9UE, south side.

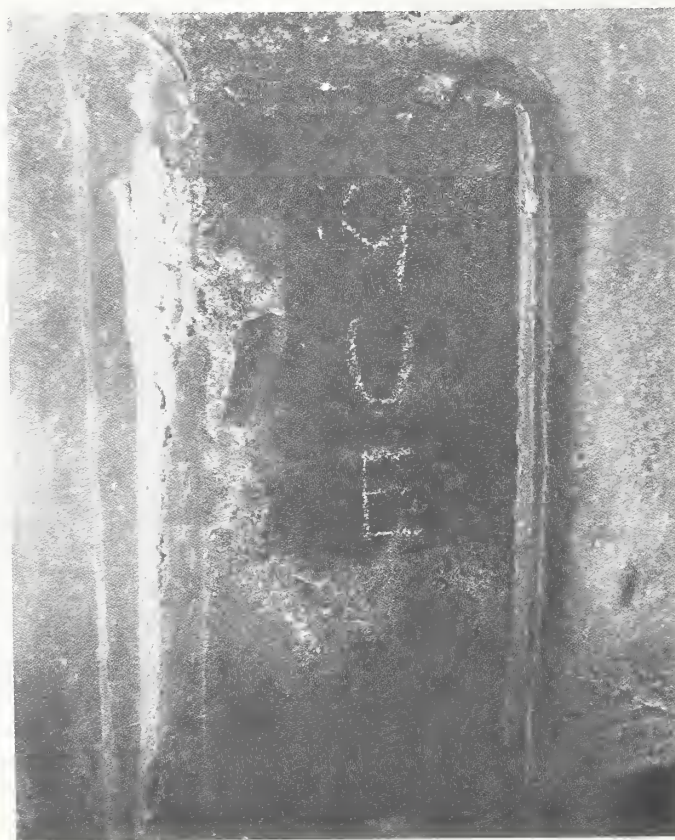
Figure 5.20 Shear failure at bottom and pull-out failure at top of clip angle, location 9UE, north side.

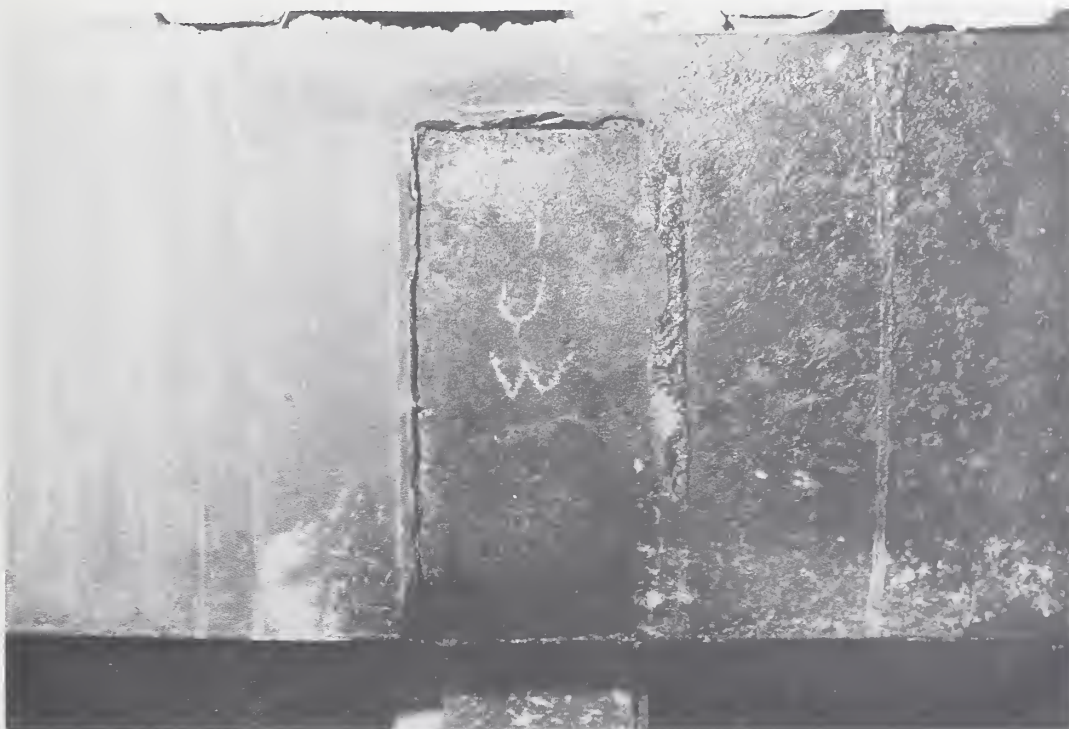
Figure 5.22 Shear failure in clip angle fillet weld at location 9UW, north side. This weld and the corresponding weld at location 9LW did not show evidence of a pull-out (tensile) failure at the top fillet weld.

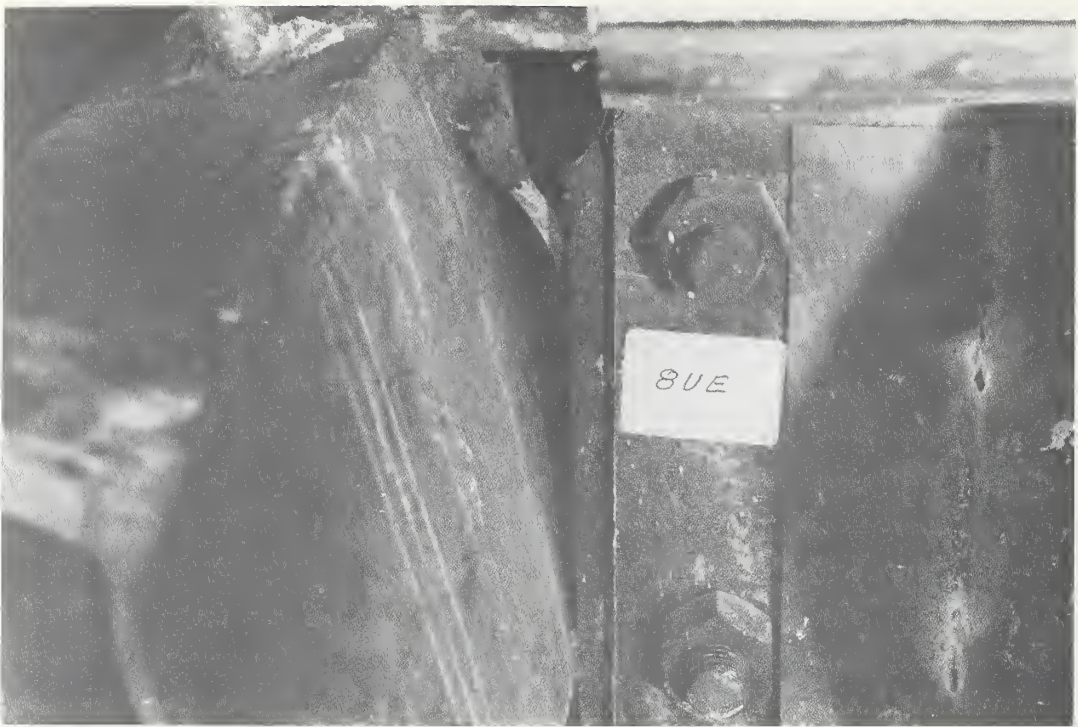
Figure 5.23 Tearing of top end of north clip angle at location 8UE.

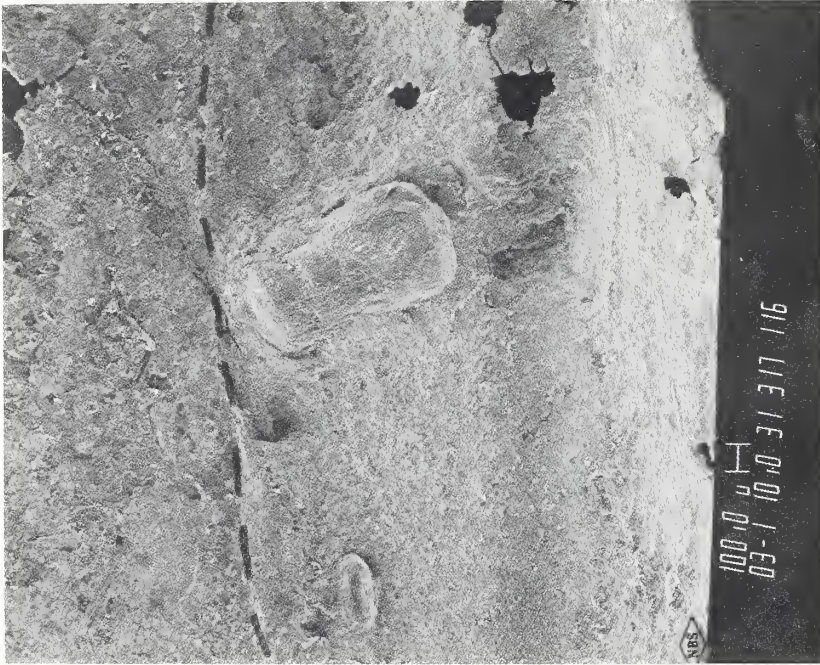
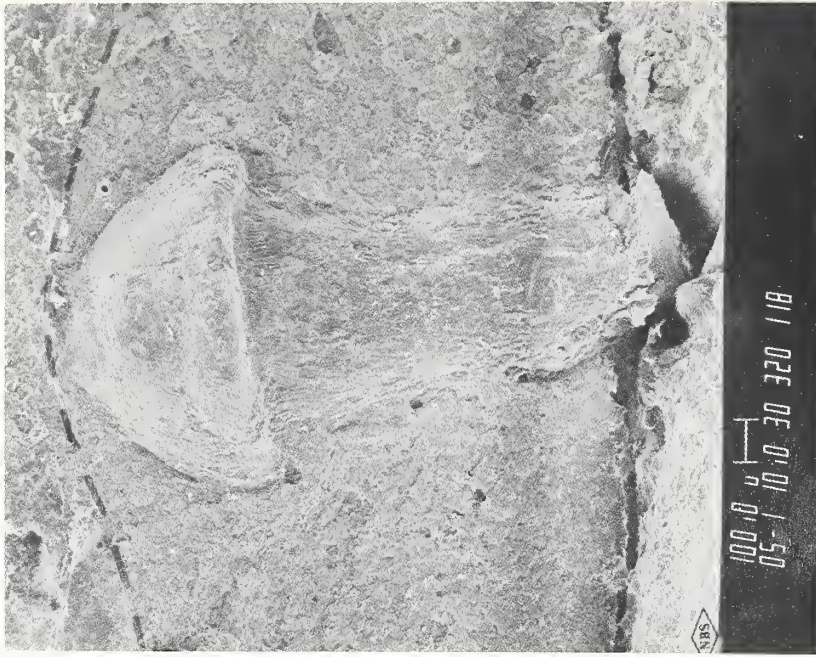
Figure 8.3 Photomicrographs showing that the crack initiated at the root of the weld and propagated to the exterior of the box beam (location 9UE). Figure (a) is located 3 mm from the end of the beam. Crack is propagating downward and slightly to the right. Figure (b) is located 18 mm from end of beam. Magnification (a) X30 and (b) X60.

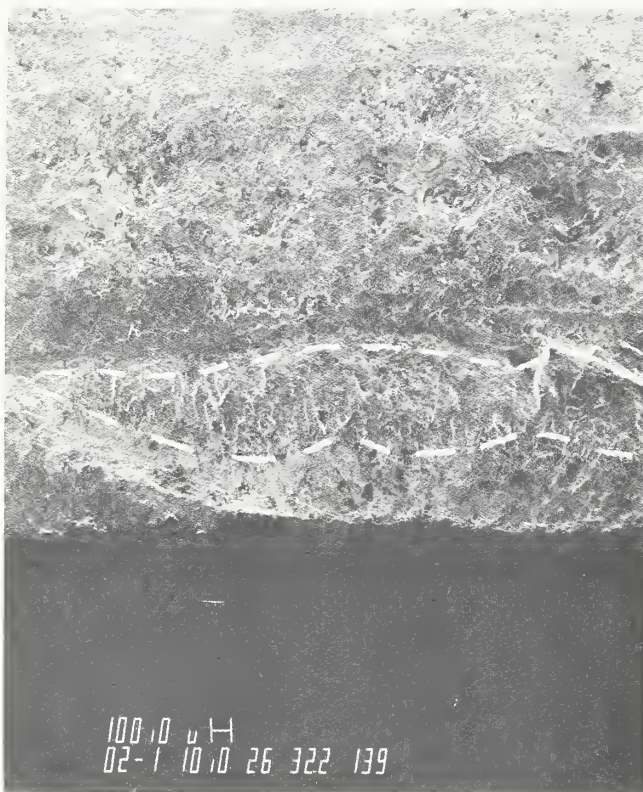
Figure 8.5 Fractographic evidence of pre-existing cracks in walkway box beam exterior longitudinal welds at locations (a) 9UW, (b) 9UE, (c) 8UW. Regions interpreted as cracks outlined by dashed lines. Magnifications X55, X250, and X25, respectively.

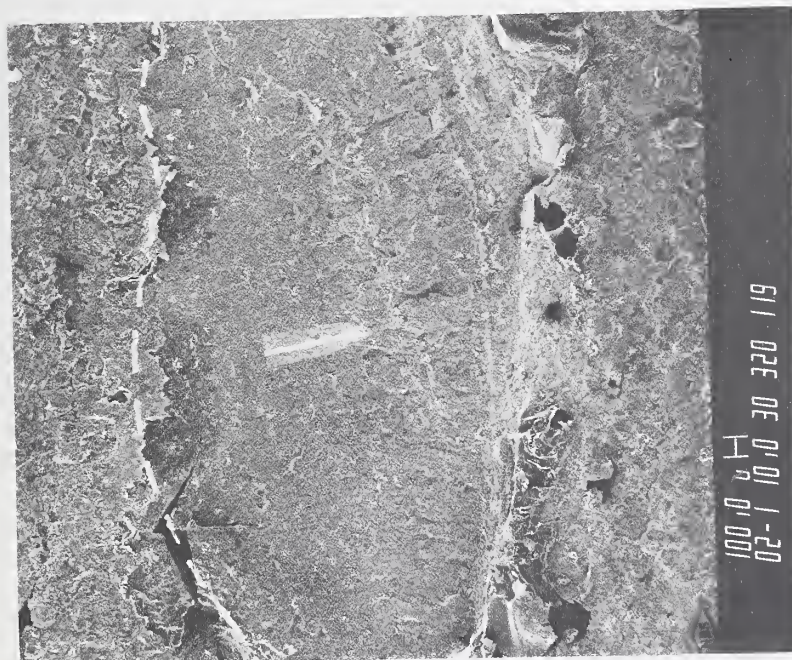
Figure 8.6 Evidence of fracture initiation from upper surface of interior tack weld (dashed line) at location 9UE. Direction of propagation is toward the weld root (arrow) normal to the welding direction. Magnification X25.

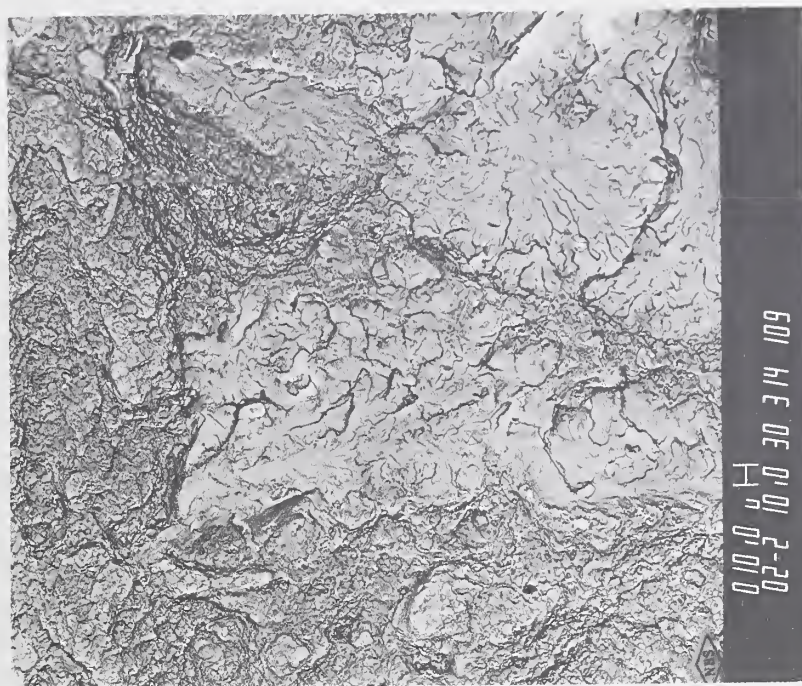
Figure 8.7 Cleavage facets observed at center line of lower exterior longitudinal weld at location 9UW (bright areas). Magnification X250.

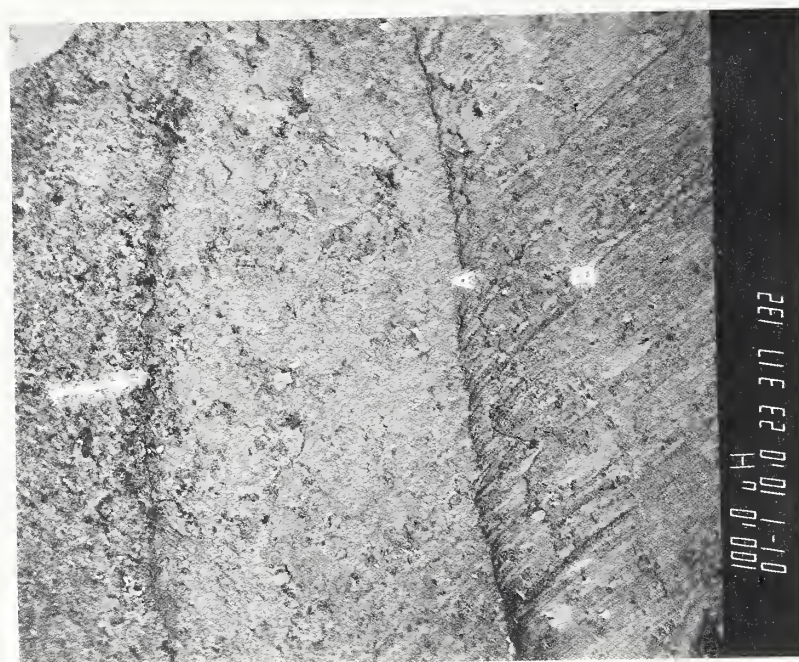
Figure 8.8 Abrasion pattern on bottom flange at location 9UE (north). Arrow denotes initial washer imprint. (A) denotes change in abrasion mechanism. (B) denotes a slip-stick region in progressive failure. Magnification X15.

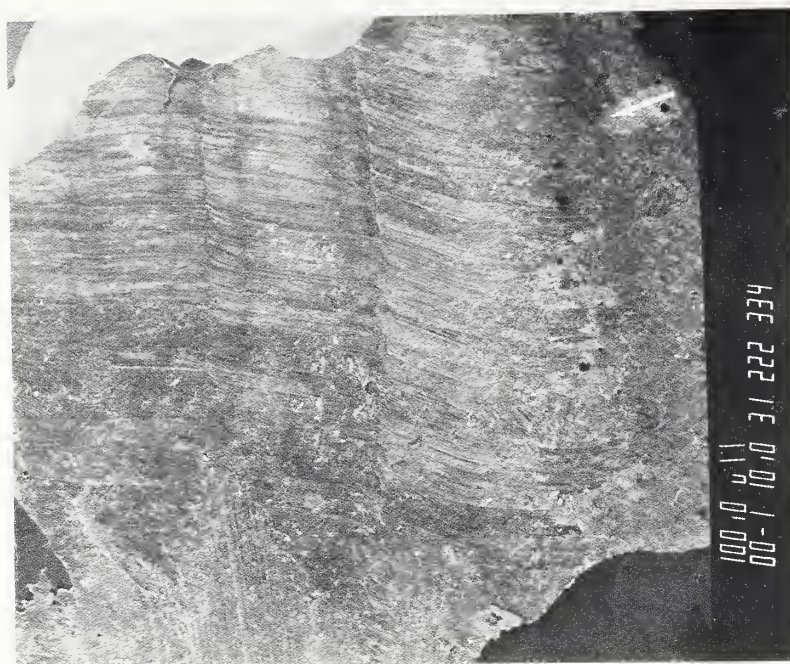
Figure 8.9 Abrasion pattern on bottom flange at location 10UE (south) showing multiple slip-stick regions. Arrow denotes initial washer contact. Magnification X15.

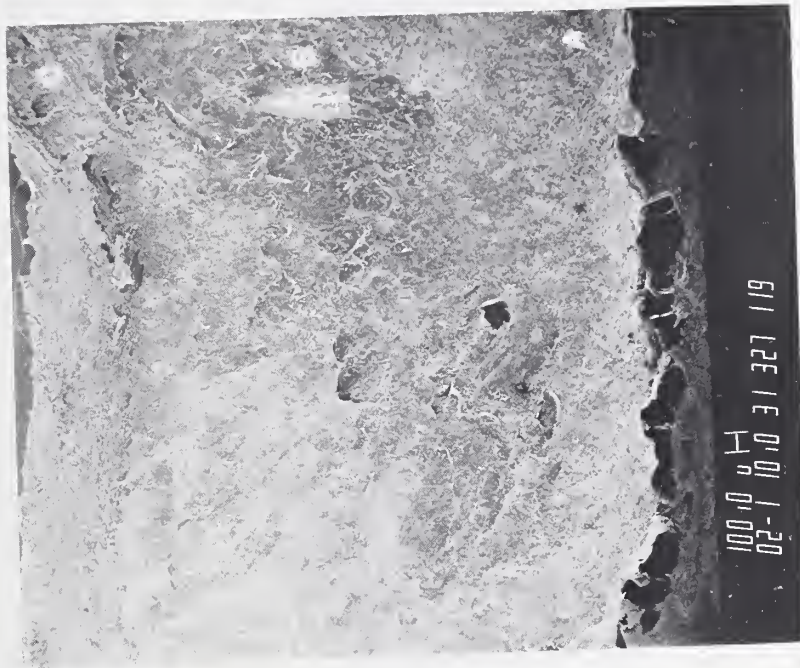
Figure 8.16 Fracture at top fillet weld at clip angle attachment, location 9UE (north). Initiation at A, propagation in direction B to shear lip at C. Magnification X25.

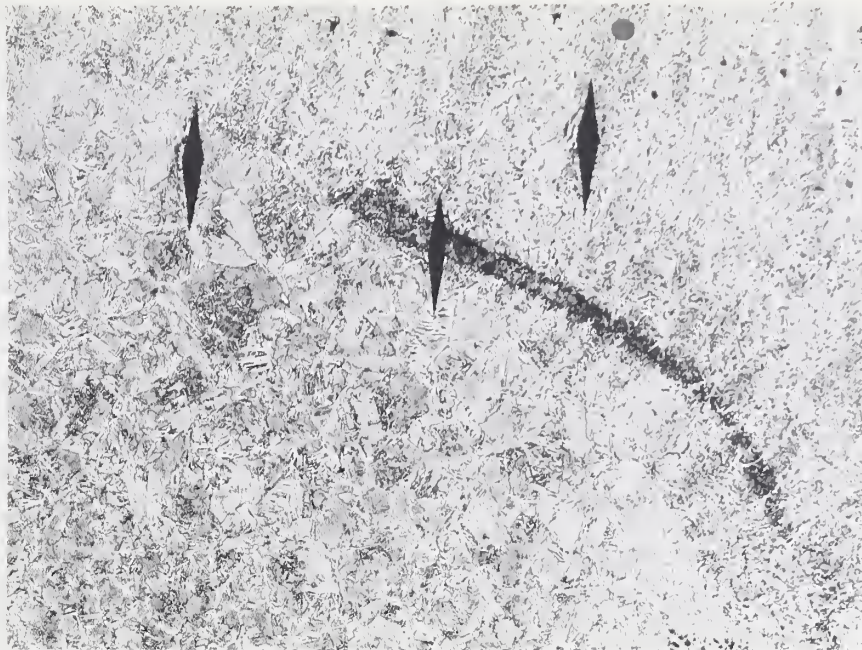
Figure A7.4.1-14 Patch of hard material (dark streak) at the transition from weld metal (top right) to the heat affected zone (bottom left) in section 1BM1. The elongated dark areas are hardness impressions. Etchant: two percent nital. X100

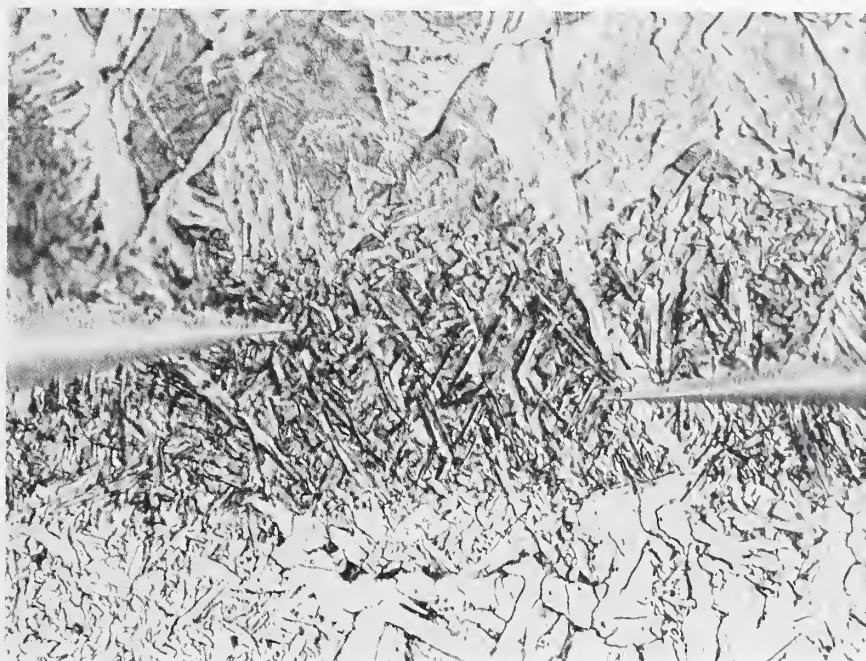
Figure A7.4.1-15 Hard area similar to that shown above, but at higher magnification. The hard area is in the center running from side to side. The microstructure appears to consist of fine grained tempered martensite. Parts of two hardness impressions can be seen at either side of the figure. Etchant: two percent nital. X800

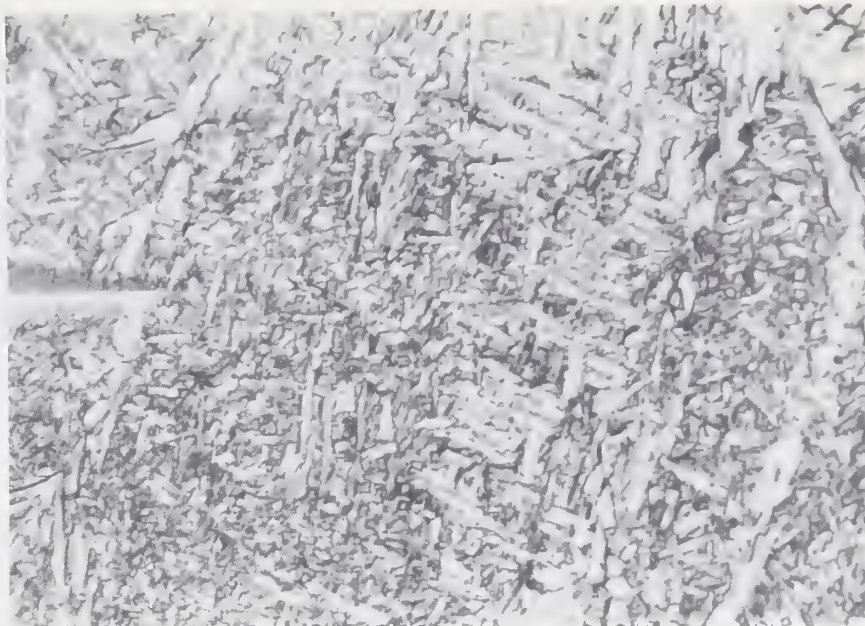
Figure A7.4.1-29 Region of the transition zone from weld metal to the heat affected zone in section 2BM2. This region is one of the hard areas. The microstructure appears to consist of tempered martensite. Part of a hardness test impression can be seen at the left center. Etchant: two percent nital. X1200
