NBS BUILDING SCIENCE SERIES 145

# Investigation of Construction Failure of Harbour Cay Condominium in Cocoa Beach, Florida

H. S. Lew  
N. J. Carino  
S. G. Fattal  
M. E. Batts

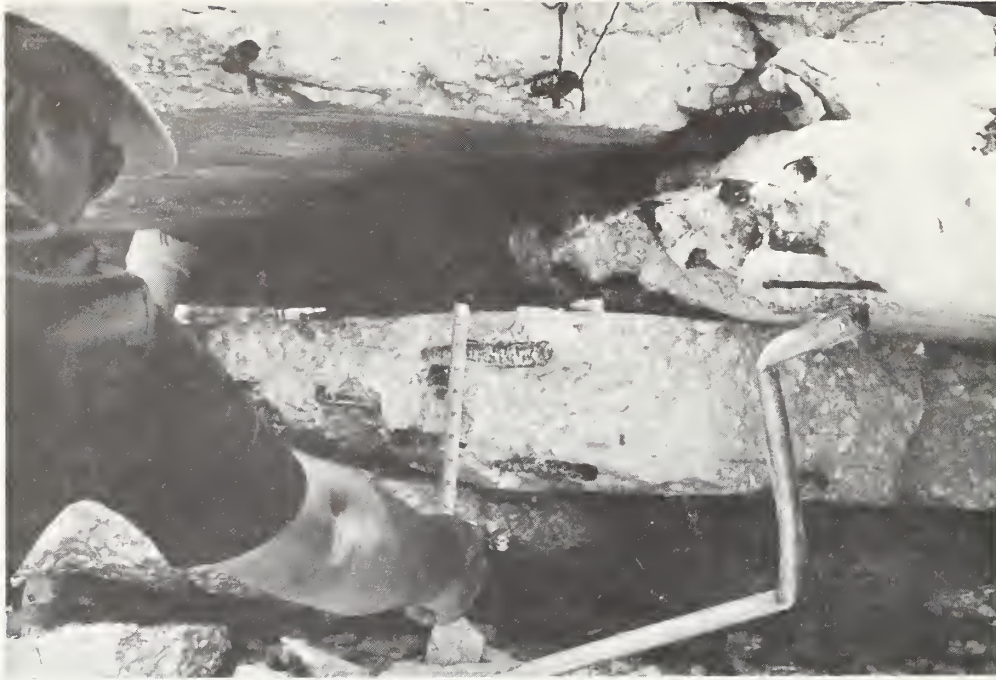
There is, therefore, an inconsistency in the construction documents. The structural drawings indicated a 3/4-in (19-mm) cover for the top slab bars, whereas the chair height indicated on the steel supplier's shop drawings would result in more than 3/4-in cover for the top bars in the column strips of the slabs. The record copies of the shop drawings contained numerous check marks. One of the six pages bore the handwritten words "approved as noted" and the signature of the design engineer of record.

Figure 2.4 Field measurement of top bar cover in column strip

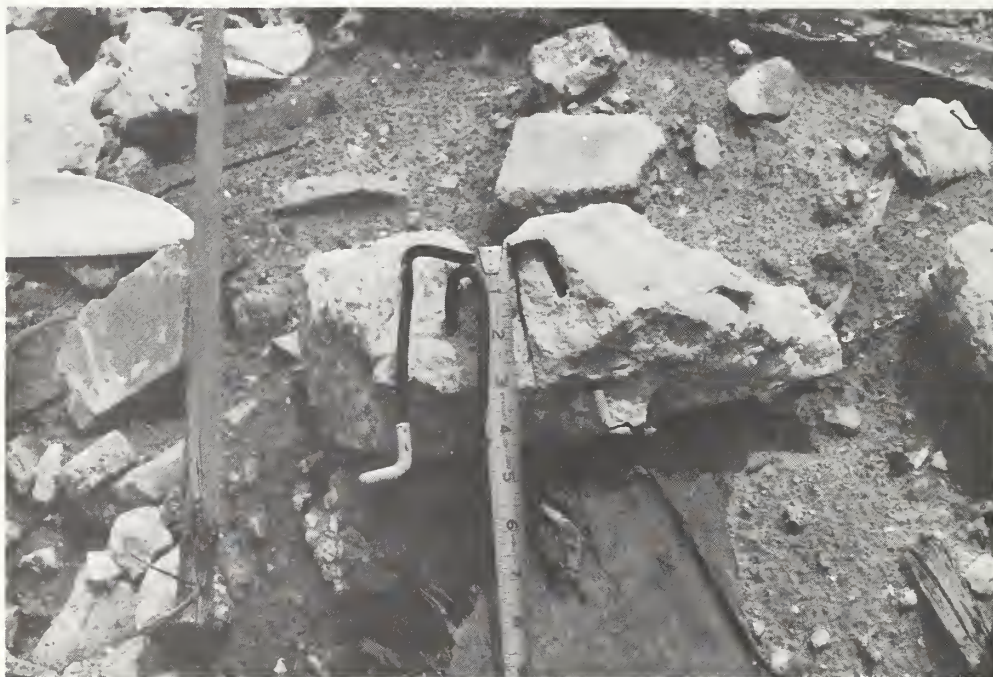
The calculated effective depth at a column where the top reinforcement in the slab consists of #8 and #9 bars is 5.3 in (135 mm). This is obtained by adding to the 4-1/4-in (108-mm) chair height the average diameter of the two bars. If the effective depth is taken to the centroid of the bars, as defined in section 2.1 of the ACI Code [2.1], its value would be 5.28 in (134 mm) or 5.35 in (136 mm) depending on which size bar is assumed to be at the top. Considering all the columns and using both methods of calculation, the effective depth is found to fall in the range of 4.97 to 5.35 in (126 to 136 mm). These figures will be somewhat less along the sides of columns at the edges of balcony and walkway slabs which are less than 8 in (203 mm) thick. The value of  $d = 5.3$  in (135 mm) is assumed in the subsequent calculations of stresses in the structure (chapter 5). Generally, these stresses are somewhat on the low side because the assumed  $d$  for the slab is high at most of the columns.

Figure 2.5 Field measurement of chair heights for top bars in column strip

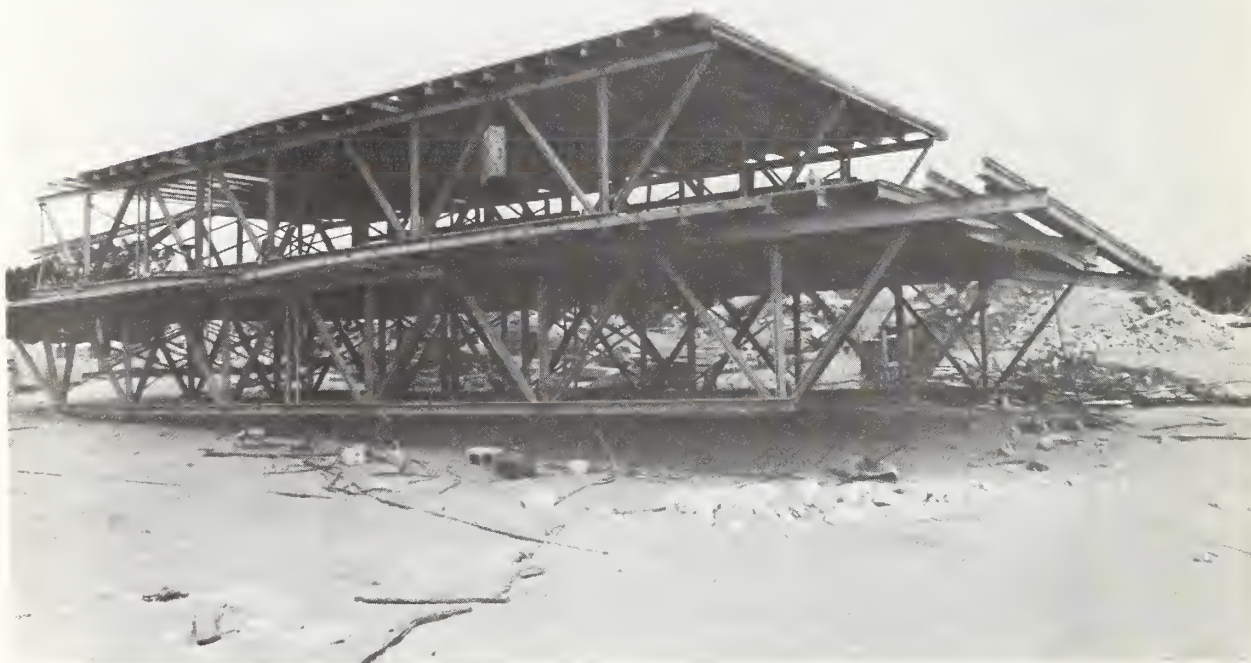
Figure 2.8 Flying forms from the two north bays recovered after the collapse

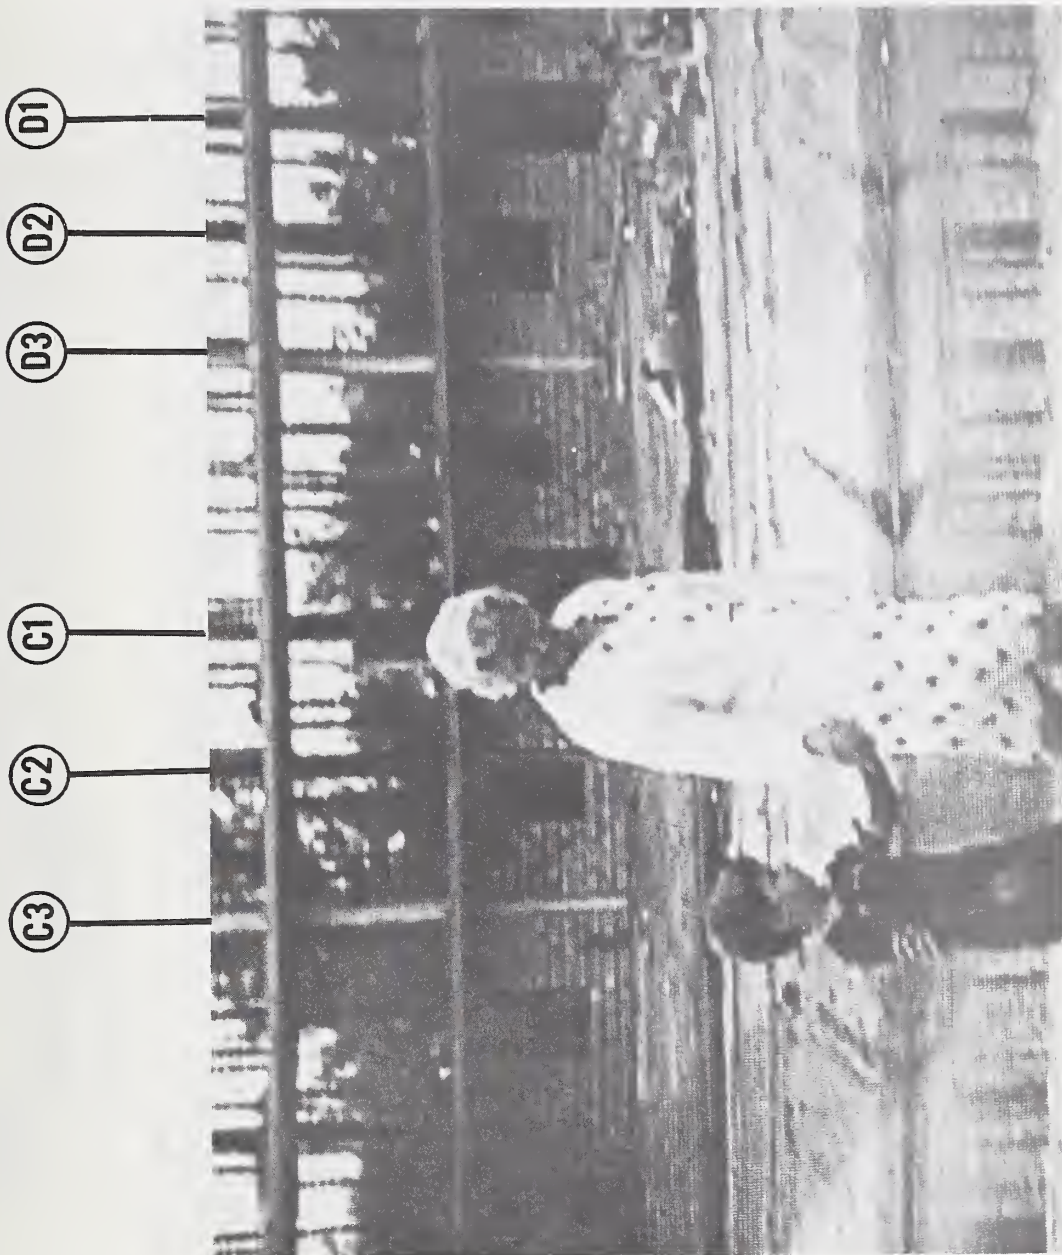
Based on worker statements (see section 3.3) and photographic evidence, there is some doubt as to whether the third and second stories were fully reshored at the time of the collapse. According to one worker account, only two lines of reshores were used in each bay of the second story. This would make the number of reshores in that bay about two-thirds that of a fully reshored story. Other accounts mention cracked reshores in the fourth story being replaced by reshores removed from the lower stories, or reshores being taken out to allow masonry work to proceed, etc.

Figure 2.13 Partial view of bay CD from east side of building

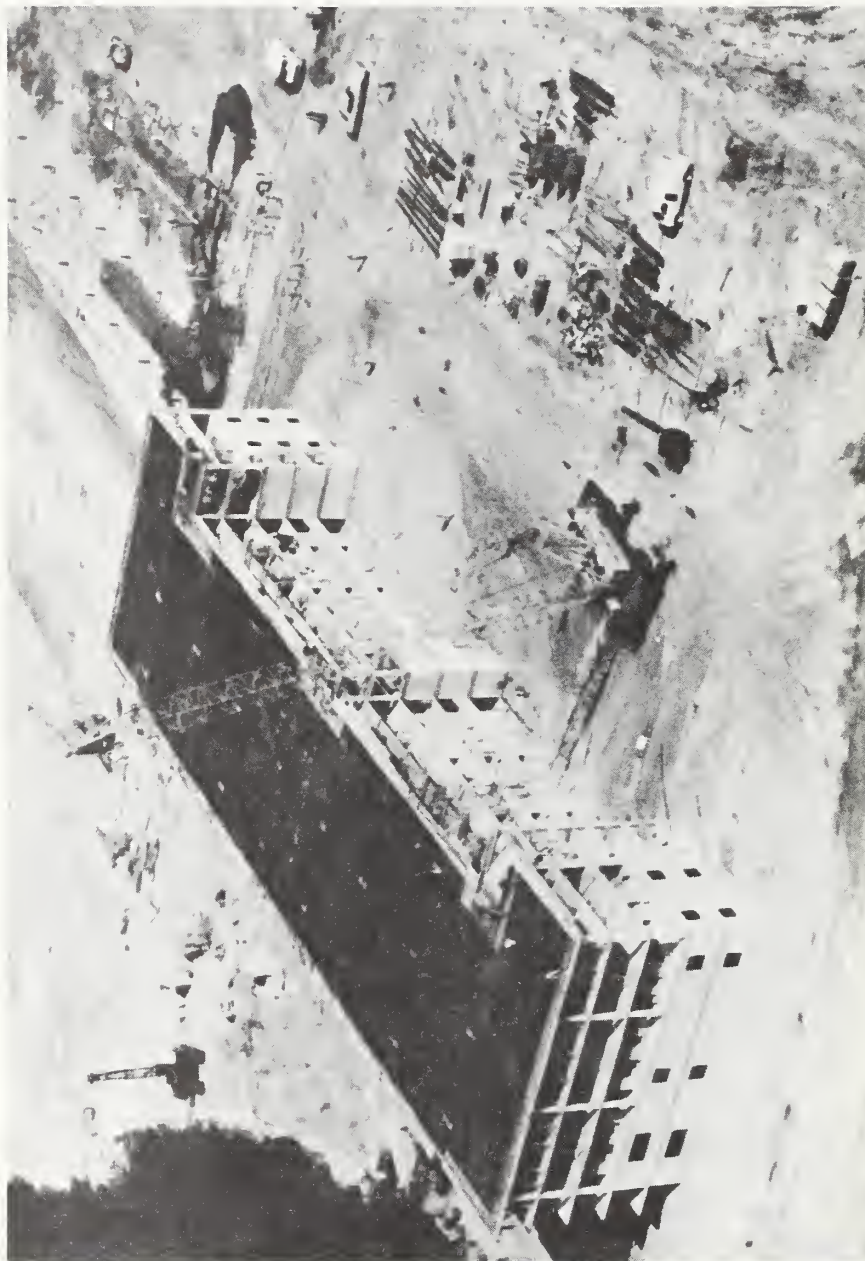
Figure 2.14 is an aerial photograph of the building viewed from the southeast side. The direction of the shadows and the presence of the steel reinforcement for the roof slab indicate the photograph to have been taken on the morning of March 26, or the day before the collapse. The steep angle of the photograph conceals the view of interior reshores in the fourth story and below. It is noted that at the south end only one exterior reshore is in place in each bay of the fourth story while no reshores are in place at the same location in the third story. This contradicts the reshoring plans supplied by the general contractor where two reshores are shown in each bay along the exterior edges of the slabs. It is possible that some of the original reshores were removed to place masonry units in the third floor, as indicated by worker statements.

Figure 2.14 Aerial view of building taken from southeast

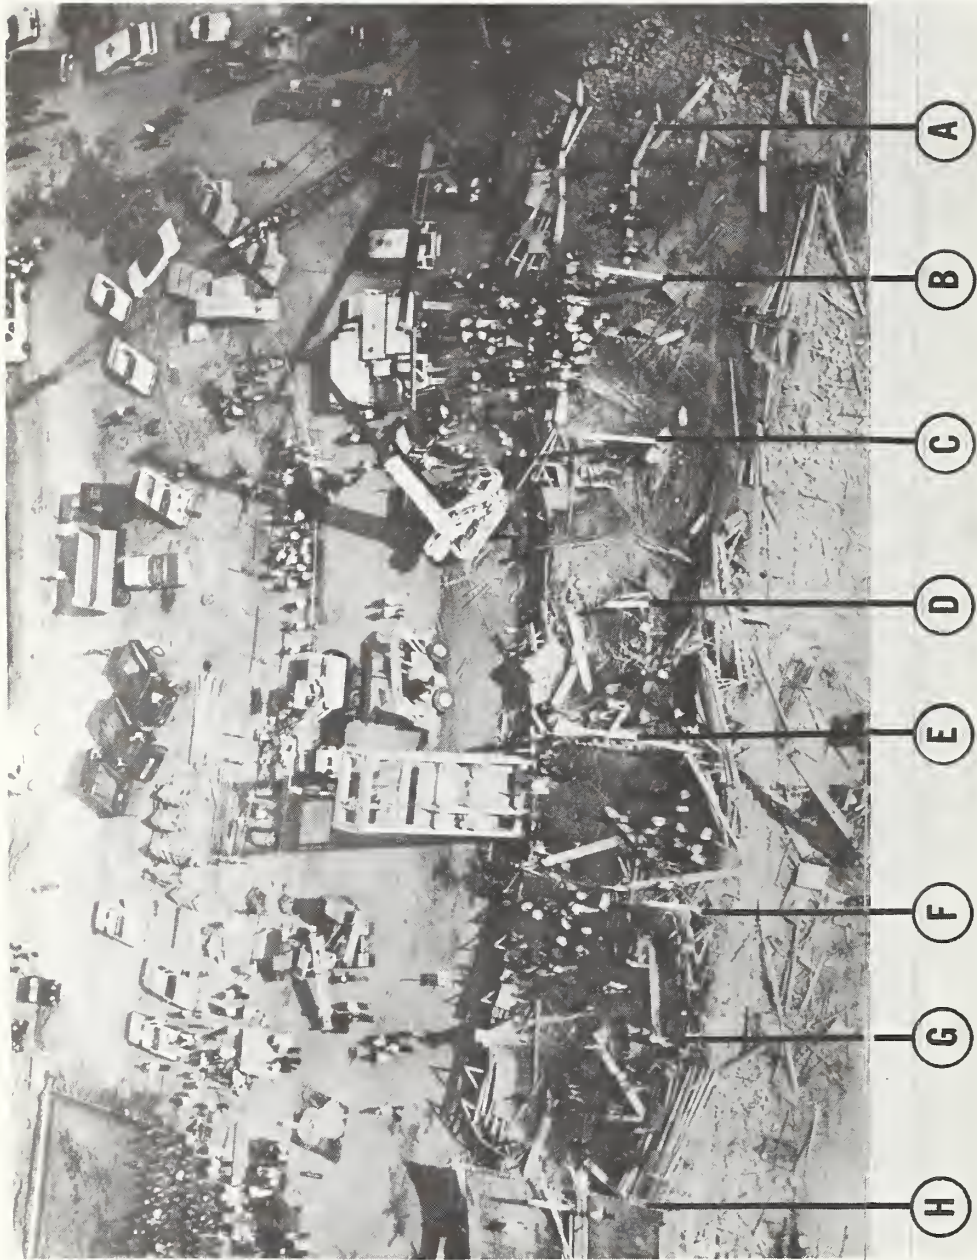
The collapse occurred at approximately 3:00 p.m., on March 27. Based on worker statements, it appears to have been triggered by a failure in the fifth story slab somewhere in the center portion of the building, and propagated straight down to the ground. This topic is discussed further in section 3.3.

Figure 2.16 General view of wreckage after the collapse

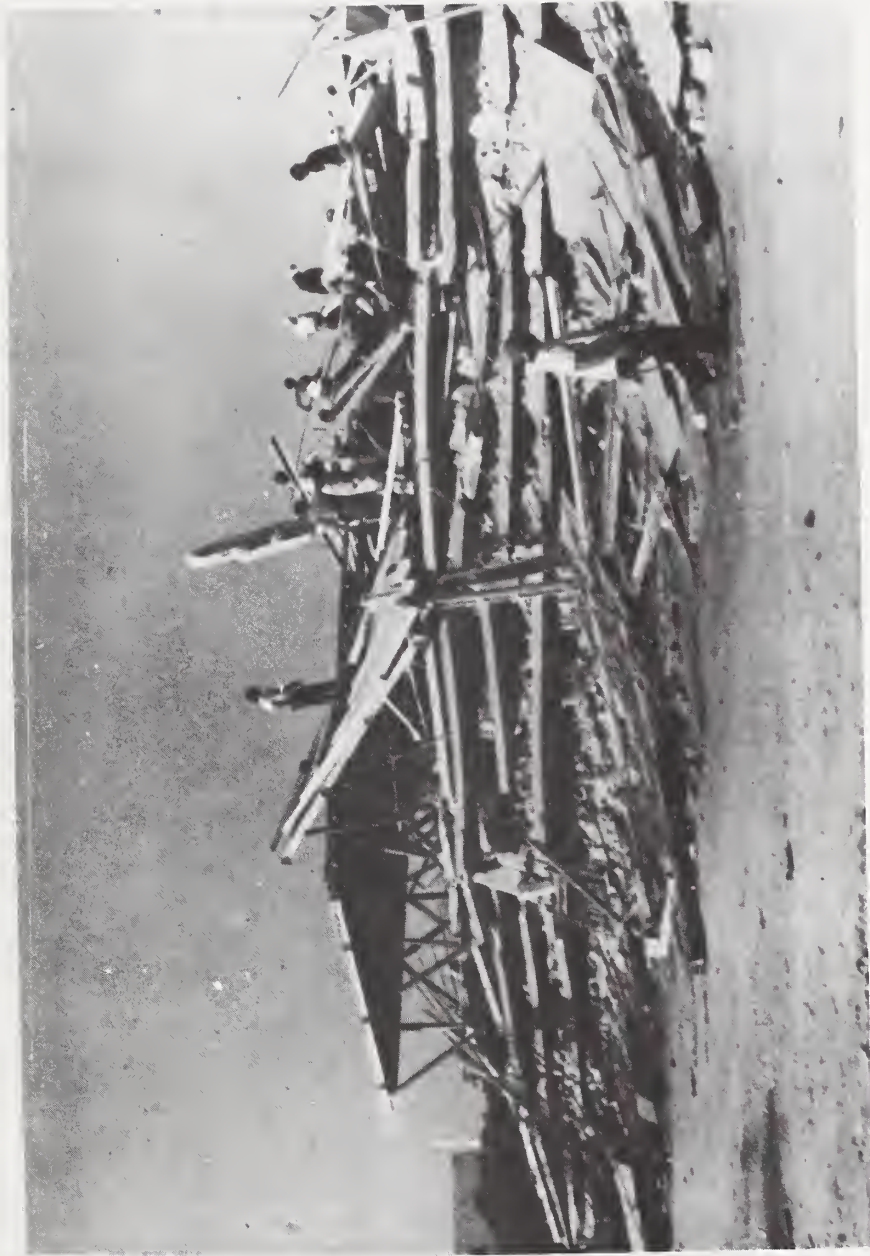
Figure 2.17 View of debris at north end of building after the collapse

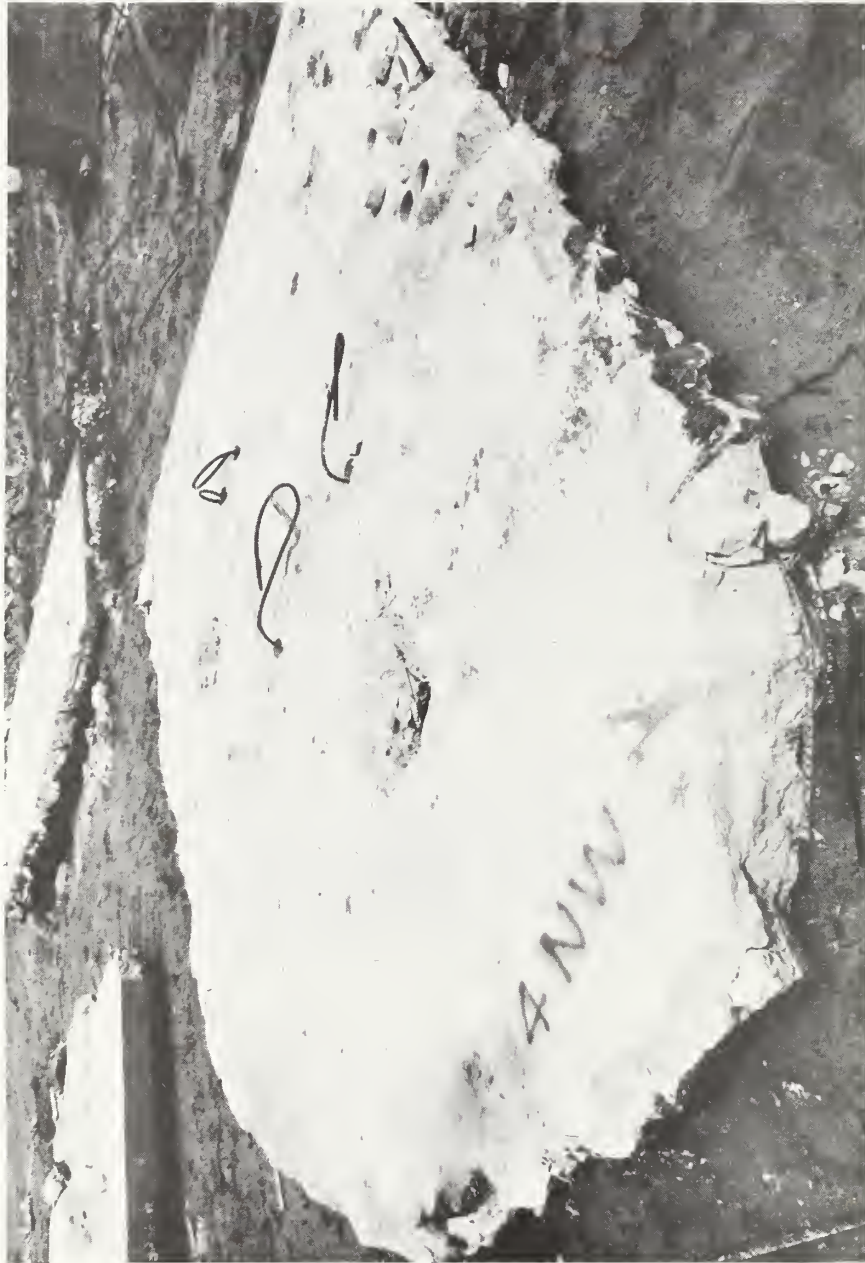
Figure 3.1 An identified portion of slab removed from the north-west section of the fourth floor

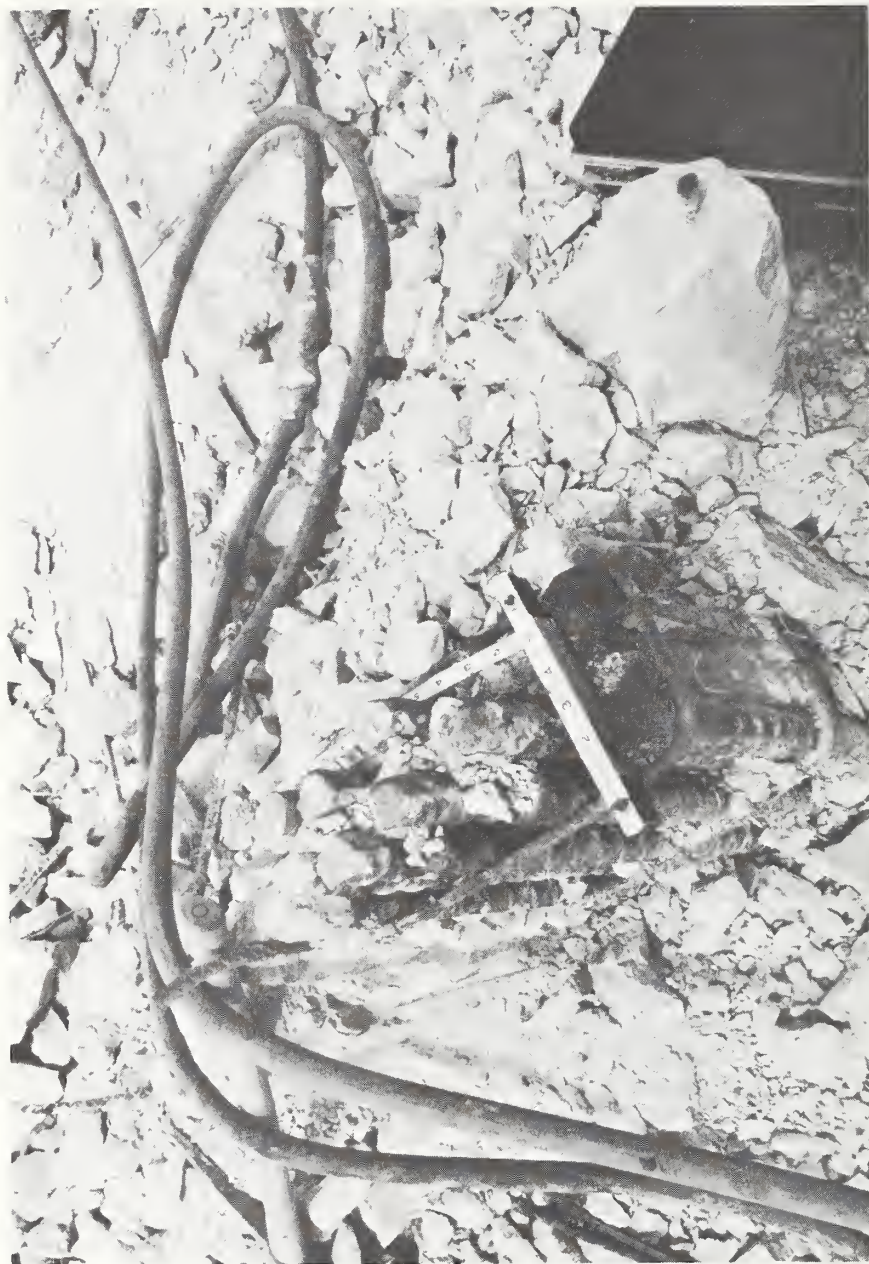
It was also noted from the first-story column sections still standing on the ground level that where 8- # 10 or 8- # 11 bars were lapped, in a 10 x 18 in (250 x 460 cm) column section, the total steel area exceeded considerably the maximum limit of four percent of the gross area of the concrete allowed by the ACI Code [2.1]. As shown in figure 3.3, the vertical reinforcement was so congested that there was hardly any space left between adjacent bars to allow the flow of concrete during placement.

Figure 3.3 Congested reinforcement in a first-story column

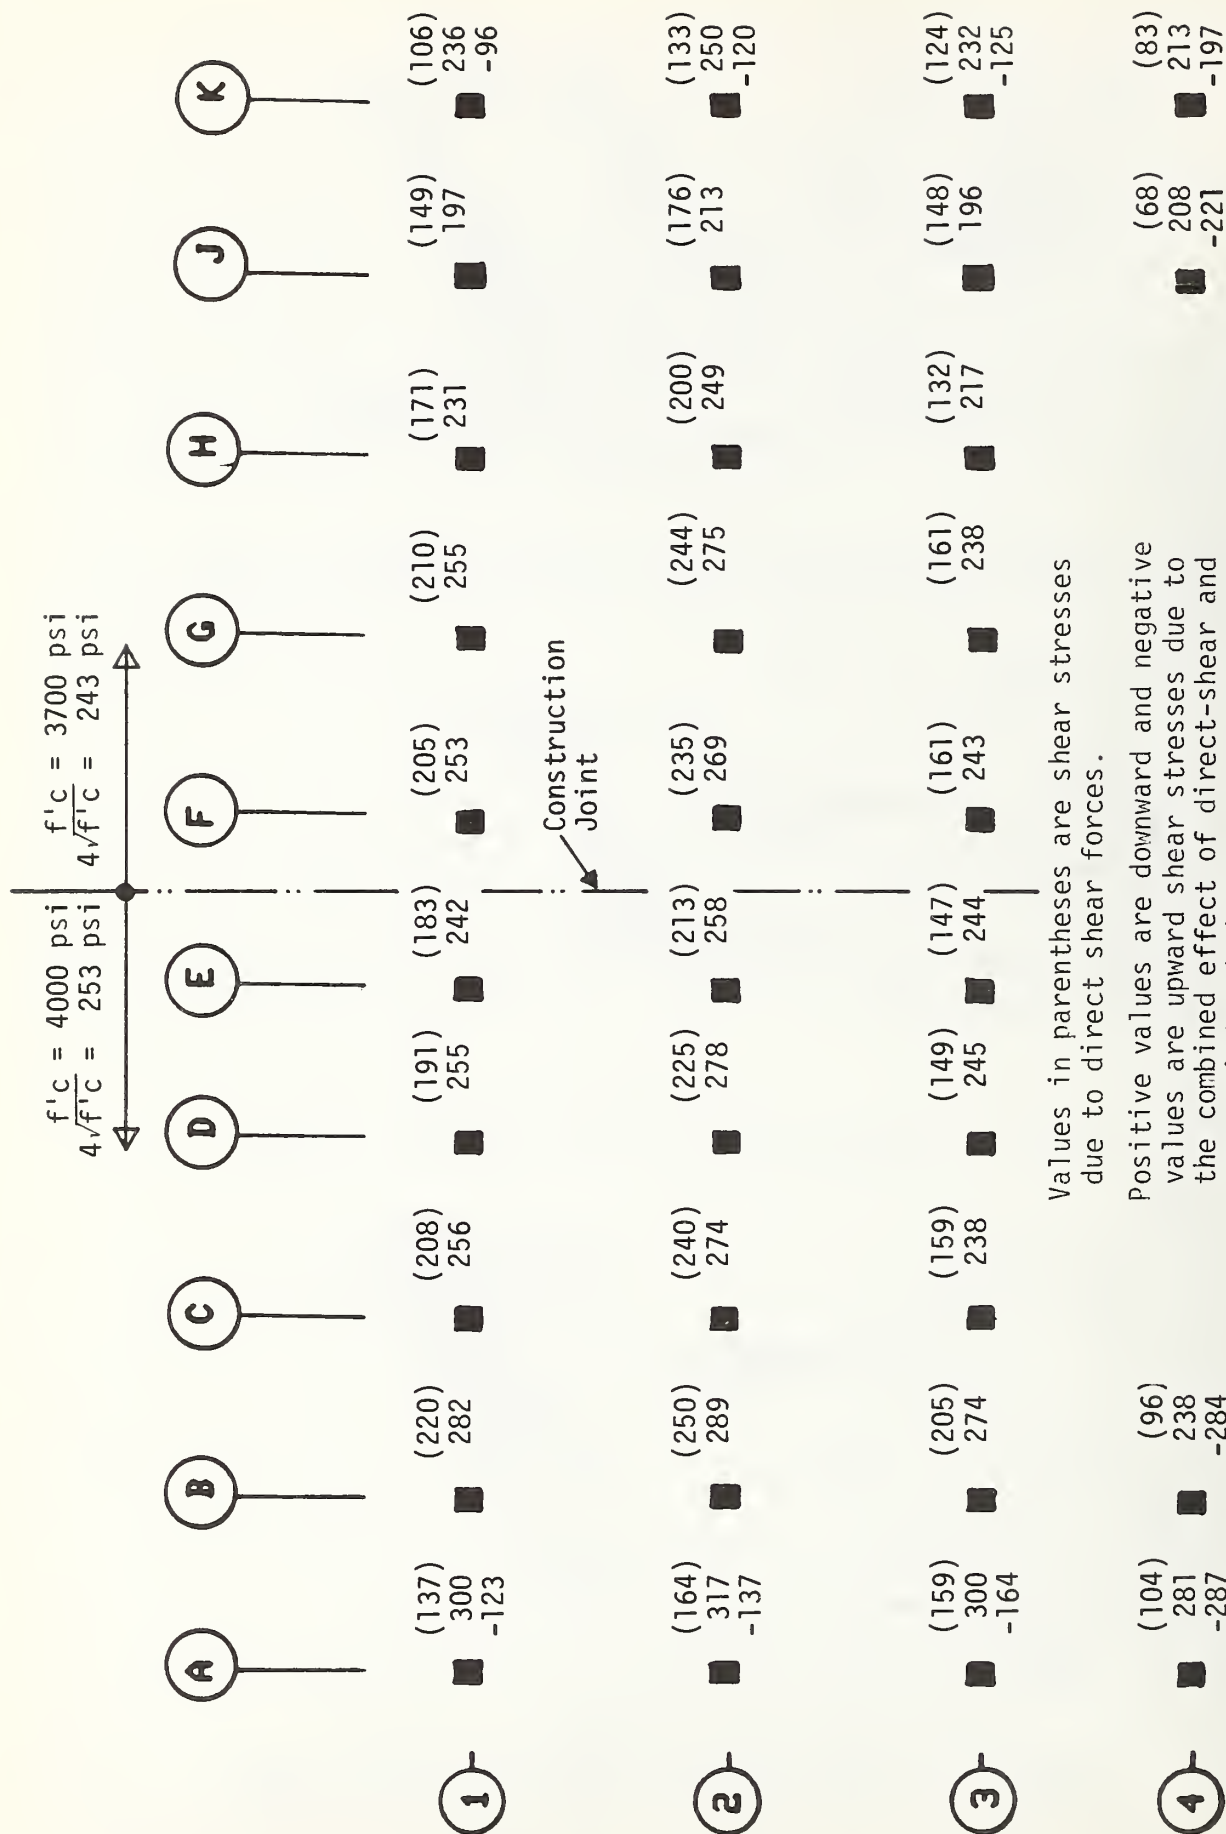
It is concluded that the most probable cause of the failure was the lack of adequate punching shear capacity in the fifth-floor slab at several of the columns to resist the applied construction loads. This deficiency was brought about by the design inadequacy which resulted in the slab thickness of 8 in instead of 11 in and by the placement of the top reinforcement at the column strips with significantly greater cover than that which would have met the cover requirement specified by the structural drawings. This resulted in an insufficient effective depth of the fifth floor slab to resist punching shear under construction loads.

Figure 6.4 Punching shear stresses in fifth floor slab
