NBS BUILDING SCIENCE SERIES 165

Engineering Aspects of the September 19, 1985 Mexico Earthquake

Following the September 19, 1985 Mexico earthquake, a team consisting of four engineers and one seismologist from the National Bureau of Standards (NBS) and the United States Geological Survey (USGS) was dispatched to Mexico City to provide technical advice to the US rescue effort and to assess structural damage. This report is primarily based on data gathered by the team, but it also contains a compilation of other available information. The report addresses the origin and characteristics of the observed ground motion, the ability of buildings designed in accordance with present and proposed seismic design provisions to resist this type of ground motion, and observed data on structural and foundation failures.

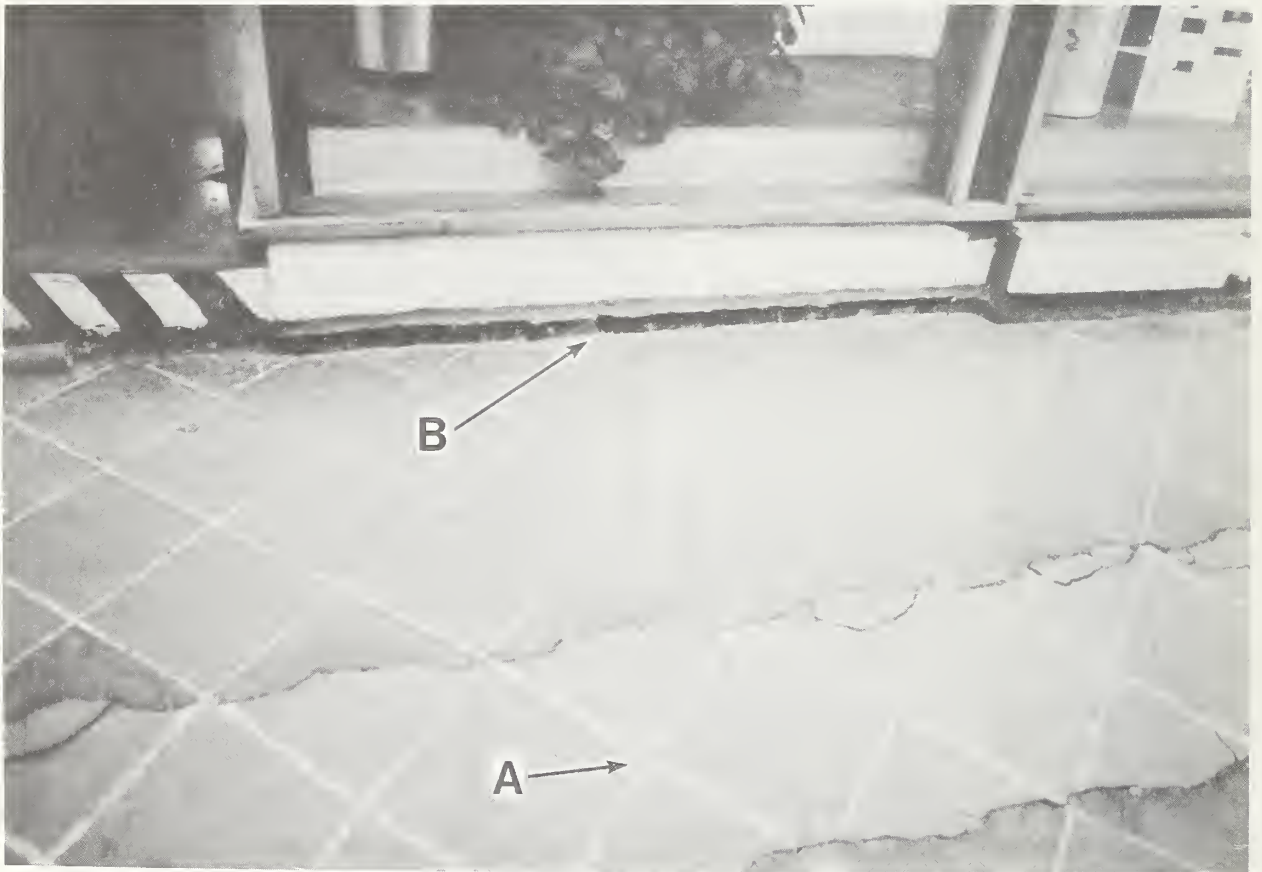
Figure 4.1. Differential displacements at the sidewalk near the Bank of America Building.

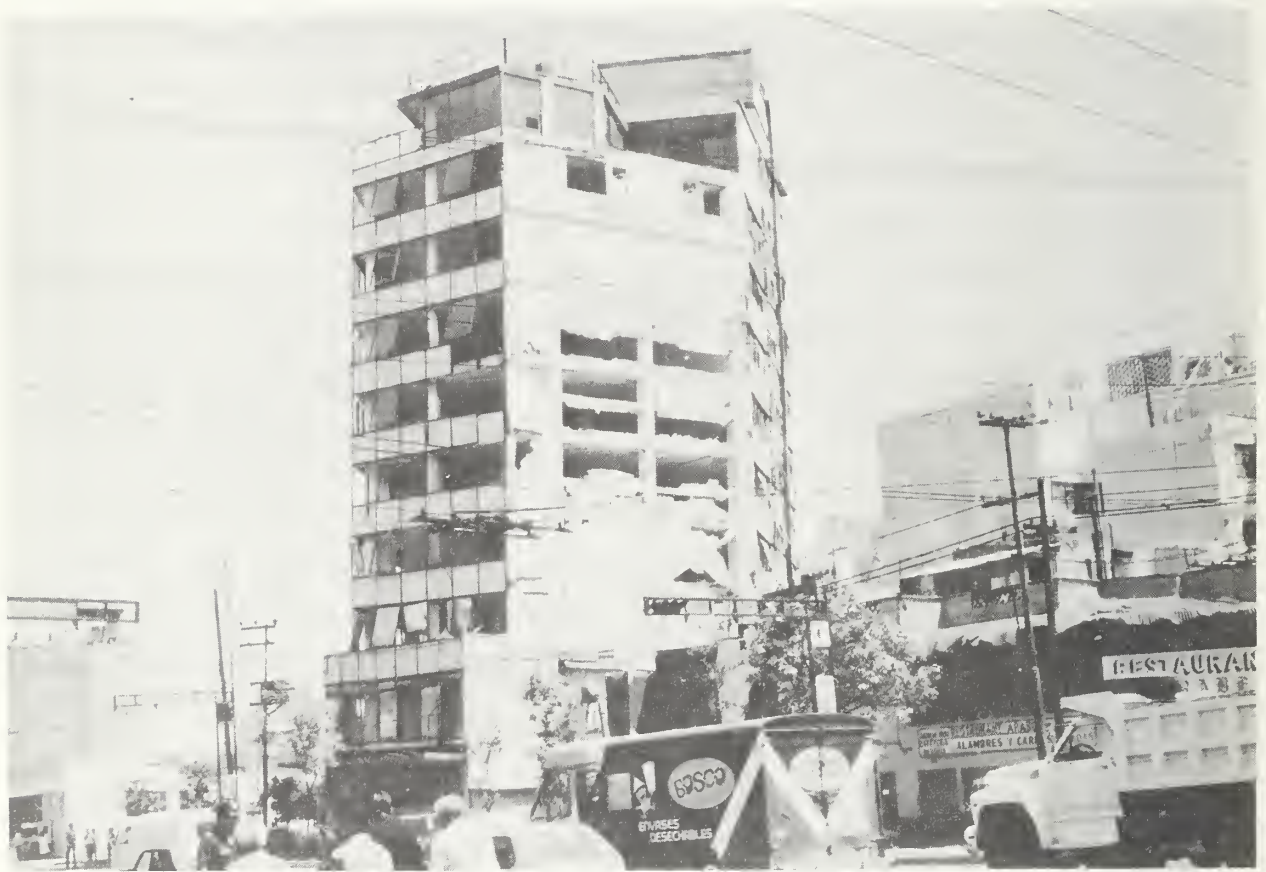
Figure 4.5. Tilted ten story building at Lazaro Cardenas and Fernando.

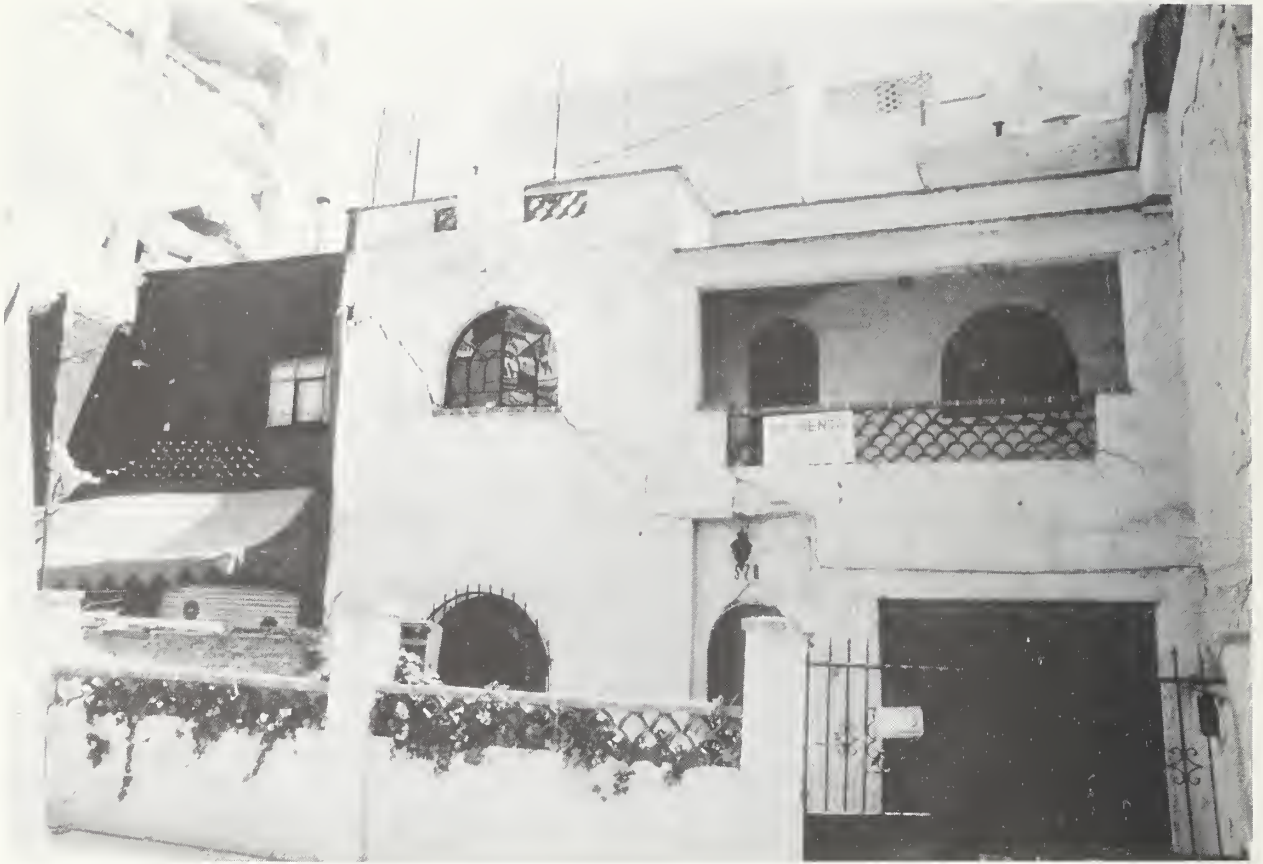
Figure 4.7. Damage to adjacent structures caused by the tilting of a ten story building at Lazaro Cardenas and Fernando.

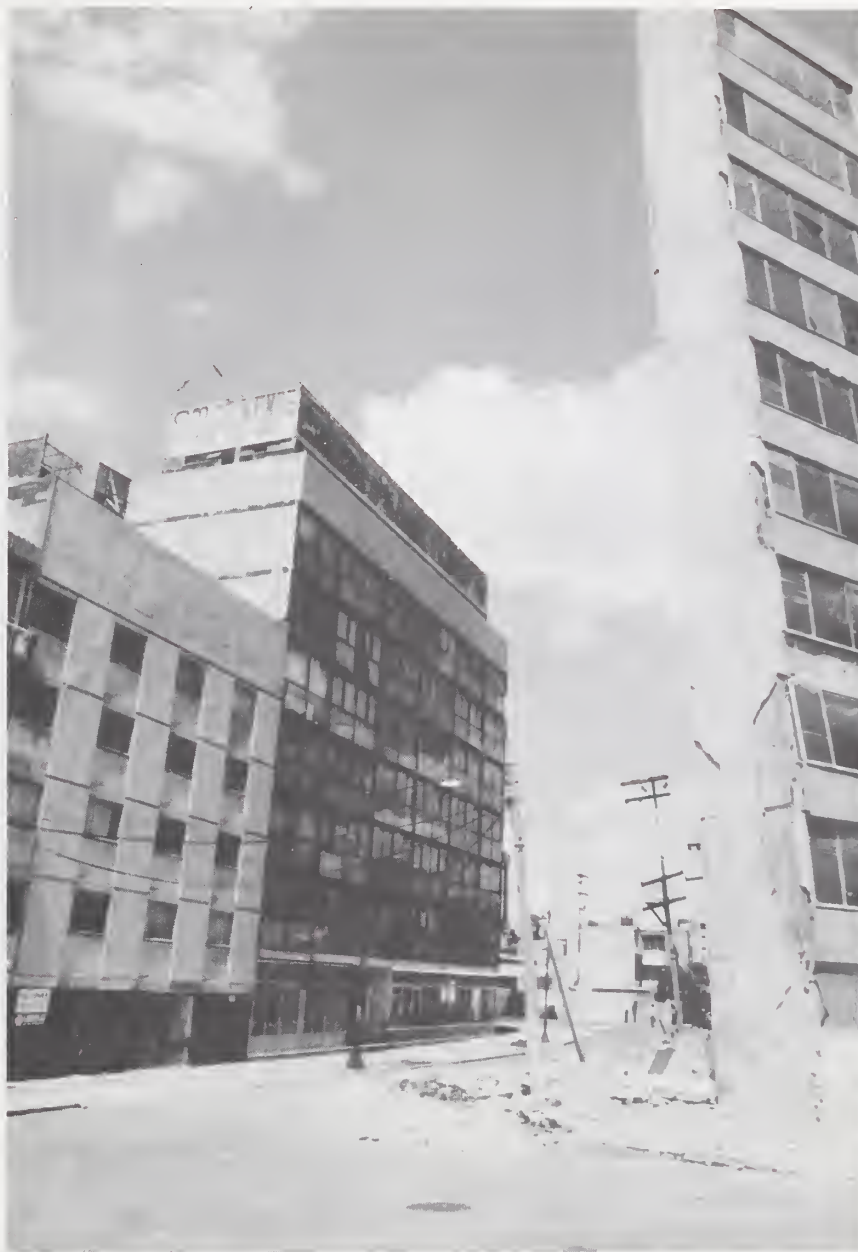
Figure 4.8. Tilted ten story building at University and Xola.

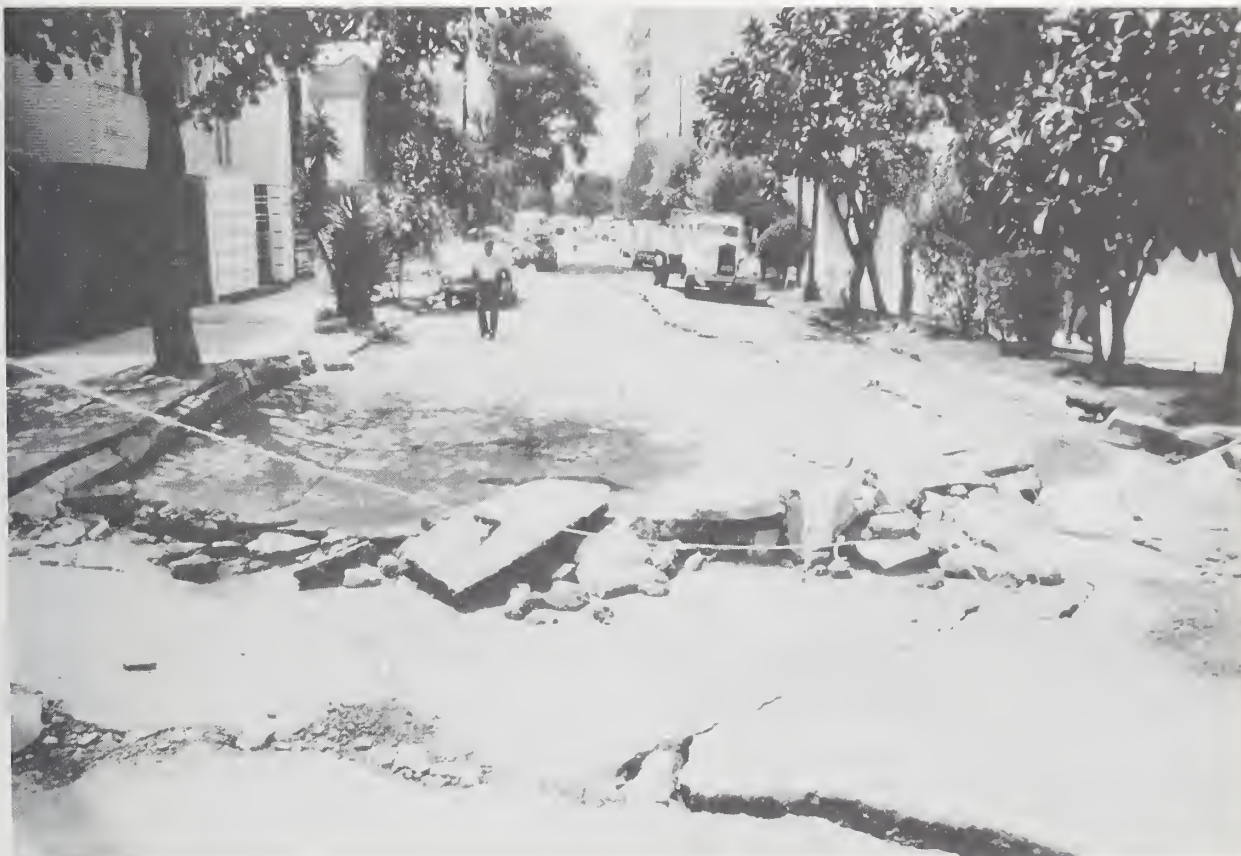
Figure 4.10. Ground disturbance on Galacia viewed from intersection of Toledo in a westerly direction.

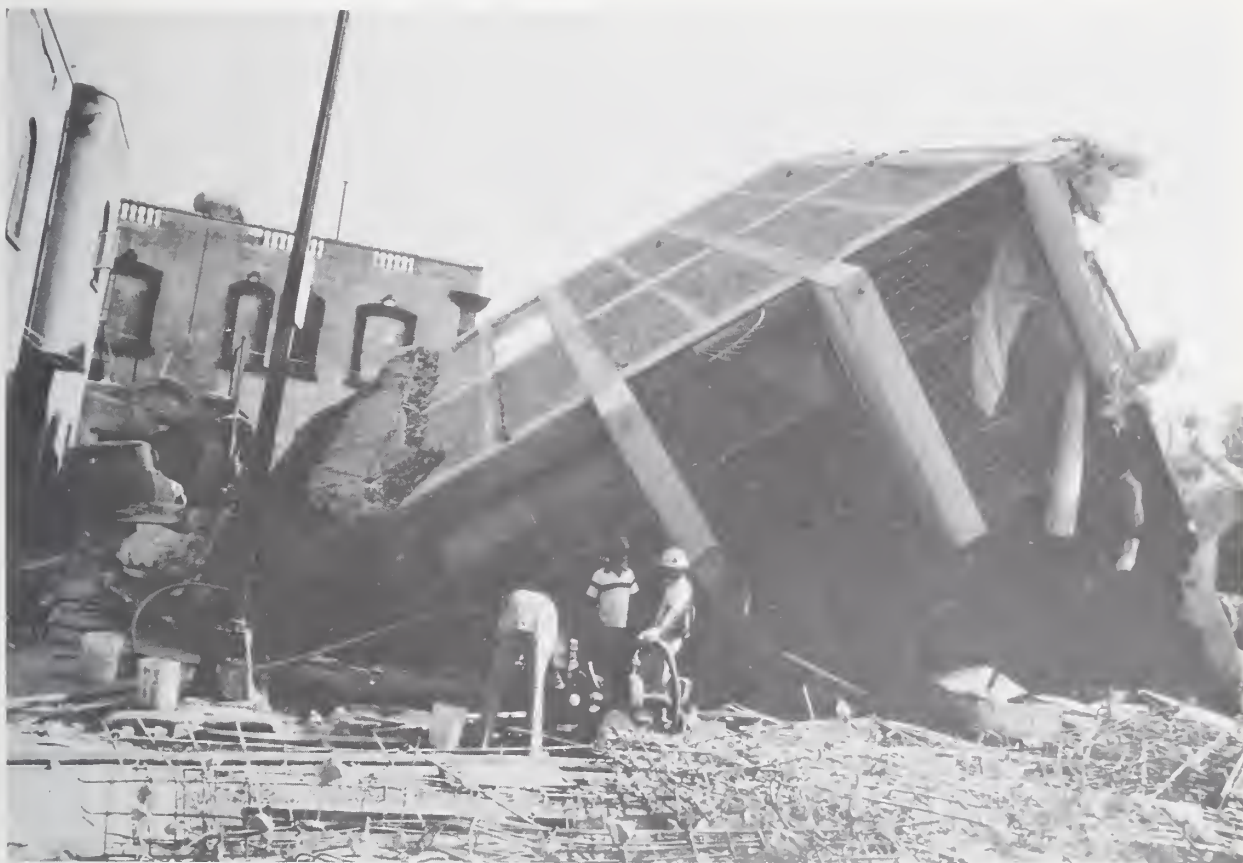
Figure 4.11. Overturned building at southeast corner of Zacatecas and Orizaba.

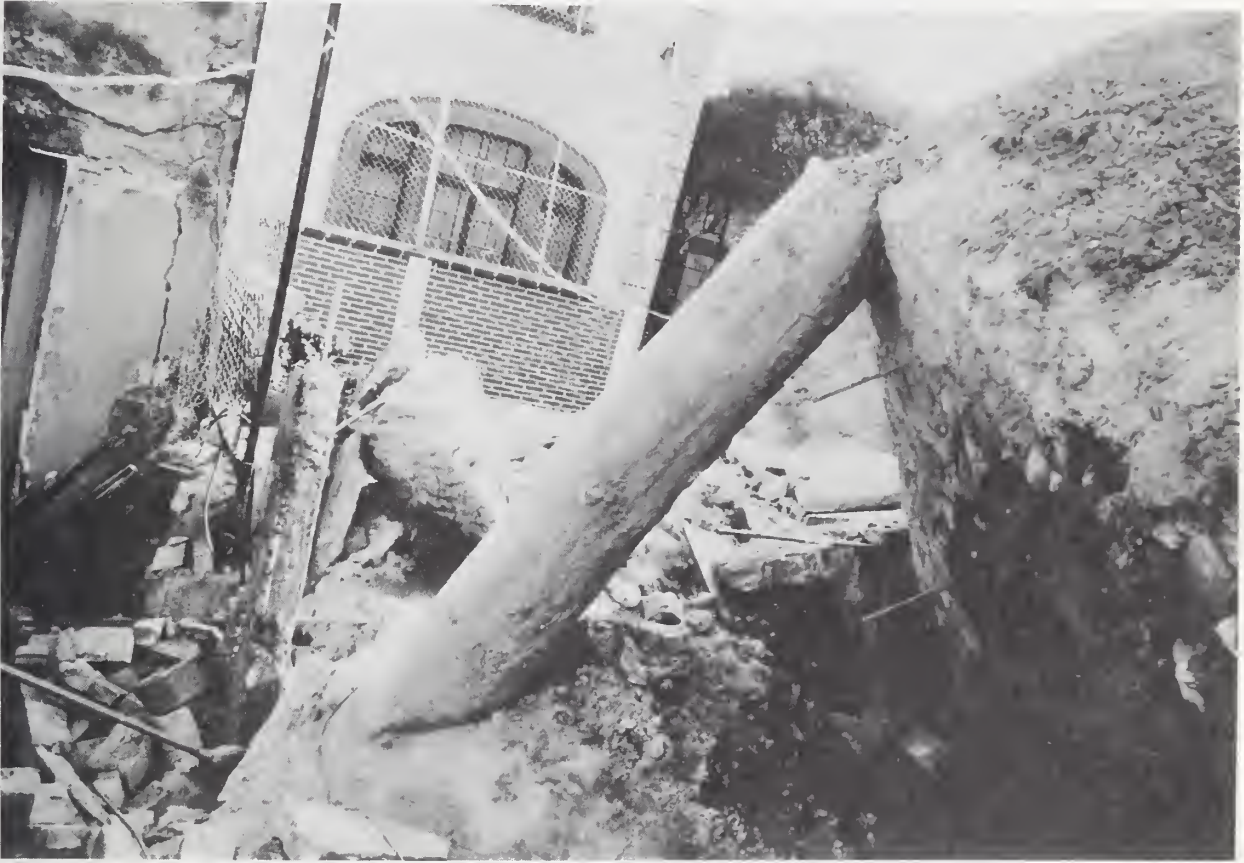
Figure 4.13. Exposed pile and dowels of the foundation of overturned building at Zacatecas and Orizaba.

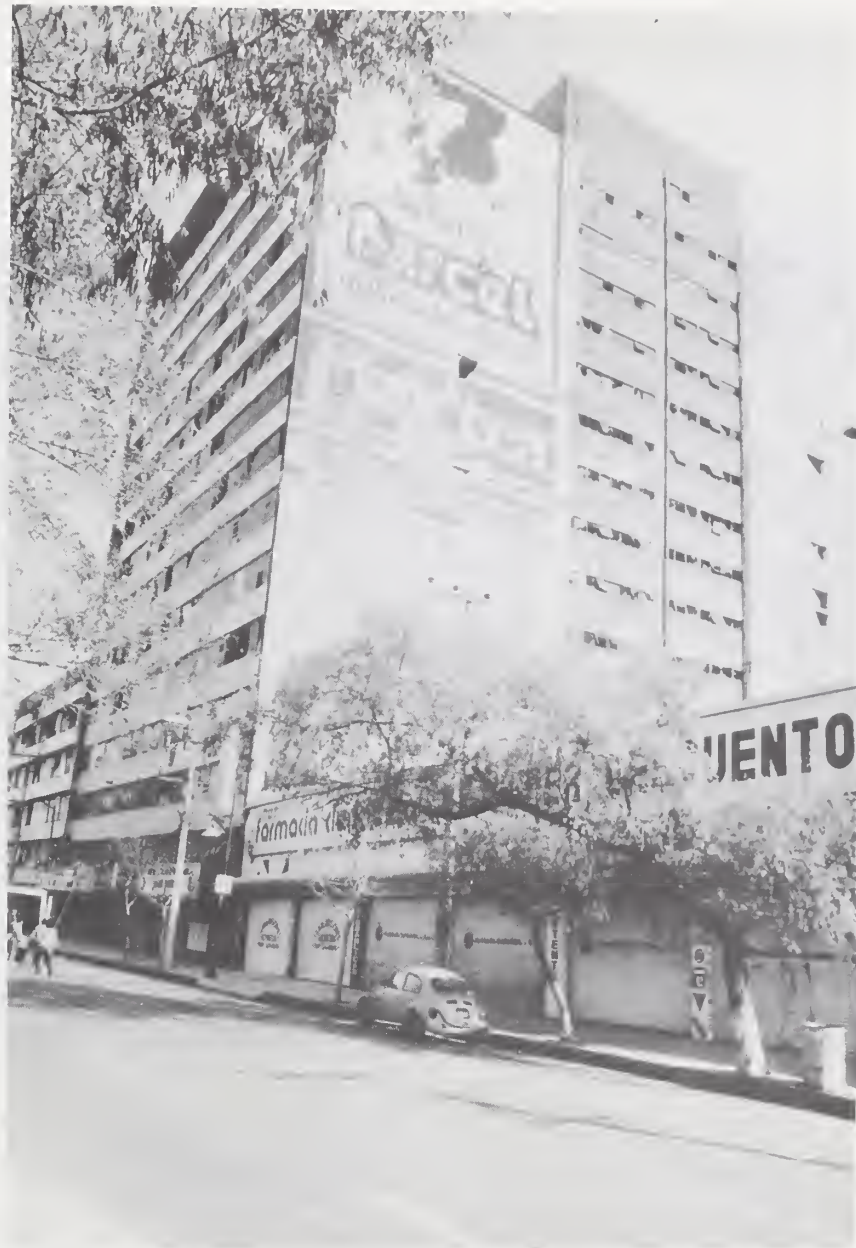
Figure 4.14. Building on the south side of Teresa de Mier which settled in one corner.

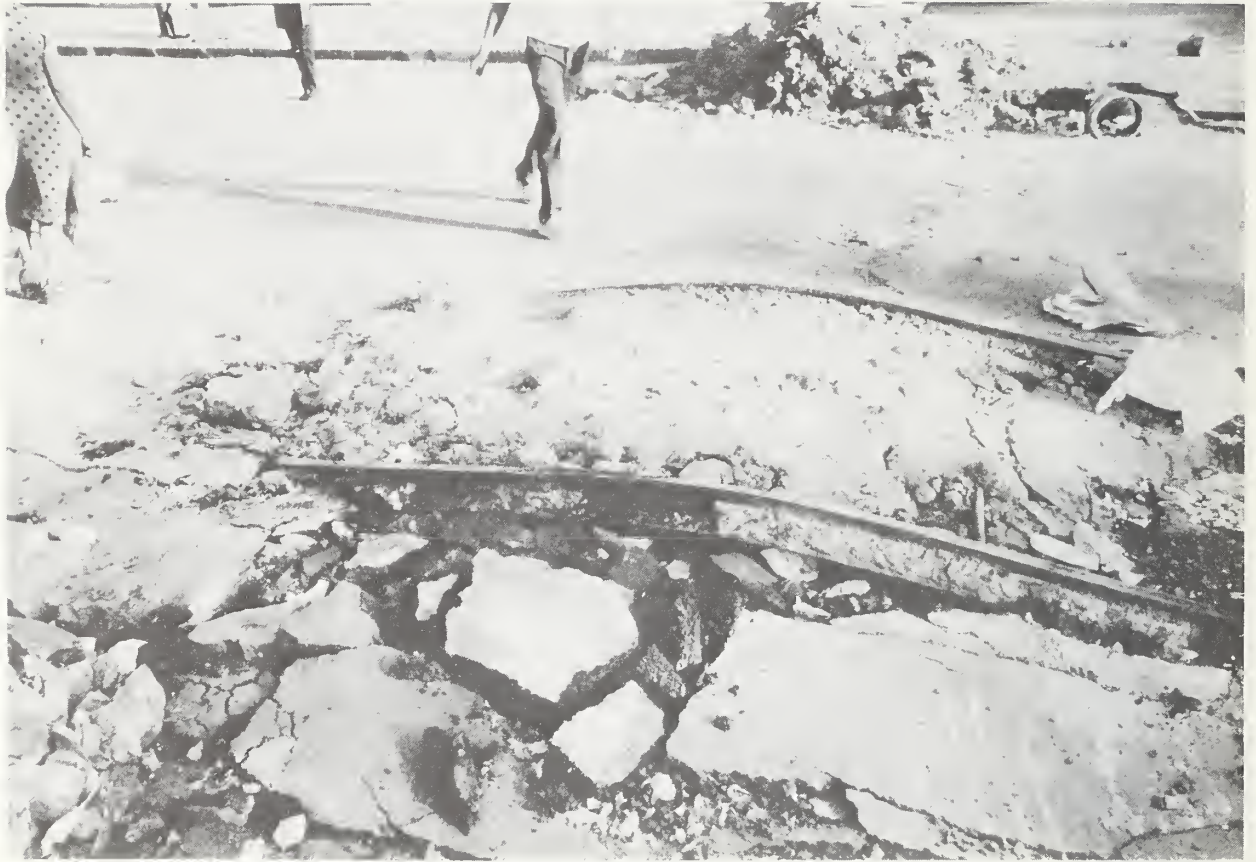
Figure 4.17. Buckled old trolley line on Obregon.

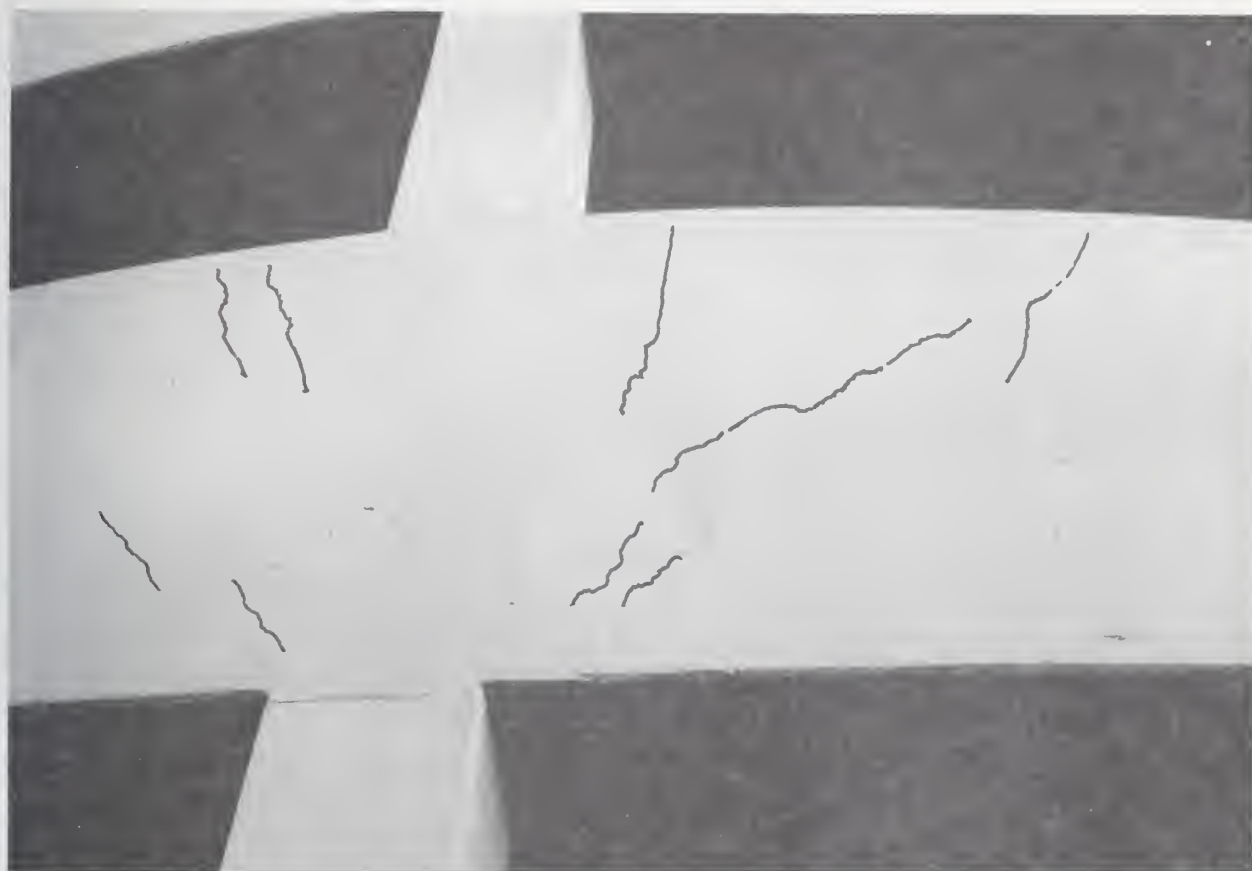
Figure 5.8. Pattern of hairline cracks near the beam column connection of the parking garage (cracks were highlighted for better visibility).

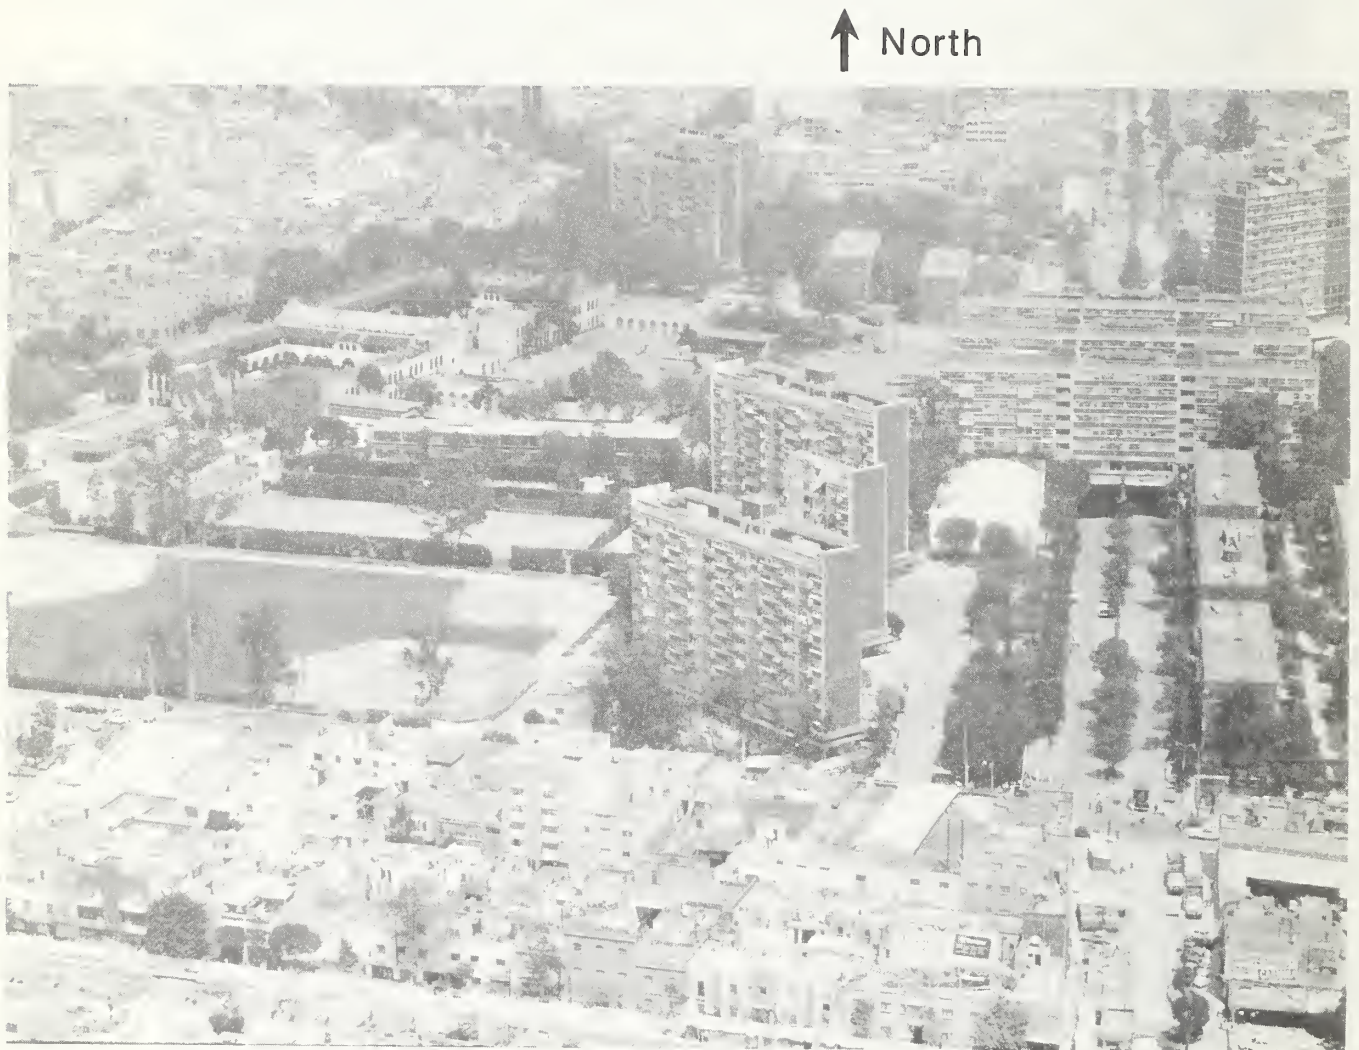
Figure 5.14. Damaged Urbana Juarez Apartment Complex west of General Hospital.

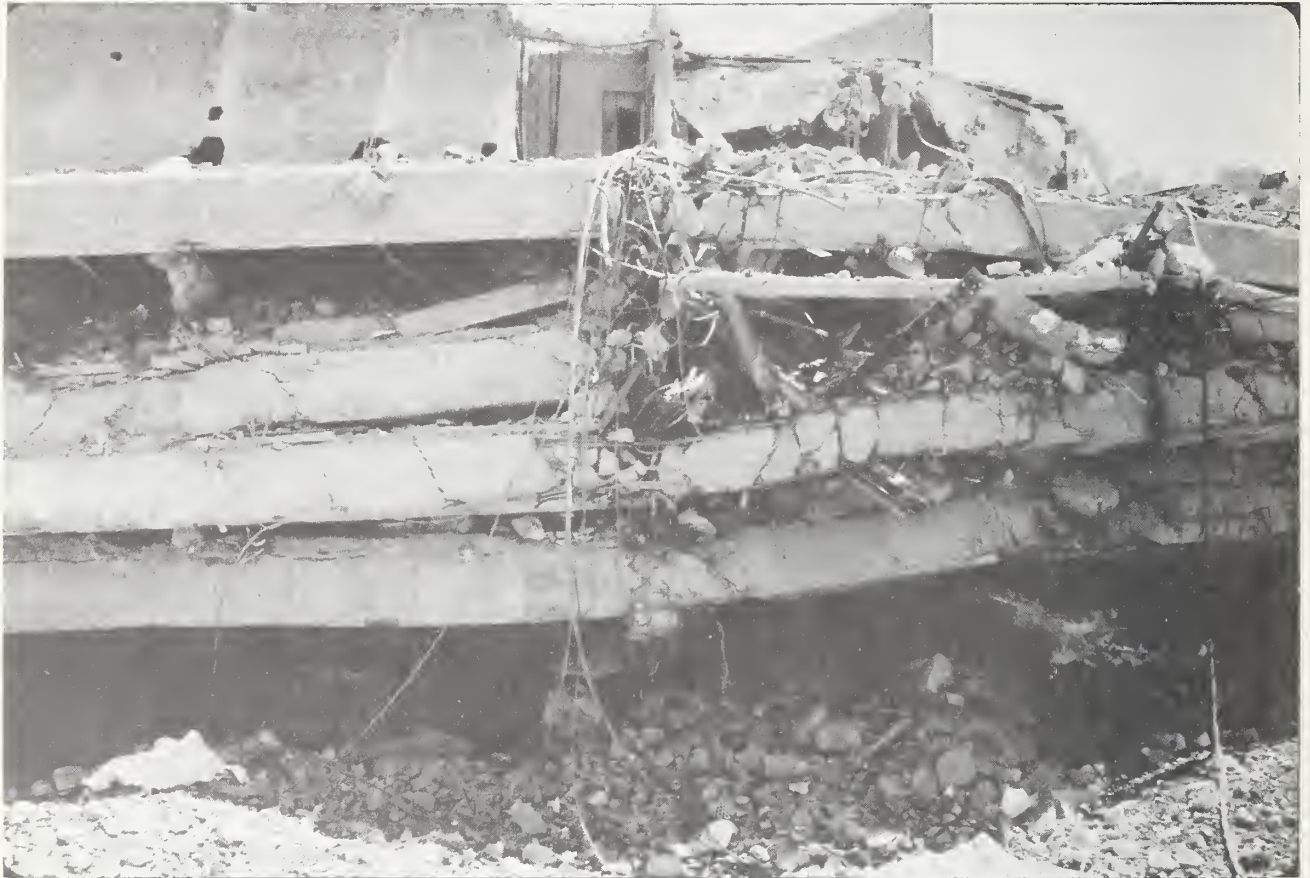
Figure 5.34. Collapsed office building near the corner of Neva and Barragan Streets.

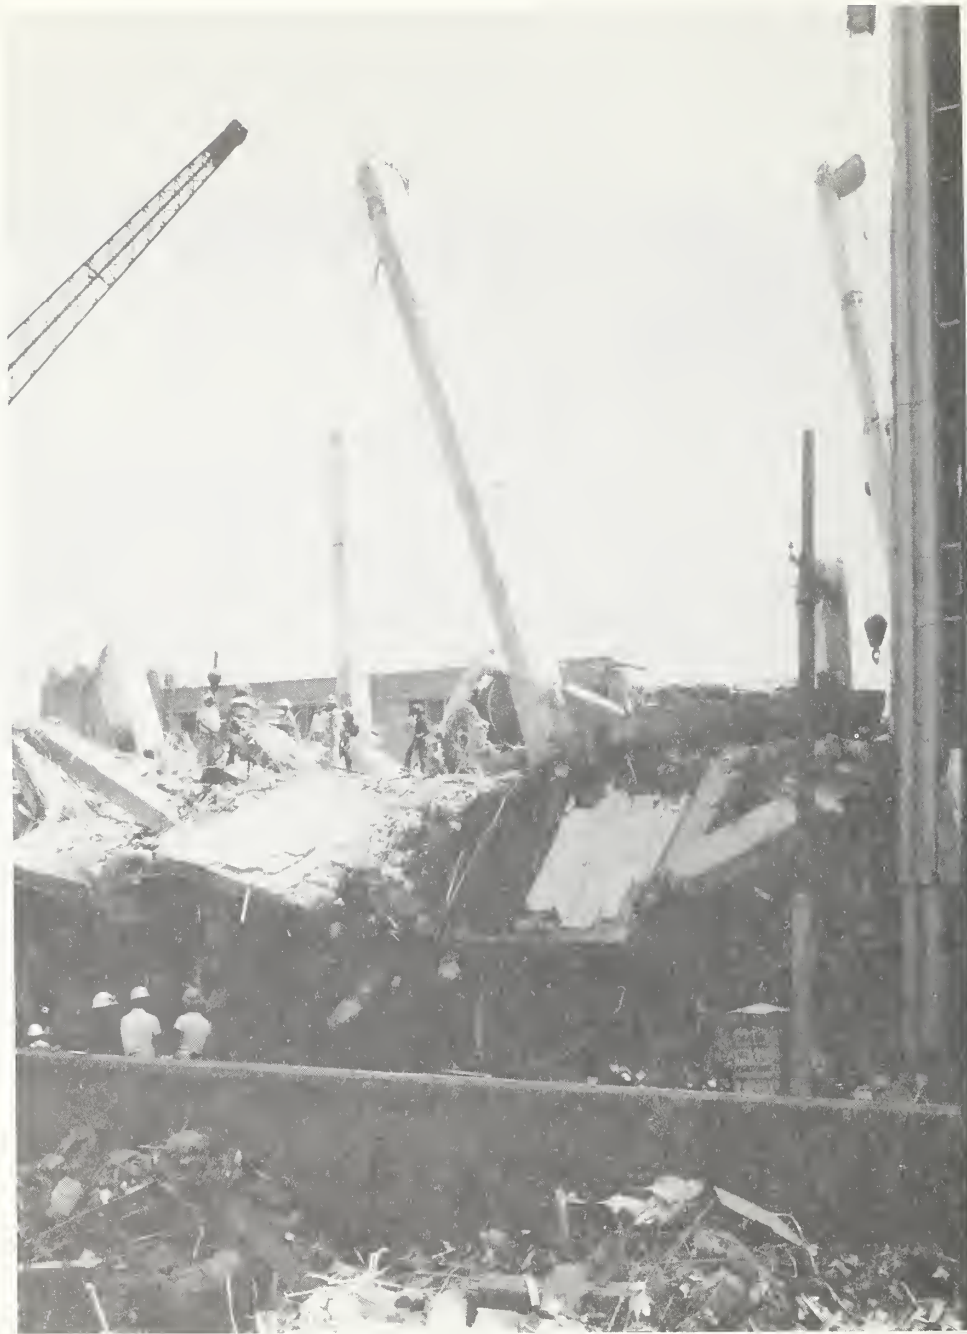
Figure 5.36. Punching shear failure of the 10 story Bancomer Building.

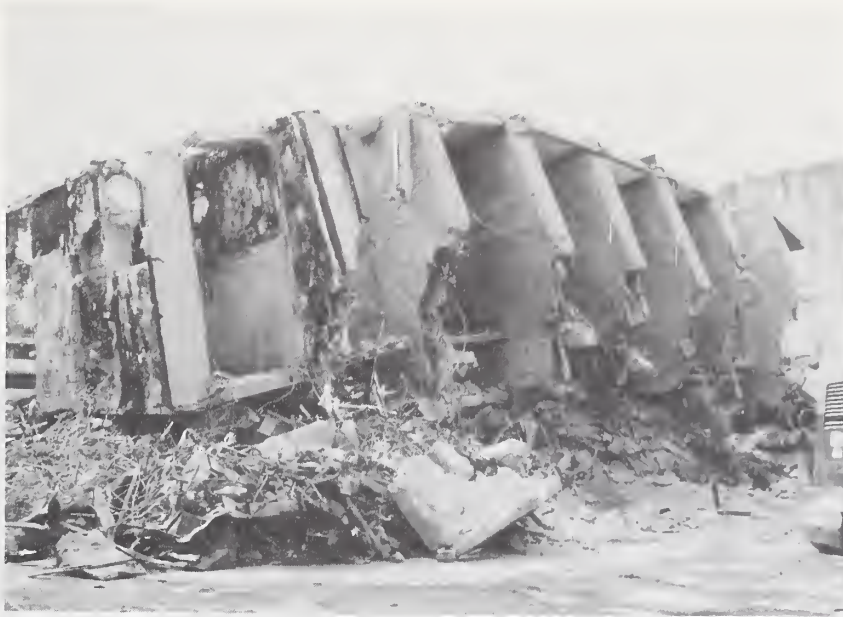
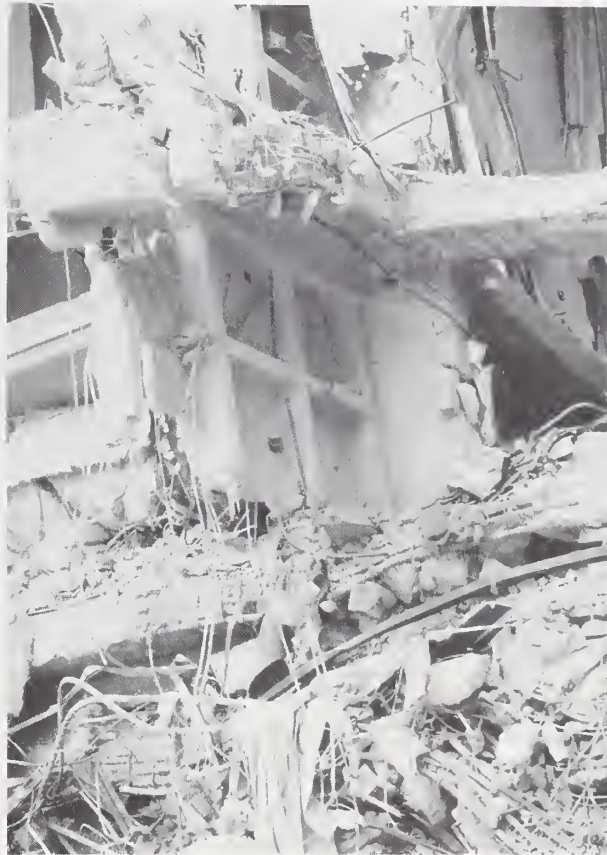
Figure 5.39. Collapsed 10 story apartment building in the corner of Dinamarca and Chapultepec. This waffle slab structure failure is attributed to base column failure and possible pounding with the neighboring structure.

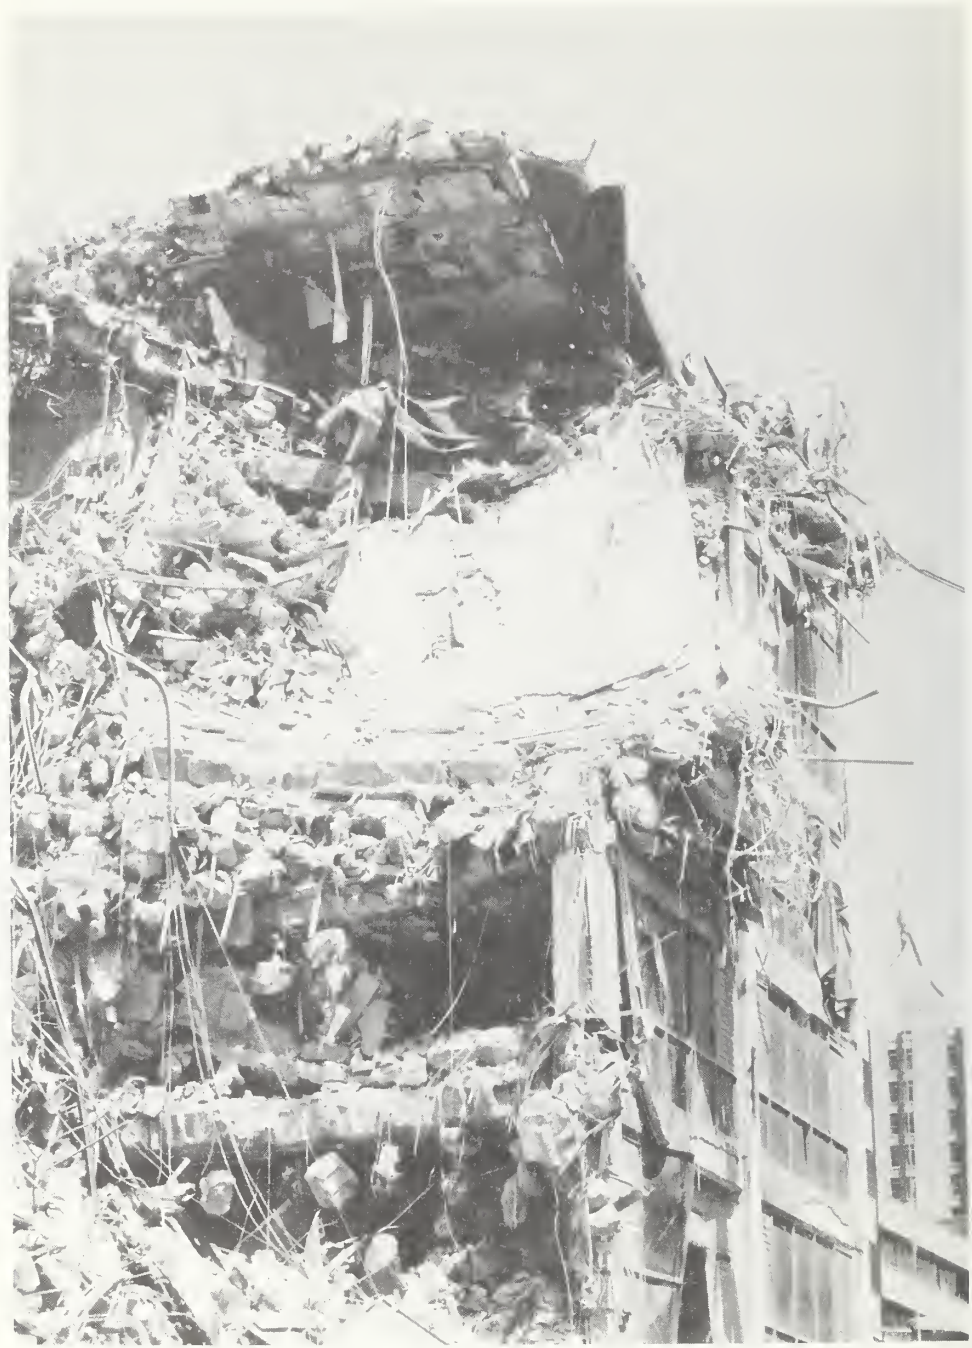
Figure 5.42. The "floor dropout" phenomenon observed in waffle slab structures with concrete block for pan forming.

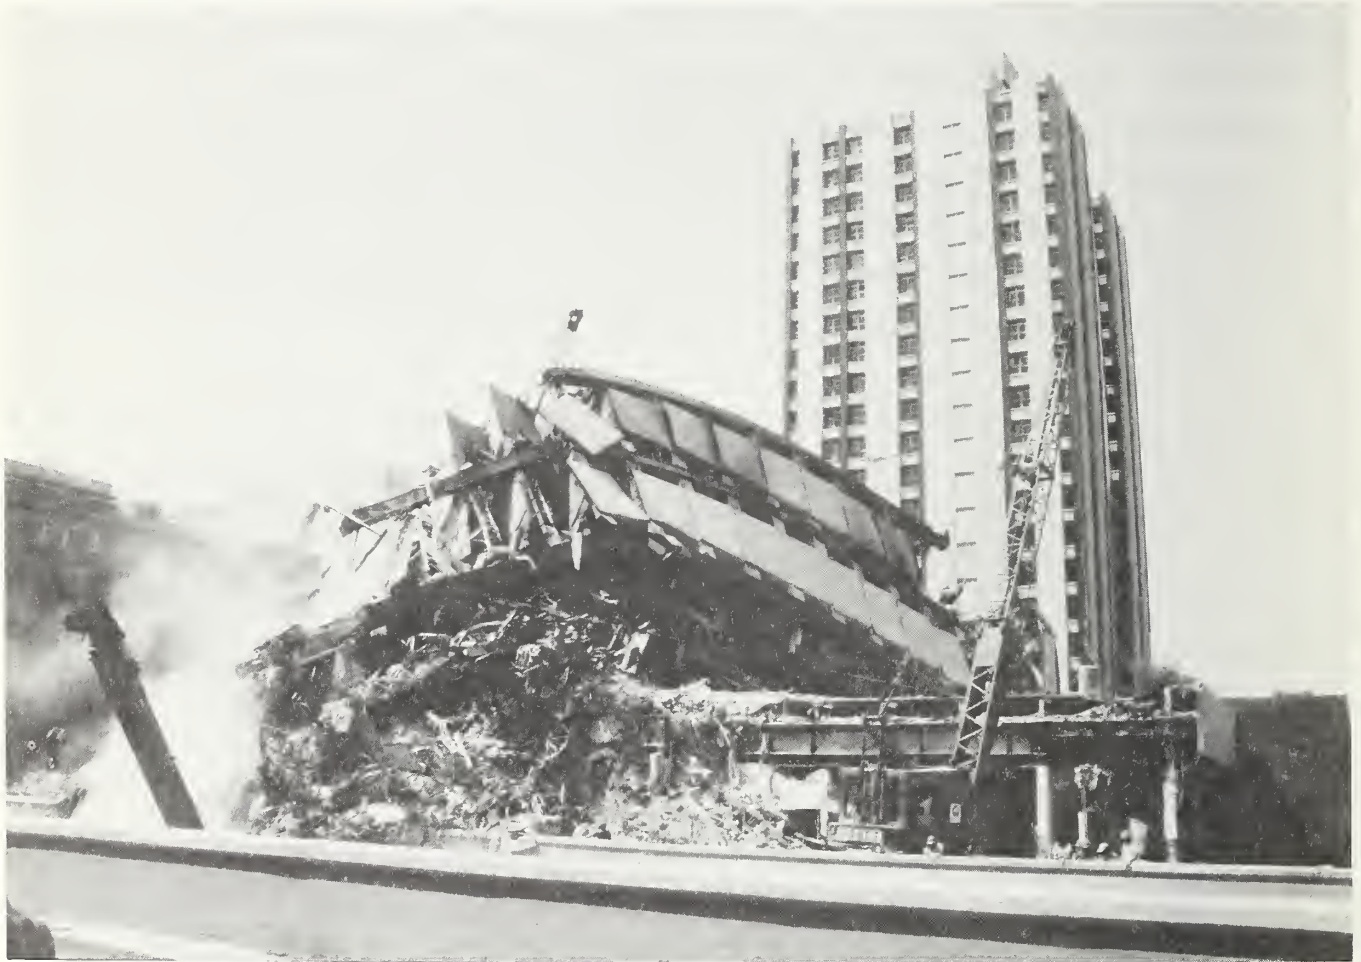
Figure 5.44. Southern towers of the Consumo Pino Suarez Complex shortly after collapse.

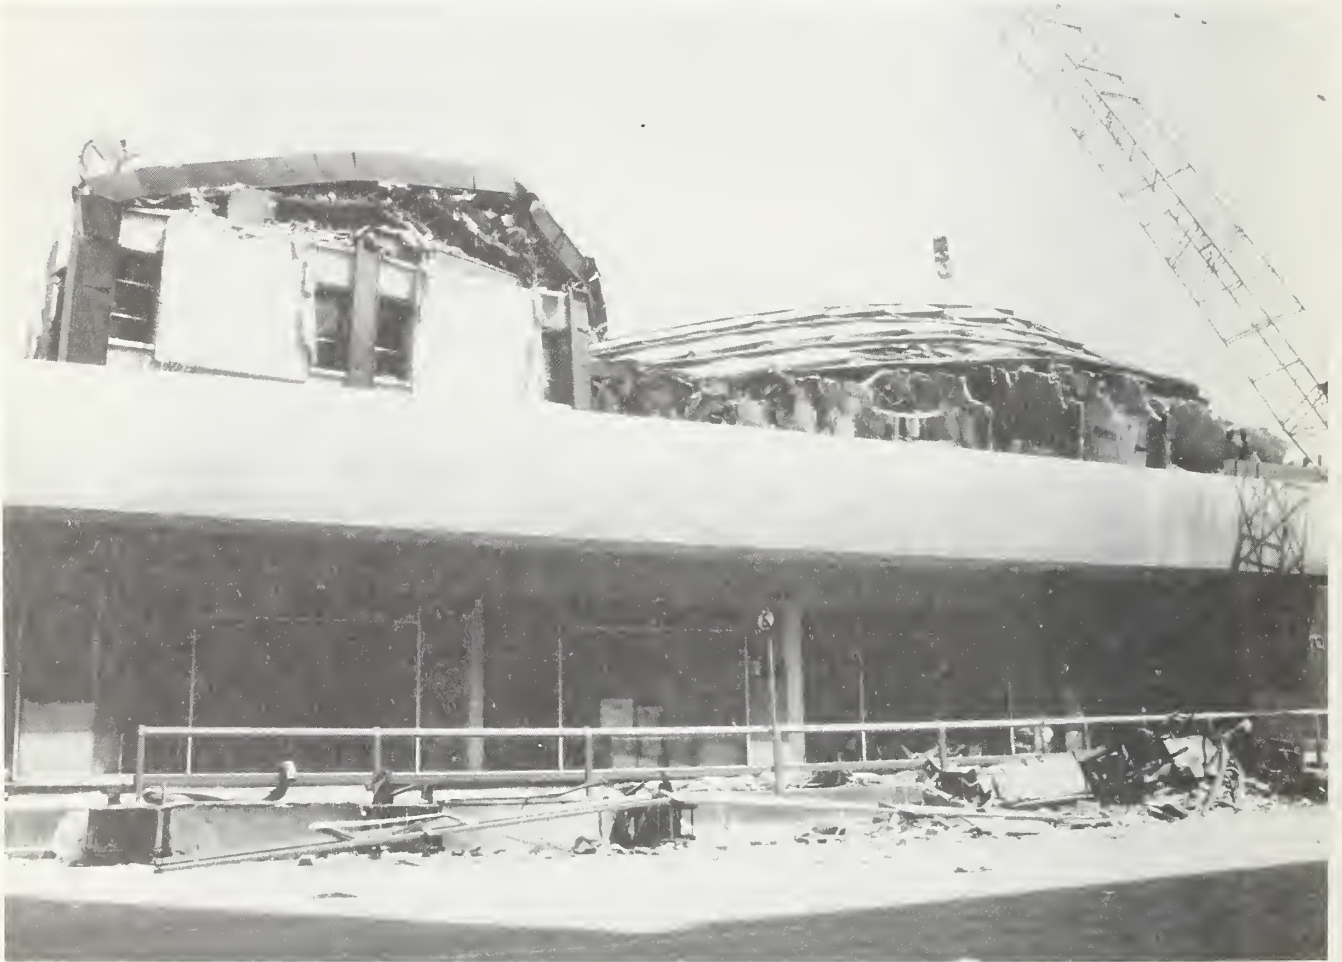
Figure 5.53. Closeup of fractured column line near second story, north side, of the southernmost 23-story structure in Pino Suarez Complex, shortly after collapse.

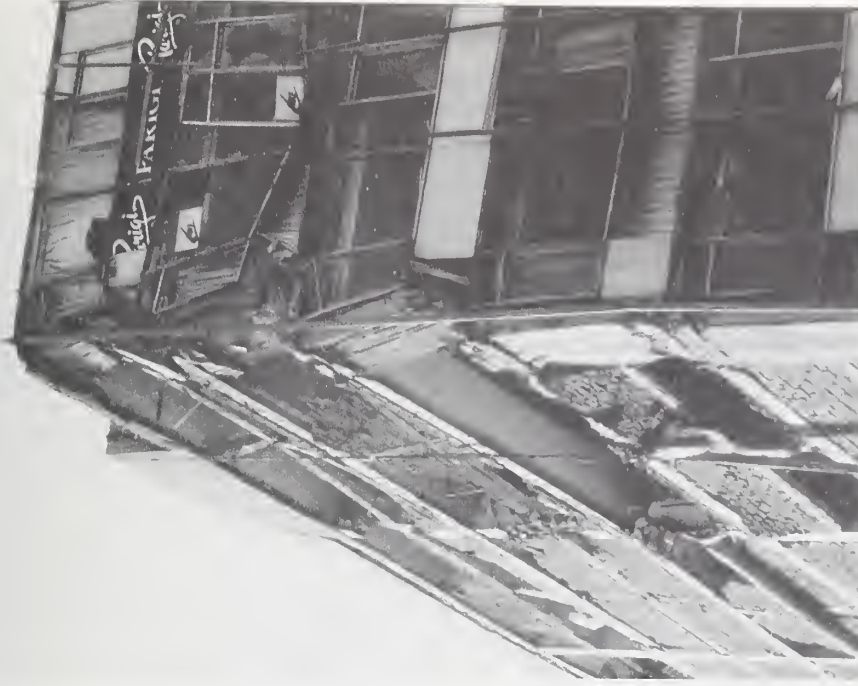
(b) Neighboring nine story building showing impact damage to columns.

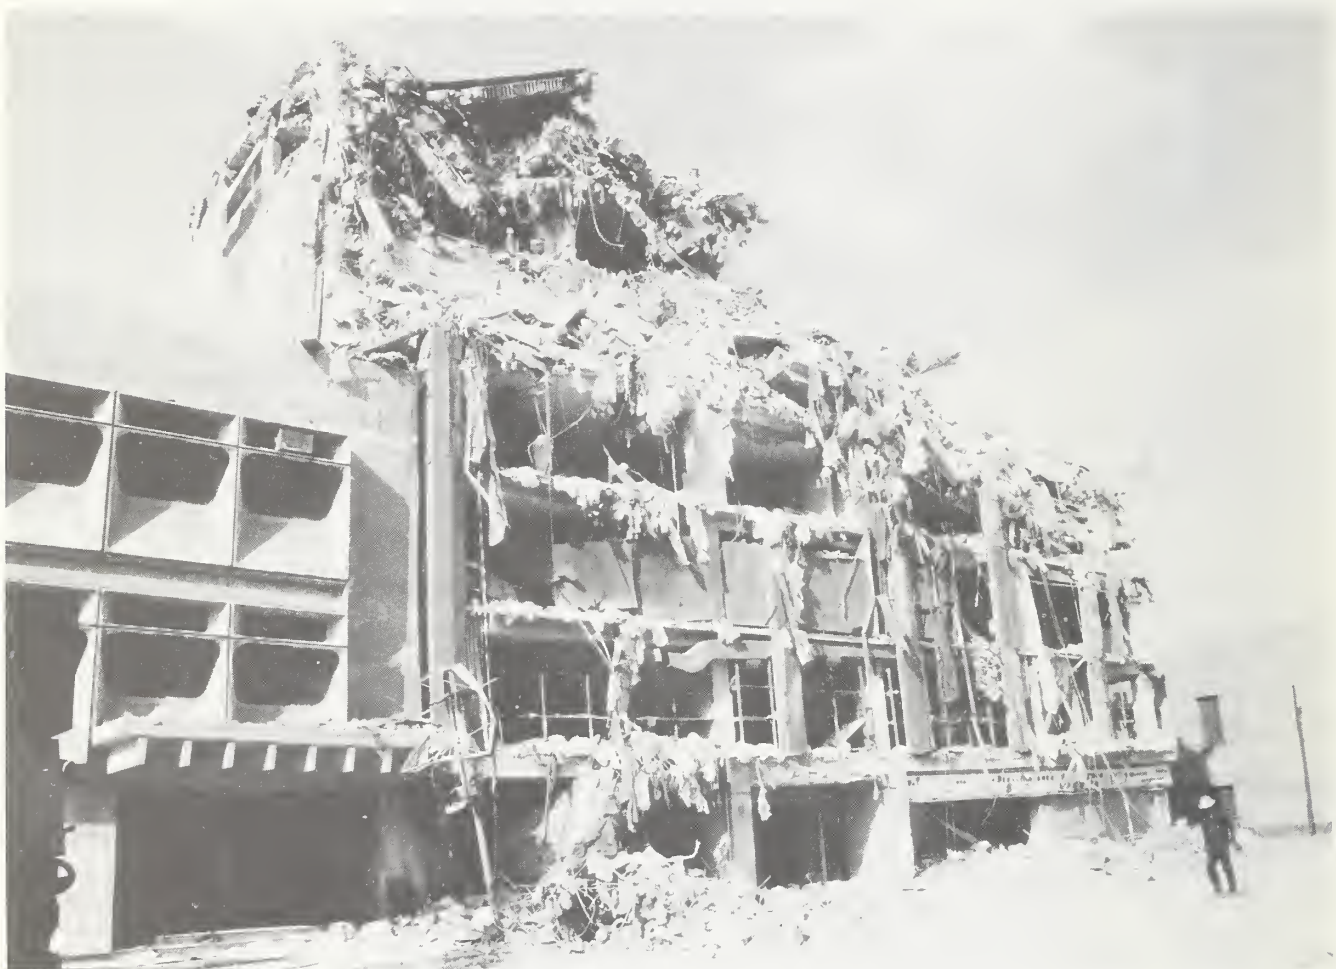
Figure 5.59. Pounding damage between buildings of dissimilar heights and stiffnesses. The upper floor of this 9-floor clothing store collapsed following pounding with its much stiffer neighboring 3-story structure. The separation between the structures was approximately 10 cm.
