NBS BUILDING SCIENCE SERIES 165

Engineering Aspects of the September 19, 1985 Mexico Earthquake

Following the September 19, 1985 Mexico earthquake, a team consisting of four engineers and one seismologist from the National Bureau of Standards (NBS) and the United States Geological Survey (USGS) was dispatched to Mexico City to provide technical advice to the US rescue effort and to assess structural damage. This report is primarily based on data gathered by the team, but it also contains a compilation of other available information. The report addresses the origin and characteristics of the observed ground motion, the ability of buildings designed in accordance with present and proposed seismic design provisions to resist this type of ground motion, and observed data on structural and foundation failures.

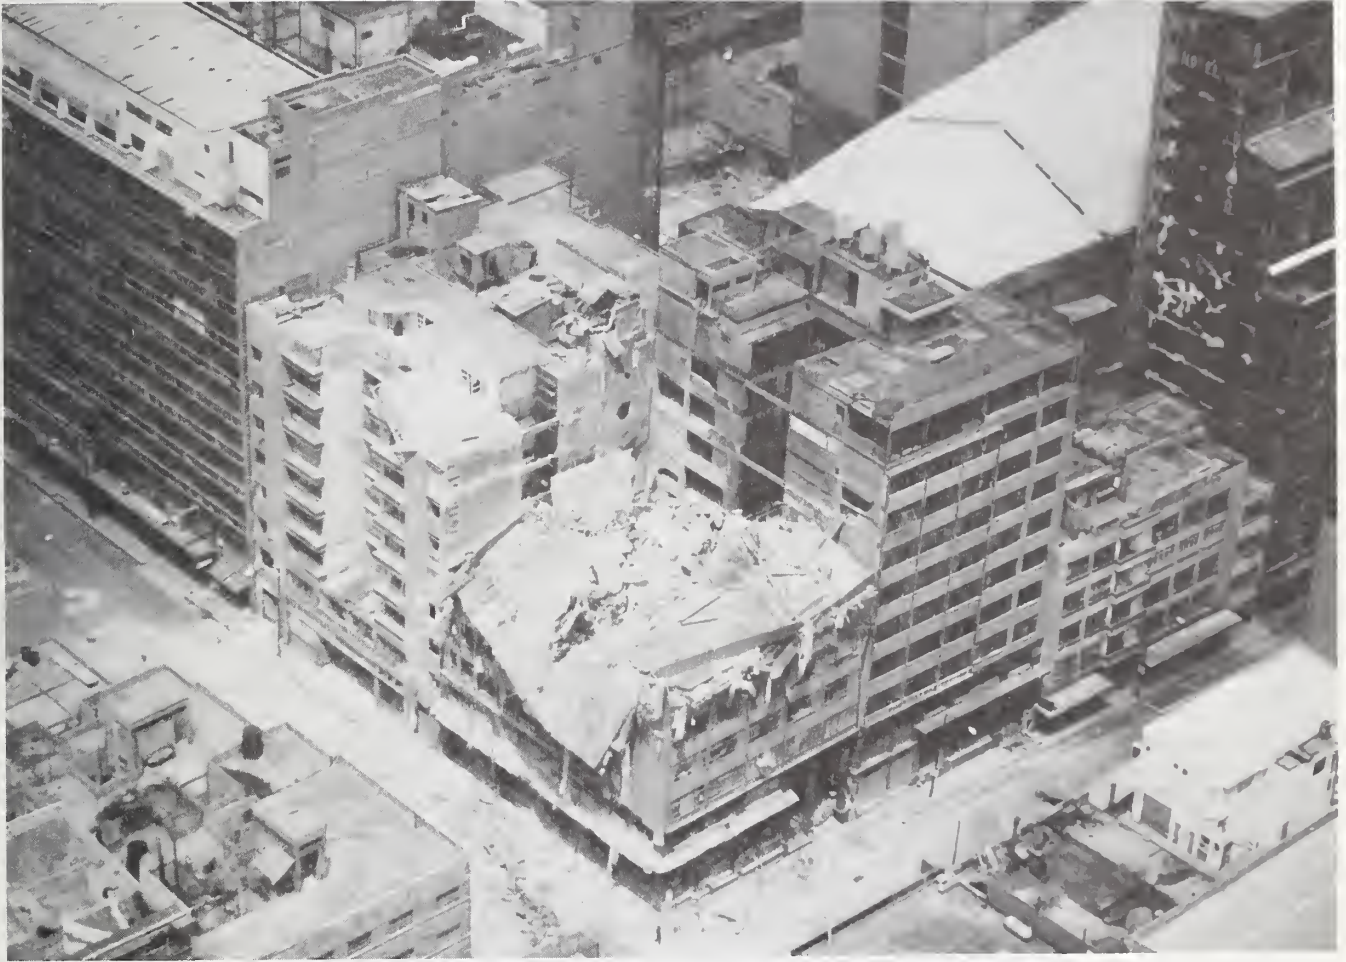
Figure 5.66. Torsionally induced pounding in corner building south of Alameda Park, near Torre Latino Americana.

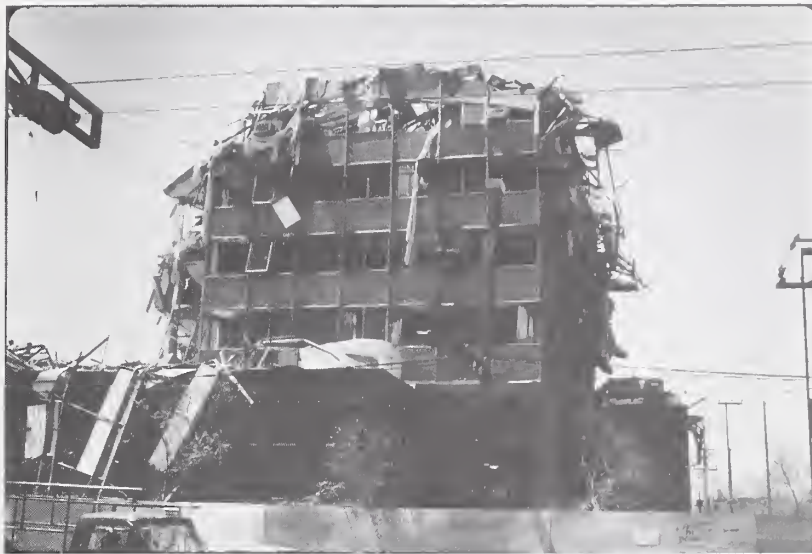
(a) Upper story failure in office building on Ave. Lazaro Cardenas.

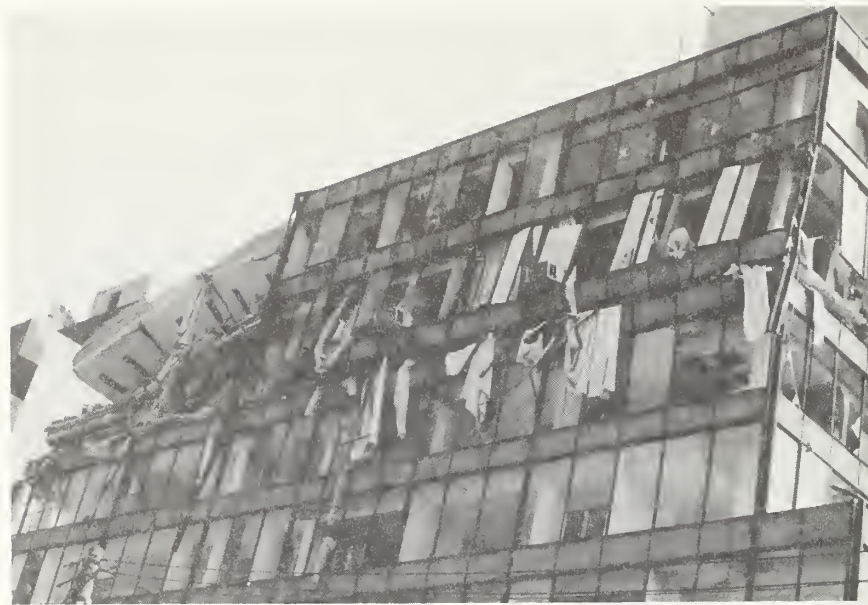
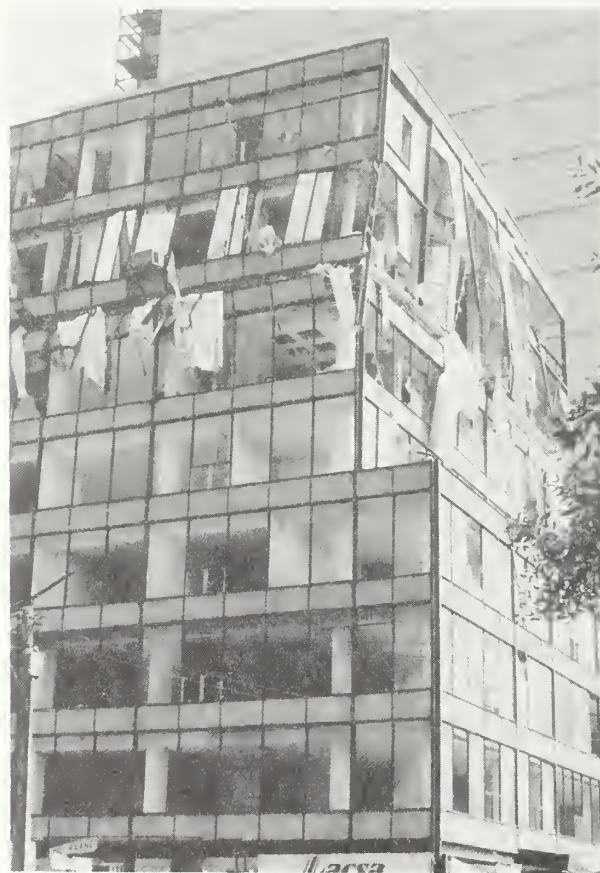
Figure 5.68. LASCA Building on Paseo de la Reforma and Marne, showing large change in column stiffness in upper two floor penthouse.

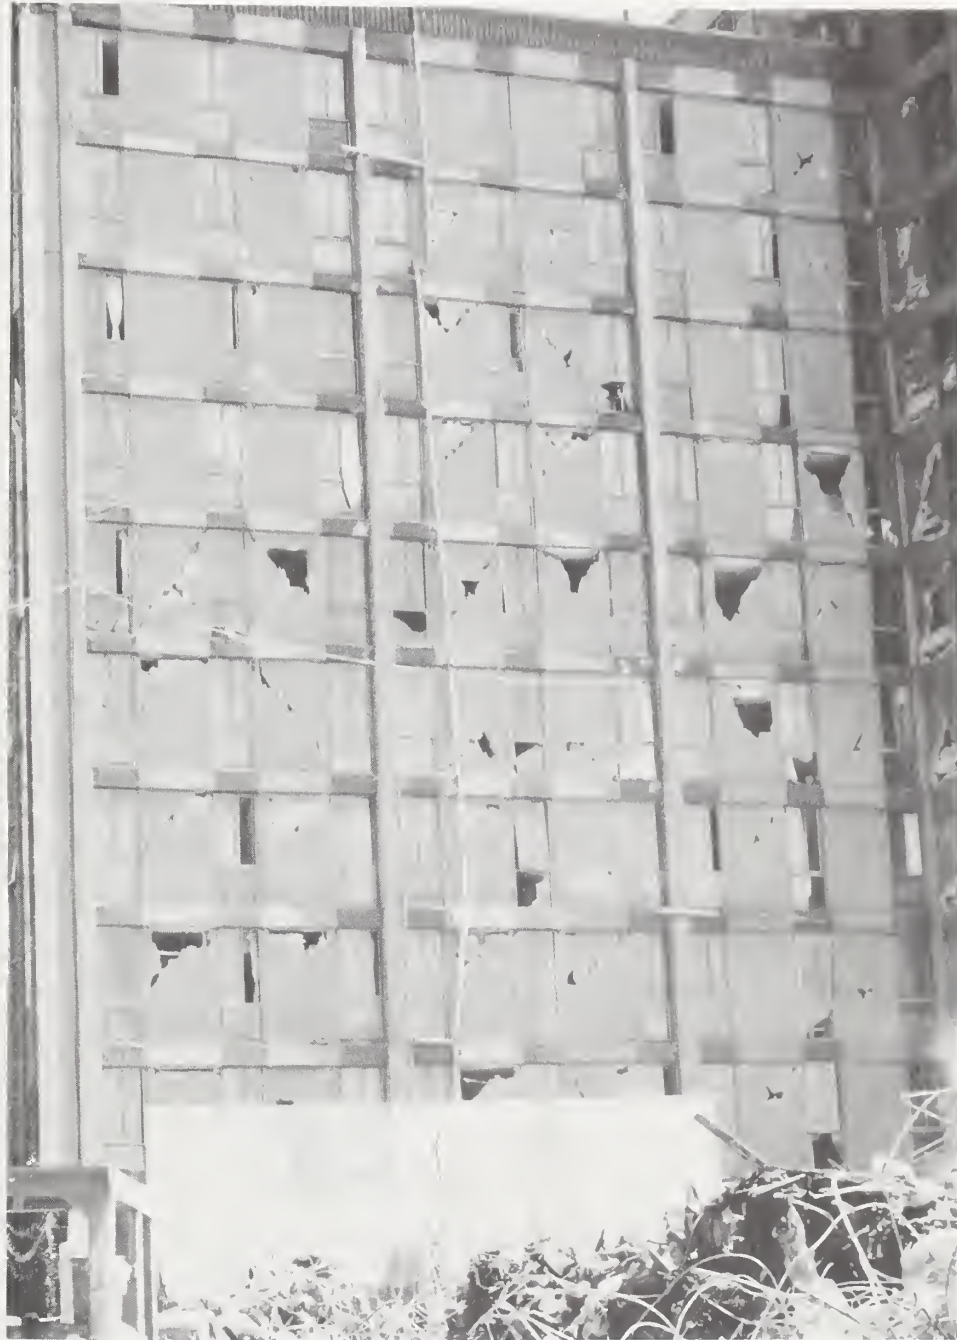
Figure 5.72. Significant diagonal shear cracking in a masonry infill structure on Ave. T. de Mier. Enough energy was dissipated in the walls to prevent collapse of the building.
