NBS BUILDING SCIENCE SERIES 86

Engineering Aspects of Cyclone Tracy Darwin, Australia, 1974

Marshall, Richard D.

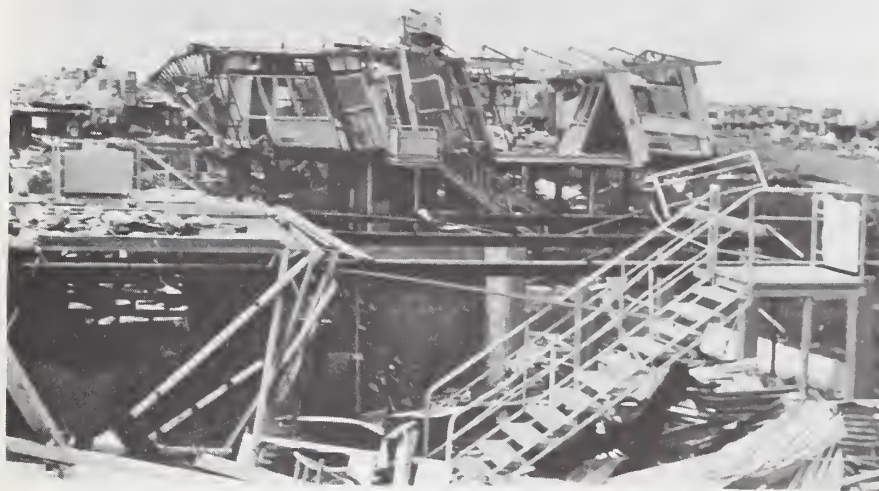
Fig. 5. Severe racking and loss of timber deck

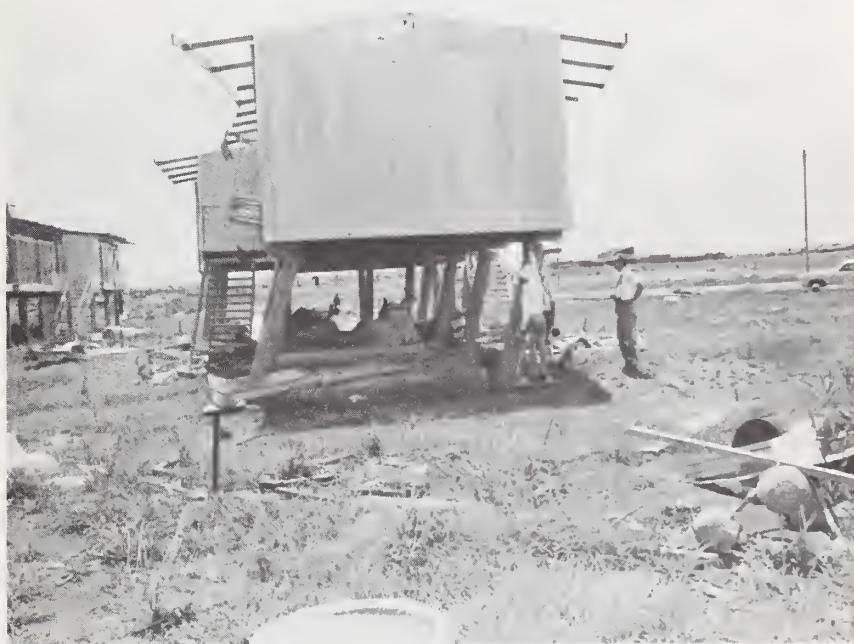
Fig. 6. Failure of concrete block shear walls and racking of concrete piers

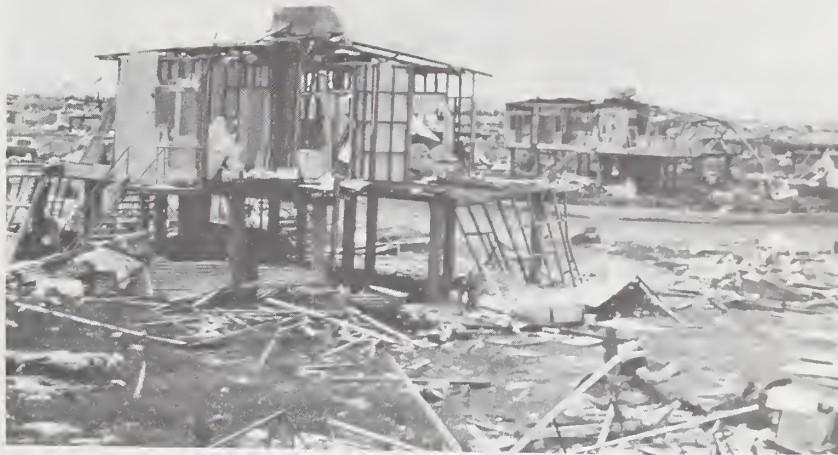
Fig. 9. Failure of endwall

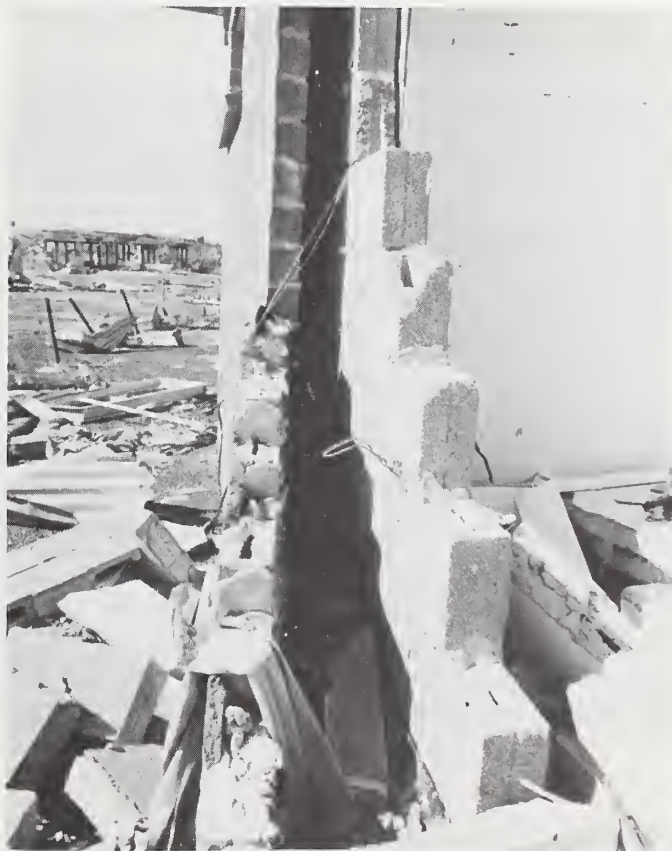
Many failures of masonry cavity walls were observed. Lack of bond beams and lateral loading due to purlin buckling were often the cause of these failures. However, a number of cases were observed where the crossties were either inadequate or improperly installed and the inner and outer wythes did not act together in resisting lateral loading. Since Australian practice with respect to masonry cavity wall construction is quite similar to that here in the U.S., this high incidence of failure is cause for concern. Most load tests on masonry walls have been carried out with vertical compression loads applied to simulate deadload. This load condition overestimates resistance to racking and lateral loads when uplift forces are sufficient to offset the deadload. In many cases observed in Darwin, it is likely that the uplift forces transmitted through the purlins were sufficiently high to place the entire wall in tension.

Fig. 10. Failure of brick and concrete block cavity wall

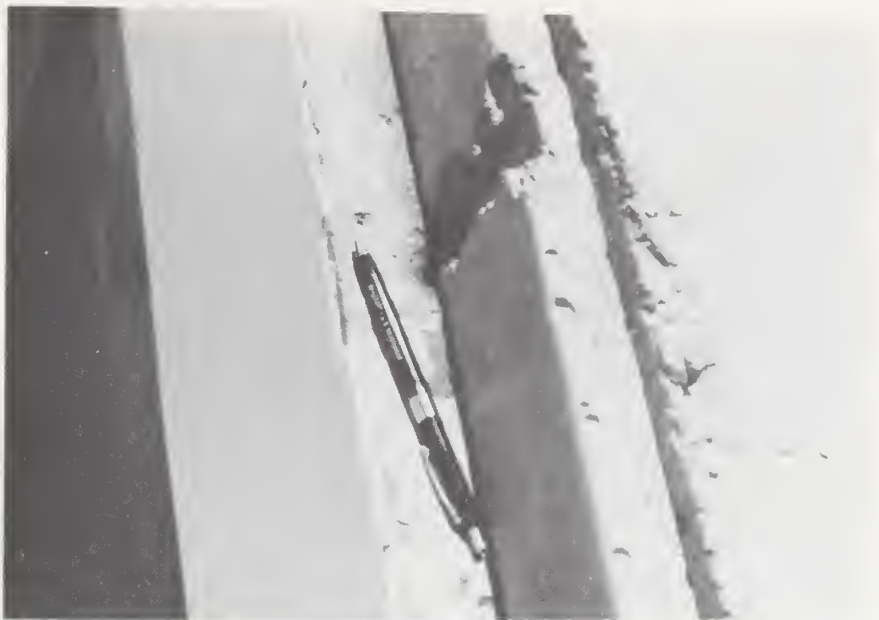
Fig. 13. Ceiling panel anchorage - bolt and adjacent panel missing

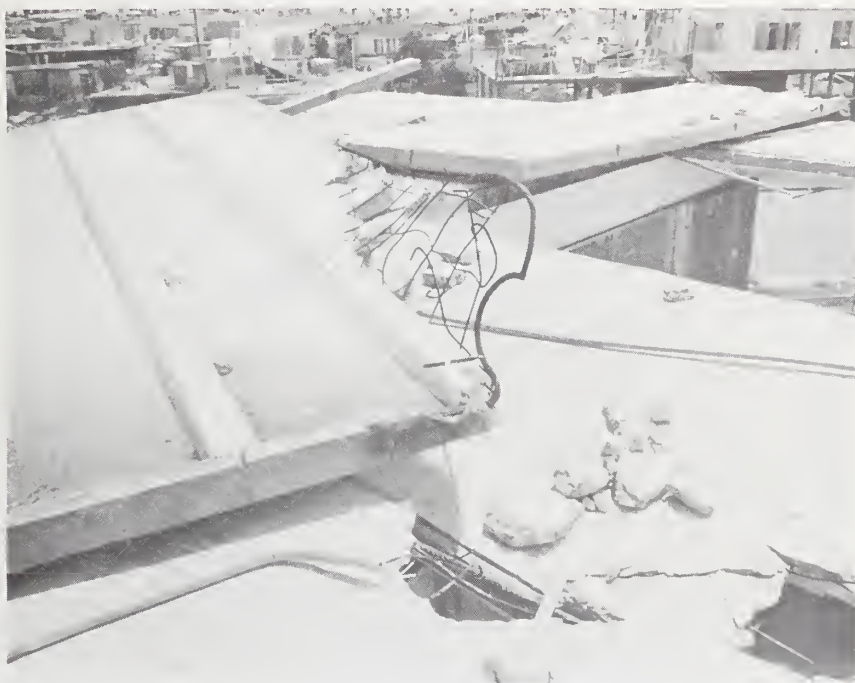
Some of the ceiling panels shifted enough to drop off of their supporting beams, causing damage to wall and floor panels. In some cases the ceiling panels were flipped over and fractured adjacent panels (see Figure 14). This occurred after loss of the CGI roof cladding and roof trusses. One house had obviously received a heavy missile impact, causing failure of a second story corner column. The beam-column connection detail revealed by this failure is shown in Figure 15.

Fig. 14. Overturned ceiling panels - CGI cladding and roof framing completely removed.

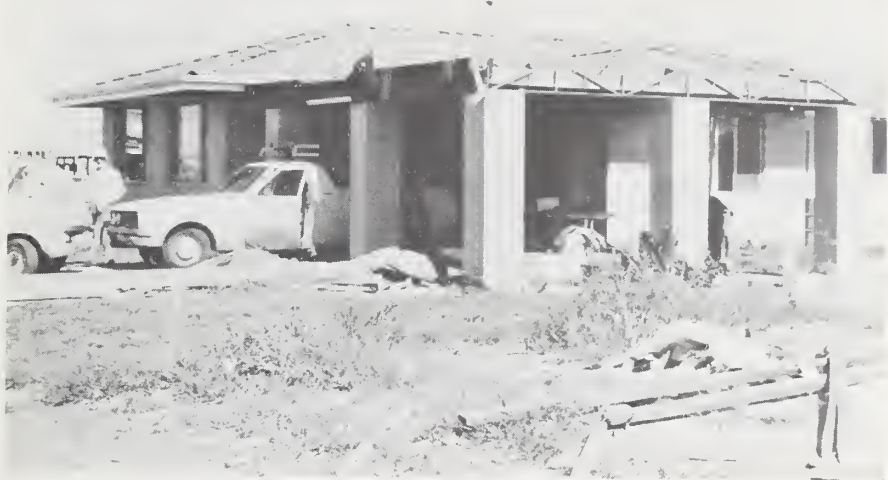
Several privately constructed houses performed well with damage being limited to loss of CGI roof cladding or tiles and some broken windows. The house shown in Figure 17 is located in Nakara and has a welded steel frame with brick veneer. Note that the roof tiles have been replaced since the storm. Commercially produced timber connectors were used in many of these houses to attach purlins and trusses.

Fig. 17. Privately constructed residence with welded steel frame and brick veneer

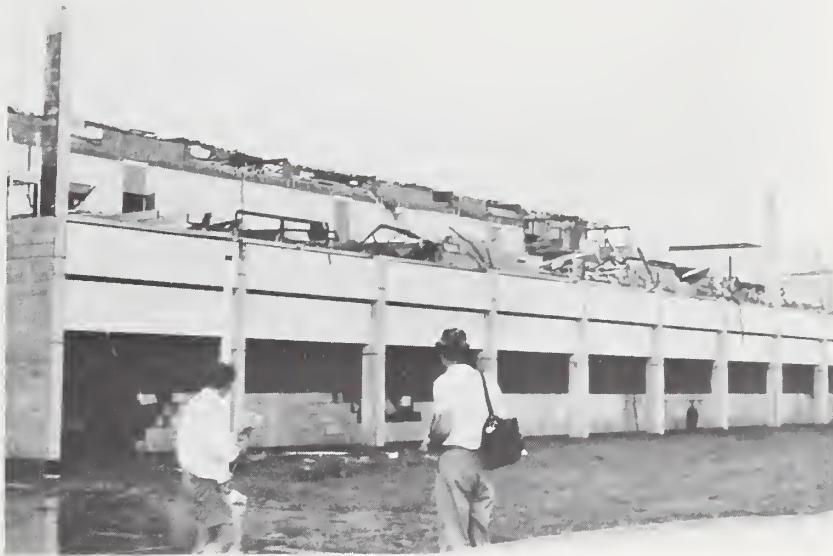
Darwin Community College is located just west of Nakara and was one of the more interesting complexes inspected because of some rather unusual structural failures. The main classroom building is a two-story reinforced concrete structure with masonry spandrel walls. The roof system consists of pan-type steel sheet carried by bar joists which are bolted to the column tops. A view of one-half of the north or windward wall is shown in Figure 20 and it is obvious that cracking has occurred in all of the columns just above the level of the second floor. The other half of the windward face of the building is shown in Figure 21. The roof structure has been folded over the exposed interior wall, and the second-story spandrel wall and several columns have failed. It was originally believed that the column failures were due to a poor splice detail, i.e., insufficient bar lap and column ties. However, a closer inspection revealed a quite different mode of failure. Following loss of the windows and/or spandrel walls the bottom chords of the bar joists failed in compression due to the high uplift pressures on the roof cladding and absence of any lateral bracing of the bottom chords. This, in turn, displaced the column tops and caused them to fail in combined bending and tension. This sequence of events was quite clear, both in the failed section and in the portion which was still standing.

Fig. 21. Failure of second story (view immediately to right of Fig. 20)

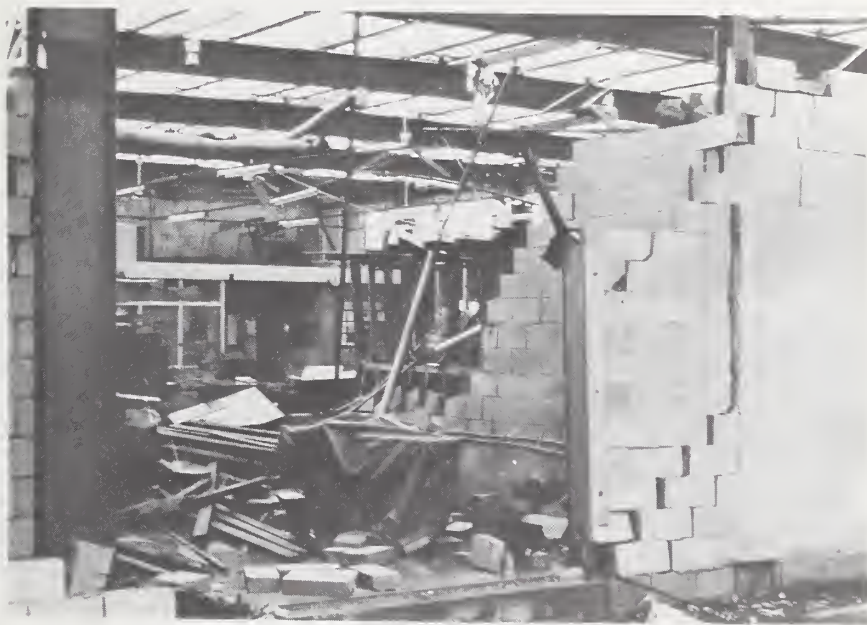
A number of failures of masonry walls were observed in the buildings housing the metal and woodworking shops of Darwin Community College. These buildings have structural steel frames and concrete block walls as seen in Figure 22. The walls were unreinforced and are believed to have failed by direct wind loading since there was no source of debris upwind of these structures. There was no apparent damage to the steel frames.

Fig. 22. Woodworking shop - Darwin Community College

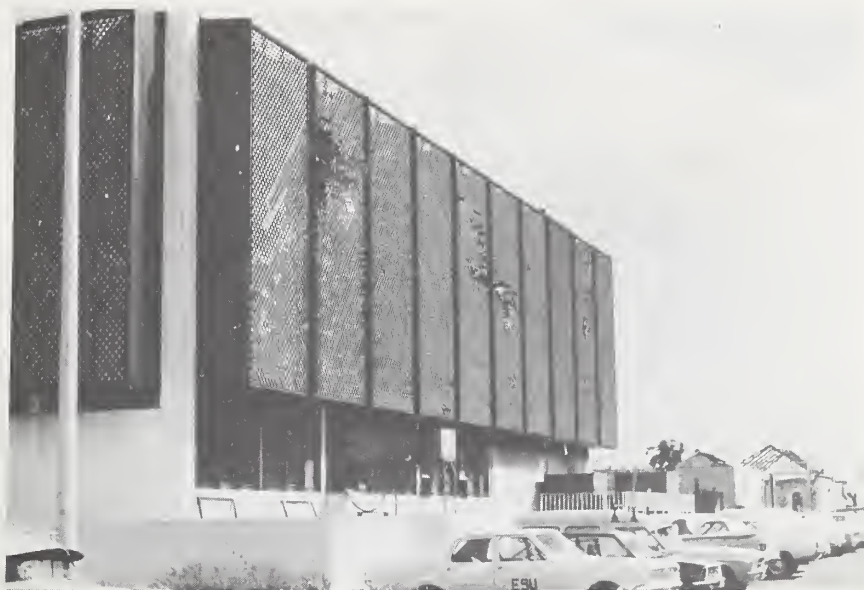
Fig. 25. Sunscreen showing points of missile impact

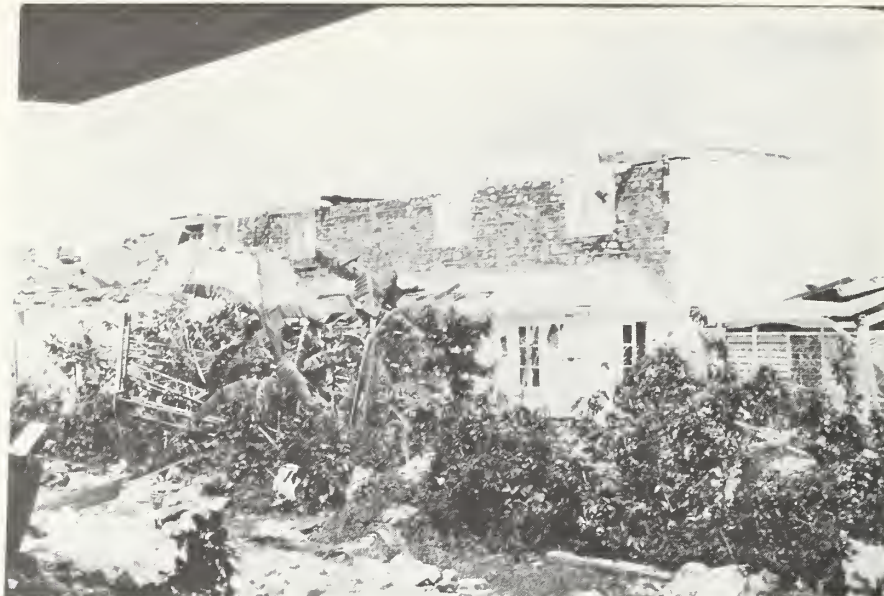
Several buildings constructed prior to 1900 have been preserved as historic buildings and are of interest because of their previous exposure to intense cyclones. These buildings are all quite similar in physical size and type of construction, having timber roof trusses and load-bearing walls of native stone approximately 400 mm thick. Most of these buildings suffered extensive damage in the cyclones of 1897 and 1937. Typical damage is shown in Figure 27.

Fig. 27. Historic building in Darwin City - hip roof completely removed

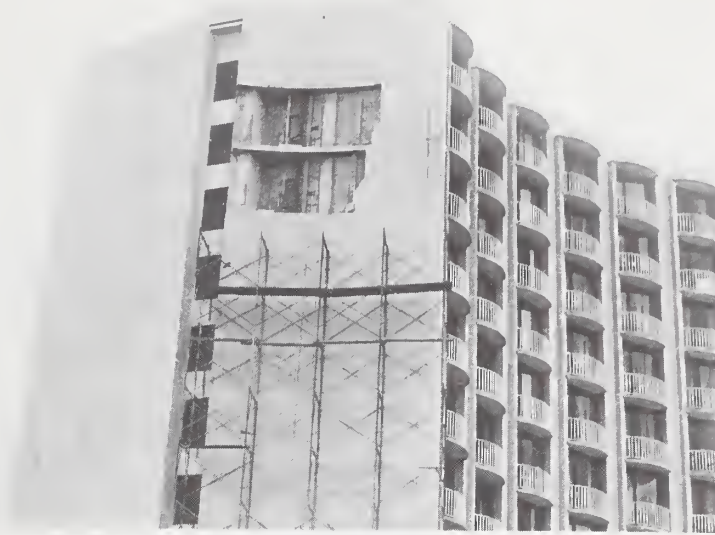
Several new hotels and office buildings have been constructed in Darwin since 1970. These include the 10-story MLC Building and the 11-story Travelodge (Figures 28 & 29) in the Darwin City area. Both are of reinforced concrete flat plate construction with concrete shear walls. Most wind damage was superficial, being limited mainly to loss of pan-type roof cladding and broken windows. There proved to be no substance to the rumor that a large missile caused the partial failure of the brick and concrete block endwalls of the Travelodge (see Figure 29). An identical failure occurred at the same level on the opposite end, undoubtedly due to extremely low surface pressures downstream of the separation points. The change in wind direction in this area would have been sufficient to create identical pressure distributions at each end of the building. The design speeds are not known, but inspection teams reported no evidence of cracking or plastic action in either structural system. Occupants did report noticeable oscillations during the storm passage. Water damage was extensive in these and other tall buildings following loss of roof cladding and glass breakage.

Fig. 29. Travelodge - Darwin City (similar damage at opposite end)

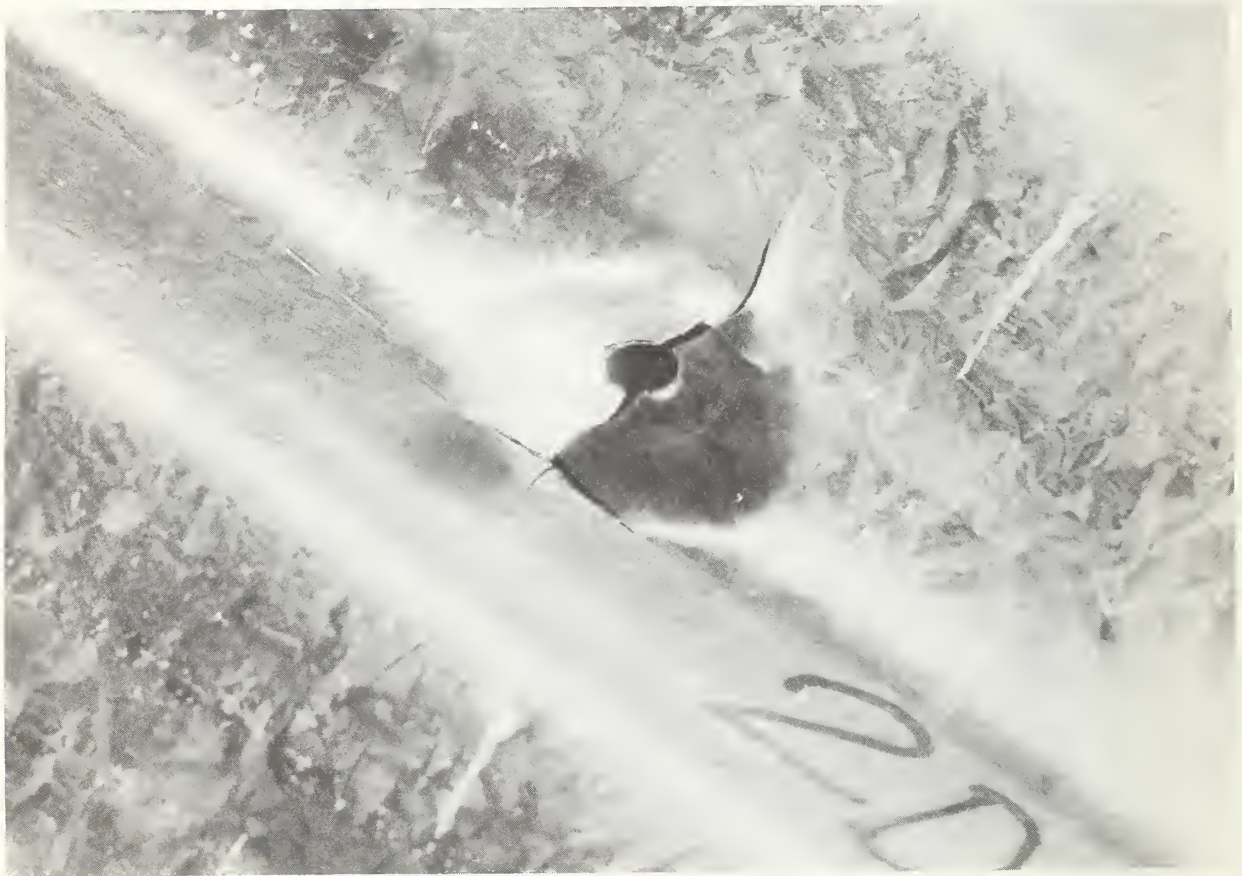
As with other tropical regions of Australia and, in fact, throughout the world, CGI cladding is widely used in Darwin. There are many variations in the sheet profiles and types of fasteners, by far the most common being a sinusoidal cross section with self-drilling, self-tapping fasteners equipped with a neoprene sealing washer. Immediately following Cyclone Tracy, laboratory tests and field inspections of single-family dwellings and industrial buildings were carried out by the Housing Research Branch, Department of Housing and Construction to establish the reasons for the widespread failure of CGI in Darwin [10]. These investigations are continuing, but preliminary findings indicate that low-cycle fatigue was the predominant failure mode. Repeated load tests carried out at approximately 30 percent of the ultimate static load capacity produced failures after 2000 to 3000 cycles. A typical failure is shown in Figure 32. Data obtained in recent full-scale investigations of wind

Fig. 32. Typical fatigue failure of CGI cladding

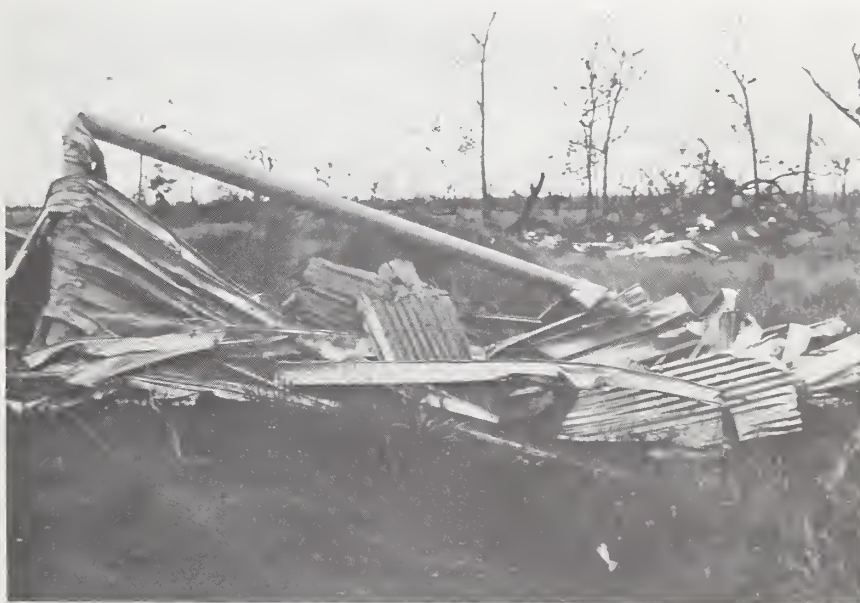
Fig. 34. Failure of lamp standard due to debris loading
