NBS BUILDING SCIENCE SERIES 94

Investigation of the Skelton House Collapse
in Fairfax County, Virginia

Investigation of the Skyline Plaza Collapse in Fairfax County, Virginia

NBS Building Research Institute, Inc. 34
Edgar V. Leyendecker and S. George Fattal

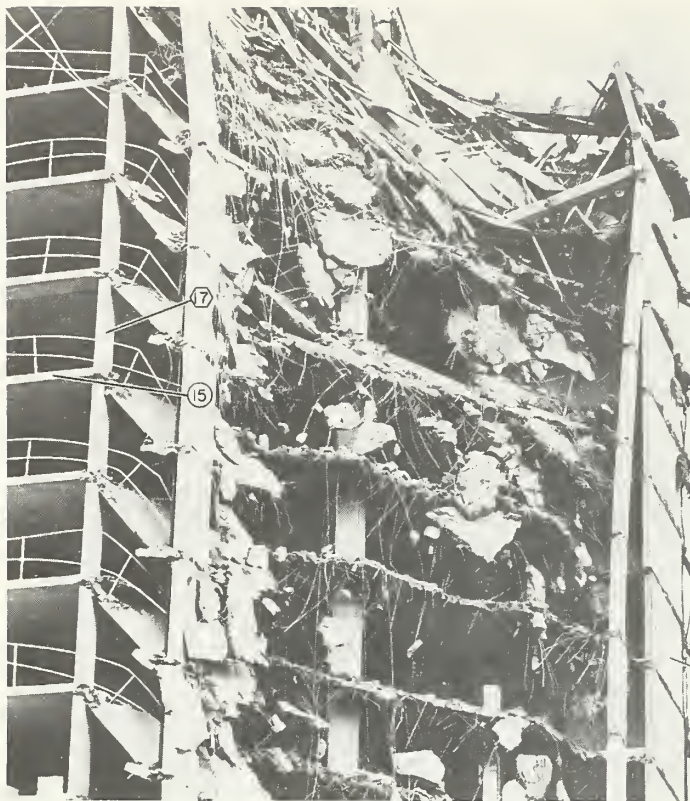
*Figure 2.7
Closeup view near the
top of the east end of
the failure zone,
looking south.*

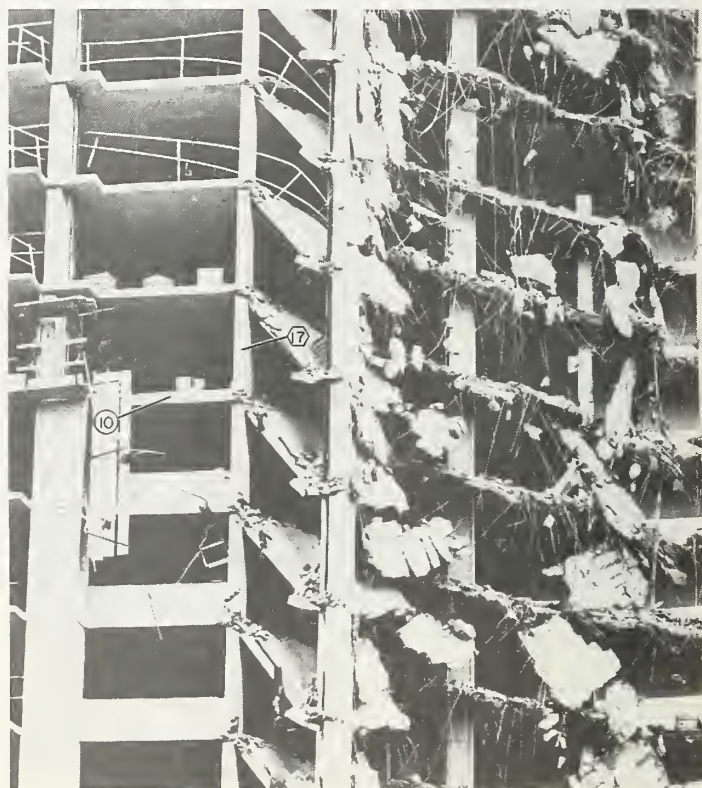
*Figure 2.8
Closeup view near the
midheight of the east
end of the failure
zone, looking south.*

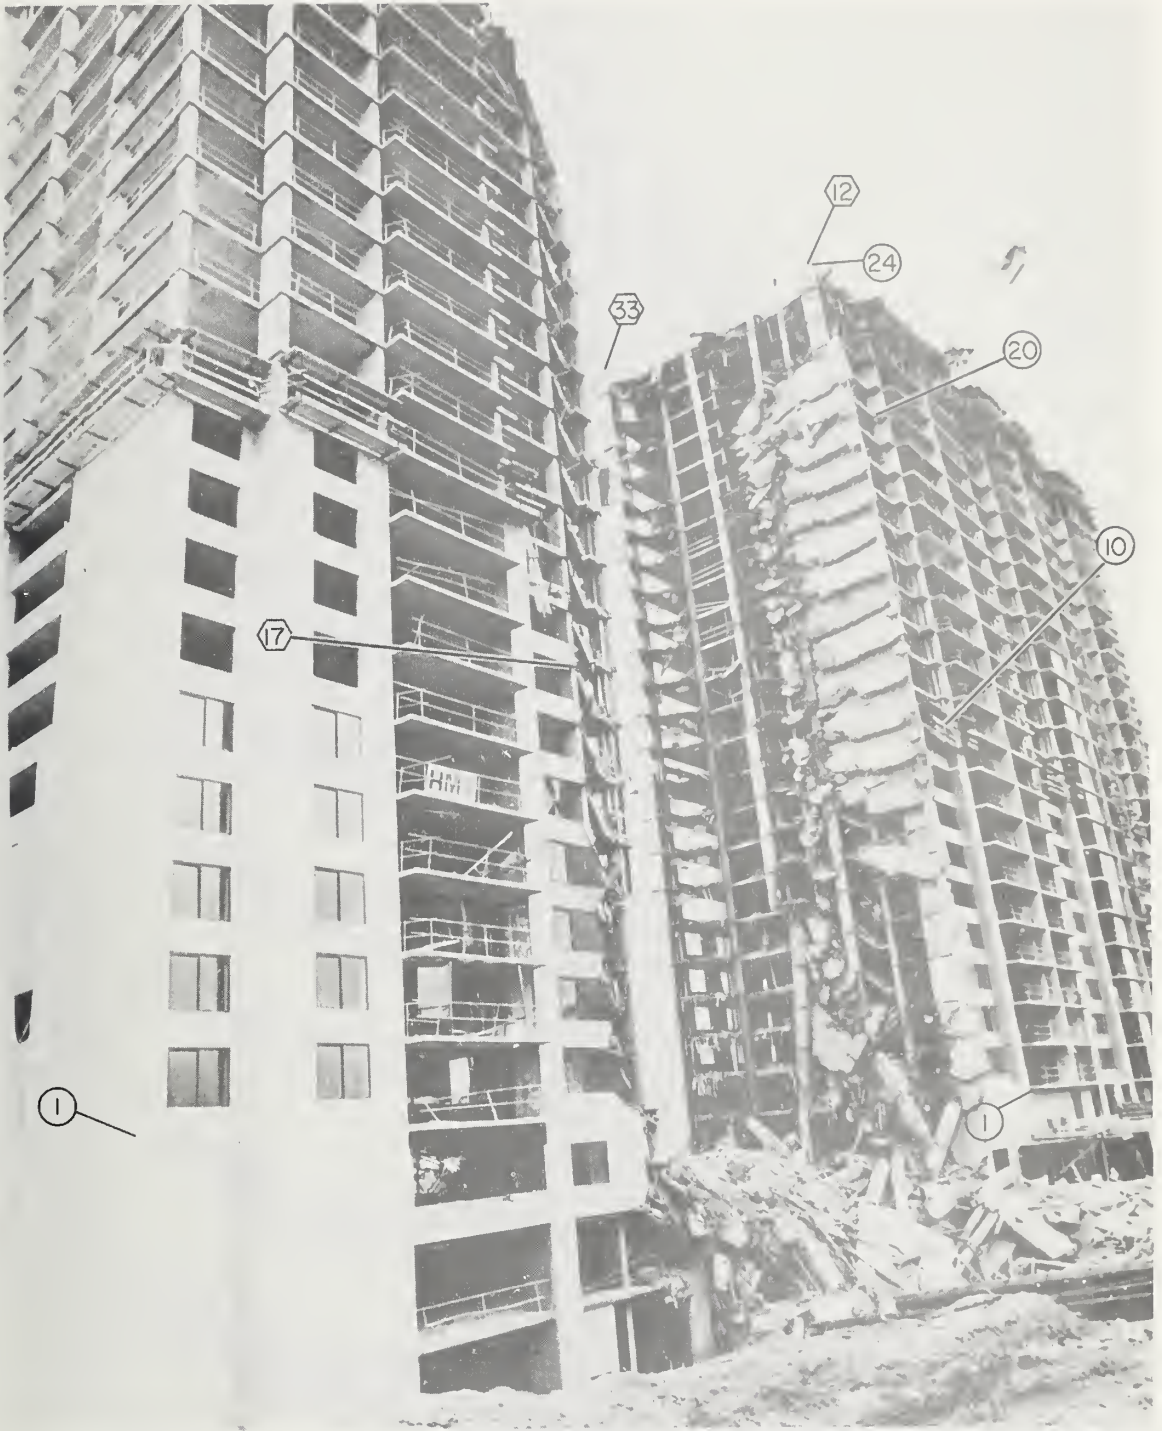
A general view of the west end of the failure zone is shown in figure 2.9 along with closeup views in figures 2.10 through 2.12. These figures also require little comment at this time; however, it should be noted that the formwork is clearly visible in figure 2.10.

Figure 2.9 General view of building A-4 as seen looking southwest.

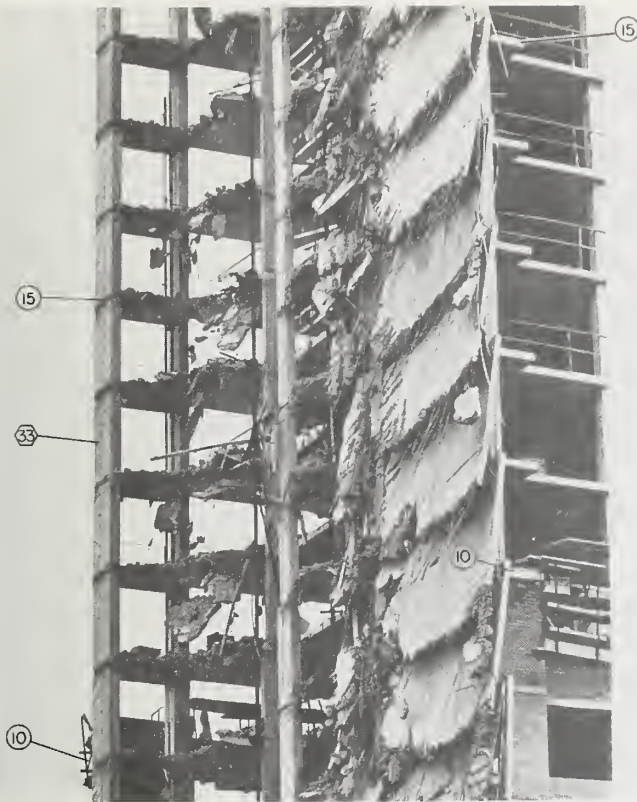
Figure 2.11
Closeup view near the
midheight of the west
end of the failure
zone, looking south-
west.

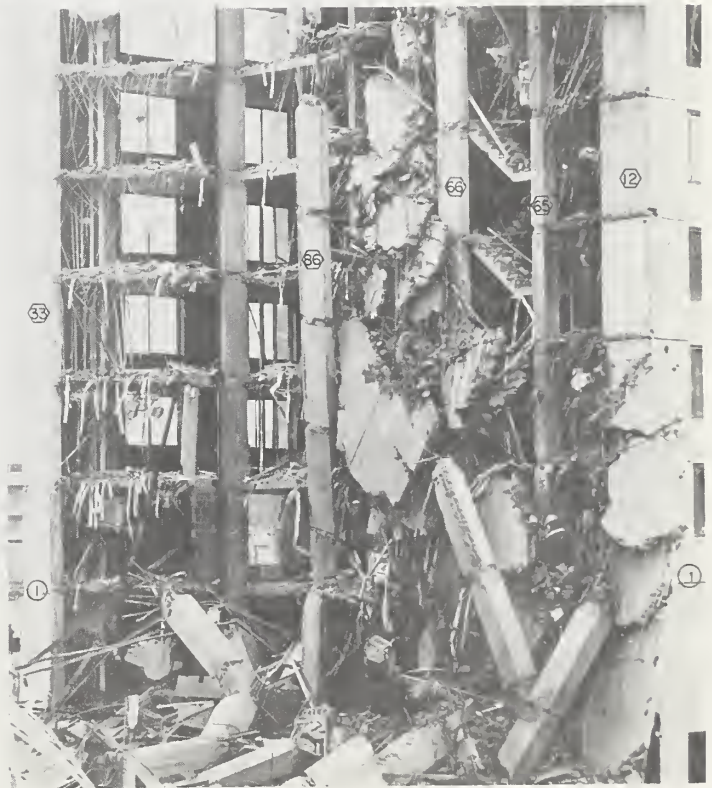
Figure 2.12
Closeup view at the
bottom of the west end
of the failure zone,
looking southwest.

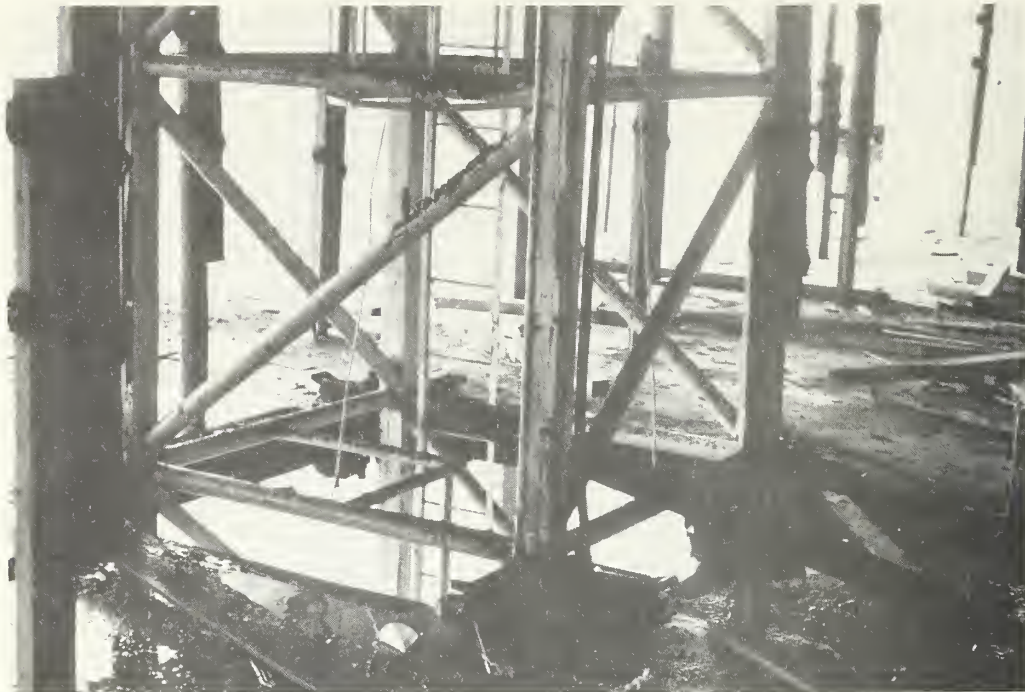
Crane no. 1 was supported by the climbing frame, the lower support, on the 20th floor as shown in figure 2.33. The upper support was provided on the 22nd floor as shown in figure 2.34. This total distance is 18 ft, slightly less than the manufacturer's specified 18 ft 4 in. A typical corner clamp detail on the 22nd floor is shown in figure 2.35. Note the cracked slab where the clamp is attached.

Figure 2.34 Upper support for crane no. 1.

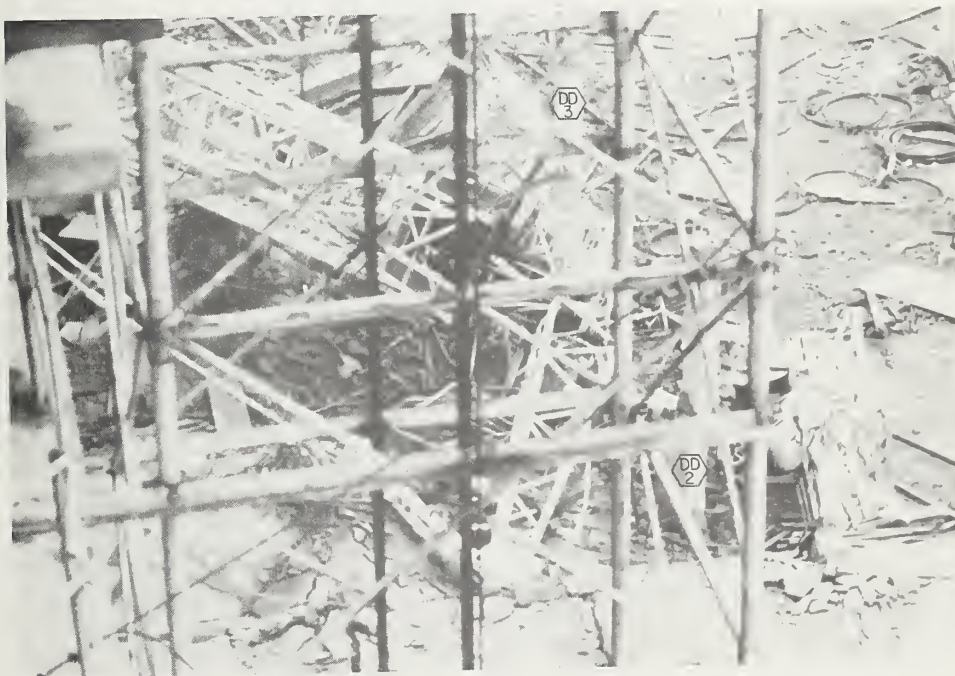
Figure 2.56 Position of fallen crane near column DD-2 looking east.
