Fractographic Examination of Sabreliner Landing Gear Fracture

Failure Analysis Report

Sabreliner, NA265-40, N360N, White Plains, New York, August 28, 1972. NTSB accident No. NYC 73-I-N037.

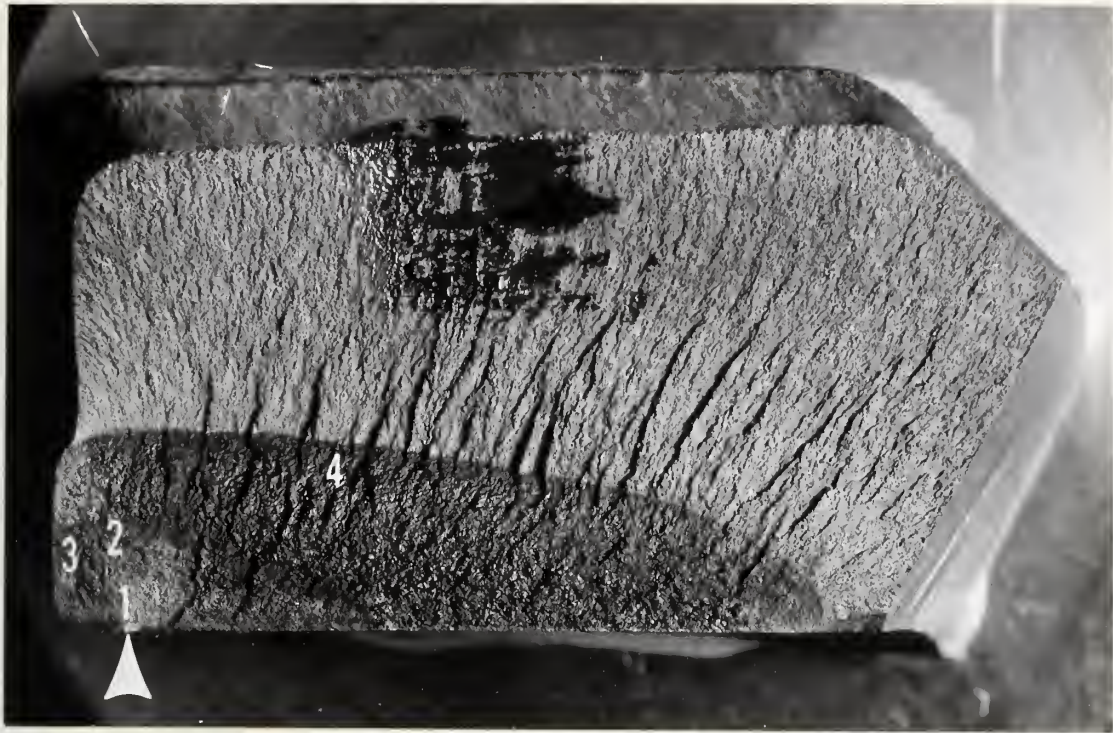
The crescent shaped area of the fracture was very dark in color compared to the rest of the fracture surface. The dark area was the region of apparent slower crack propagation. The principal crack origin appears to be at the location indicated by the arrow in figure 1. At least one crack arrest line could easily be detected in the slower crack propagation region. There was a fairly sharp change in the fracture plane at the point where the slowly propagating crack front stopped and the rapidly propagating crack began (figure 2).

As mentioned above, it is difficult to arrive at definite conclusions about the mode of fracture. The best interpretations of the scanning electron photomicrographs indicate that a crack, which originated at the location shown by the arrow in figure 1, probably started and propagated initially by stress corrosion cracking. It then grew by a combination of stress corrosion cracking and corrosion fatigue. When the crack had propagated to the end of the dark crescent region, the remaining cross section of the part failed from ductile overload.

Figure 1. Fracture surface of the submitted part as received. Arrow indicates fracture origin. Numbers 1 through 4 indicate areas of the fracture surface examined with the scanning electron microscope. X 6

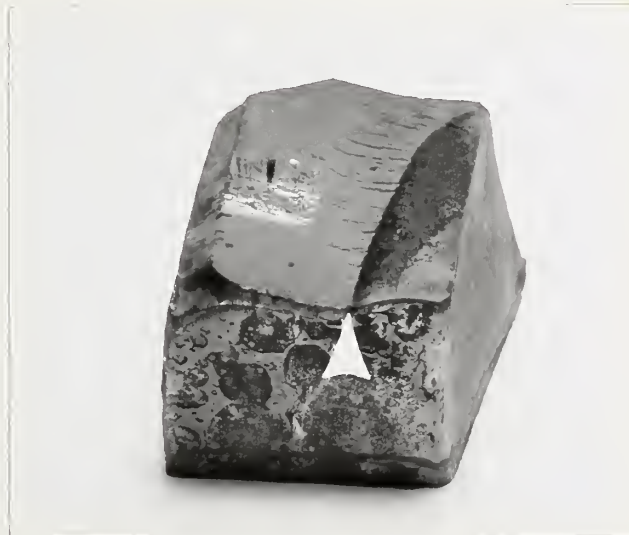
Figure 2. View of the fracture surface showing the change in the plane of the fracture at the junction (arrow) between the slower propagating part of the fracture and the faster propagating part of the fracture. X 3

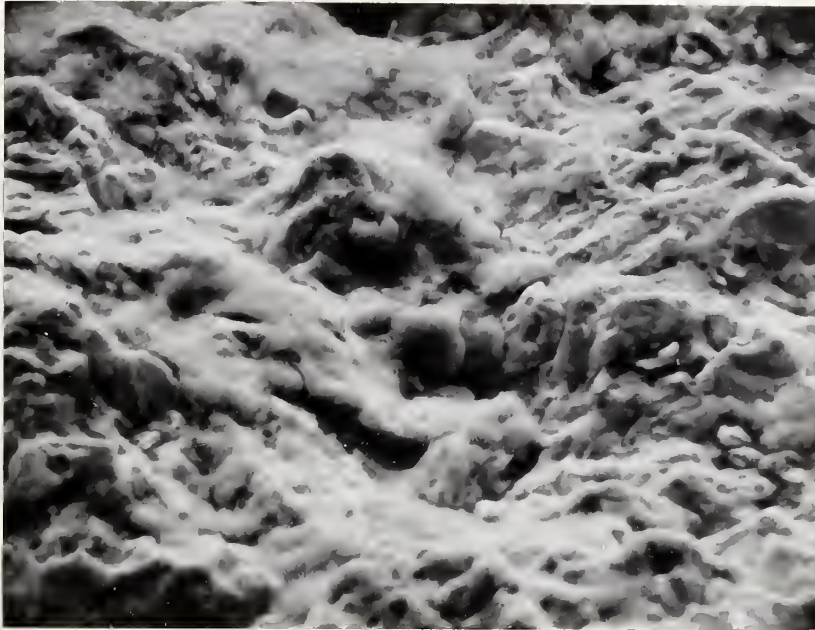
surface was covered with a film which was probably composed of corrosion product. Examples of the film covered surface are shown in figures 3 and 4. The film was sufficiently thick in most areas to mask the features of the fracture surface.

Figure 3. SEM showing fracture surface in slower crack propagating region before cleaning by replication. X 1375

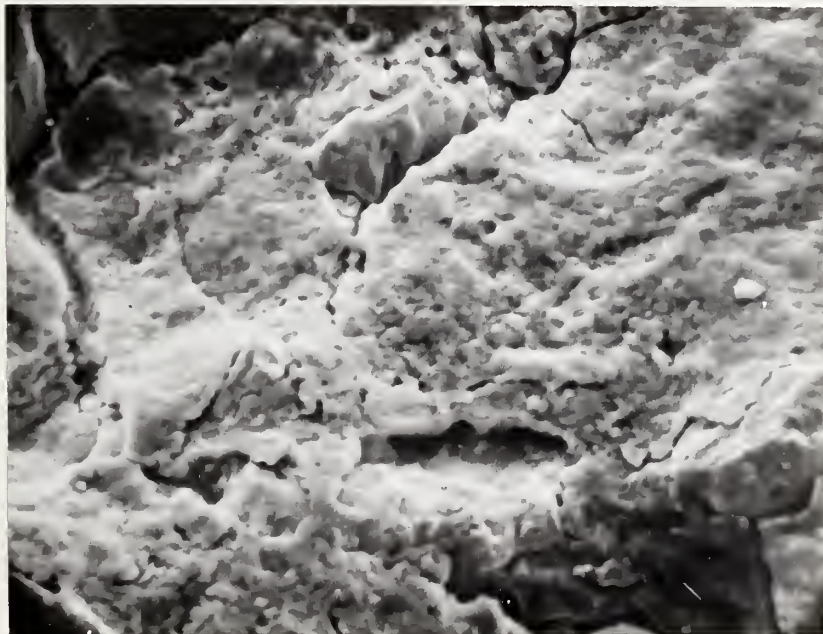
Figure 4. SEM showing fracture surface in slower crack propagating region before cleaning by replication. X 2400

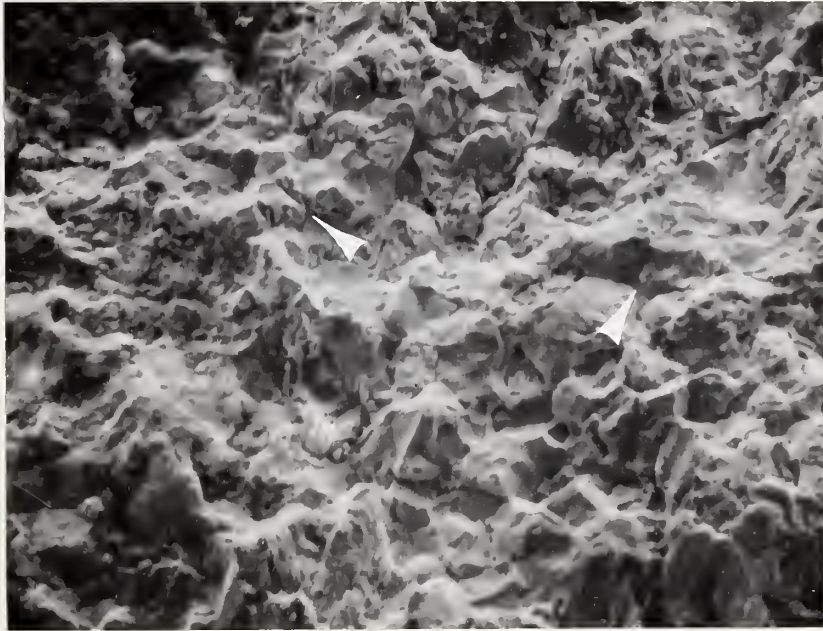
Near the fracture origin (locations 1 and 2, figure 1), intergranular cracking appeared to be the dominant fracture mode. Examples of this are shown in figures 5 and 6. In figure 6, the fracture features are less distinct than in figure 5. If intergranular cracking is indeed the fracture mode observed, then the probable mechanism of fracture exhibited in figures 5 and 6 is stress corrosion cracking.

Figure 5. SEM from fracture surface at location 1, figure 1, showing apparent intergranular cracking as the dominant mode of fracture in this region. Two grain boundaries are indicated by arrows. X 1175

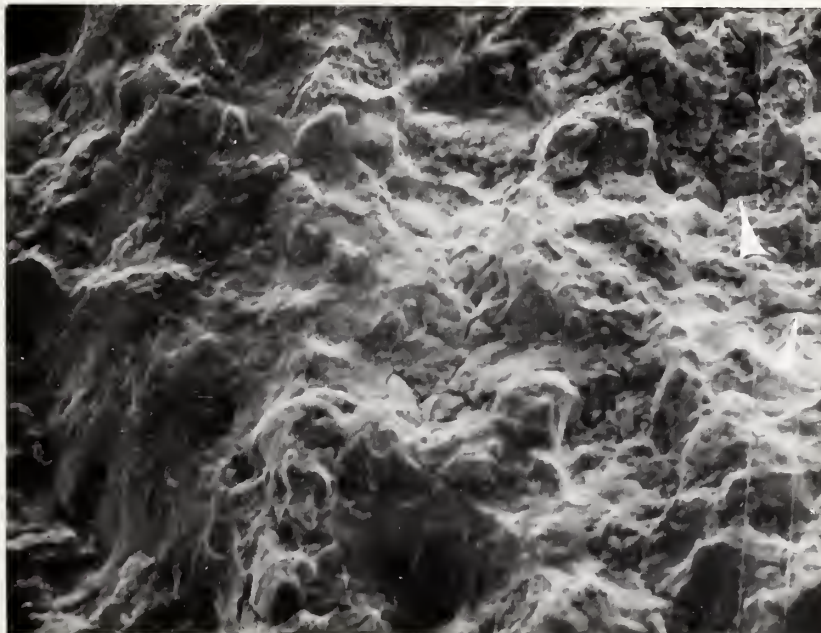
Figure 6. SEM from fracture surface at location 2, figure 1, showing apparent intergranular cracking as the dominant mode of fracture in this region. Two grain boundaries are indicated by arrows. X 1150

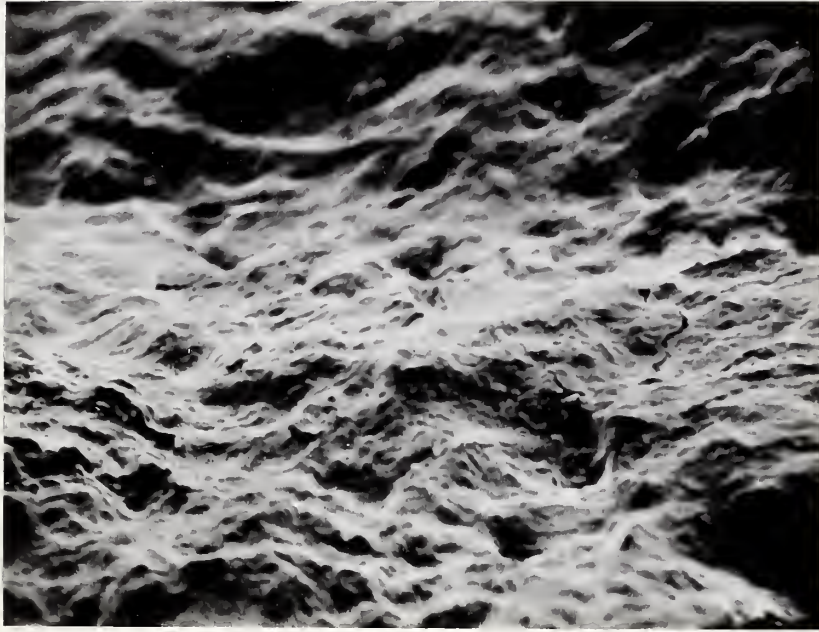
There was some evidence of corrosion fatigue as shown in figures 7 and 8 (locations 3 and 4, respectively, figure 1). What appear to be striations can be seen in both figures.

Figure 7. SEM from fracture surface at location 3, figure 1, showing what may be fatigue striations. X 1100

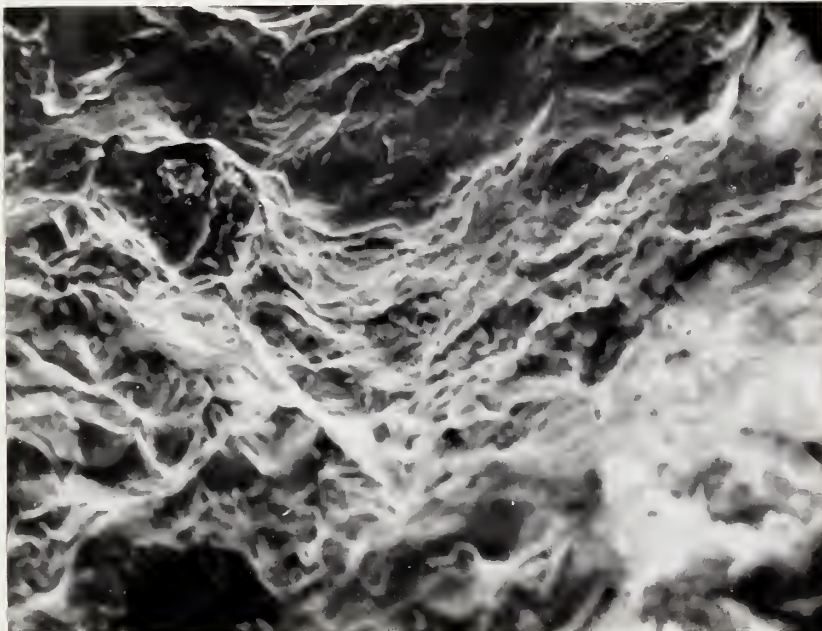
Figure 8. SEM from fracture surface at location 4, figure 1, showing what may be fatigue striations. X 2300

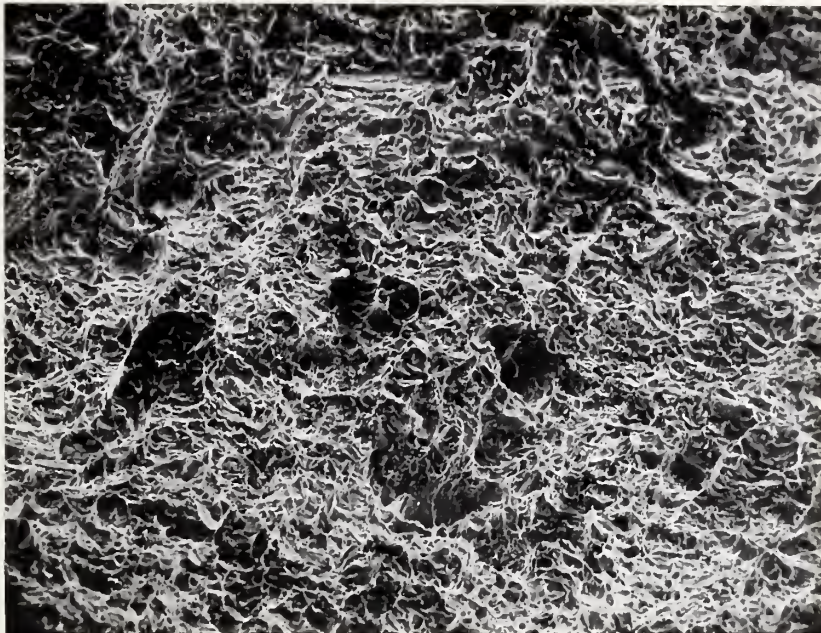
The fracture surface in the faster crack propagating area beyond the crescent shaped area exhibited dimpled rupture as shown in figures 9 and 10. The mode of fracture here is ductile overload.

Figure 9. SEM from fracture surface in faster crack propagating region showing dimpled rupture. X 510

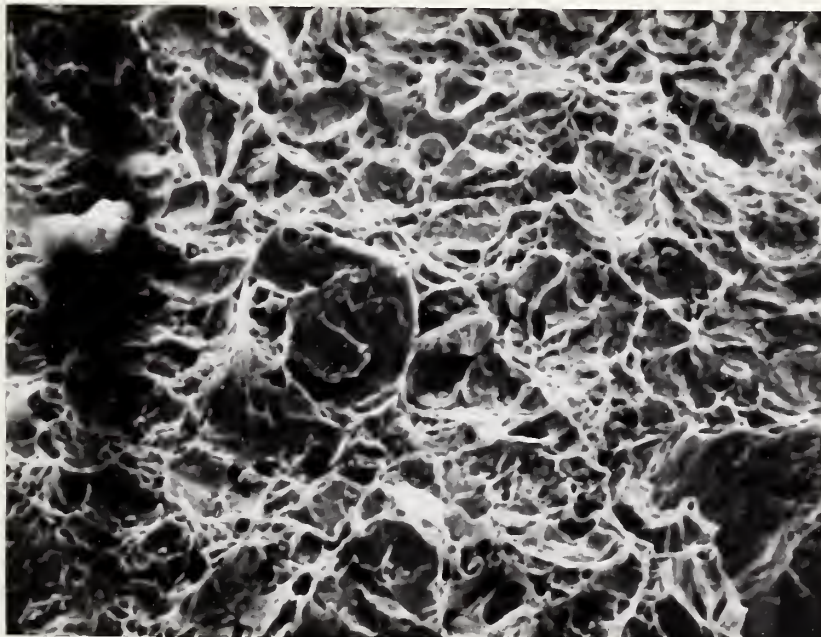
Figure 10. Part of field shown in figure 9 at higher magnification. X 2000
