NBSIR 73-133

Performance of Anodized and Chemically Surface Treated Aluminum Alloy Rivets in a Marine Environment

March 1973

**Final Report
Bureau of Aeronautics (Naval Air Command)
Department of the Navy, Letter, Aer-AE-417/89
dated 19 March 1957**

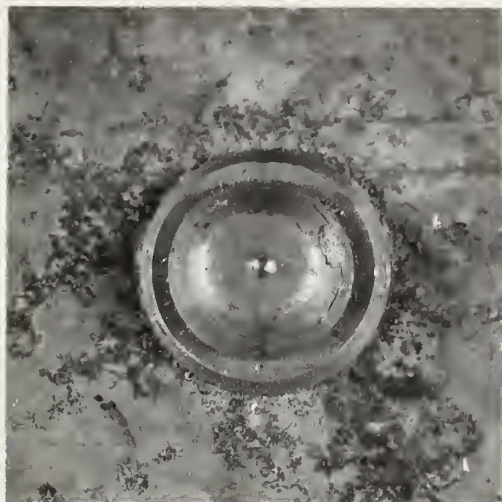
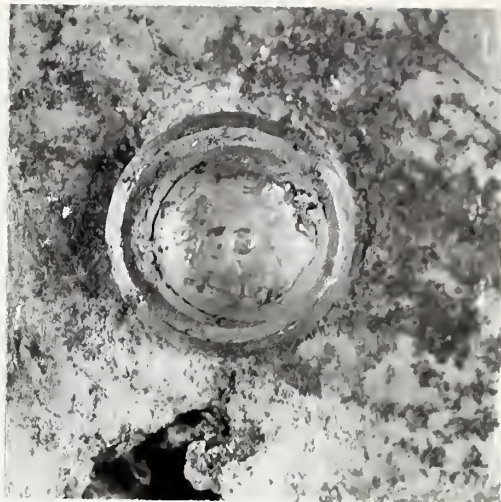
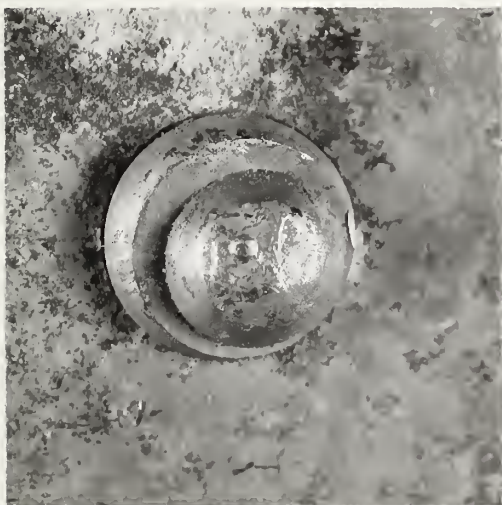
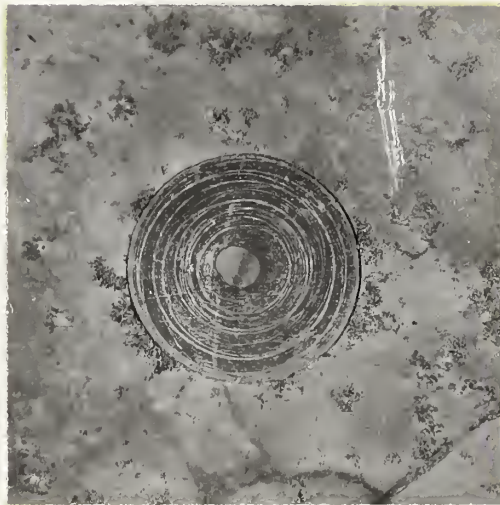
The 2017 aluminum alloy rivets which had been given the Iridite 14 treatment exhibited very good resistance to corrosion after approximately 27 months' exposure. After exposure for approximately 79 months all 2017 aluminum alloy rivets were equally corroded (Figure 2). However, in general, the 2017 aluminum alloy rivets showed good resistance to corrosion whether coated or not coated.

Figure 2. Appearance of 2017 Aluminum Alloy Rivets in Clad 2219-T6 Aluminum Alloy Sheet after Approximately 79 Months Exposure in Tidal Immersion at Harbor Island, North Carolina. X3.3

- a) Bare
- b) Coated, Alumilite 205
- c) Coated, Alumilite 204
- d) Coated, Iridite 14

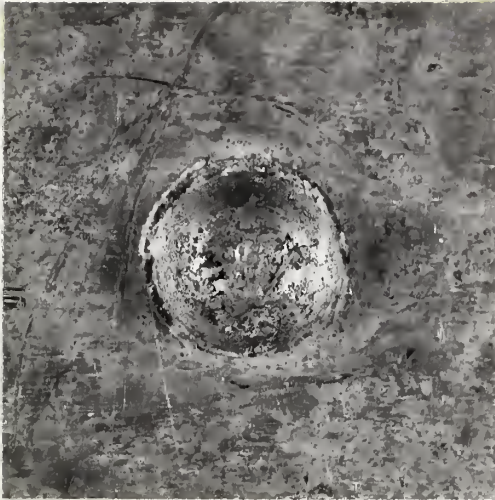
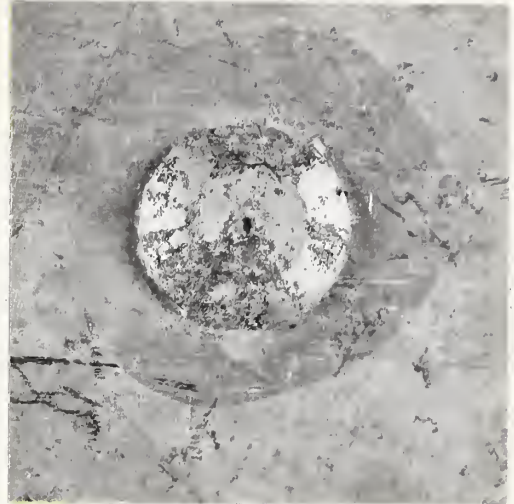
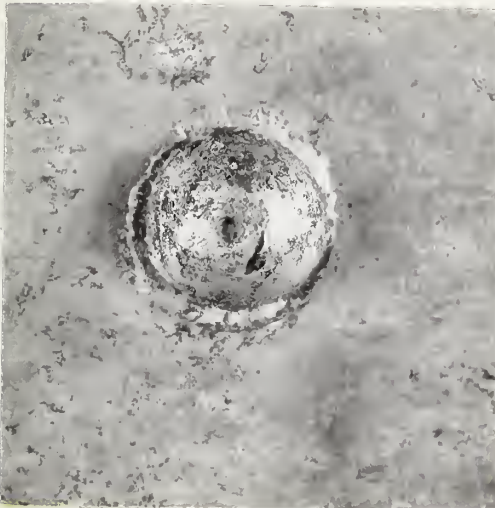
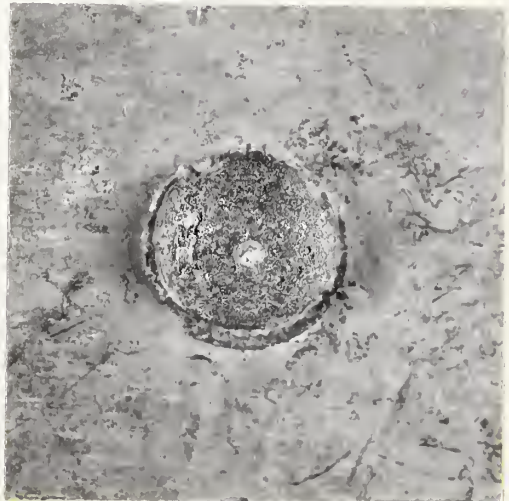
With some exceptions, bare or surface treated 2117 aluminum alloy rivets showed good resistance to corrosion. When driven in the 2024-T4 aluminum alloy sheet, these rivets were found to be pitted and badly corroded after exposure for approximately 27 months. This is shown in Figure 3. The rivets given the Alumilite 205 treatment exhibited the least attack while the bare, uncoated rivets had developed shallow pitting and all of the rivets which were given Alodine 1200 including those given the reheat treatment were deeply pitted.

Figure 3. Appearance of 2117 Aluminum Alloy Rivets in Bare 2024 Aluminum Alloy Sheet after Approximately 27 Months Exposure in Tidal Immersion at Harbor Island, North Carolina. X3.3

- a) Bare
- b) Coated, Alumilite 205
- c) Coated, Alodine 1200
- d) Coated, Alodine 1200 Reheat Treated

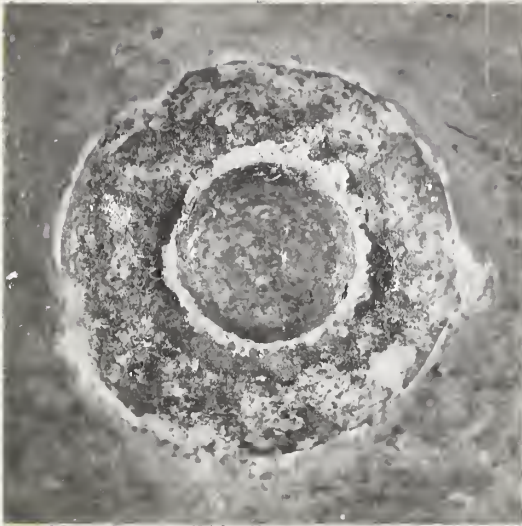
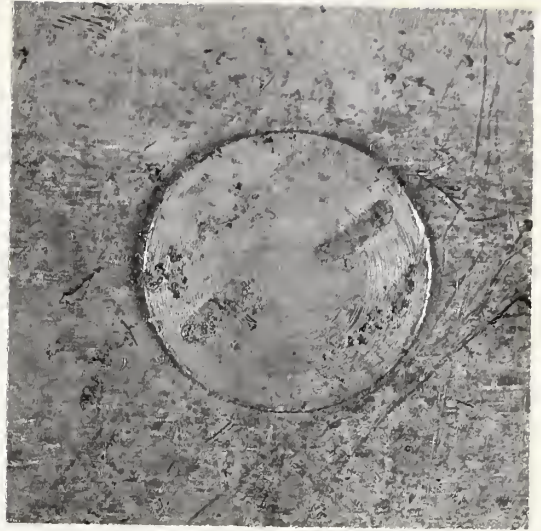
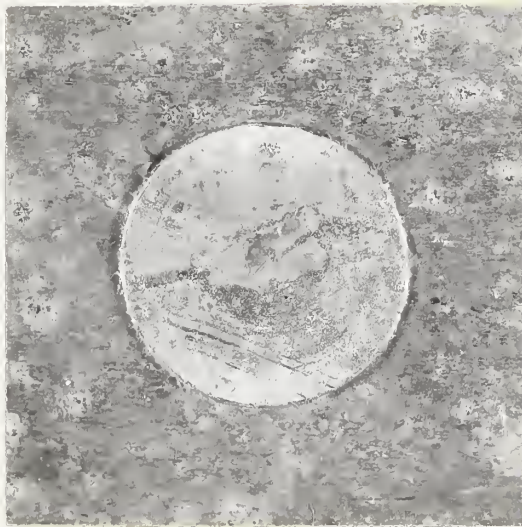
Of the 2024 aluminum alloy rivets, those which had been given the special (stabilizing) heat treatment and were driven uncoated were found to be more susceptible to corrosion than either the non-stabilized uncoated rivet or the non-stabilized rivet given the Alumilite treatment 205 (Figure 4).

Figure 4. Appearance of 2024 Aluminum Alloy Rivets in Bare 2024-T4 Aluminum Alloy Sheet after Exposure Indicated in Tidal Immersion at Harbor Island, North Carolina. X3.3

- a) Bare, 27 Months
- b) Bare, Stabilizing Heat Treatment, 15 Months
- c) Coated, Alumilite 205, 15 Months

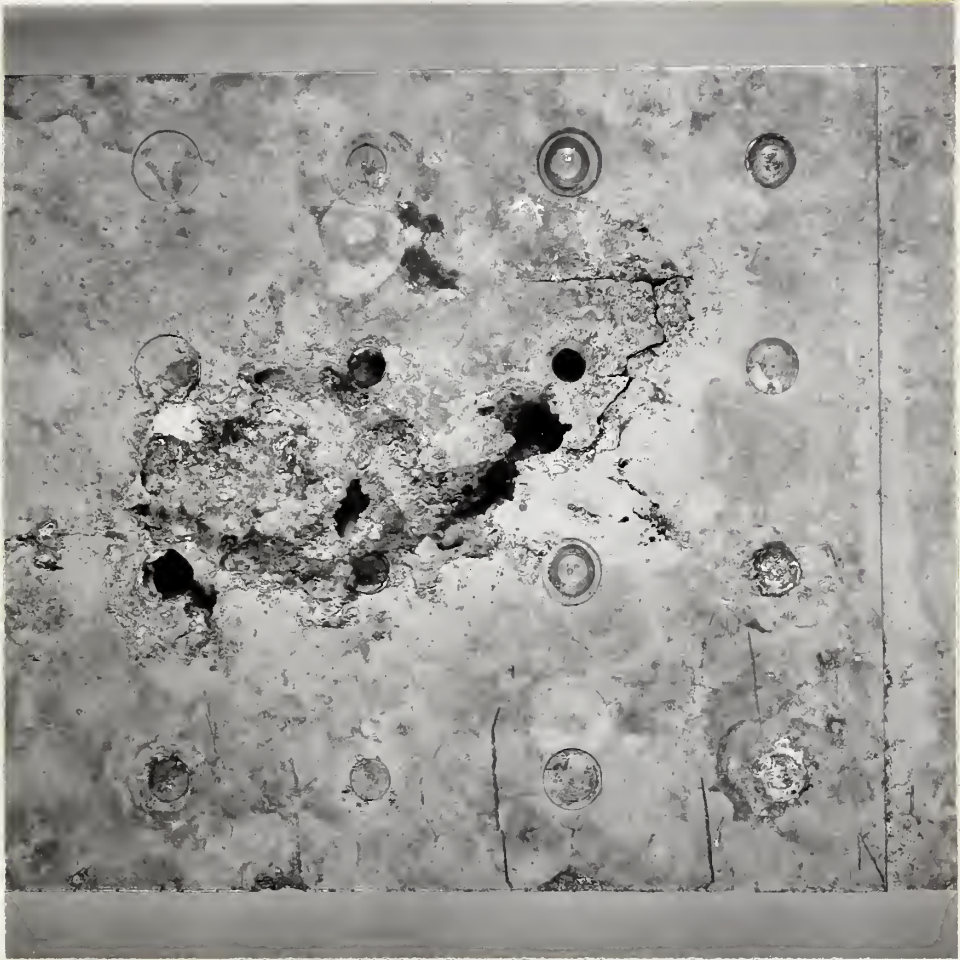
In general, the effects of coupling were less obvious on the clad material as compared to the unclad material. With the exception of the clad 2219-T6 aluminum alloy sheet material where pitted areas were noted adjacent to the anodized 2017 and the 2219 aluminum alloy rivets, the cladding appeared to substantially reduce the crevice corrosion at the faying surfaces of the aluminum alloy sheet materials. This is shown in Figures 5 and 6.

Figure 5. Appearance of Faying Surface of Bare 2024-T4 Aluminum Alloy Sheet after Exposure for 79 Months in Tidal Immersion at Harbor Island, North Carolina. X 1

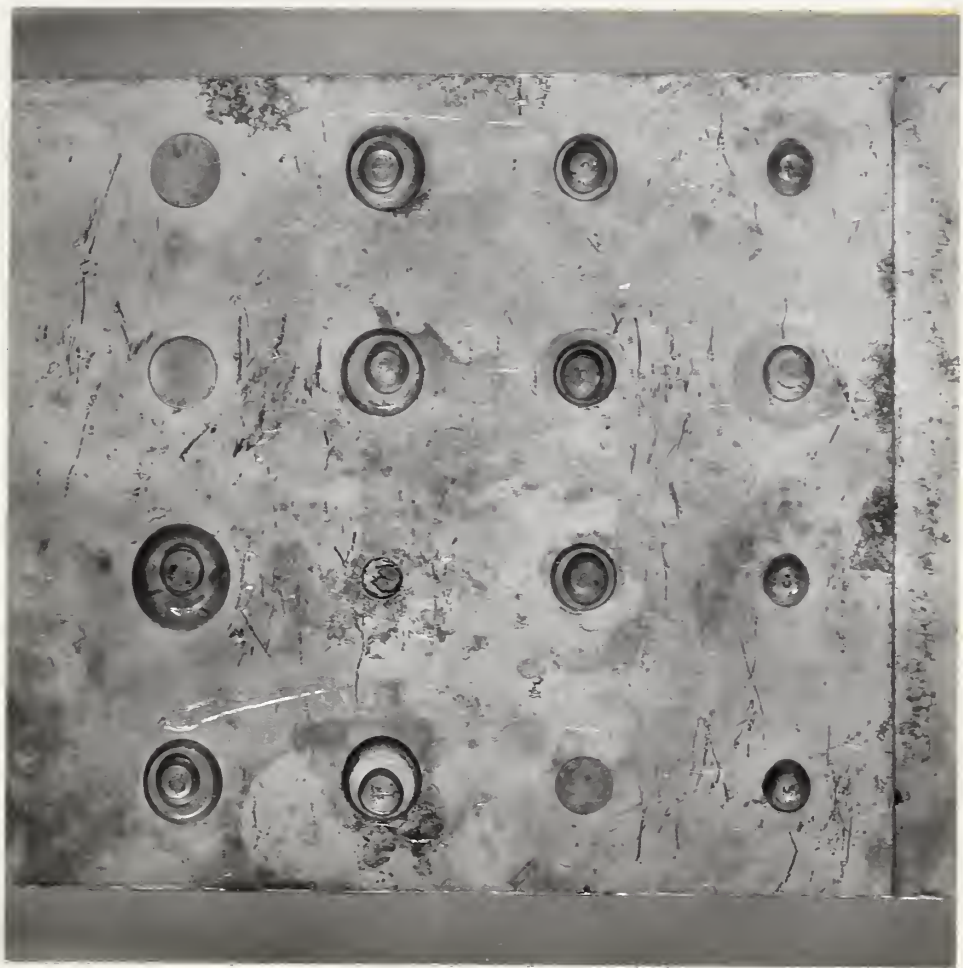
Figure 6 . Appearance of Faying Surface of Clad 2024-T4 Aluminum Alloy Sheet after Exposure for 79 Months in Tidal Immersion at Harbor Island, North Carolina. X 1
