NBSIR 73-135

Fire Endurance Tests of Steel Sandwich Panel Exterior Wall and Roof/Ceiling Constructions

December 1972

Final Report

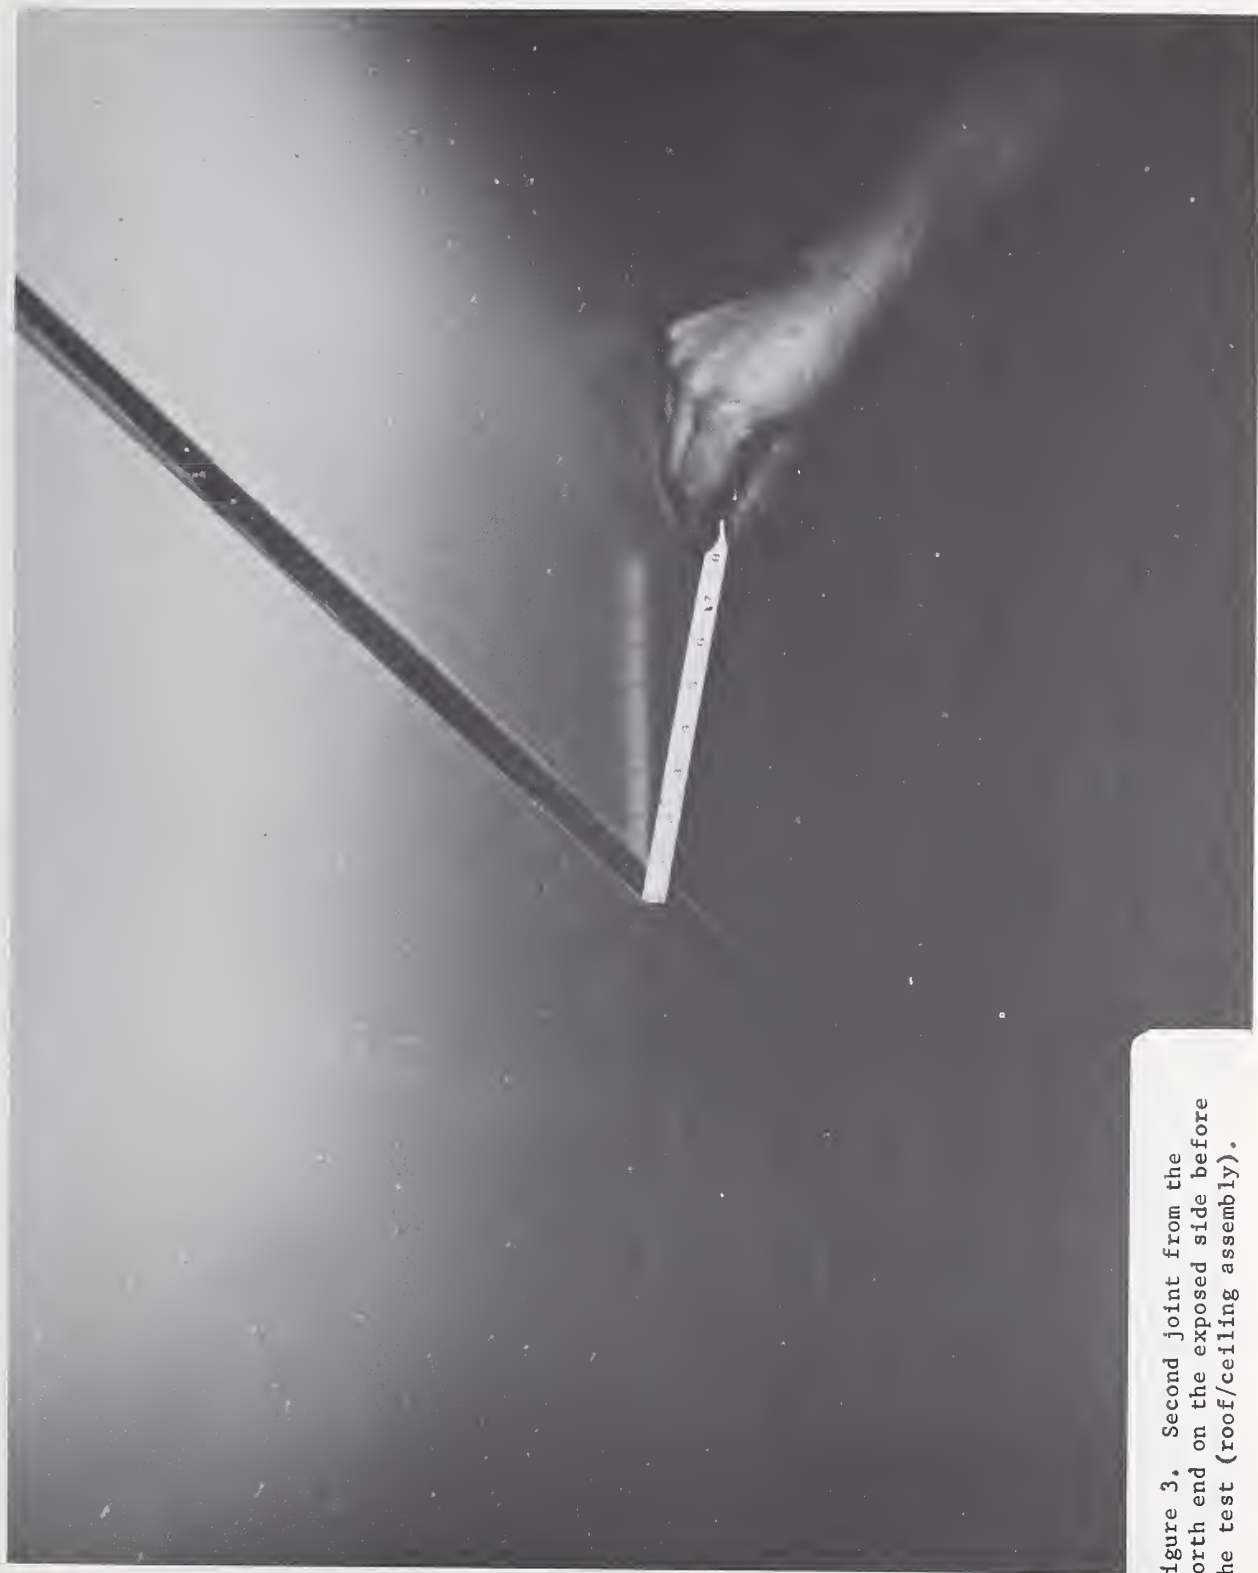
Figure 3. Second joint from the north end on the exposed side before the test (roof/ceiling assembly).

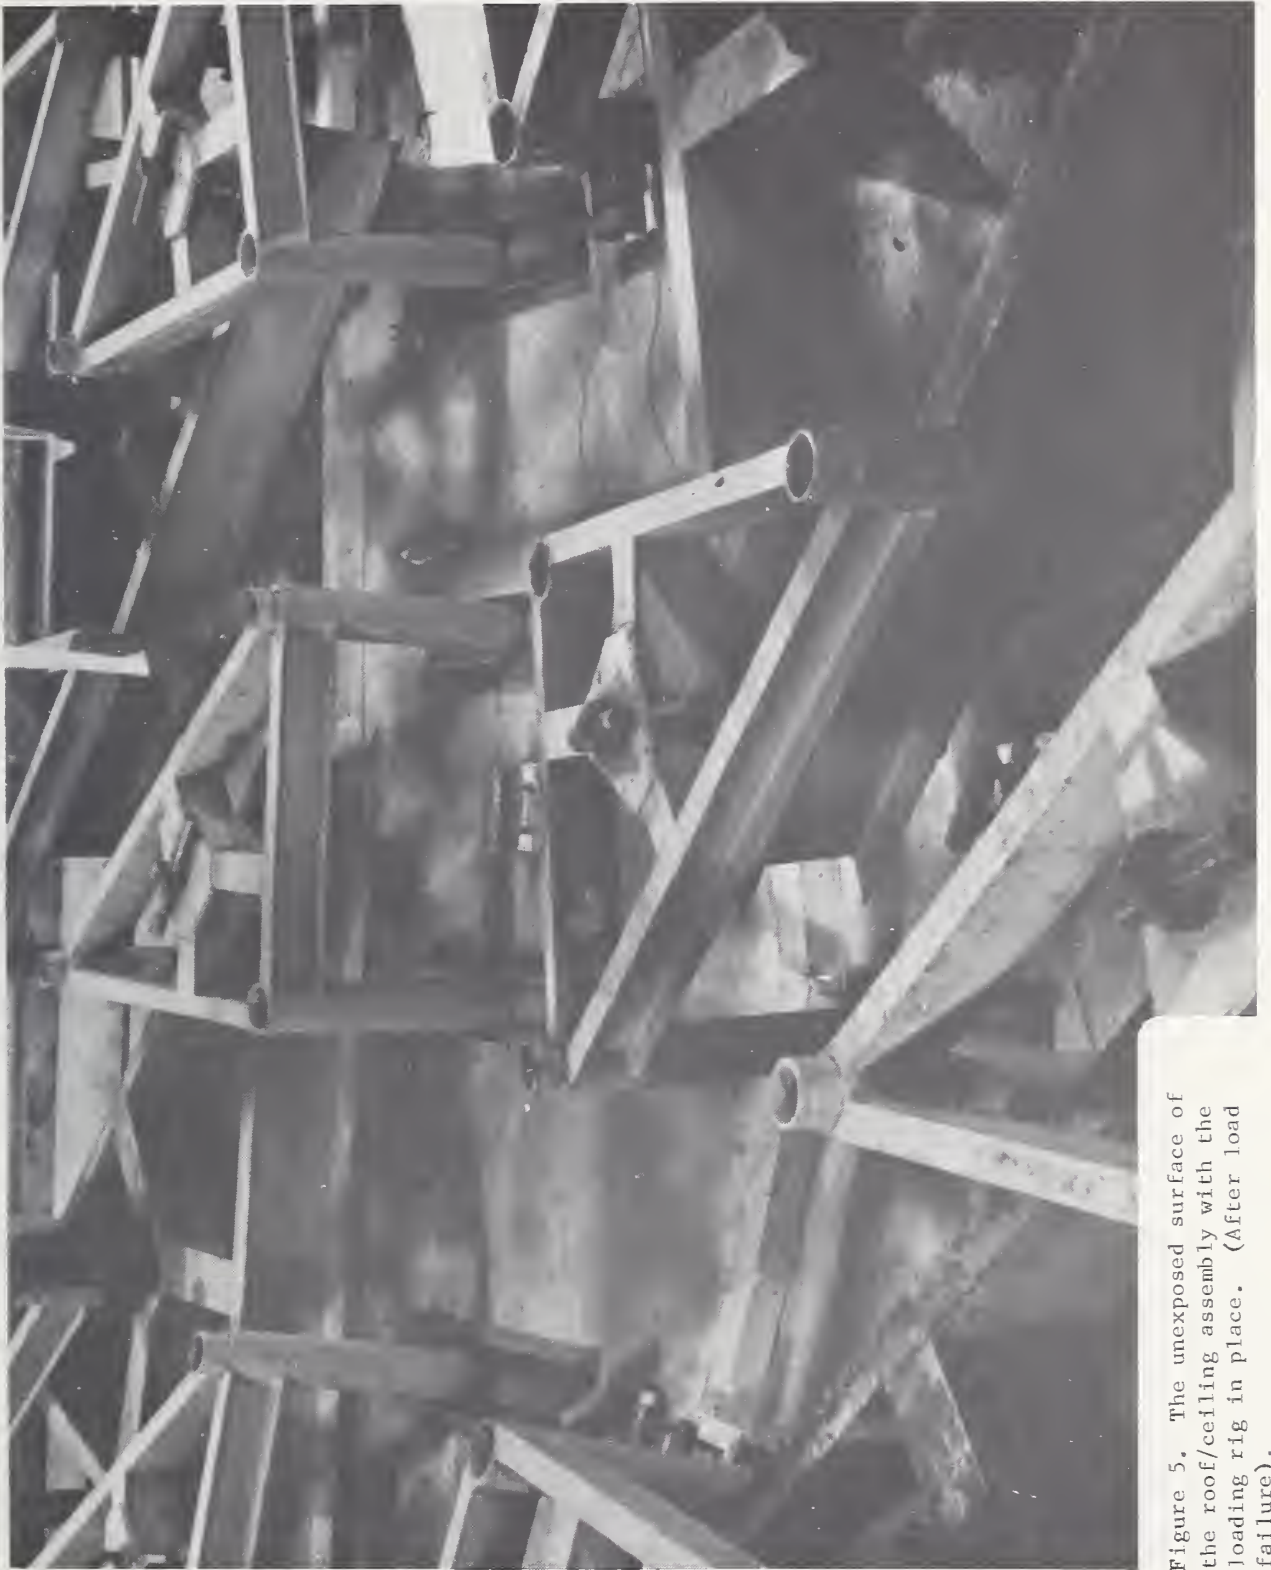
Figure 5. The unexposed surface of the roof/ceiling assembly with the loading rig in place. (After load failure).

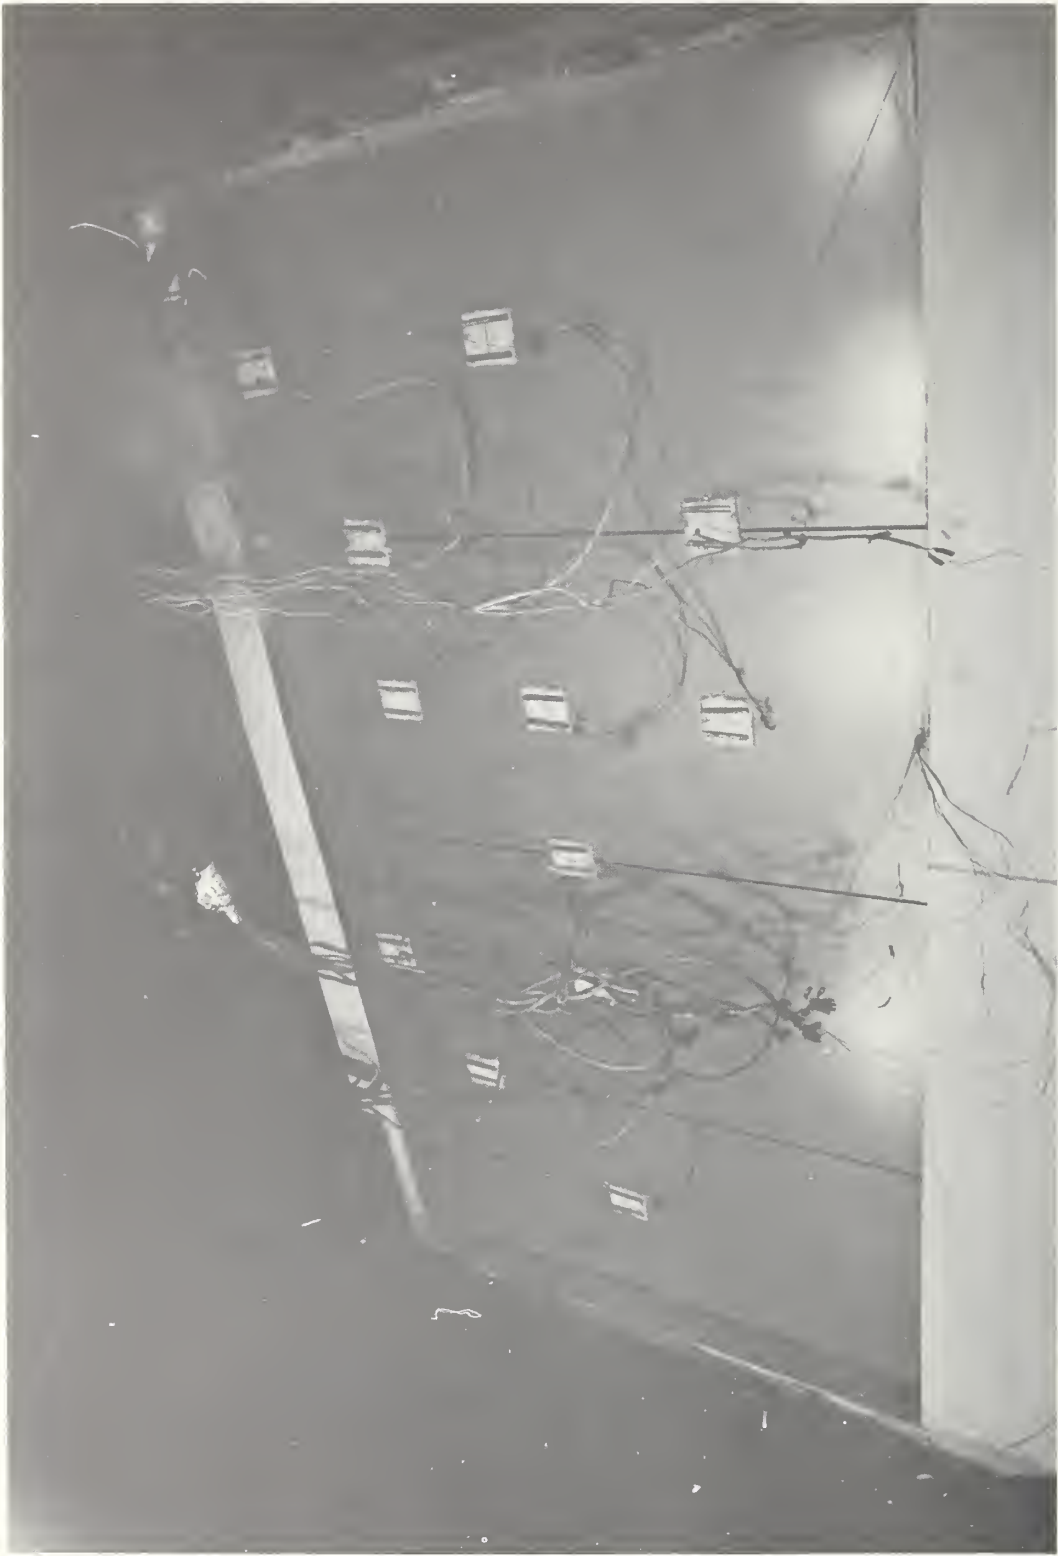
During the test, smoke appeared in the furnace almost at the beginning of the test, and by 2 min. it was seeping through to the unexposed side of the wall (Figure 14). Buckling of the exposed wall surface was observed at 2 1/2 min. At 5 min the smoke was of sufficient volume and density to largely obscure the surface (Figure 15). Flaming occurred on the exposed joints at 3 1/2 min, with extensive flaming by 8 min (Figure 16).

<u>Time</u> Min:Sec	<u>Observations</u>
0:00	Start of test.
2:00	Smoke appearing on top of the unexposed side of the panel. (Figure 14.) Cracking sound from back of the specimen.

Figure 14. Smoke appearing on top of the unexposed side of the wall. Test time of 2 min.

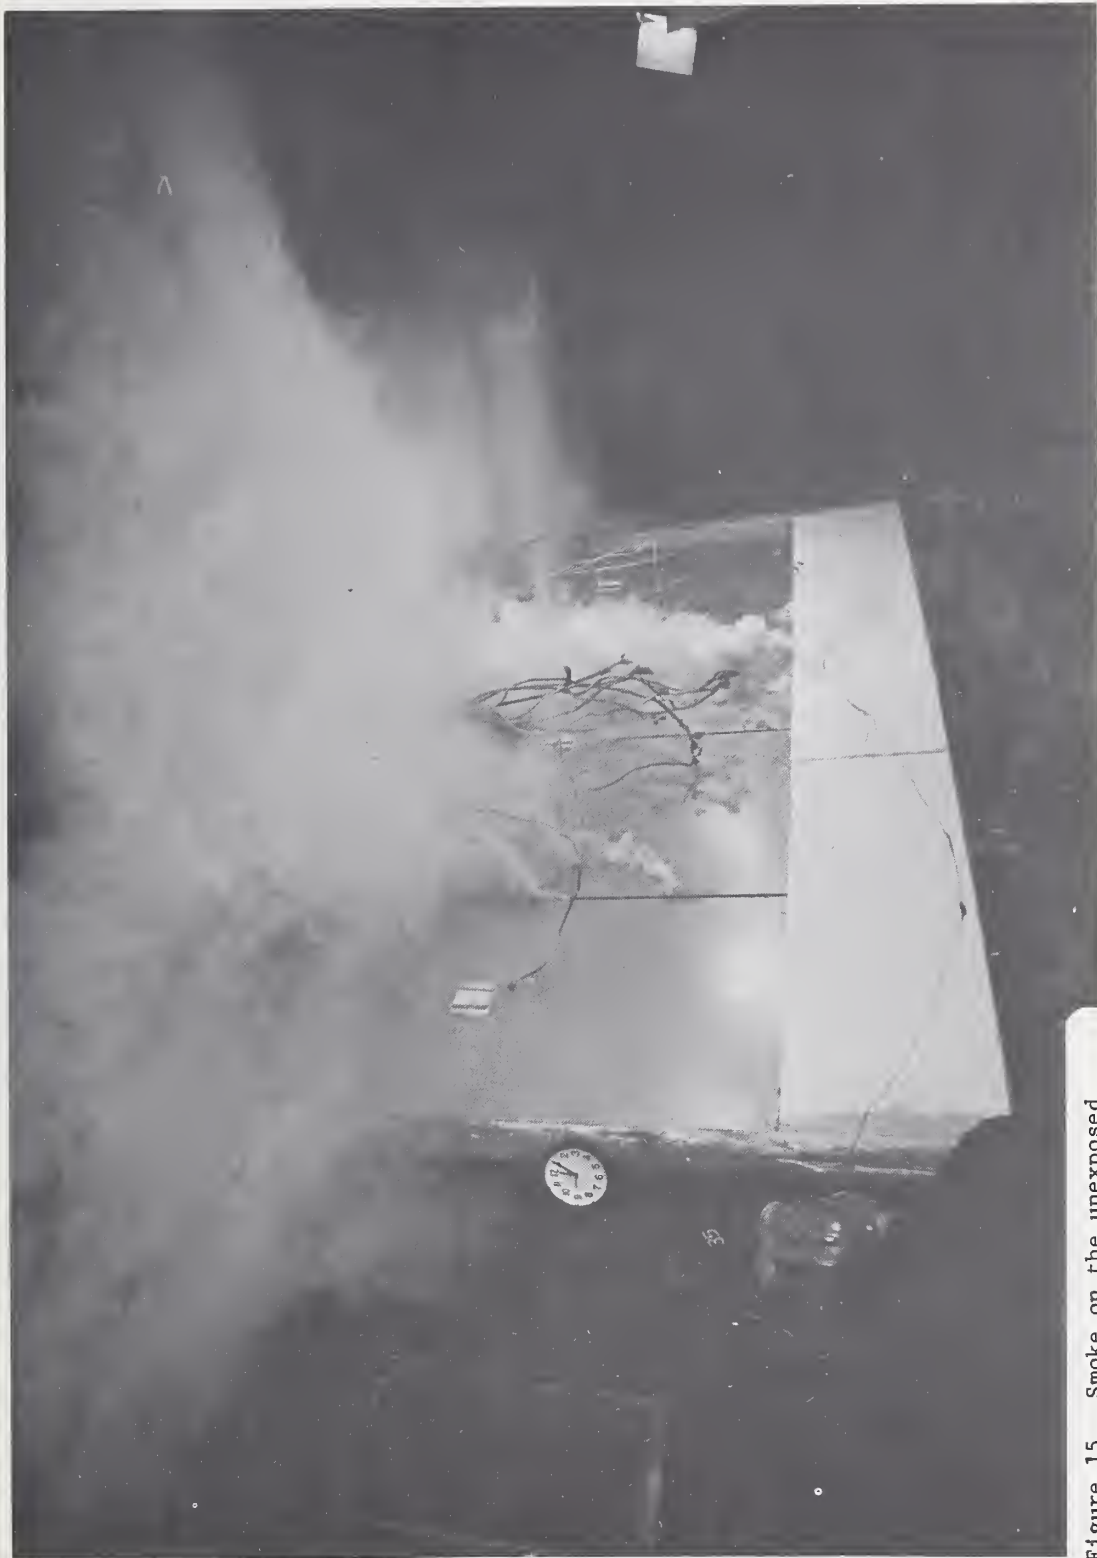
2:30	Exposed surface buckling.
3:30	Flames observed on the joints of the exposed surface.
4:00	Much black smoke filling the furnace.
5:00	Much gray dense smoke appearing on the unexposed side through joints and at the hole at the bottom of the second panel from the north end where the internal thermocouples came out. (Figure 15).

Figure 15. Smoke on the unexposed side of the wall. Test time of 5 min.

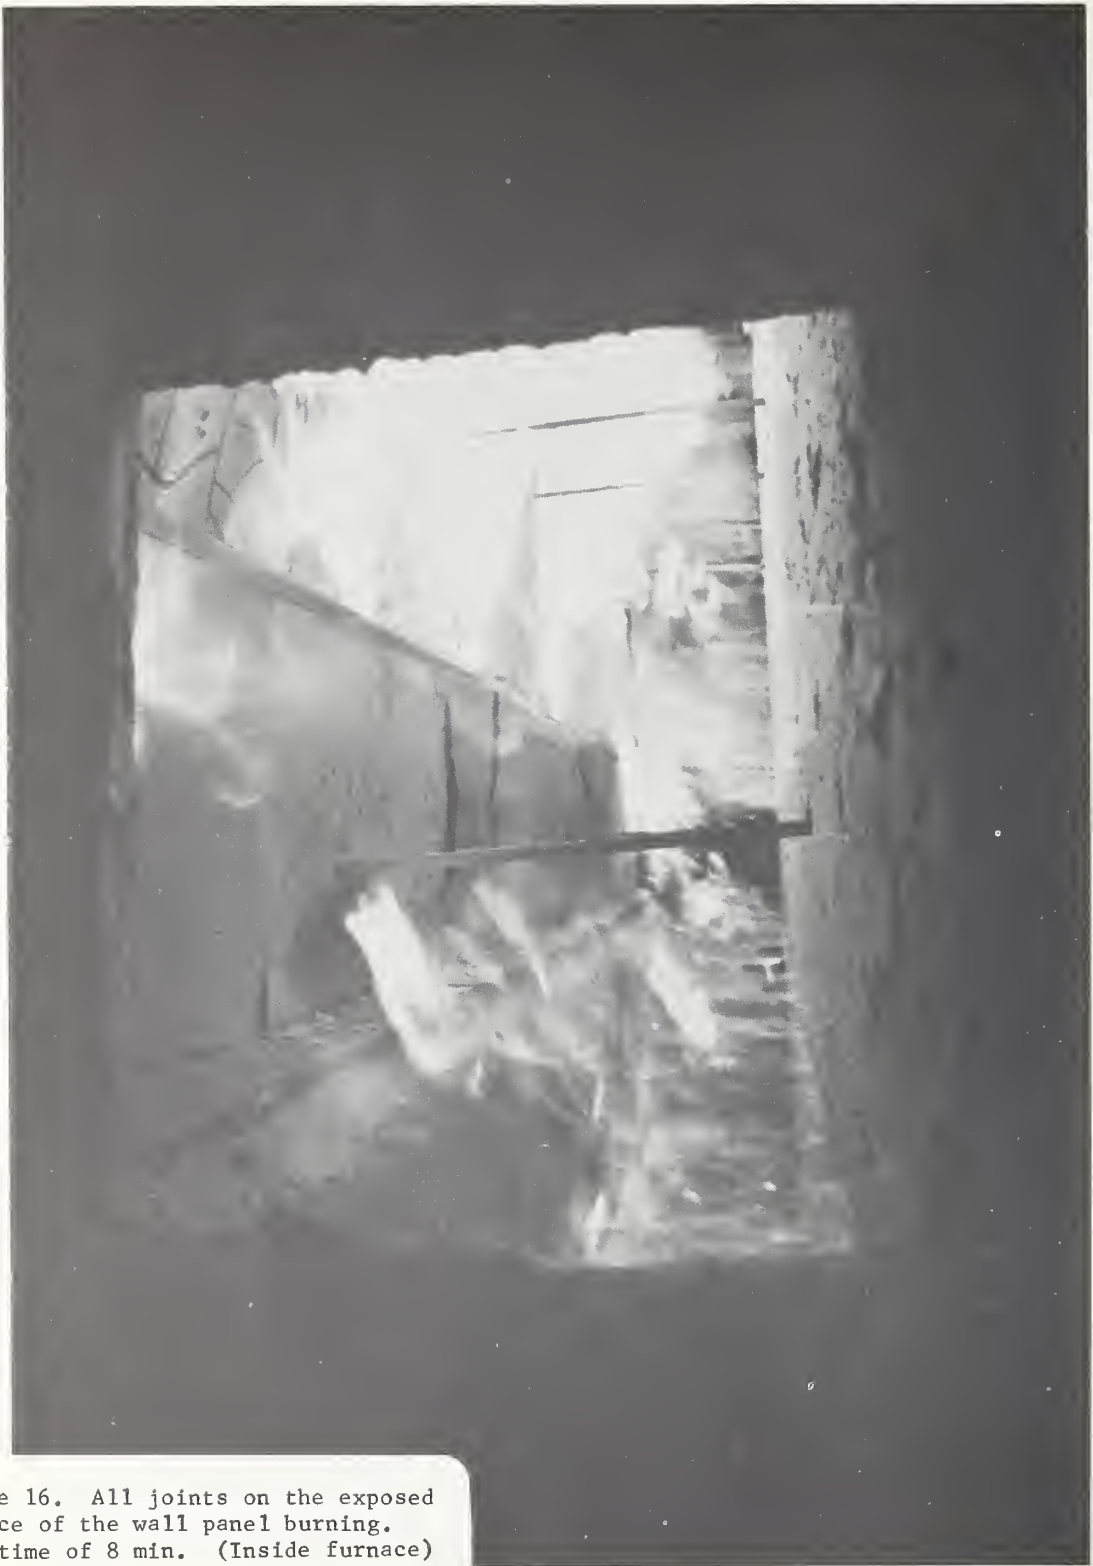
6:00	Smoke seemed to clear up.
8:00	All joints on the exposed surface flaming severely. (Figure 16 is a photograph taken through observations window.)
9:00	The color of the unexposed surface appearing to change from light buff to brown. An average temperature rise of 139°C above its initial temperature on the unexposed surface was observed.

Figure 16. All joints on the exposed surface of the wall panel burning. Test time of 8 min. (Inside furnace)

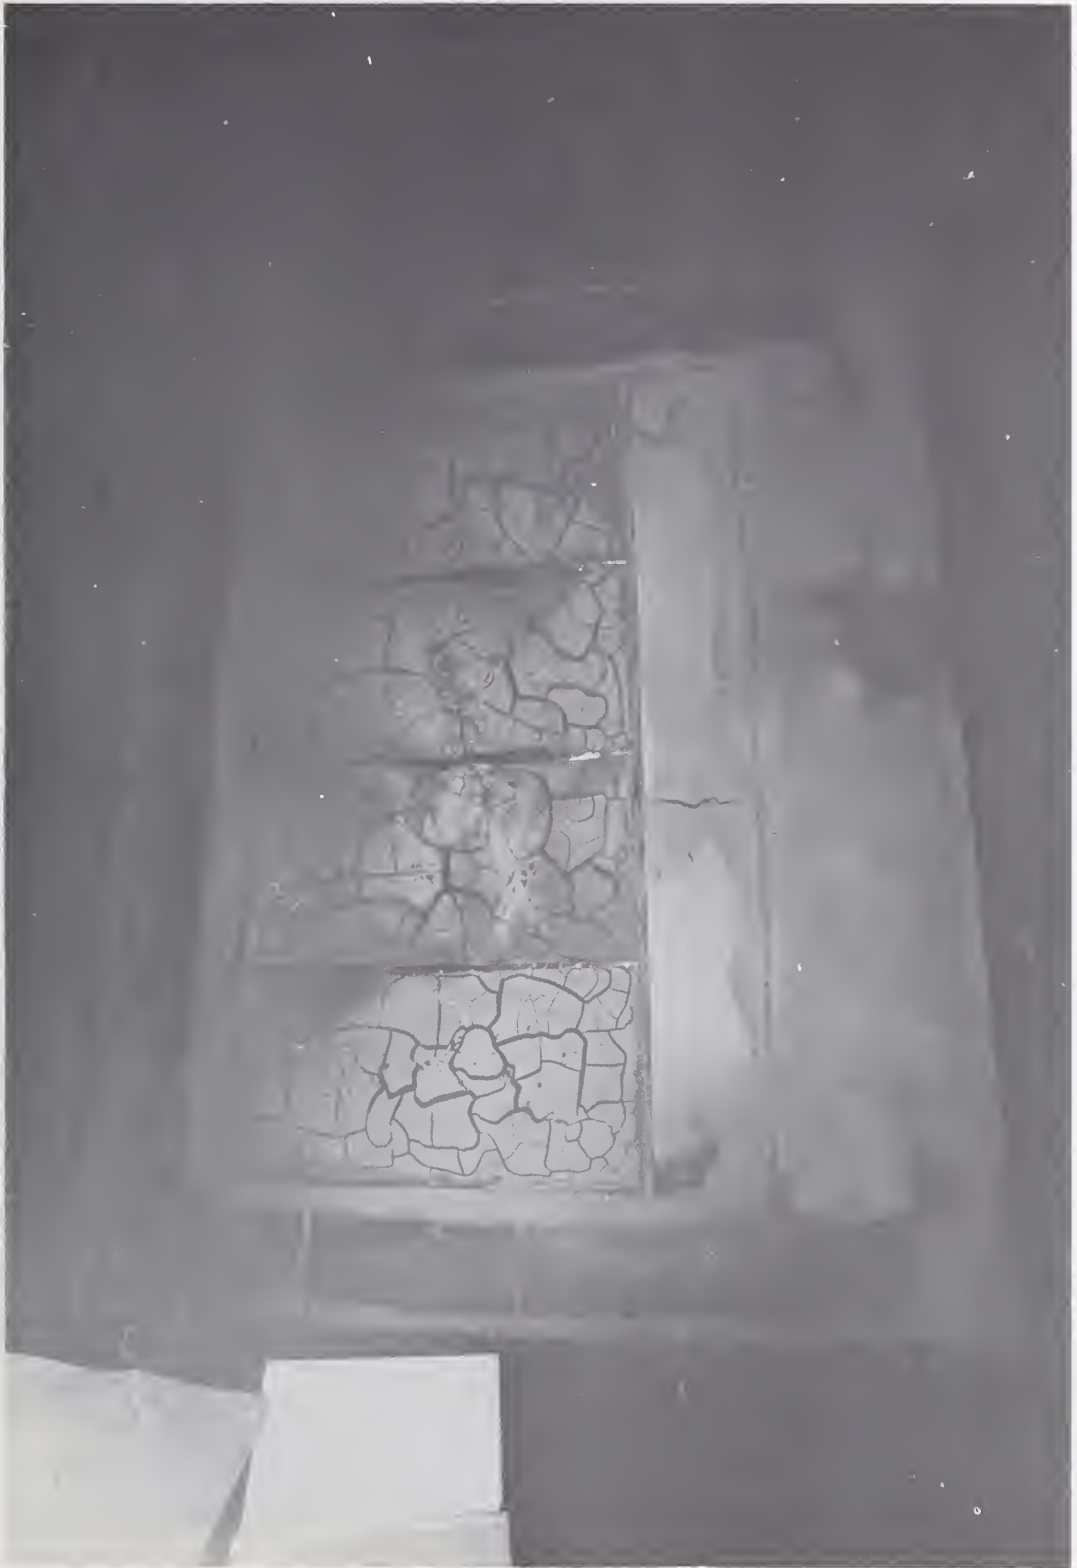
Figure 17 is a photograph showing the fire side of the panel after it was removed from the furnace just before extinguishment of the fire. Surfaces were buckled and most of the wood members, paper honeycomb, and polyurethane foam were consumed.

Figure 17. The fire side of the wall panel after it was removed from the surface just before extinguishment of the fire.

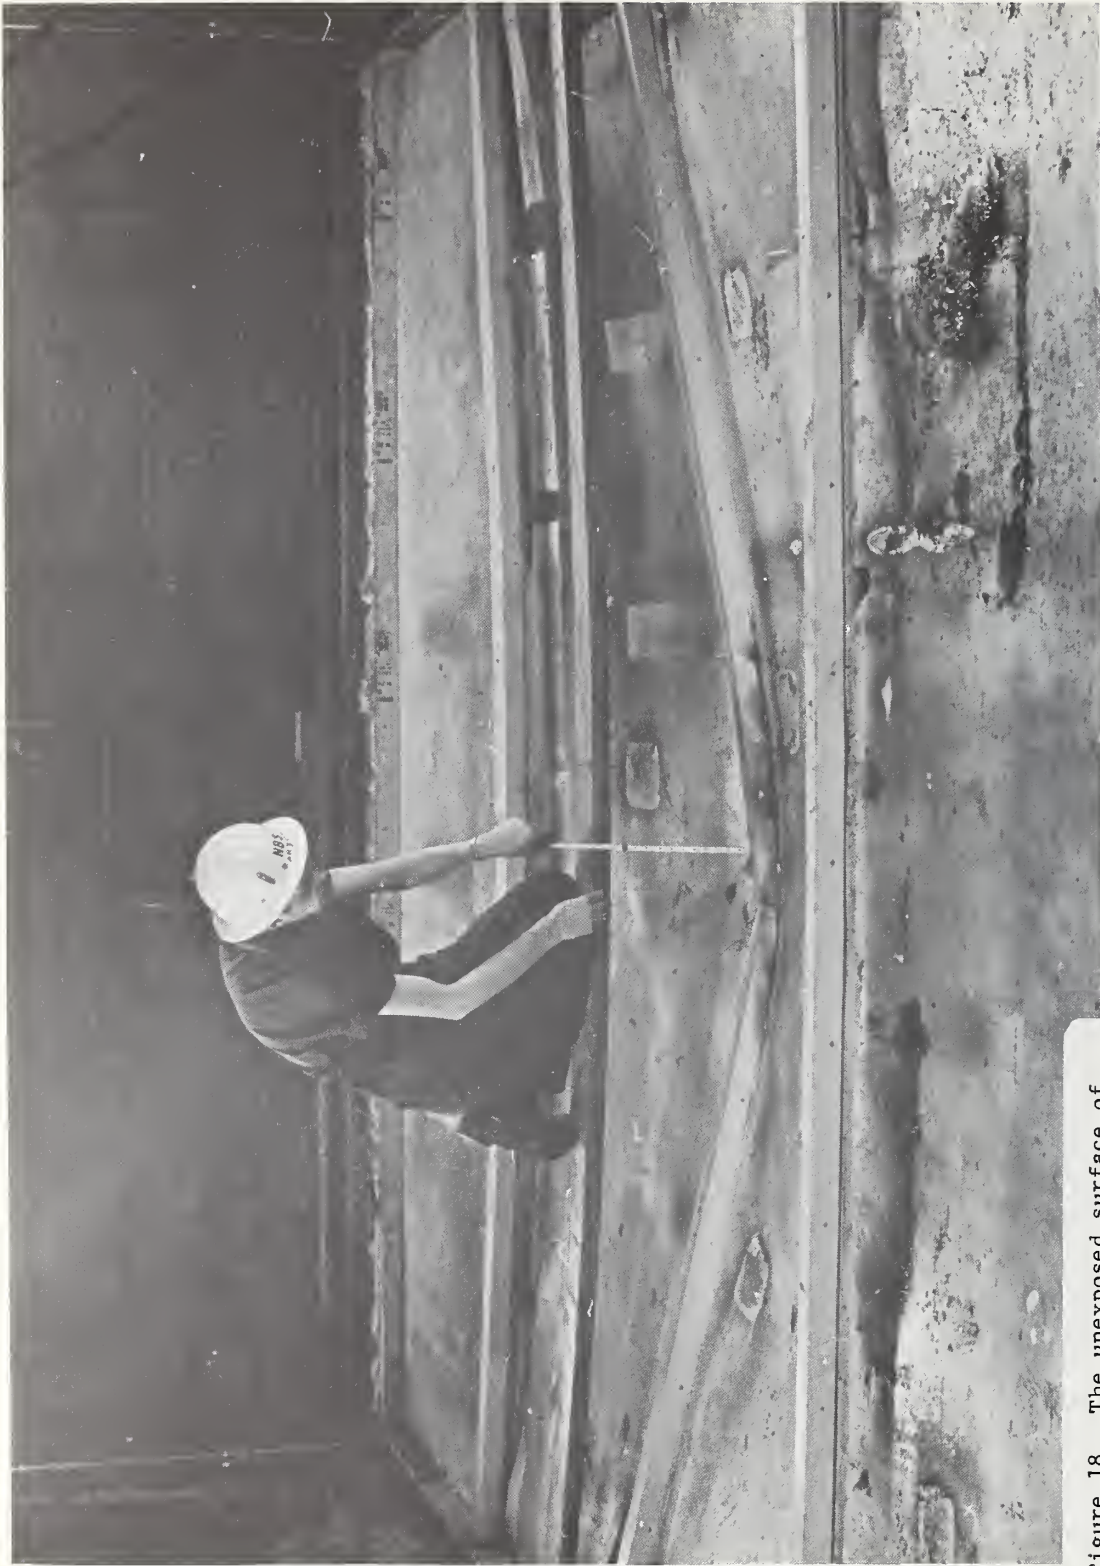
For the roof/ceiling assembly, the fire endurance time was 9 min:09 sec with failure by maximum temperature rise on the unexposed surface (rise of 325°F or 181°C). This was corrected from 8 min:30 sec observed because of excessive furnace temperatures. Deflections showed a steady increase until the occurrence of a sudden failure to withstand the applied load at 17 min at the joint nearest the center of the specimen (Figures 18 and 19).

The photographs in Figures 18 and 19 show the unexposed surface of the assembly after the loading rig was removed and the exposed surface at the failed joint, respectively, at the end of the test.

Figure 18. The unexposed surface of the roof/ceiling assembly after the loading rig was removed at the end of the test.

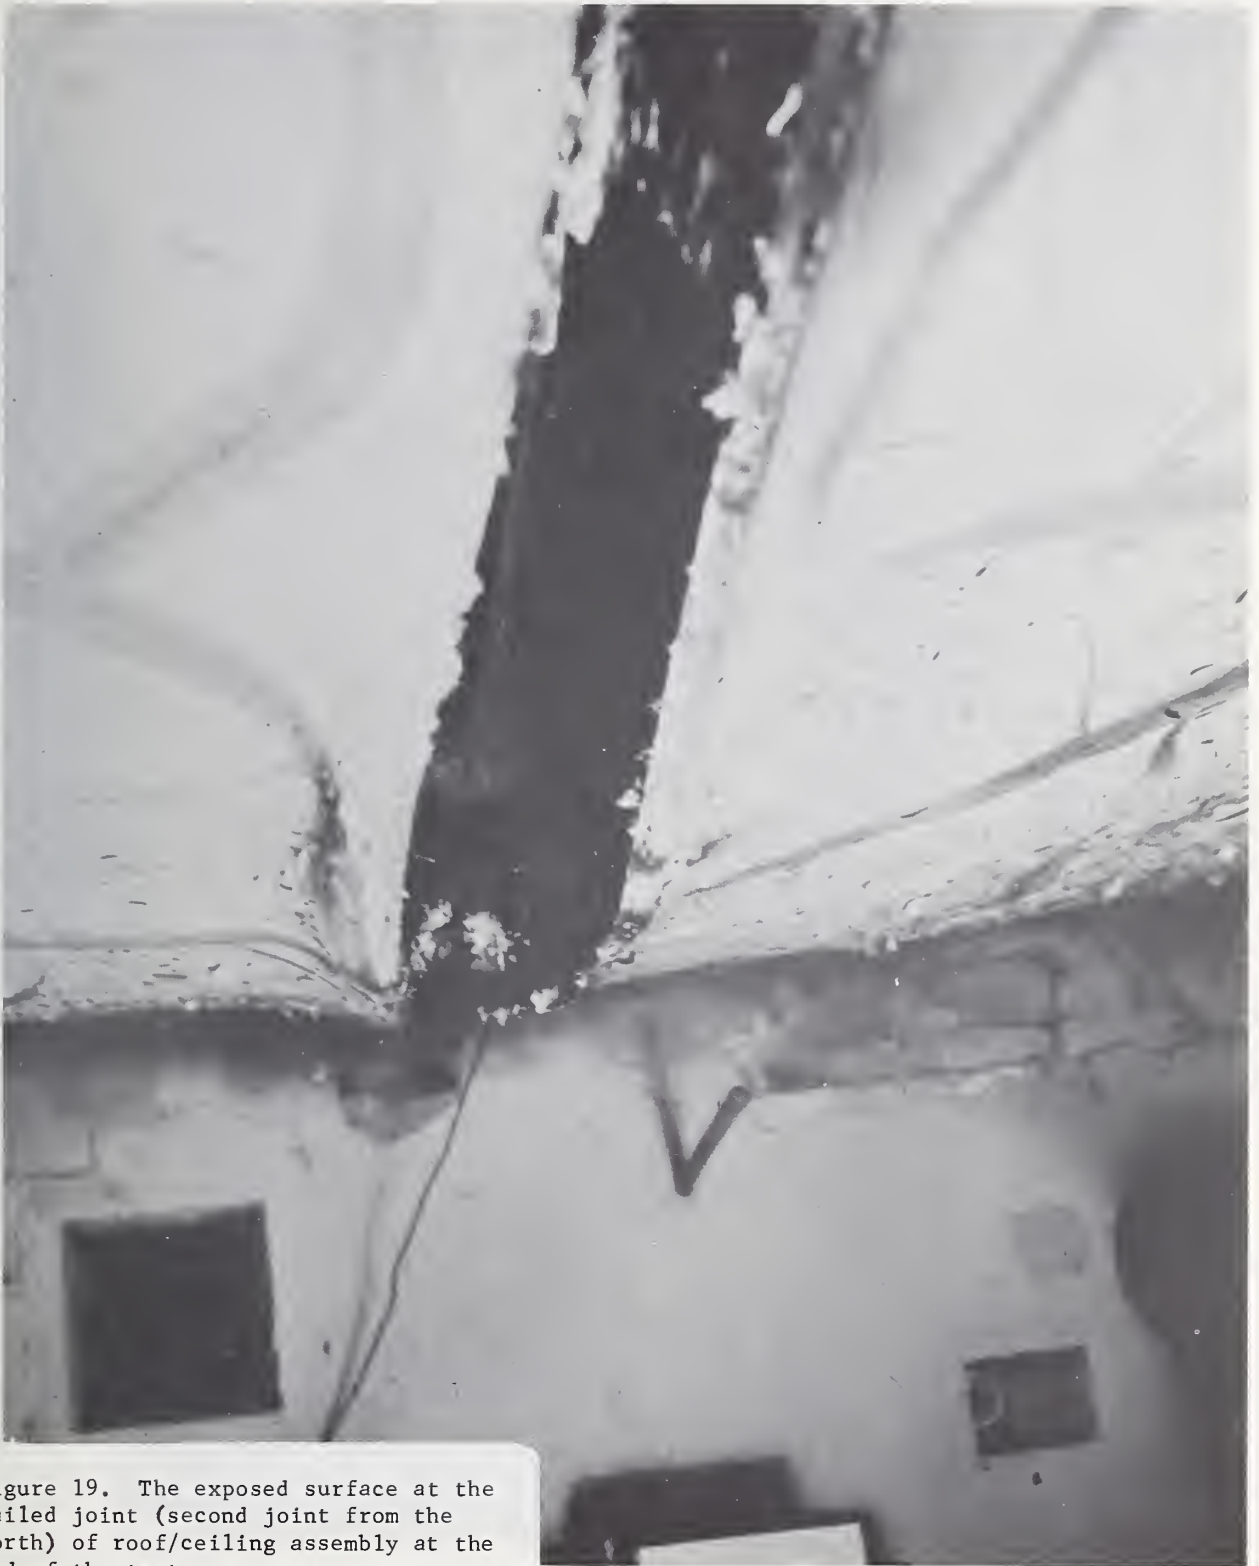
Although most of the wood members and polyurethane foam was consumed during the test and the paper honeycomb was charred and delaminated from the bottom facing, it was not necessary to apply any extinguishment agent after the test. All of the exposed joints had opened up and the failed joint showed the maximum opening of 4-1/4 inch (figure 19) compared with 11/16 inch (Figure 13) before the test.

Figure 19. The exposed surface at the failed joint (second joint from the north) of roof/ceiling assembly at the end of the test.

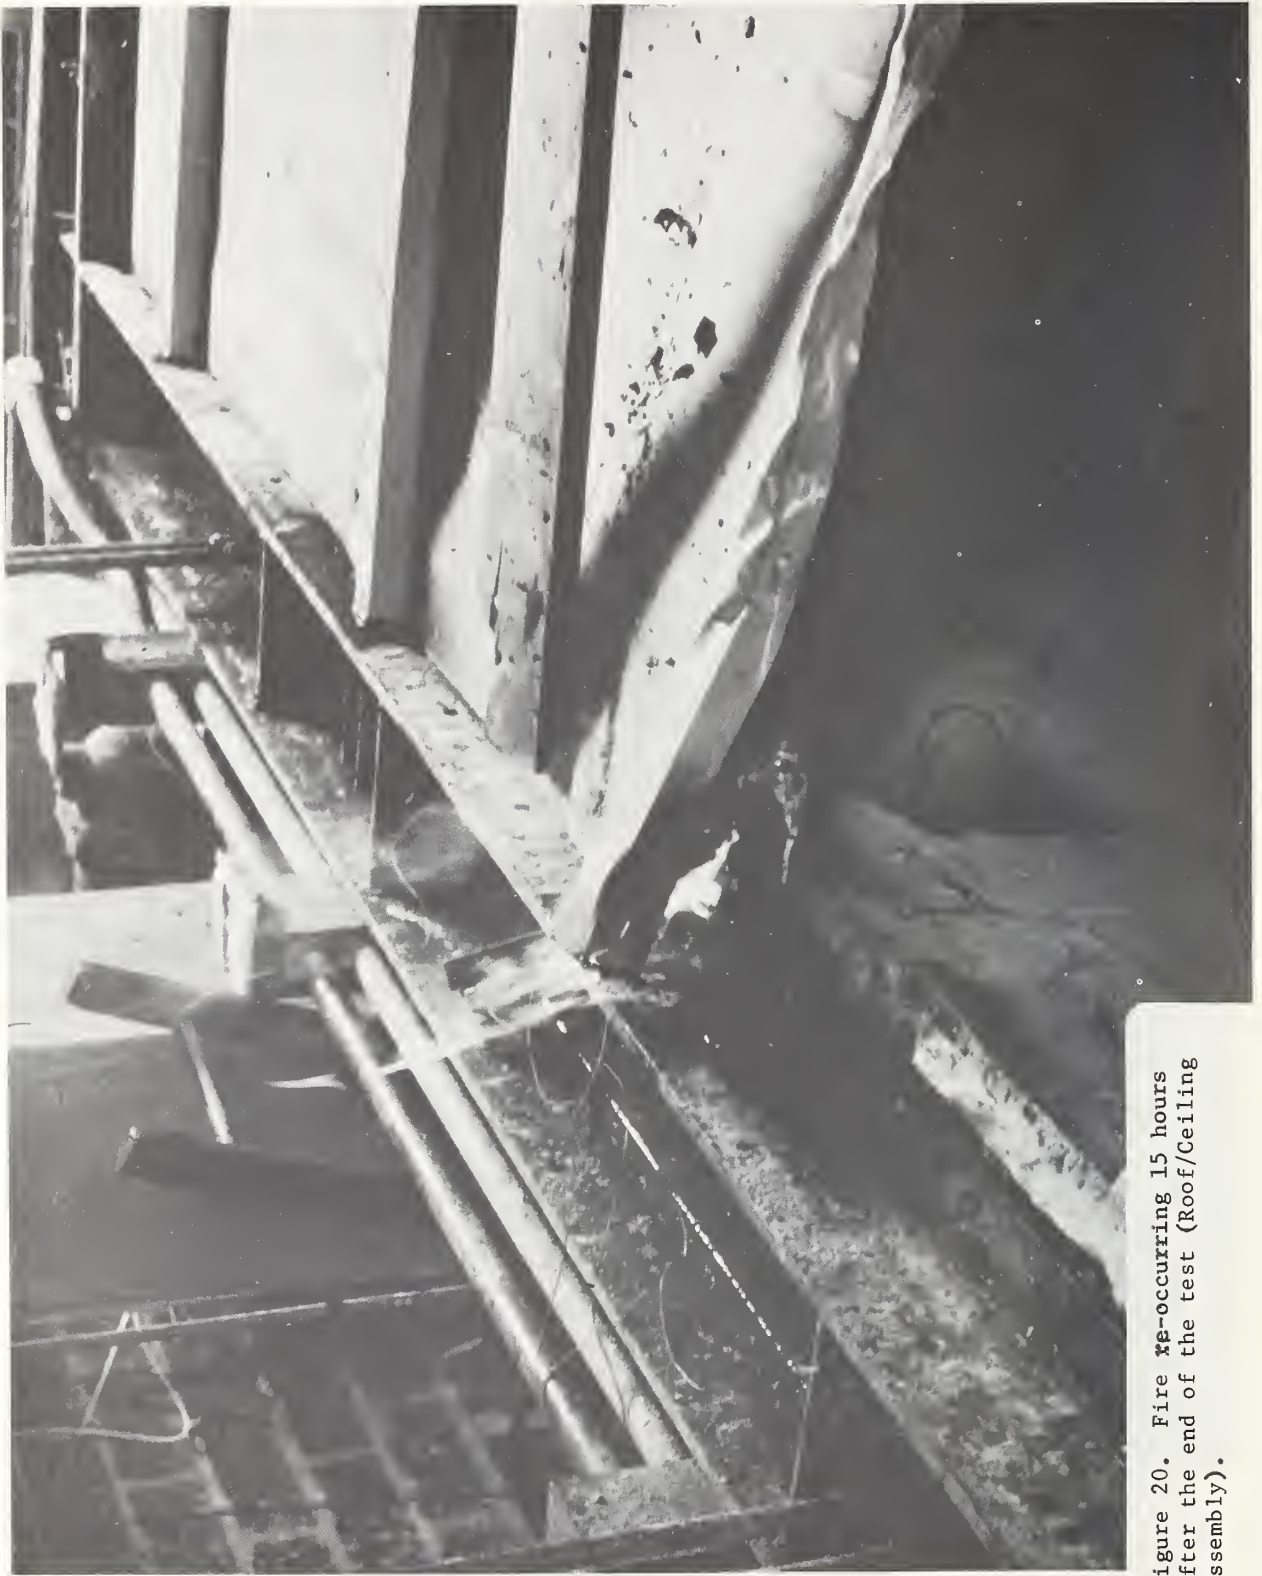
When the specimen was being demantled 15 hours after the end of the test, some flaming occurred at the east end of the second joint from the north end to a height of several feet (Figure 20).

Fifteen hours after the end of the test, the specimen, when it was dismantled, burst into flame at the east end of the second joint from the north end. The height of flame was approximately 3 ft. (See Figure 20.)

Figure 20. Fire occurring 15 hours after the end of the test (Roof/Ceiling Assembly).
