NBSIR 73-141

Fire Endurance Tests of Plywood on Steel Joist Floor Assemblies, With and Without Ceiling

(Test Numbers 492, 497)

Final Report

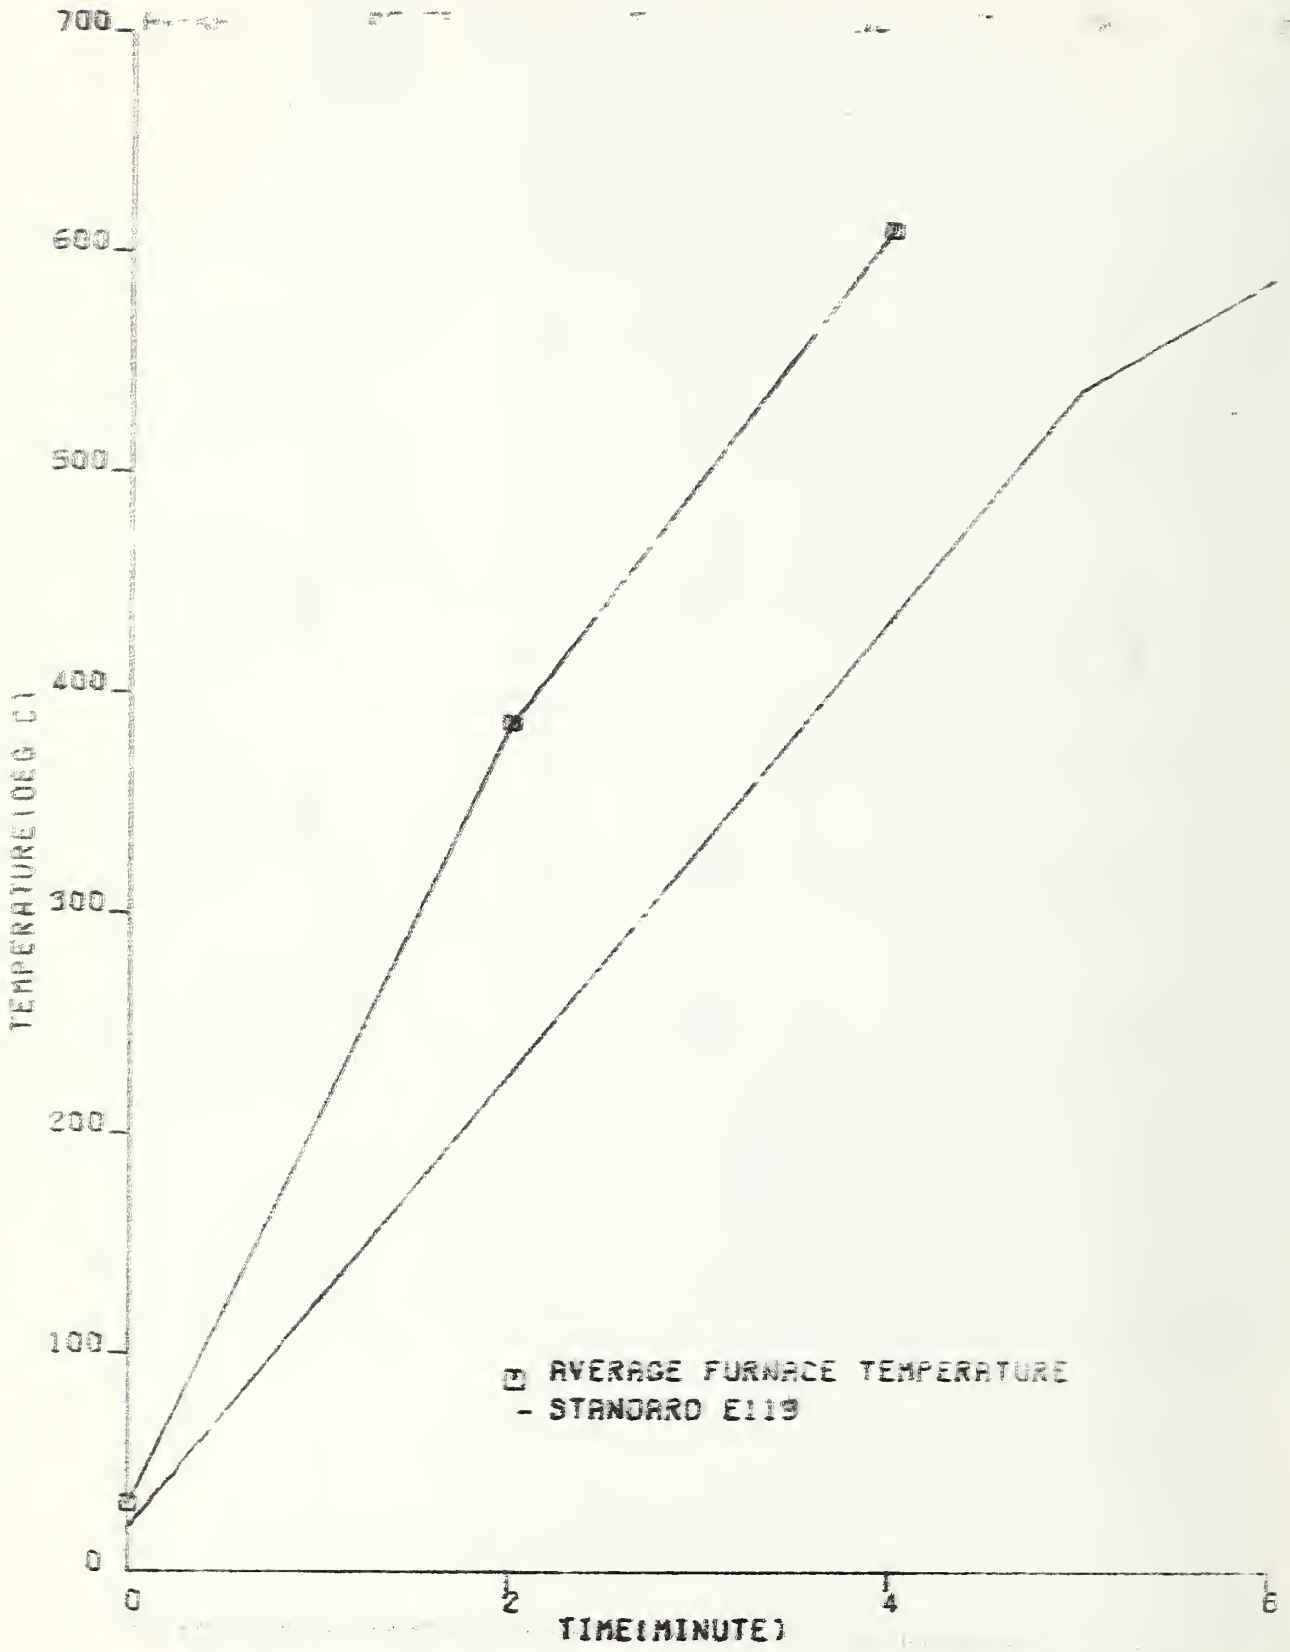
Figure 9 - FLOOR OVER FOUNDATION SPACE - AVERAGE FURNACE TEMPERATURE COMPARED WITH STANDARD E 119 CURVE

The ASTM E 119 fire test standard requires compensation for fire exposures deviating from the standard time-temperature relation only if indicated failure times are 1/2-hr. or greater. As the fire exposure severity in this case was appreciably greater than that required by the standard (figure 9), it was appropriate to apply corrections for the times to the two modes of failure despite their brevity. Applying these corrections estimates to the results, the end point times become 3 min. 30 sec. and 4 min. 5 sec. for flame through and failure to sustain load, respectively.

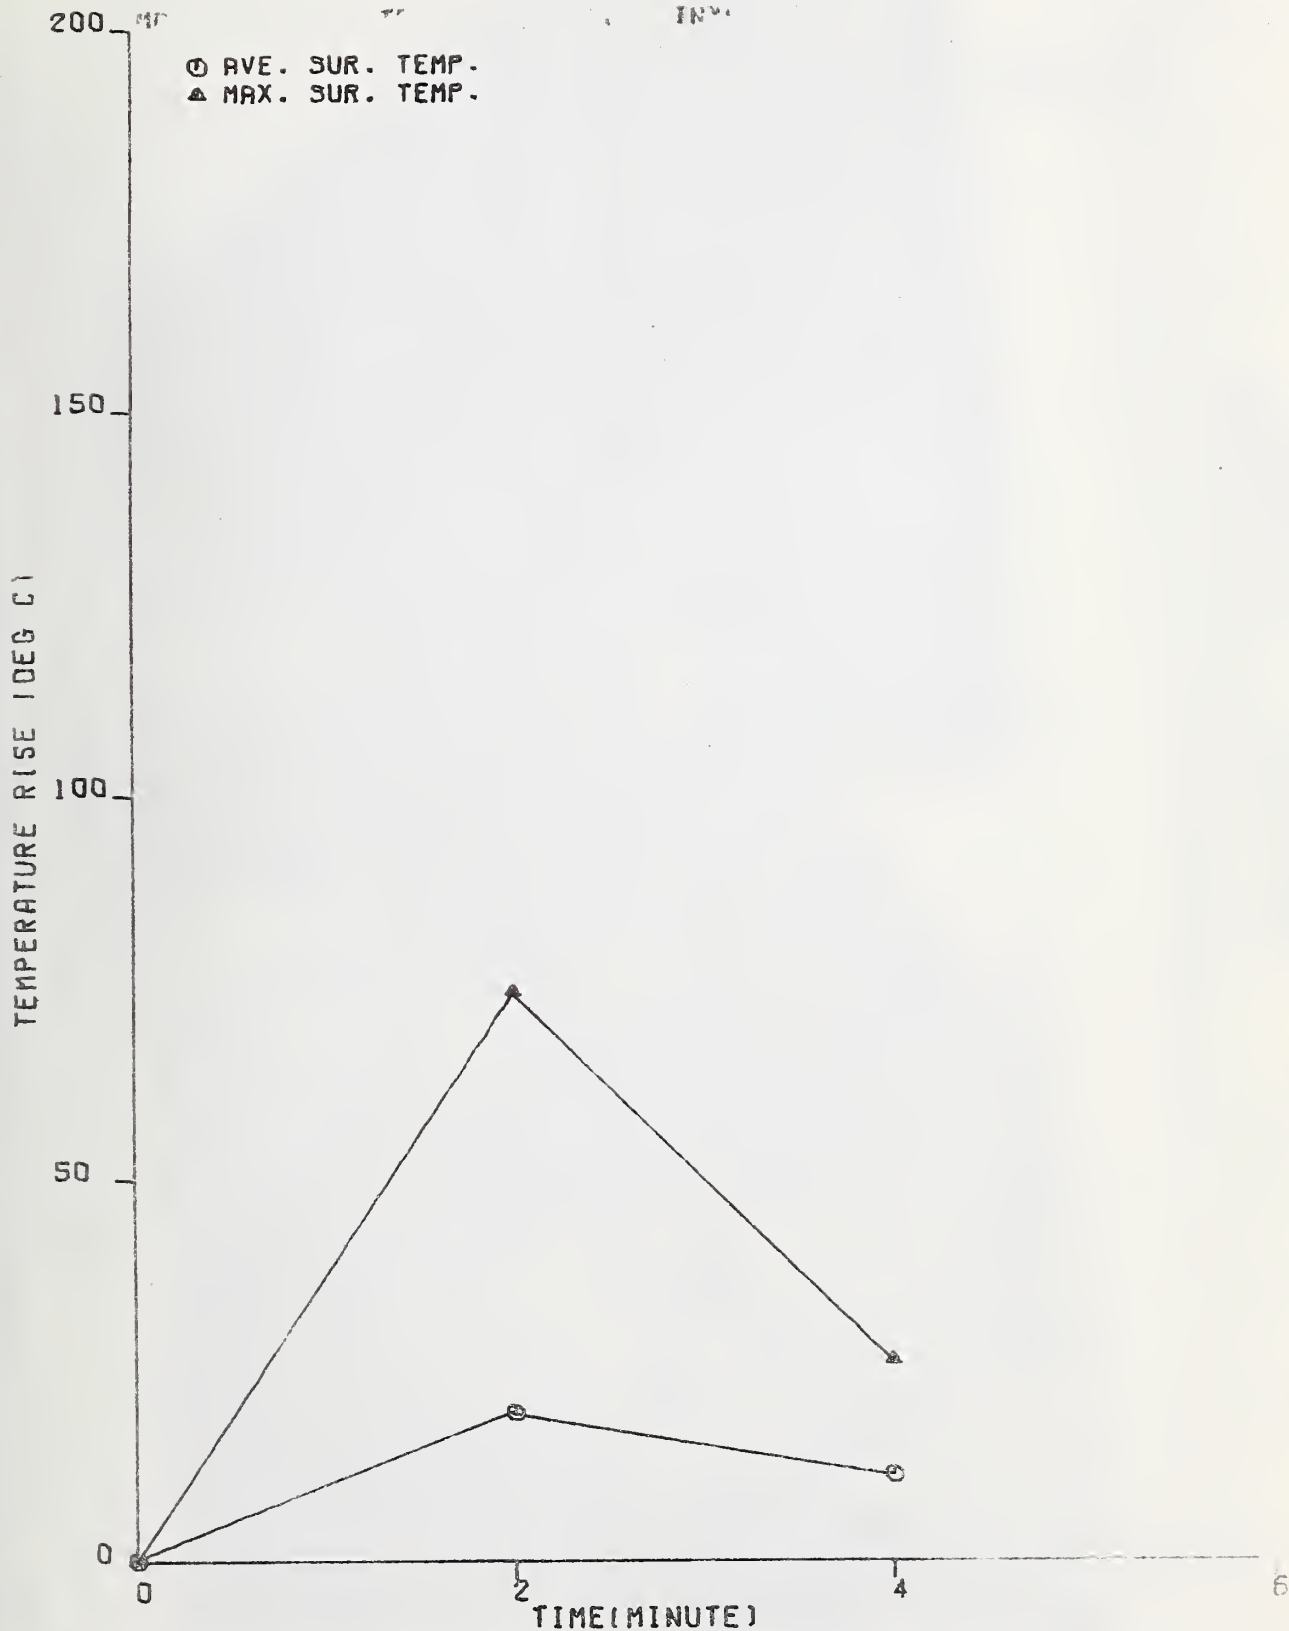
Figure 10 - FLOOR OVER FOUNDATION SPACE - MAXIMUM AND AVERAGE TEMPERATURE RISE OVER VINYL ON THE UNEXPOSED SURFACE

Maximum and average temperature rises on the unexposed surface (over vinyl floor covering, figure 10; over carpeting, figure 11) were low, and did not approach the limits defining failure by transmission of heat. The recorded data indicated little or no effect of the flame penetration, probably because this occurred at one end of the floor, somewhat away from the thermocouples.

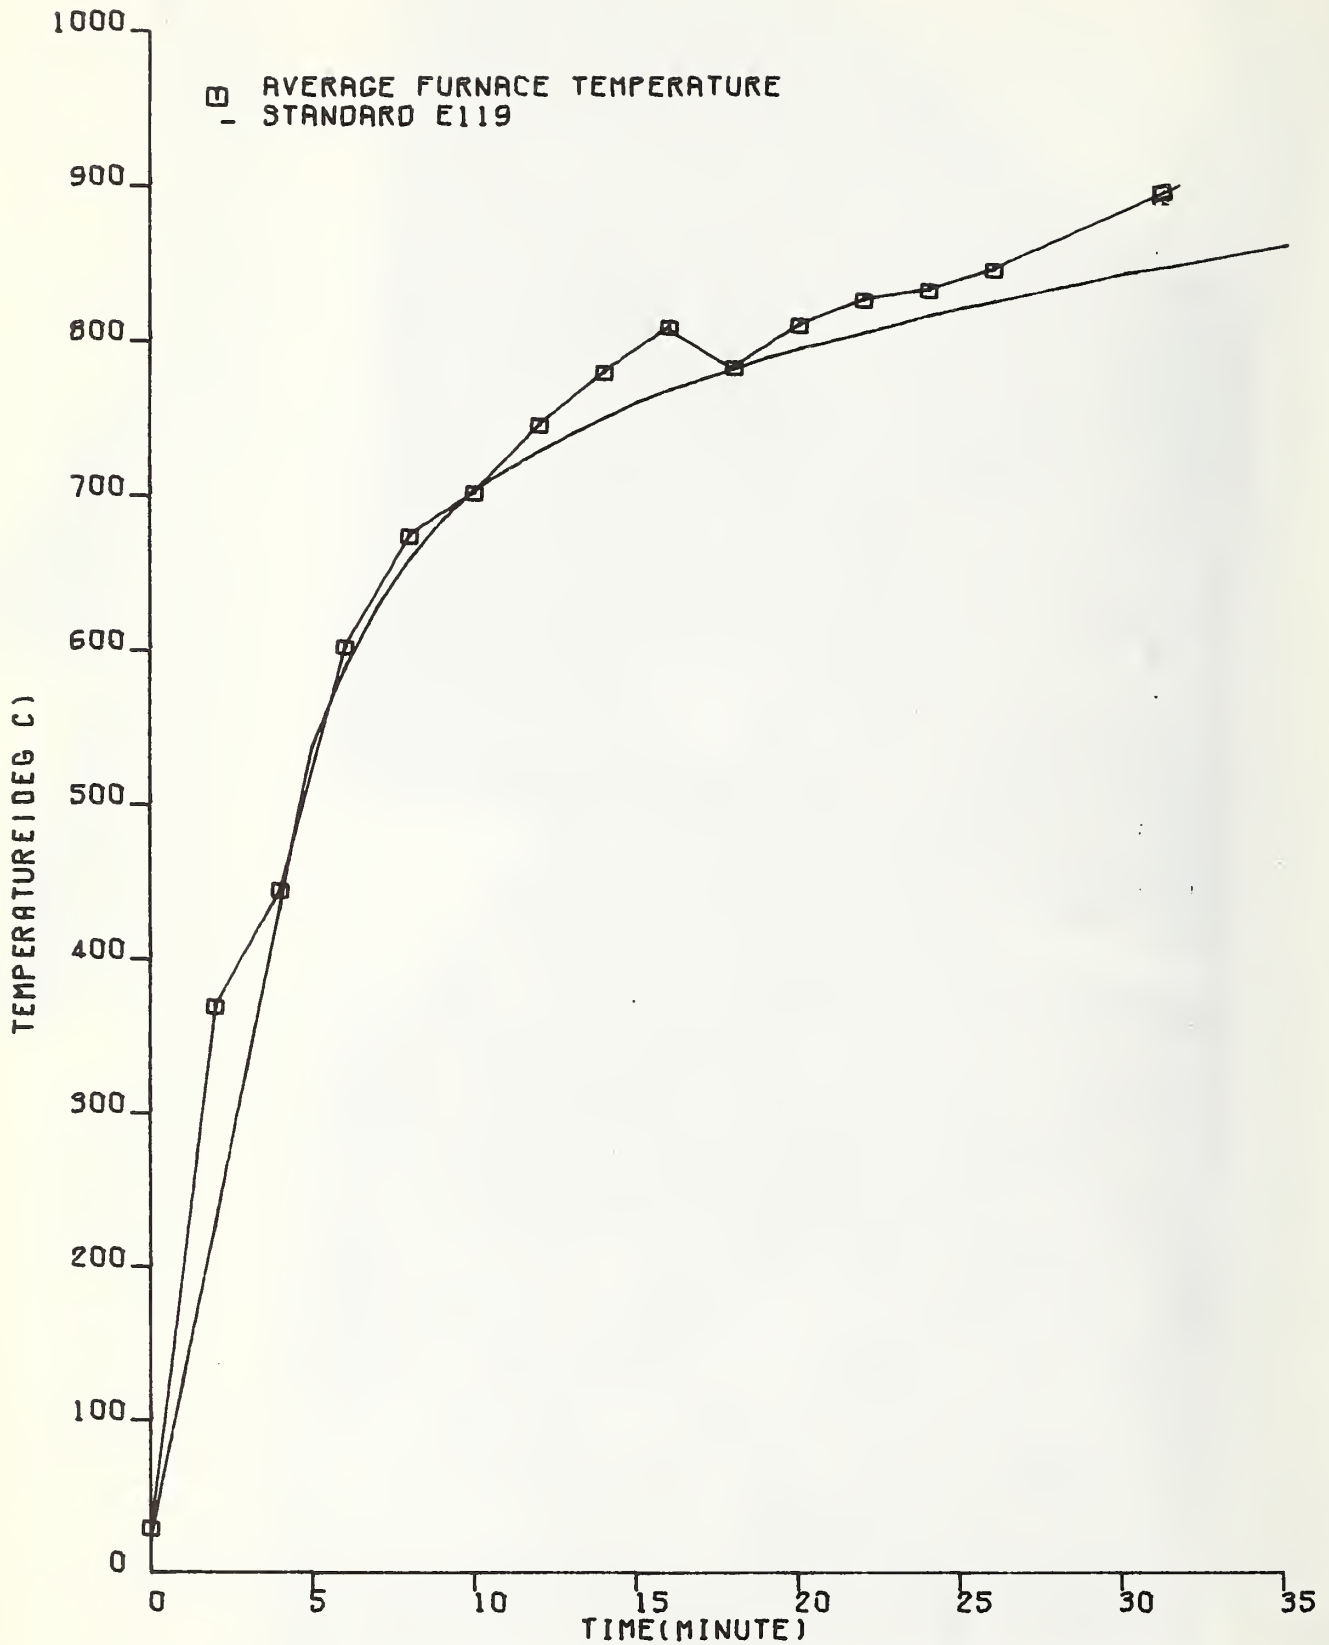
Figure 13 - FLOOR-CEILING ASSEMBLY - AVERAGE FURNACE TEMPERATURE COMPARED WITH STANDARD E 119 CURVE,

For the floor-ceiling assembly, failure occurred at 29 min. after start of the test by passage of flame through to the unexposed surface. At 33 min., local collapse of the assembly was observed at the end away from the ductwork and diffusers. As can be seen in figure 13 the actual fire exposure severity was slightly greater than that specified in the

standard and a correction of approximately 1 min. should be added to the noted failure.

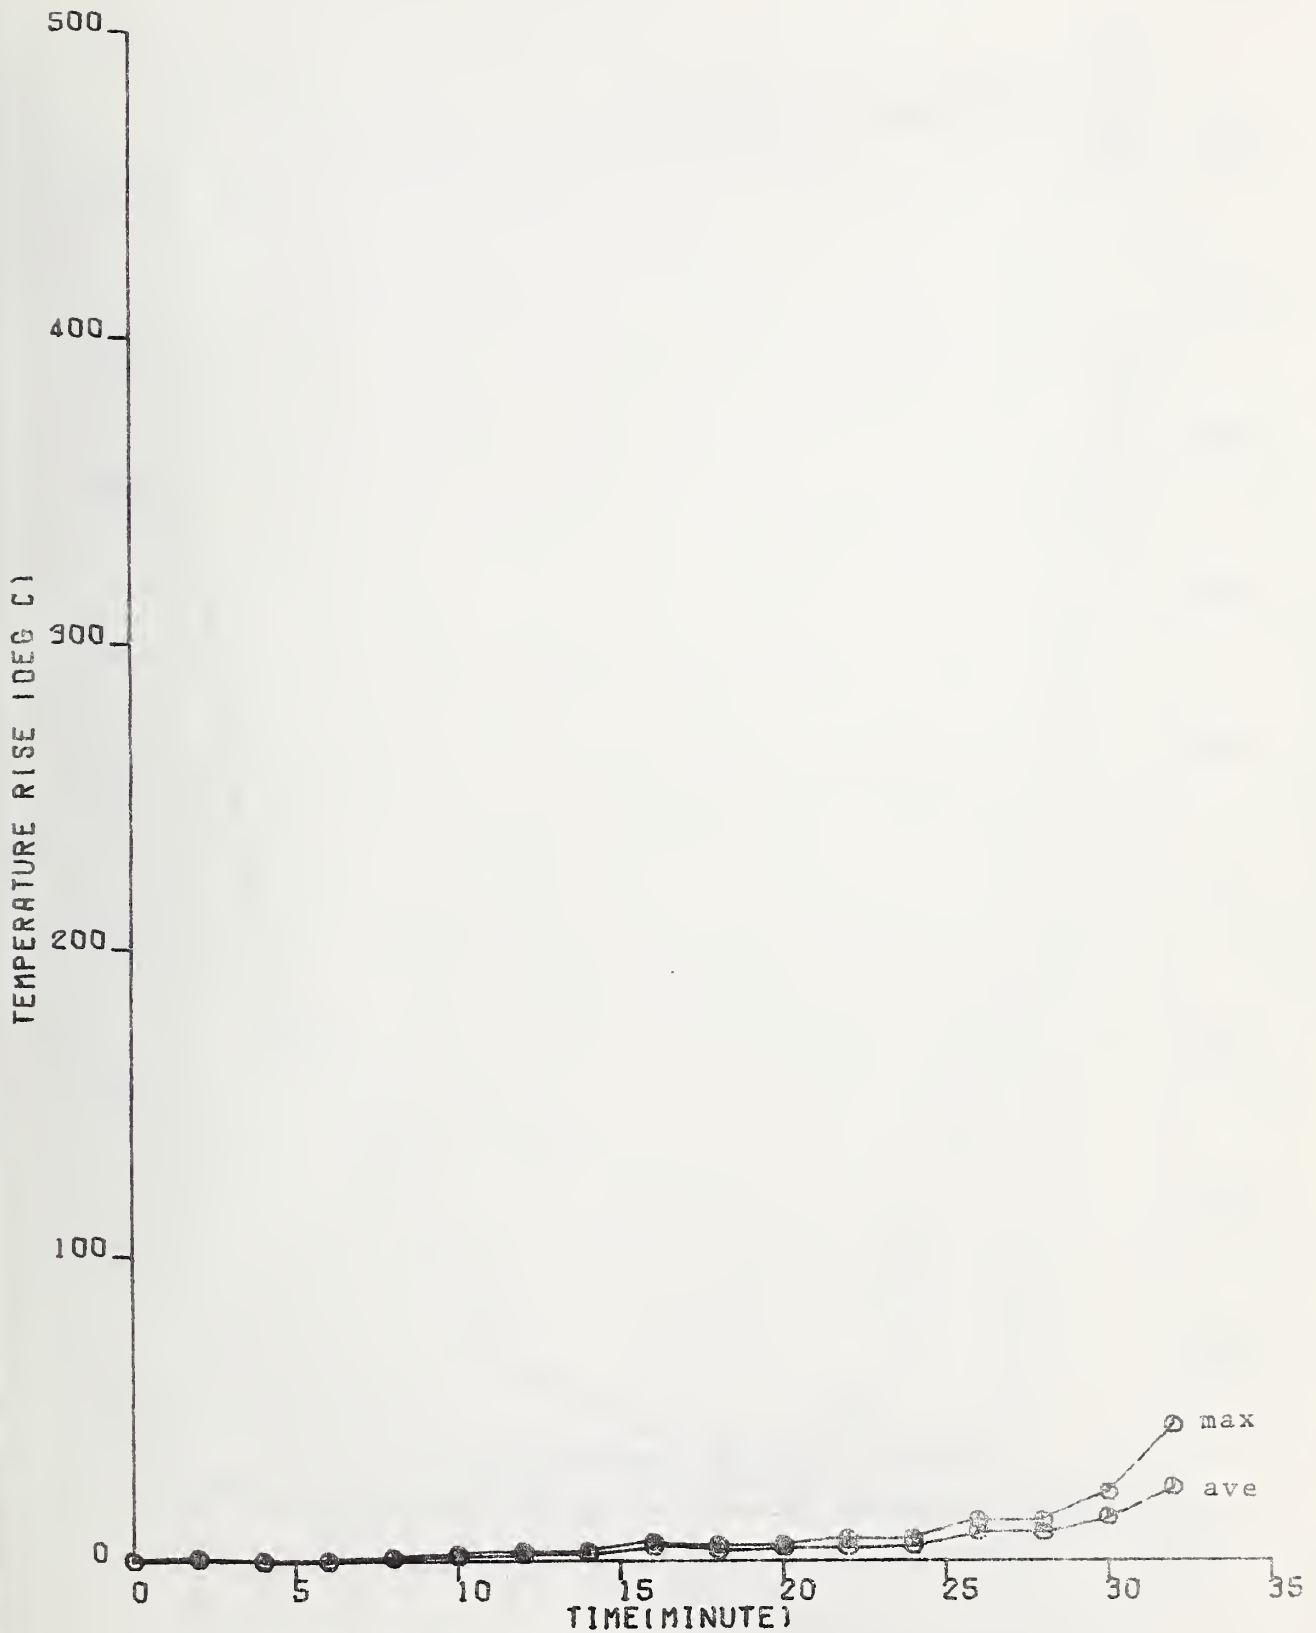
Figure 14 - FLOOR-CEILING ASSEMBLY
 Maximum and Average Temperature
 Rise on Unexposed Surface (Carpet)

Average and maximum temperature rises on the unexposed surface were not significant, with the maximum rise not exceeding 50 degrees C on the carpet at the end of the test, as can be seen in figure 14. Surface temperature rises in the area covered with vinyl flooring did not approach those over the carpet. As before, the flame through occurred in an area away from the thermocouple locations.

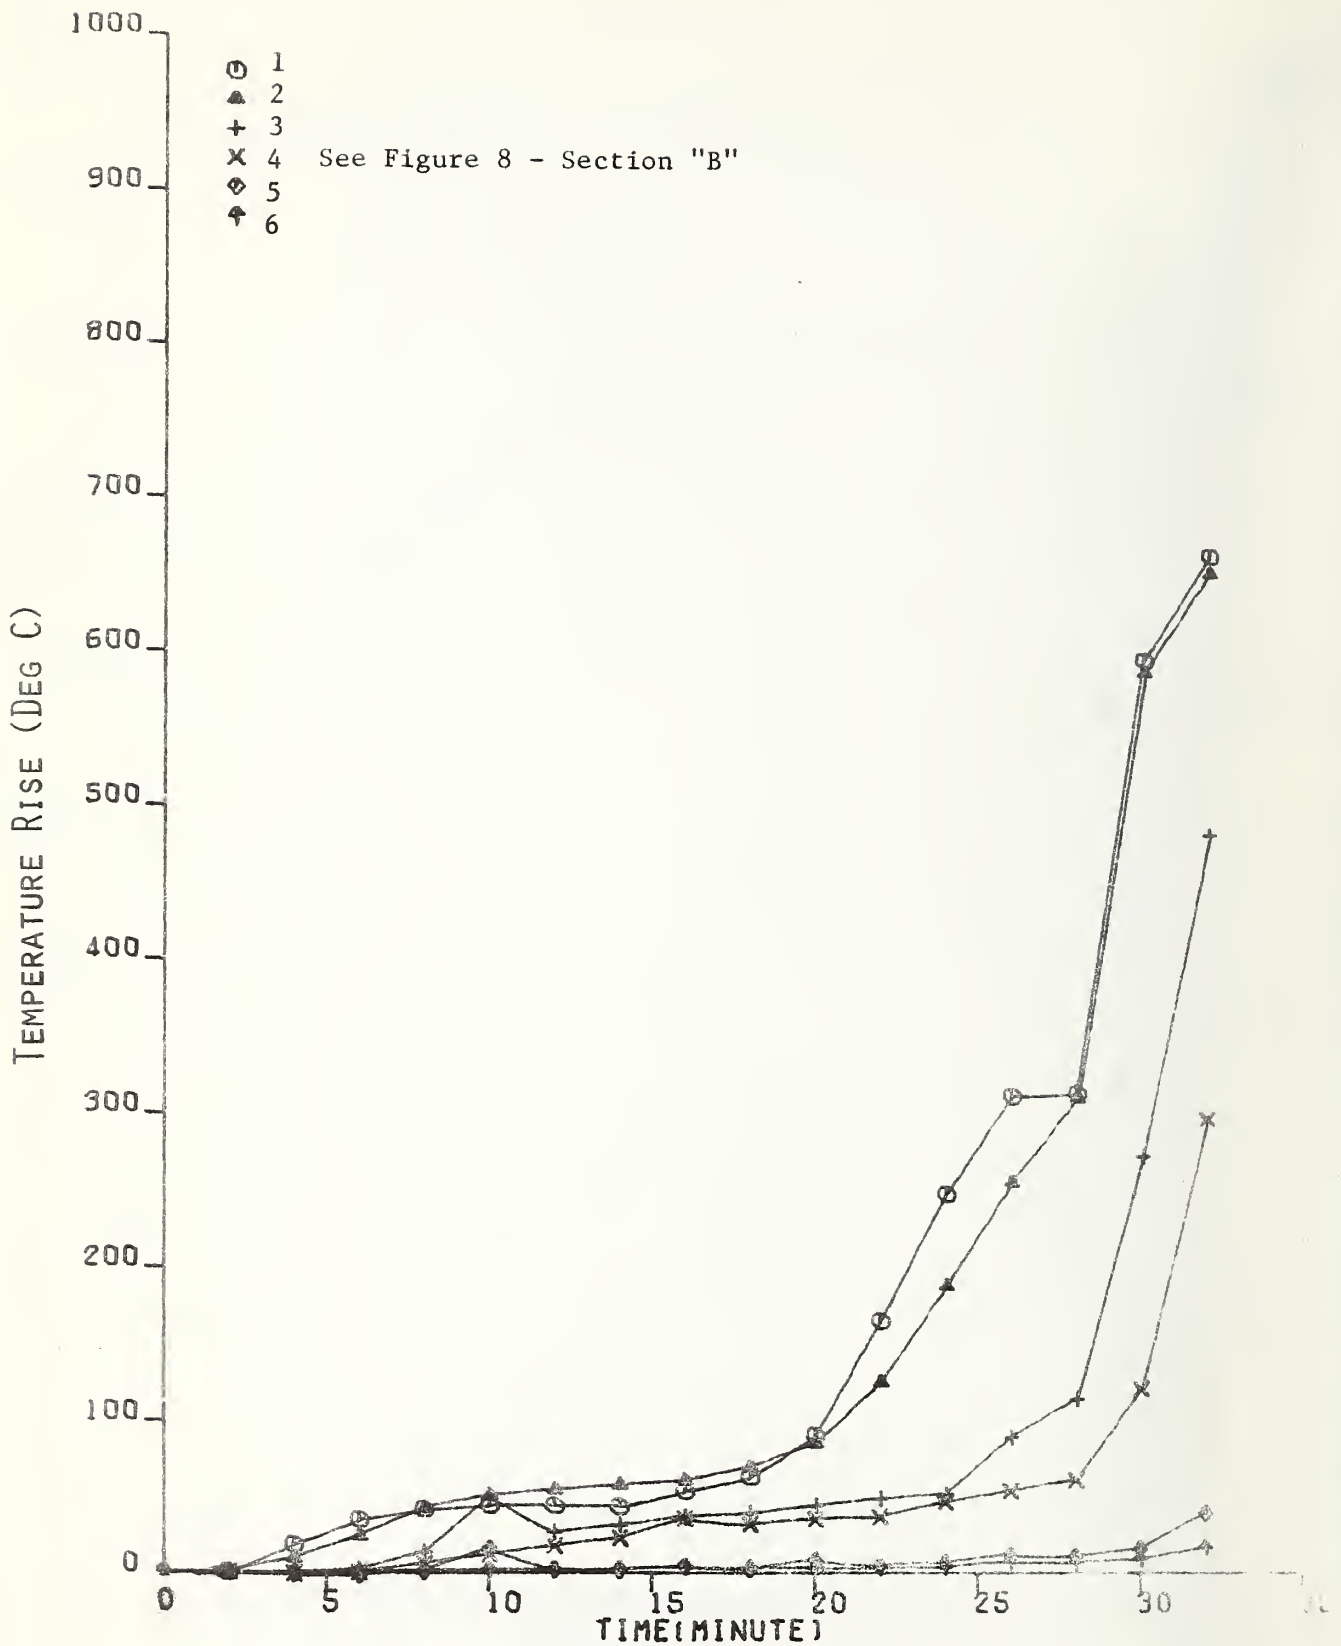
Figure 15 - FLOOR-CEILING ASSEMBLY
Average Temperature Rise
on Steel Joists

Temperature rises on the steel joists and adjacent structure are illustrated in figure 15 (average) and figure 16 (maximum). Similar rises in the area of the ceiling duct are shown in figure 17, giving the average temperature changes. Maxima in this location were not significantly higher. Temperature rises through the assembly at locations not at joists were noted to be somewhat lower than those indicated for the thermocouples at sections through the joists.
