NBSIR 73-150

Examination of Compressor Parts from Allison Engine from Fairchild Hiller Helicopter

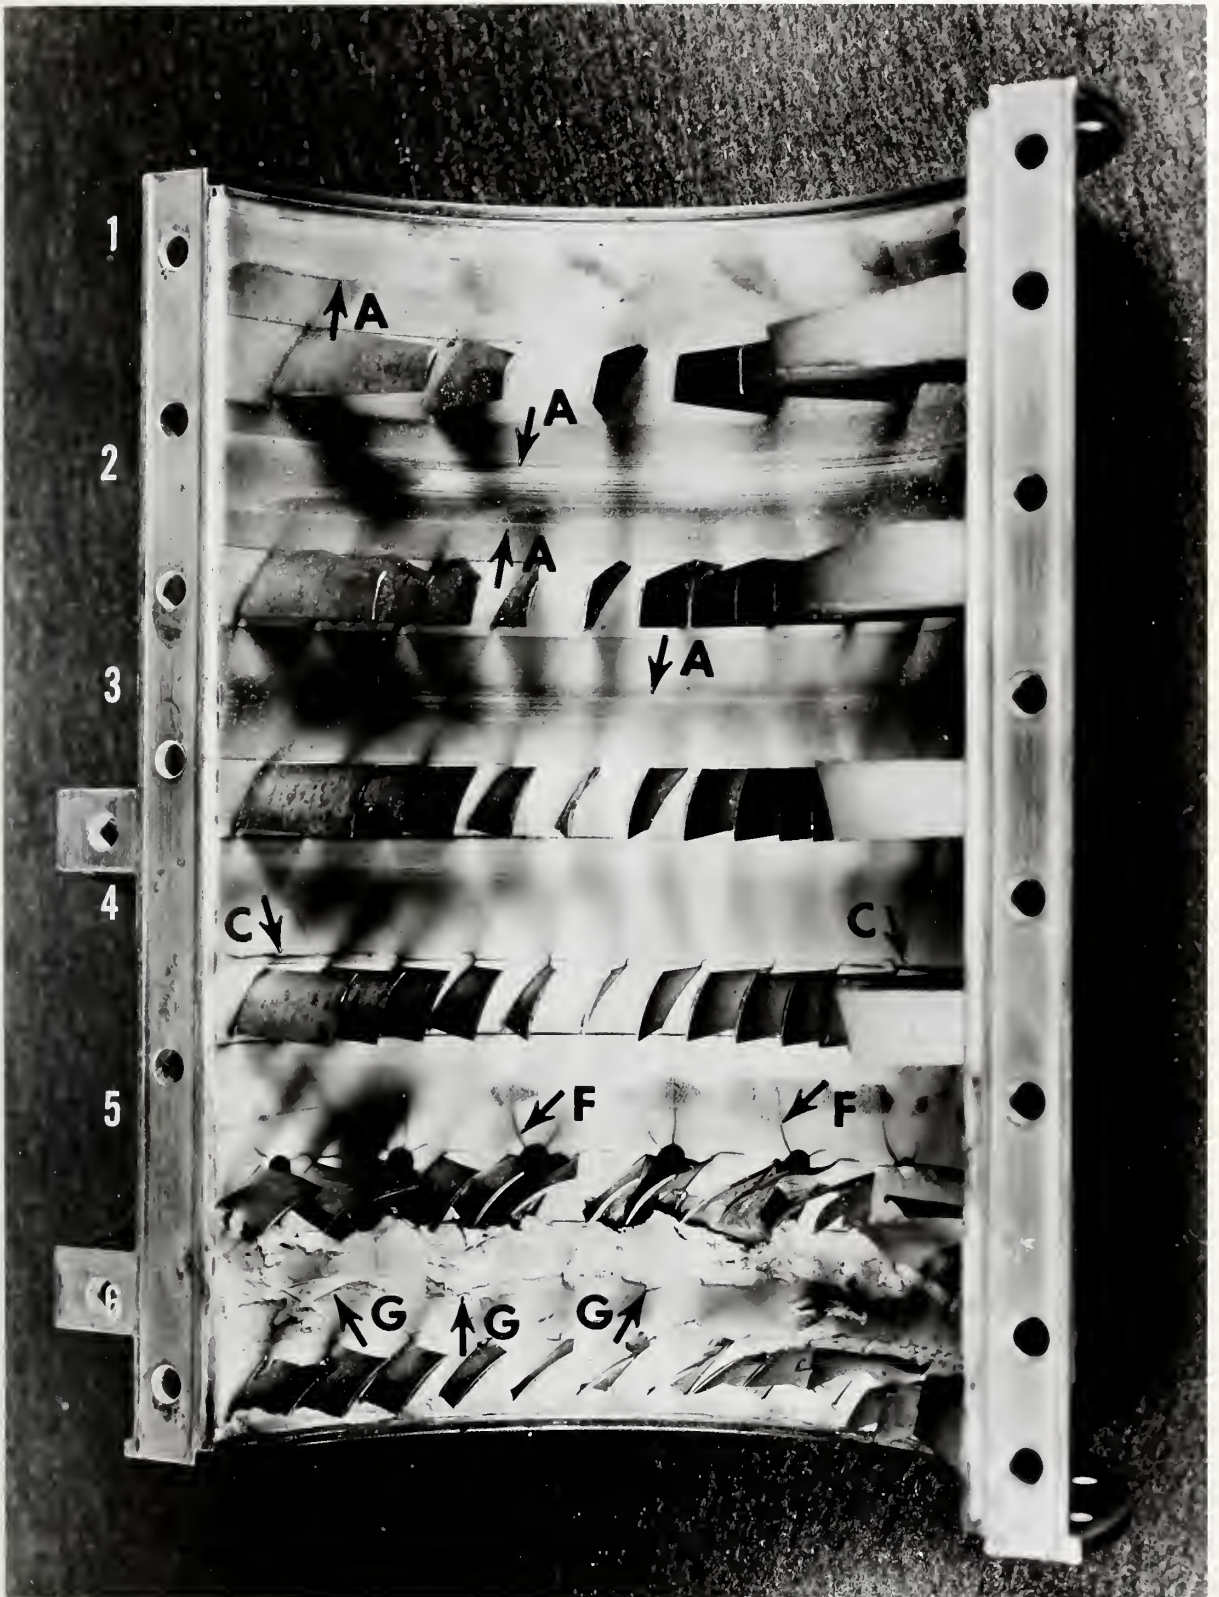
Figure 2a. Half of open compressor case. X 1

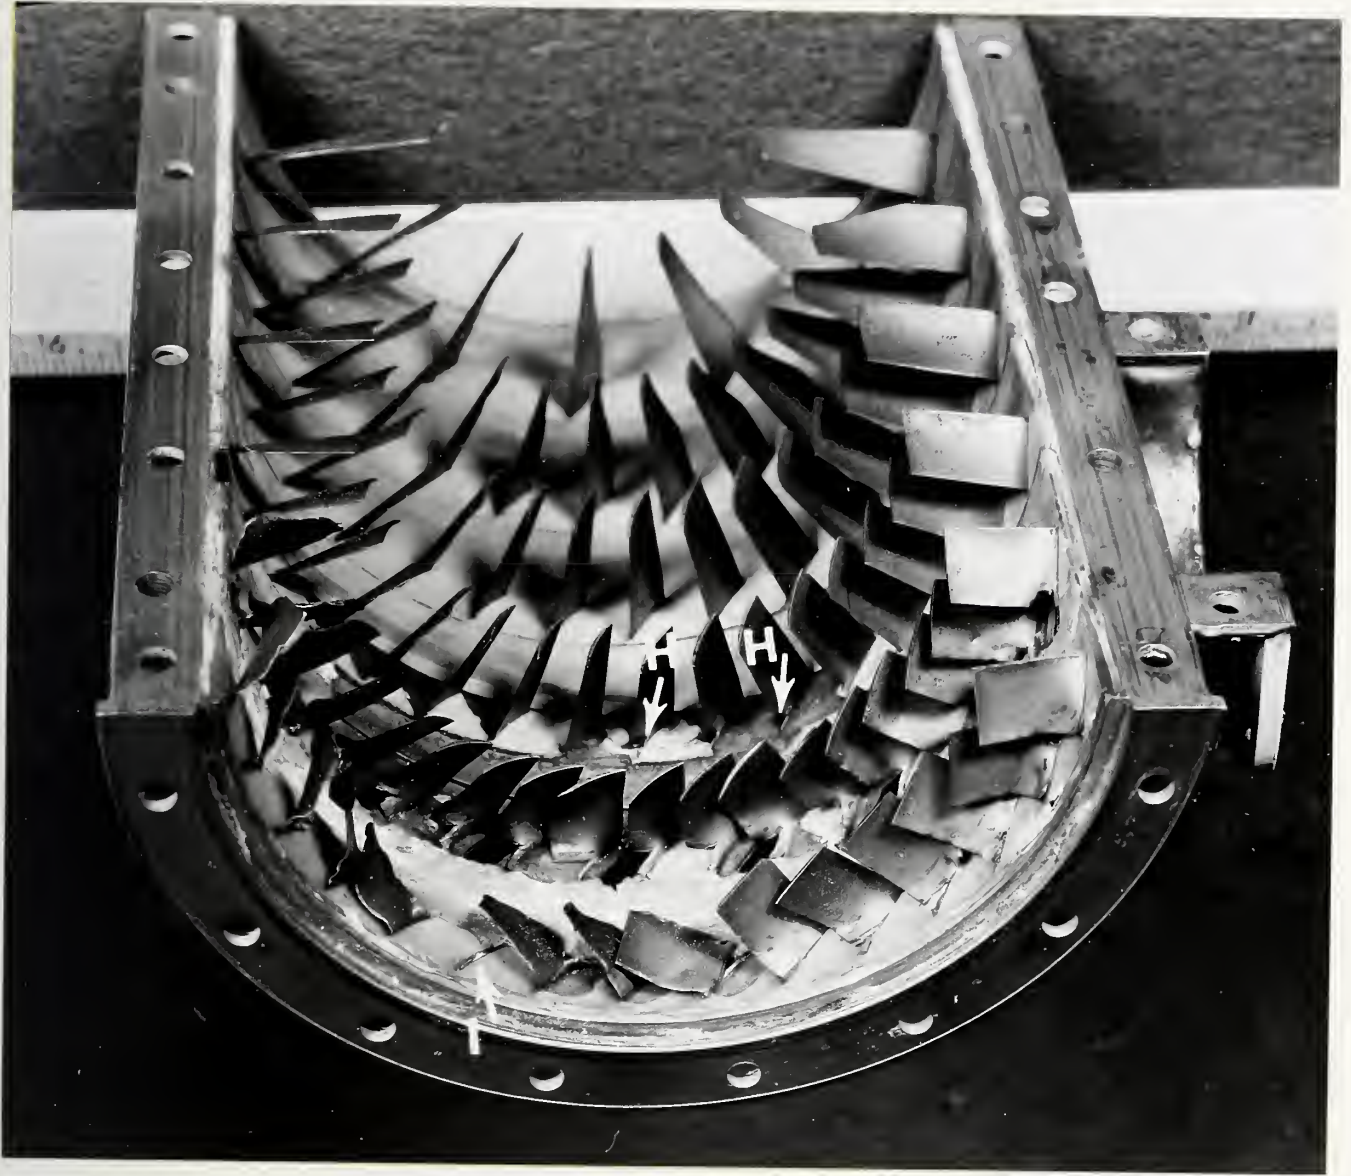
Figure 3a. Half of open compressor case shown in figure 2b. Examples of damaged fourth stage stator blades are indicated by arrows H. A missing sixth stage stator blade is indicated by arrow I. Damage to the fifth and sixth stage blades can be seen. X 1

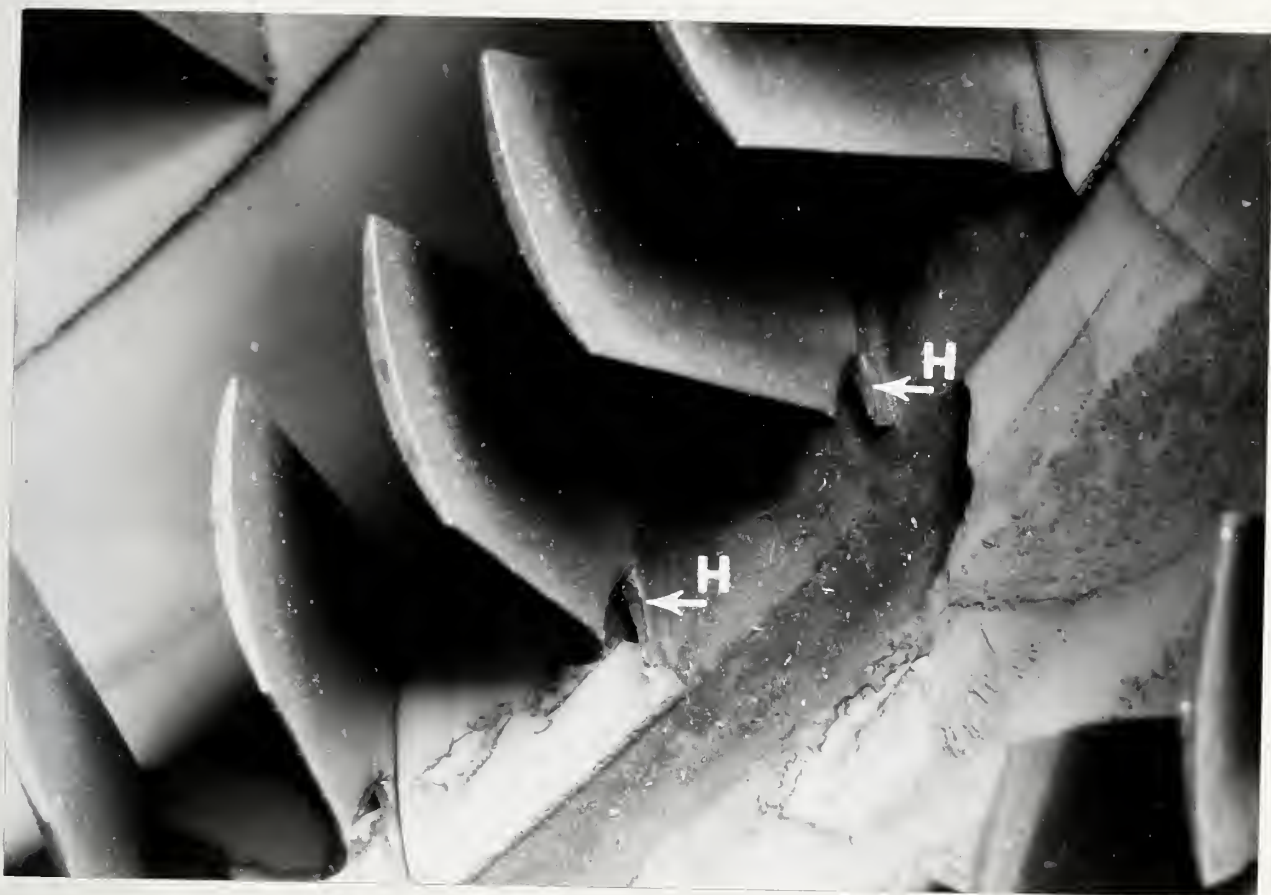
Figure 3b. Part of the half of the compressor case shown in figure 3a, but at higher magnification. Arrows H indicate examples of the damaged fourth stage stator blades. X 4

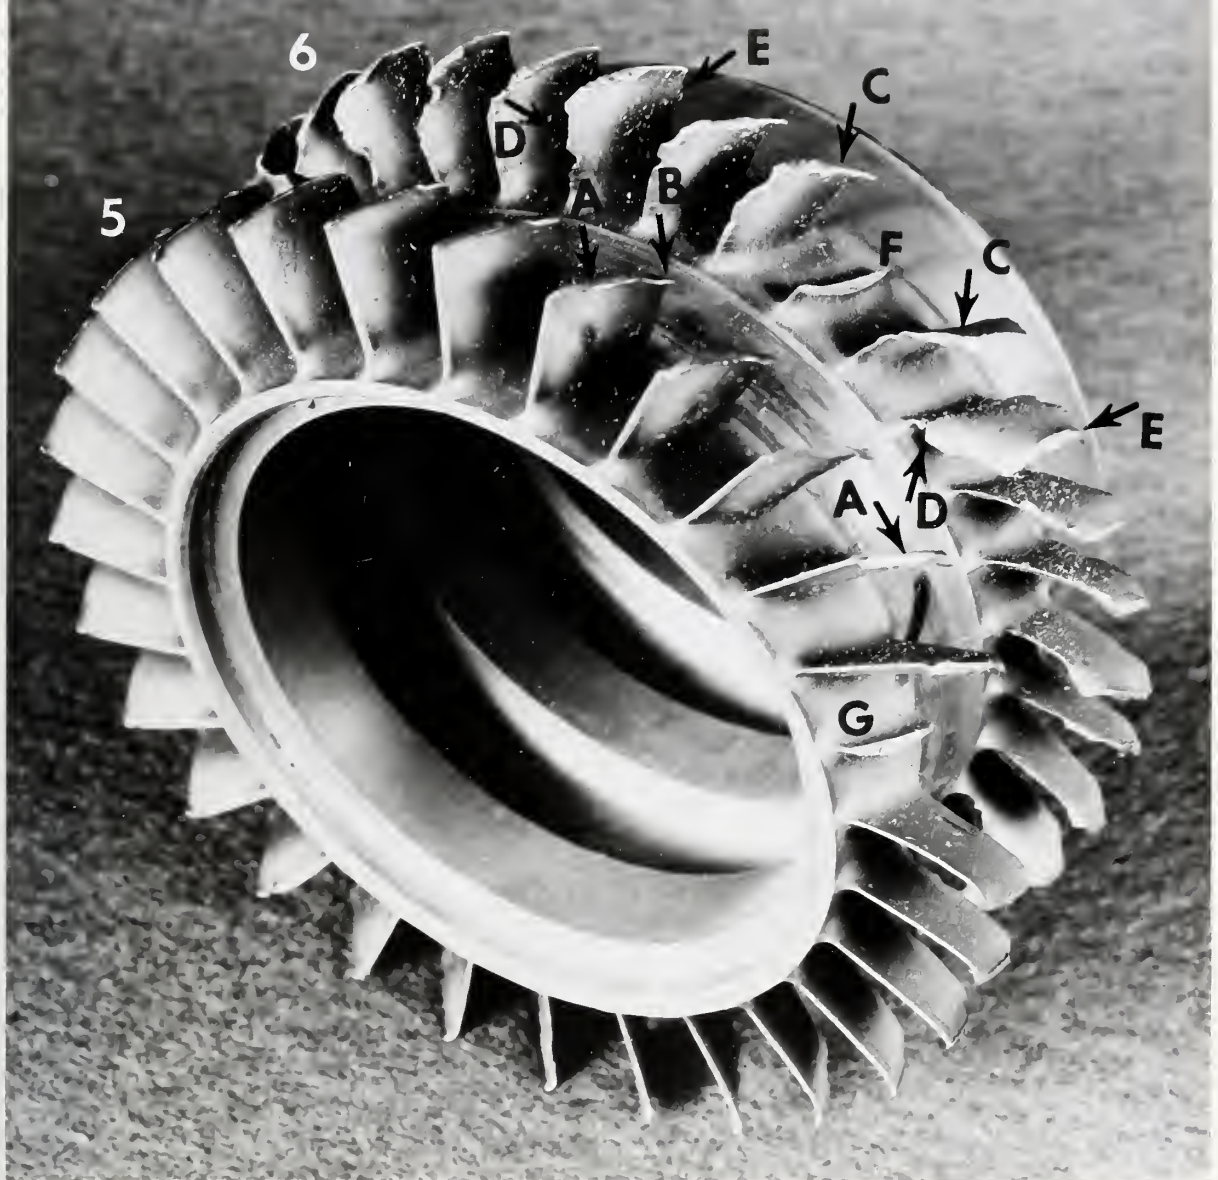
Figure 4. Fifth and sixth stage compressor wheel assembly as received. X 1

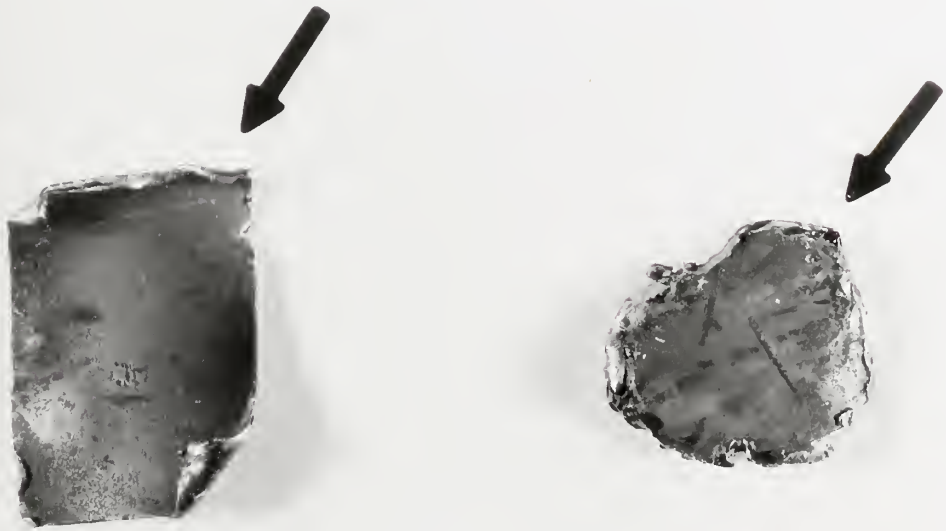
Figure 5. The separated portions of a stator blade (left) and a compressor blade (right). The arrows indicate spots which were yellowish-orange in color. X 3

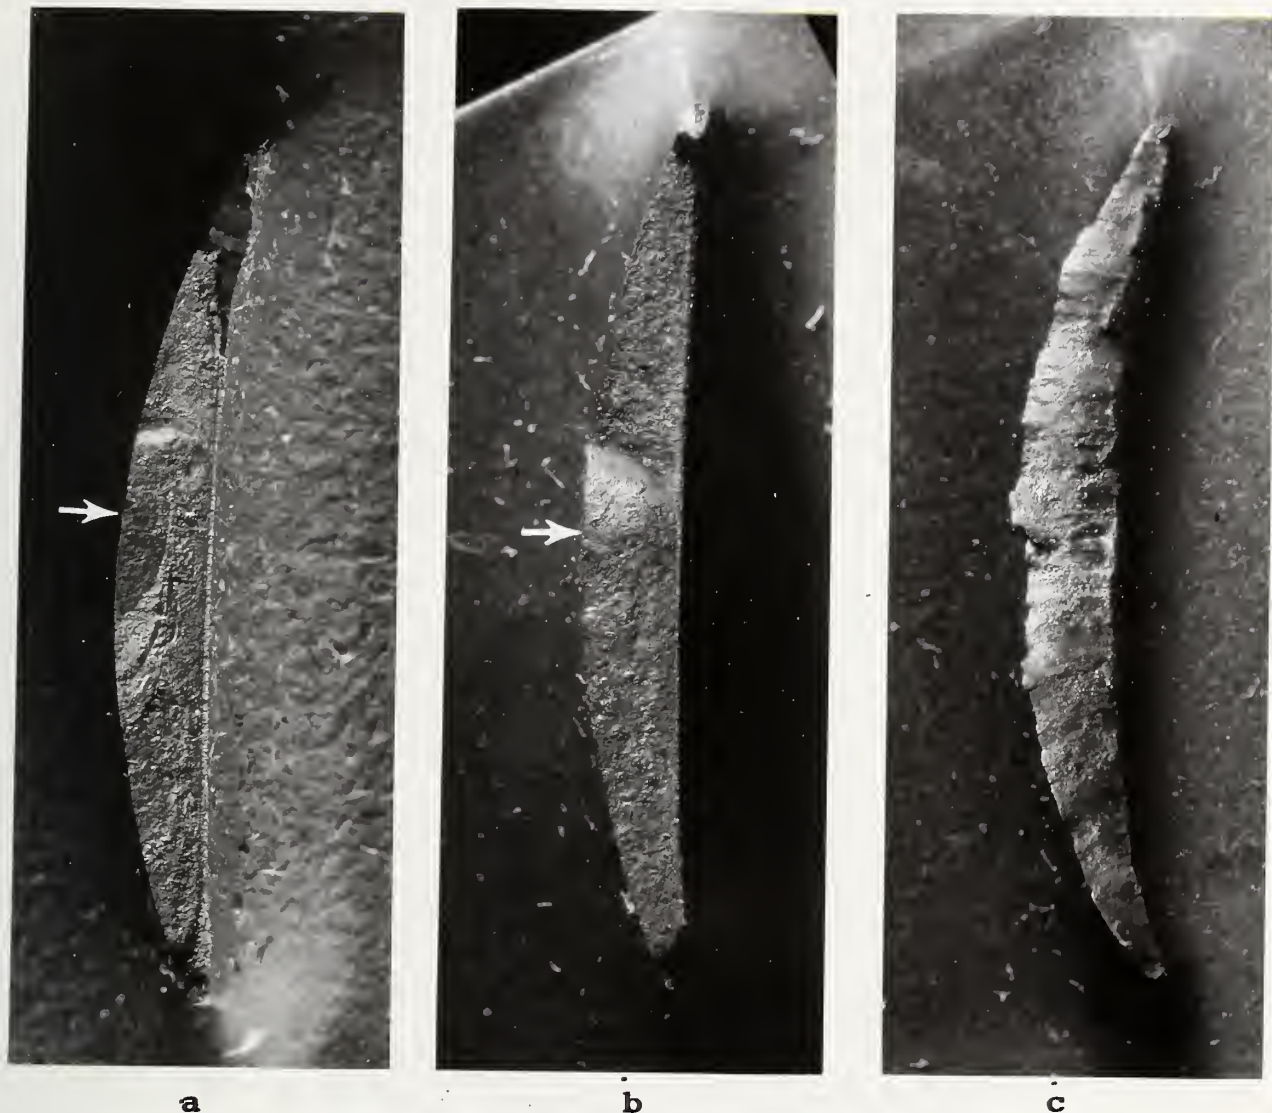
Figure 6. Fracture surfaces of the three fractured compressor blades. Arrows indicate the apparent primary crack origins in 6a and 6b. X 10

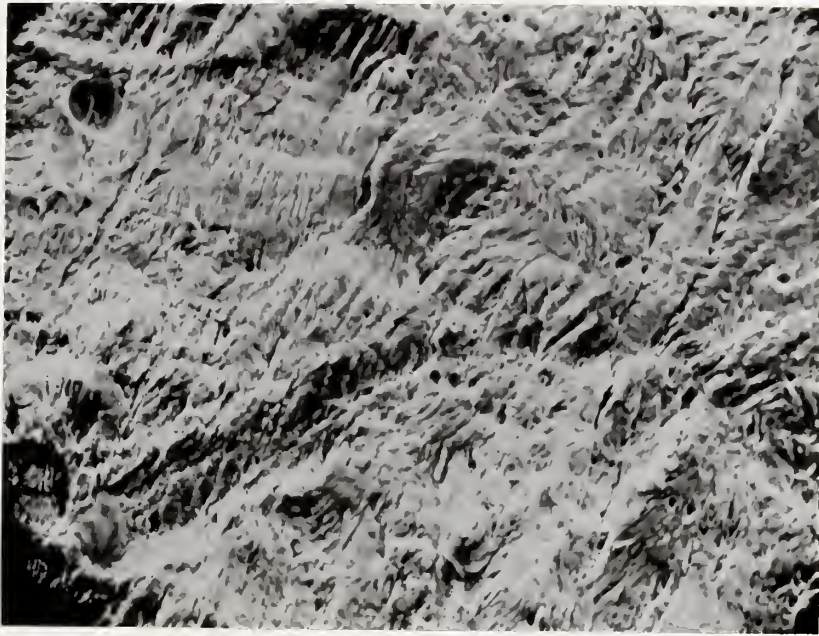
Figure 8. SEM of fracture surface of blade F in slowly propagating crack region showing evidence of apparent fatigue striations. X 540

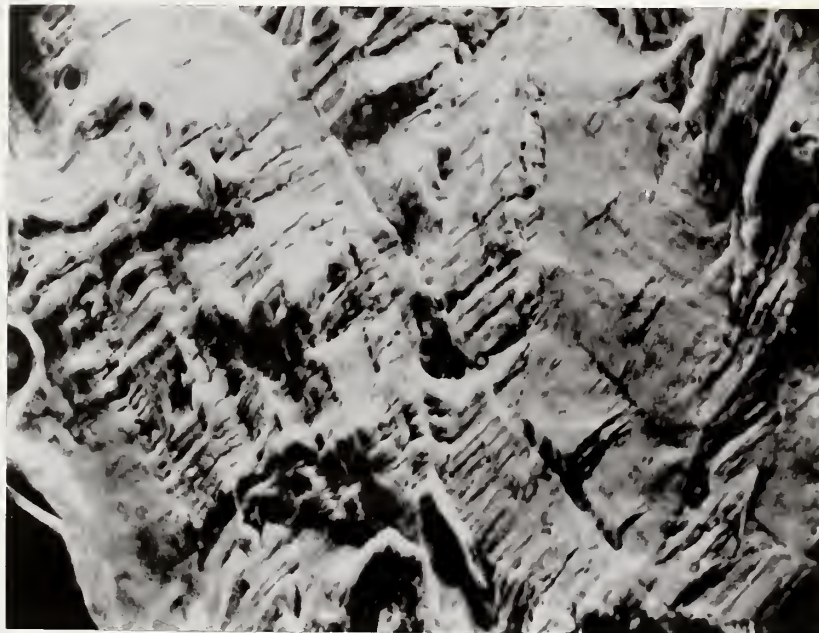
Figure 9. SEM of fracture surface of blade F in slowly propagating crack region showing evidence of apparent fatigue striations. X 2200

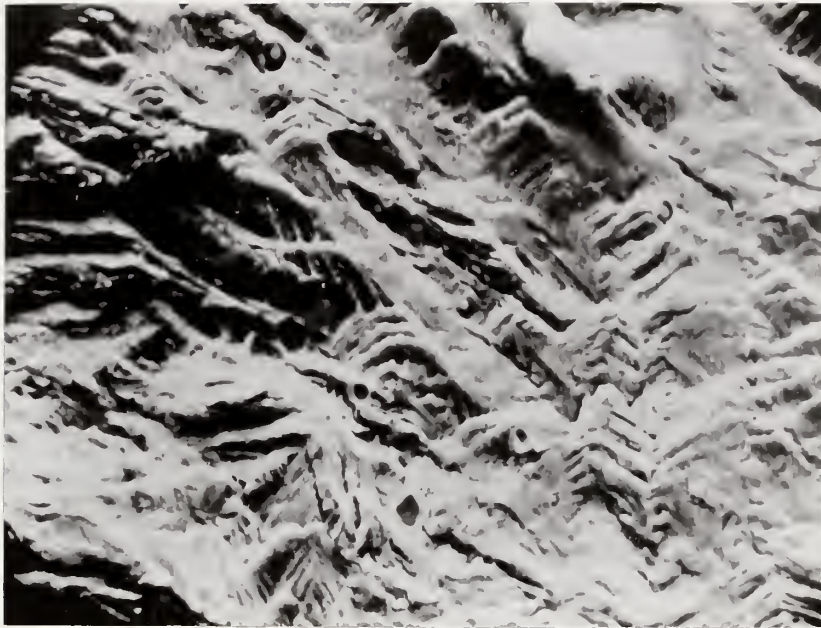
Figure 10. SEM of fracture surface of blade G in slowly propagating crack region showing evidence of apparent fatigue striations. X 1000

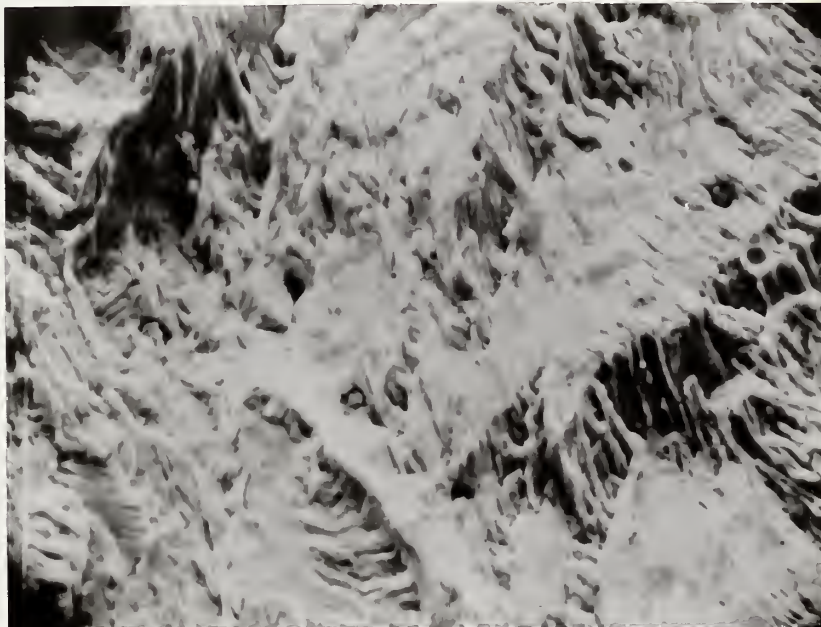
Figure 11. SEM of fracture surface of blade G in slowly propagating crack region showing evidence of apparent fatigue striations. X 1200

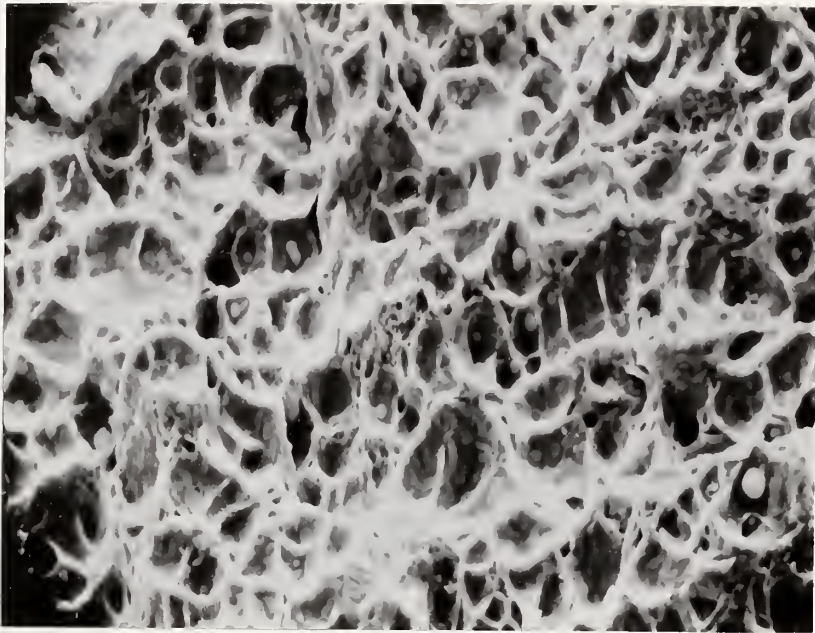
Figure 12. SEM in overload region of fracture surface of blade F showing dimpled rupture. X 550

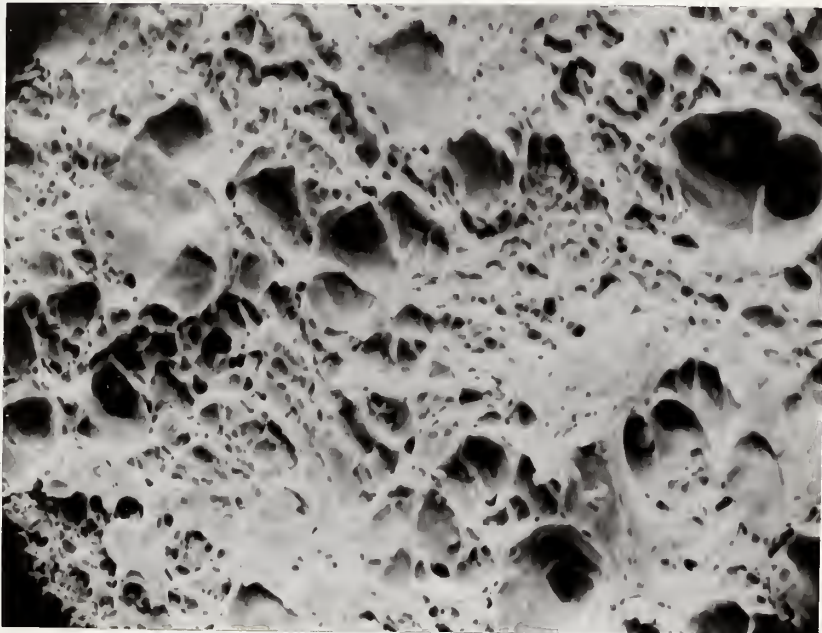
Figure 13. SEM of fracture surface of blade H showing dimpled rupture. X 1150

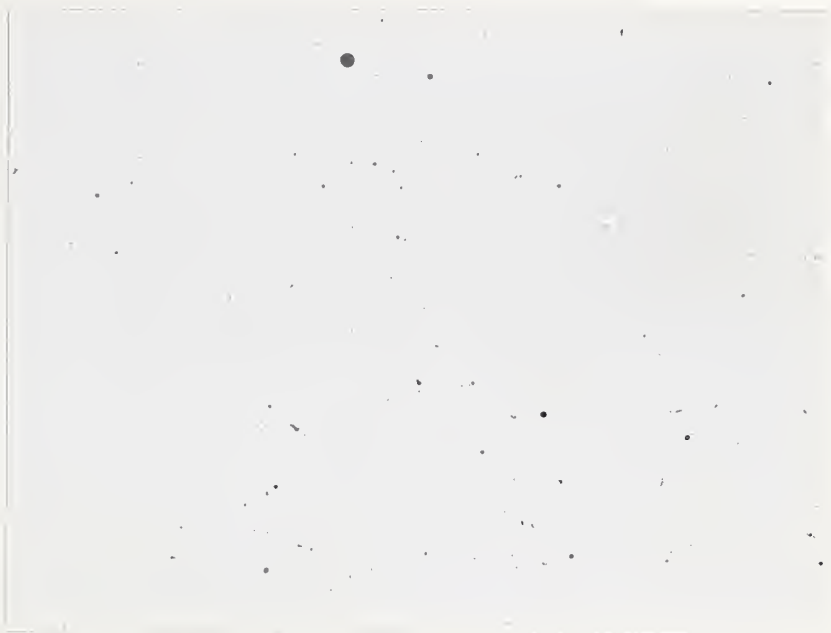
Figure 14. Unetched microstructure of cross section through blade G. This field was considered to have an inclusion content typical of the three cross sections examined. X 100

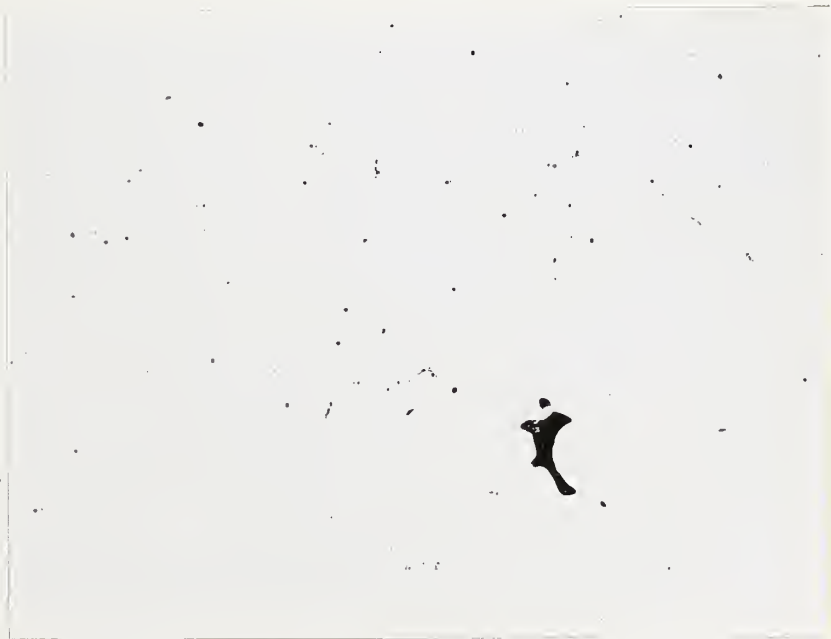
Figure 15. Unetched microstructure of cross section through blade F. This field was considered to have the greatest inclusion content for this cross section. X 100

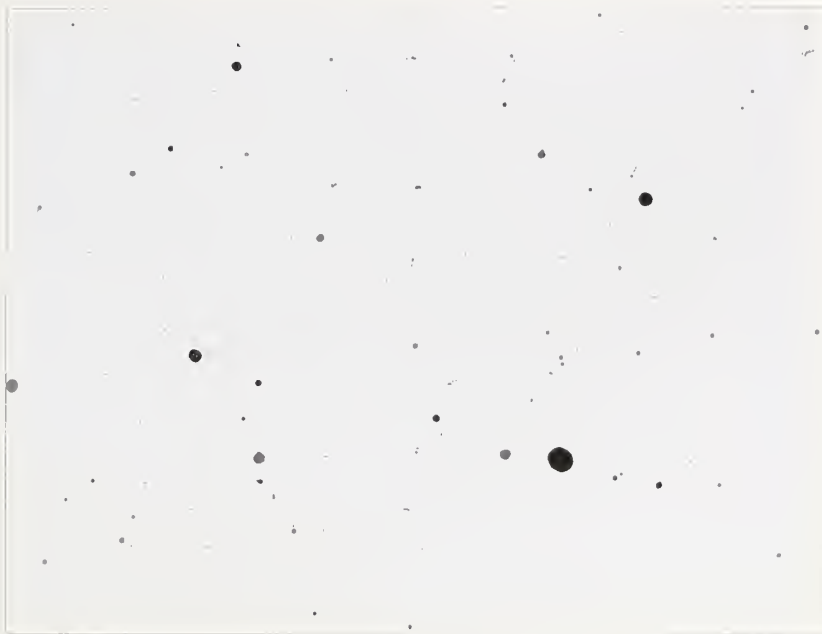
Figure 16. Unetched microstructure of cross section through blade G. This field was considered to have the greatest inclusion content for this cross section. X 100

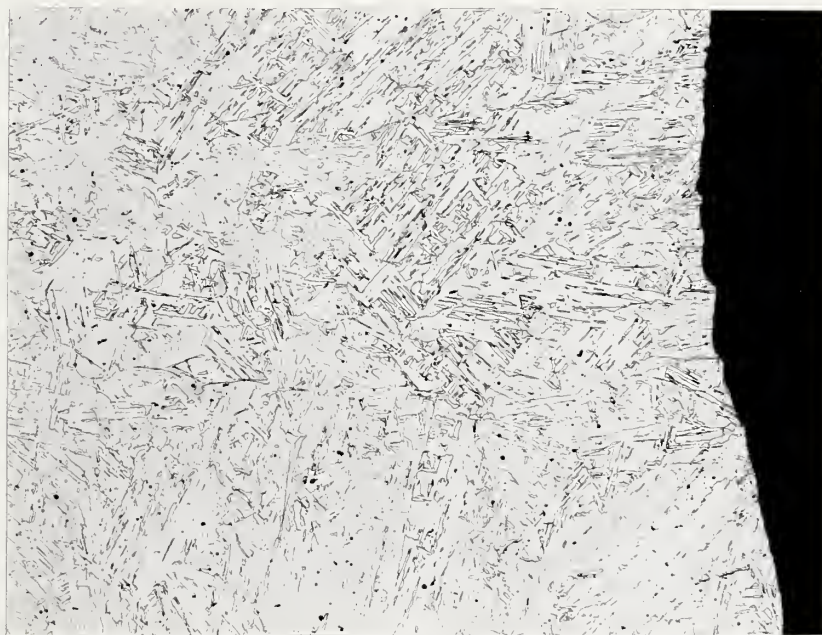
Figure 17. Etched microstructure of cross section through blade F showing fracture profile at right. Fracture is transgranular. Microstructure consists primarily of tempered martensite and "stringer" shaped patches of ferrite. Etch: Acidified picral. X 100

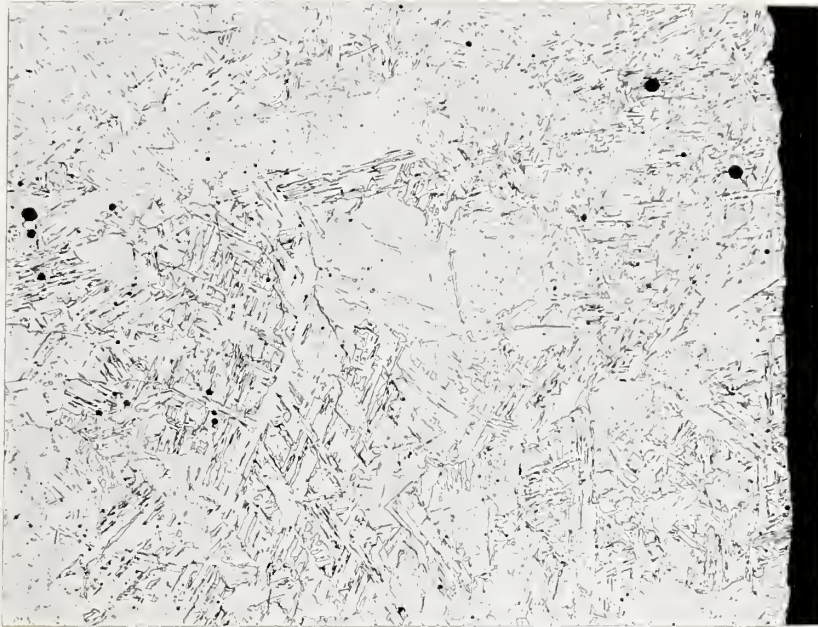
Figure 18. Etched microstructure of cross section through blade G showing fracture profile at right. Fracture is transgranular. Microstructure consists primarily of tempered martensite and "stringer" shaped areas of ferrite. Etch: Acidified picral. X 100

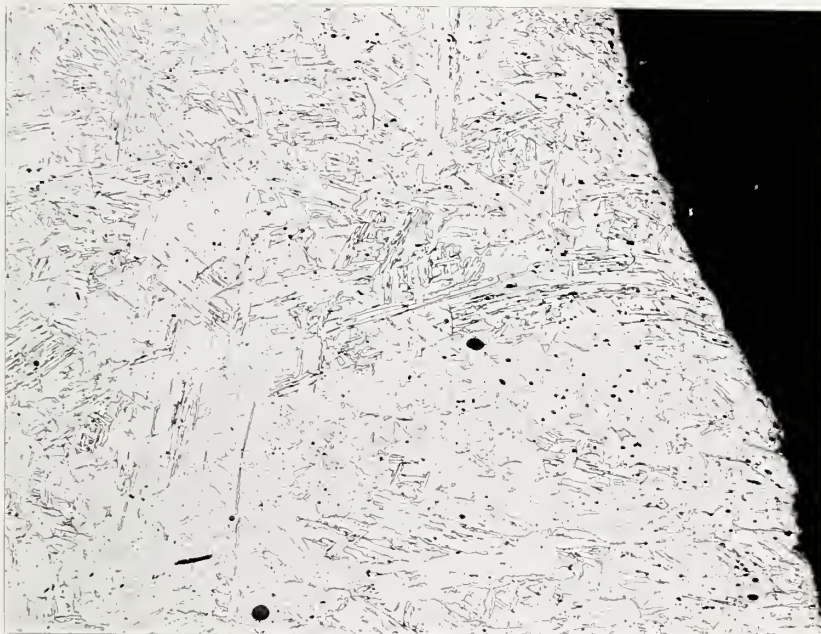
Figure 19. Etched microstructure of cross section through blade H showing fracture profile at right. Fracture is transgranular and there is considerable deformation adjacent to the fracture. Microstructure consists primarily of tempered martensite and "stringer" shaped areas of ferrite. Etch: Acidified picral. X 100

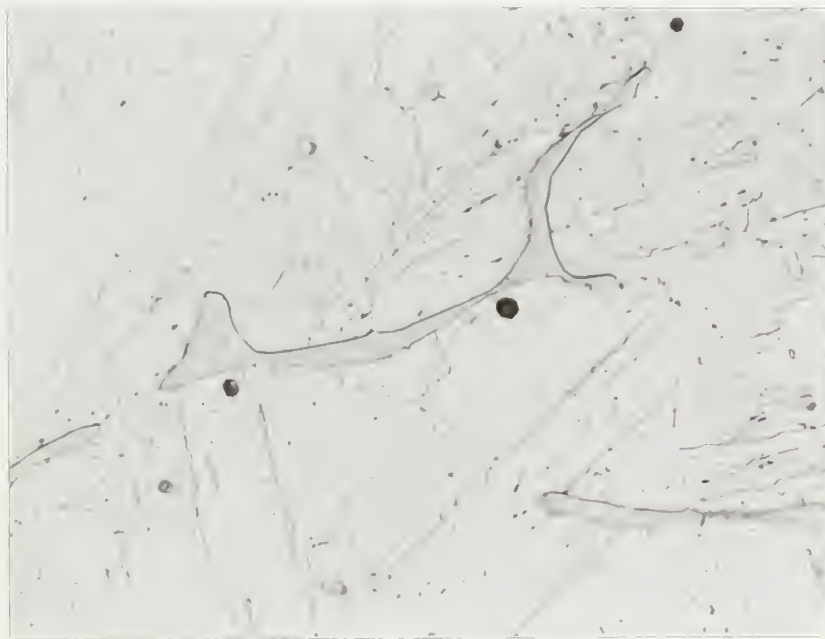
Figure 20. Etched microstructure of cross section through blade G at higher magnification than figures 17 through 19. The elongated "stringer" shaped areas appear to be ferrite. The matrix is tempered martensite. Etch: Acidified picral. X 1000
