NBSIR 73-164

Fire Endurance Test of a Steel Sandwich Panel Floor Construction

Final Report

As a part of the evaluation of a housing system proposed under Operation BREAKTHROUGH, a fire endurance test was performed at the National Bureau of Standards on a floor, made up of sandwich panels consisting of a paper honeycomb core with steel and plywood surfaces, supported on steel joists.

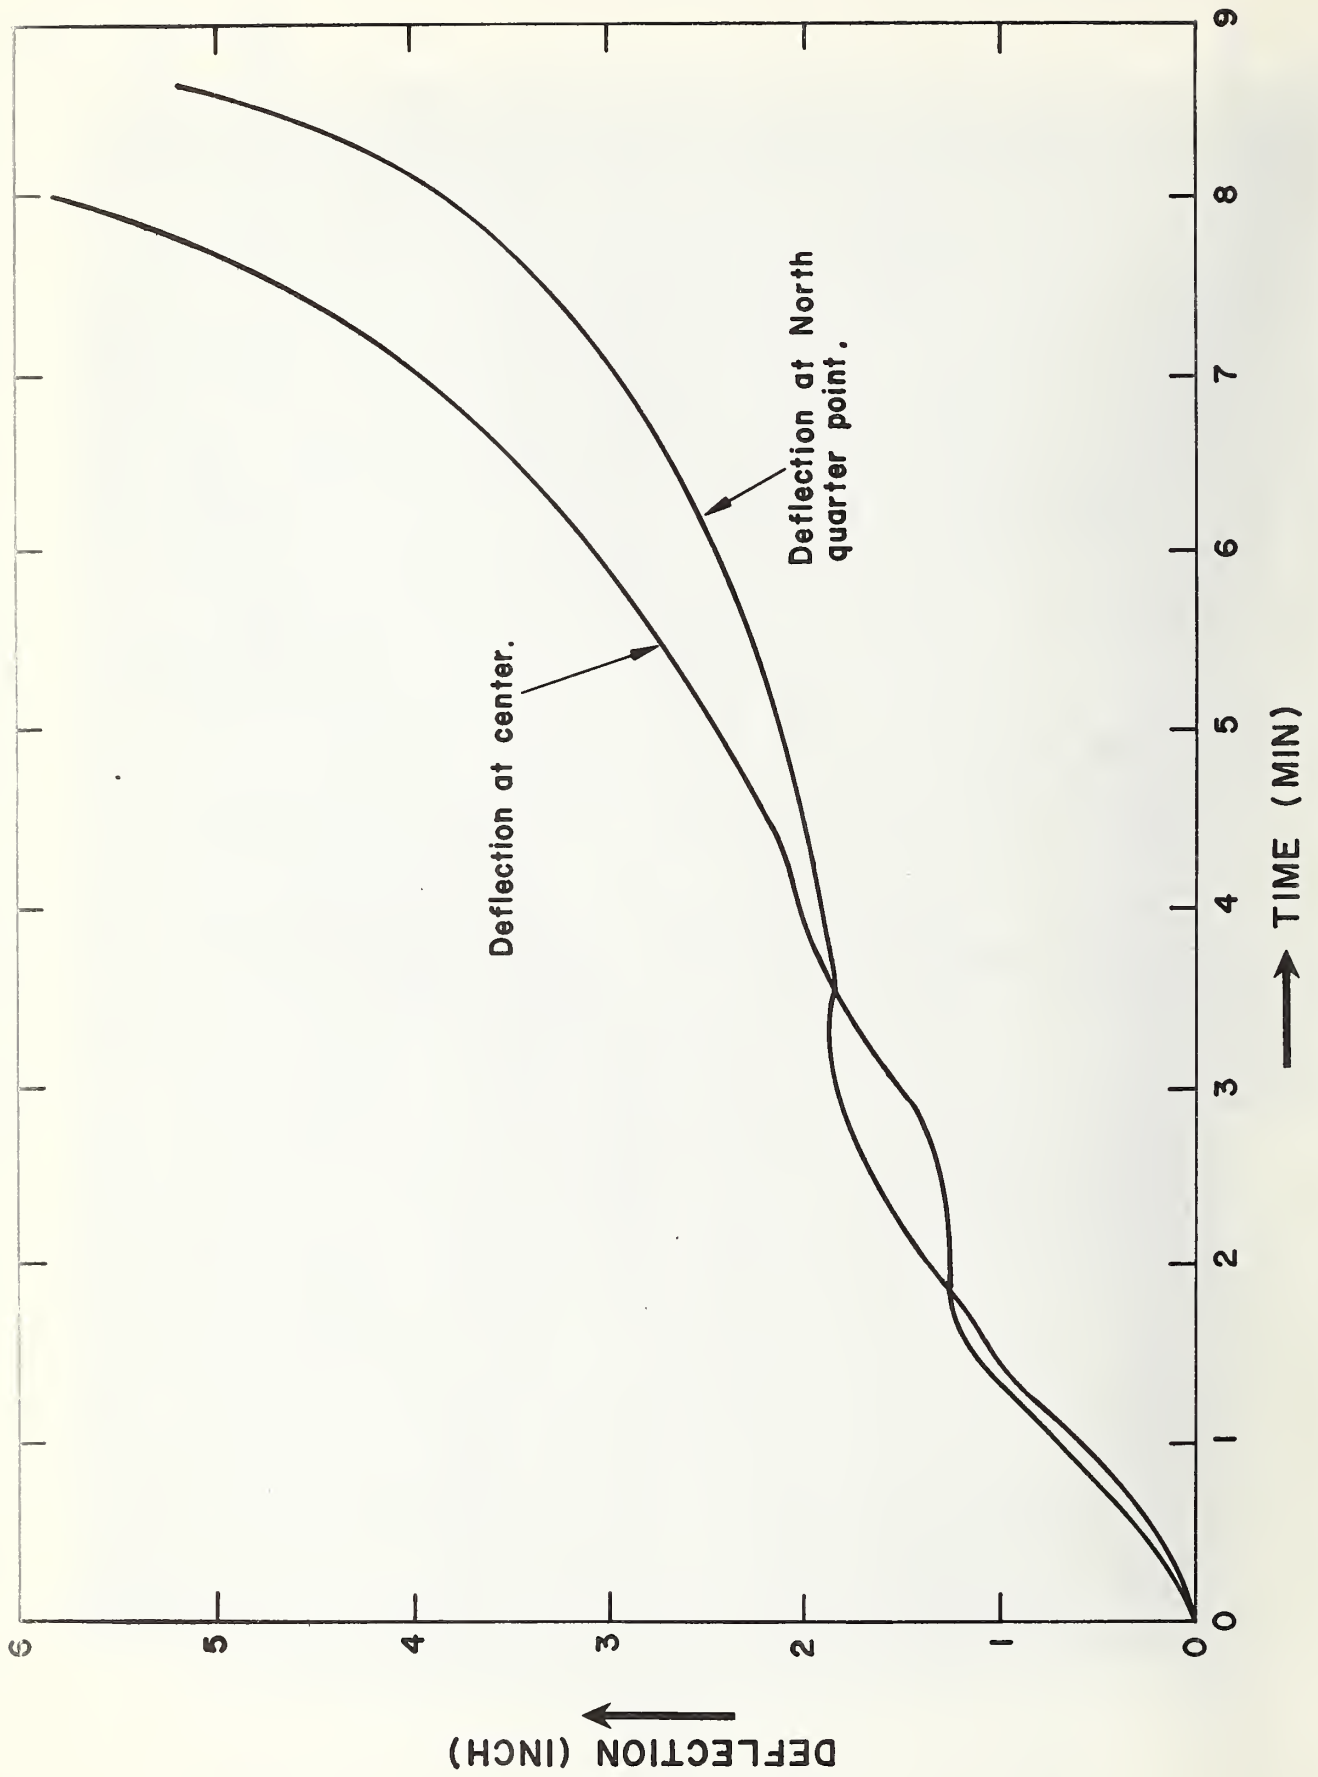
Figure : Increase of Deflection During the Test

which increased continuously during the test, are shown in Figure 7. The location where flaming occurred and the pattern of surface deflection after load removal can be seen in Figure 8.

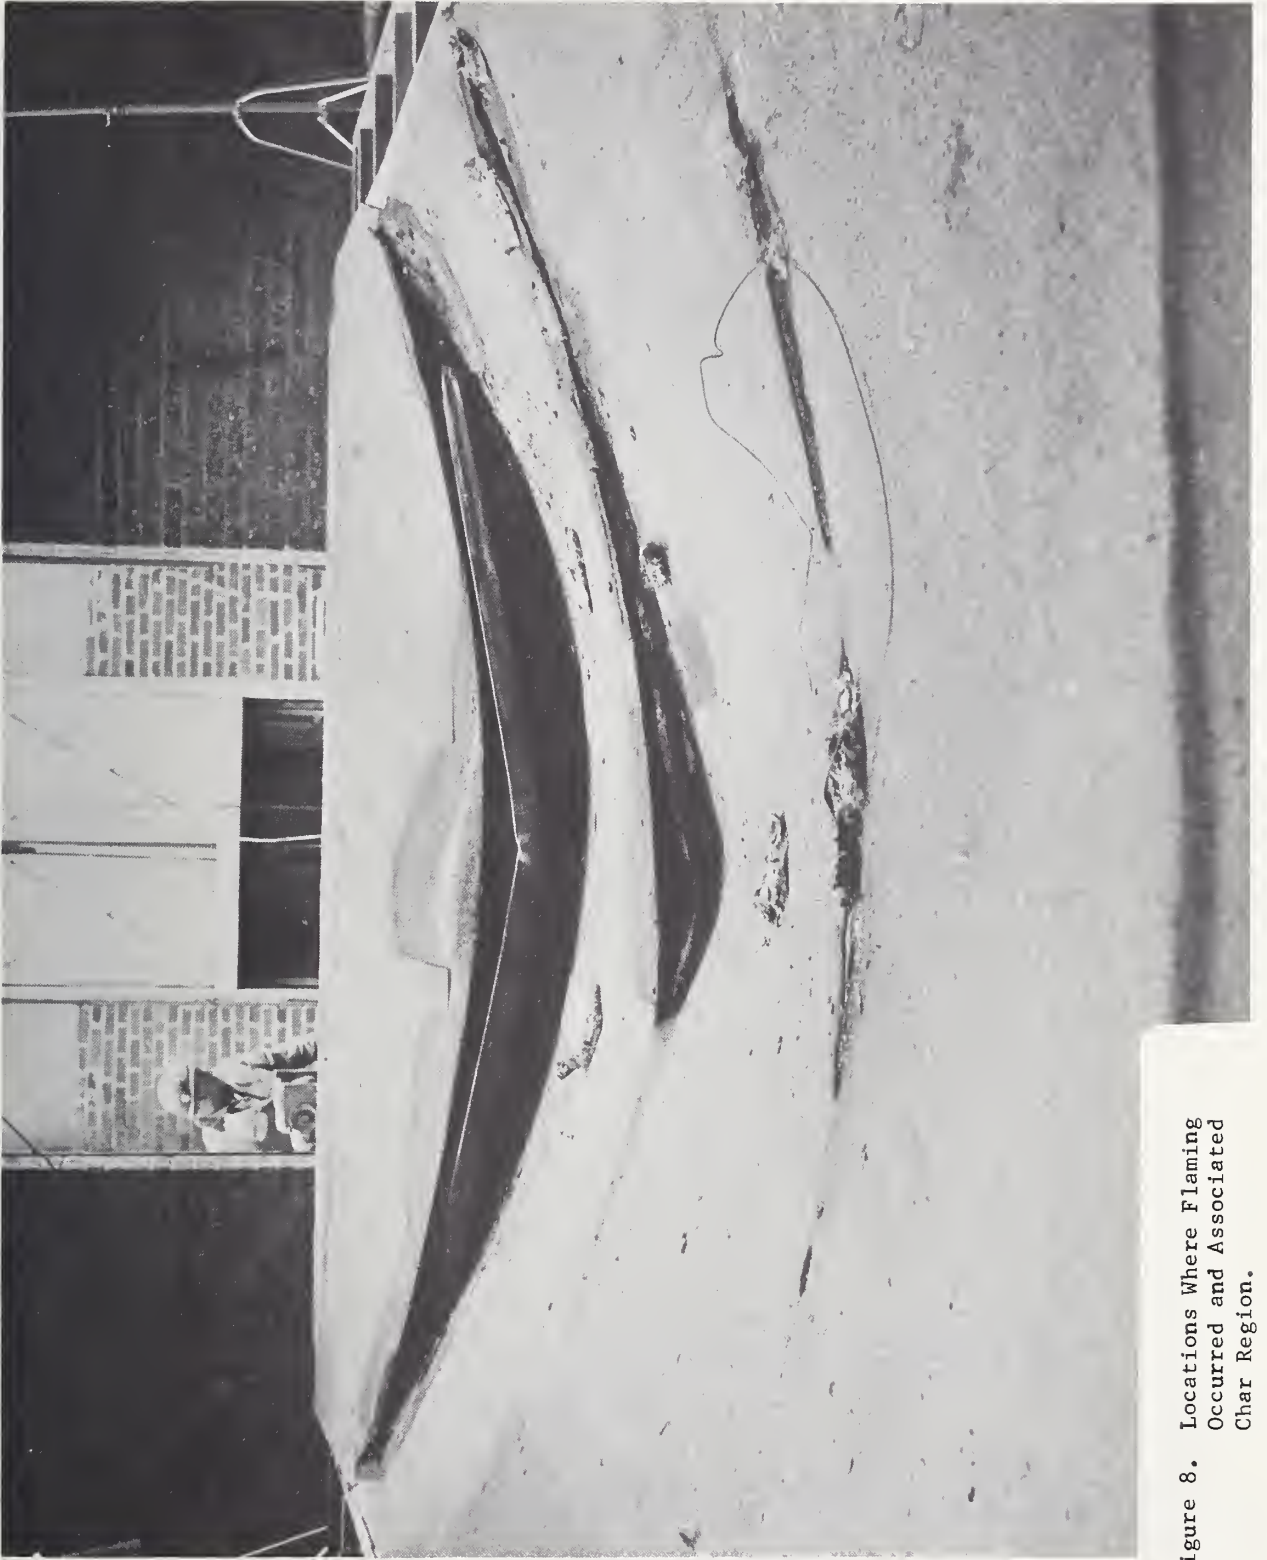
Figure 8. Locations Where Flaming Occurred and Associated Char Region.

Flame penetration, denoting failure, occurred at a joint between two panels at 8 min. 45 sec. after start of the test. This was followed by load failure at 9 min., as evidenced by the inability to maintain hydraulic pressure in the loading system. The deflections of the floor,

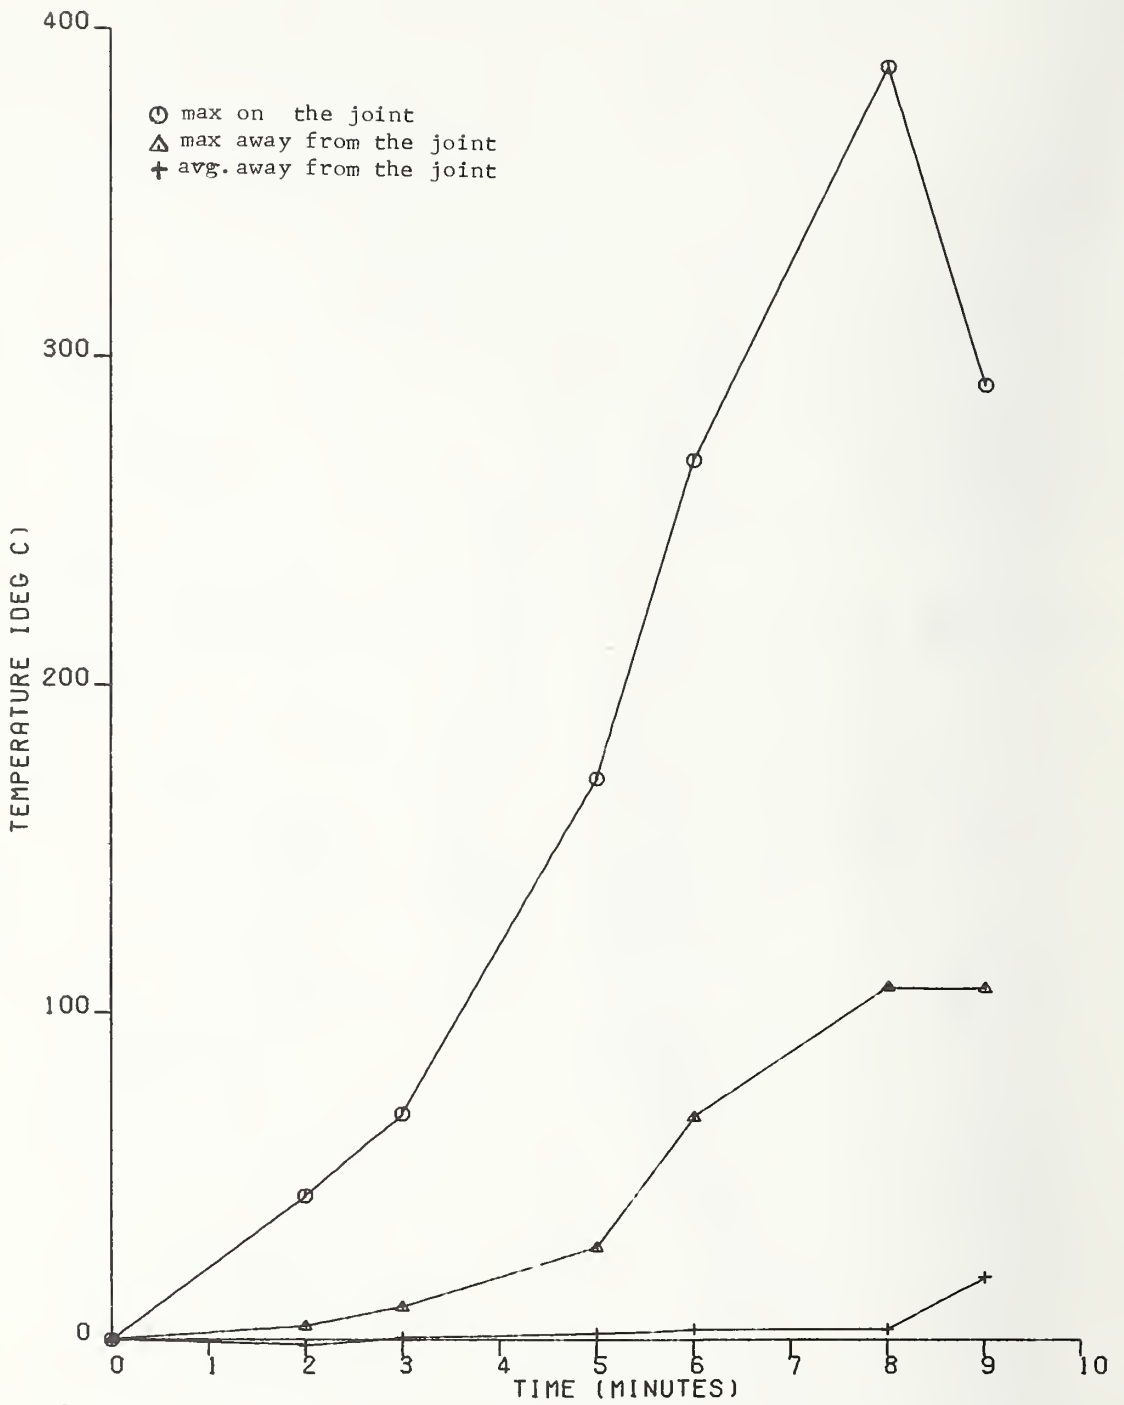
FIGURE 9

The average temperature rise indicated by the thermocouples on the unexposed surface away from the joints was less than 35°C (96°F) and a maximum temperature rise of over 300°C (572°F) was observed on a joint during the test, as shown in Figure 9. Temperature histories of other thermocouples in the structure are given in Figures 10 and 11.

MAXIMUM AND SURFACE TEMPERATURE RISE FOR TEST 480

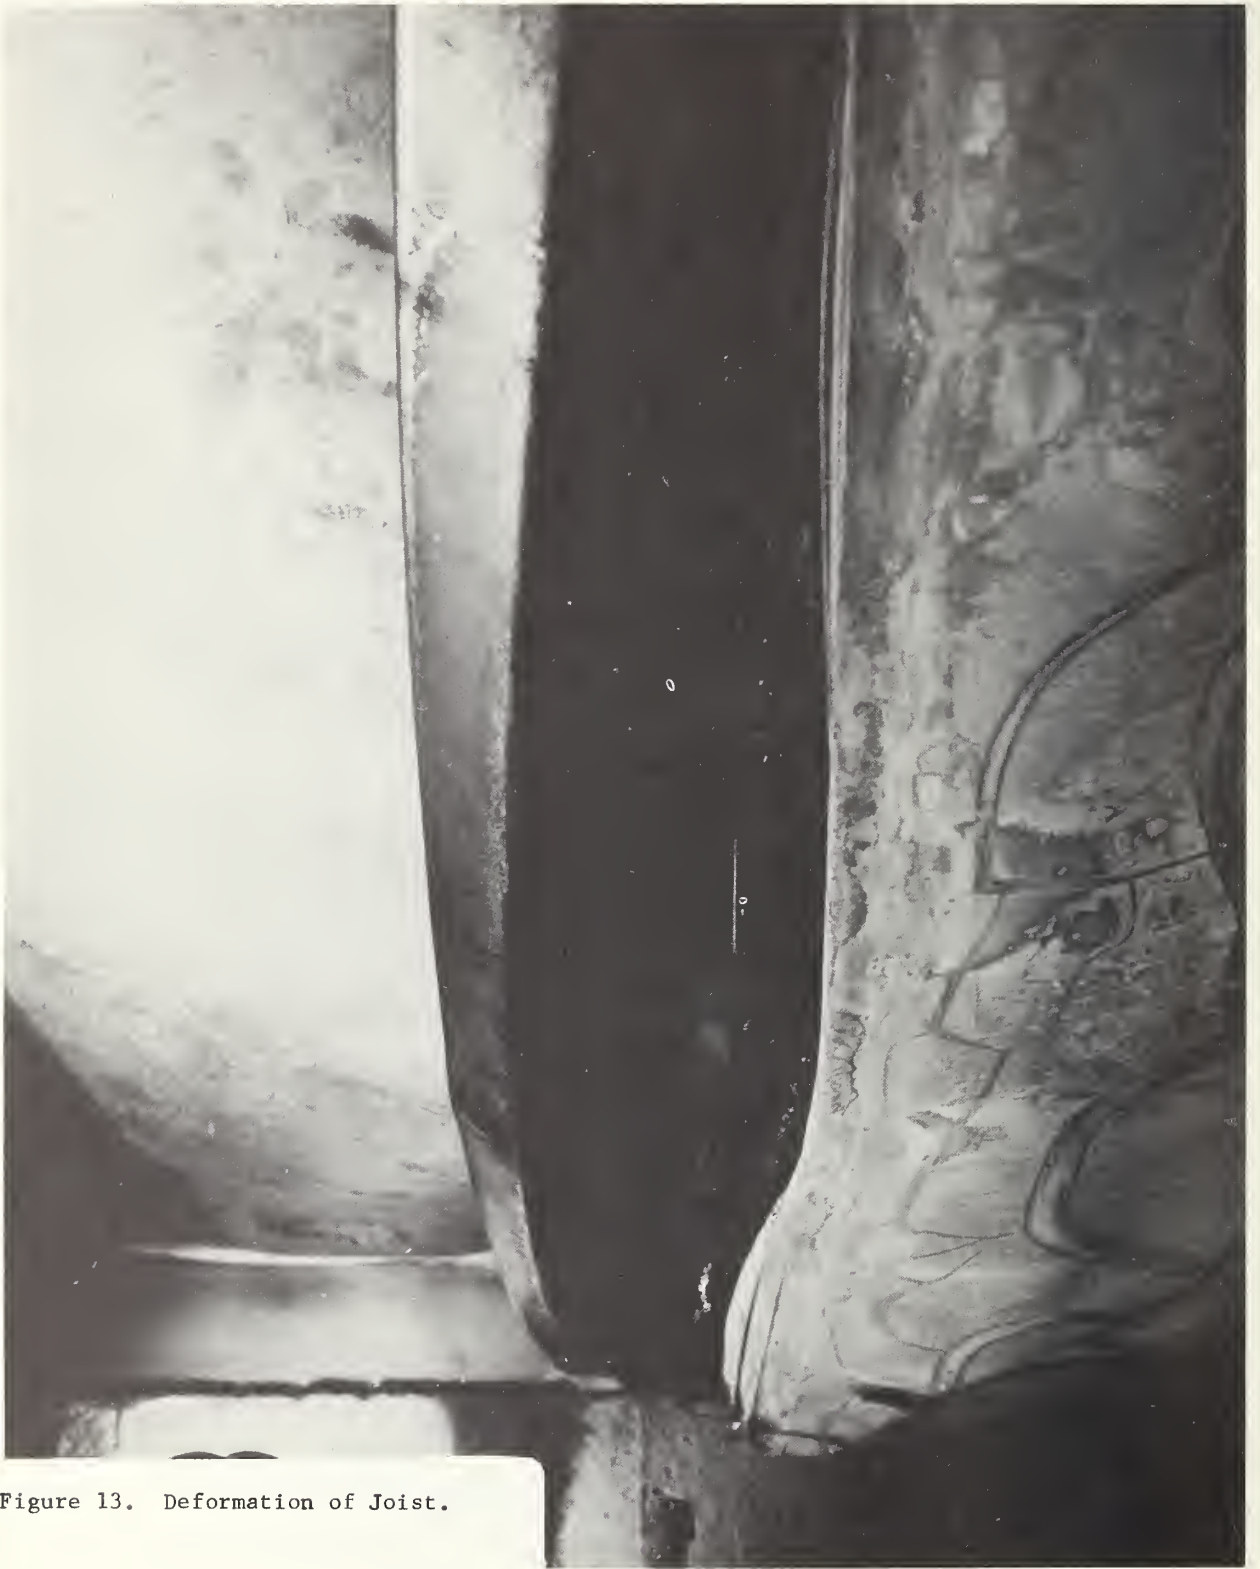
Figure 13. Deformation of Joist.

The deflection and torsional rotation of the light gage steel joists were main causes of failure in the test. The joists were then unable to sustain the applied load and resulted in opening of the joints permitting flame through. Because of their asymmetry, the joists, unless restrained, will have a mode of failure in torsional bending with the open side down. An illustration of this phenomenon is indicated in the after-test photographs of Figures 13 and 14.

The early deformation of the joists followed the general behavior pattern of unprotected steel structural members in the standard fire test. Many steels lose approximately half their strength^{2/}, and with this the usual design safety factor, at about 538°C (1000°F) which was the furnace temperature at 5 minutes. Therefore, extended duration beyond this time cannot justifiably be expected. From Figure 10, it can be seen that this limiting temperature was attained at the thermocouple at the top of a joist at about the time that failure occurred.
