NBSIR 73-168

Fire Endurance Test of a Fiber Glass Reinforced Polyester Double Wall Assembly

Final Report

As a part of the evaluation of a housing system proposed under Operation BREAKTHROUGH a standard fire endurance test was performed on a double wall assembly comprising a load-bearing interdwelling (party) wall for single family attached housing. The test method was in accordance with the requirements of ASTM E 119, and the applied load was 700 pounds per linear foot (plf) per wall. The test results are valid only for walls of similar construction loaded at or below the stress level developed by this loading.

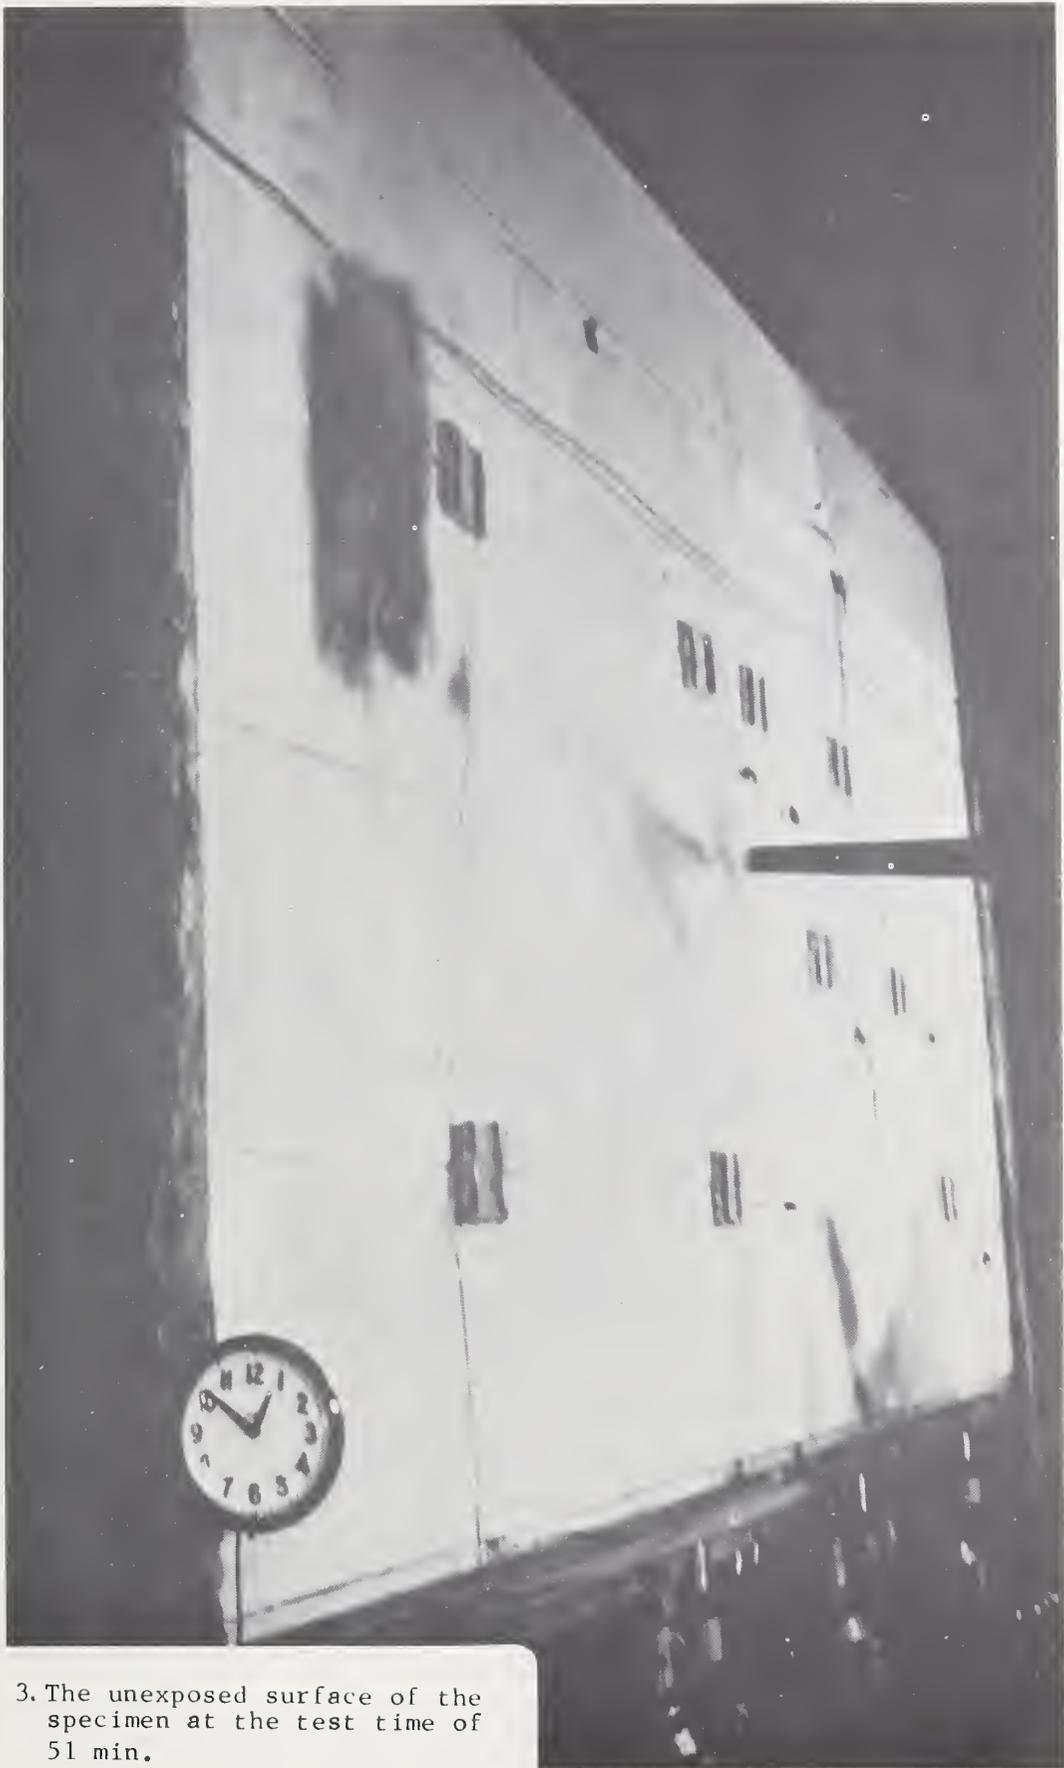
Figure 6 indicates that the maximum permissible temperature rise of 181°C on the unexposed surface of the second wall occurred at 54 minutes on the thermocouple located on the south top corner. However, the failure time was taken to be 42 minutes by evidence of a charred brown spot on the south top quadrant on the unexposed surface, away from a measuring thermocouple. According to previous experience, the surface temperature corresponding to charring similar to that shown in Figure 3 is greater than 250°C.

The localized thermal failure of the second wall occurred at 42 minutes, while the remaining portion of the wall remained an effective thermal barrier. This was possibly due to incomplete placement of the mineral wool insulation during assembly and improved quality control might insure improved performance.

- 50:00 30% of the second wall (north end) still protected by remnants of the first wall, but the rest is completely engulfed in flames. There is now a large brown spot appearing at the south end (Figure 3).

Figure 3. The unexposed surface of the specimen at the test time of 51 min.

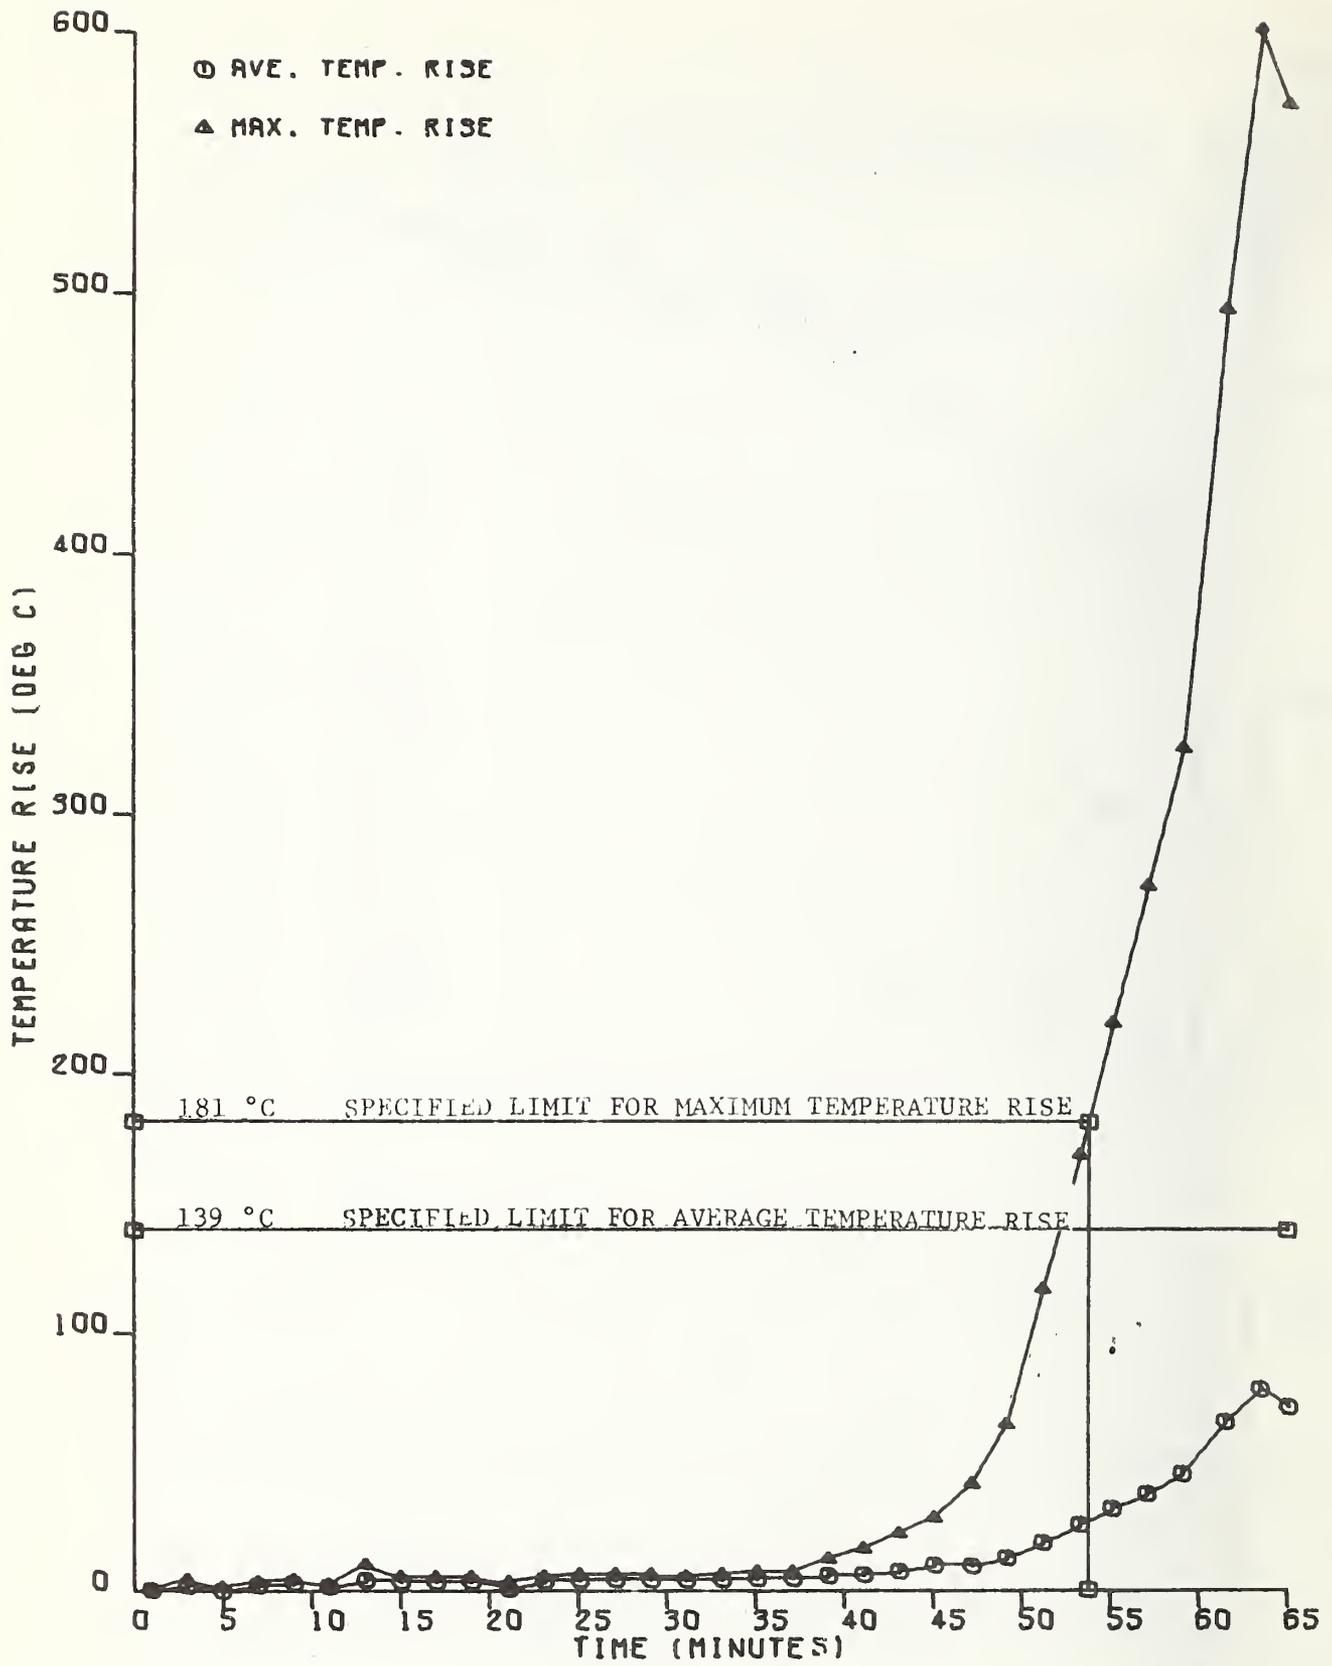
Figure 6.
 AVERAGE AND MAXIMUM TEMPERATURE RISE ON THE UNEXPOSED SURFACE.

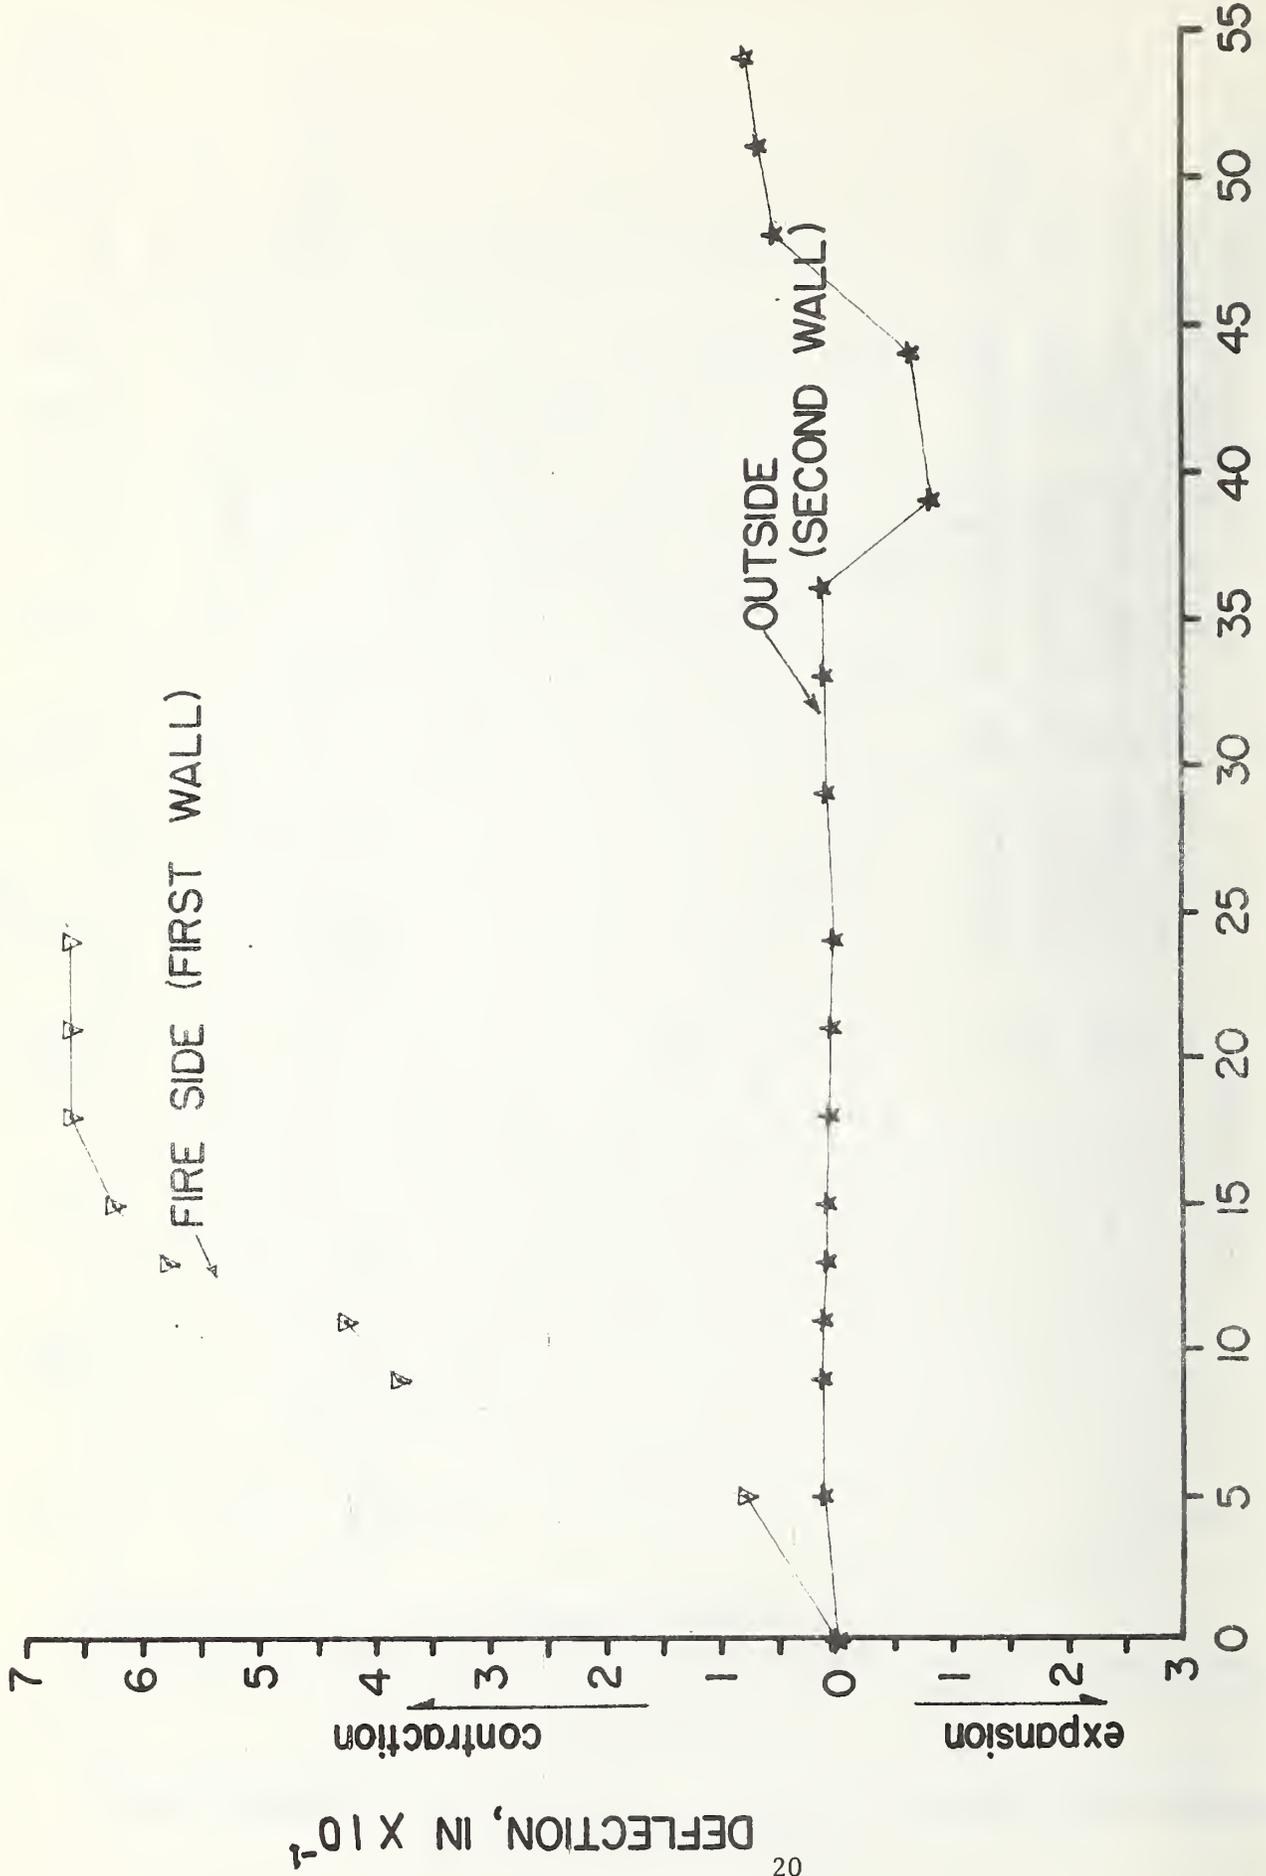
Structural failure of the first wall occurred at 27 minutes: 25 seconds, as evidenced by a sudden rapid vertical deflection of the lower edge of the panel and the inability to maintain the applied hydraulic load. Immediately prior to the failure of the first wall the measured vertical deflection of the first wall was 1.06 in.

Figure 10. Vertical deflections of the first and second wall.

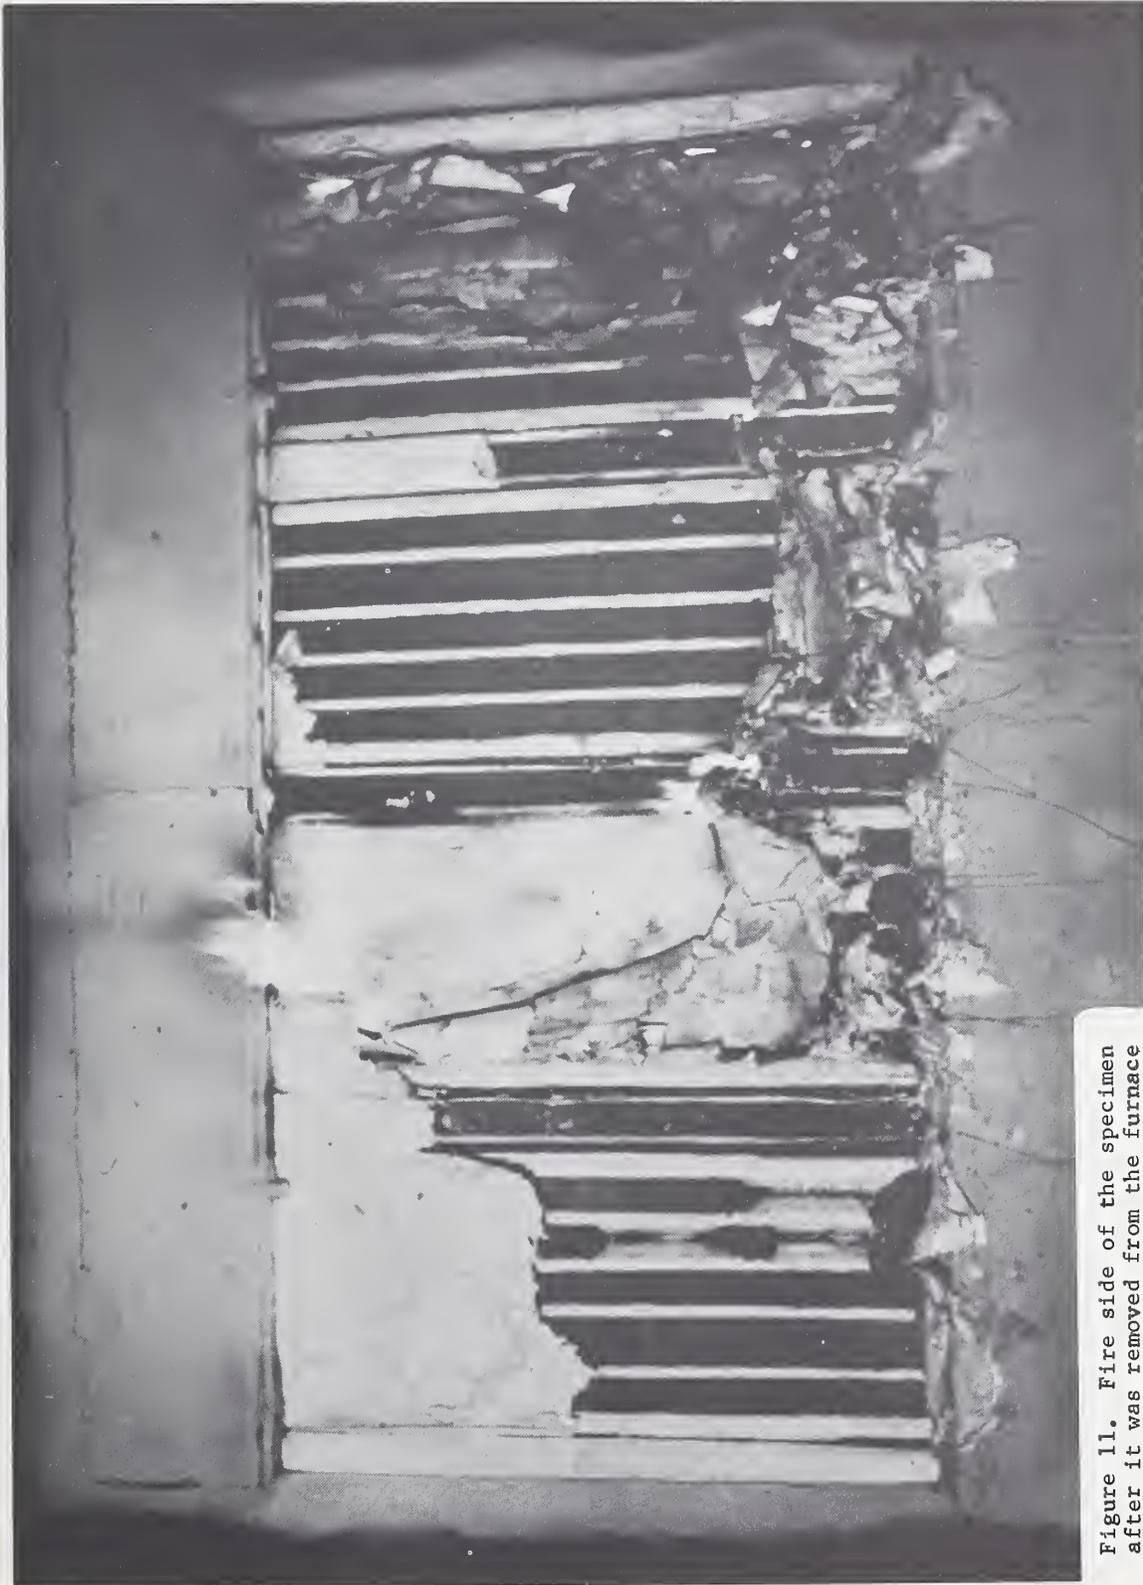
The permissible average temperature rise of 139°C on the unexposed surface did not occur during the test. The remainder of the thermocouples on the unexposed surface, except the one on the south top corner, did not exceed 50°C rise during test. After the test, it was noticed that the insulation in the second wall panel was intact except in the south upper quadrant area.

After the exposed GRP sheet and the mineral wool insulation had fallen off, the corrugated stiffeners of the first wall were directly exposed to the furnace fire. It was observed that the intumescent paint did not expand and did not provide appreciable protection.

Figure 11. Fire side of the specimen after it was removed from the furnace at the end of the test. Note that the insulation in the south quadrant area of the second wall had fallen off.

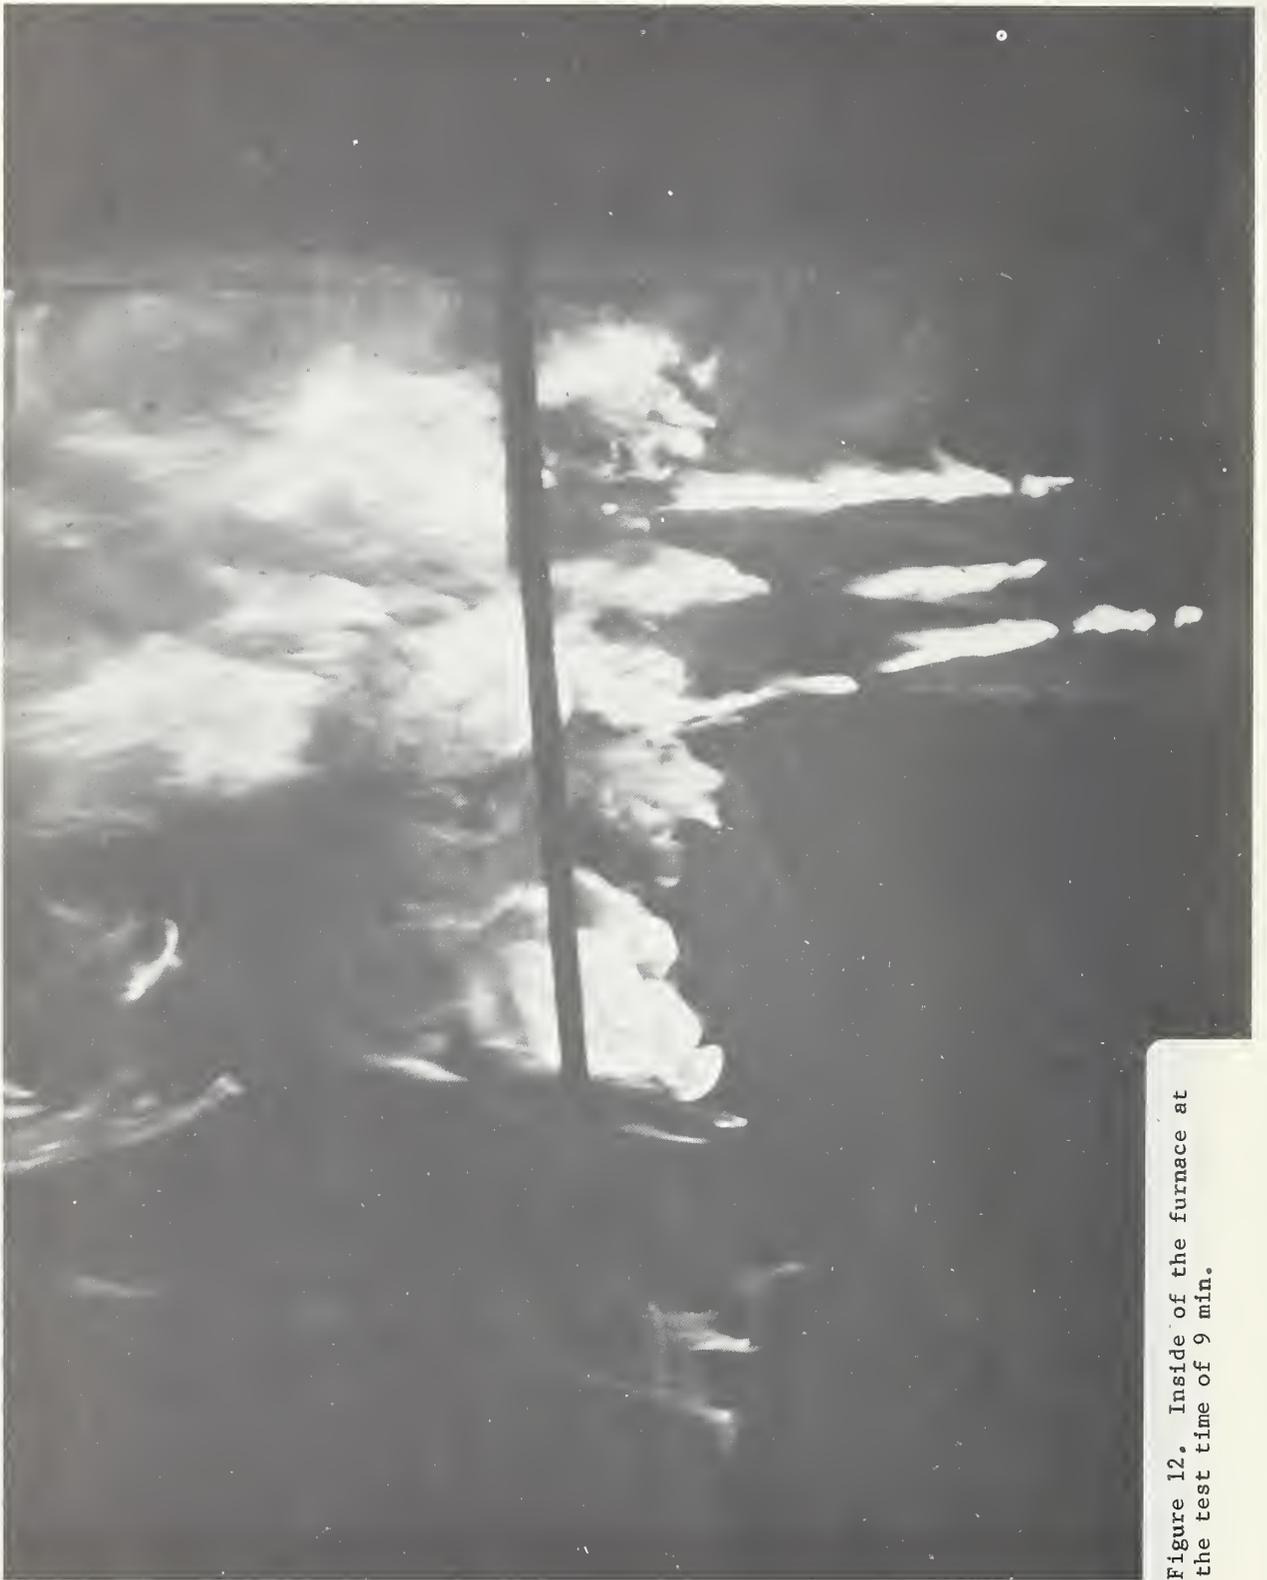
9:00	Large pieces of insulation and burning glass fiber skin from the middle of the specimen fell into the furnace (Figure 12).
11:00	Increasing quantities of white smoke coming out of the corners of the specimen.

Figure 12. Inside of the furnace at the test time of 9 min.
