NBSIR 73-169

Fire Endurance Test of a Wood Stud Interdwelling Double Wall Construction

Final Report

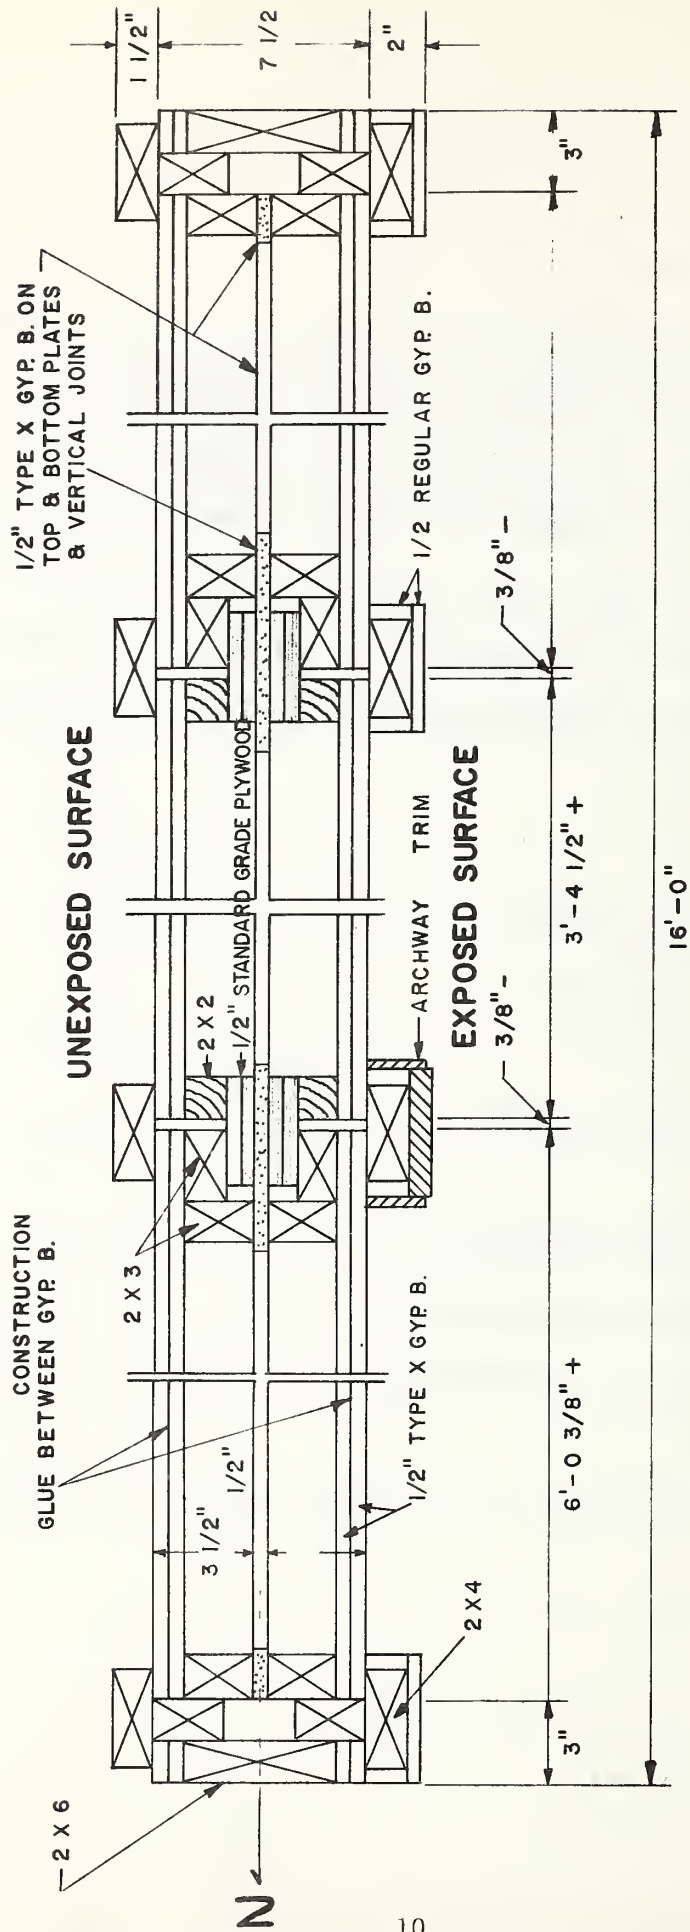
Figure 1 Construction Detail

Although failure did not occur at any of the panel joints during the test, the joint behind the wood trim would have failed before the joint behind the gypsum board, if the test had been continued. The batten behind the wood trim began to fall at 57 min, while the one behind the gypsum board was found intact at 1 hr 31 min. (See the Log of Test Observations in the Table I).

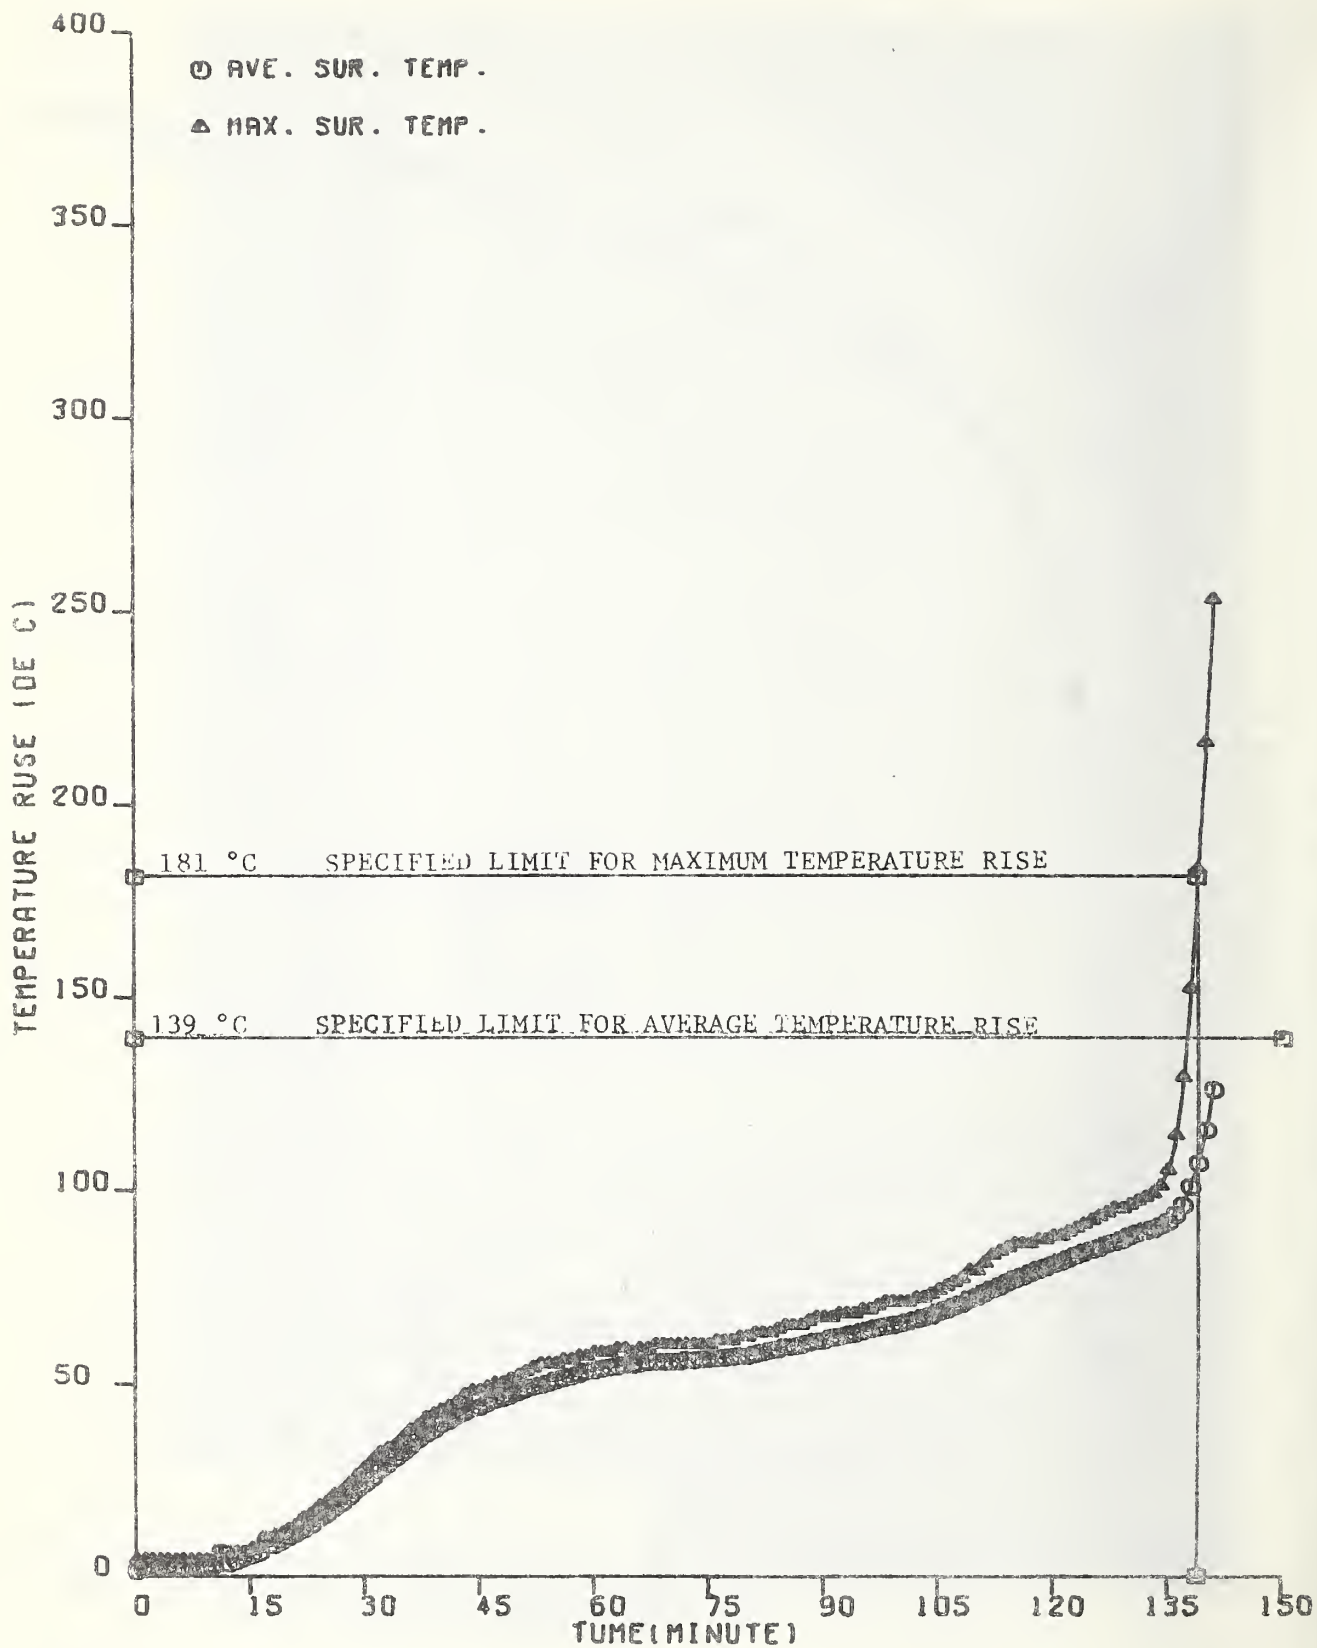
Figure 5.

The overall fire endurance of the assembly was 2 hr 19 min with failure by an excessive temperature rise (over 181°C) at a single point on the unexposed surface of the second (unexposed) wall of the north end panel.

MAX. AND AVE. TEMPERATURE RISE ON THE UNEXPOSED SURFACE TEST 504

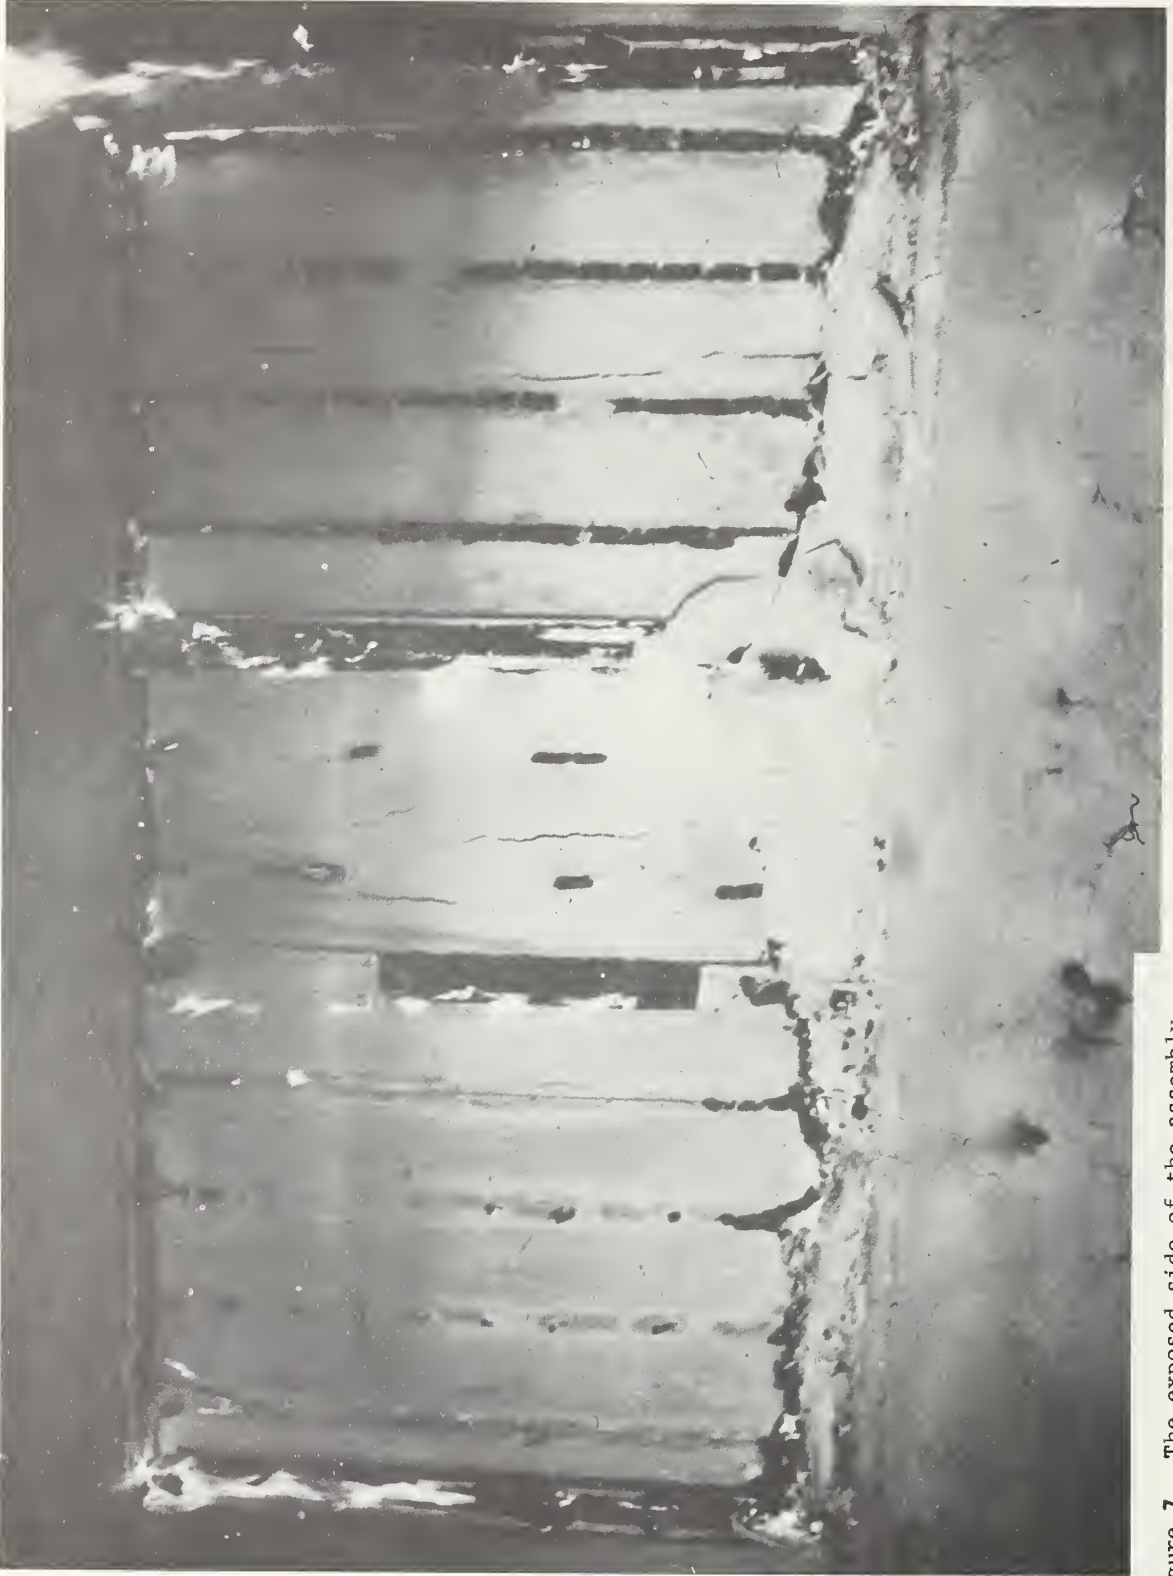
Figure 7. The exposed side of the assembly after it was removed from the furnace.

The failure of the first (fire exposed) wall occurred at 1 hr 17 min when flame penetrated through a gypsum joint opening in the base layer of gypsum board of the fire wall in the middle of the north end panel.

Figure 7 shows the exposed side of the assembly after it was removed from the furnace. All of the first wall has collapsed and most of the wood studs of the second wall have burned away. Note also long cracks on the gypsum boards.
