NBSIR 73-170

Fire Endurance Test of an Interdwelling Double Wall Constructed of Polyurethane Foam-Filled Sandwich Panels

B. C. Son

Final Report

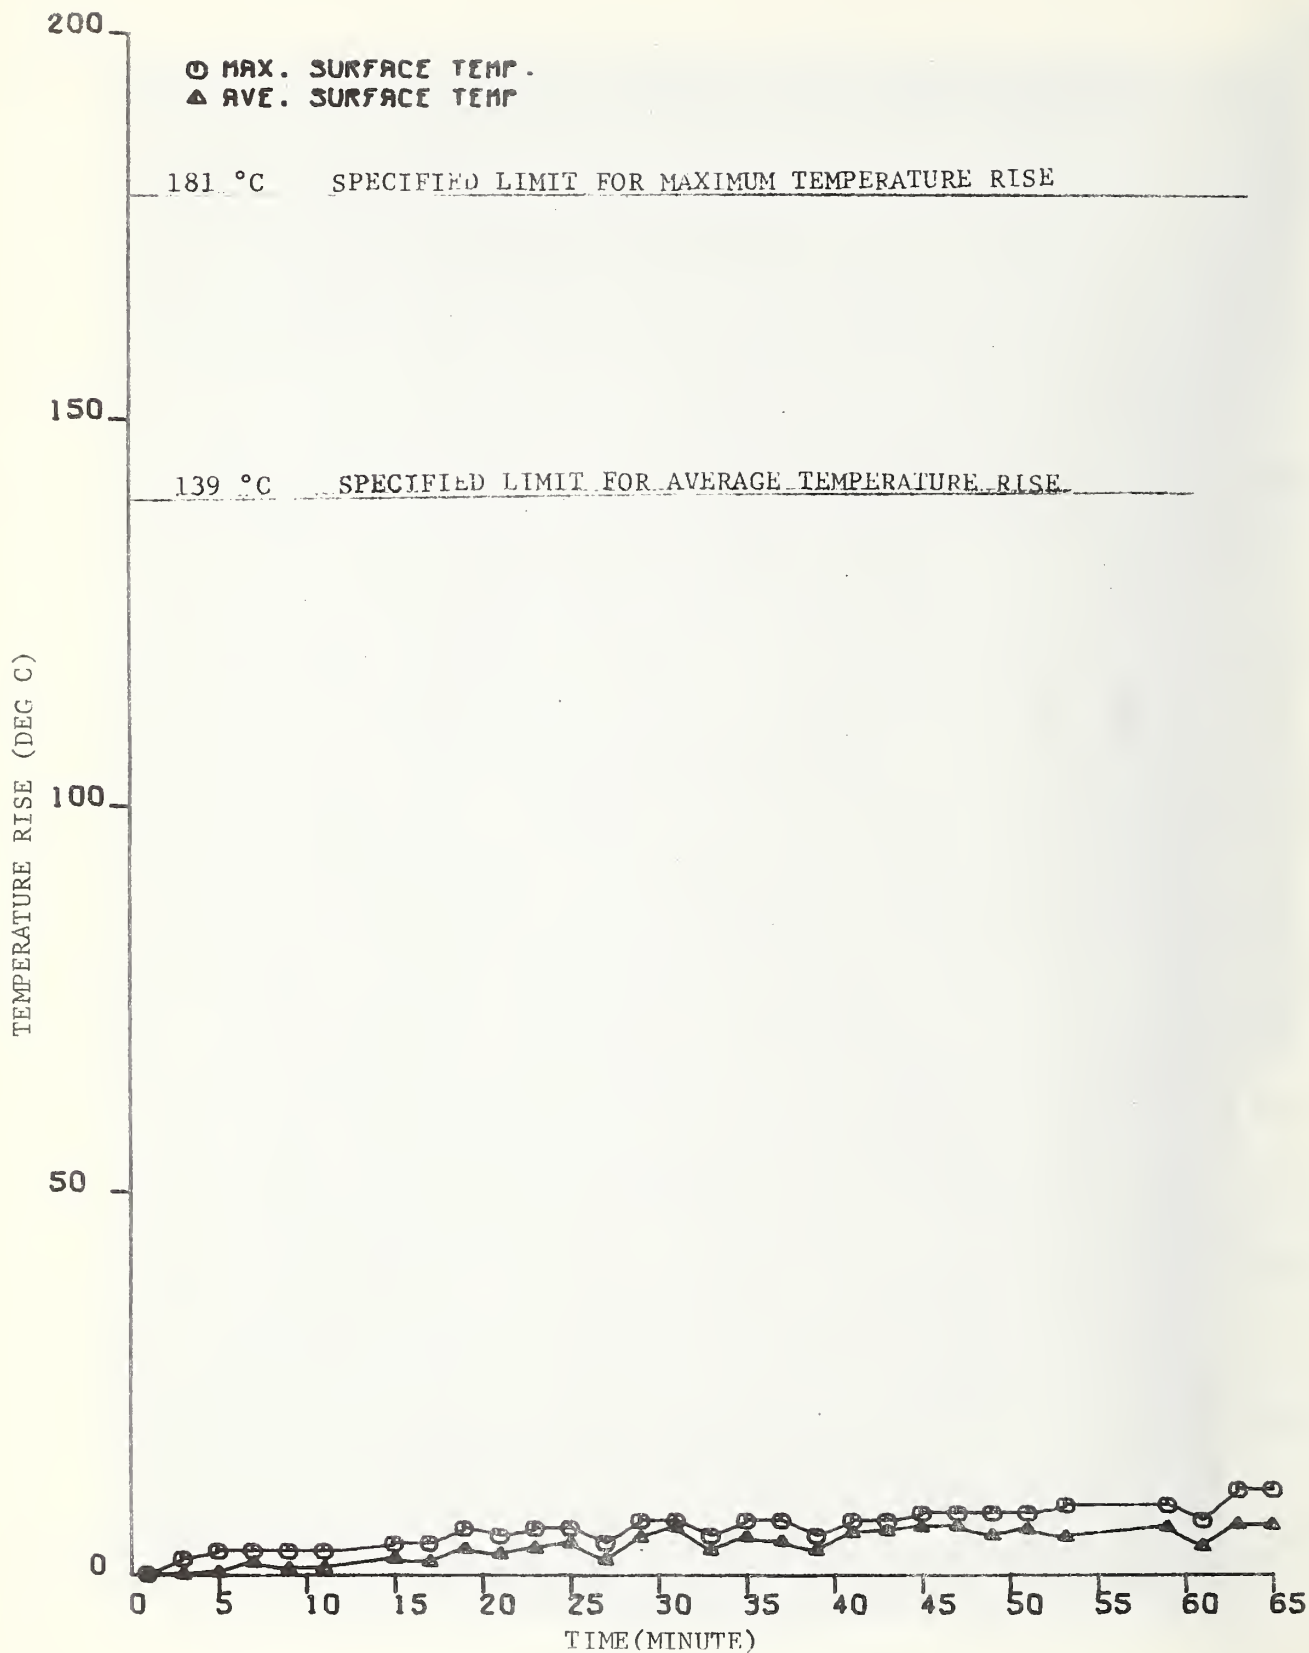
The average and the maximum temperature rises on the unexposed surface during the test are shown in Figure 8. The average and maximum temperature rise across the assembly are shown in Figures 9 and 10. It is clear that very little heat was transmitted through the double wall assembly during the 66 min. test.

MAXIMUM AND AVERAGE TEMPERATURE RISE ON THE UNEXPOSED SURFACE TEST 505.

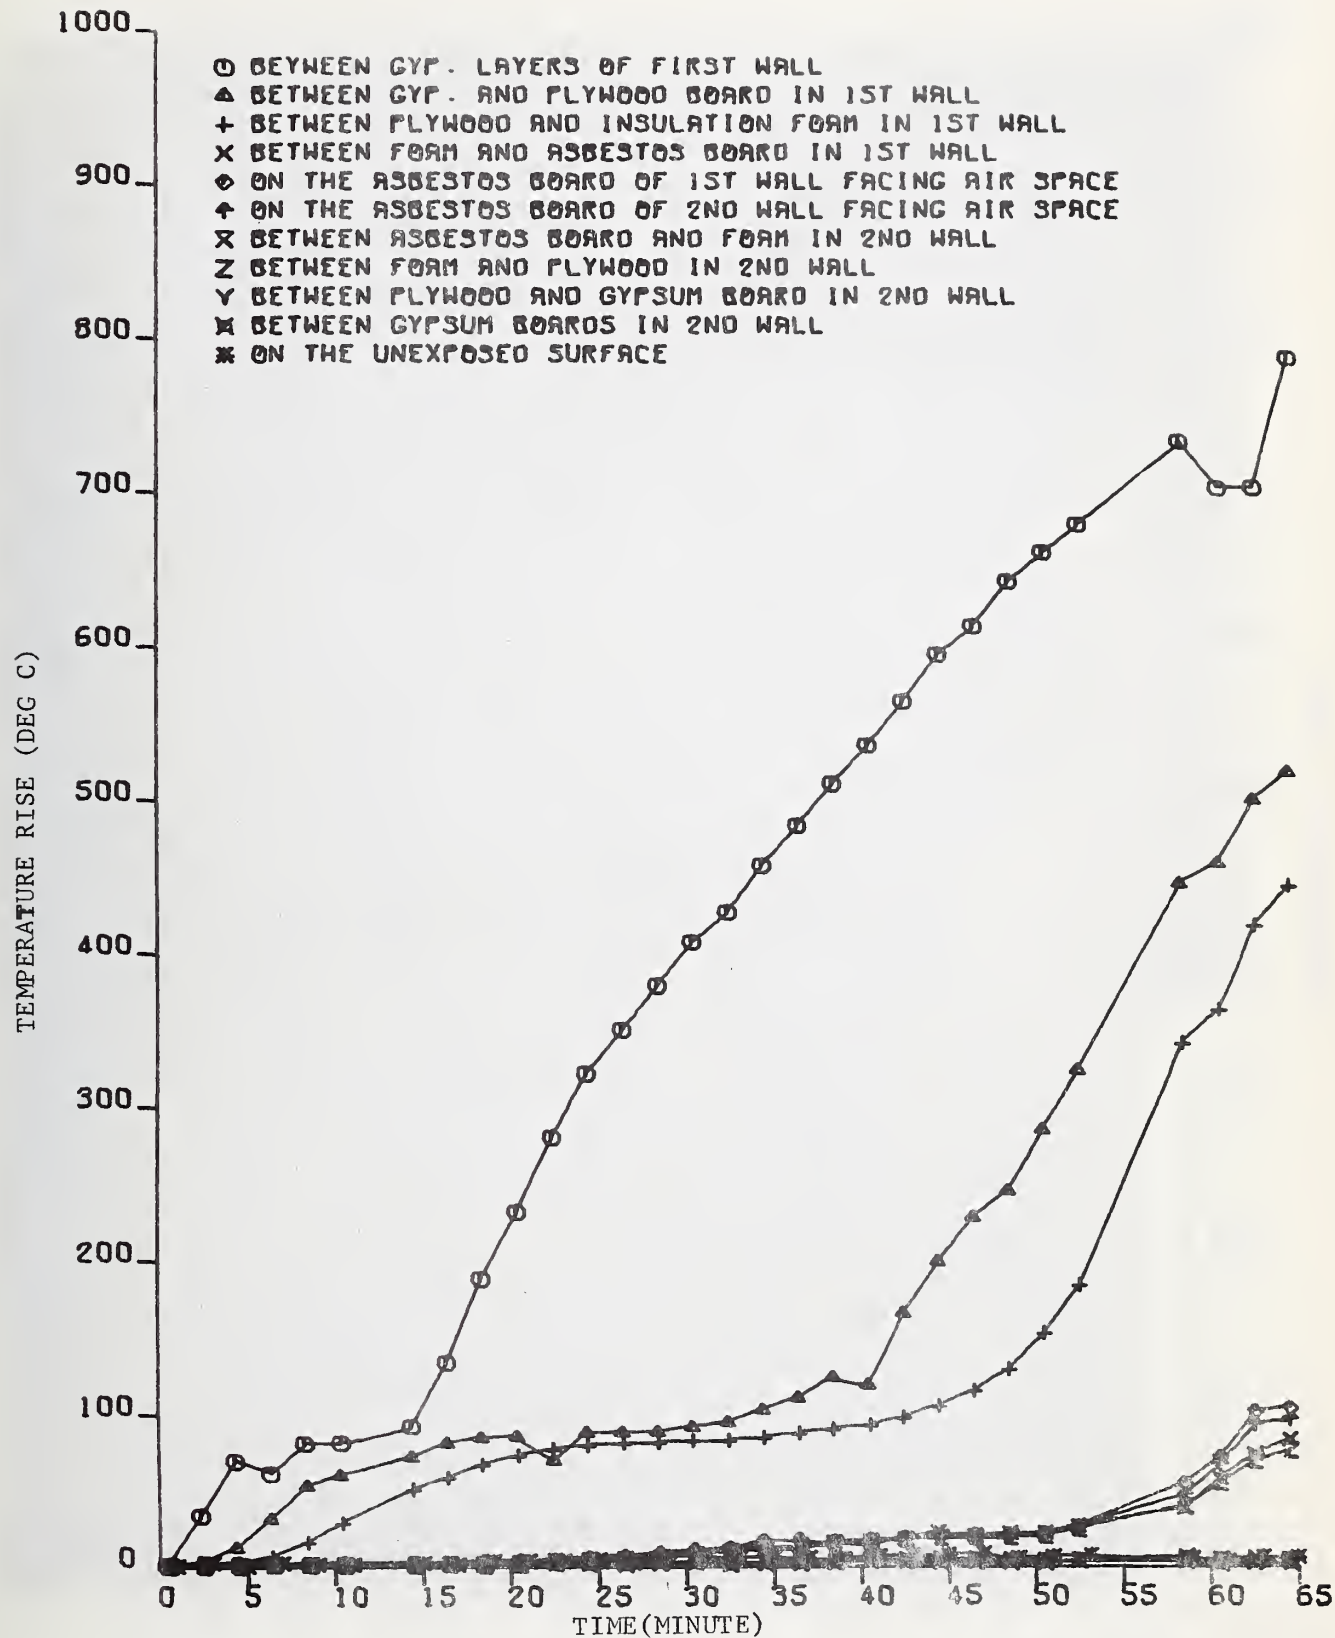
Figure 9.

AVERAGE TEMPERATURE RISE ACROSS THE ASSEMBLY TEST 505.

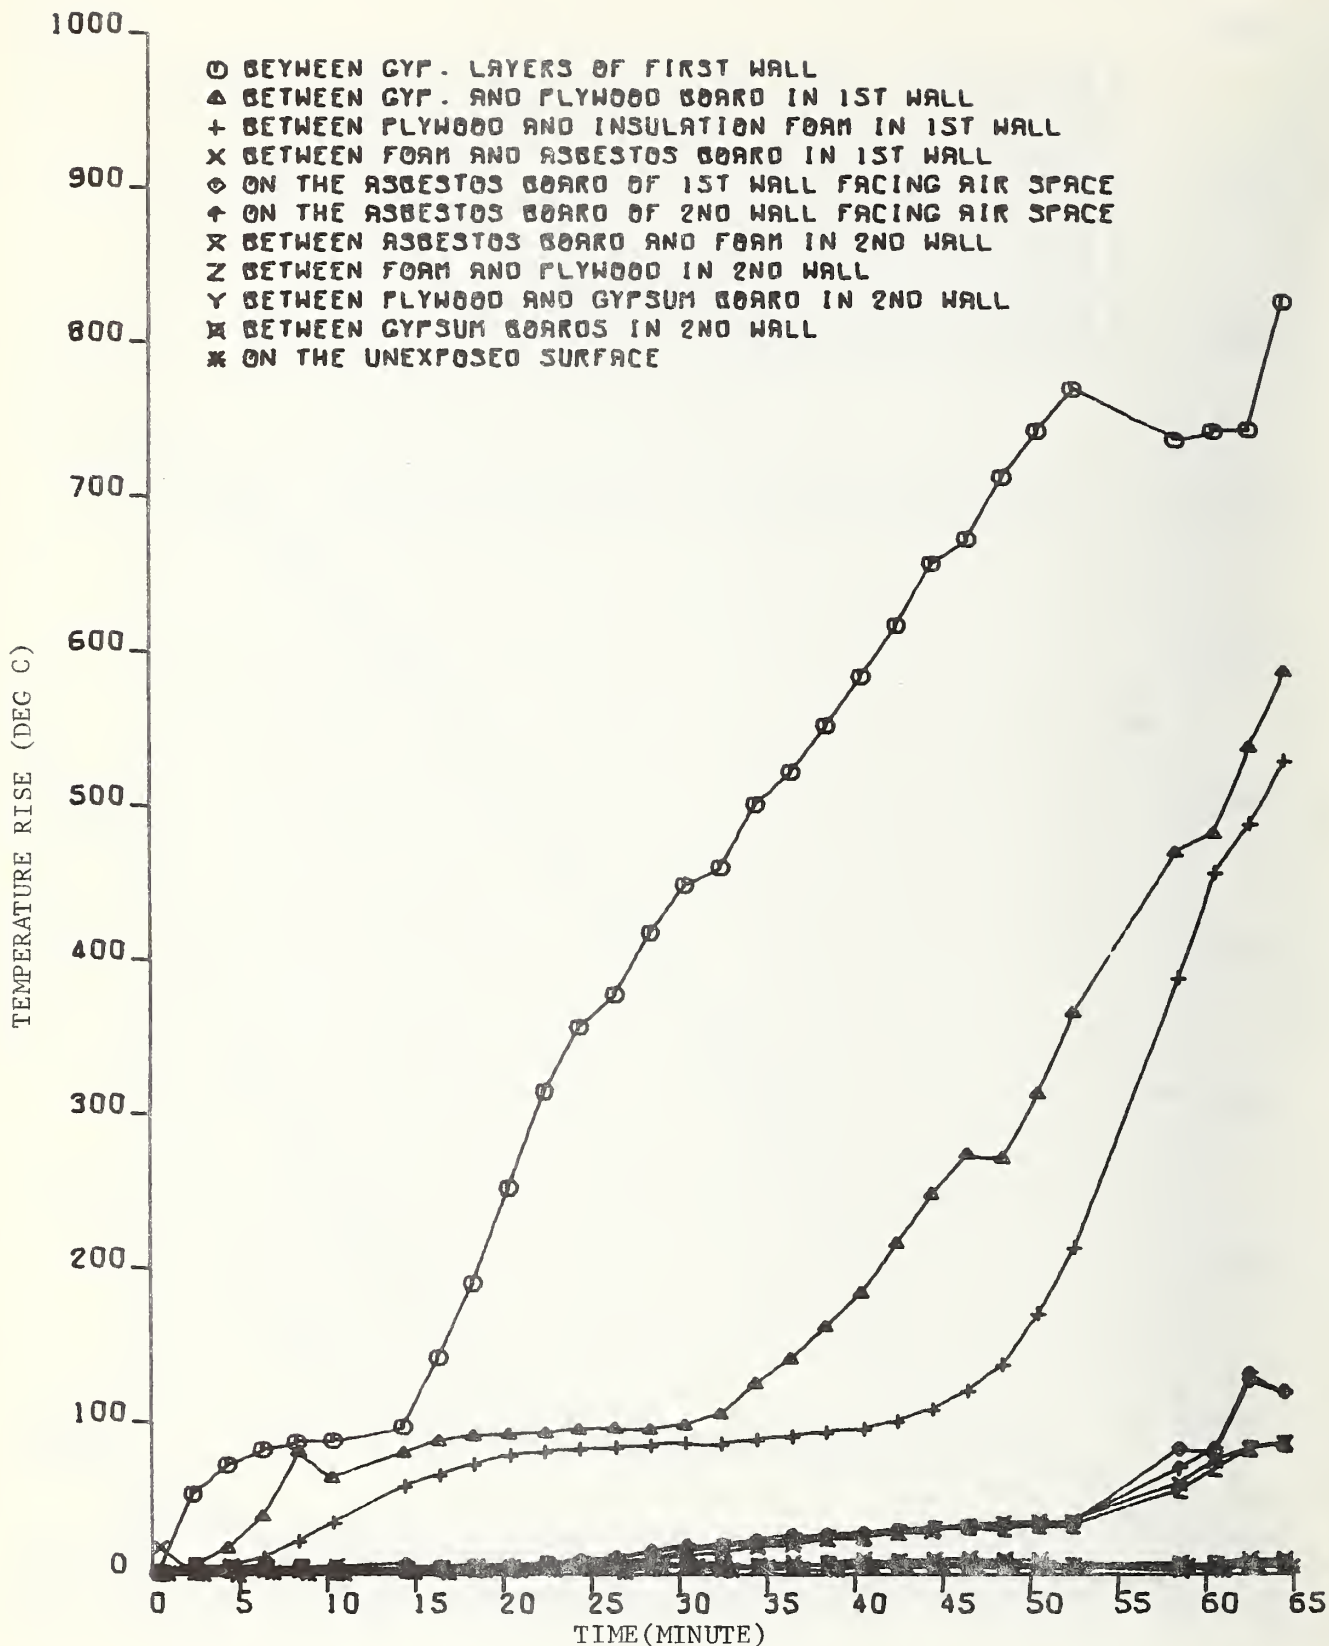
Figure 10.

MAXIMUM TEMPERATURE RISE ACROSS THE ASSEMBLY TEST 505.

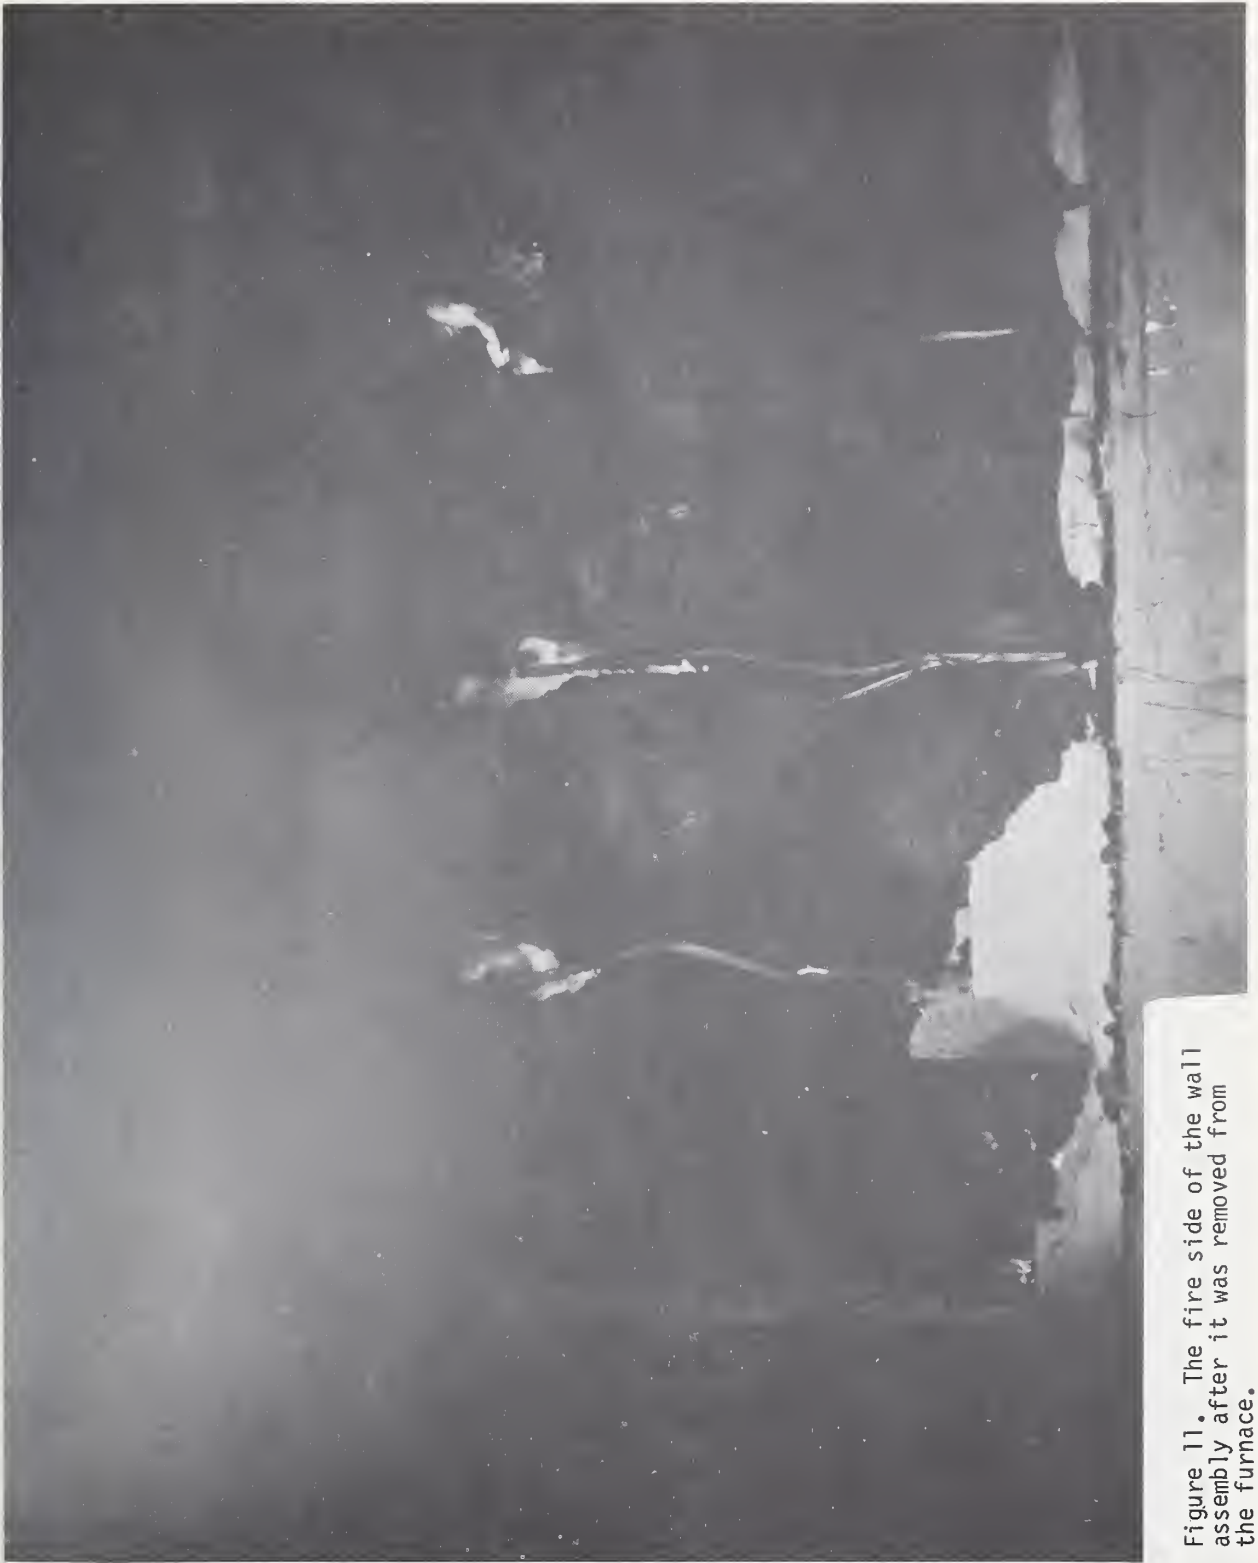
Figure 11 shows the fire side of the wall assembly immediately after removal from the furnace. Note buckling (and melting) of the aluminum frame in the first wall. The buckling of the vertical aluminum frame occurred at the time of load failure of the first wall. The flaming at the joint is from the resilient wedge behind the joint. The asbestos boards of the first fire side wall were also buckled and cracked but no large holes were observed.

Figure 11. The fire side of the wall assembly after it was removed from the furnace.

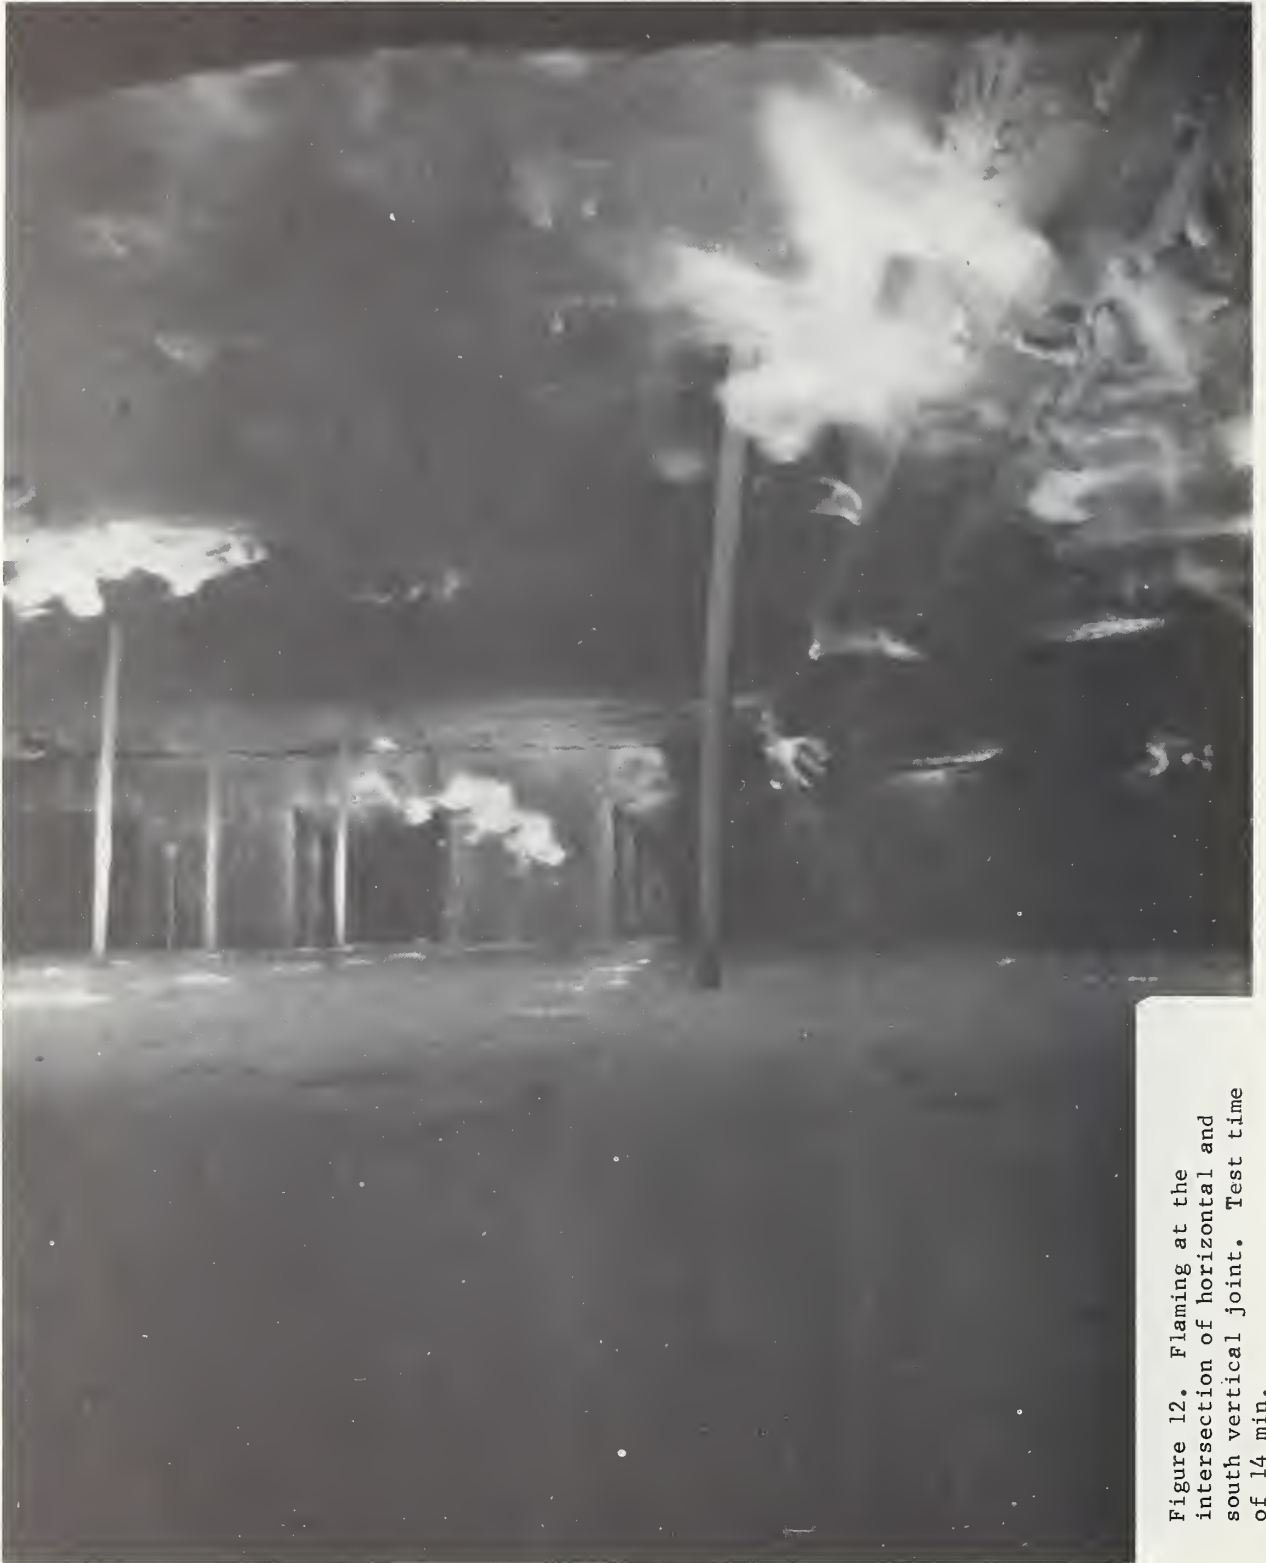
11:00	The spackling on exposed vertical joints peeling off.
12:00	There appears to be an opening in the south end horizontal joint.
14:00	There is blackening at top of specimen (exposed side south end). Flaming at the intersection of horizontal and south vertical joint. (See Figure 12.)

Figure 12. Flaming at the intersection of horizontal and south vertical joint. Test time of 14 min.

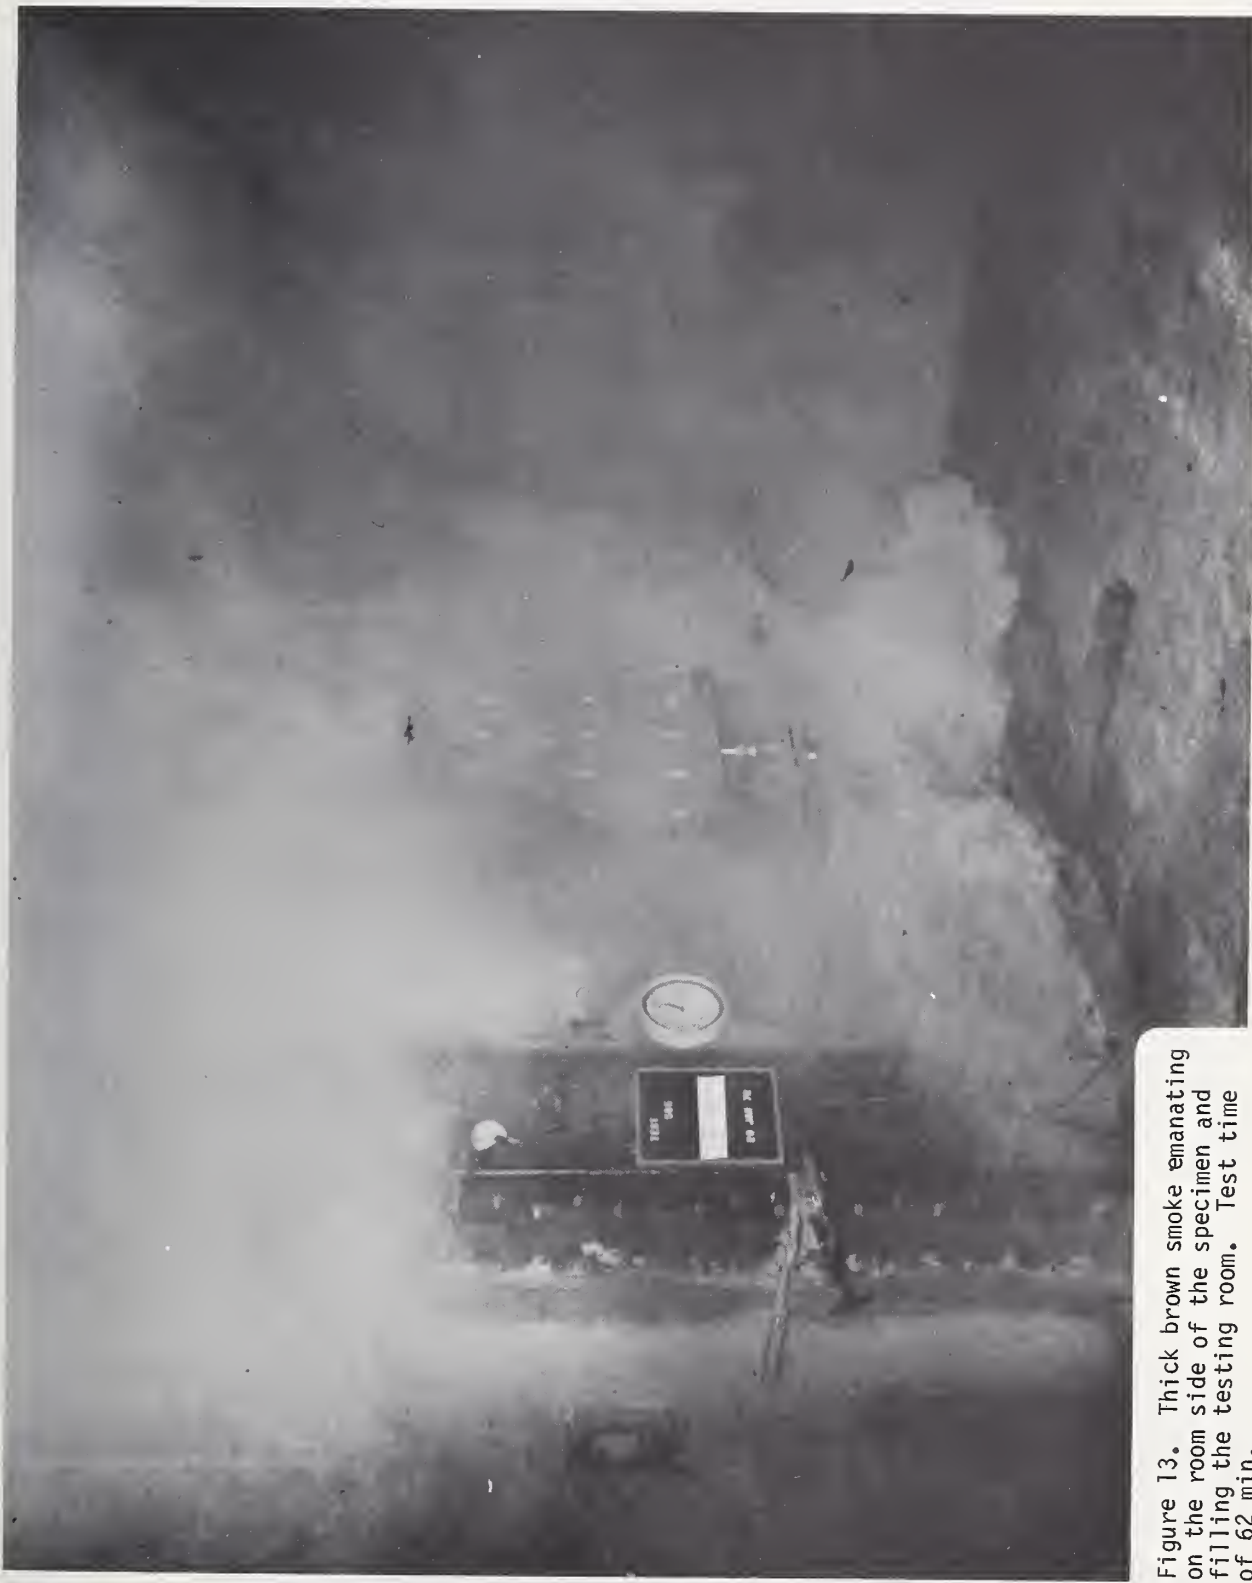
61:00	First wall on furnace side buckling inward at south horizontal and lower center vertical joints. (See Figure 13).
62:00	There is a great amount of smoke filling the whole room. The first wall falling inward.

Figure 13. Thick brown smoke emanating on the room side of the specimen and filling the testing room. Test time of 62 min.
