Investigation of the Skyline Plaza Collapse in Fairfax County, Virginia

E. V. Leyendecker and S. G. Fattal

Center for Building Technology
Institute for Applied Technology
National Bureau of Standards
Washington, D. C. 20234

Final Report

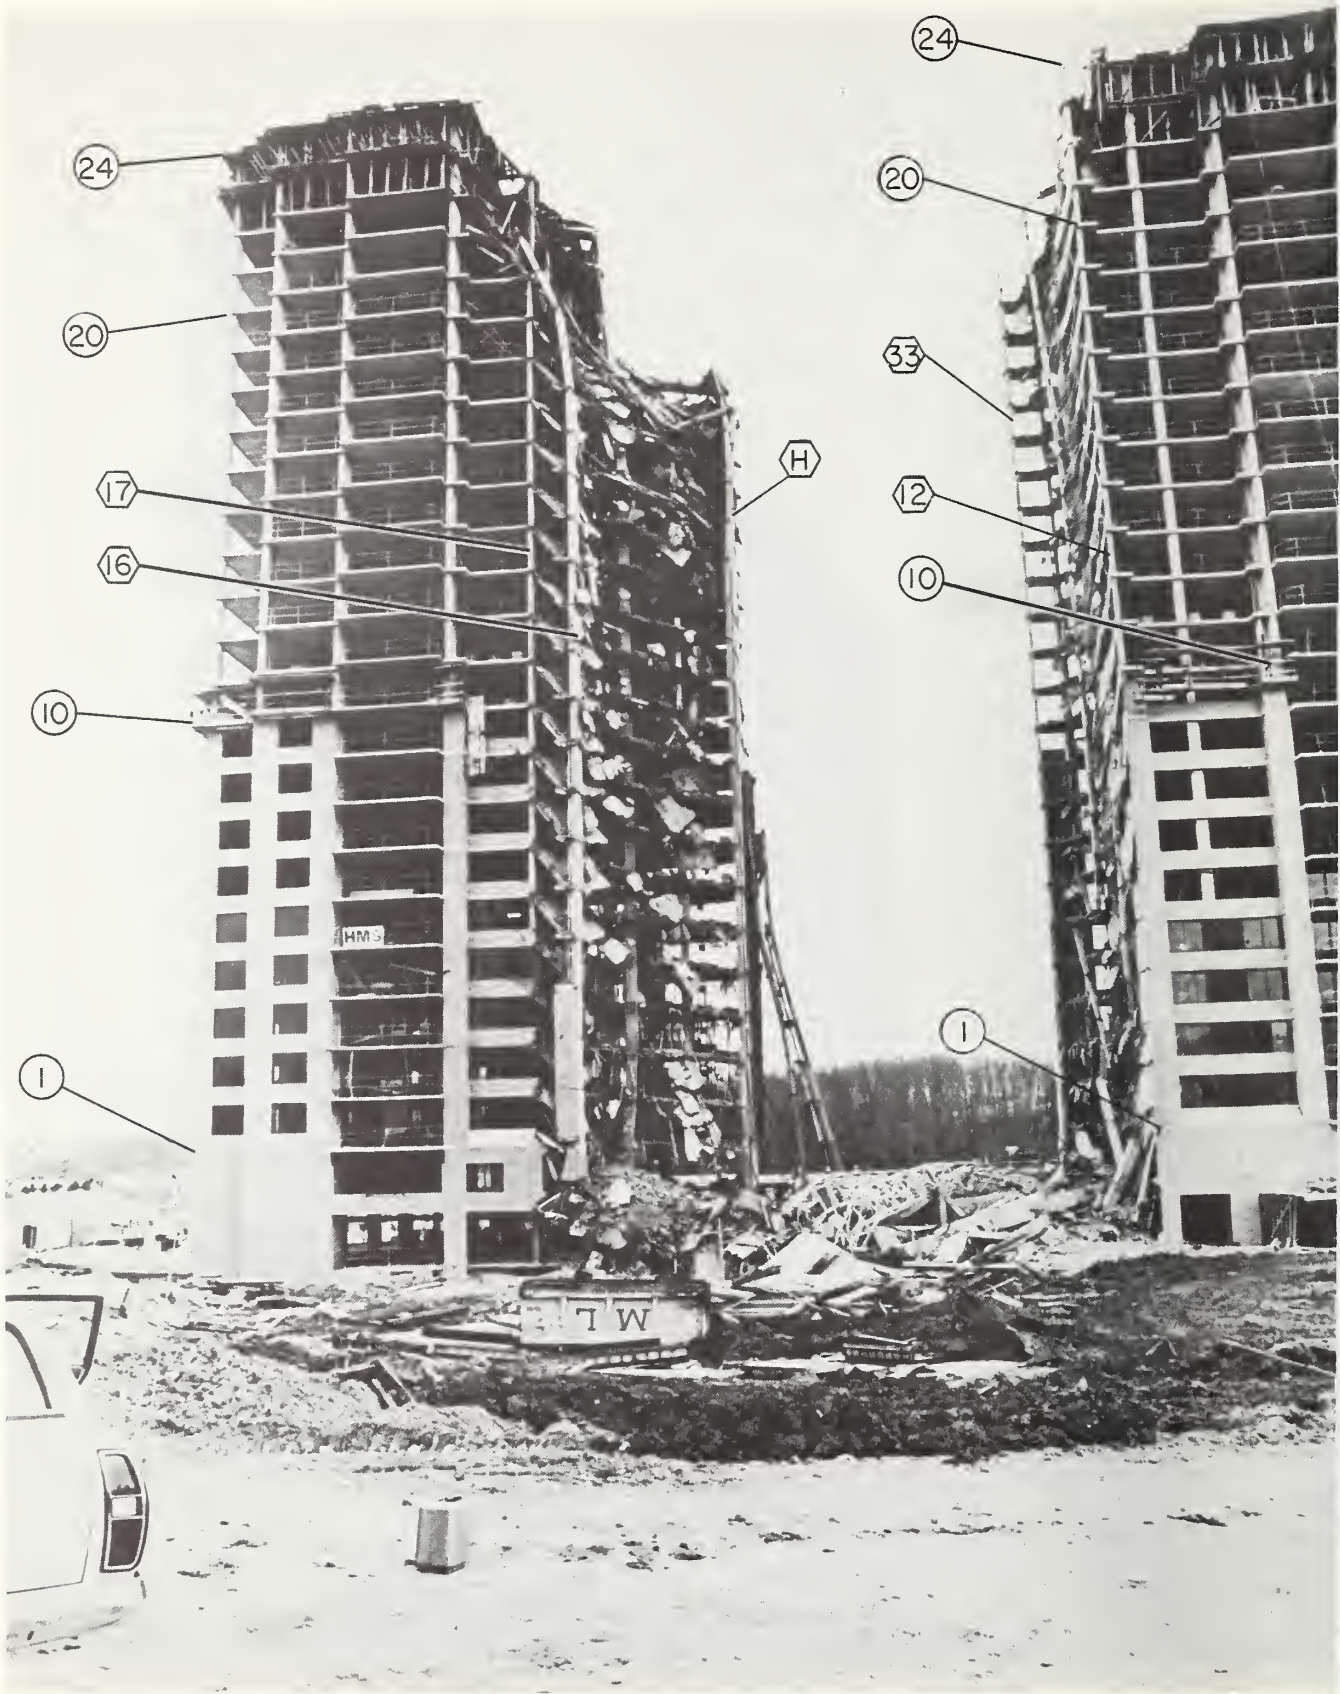
A partial view of the north face of building A-4 is shown in figure 2.5. A number of columns and floors are identified. The collapse extended between shear wall H and column 33 on the south face, a distance of about 65 ft (refer to figure 2.1). On the north face the collapse extended between columns 12 and 17, a distance of about 104 ft. Note that for most floors the slab between columns 16 and 17 did not sever from the main building but is sagging for a one-story height. Below the 20th floor, the horizontal extent of the collapse is as discussed above. Above the 20th floor, the failure zone extended slightly to the west and a greater amount to the east.

Figure 2.5 General view of the north face of building A44.

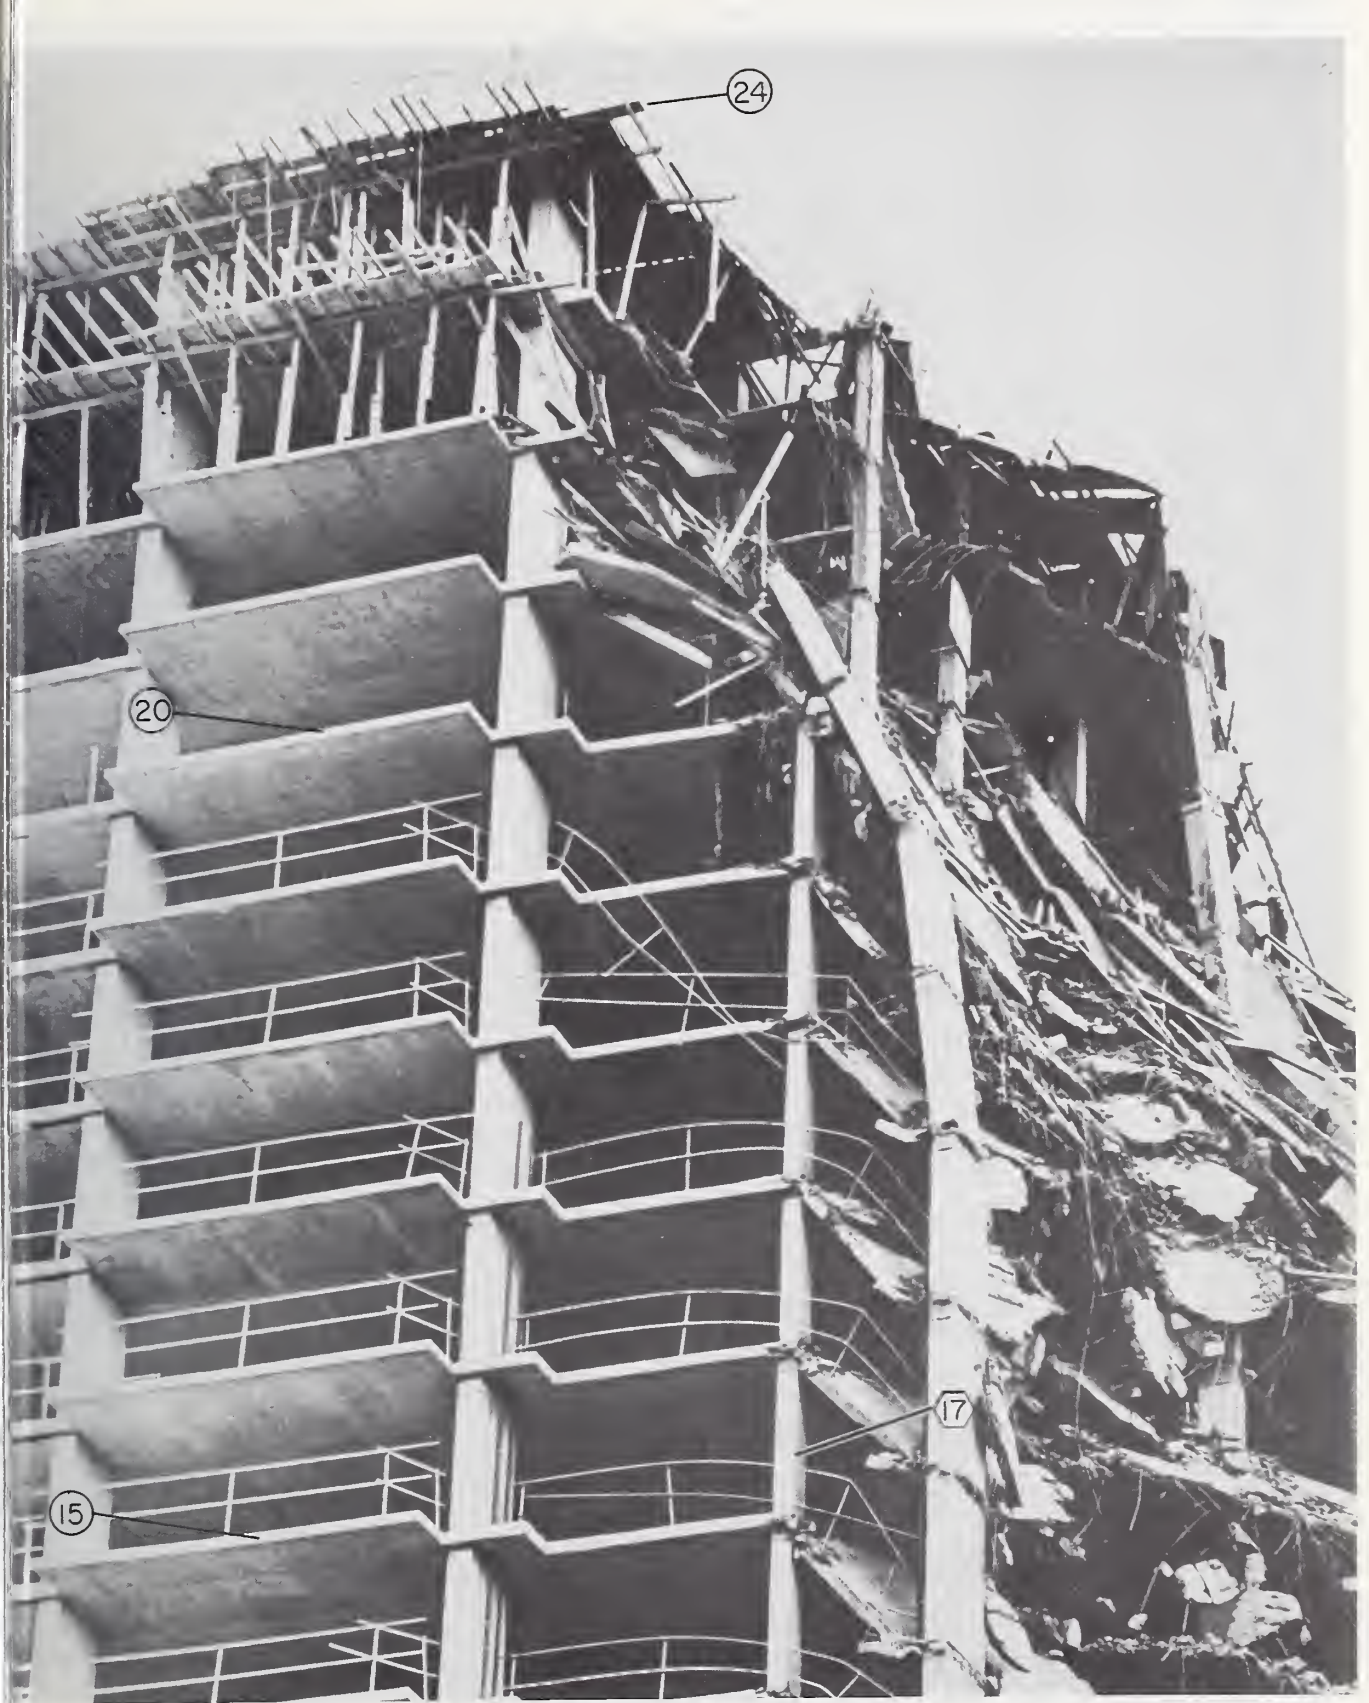
Figures 2.6 through 2.8 are closeup views of the east end of the failure zone. These figures require little comment at this time; however, it should be noted that the formwork is clearly visible in figure 2.6.

Figure 2.6 Closeup view of the top of the east end of the failure zone, looking south.

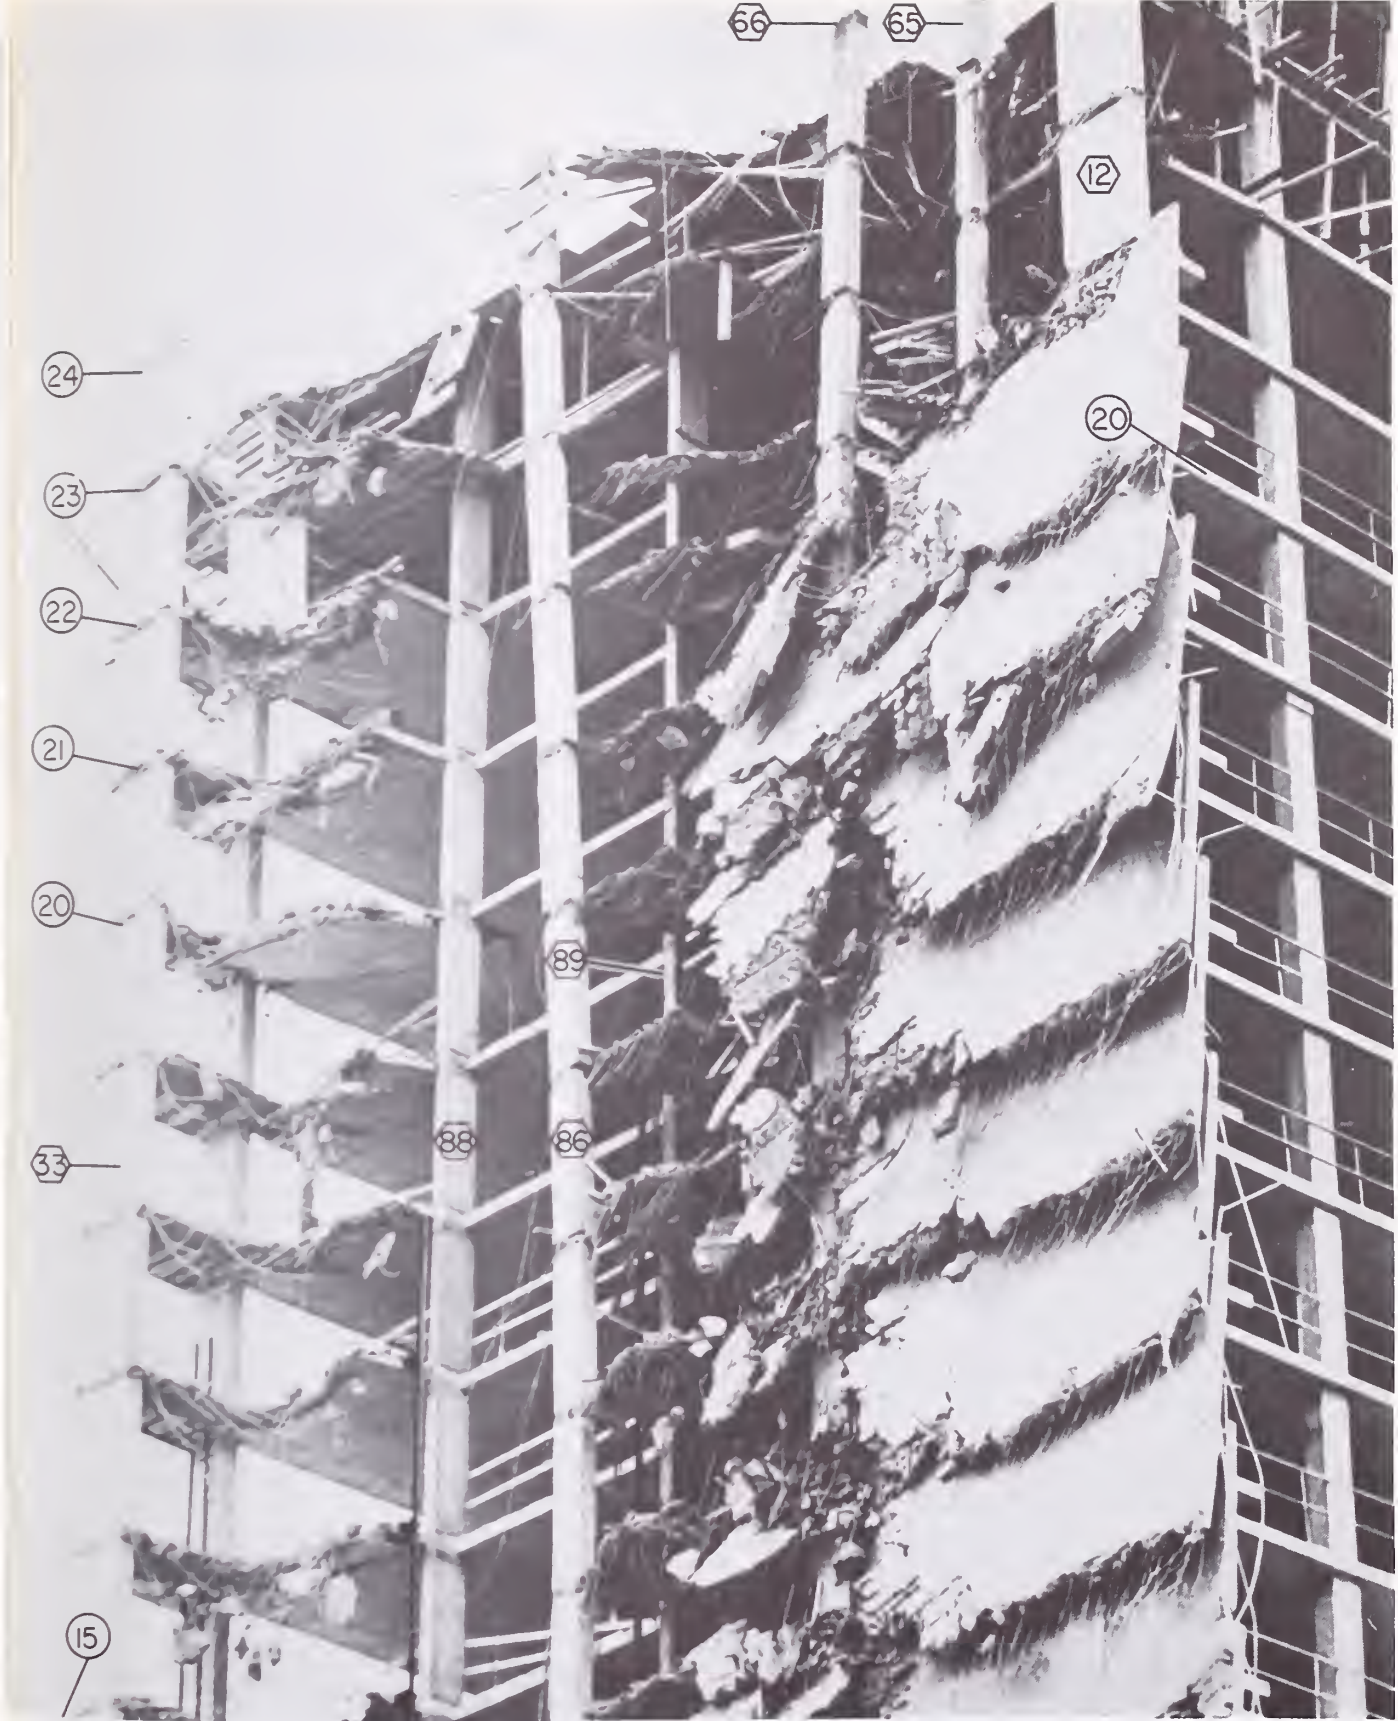
A general view of the west end of the failure zone is shown in figure 2.9 along with closeup views in figures 2.10 through 2.12. These figures also require little comment at this time; however, it should be noted that the formwork is clearly visible in figure 2.10.

Figure 2.10 Closeup view of the top of the west end of the failure zone, looking southwest.

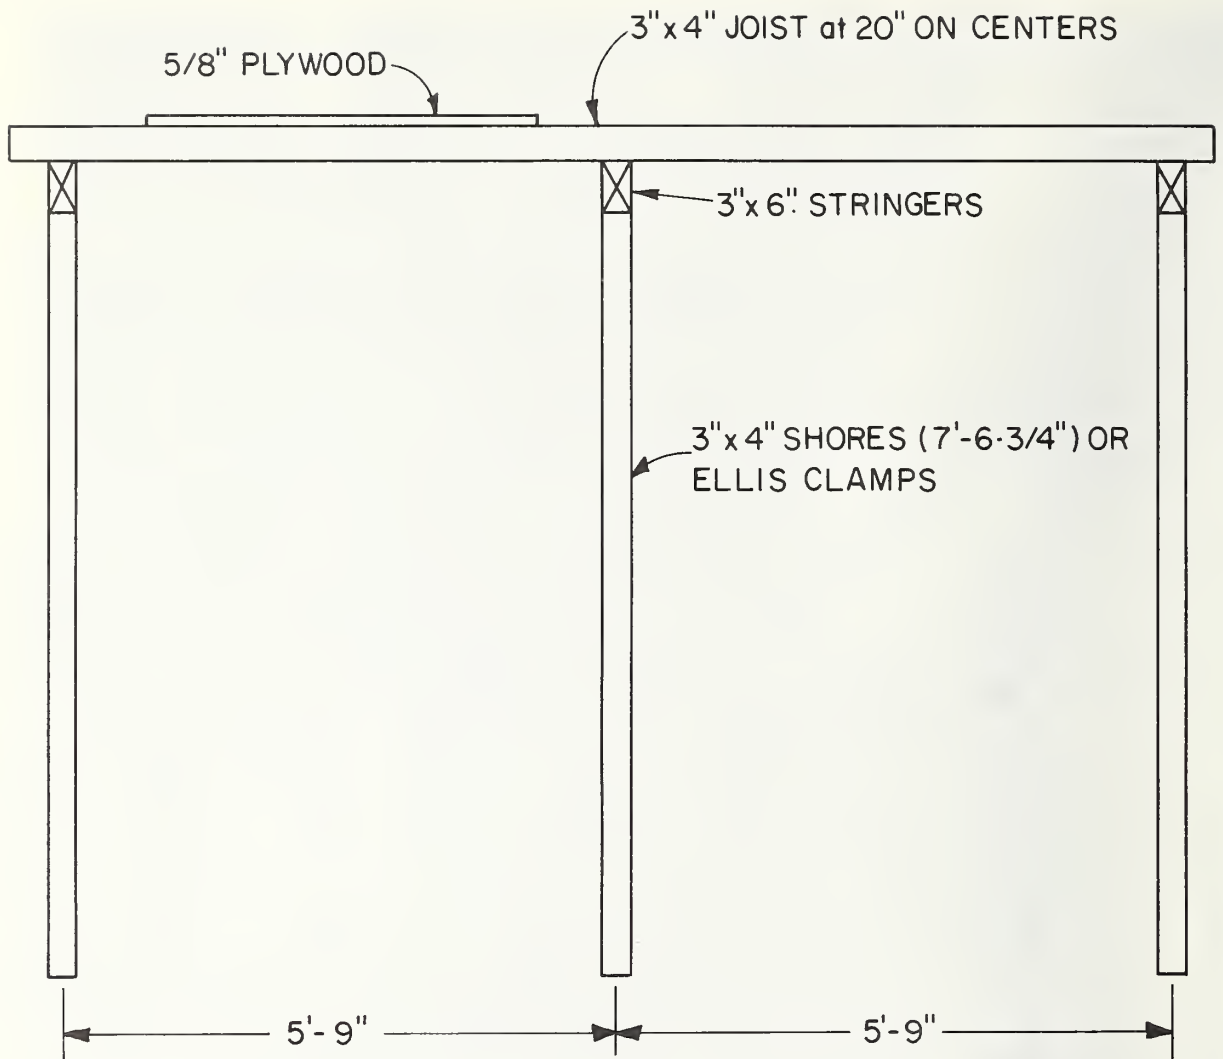
The formwork in figure 2.17 is typical for the floor slabs with design noted by the concrete contractor as being based on the publication, Formwork for Concrete, SP-4 [11]. Formwork sheets submitted to Fairfax County [18] contained no mention of lateral bracing for the form system. However, a limited amount of bracing may be seen in figure 2.16 and some subsequent figures. OSHA regulations (ANSI-A10.9, Sections 6.3.2 and 8.1.5) [2]² require a lateral bracing system capable of resisting a lateral force of at least 2 percent of the dead load of the slab.

Figure 2.17 Formwork for a typical floor.

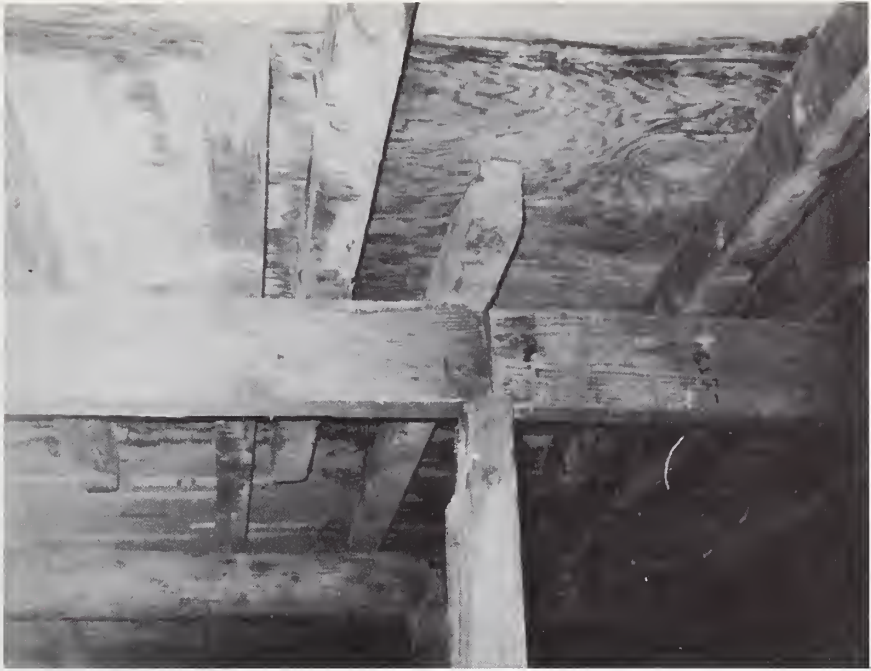
As in the case of the 24th story, the 23rd story lumber which was apparently damaged was reused. Examples of battered shores are shown in figure 2.22. Note the large reduction in bearing area. As in the case of the 24th story, OSHA regulations (ANSI-A10.9, sections 8.1.24 and 8.1.25) [2] required correction of these conditions prior to placing concrete.

Figure 2.22 Selected details of 23rd story forms.

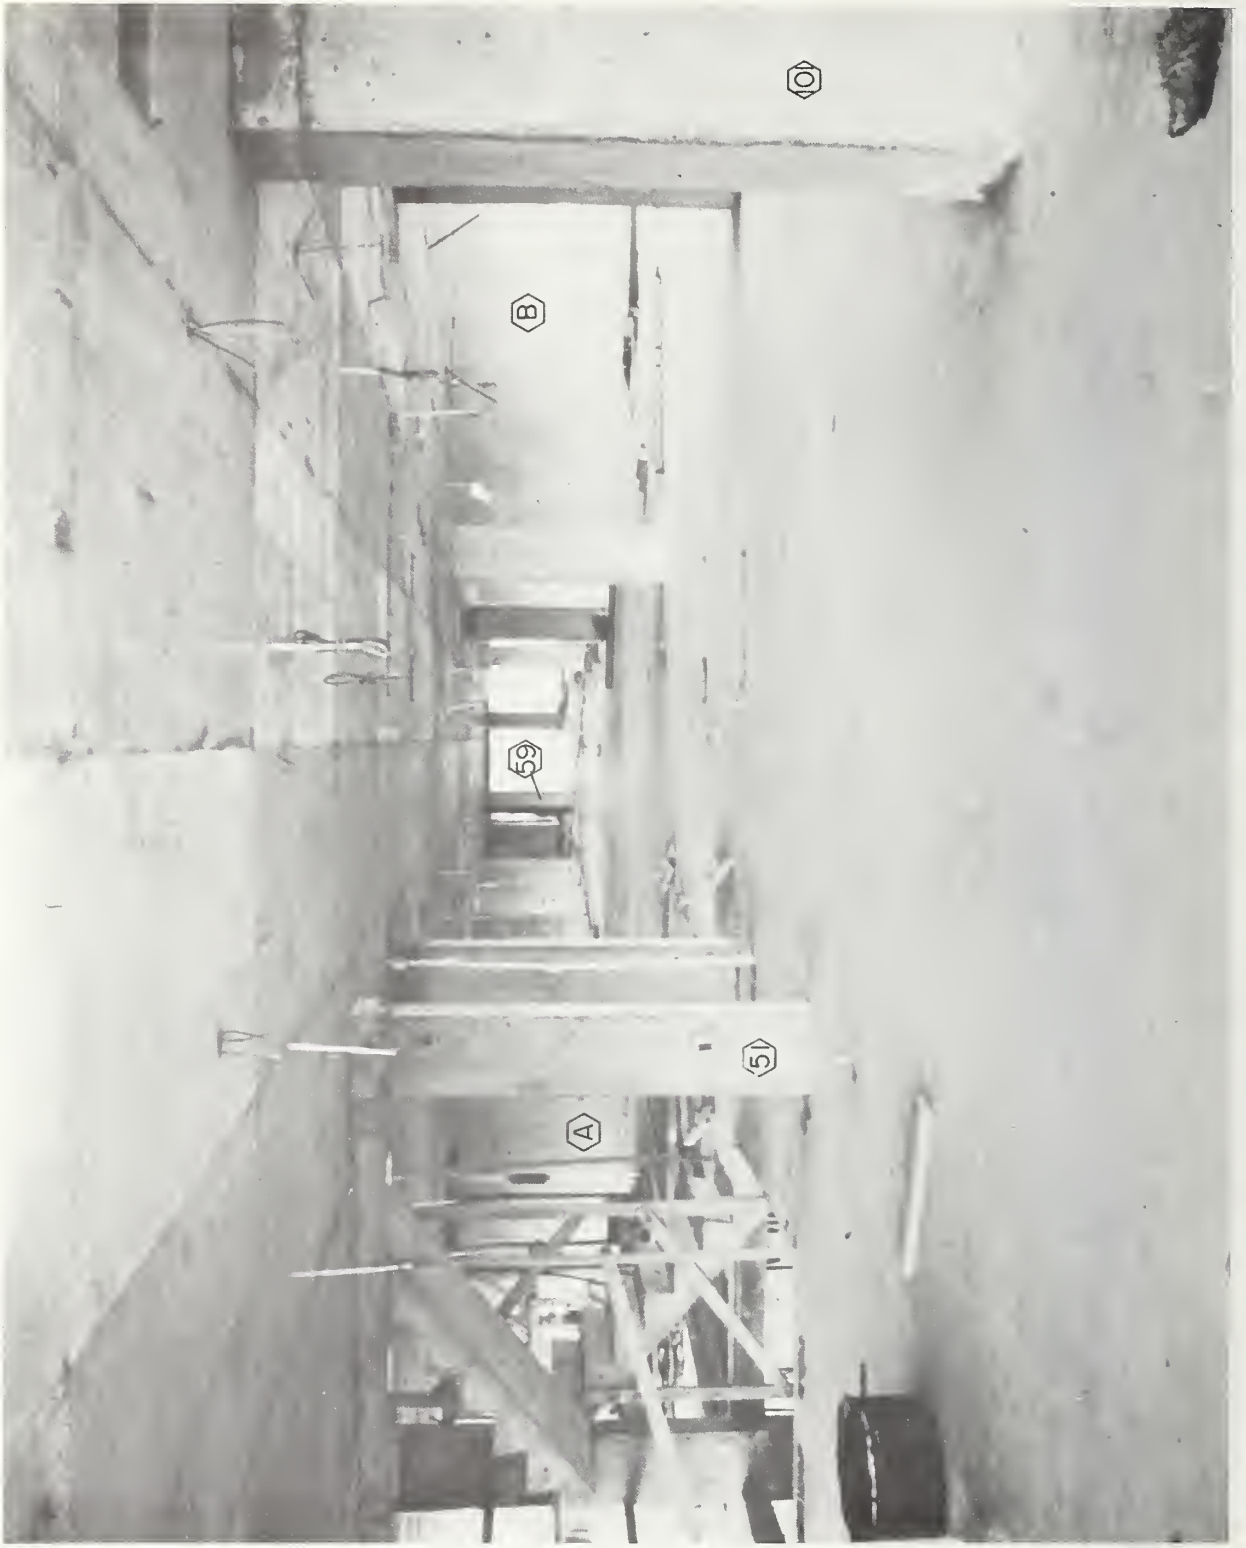
As shown in figure 2.25, the 20th floor was completely bare of reshoring. This was reportedly the case for sections 1 through 4. Note the presence of shear walls A and B. These walls were not present (the design did not require them) above the 20th story. Note also the erection crane which is barely visible to the left of the designation for shear wall A. A view of the failure section at the end of the 20th floor is shown in figure 2.26.

Figure 2.25 Section 1 and 2 of 20th story, looking east.

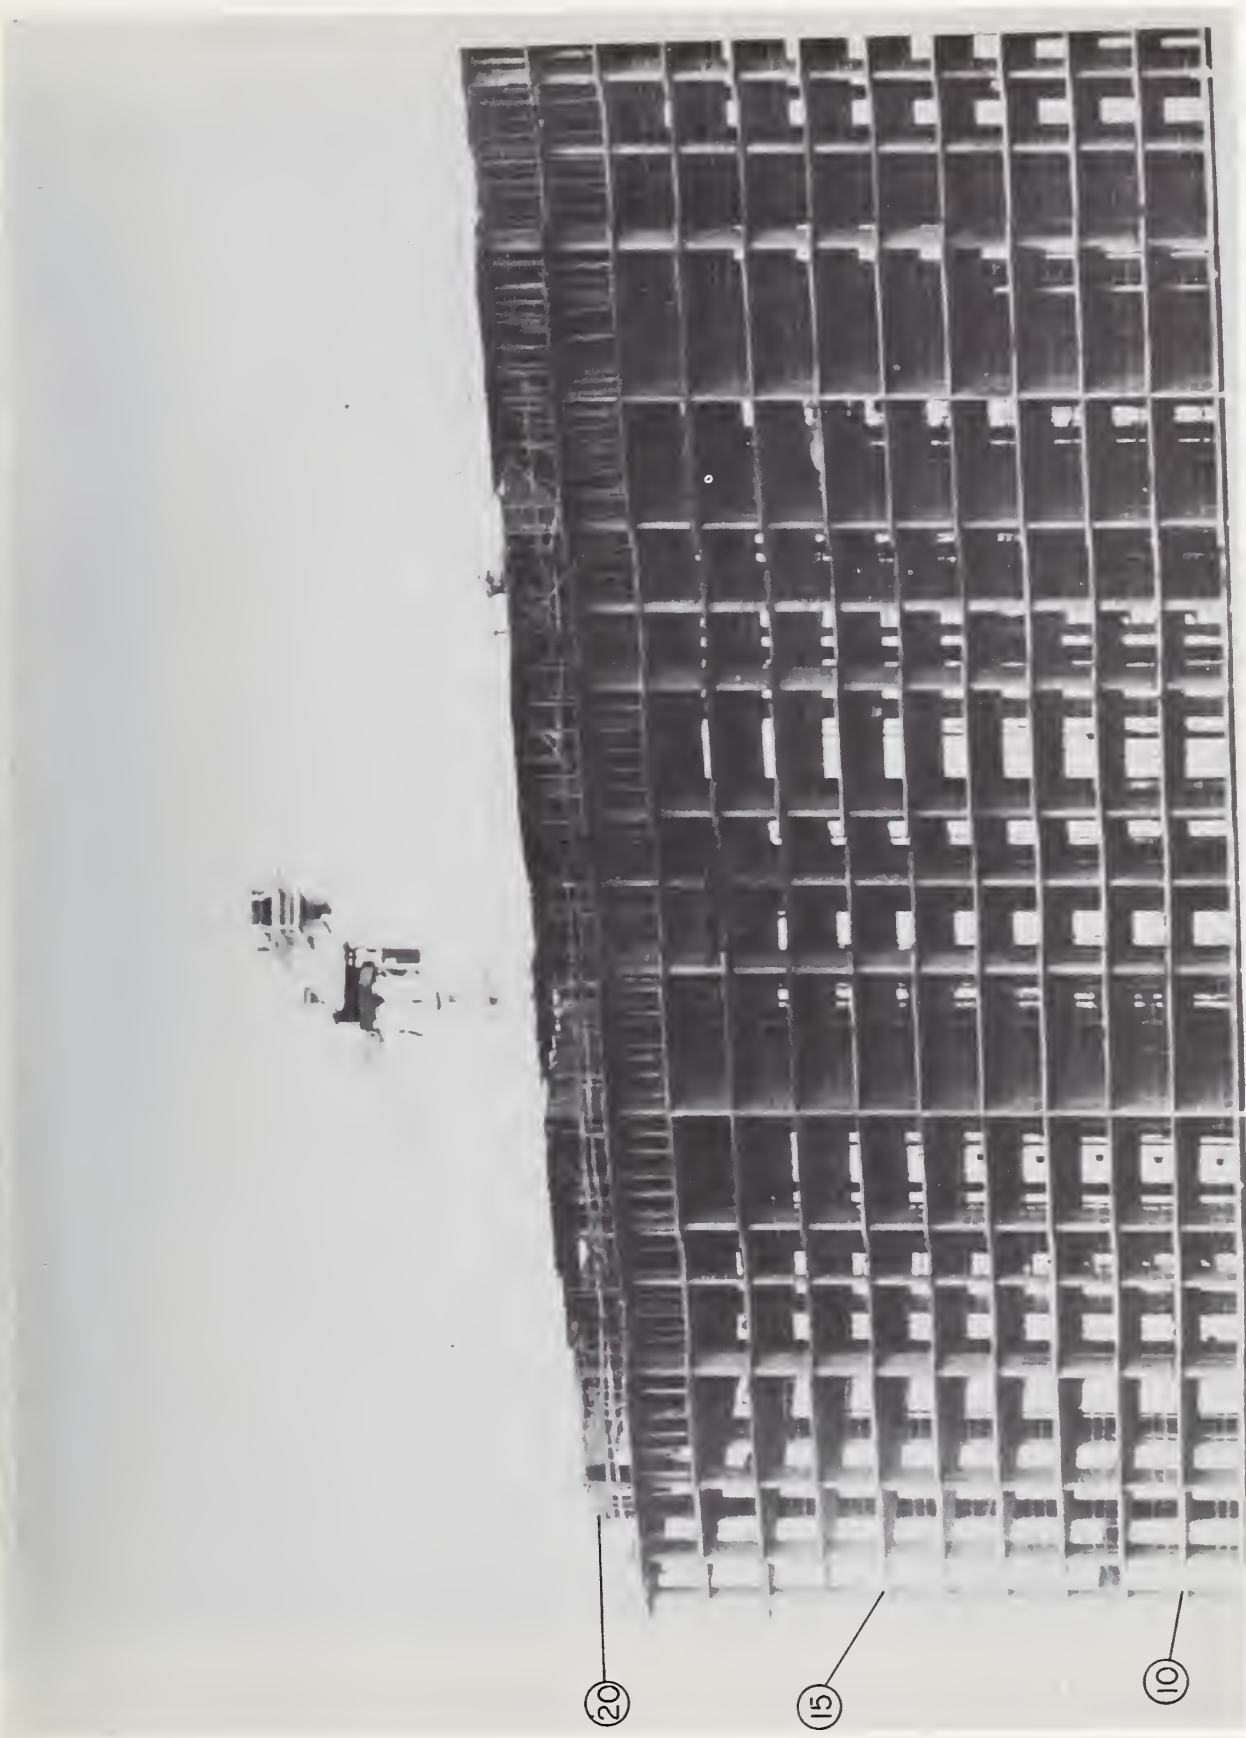
Examination of figure 2.38 establishes the lower crane support on the 10th floor and establishes that the crane, as installed, could operate through a ten-story height of building. It should be noted that the crane had marginal clearance to cast the 20th floor although it appears that it could. The photos were not clear enough to determine shoring conditions under the crane.

Figure 2.38 Closeup view of figure 2.36 showing crane no. 2 base support.

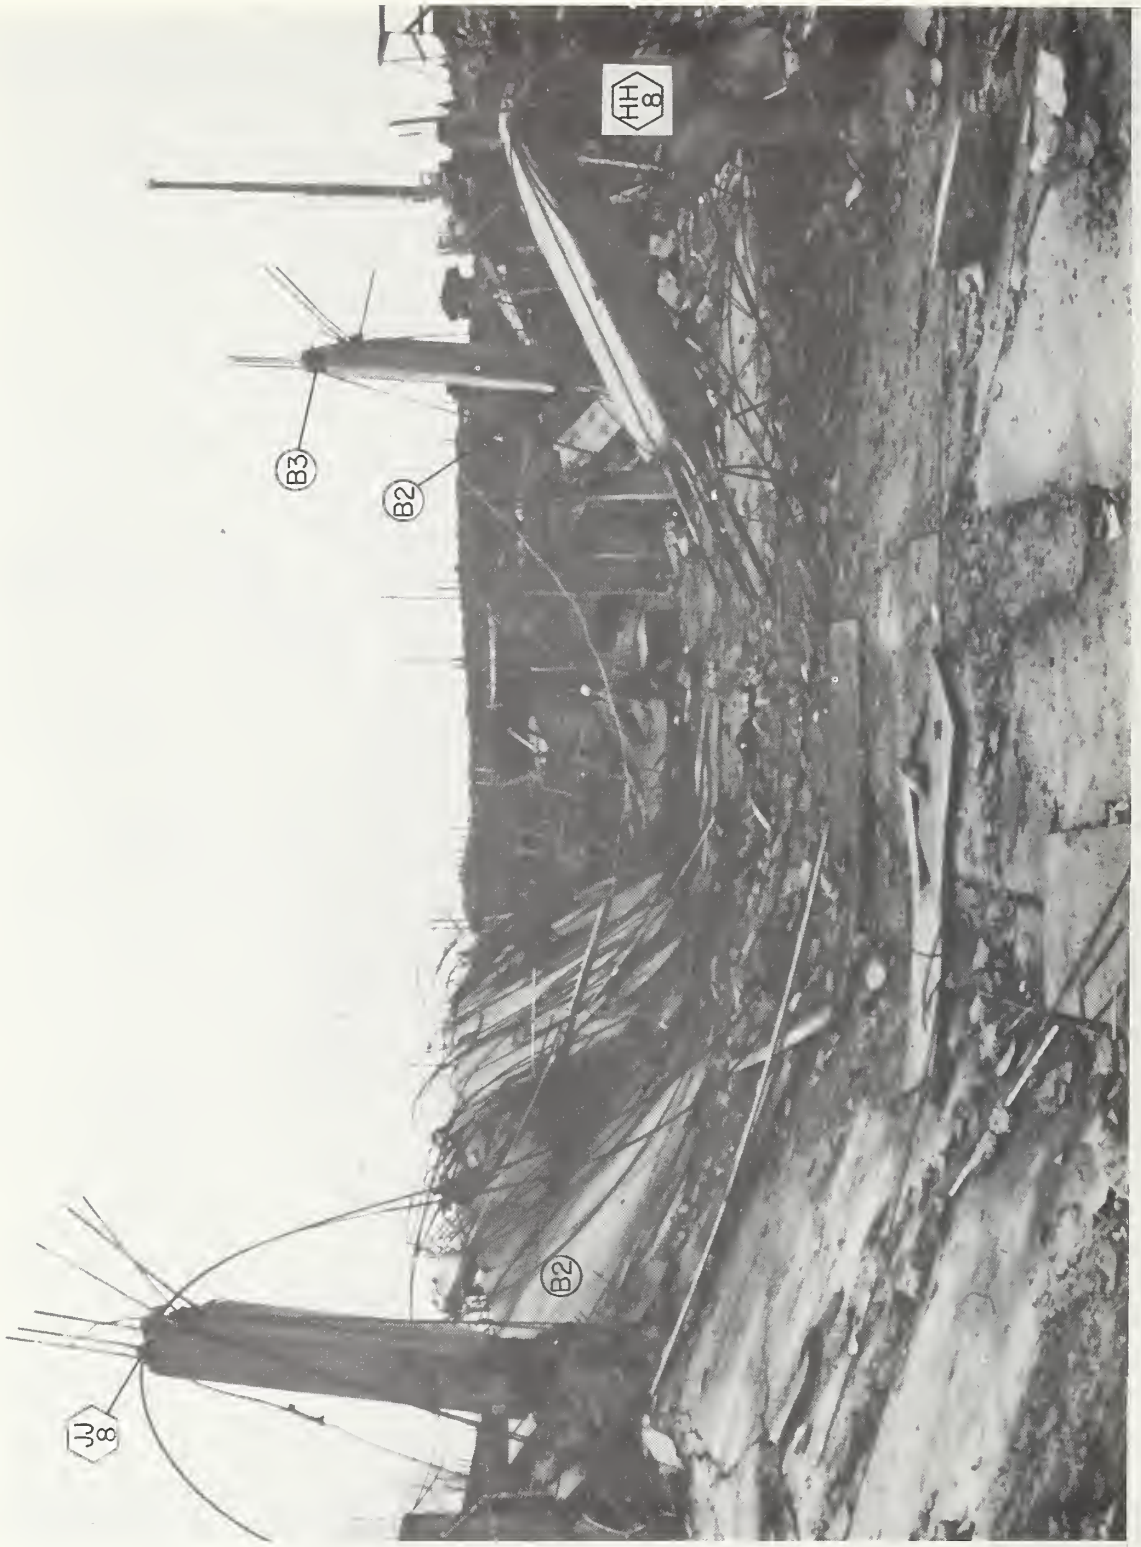
The garage slabs generally came "straight" down except near the slab edges. In the latter cases the columns usually failed in bending. Figure 2.45 shows a view of slab B-2 with the edge between columns JJ-5 and JJ-8 visible on the left. The view of this edge from the south is shown in figure 2.46. Note that the columns failed at the B-3 level. Formwork can be seen lying on top of the slab B-3. These forms apparently were in place under slab B-2.

Figure 2.45 View looking west of slab B-2 between column lines HH and JJ.

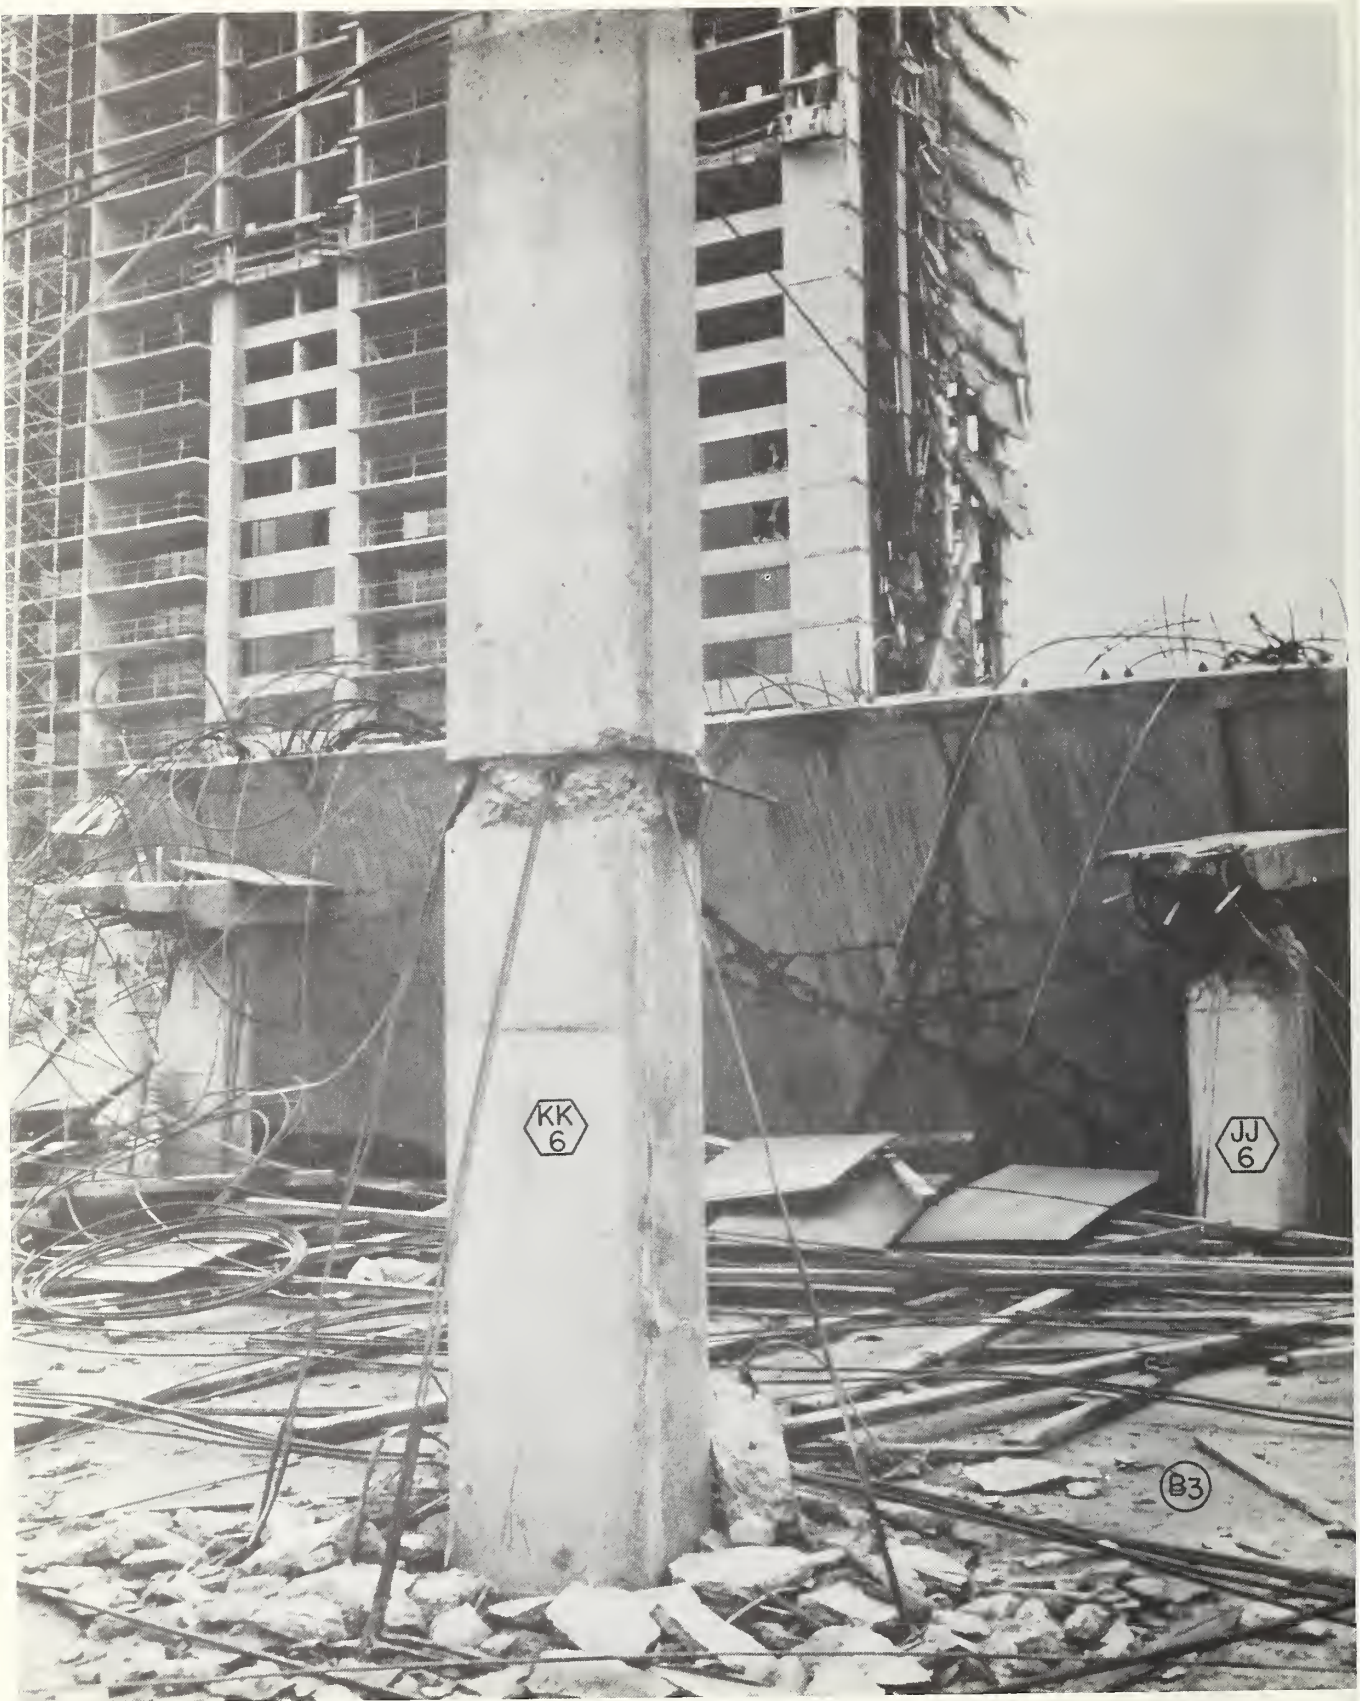
Column KK-6 may be seen in figure 2.47. Once again the shear cone usually associated with a slab punching failure is not visible in the photograph. Note the ruptured reinforcing bars at the base of the column. These are shown more clearly in figure 2.48 (but not for column KK-6).

Figure 2.47 Typical column in the parking garage.

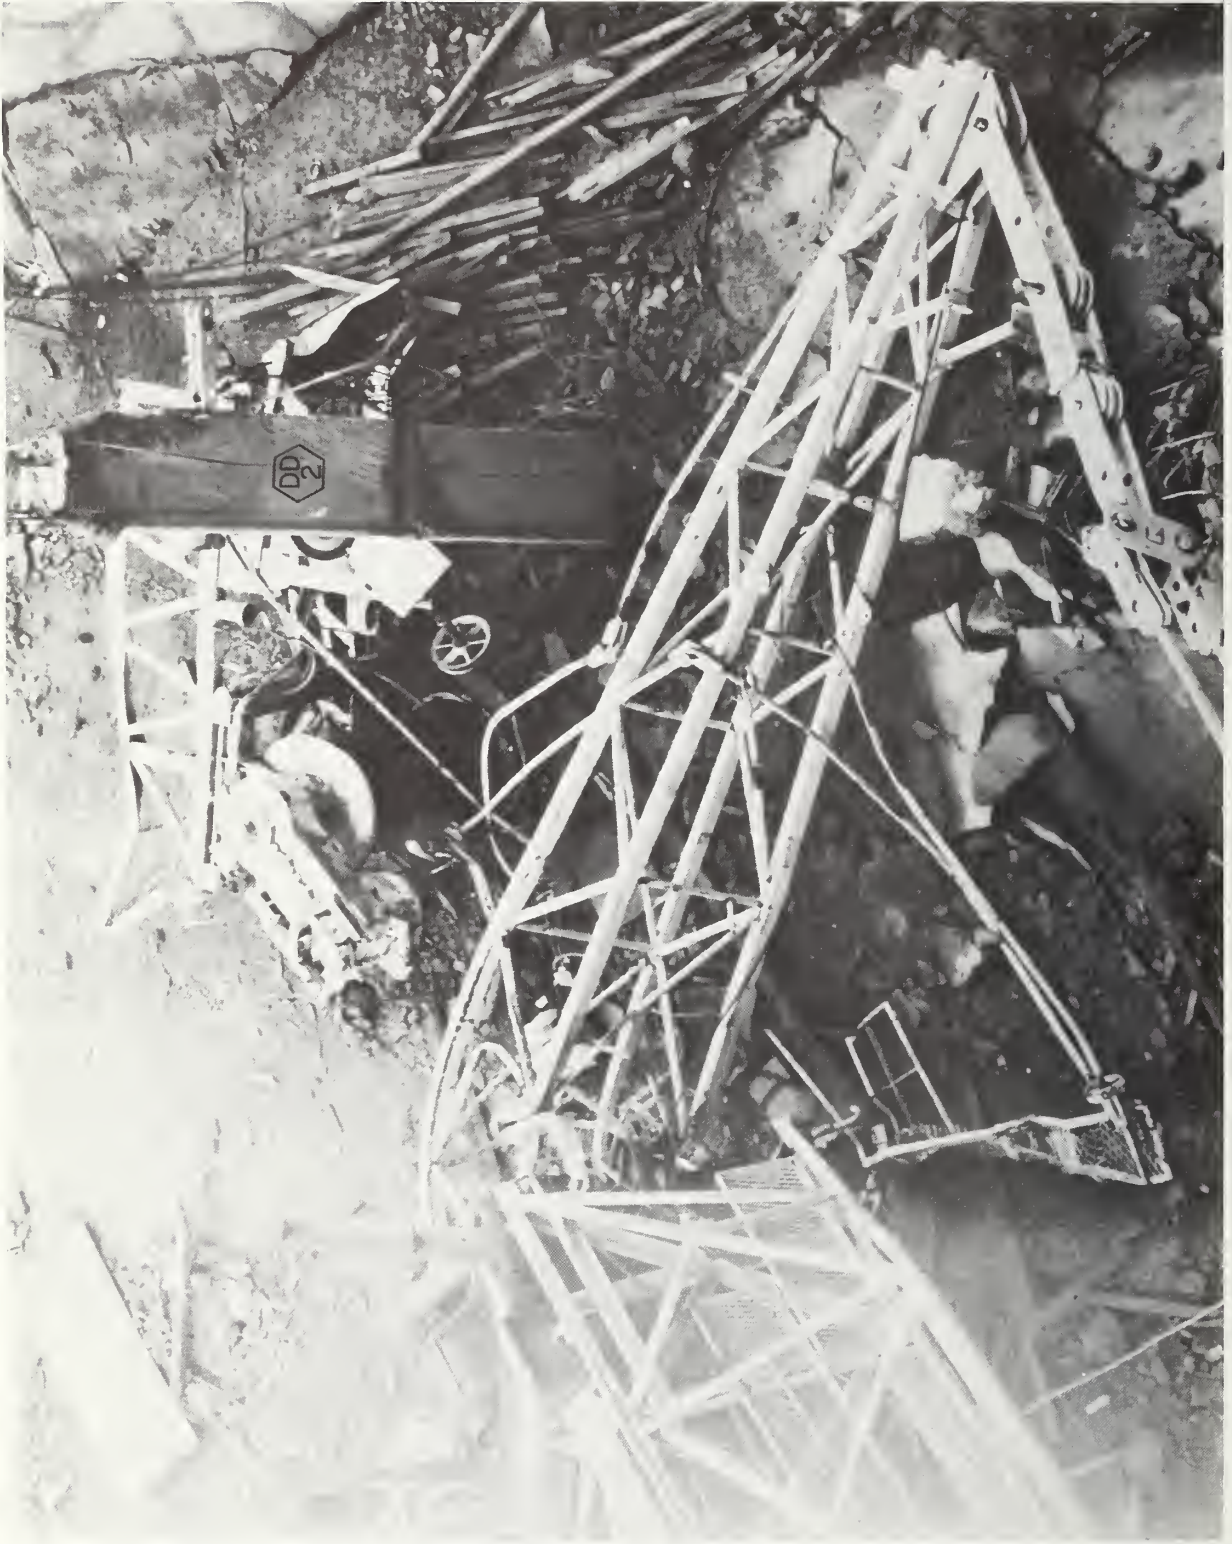
Figure 2.55 Position of fallen crane near column DD-2 looking south.

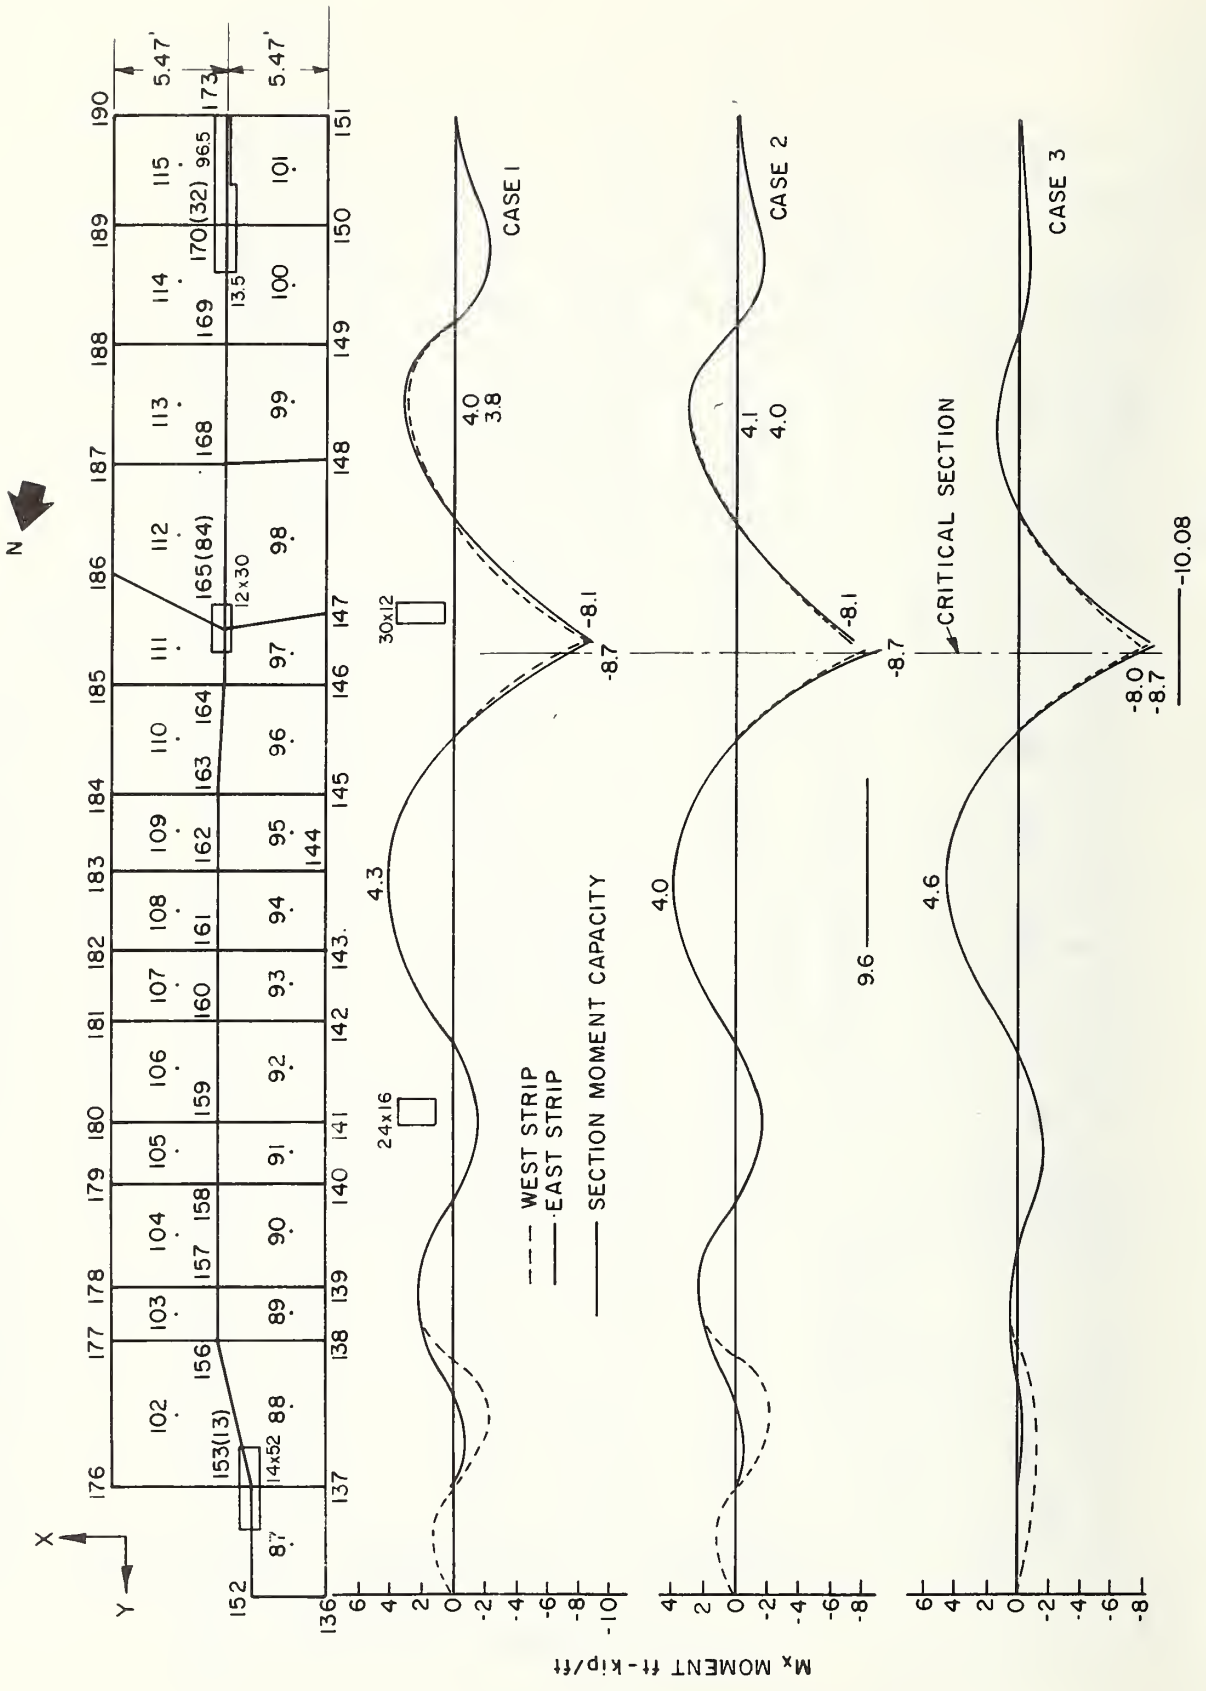
The next most severe condition occurred in the column strip shown in figure 4.9. Maximum negative moments in elements adjacent to column 84 (node 165) were in the order of 7 to 8 ft-kip/ft at the critical section. This compares with a 10 ft-kip/ft ultimate moment capacity in the slab. The difference is not large enough to preclude yielding or even some yield line propagation from column 84 in the east-west direction; however, if such yielding were to occur the situation would be very similar to the

localized condition around column 31. Again, it is concluded that this was not a significant contributory factor to the collapse of the 23rd floor.

Figure 4.9 MOMENTS IN COLUMN STRIP 13-84-32
