Investigation of the Skyline Plaza Collapse in Fairfax County, Virginia

E. V. Leyendecker and S. G. Fattal

Center for Building Technology
Institute for Applied Technology
National Bureau of Standards
Washington, D. C. 20234

Final Report

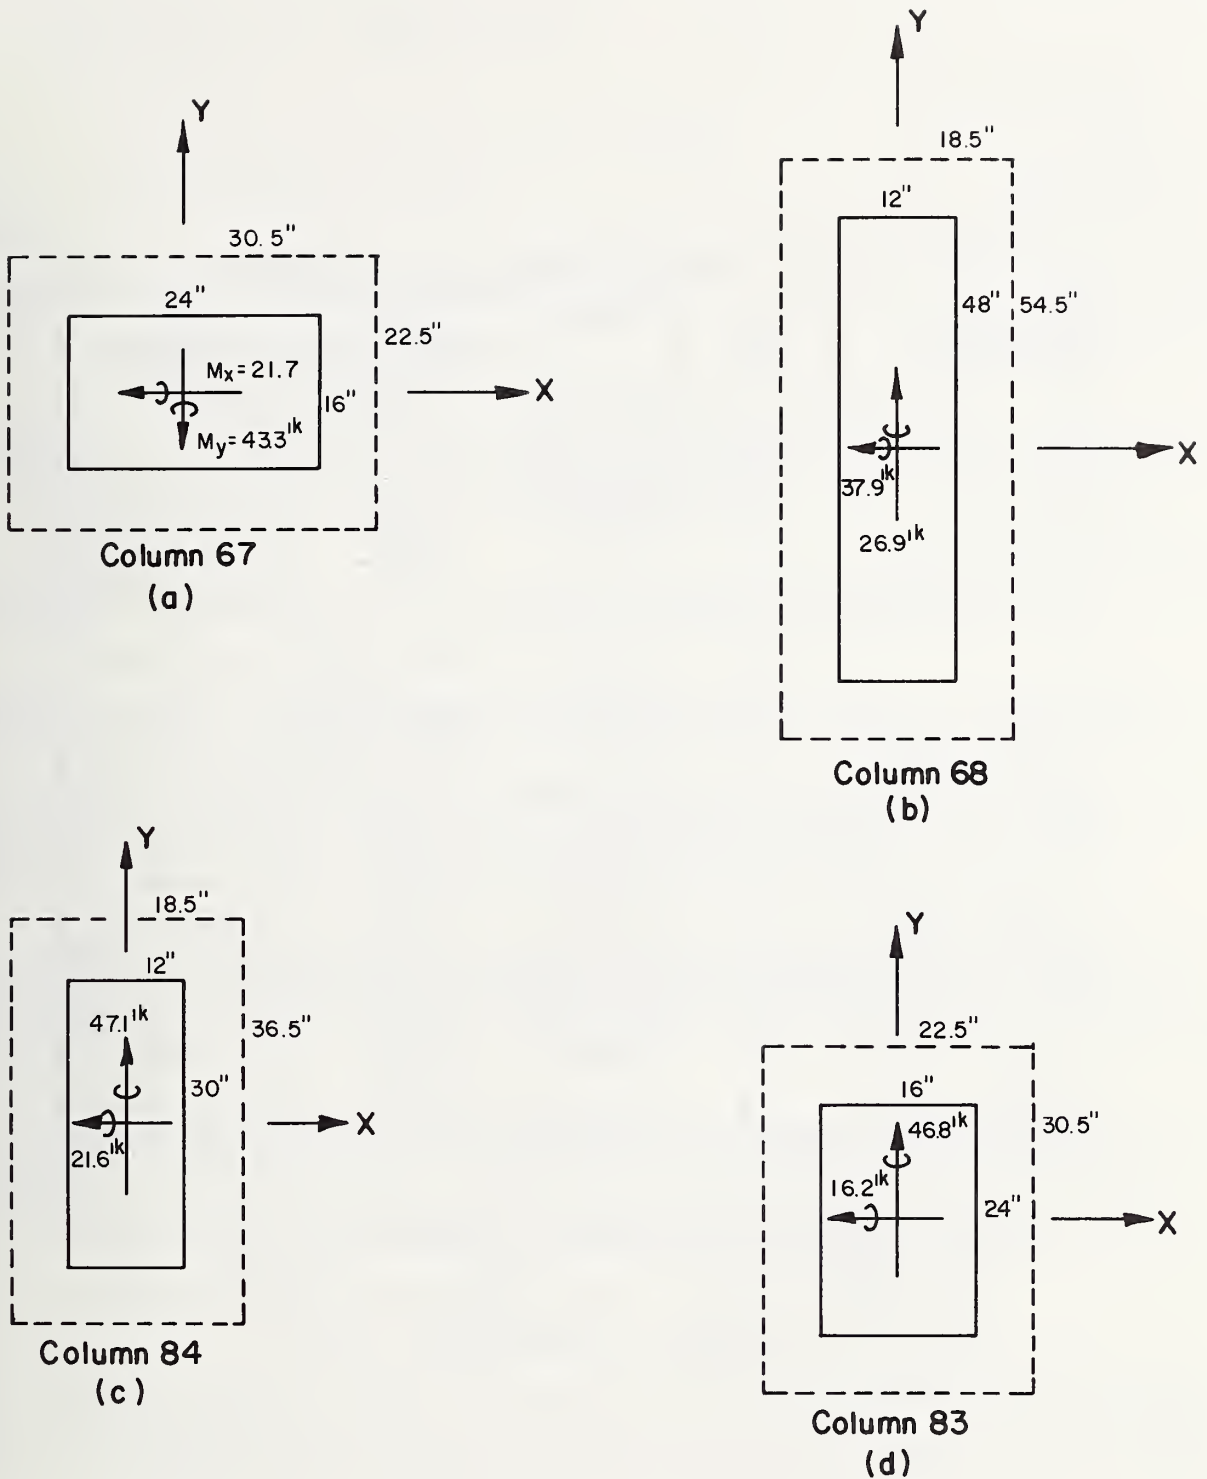
Figure 4.12 CRITICAL SECTION FOR SHEAR IN THE SLAB AROUND COLUMNS 67, 68, 83, 84

Column No.	Case	v_{\max} psi	f'_c ^{1/} required psi	f'_c estimated psi
67 (16 x 24)	1	147	1870	960-1440
	2	147	1870	3000
	3	128	1417	960-1440
68 (48 x 12)	1	113	1104 (1724)	960-1440
	2	113	1104 (1724)	3000
	3	116	1164 (1816)	960-1440
83 (24 x 16)	1	148	1894	960-1440
	2	148	1894	3000
	3	130	1462	960-1440
84 (30 x 12)	1	149	1920	960-1440
	2	149	1920	3000
	3	145	1819	960-1440
