NBSIR 73-242

Pilot Demonstration of Lead Based Paint Hazard Elimination Methods

Report on Field Study No. 1

June 1973

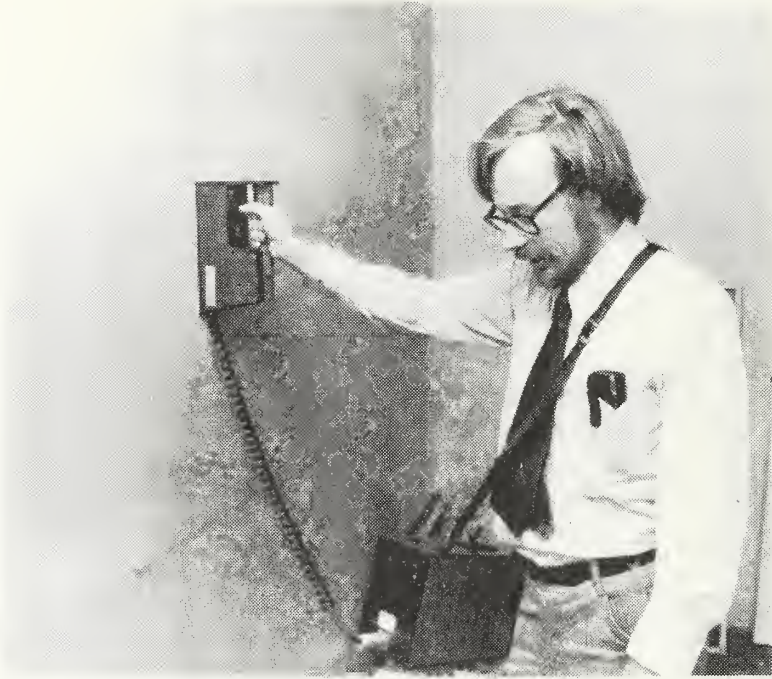
Figure 3. Measuring lead content in painted surfaces with Portable X-Ray Fluorescent instrument.

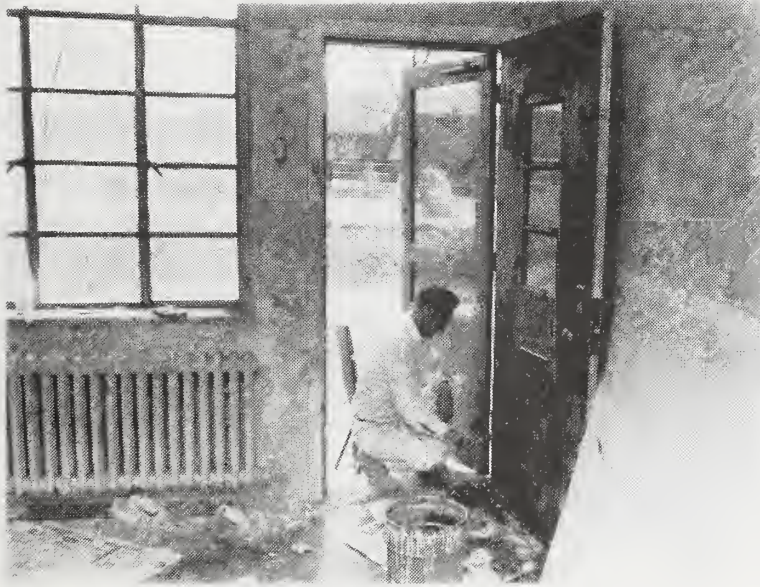
Figure 4. Scraping of old paint loosened by chemical paint remover on exterior door.

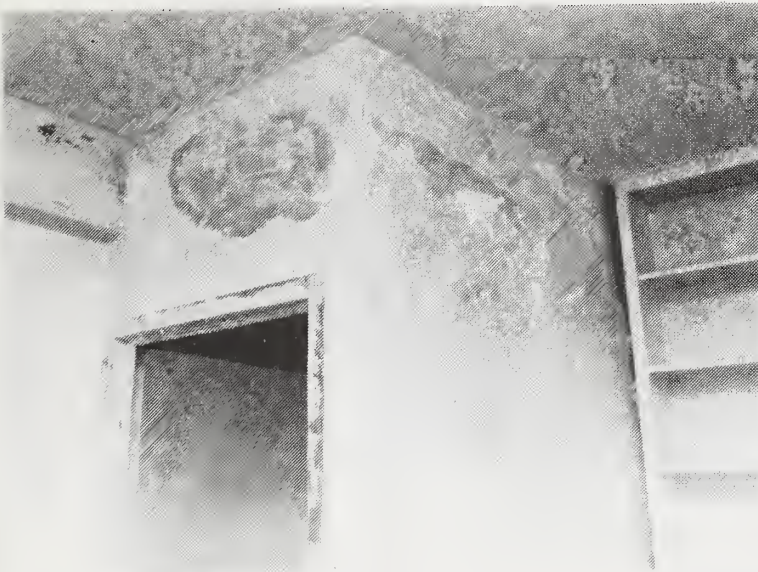
Figure 5. Plaster wall in kitchen during removal of old paint. Note the good condition of ceiling paint over concrete.

created additional problems. Much of the plaster was loosened from the wall or was badly scratched by the scraping operation which followed the paint remover application (as can be seen in figures 5, 6, and 7). Preparation of the kitchen walls with a white coat of plaster was required prior to painting.

2. In the case of the kitchen plaster walls, time and labor costs could have been reduced by just removing the loose paint, repairing damaged areas, and covering with medium to heavy-weight vinyl wall covering, and;

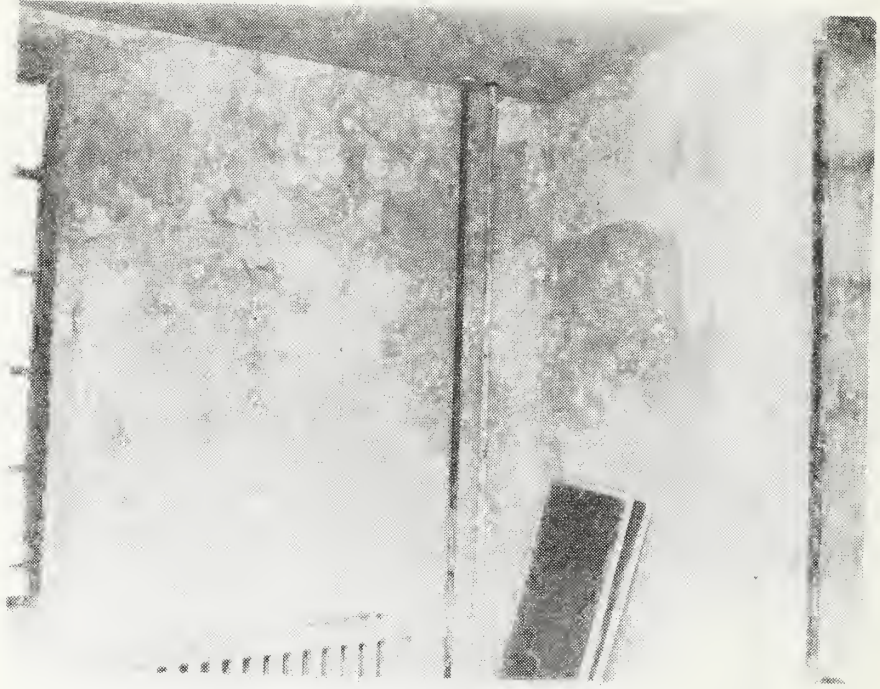
Figure 6. Metal window frame and section of left steam pipe after removal of paint before buffing with steel wool.

A. Lead Paint Removal: The water wash paint removal system worked satisfactorily (although it was quite time consuming) on the metal sills and frames of the casement windows. Some ineffectiveness of the liquid paint remover was noted because of rapid evaporation of solvents caused by heat in the steam pipe.

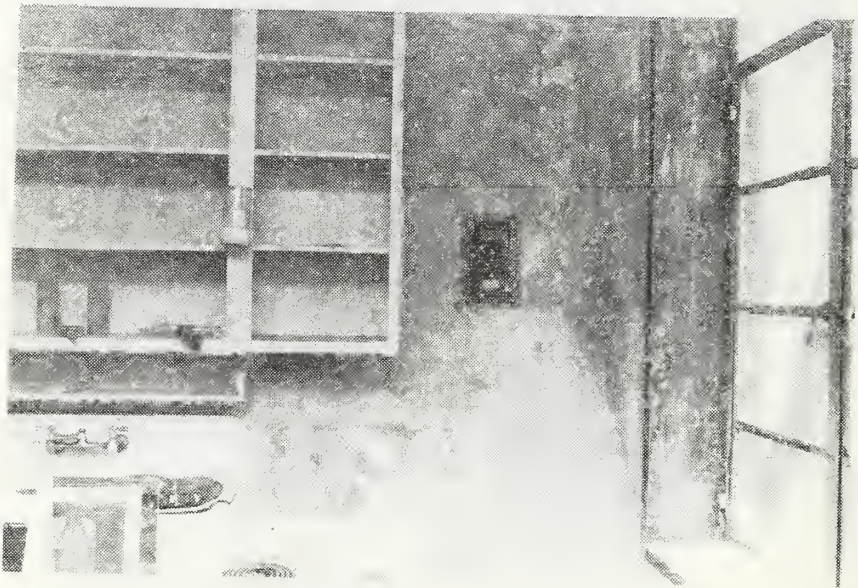
Figure 7. Plaster wall in kitchen after removal of old paint and plaster repair in lower corner.

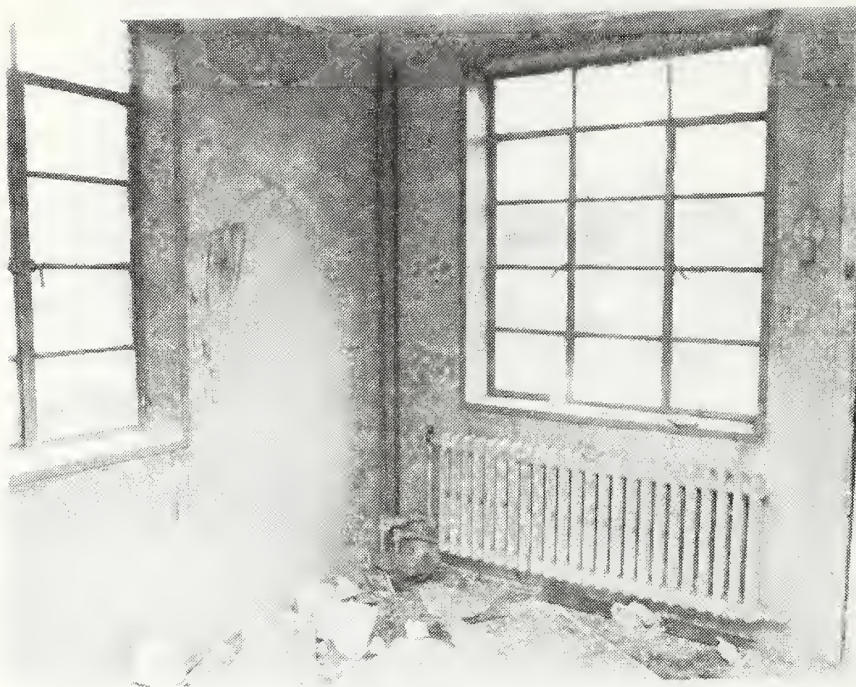
B. Prefinished Covering Materials: Two covering products were used to provide both a barrier over leaded paints and a final finish, on the wall surfaces in the living room, bedroom, hallway and bathroom. These painted plaster wall surfaces required no preparation before applying the adhesives and the prefinished covering materials. Loose paint and plaster under the windows in the living room and bedroom were removed and damaged areas were patched and smoothed. Figure 8 shows the living room walls prior to application of the covering material.

Figure 8. Living room walls in original condition. Window frames have been painted with 1 coat rust inhibitive primer.

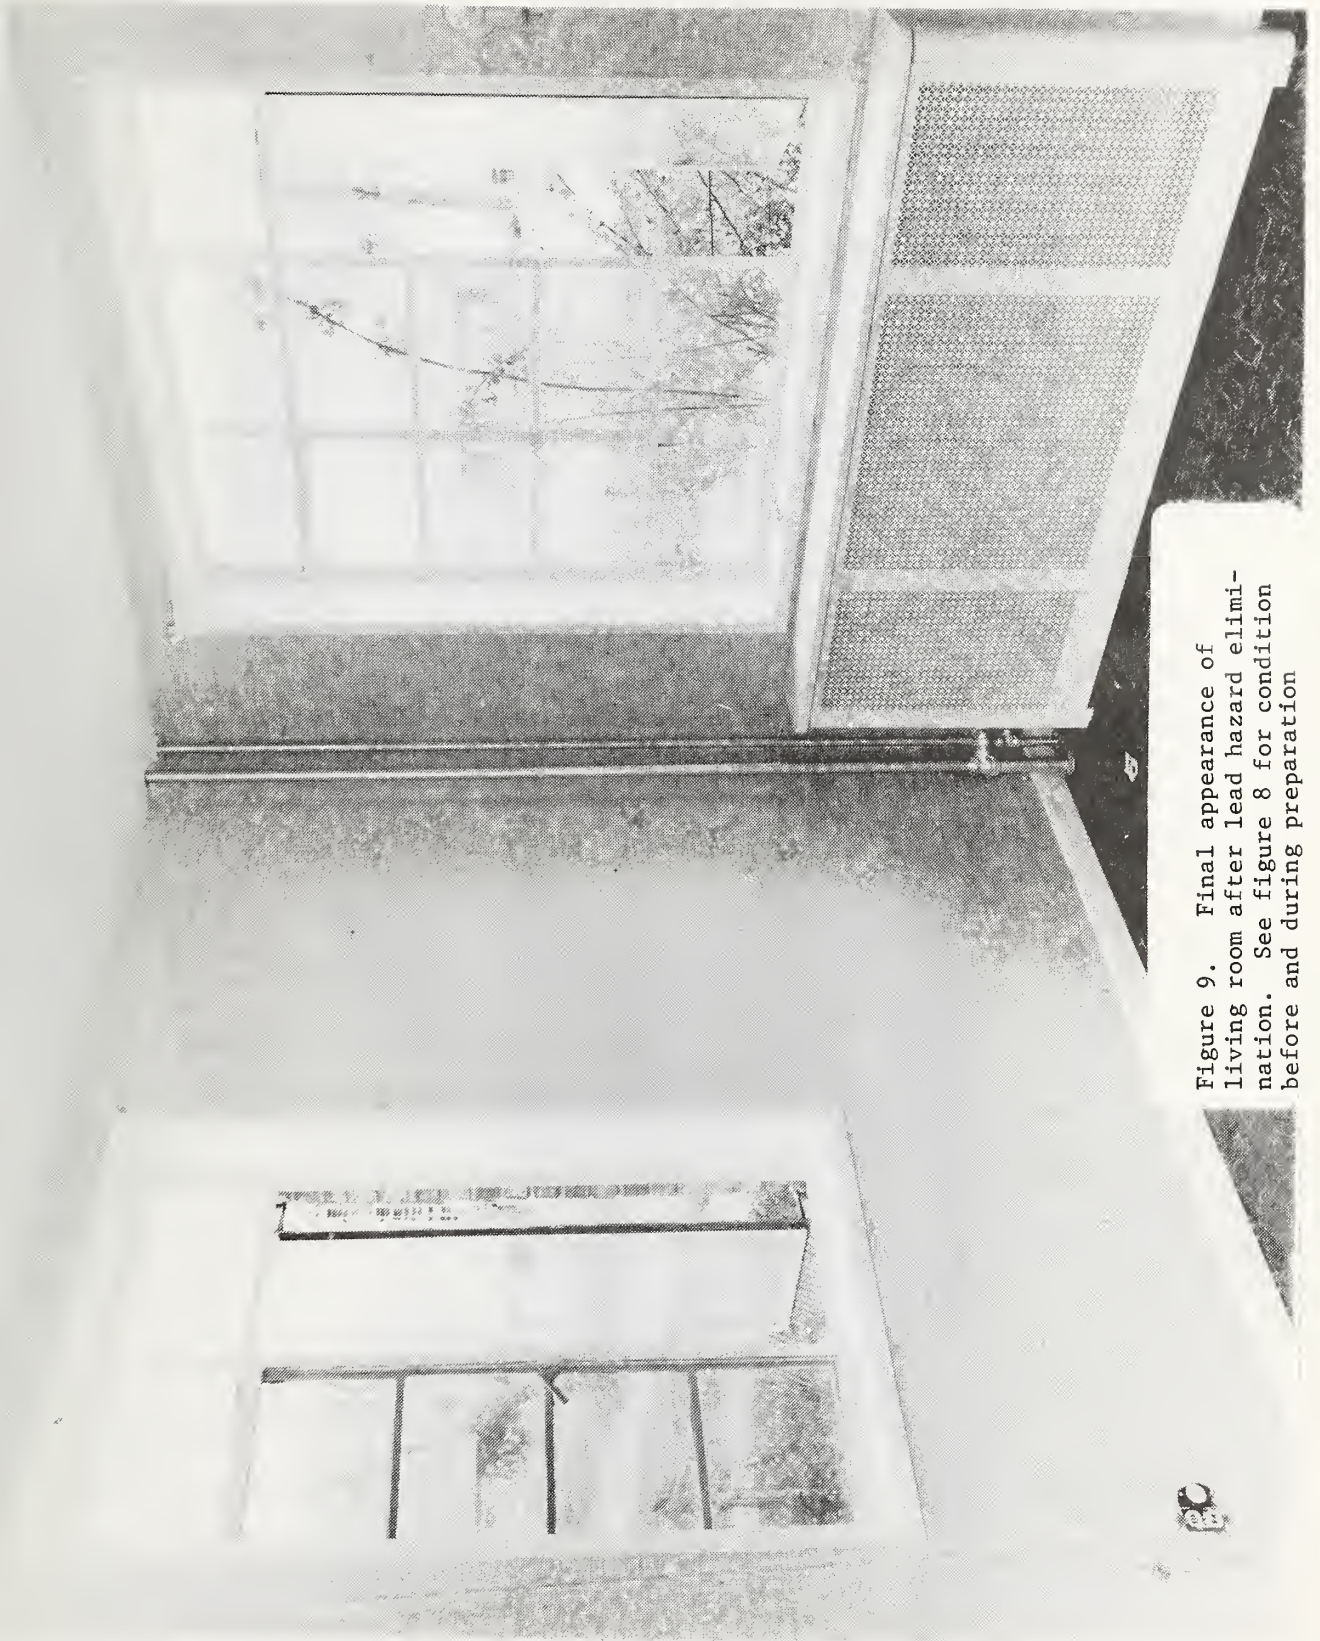
cover the walls behind the radiators with asbestos cement board and thus prevent continued flaking of plaster and paint and then to cover the radiators with factory pre-finished metal radiator enclosures. The small openings at the floor and on the face of the cover should prevent access to the remaining lead paint on the radiators as can be seen in figure 9.

Figure 9. Final appearance of living room after lead hazard elimination. See figure 8 for condition before and during preparation

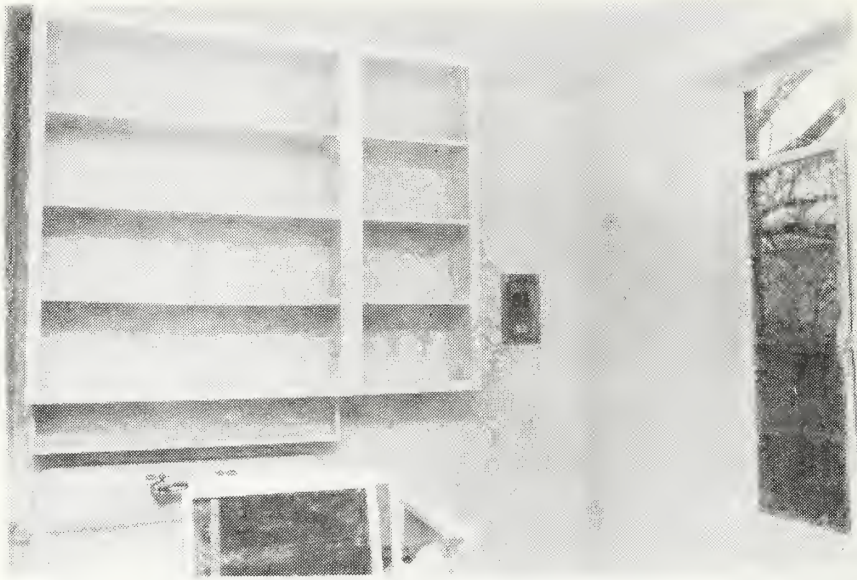
Figure 10. Re-finished plaster walls, shelving and metal window in kitchen.

1. Kitchen walls, interior wood doors, and shelves, as shown in figure 10.

- 1 coat alkyd enamel undercoat (0.005% lead)

- 1 coat alkyd semi-gloss enamel (0.25% lead)

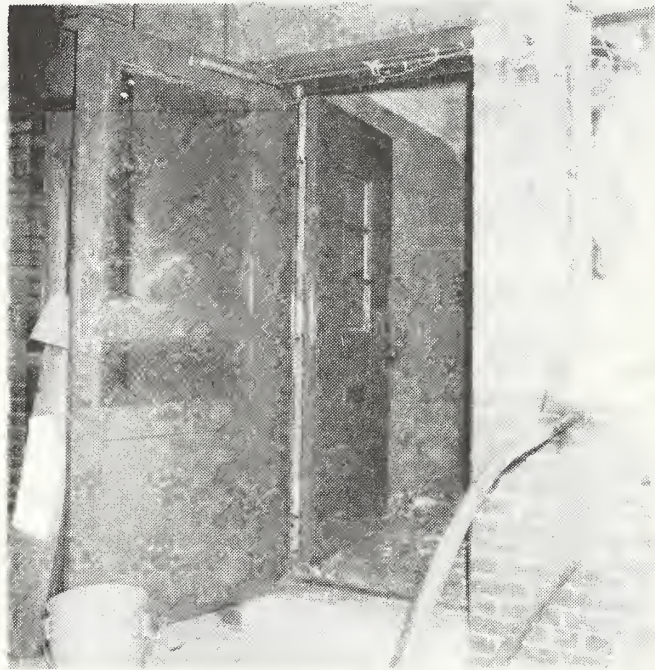
Figure 11. Re-finished wood exterior door, screen door and frame.

2. Exterior door, exterior screen door and frames, as shown in figure 11.

- 1 coat oil base exterior primer (0.38% lead)

- 1 coat oil base gloss exterior paint (0.38% lead)

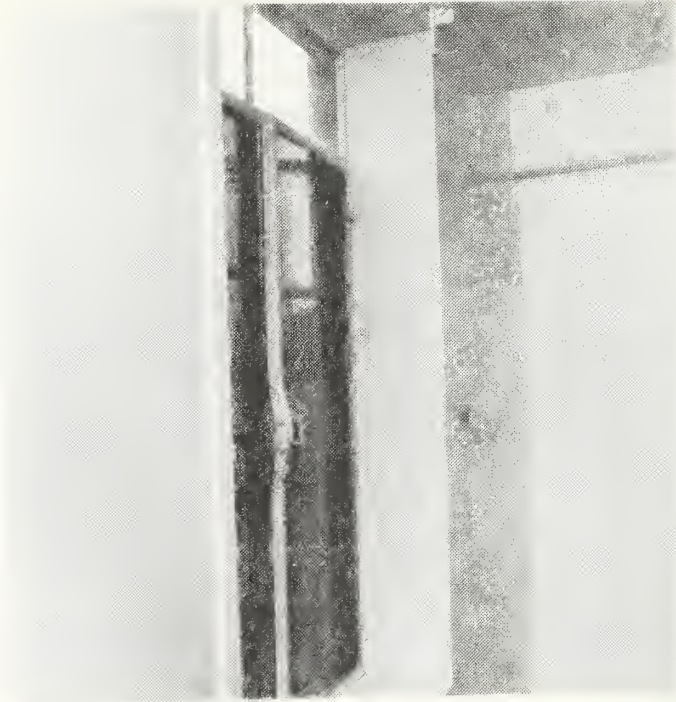
Figure 12. Re-finished plaster walls, metal window and concrete ceiling in kitchen.

3. Windows and interior metal door frames, as shown in figure 12.

1 coat rust inhibitive primer (0.002% lead)

1 coat alkyd semi-gloss enamel (0.25% lead)

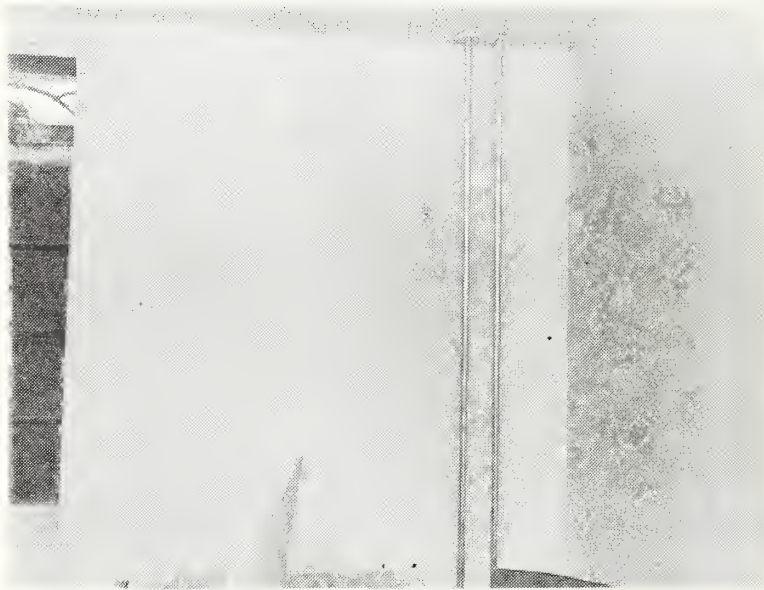
Figure 13. Metal steam pipes in kitchen coated with 1 coat rust inhibitive primer and 1 coat heat resistant aluminum paint.

4. Metal steam pipes, as shown in figure 13.

1 coat rust inhibitive primer (0.002% lead)

1 coat aluminum oil base paint (0.001% lead)
