Examination of Failed Six Inch Cast Iron Pipe Natural Gas Main; Illinois Power Company, East Saint Louis, Illinois

October 15, 1973

Failure Analysis Report

Prepared for
Office of Pipeline Safety
Department of Transportation
Washington, D. C. 20590

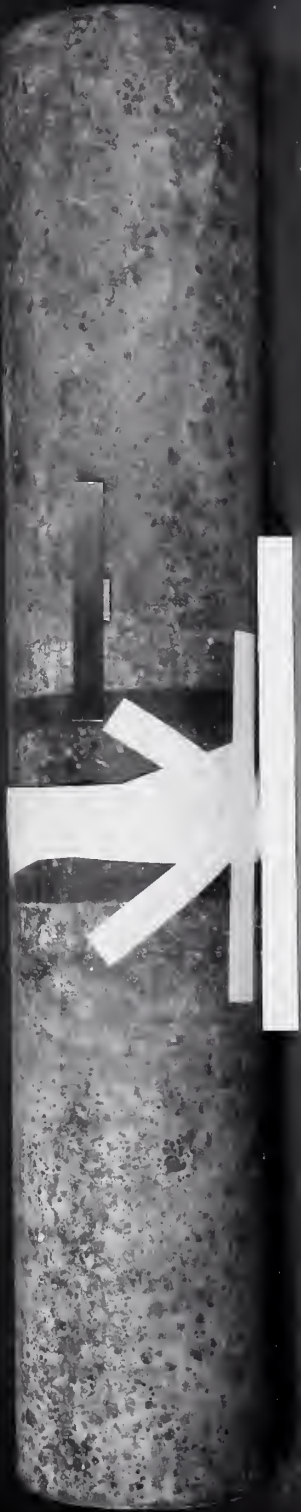
Figure 1. Length of Fractured Cast Iron Pipe As-received by NBS for Examination. Tape had been applied to prevent damage to fracture surfaces during shipping. Approx. 1/5 X

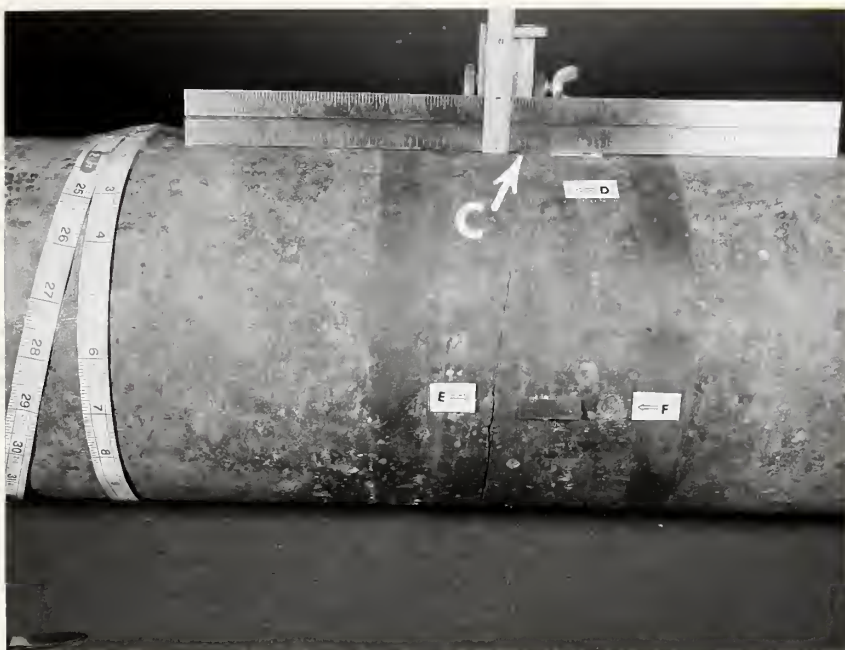
A six-foot, flexible steel tape was wrapped around the circumference of the pipe at a distance of about 6 inches from the crack, with the zero point of the tape located approximately at the center of the uncracked region, arrow C, Figure 2a. The tape and a steel scale were used to allow measurements of deflection and gap at various positions on the pipe. The maximum deflection occurred at C and measured between 0.045 and 0.050 inches in 6 inches. The maximum gap appeared to be at G, approximately 150 degrees from C (see Figure 2b). An accurate gap measurement could not be made at G because the scale used in measurement did not fit flatly on the pipe surface on either side of the fracture.

- a. Maximum deflection, 0.04-0.05 inch in 6 inches, occurred at C.
- b. Maximum gap produced in fracturing occurred adjacent to G. An accurate gap measurement could not be made because of surface conditions. Specimens for metallographic examination were obtained from the boxed area.

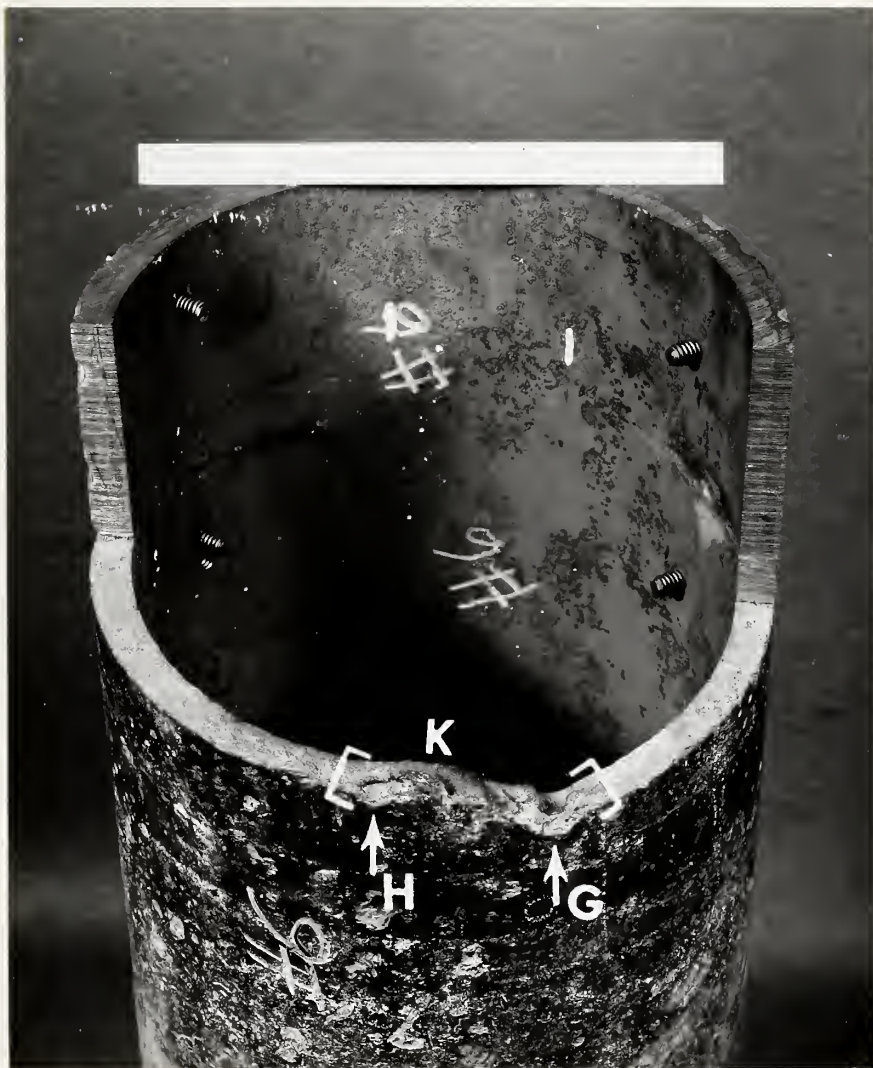
The outer surface of the pipe between G and H (area K) was deeply pitted. It was found that pitting resulting from graphitization reduced the wall thickness at H, where the examination specimens were obtained, as much as 56 percent. A notch was produced within area K that acted as a severe stress concentrator. For this reason it is believed that initiation of the pipe fracture was localized at this spot of graphitization.

Severe graphitization at K in the pipe section produced a notch that acted as a stress-concentrator and aided crack initiation in that area. Crack propagation, from the appearance of the fresh fracture surface, appears to have been rapid thereafter and probably occurred in a single event. An externally applied load produced by settlement could have been of sufficient magnitude to cause the break.

- a. Area K (within brackets) contains the probable fracture origin. Deep pits were observed adjacent to the fracture surface of the pipe at arrows G and H. Note that the fracture surface both to the left and to the right of the bracketed area is quite flat.
X 1/2

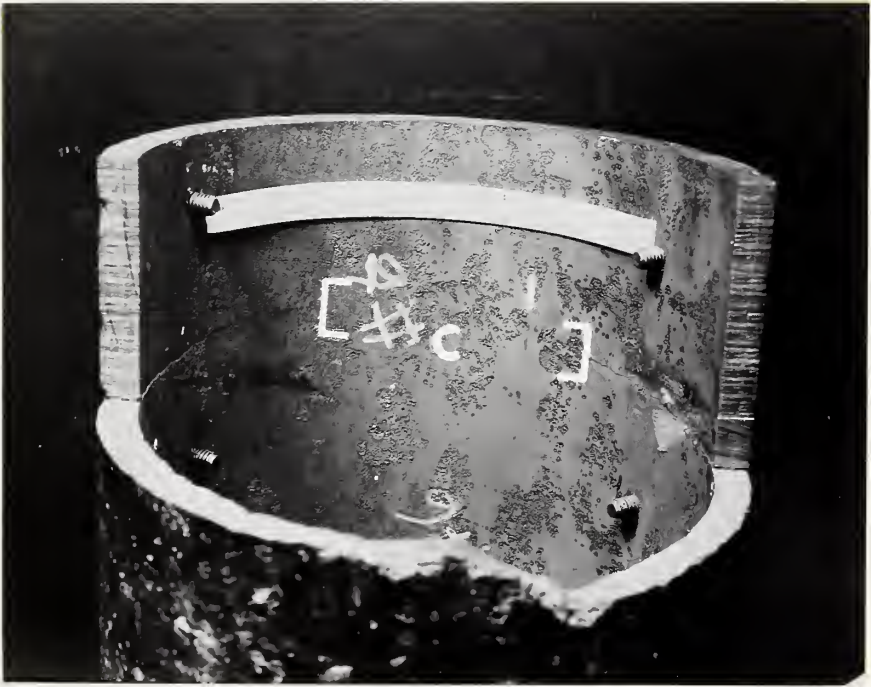
b

- b. Area C. (within brackets) contains the unfractured section and the converging crack tips. Shallow lace-like pitting shown in this view was present throughout the interior surface of the pipe length submitted. X 1/2

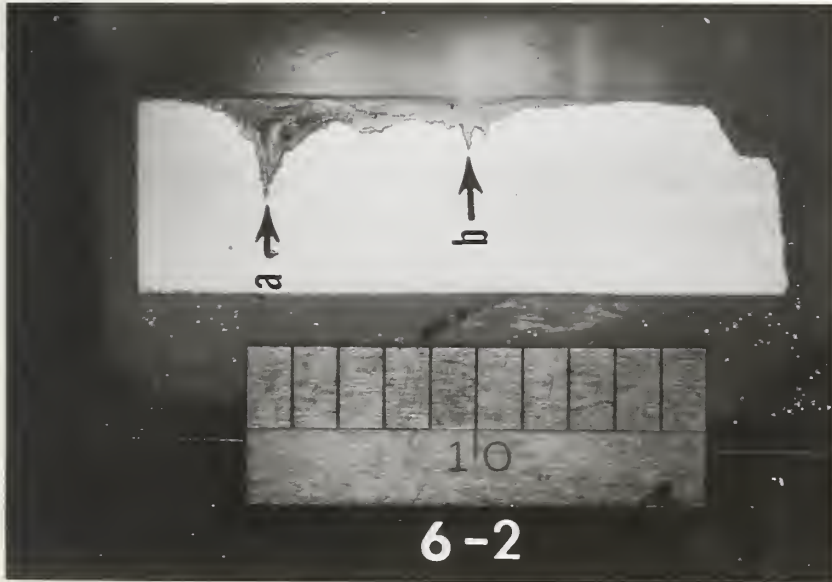
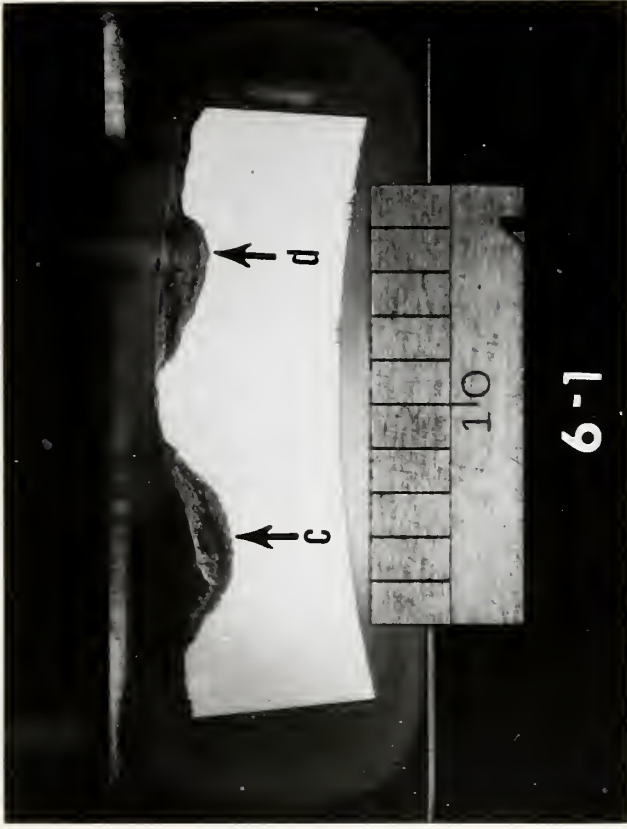
Figures 3a and 3b show the fracture surface and the unfractured section, respectively. Features observed are described in the legends for these two figures. Figures 4a and 4b are views of longitudinal and transverse sub-sections, respectively, adjacent to the probable fracture origin. The plane viewed in Figure 4a is at a right angle to the fracture plane while in Figure 4b, the plane viewed is parallel to the fracture plane. The arrows point to patches of graphitization present on the outside surface of the pipe. Graphitization is a phenomenon whereby the iron in the cast iron is progressively corroded leaving a porous mass of carbon and iron oxide.

Figure 4. Views of Cross Sections Adjacent to Point H, Fig. 2b. Arrows point to patches of graphitization penetrating from outside surface. Approximate depths of graphitization are: at arrow a, 0.21 inch; b, 0.11 inch; c, 0.14 inch; d, 0.10 inch. The original pipe wall thickness was approximately 0.375 inch. Magnification X 2

a. Longitudinal section.

b. Transverse section.

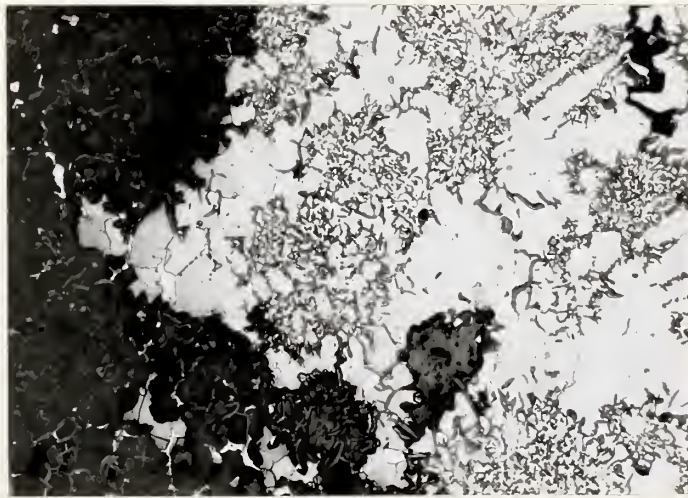
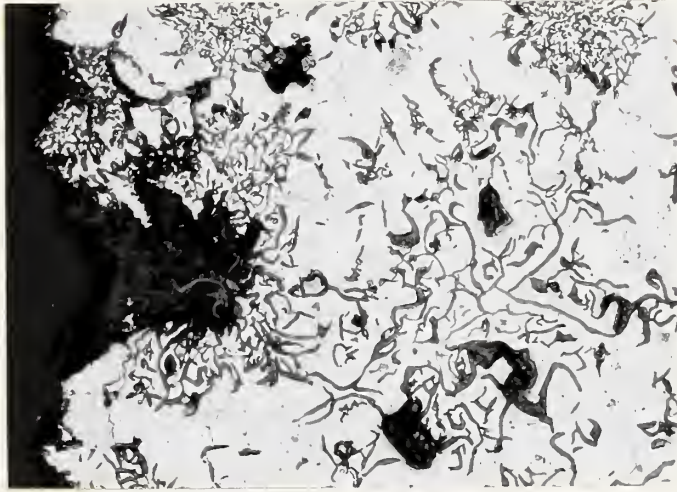
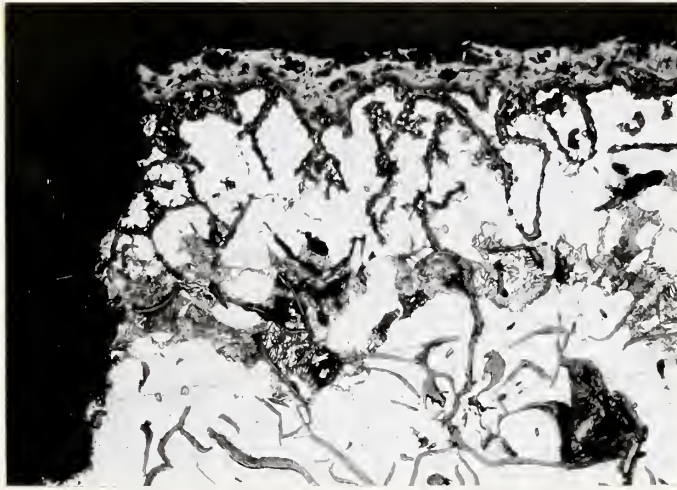
Figures 5a through 5c show the microstructure of the cast iron pipe adjacent to the fracture surface in a traverse made from the outside surface to the inside surface of a longitudinal cross-section specimen. The area shown in Figure 5a is adjacent to the probable fracture origin at the outside surface of the pipe. Both complete and partial graphitization were observed at the outside surface. Below the graphitized zone the structure is essentially a ferrite matrix containing type B graphite in a rosette grouping. Graphitization was observed adjacent to the fracture surface at the center of the section. The core of the pipe wall consisted essentially of a ferrite matrix containing both type A and type B graphite (see Figure 5b). Figure 5c shows the inside surface of the pipe. An oxide layer (dark) is present on the inside surface of the pipe wall. A narrow band of pearlite was observed adjacent to the inside wall. The remainder of the structure is essentially a ferrite matrix containing coarse type A graphite. Figure 6 shows the structure adjacent to the narrow band of pearlite shown in Figure 5c at a higher magnification. Areas of the iron-iron phosphide eutectic (small rounded particles in light-colored ferrite), coarse type A graphite flakes in a ferrite matrix, and lamellar pearlite are present.

The microstructure of the pipe wall was found to be largely ferritic. A narrow band of pearlite was observed adjacent to the inside wall surface. The iron-iron phosphide eutectic was observed, quite heavily concentrated, adjacent to the inside surface. Graphite flake sizes ranged from moderate adjacent to the outside of the pipe wall to quite coarse adjacent to the inside surface.

Figure 5. Microstructures at Point H Adjacent to Probable Fracture Origin Longitudinal Cross-section. Etched with nital. X 250

- a. Adjacent to outside of pipe wall. At top is a zone of graphitized and partially graphitized material (dark). Below the graphitized zone the structure is essentially a ferrite matrix containing type B graphite in a rosette grouping.
- b. Center of pipe wall. Graphitization (dark) at fracture surface. Core of pipe wall is essentially a ferrite matrix containing both types A and B graphite.
- c. Inside edge of pipe wall. At right is an oxide layer on inside surface of pipe wall; adjacent to this is a narrow band of pearlite. Remainder of structure is essentially a ferrite matrix containing coarse type A graphite.

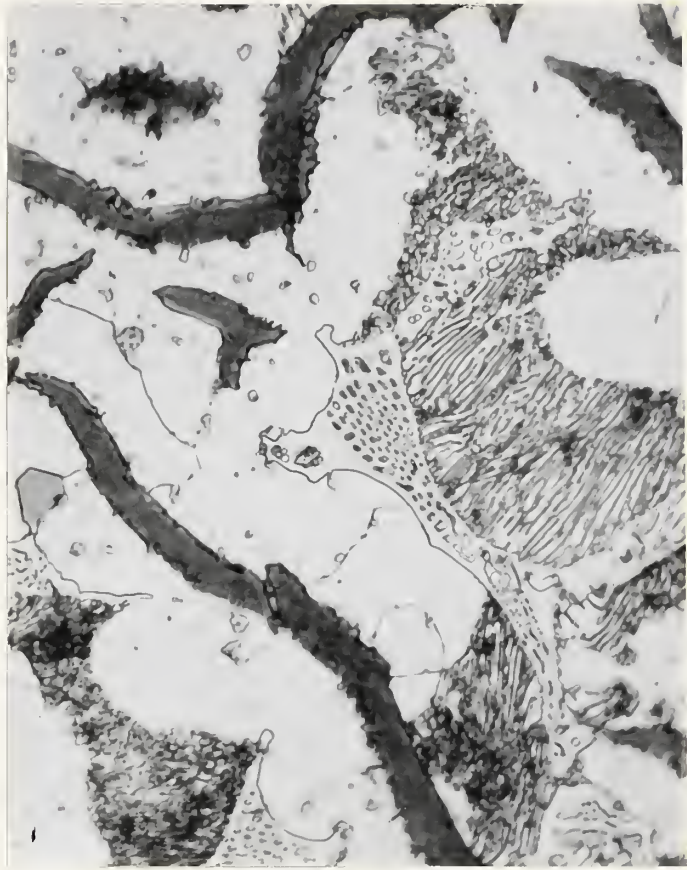
Type A and type B graphite in a ferrite matrix such as that observed in the microstructure produce a relatively weak cast iron [2]. The iron-iron phosphide eutectic, also observed is known to contribute to brittleness [4]. Material having these structural features does not meet the requirements of the specifications [5] usually required for cast iron pipe to be used in natural gas service.

Figure 6. Microstructure Adjacent to Narrow Band of Pearlite Shown in Figure 5c at a Higher Magnification. Etched with nital. X 1000

Areas of the iron-iron phosphide eutectic (small rounded particles in light-colored ferrite), coarse type A graphite flakes in a ferrite matrix, and lamellar pearlite are present.
