NBSIR 73-284

Examination of United Aircraft of Canada Compressor Turbine Disk and Blade Assembly

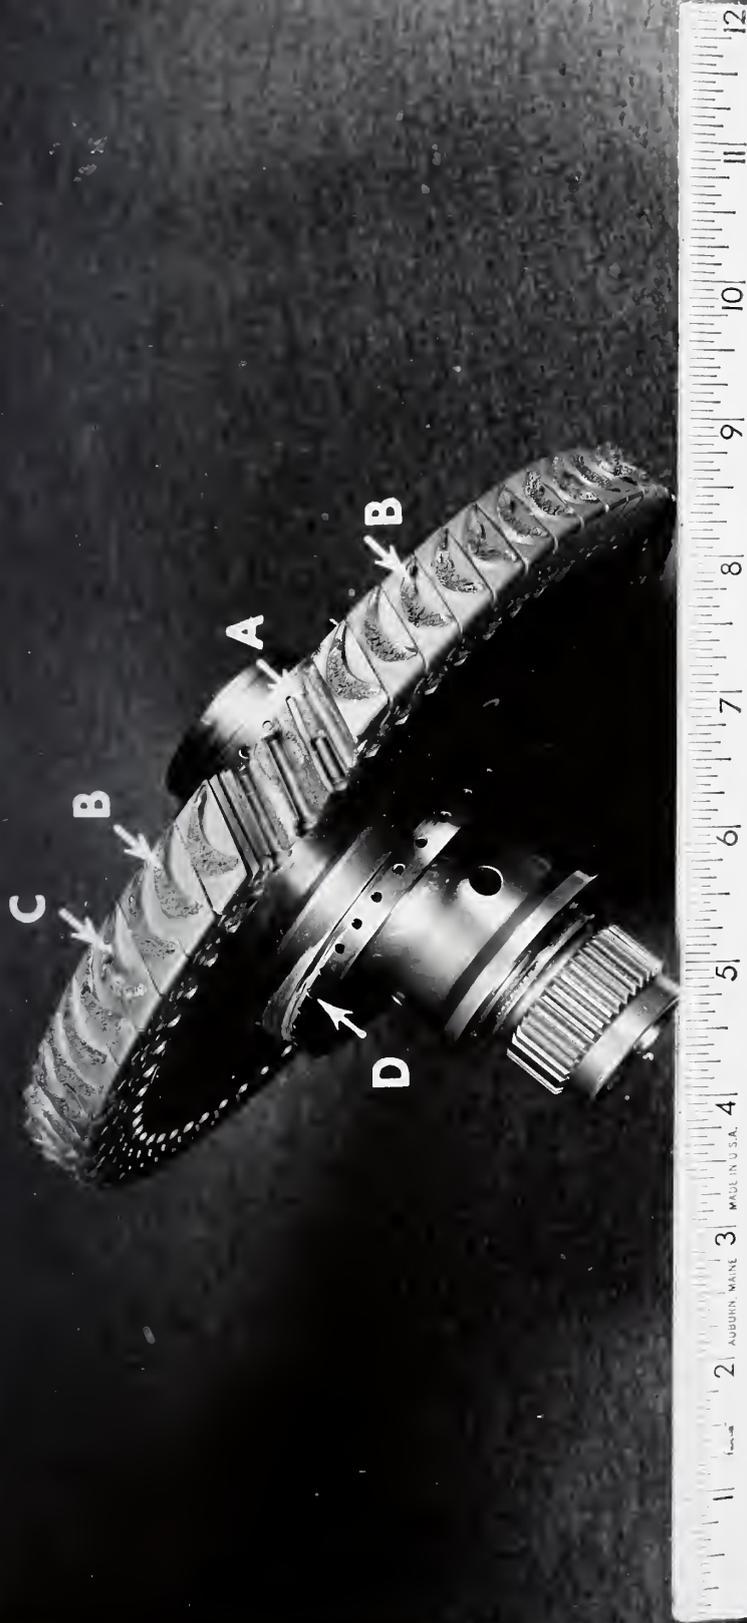
Figure 1. Compressor turbine disk and blade assembly as received. Fractured disk fir trees are in center of photograph. Arrow A indicates portion of fractured blade remaining in assembly in region of fractured disk fir trees. Arrows B indicate examples of fractured blades away from disk fir tree fractures. Arrow C indicates example of fractured blade exhibiting mechanical damage. Arrow D indicates location of mechanical damage to outside of balancing weight ring.

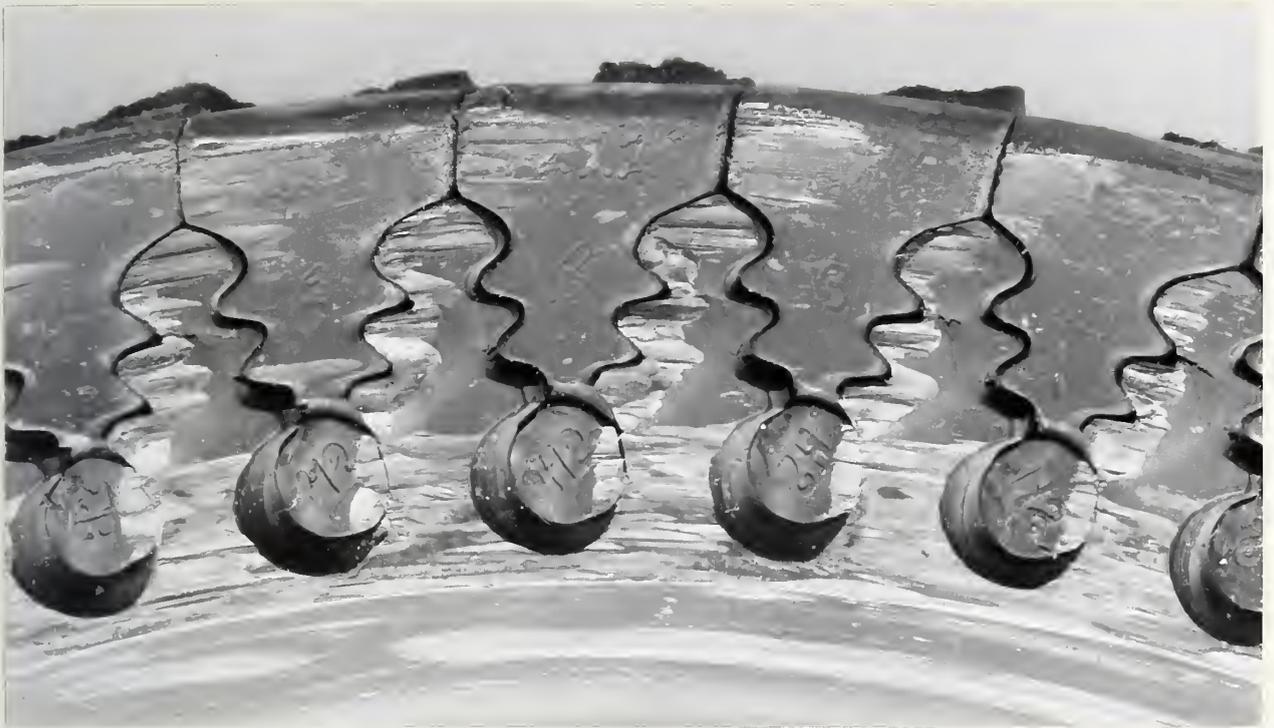
Figure 2. Part of the side of the turbine disk and blade assembly containing the spline showing circumferential rubbing damage to the rivet heads and to the fir tree areas of the disk and blades. X 4

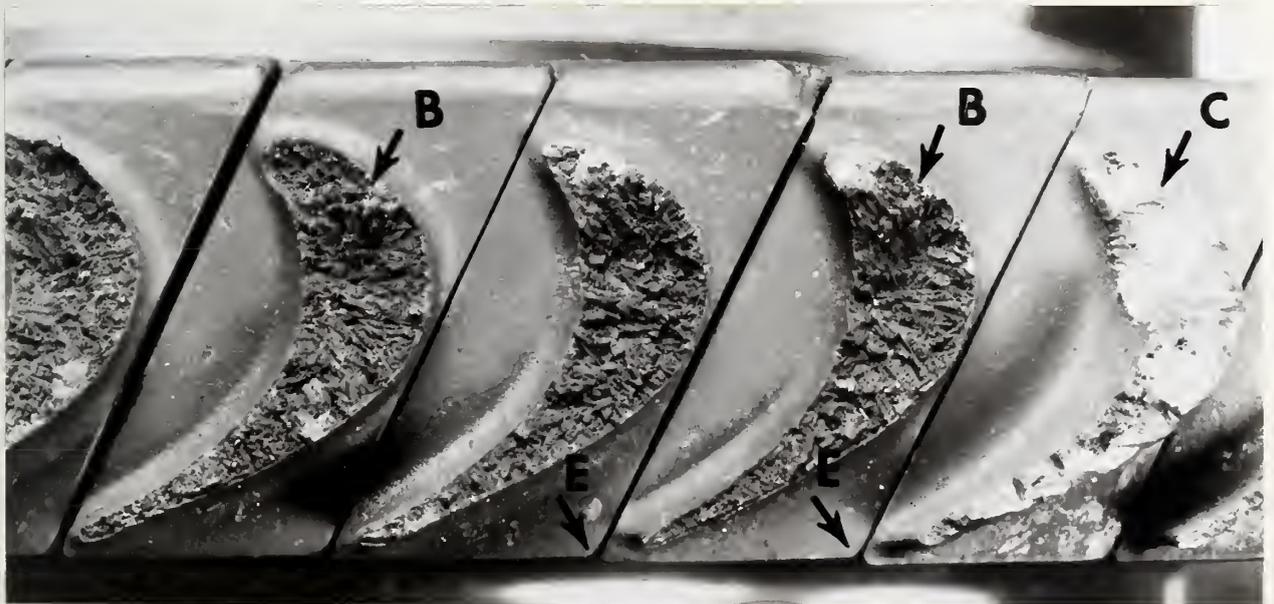
Figure 3. Part of the compressor turbine disk and blade assembly showing blade base askewness (arrows E) and the fracture surfaces of several blades. Arrows B indicate fractures representative of most of the blades. Arrow C indicates a blade fracture surface exhibiting severe mechanical damage. X 4

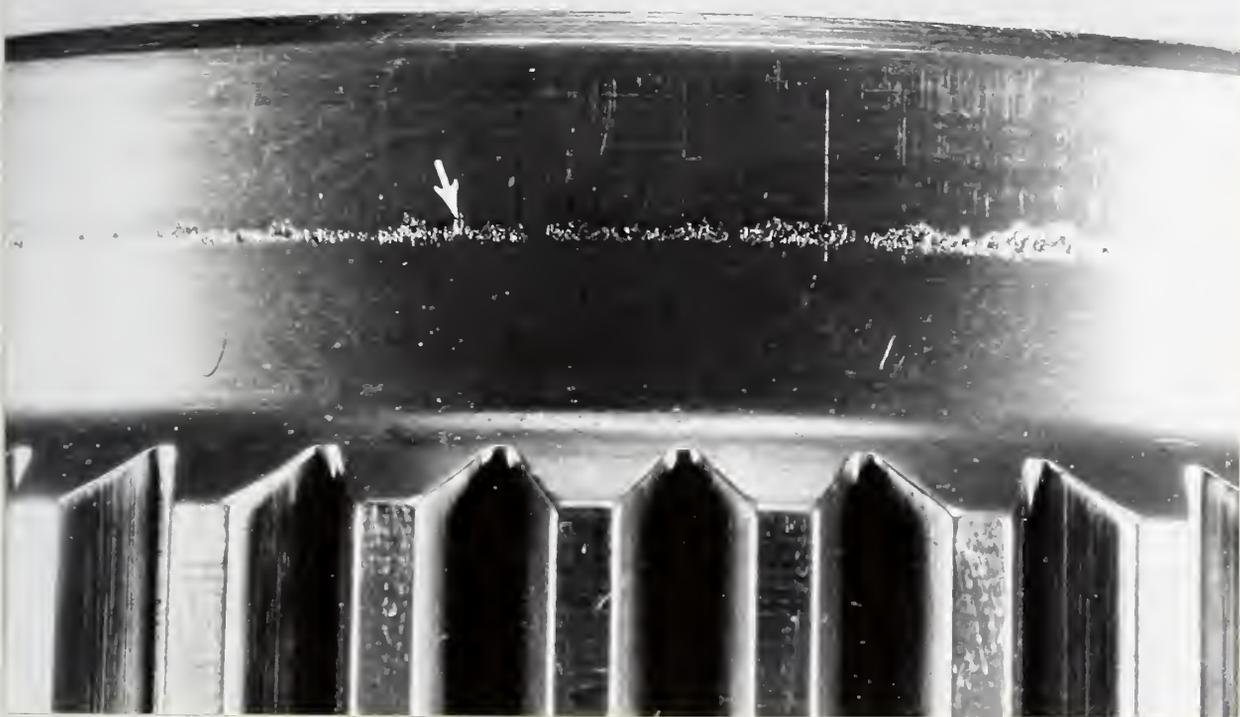
Figure 4. Part of the compressor turbine disk hub between the spline and the end of the hub showing fretting damage (indicated by arrow). X 10

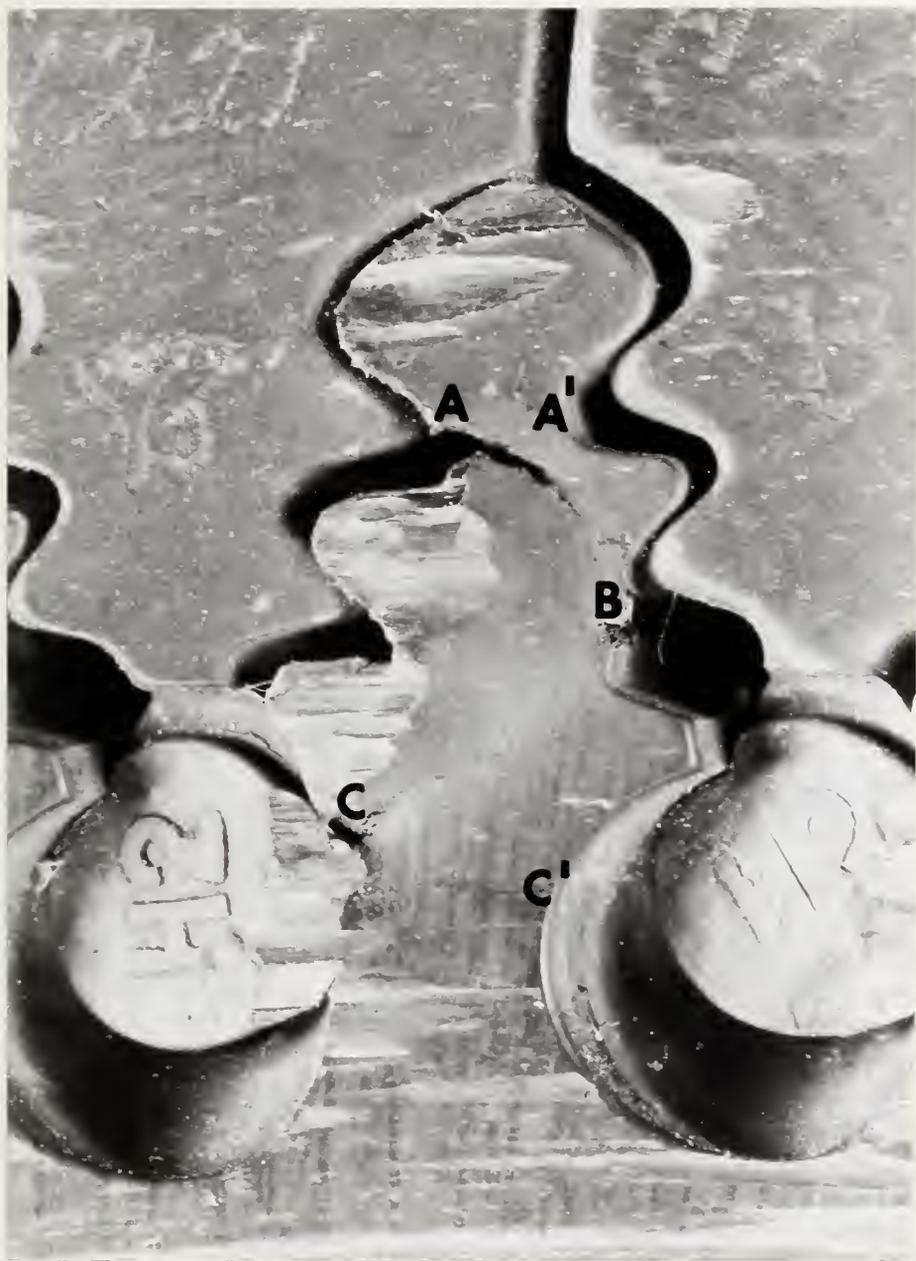
Figure 5. One of the fir trees of the disk (center) and two blade fir trees. The regions of crack initiation in the disk fir trees are indicated by A, B, and C. Of the three fir trees which had fractured, the fracture crack passed through A-A', in one, through B-C in one, and through C-C' for the other. X 10

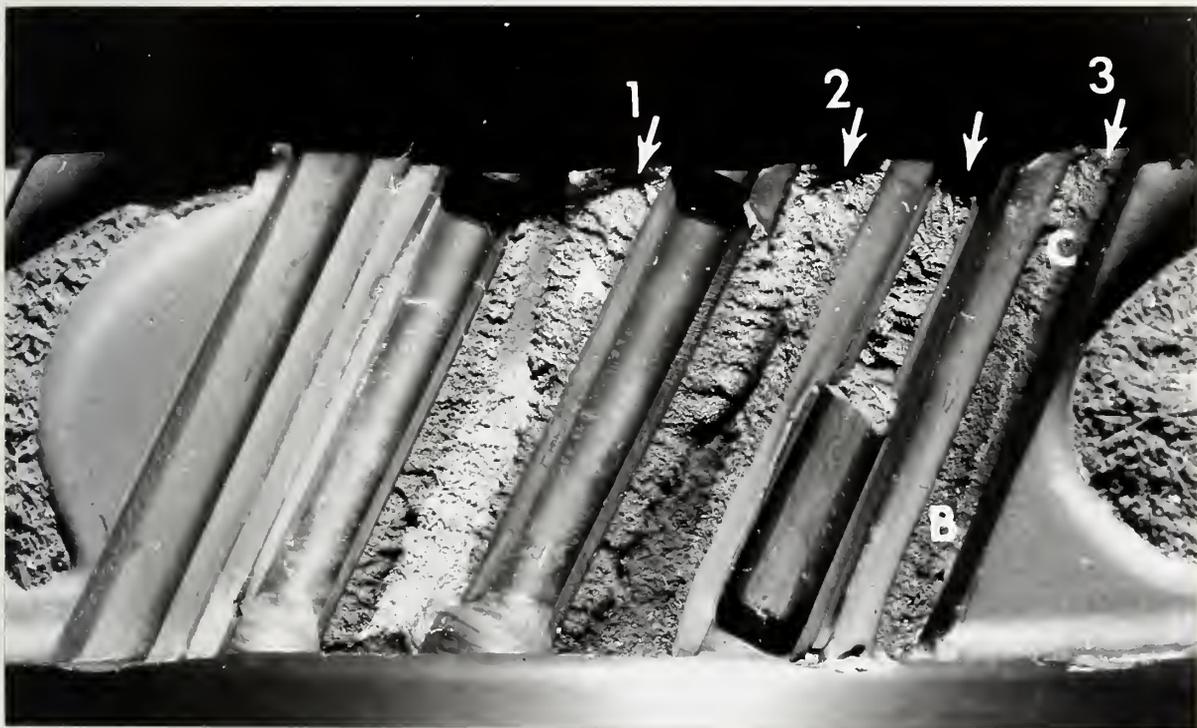
Figure 6. Fracture surfaces of the three fractured disk fir trees, indicated by arrows 1, 2, and 3. Part of one of the blade fir trees which had fractured and remained attached to the disk is indicated by the unmarked arrow. The locations of the scanning electron photomicrographs shown in figures 7, 8, and 9 are indicated by A, B, and C, respectively. X 4

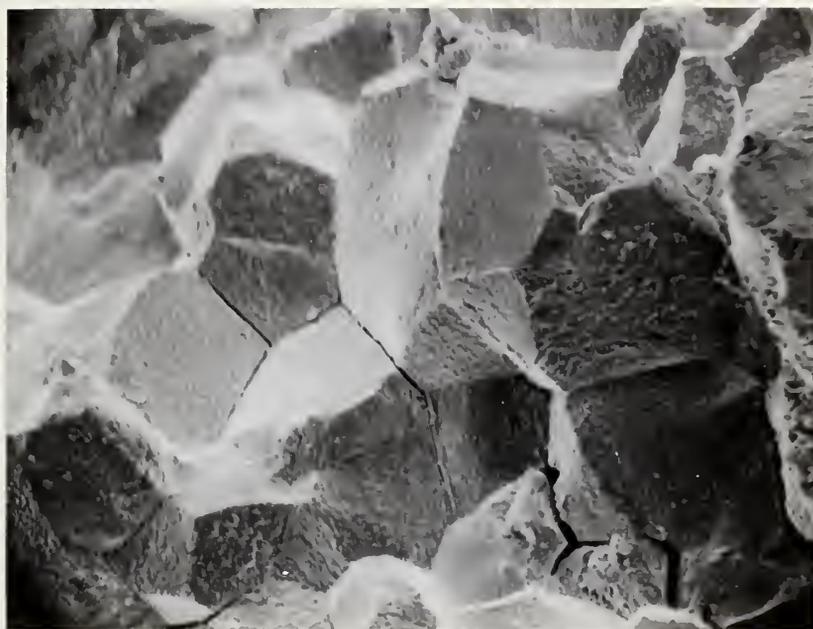
Figure 7. Scanning electron photomicrograph showing intergranular cracking. The area shown was located approximately at A on fracture 1, figure 6. This is representative of the fracture features exhibited by the dark gray areas of the fracture surfaces. X 520

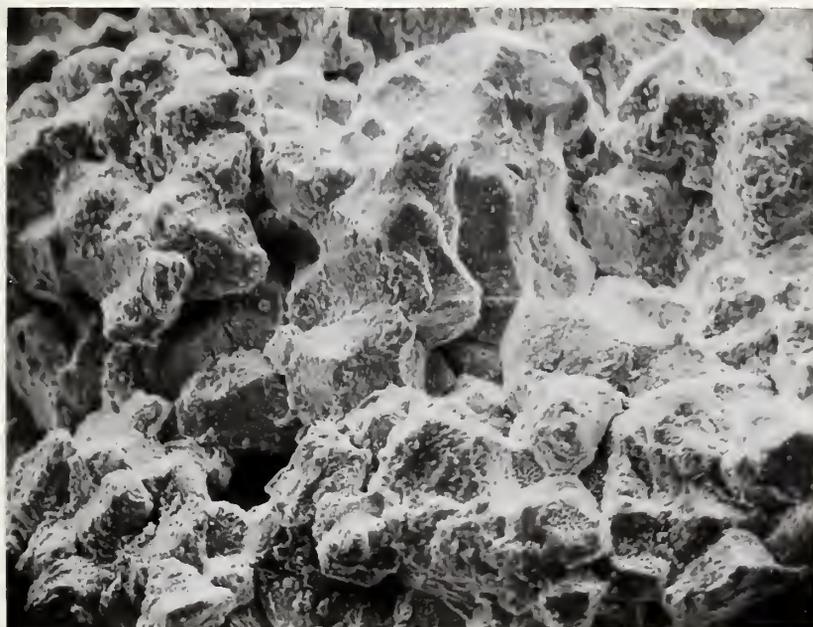
Figure 8. Scanning electron photomicrograph showing intergranular cracking. There appears to be some corrosion product here. The area shown was located approximately at B on fracture 3, figure 6. X 330

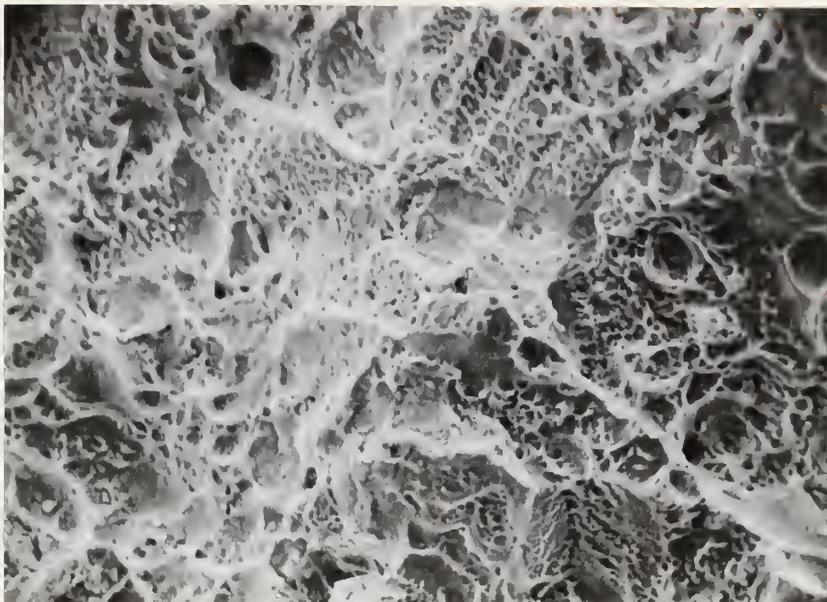
Figure 9. Scanning electron photomicrograph showing dimpled rupture. The area shown was located approximately at C on fracture 3, figure 6. This is representative of the fracture features exhibited by the blue areas of the fracture surfaces. X 850

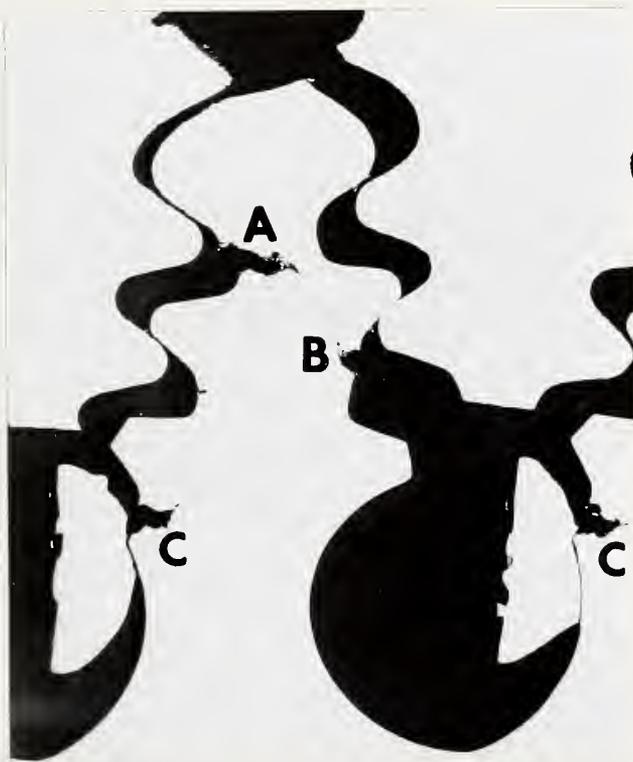
Figure 10. Circumferential section through assembly showing parts of two blade fir trees (upper right and upper left), parts of two rivet heads, and parts of two disk fir trees. Crack regions A, B, and C are indicated as in figure 5. Dark areas contain mounting material. Unetched. X 7

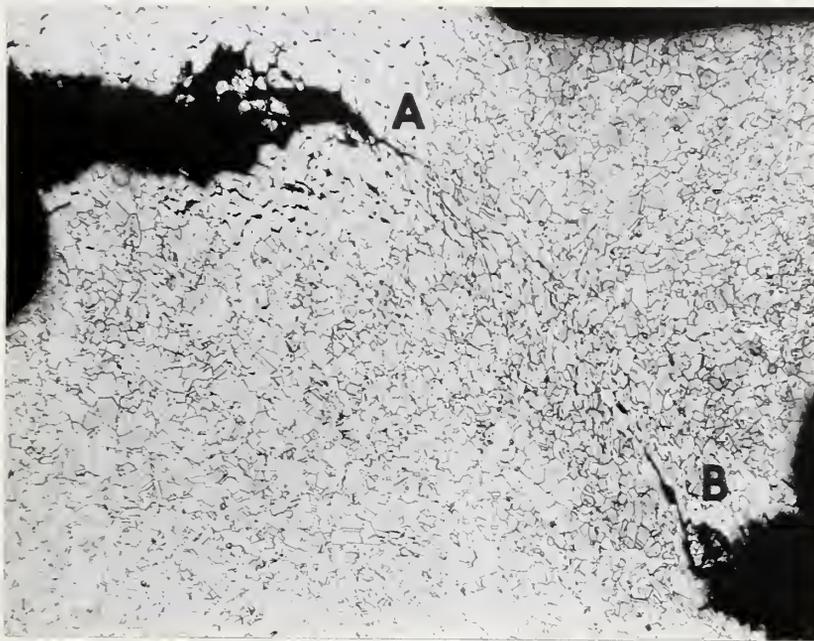
Figure 11. Crack regions A and B from figure 10 at higher magnification. Section was etched to show the deformation in the material between the two cracked regions. Etch: Kalling's. X 40

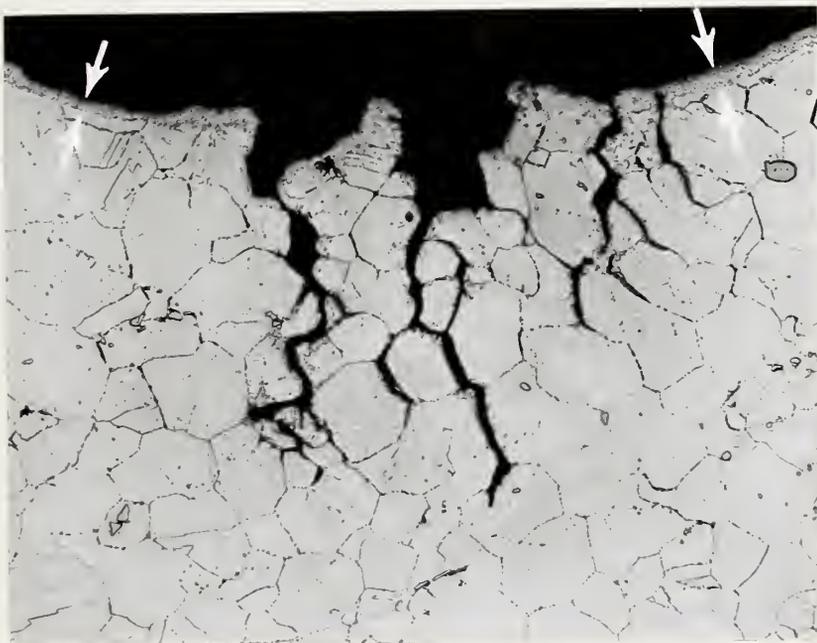
Figure 12. Etched circumferential section in crack region B of one of the disk fir trees. The intergranular nature of the cracks is evident. A narrow region near the surface of the tree (indicated by arrows) termed a depleted zone can be seen. Etch: Kalling's. X 200

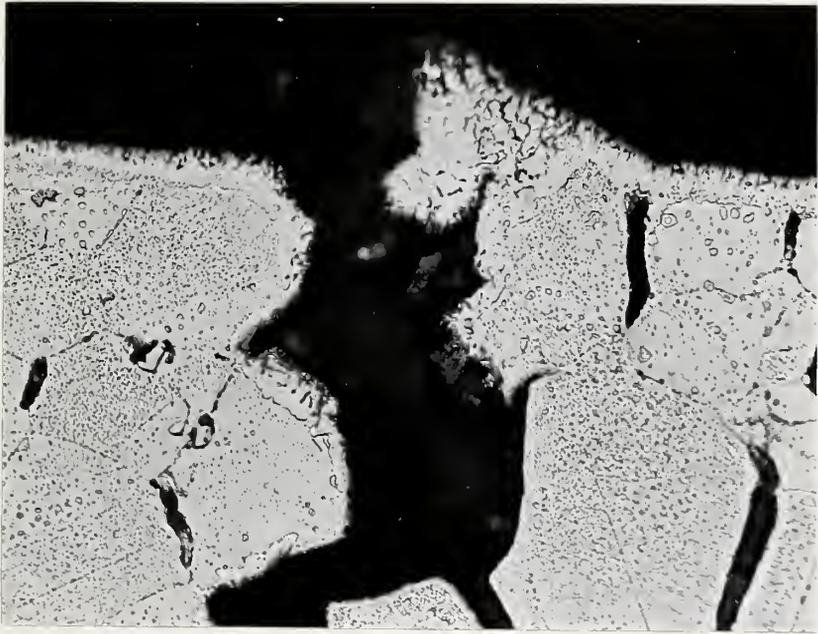
Figure 13. Etched circumferential section showing depleted zone along part of the crack wall as well as along the surface of the tree.
Etch: Kalling's. X 500
