Pilot Demonstration of Lead Based Paint Hazard Elimination Methods

Report on Field Study No. 2

T. H. Boone, T. R. Ray, W. G. Street

December 1973

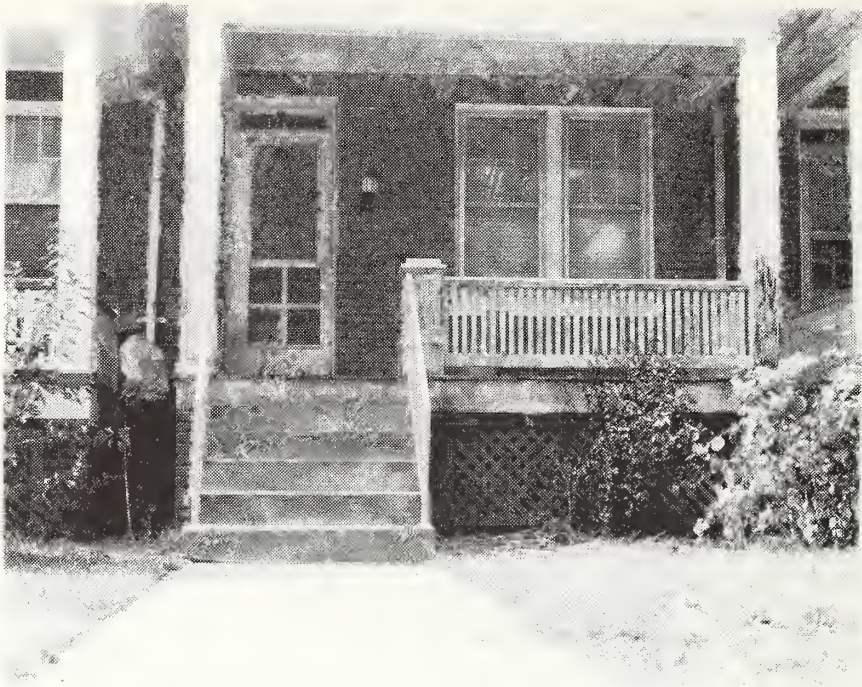
Figure 1. Front porch of pilot demonstration dwelling unit at the start of the paint removal process.

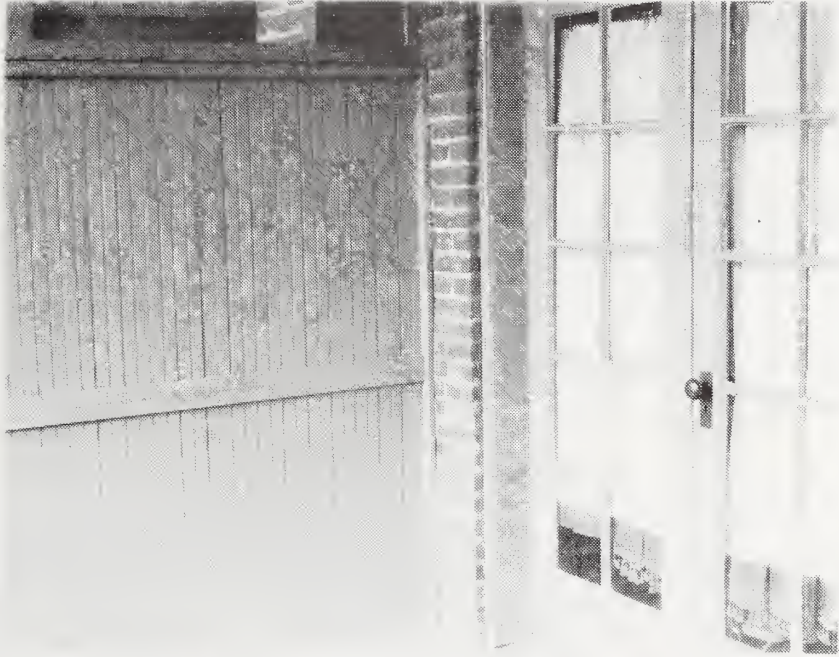
Figure 3. Interior wall and door of back screened porch before removal of paint.

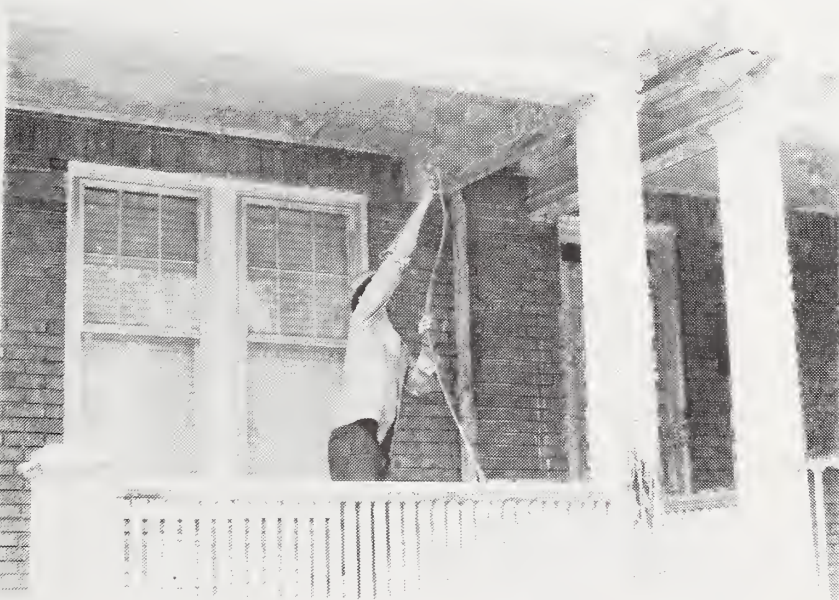
Figure 4. Application of paint remover on painted wood surfaces with spray equipment.

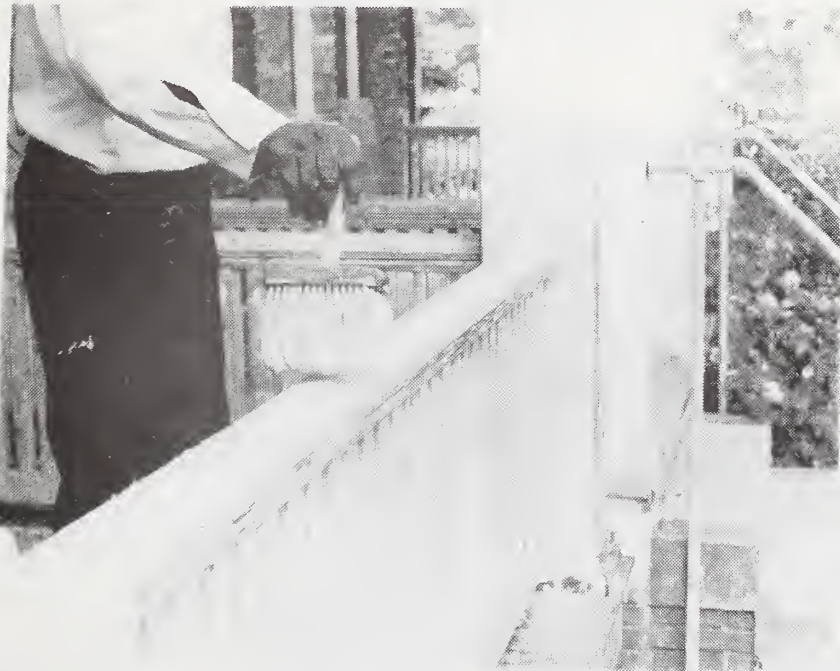
Figure 6. Application of paint remover on painted wood railing by brush.

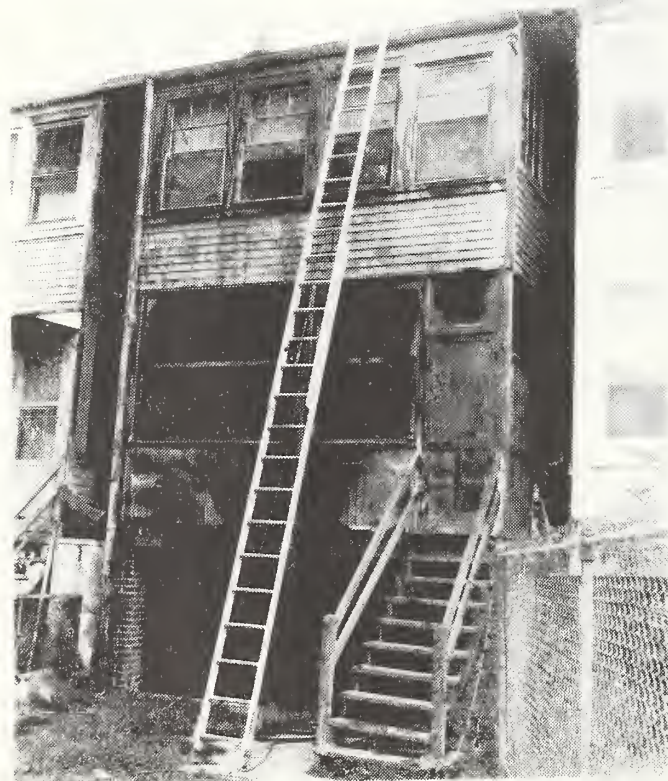
Figure 8. Appearance of paint on wood siding and trim on first floor and basement areas and on metal siding below second floor windows after 30 minutes dwell time of paint remover.

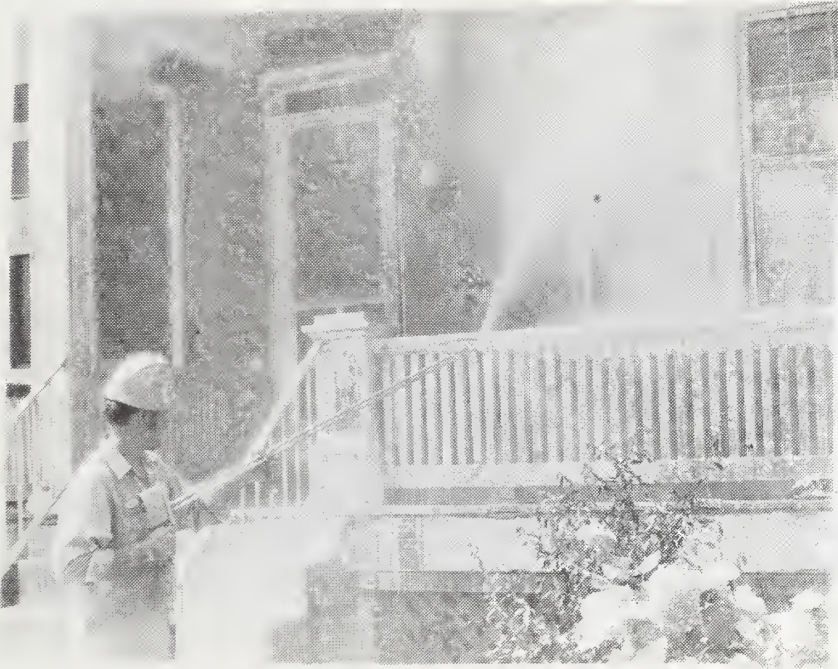
Figure 9. Flushing off old paint with high pressure water spray after treatment with paint remover.

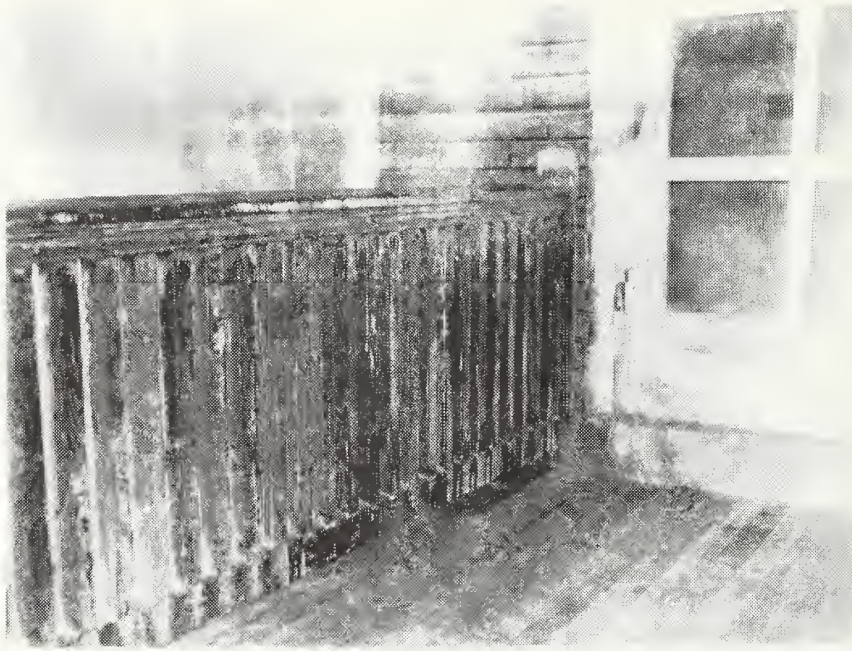
All rough surfaces were hand sanded to a smooth texture. At certain points where paint had accumulated in heavy quantities as a result of multiple past repainting (such as at the base of the verticals on the front porch railing), it was necessary to manually remove the remaining softened paint residue. Figures 11 and 12 show the front porch railing on which accumulated softened paint residue can be seen at the bottom of the verticals. After completion of the paint removal process, all surfaces were allowed to dry thoroughly.

Figure 11. Porch rails after application of three coats of paint remover and water spray flush. Hand scraping was necessary to completely remove paint from the base of railings.

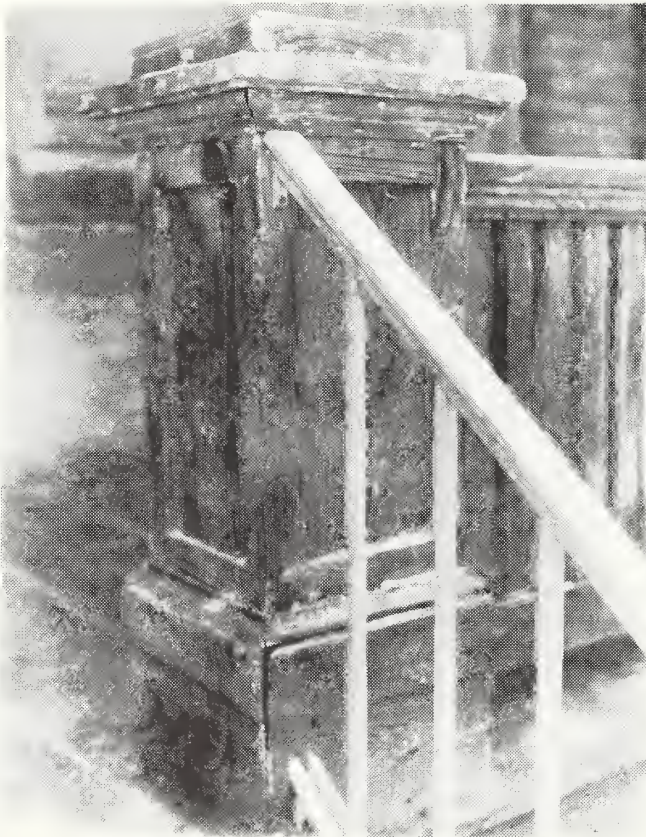
Figure 12. Porch post during water flush operation. Note warpage of post base caused by water soakage during paint removal.

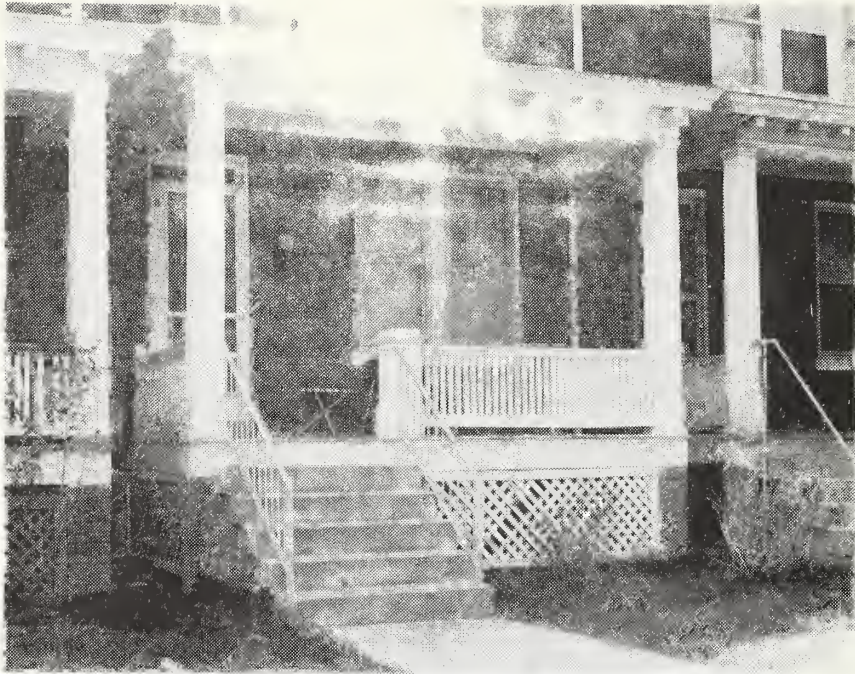
2. The contractor failed to pick up water rinse which contained old lead paint particles and paint remover chemicals. This contaminated water was allowed to soak into the back and front yards, run off into the gutter and, under certain circumstances, splash onto adjoining property or yards (see figures 13 and 14).

4. Because there were multiple layers of old paint on most wood surfaces, it was necessary to repeat the remover application followed by water rinsing 3 or 4 times. This procedure caused warpage, swelling, buckling, and splintering of some wood surfaces. Sanding, recaulking, renailing and in some areas additional coats of paint were required to make the final appearance acceptable as shown in figures 14, 15, 16, and 17.

Figure 14. Front porch of pilot demonstration after removal of old paint and repainting. Note loss of foliage on bushes. The damaged grass sod was removed and replaced with new sod.

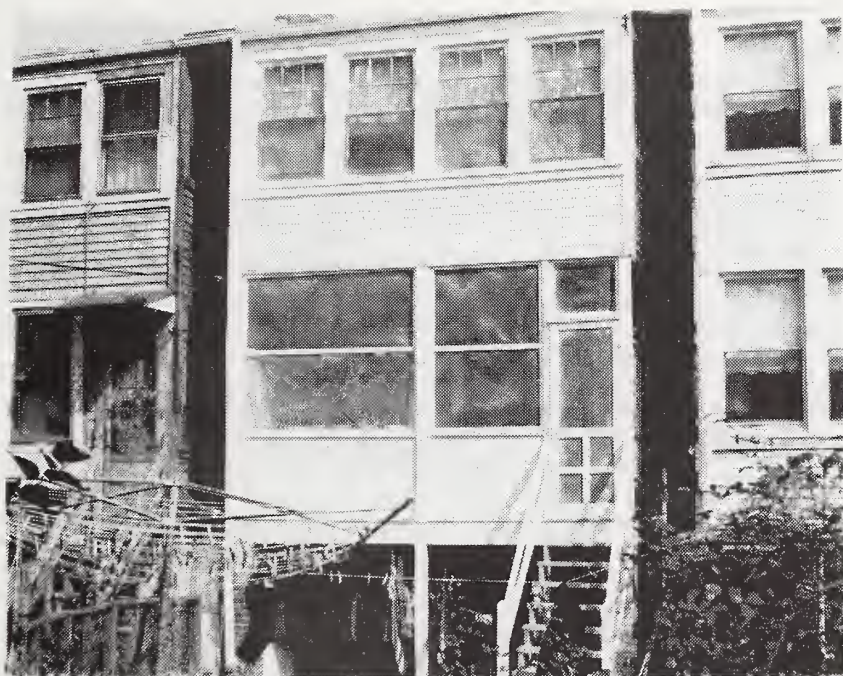
Figure 16. Back screened porch, enclosed second floor porch and basement area way of pilot demonstration after removal of old paint and repainting.

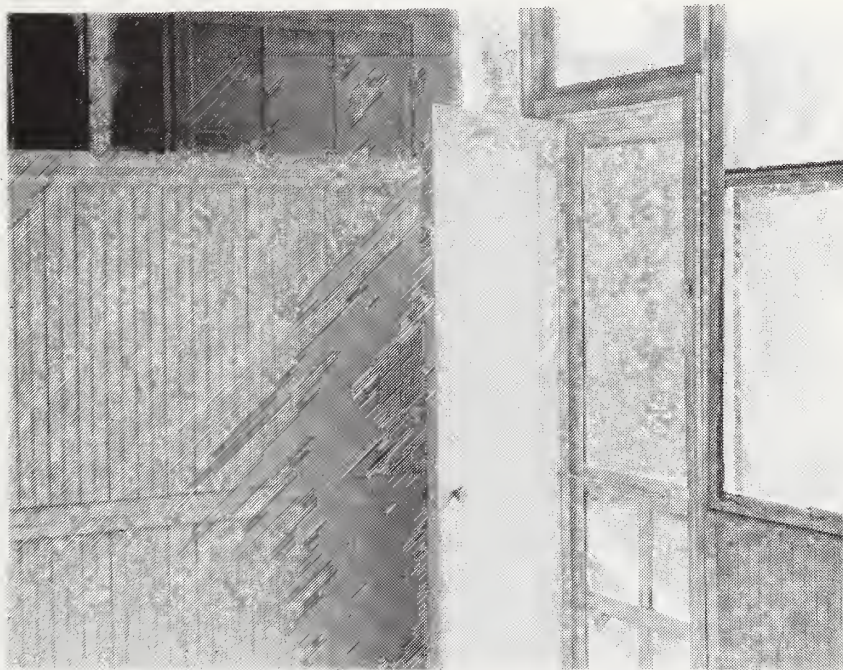
Figure 17. Interior view of wall and door of screened porch after removal of old paint and repainting.
