NBSIR 74-449

Fire Endurance Tests on Walls and Plumbing Chases Containing Either Metallic or Nonmetallic Drain Waste and Vent Systems

November 1973

Interim Report

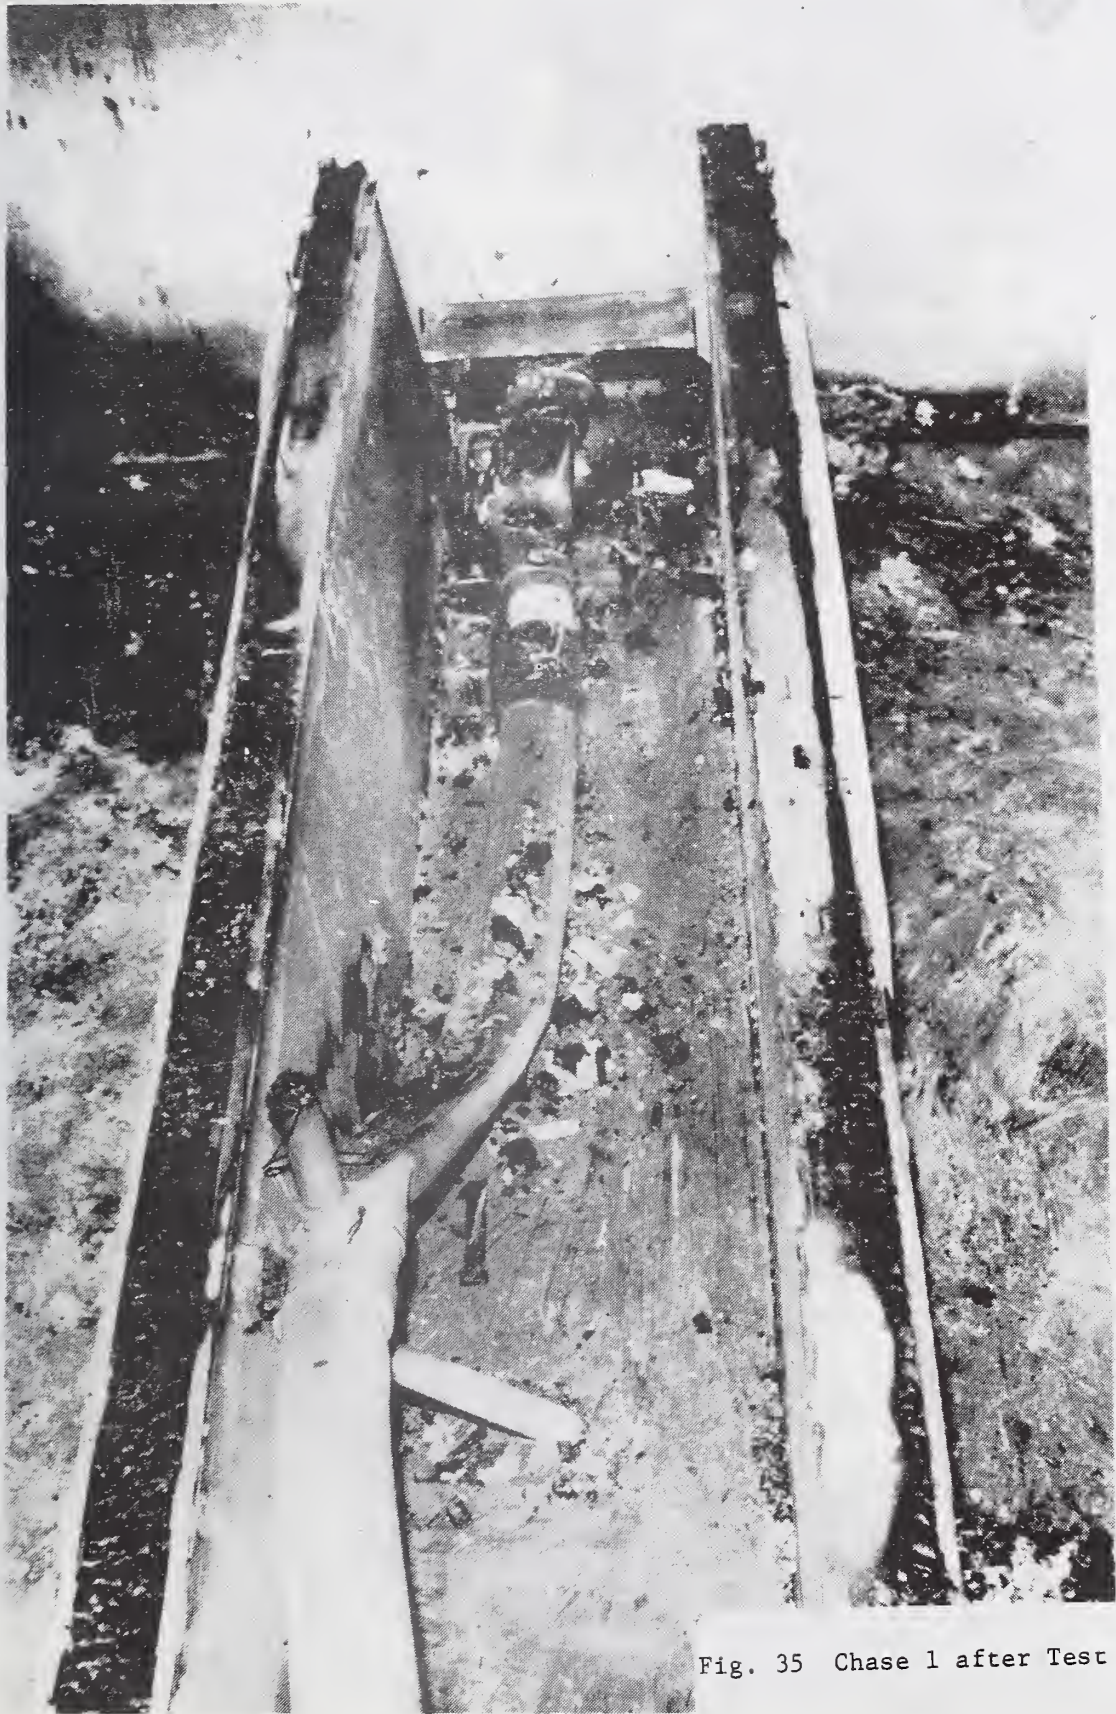
Chase 1 is shown after the test in figure 35. The collapse of the stack took place after the test was over. The charring of the stack was due to some debris which fell on it. The lateral leading to the furnace was burned off 5-1/2 inches from the tee at the point of attachment of the number 2 thermocouple. The burning of the lateral did not extend beyond the inside layer of gypsum board. The inside of the remaining lateral was partially closed off due to char formation leaving a 1 inch diameter passage through it. The damage inside chase 1 could be regarded as slight.

Fig. 35 Chase 1 after Test 1.

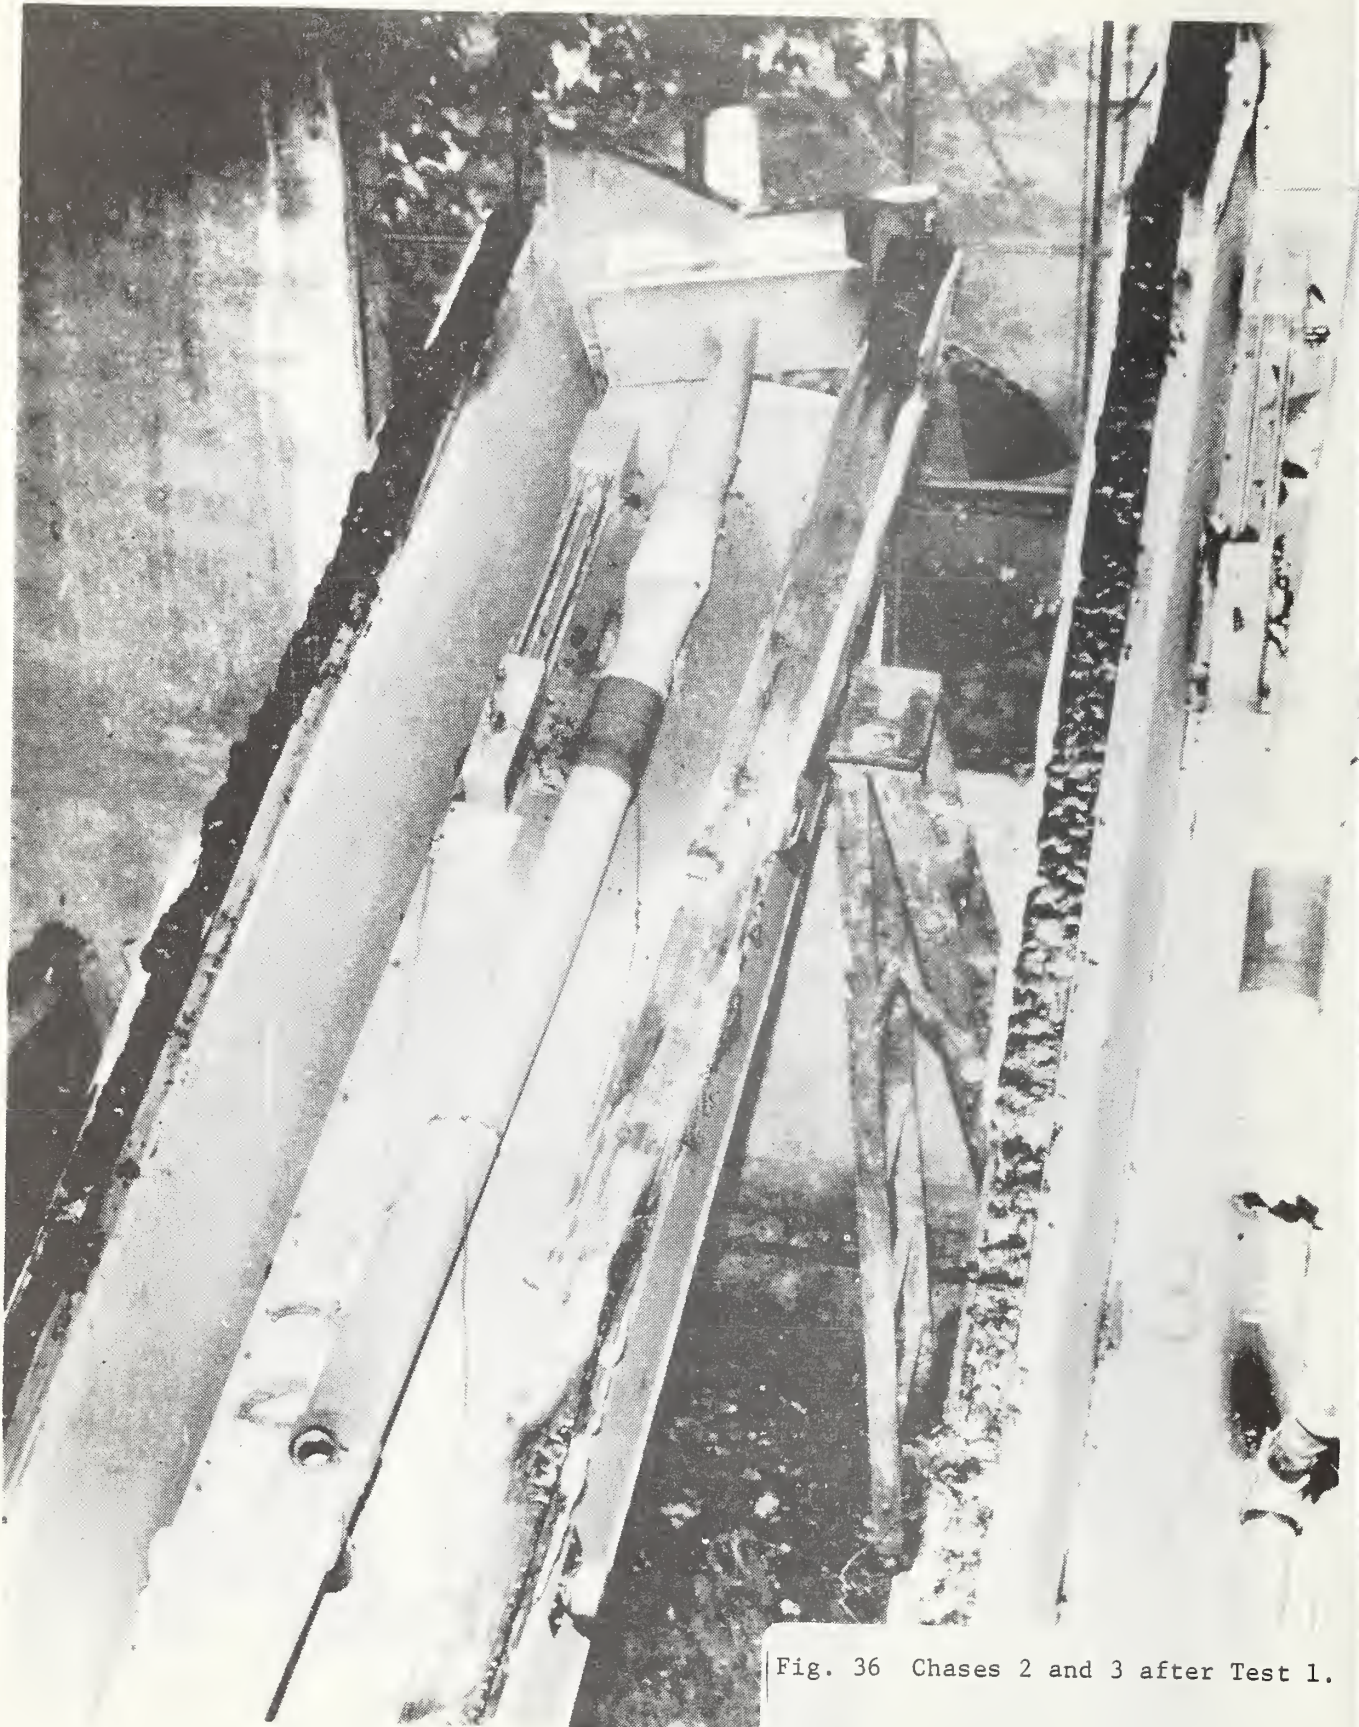
Figure 36 shows chases 2 and 3. In chase 2 the lateral burned a distance of about 2 inches into the sleeve and closed the remainder of the lateral off by char formation. The scorch on the stack just above the lower lateral in chase 3 is probably also due to the presence of hot debris which fell on it after the test. The damage in these two chases could also be regarded as slight.

Fig. 36 Chases 2 and 3 after Test 1.

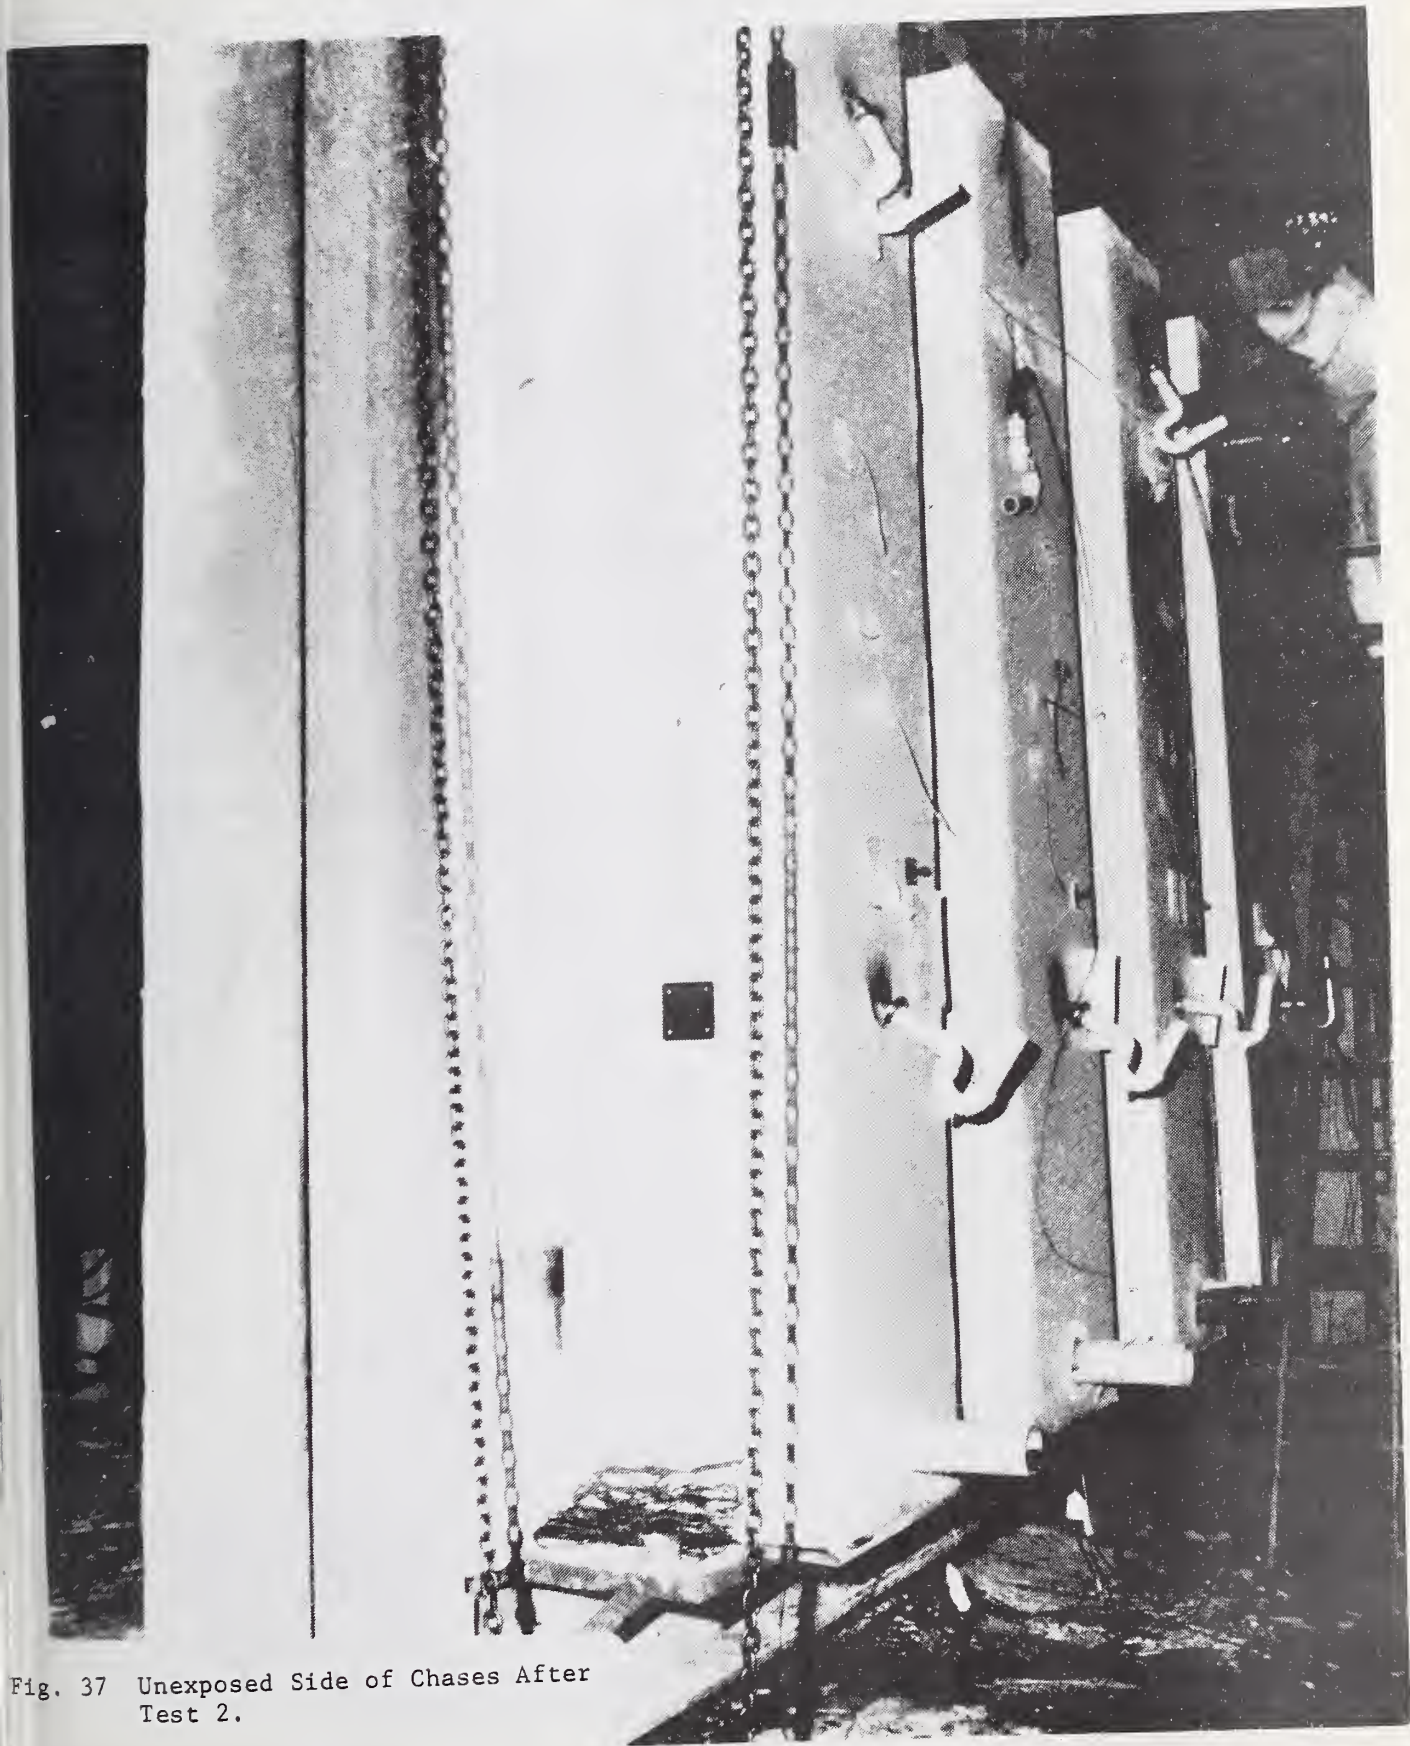
The unexposed side of the chases can be seen in figure 37. The P-trap hanging down along the wall was removed from its lateral after the test. Although the P-traps sagged on the unexposed side of the chases (due to inadequate wire support), they remained in place and did

not pass flame or hot gases sufficient to ignite cotton pads during the test. The upper laterals pulled out of the stacks in chases 5, 6, and 7 and then sagged on the inside of the chases making it impossible for the P-traps to fall. The lower laterals on the unexposed side of the stack in chases 5 and 7 remained intact. In chase 6 the lower laterals remained in the sleeves attached to the walls. In chases 5 and 7 the laterals on the exposed side of the stack burned past the wall into the chase, pulled out of the reducing double sanitary tee and fell to the bottom of the chase. The stacks in chases 5 and 6 melted down into a mass about 4 feet long, and congealed around the thermocouple wires used to measure the temperature in the gas stream. The damage in chase 5 can be seen in figure 38. Although there was a considerable amount of charring of this mass there was no evidence of flaming. The hubless cast iron stacks in chases 7 and 8 remained in place and the neoprene gaskets in the clamps appeared to be in good condition after the test.

Fig. 37 Unexposed Side of Chases After Test 2.

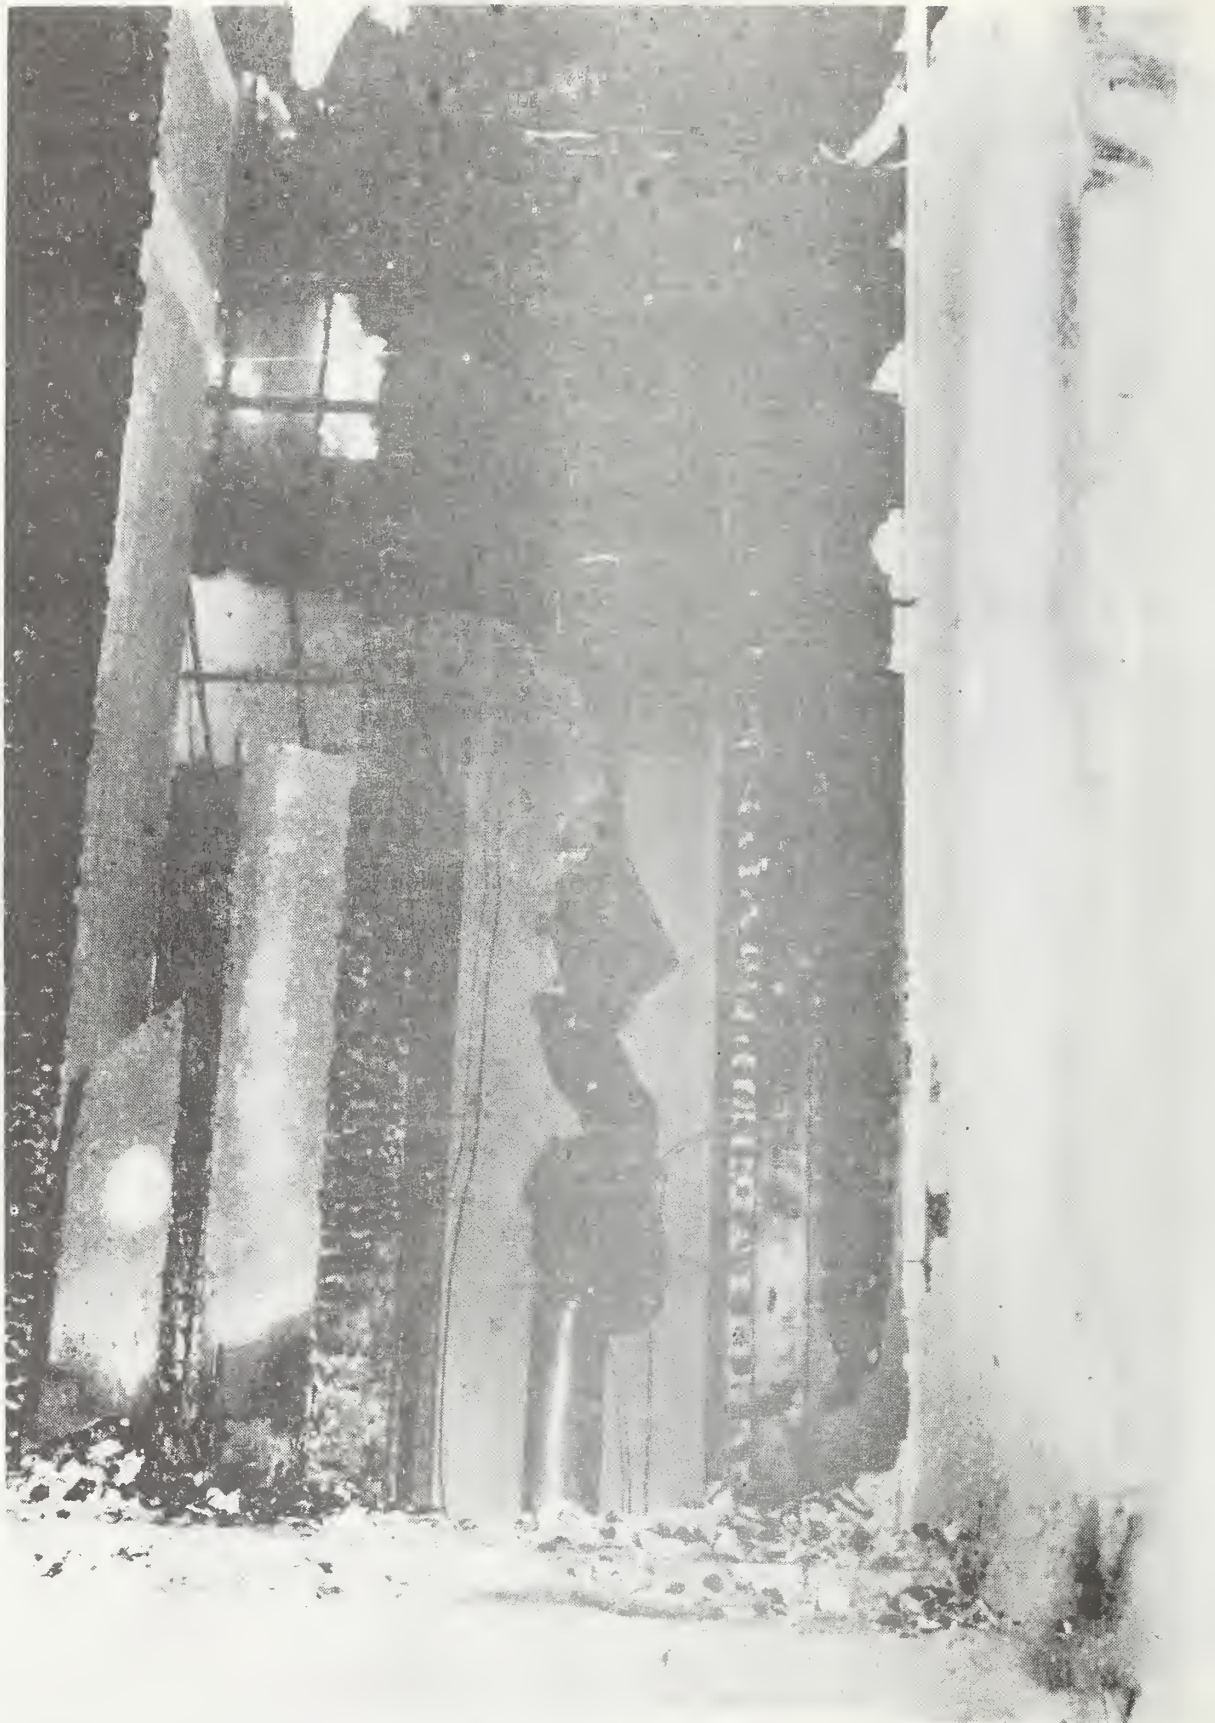
Fig. 38 Chamber 5 after Test 2.

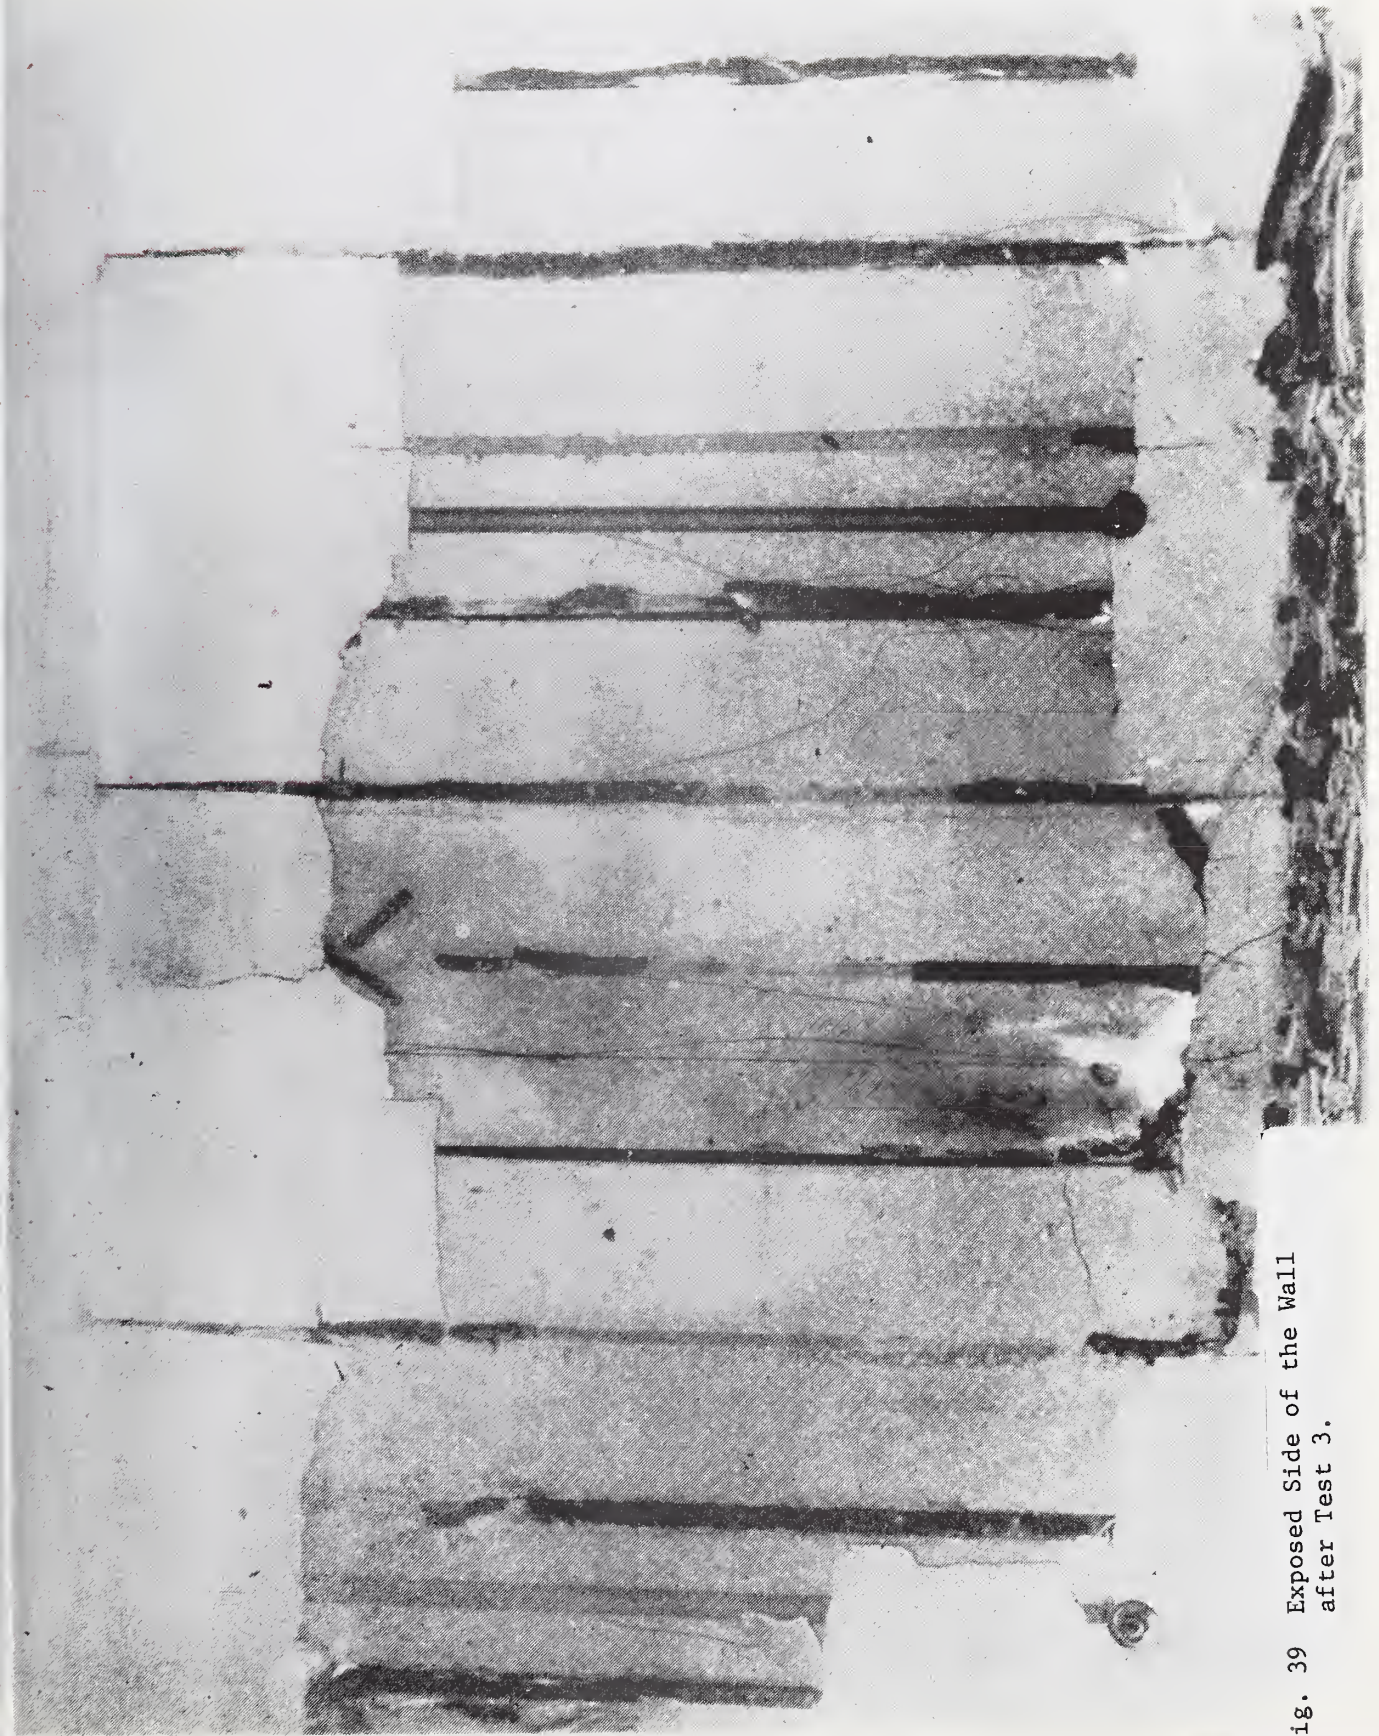
The condition of the DWV installations after Test 3, which was stopped at 55 minutes, can be seen in figure 39. The copper and galvanized iron stacks were still standing. The ABS stack was completely consumed and the PVC stack had some fragments left which amounted to less than 10 percent of the original pipe. Figure 40 shows the lower PVC trap on the unexposed side of the wall about 15 minutes after the test was terminated. The paper on the gypsum board wall was charred by the penetration of high temperatures through the wall, yet the PVC P-trap remained undamaged.

Fig. 39 Exposed Side of the Wall
after Test 3.

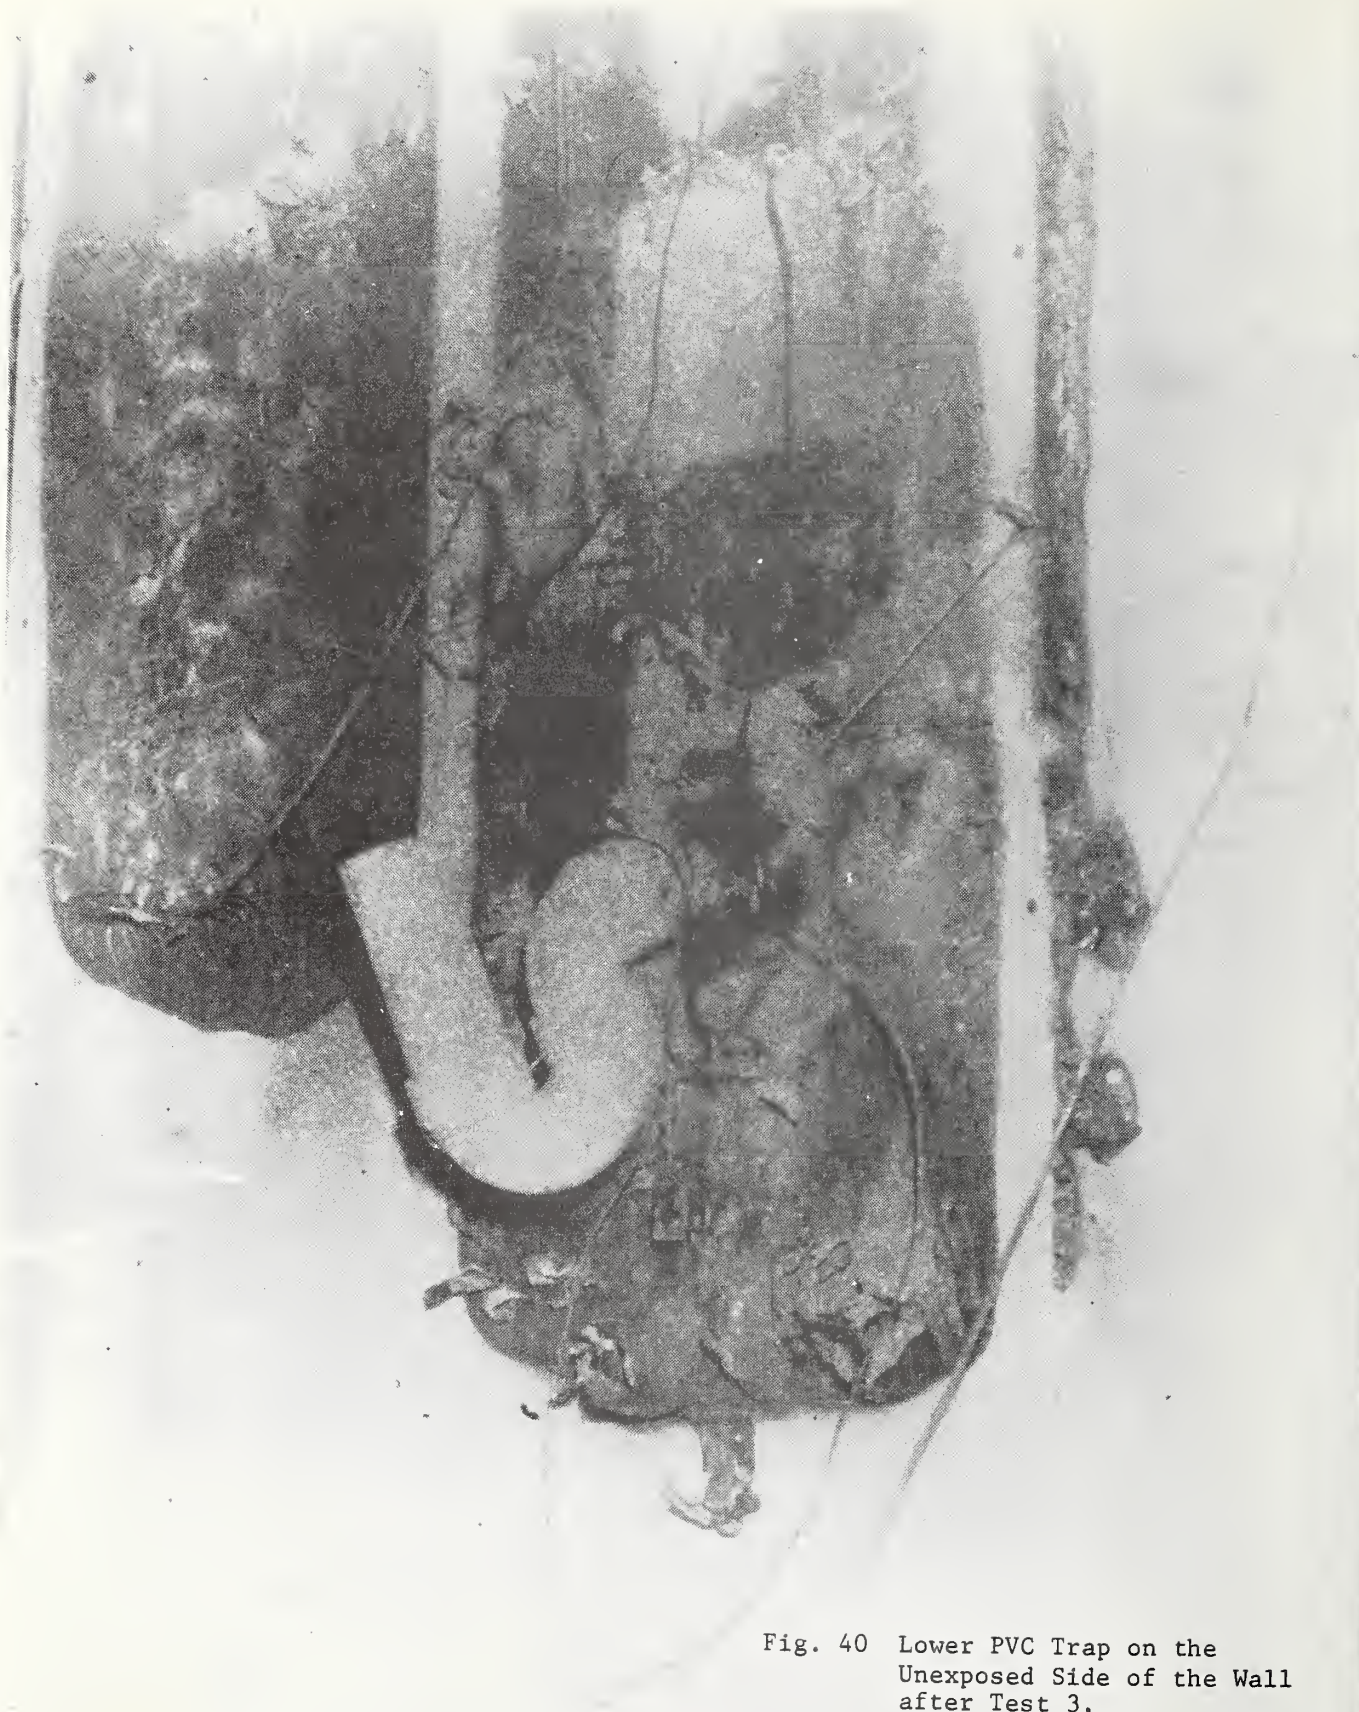
Fig. 40 Lower PVC Trap on the
Unexposed Side of the Wall
after Test 3.

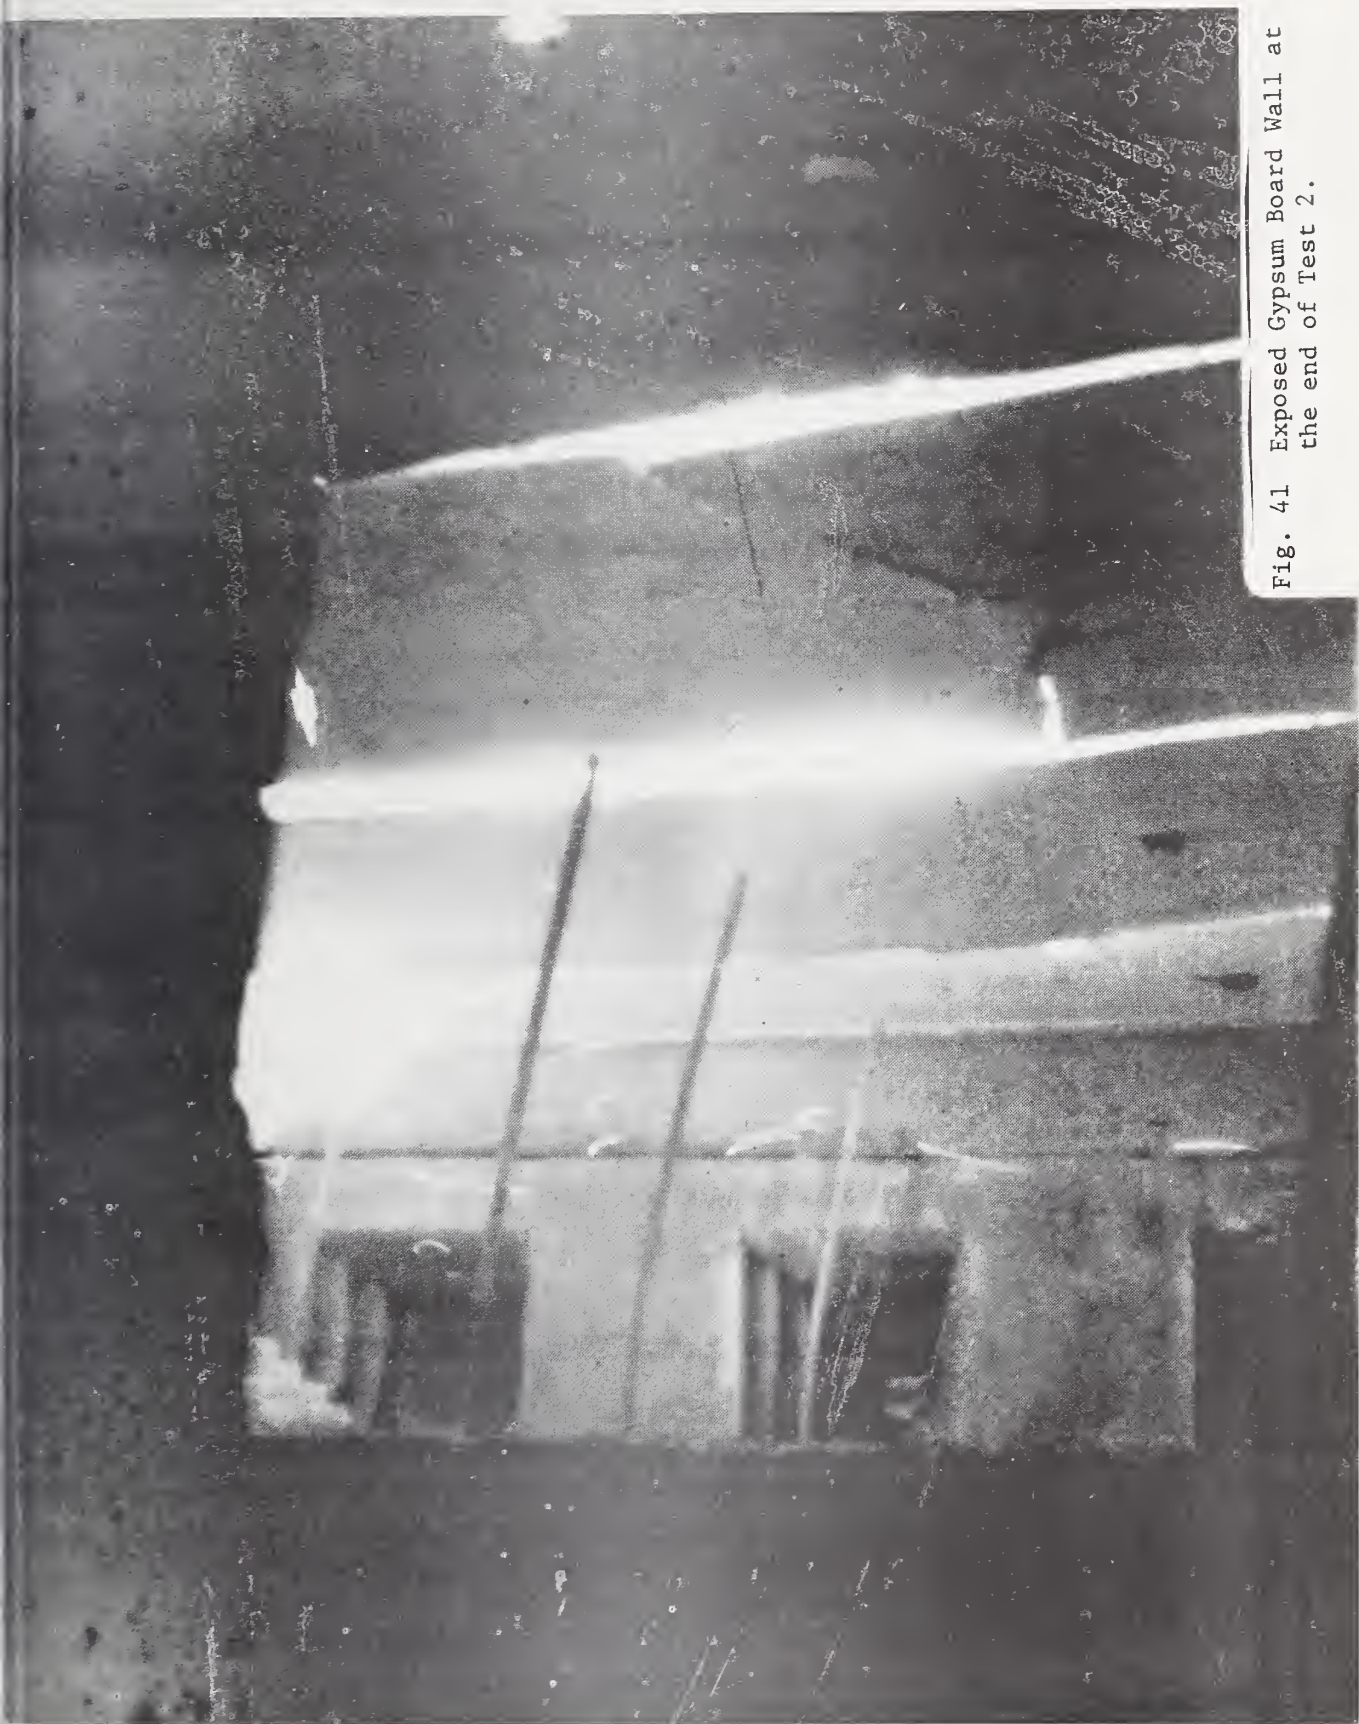
The second test was stopped (gas off) at 50 minutes when the unexposed surface of the wall between chases 1 and 2 indicated a temperature of 483°C and was rising rapidly. Figure 41 shows the vertical crack in the third gypsum board panel which permitted a high heat transfer rate to the back wall. The reason why the crack developed as early as it did is not known. The test was stopped to examine the condition of the pipe at this time. Sprinklers which had been installed in the chase were turned on as soon as the gas supply to the furnace was turned off. The temperature rise of the unexposed surface of the walls between the other chases were well below 181°C at the time the test was terminated.

Fig. 41 Exposed Gypsum Board Wall at the end of Test 2.
