NBSIR 74-472

Analysis of Railroad Wheel Failure - Derailment at Richmond Hill, New York, March 10, 1973

C. G. Interrante and G. E. Hicho

Failure Analysis Report

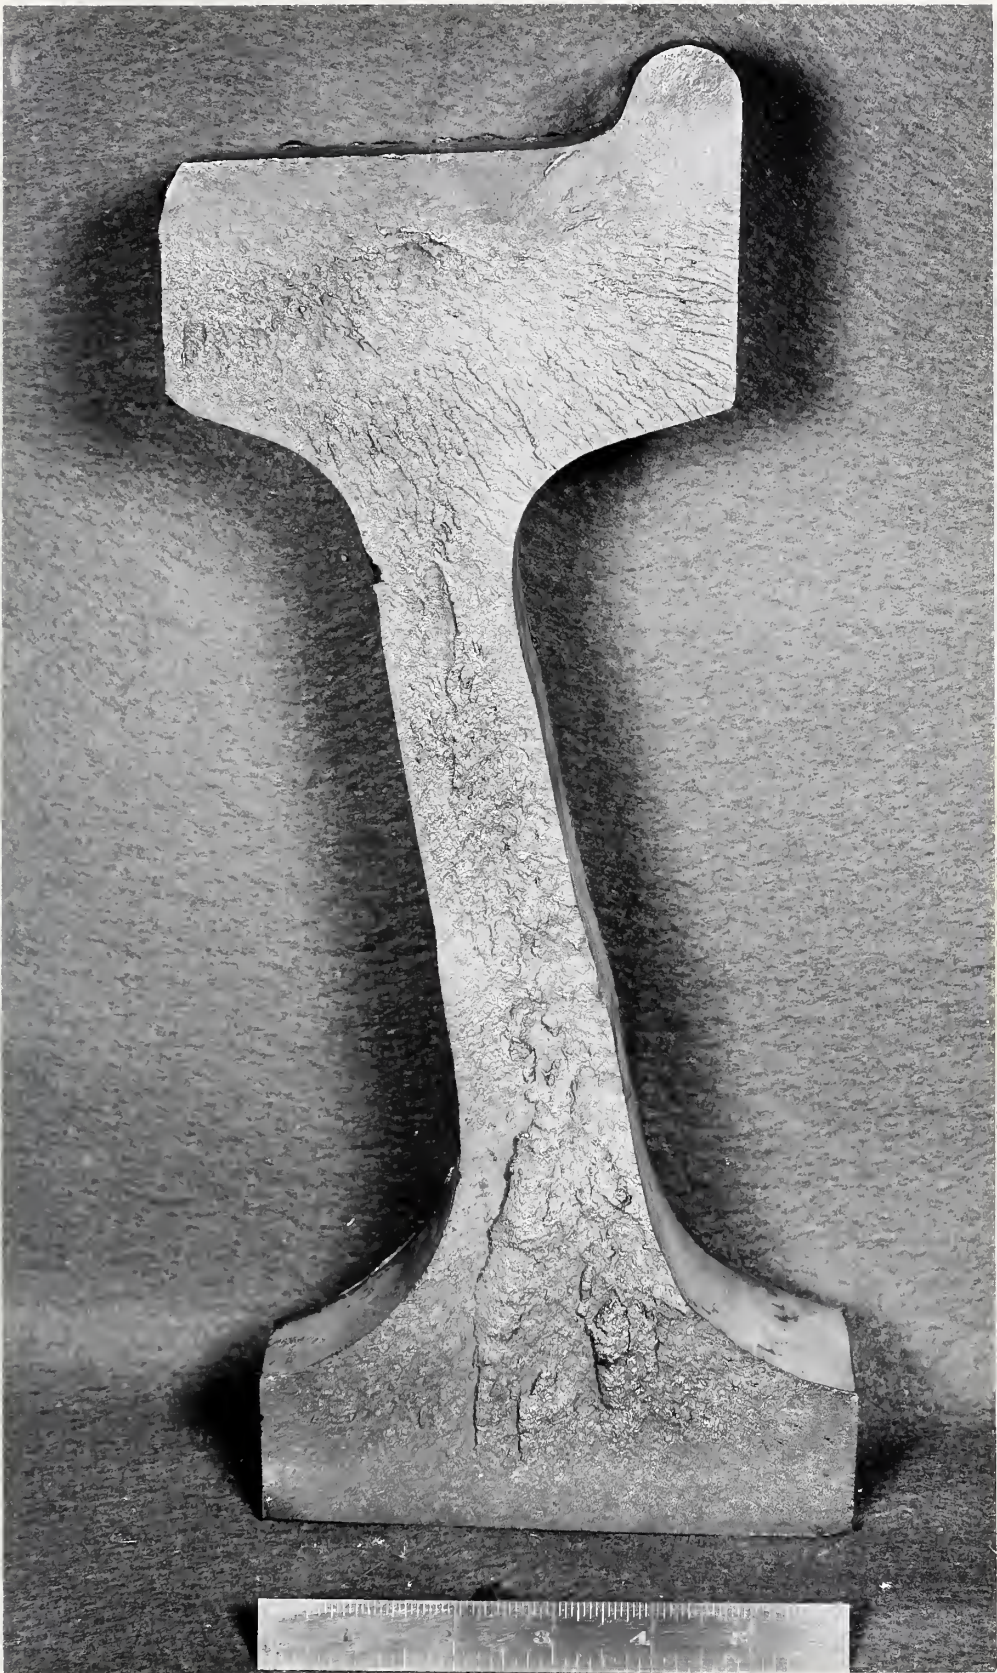
A radial-circumferential section was torch cut from the failed wheel and sent to the National Bureau of Standards (NBS) for failure analyses. This section contained one of the two radial-axial faces of the fracture, as is shown in Figure 1.

Figure 1. Radial-Circumferential Section of the Fractured Wheel, As Received at NBS. Mag. X 1/2

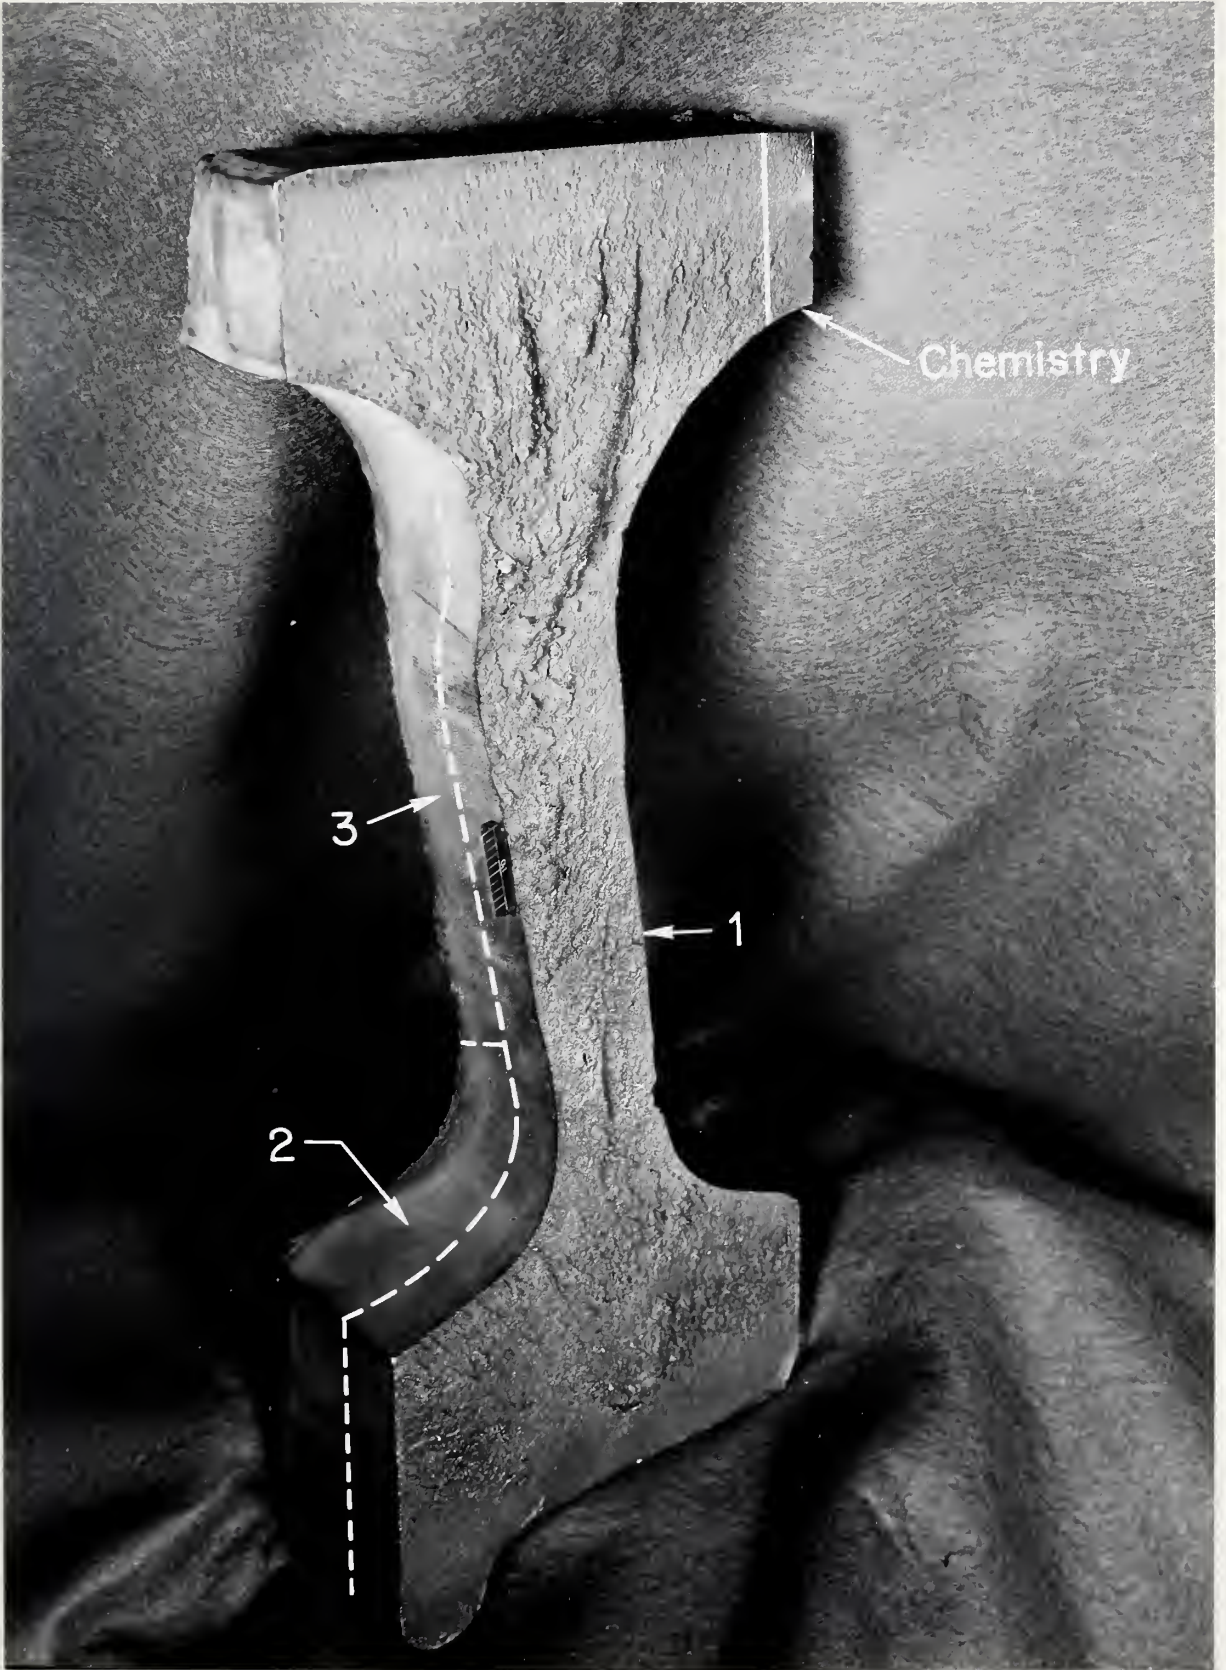
Figure 2. Fractured Wheel Section Showing the Three Parts Into Which It Was Saw Cut.

Section 1 was used for macroscopic and microscopic examinations of the fracture. Section 2 was used for hardness and heat-affected zone measurements, macroscopic and microscopic examination; and Section 3 was used for chemical analyses. Mag. $\times 1/2$

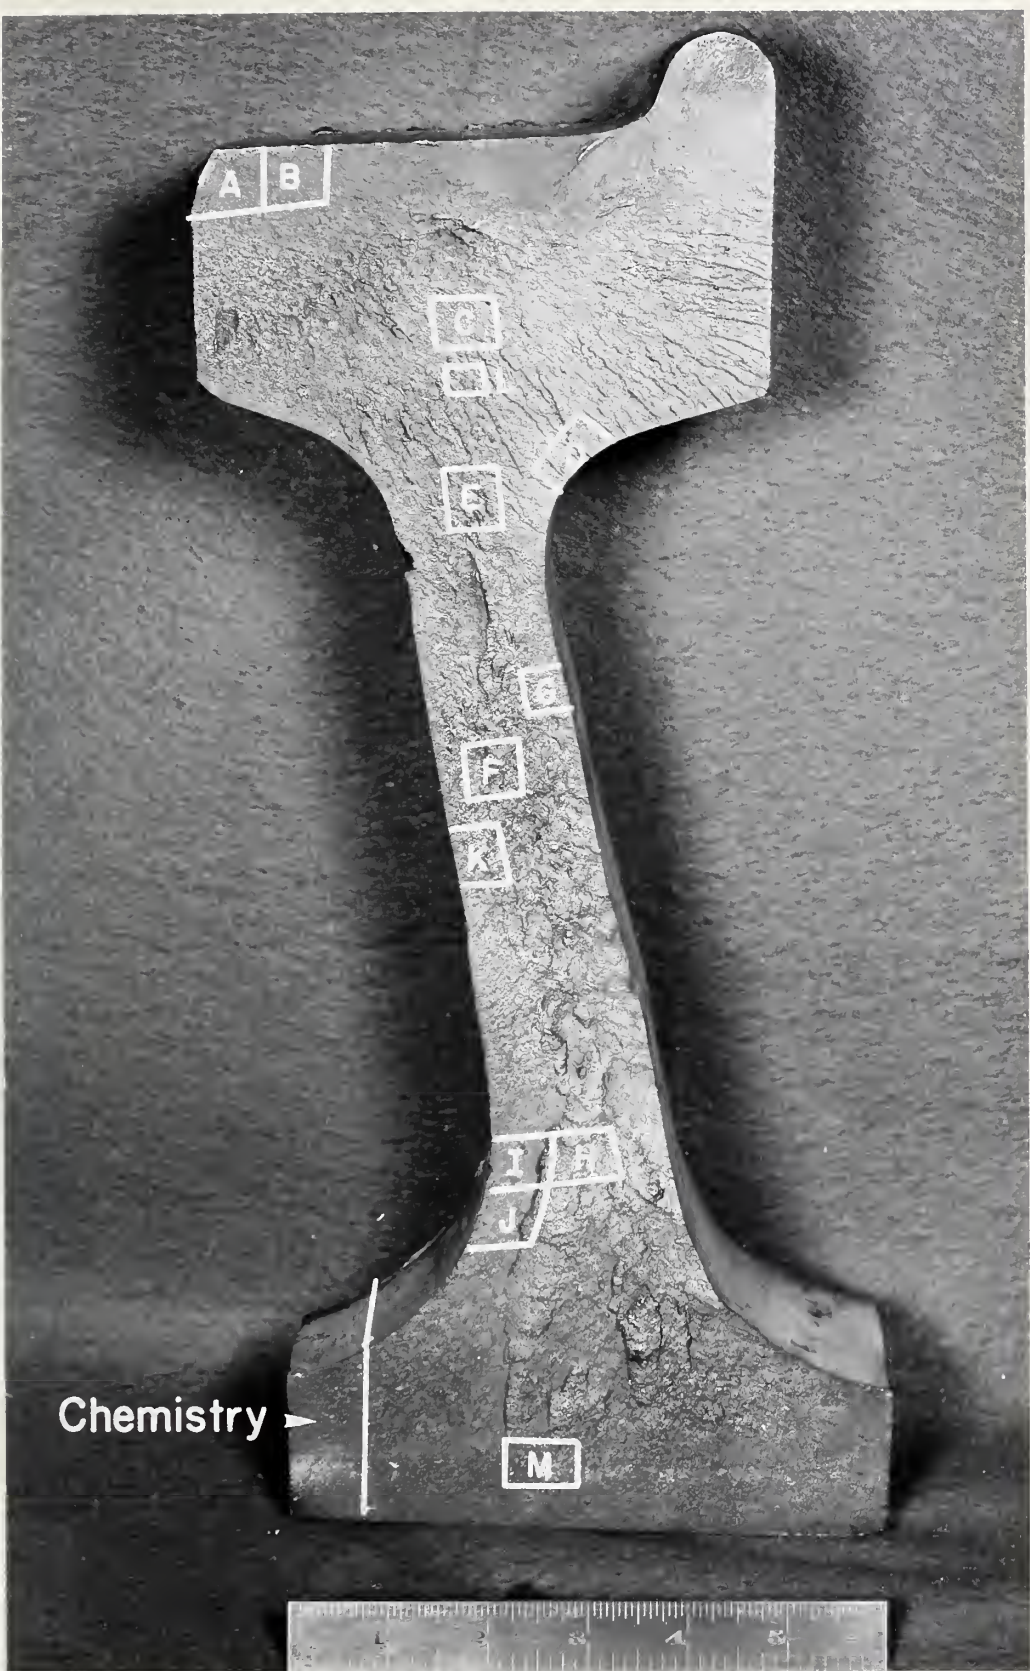
Macroscopically, the fracture surface appeared uniformly rough over the entire face except for two regions that were somewhat smoother. These regions are near the tread and near the bore, as is apparent in Figure 3. The smooth parts extend for about 3/4 inches from the tread and from the bore.

Figure 3. Locations of Replicas, A Through M, Taken on the Fracture Face.

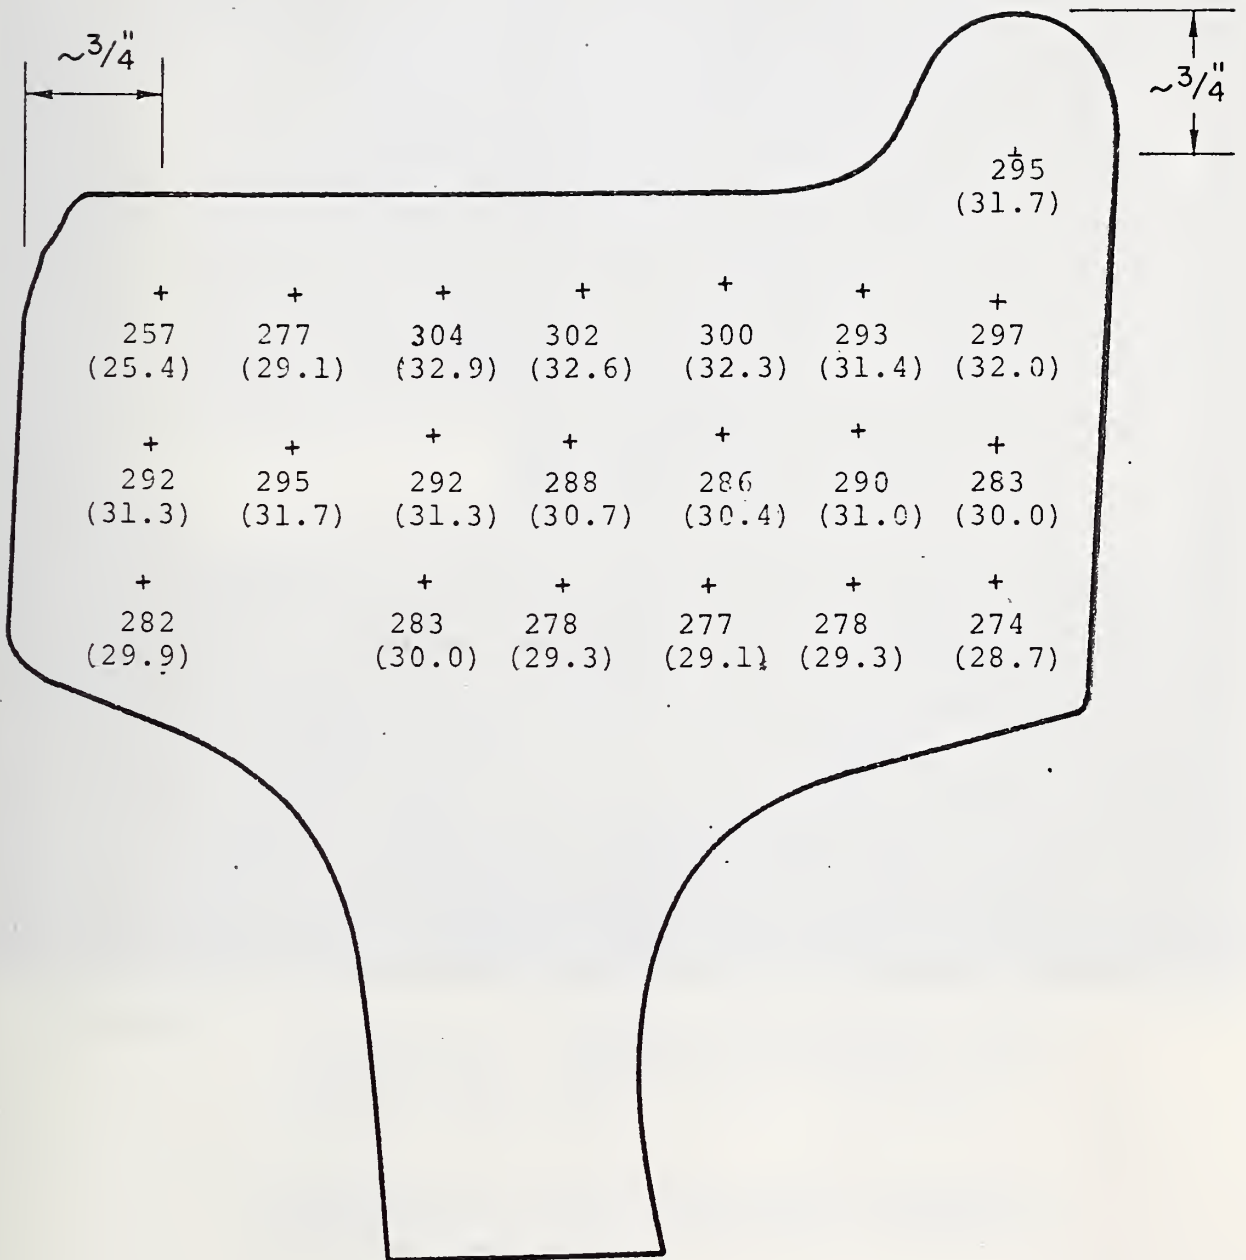
The results of Brinell hardness measurements, given in Figure 4, indicate that, within the wear zone of the first 1-1/2 inches of rim metal, the hardness is uniformly good, being within the range of 277 to 341 BHN specified for Class B wheels, except for a single value of 257 BHN for the location nearest to the front of the tread.

Figure 4. Schematic Representation of the Location of Brinell Hardness Impressions and Equivalent Rockwell C Values (in parenthesis). Mag. X 1

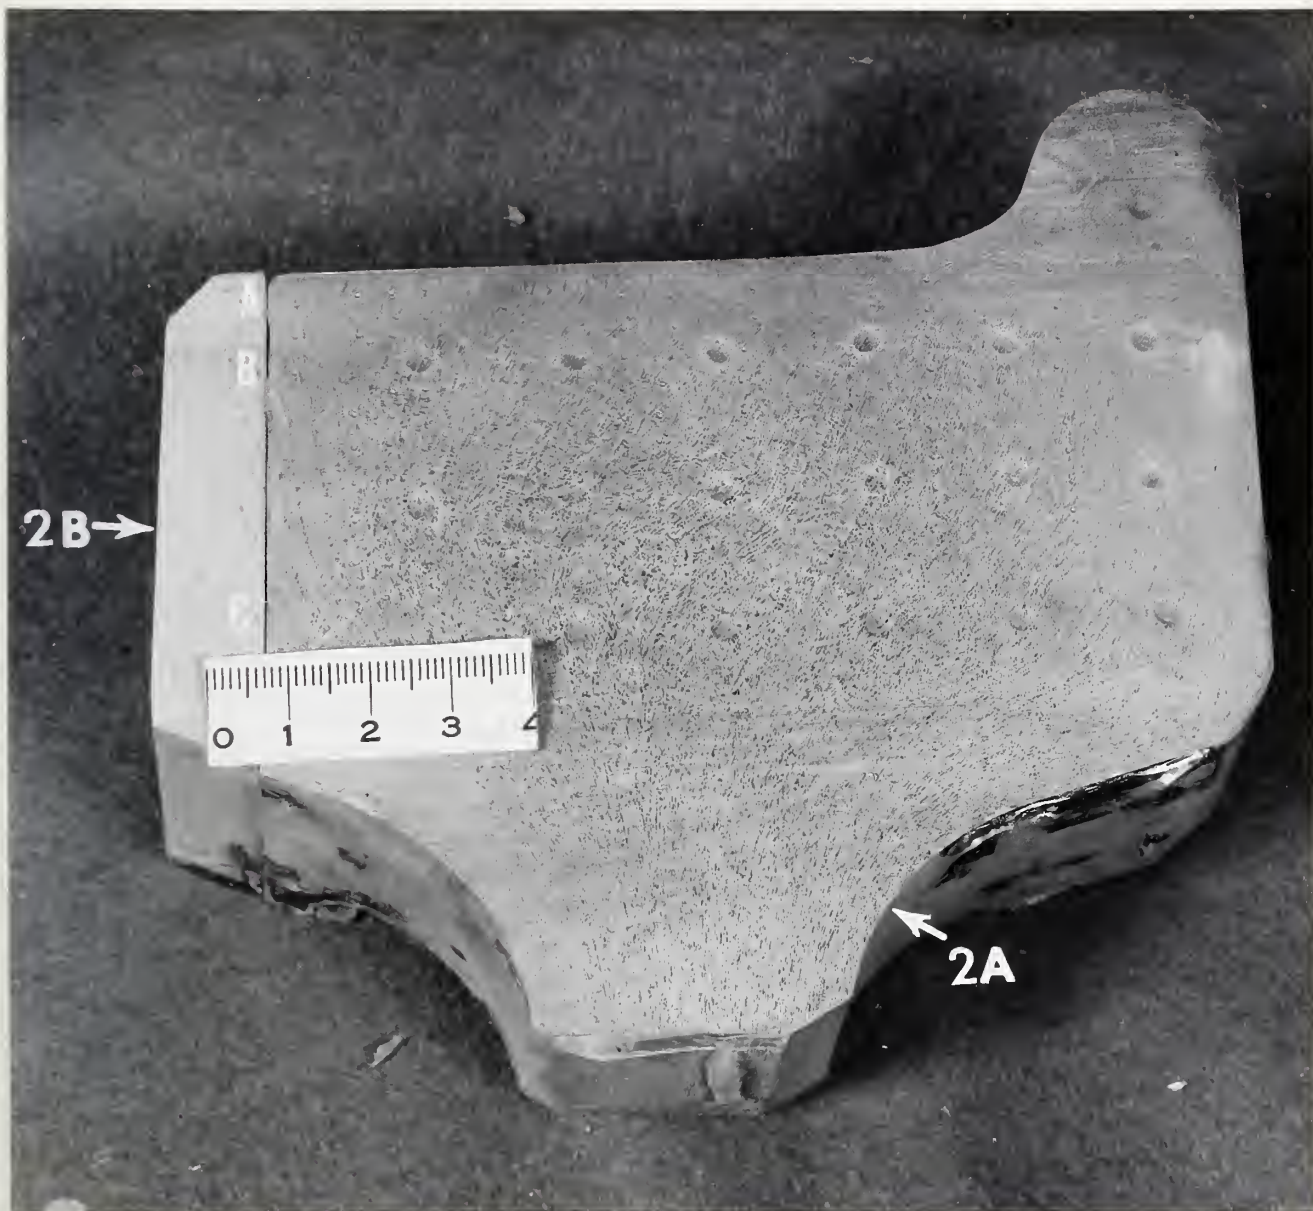
The appearance of a polished and etched radial-axial face of the rim (section 2) is shown as Figure 5, as etched with a hot 10% HNO₃ solution. No major defects were observed on this surface, but a heat-affected zone (HAZ) of greater than 2 inches along the tread and greater than 1/2 inch in depth is observable. The HAZ has a shape similar to that of the thermal crack but the HAZ is much larger. The flow lines produced by the shaping of the wheel are visible on the etched surface. They indicate that the wheel was produced as a wrought (i.e. not cast) product.

Figure 5. Photograph of Section 2 Showing the Brinell and Rockwell C Hardness Impressions, the Etched Sample, and the Saw Cut Between Pieces 2A and 2B.

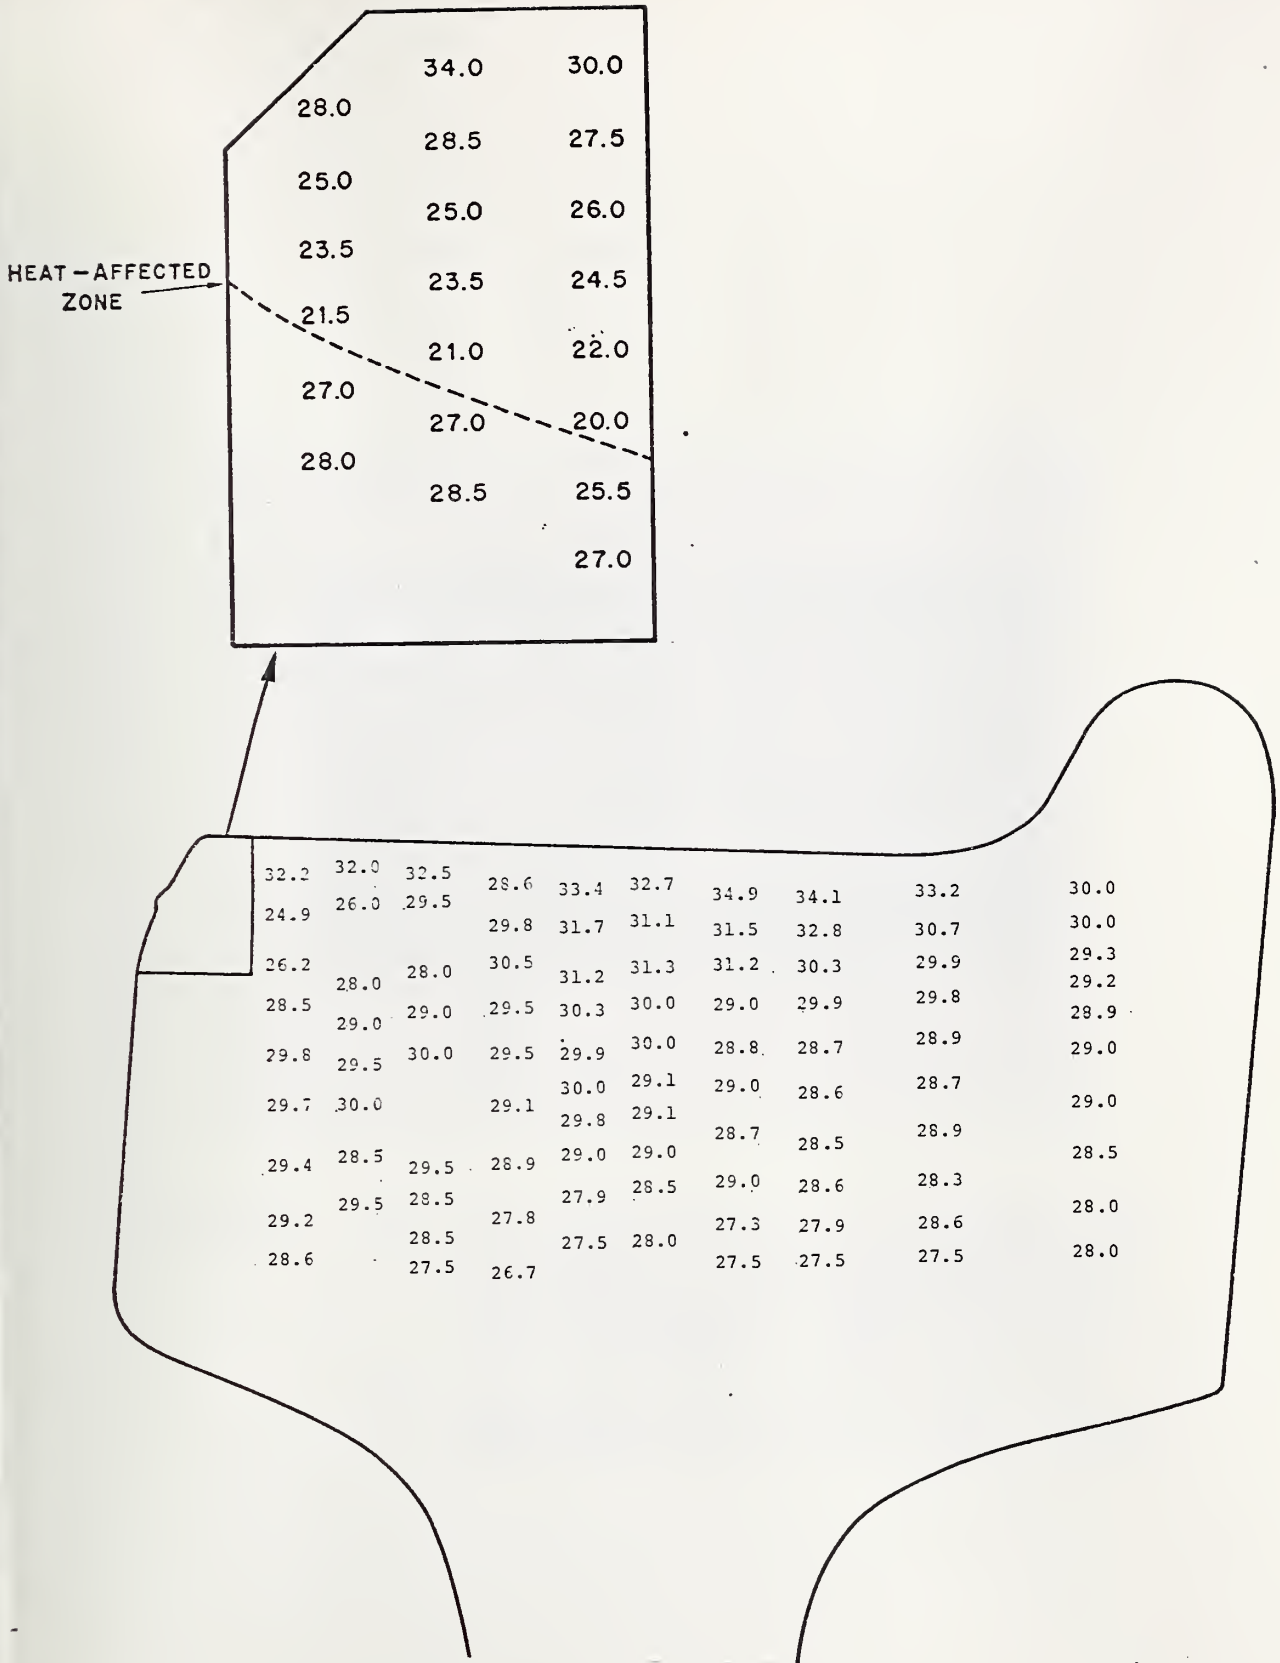
Figure 6. Results of Rockwell "C" Hardness Measurements Taken On Section No. 2. Locations of R_C impressions correspond to locations of decimal points shown here.

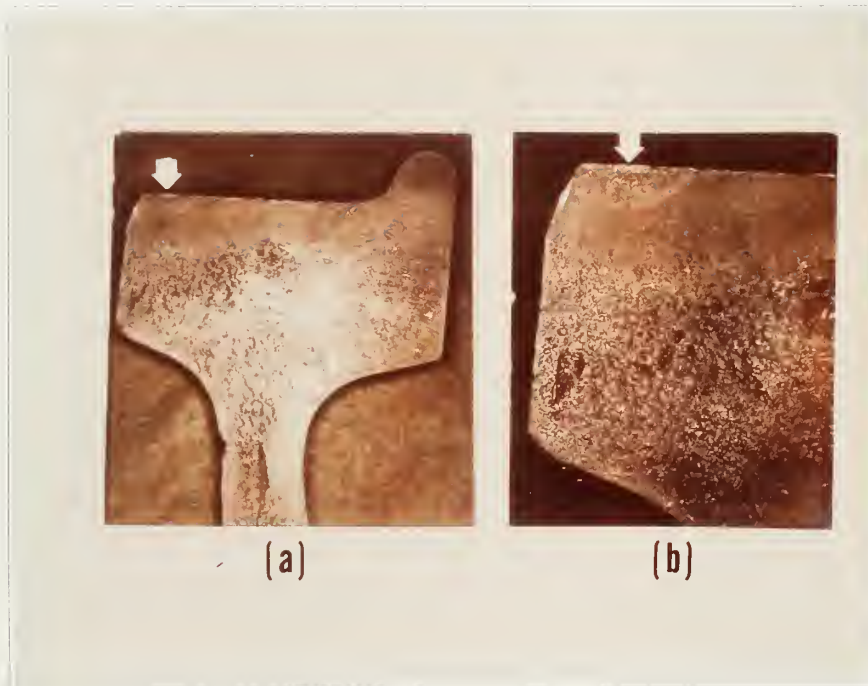
In the rim, the rough parts of the fracture show many lines with an apparent focal point on the tread near the front face of the rim, indicating that the rim fracture was the result of propagation of a crack that had initiated at the focal point. This focal point is designated by an arrow in color photographs of the rim in Figures 7(a) and 7(b).

Below the arrow there is a thermal crack which differs in appearance from that of the other parts of the heavily oxidized regions along the length of the tread. The thermal crack measures about 0.98 inches along the tread (c) and about 0.33 inches deep (a) for a c/a ratio of about 3. This is the size and shape of the flaw believed to have existed just prior to the rapid failure of the wheel.

Figure 7. (a) Color Photograph of the Fracture Face of the Rim, Showing the Location of the Thermal Crack (Initiation Site) and the Oxidized Region Near the Tread and in the Flange. Mag. $\sim X 1/3$

(b) Close Up of the Thermal Crack Near the Front Face of the Rim. Mag. $\sim X 2/3$

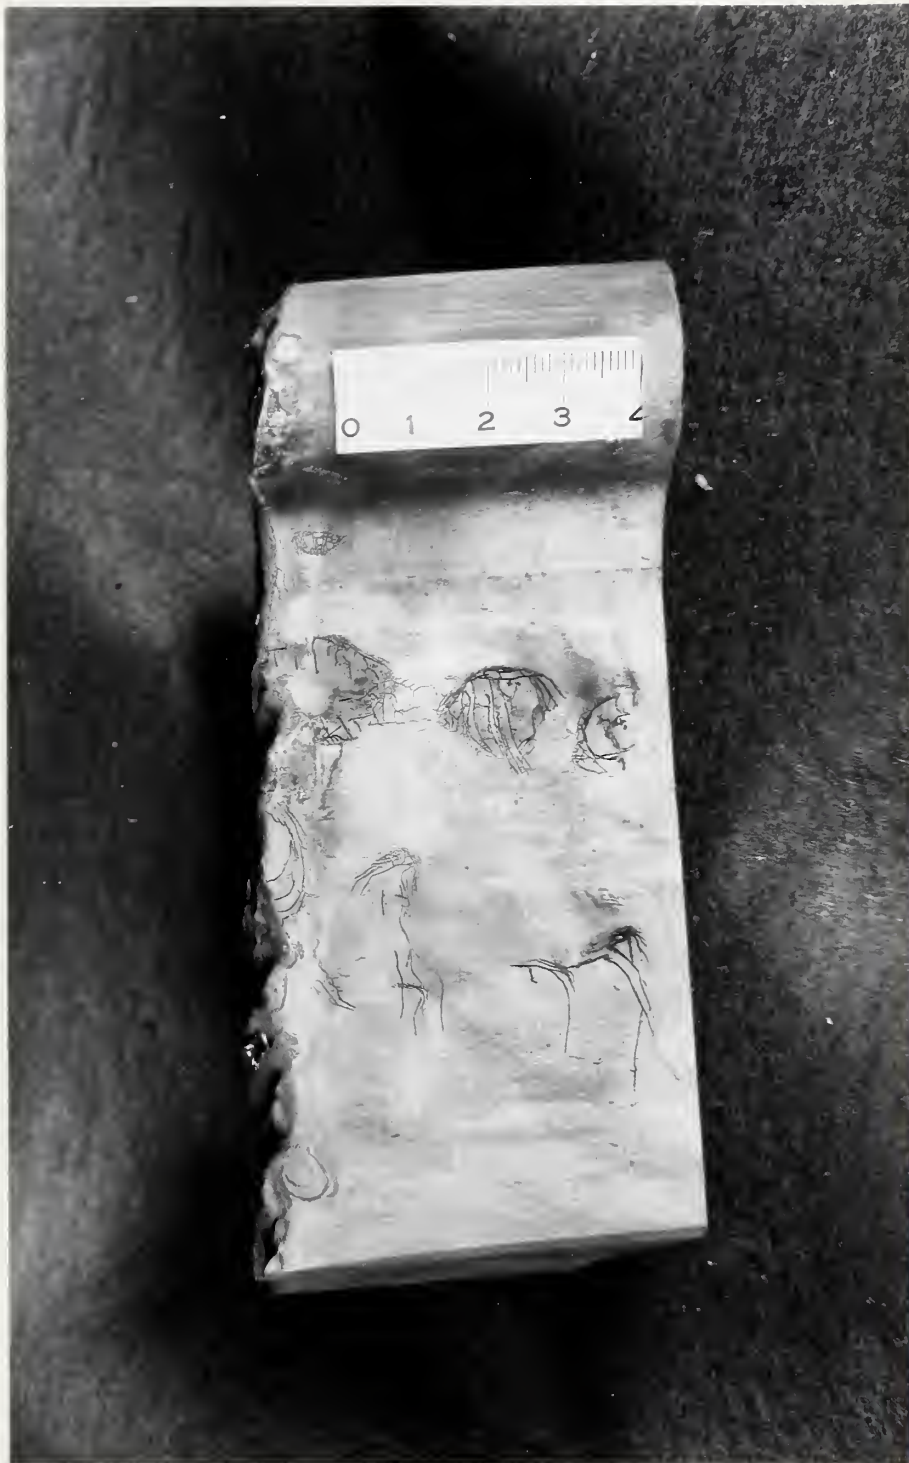
Thermal checks are present, throughout the tread of section 2, as shown in Figure 8. The tread of section 1 also has a set of thermal checks near the fracture origin. However, the question as to whether the thermal checks actually lead up to and thereby initiated the thermal crack could not be answered unambiguously from the single fracture face available to us for this investigation.

Figure 8. Thermal Checks Observed on the Tread of Section 2 After Hot Etching in 1:1 HCl. Mag. ~ X 1

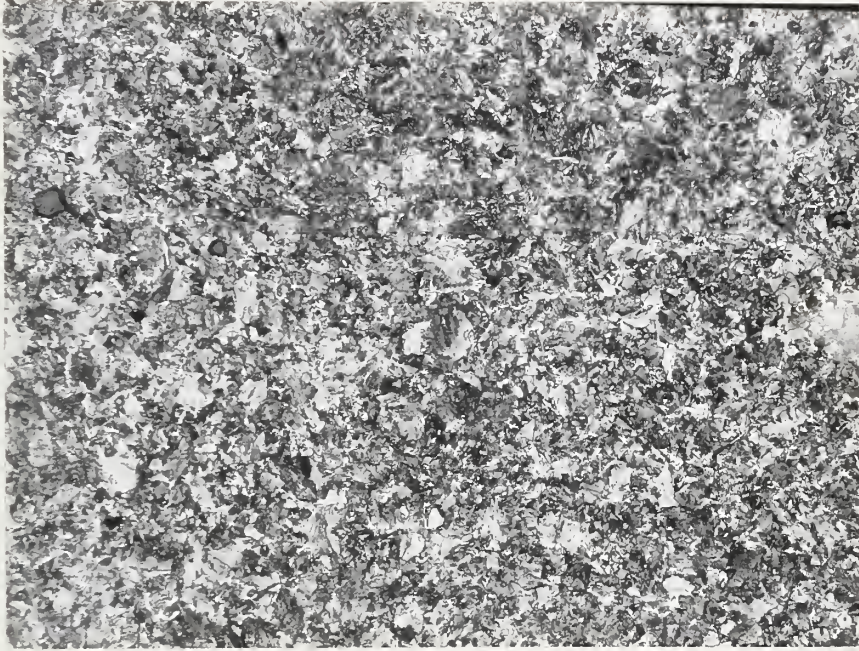
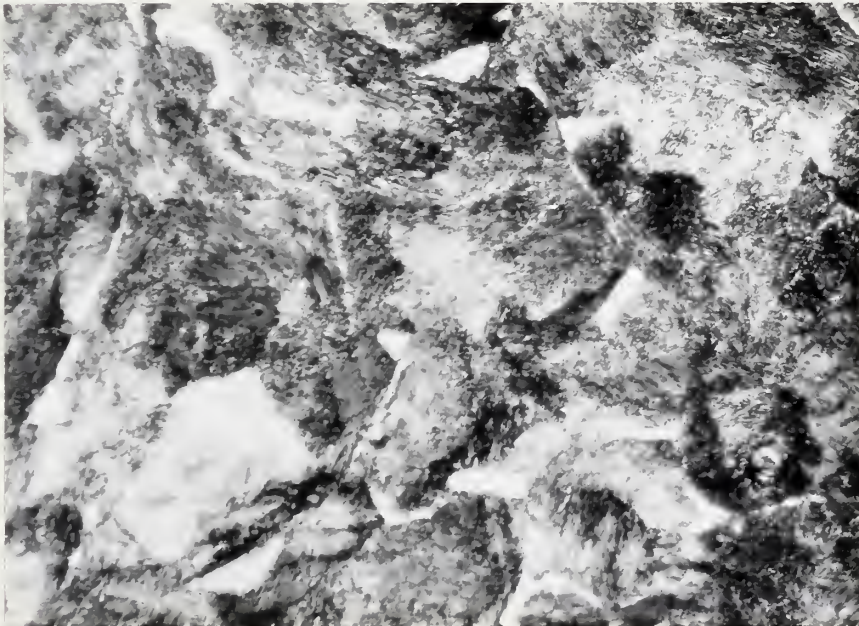
The microstructures of the unaffected base metal, of the fine-grained region near the inside boundary of the HAZ, and of the coarse-grained HAZ region near the focal point of the thermal crack are each shown at two magnifications in Figures 9, 10, and 11, respectively. These microstructures were observed on piece 2B at the locations designated C, B, and A, respectively, in Figure 5.

Figure 9. Photomicrographs Taken at Region C (Figure 5) Showing the Unaffected Base Metal of the Rim.

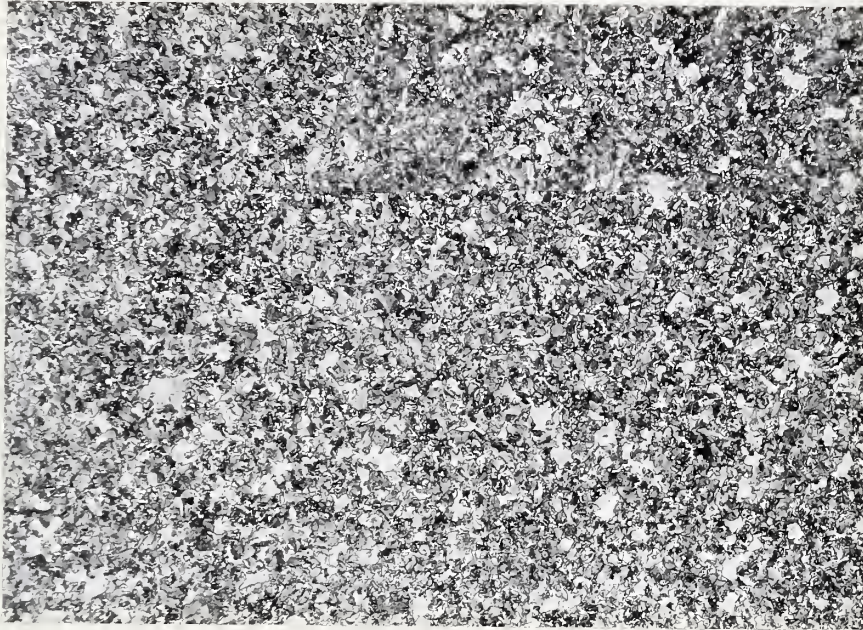
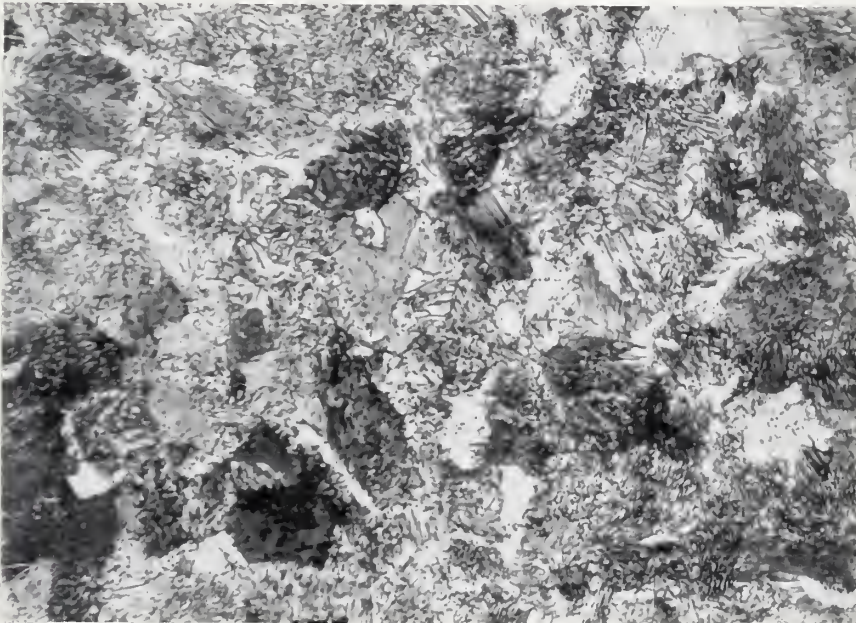
Figure 10. Photomicrographs Taken at Region B (Figure 5) Near the Inside of the HAZ Boundary.

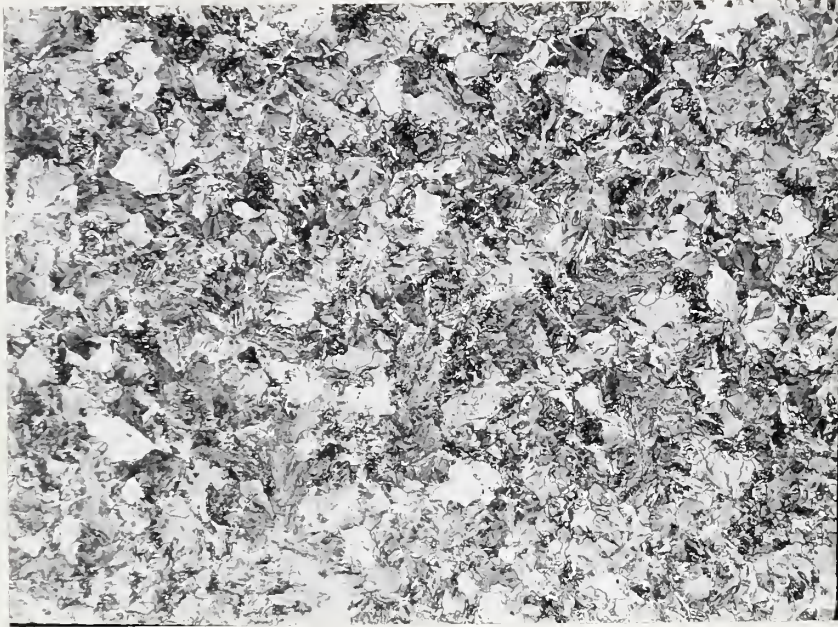
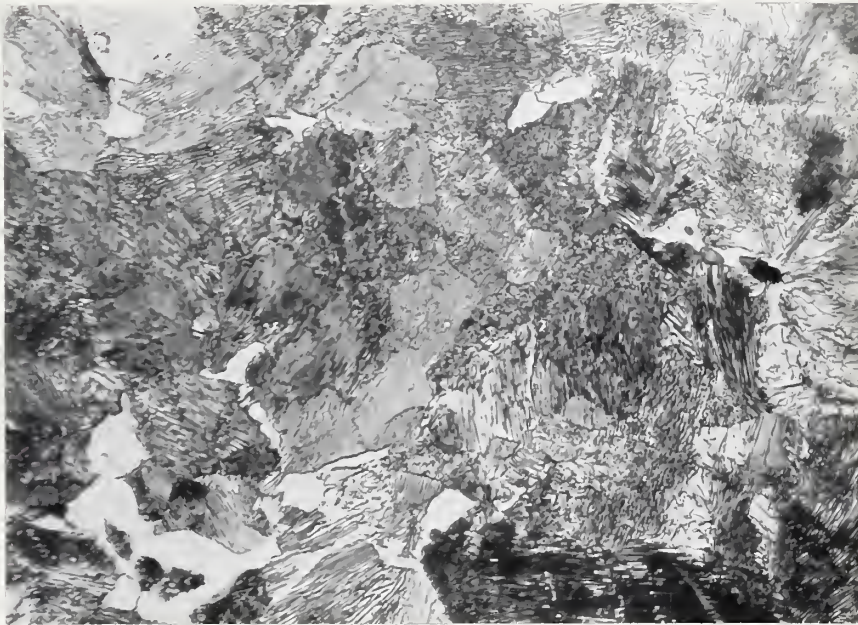
Figure 11. Photomicrographs Taken at Region A (Figure 5) Showing the Coarse-Grained Heat-Affected Zone Observed Near the Tread.

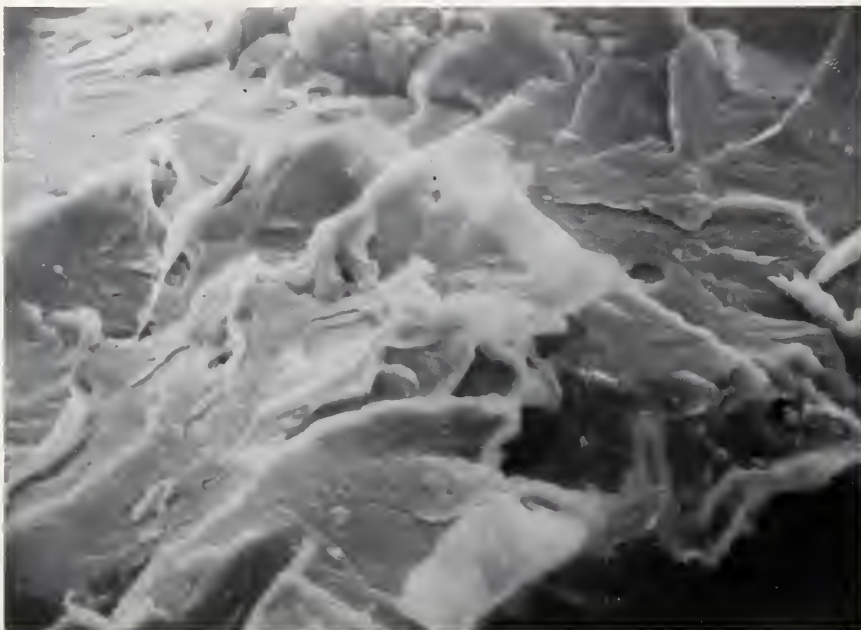
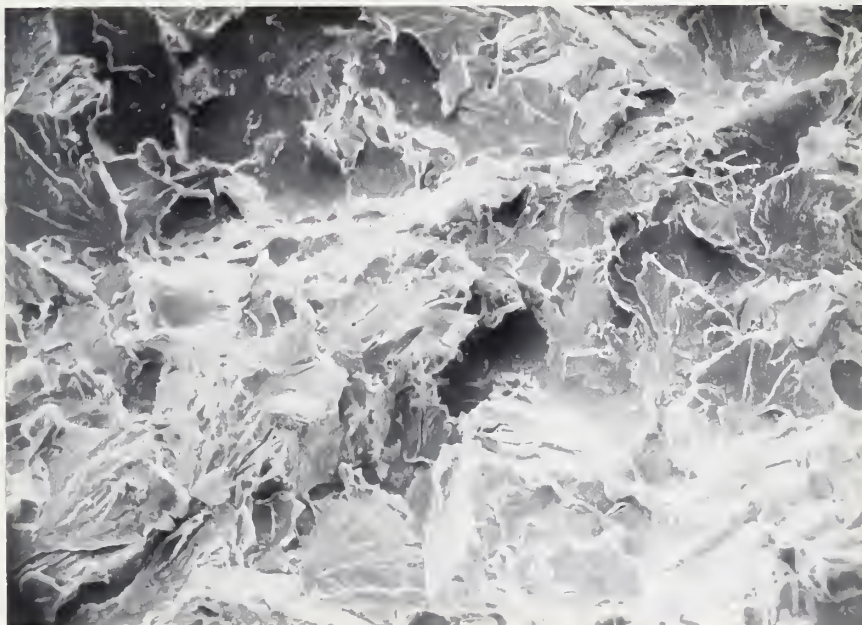
The appearances of replicas taken from locations C, D, A, and L (Figure 3), were similar, with each showing fracture by a predominantly quasi-cleavage mode, as is shown in Figures 12 through 14. Figures 12 and 13 are considered to be representative of the overall failure mode. Figure 12 shows fractographs taken in location C, the geometric center of the rim section. Figure 13 is a stereo-pair fractograph taken at area L, in a lower part of the rim. The fracture surface at D, the back-rim plate fillet, was similar to those shown here. Figure 14 taken in location A near the boundary of the heat-affected zone near (or just within) the thermal crack shows quasi-cleavage failure with some oxides also being present on the surface.

Figure 12. SEM Fractographs Taken at Location C of Figure 3, Showing the Predominately Quasi-Cleavage Fracture Mode Observed in the Rim.

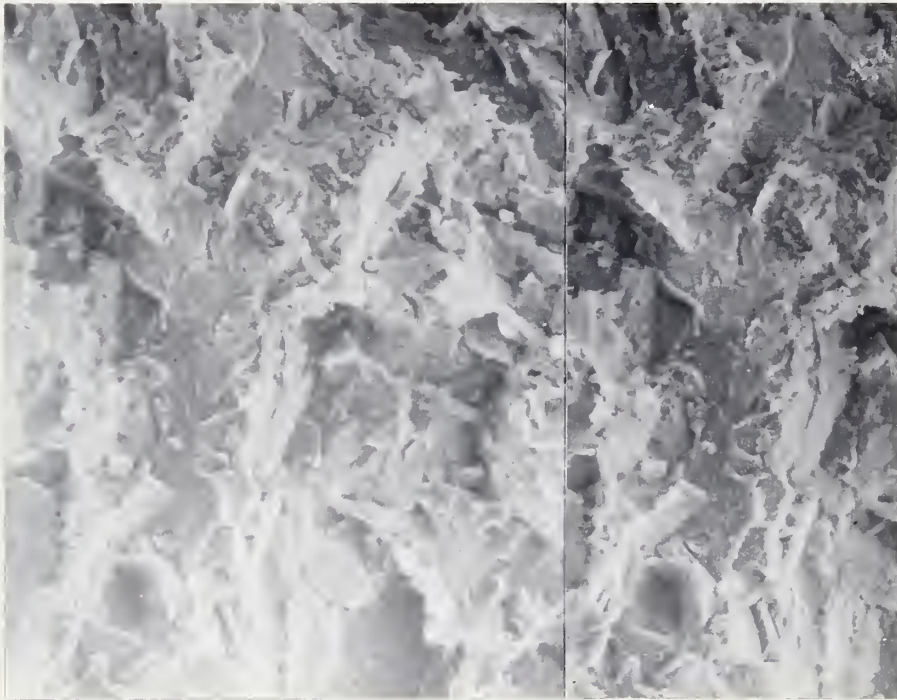
Figure 13. SEM Stereo-Pair Fractograph Taken at Location L of Figure 3, Showing the Predominately Quasi-Cleavage Fracture Mode Observed in the Rim. Mag. X 490

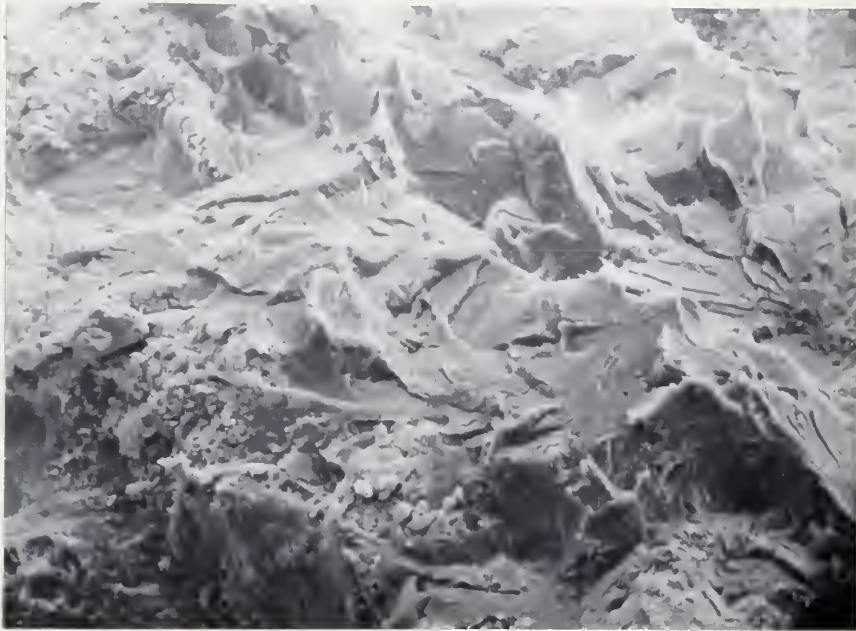
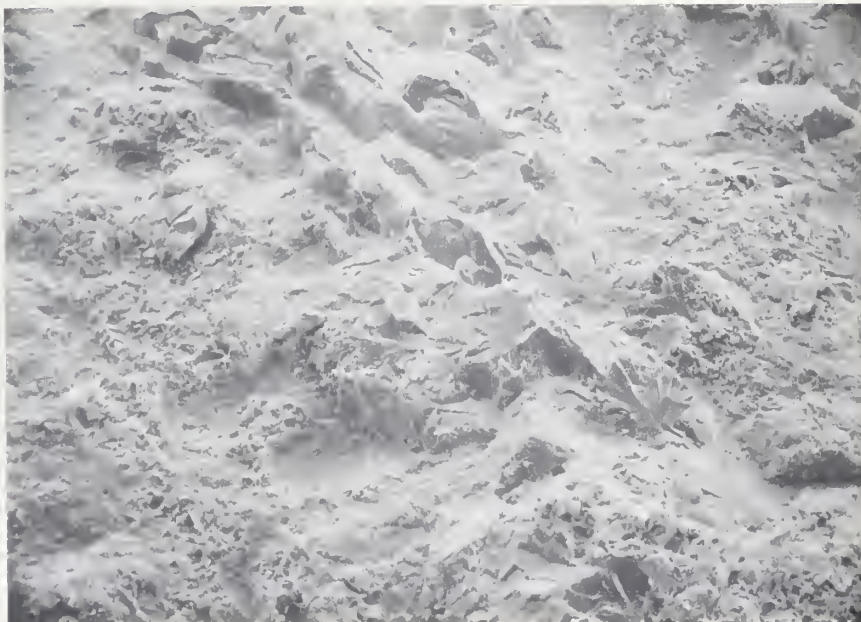
Figure 14. SEM Fractographs Taken at Location A of Figure 3, Showing Quasi-Cleavage Fracture and Oxide Formations Observed Near the Boundary of the Heat-Affected Zone of the Rim.

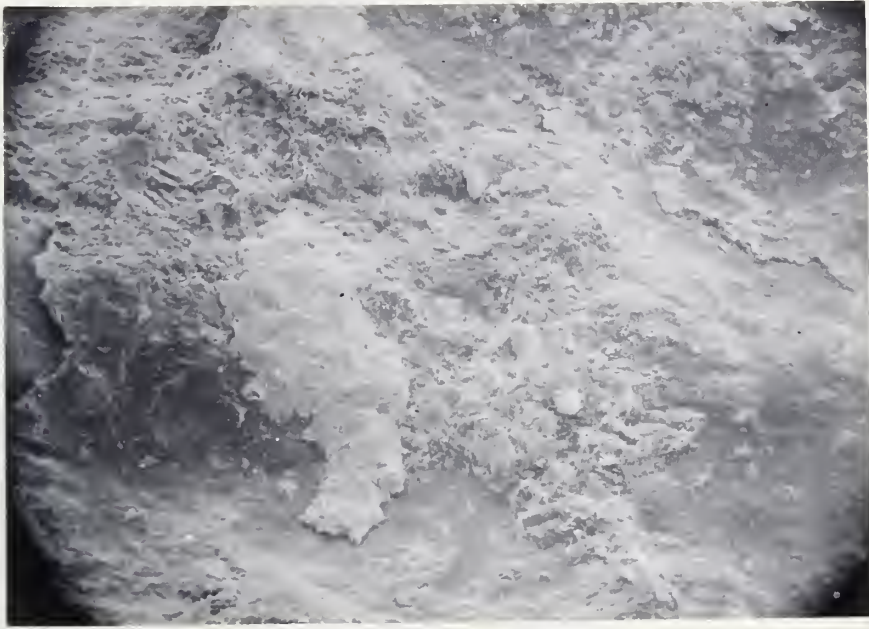
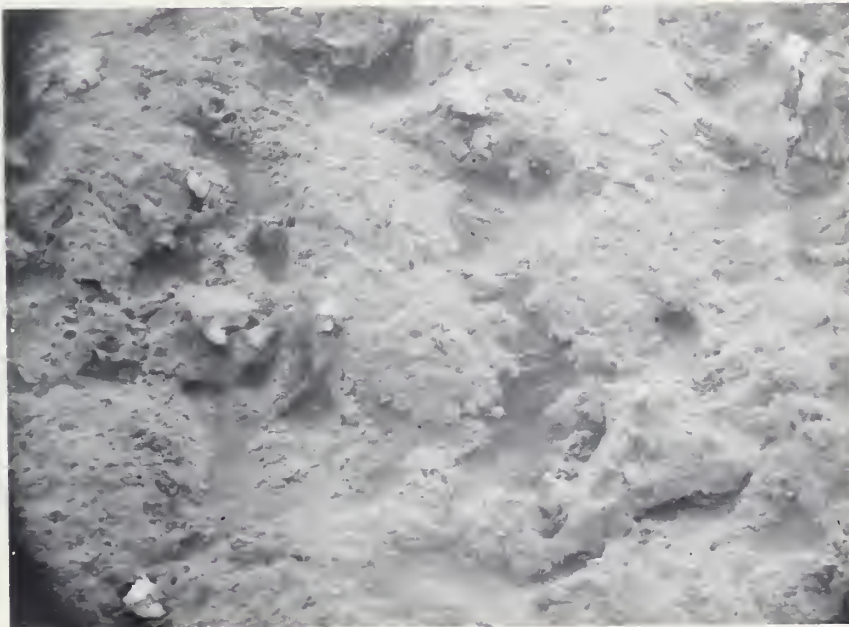
The fracture mode could not be clearly established for location A, near the focal point of the thermal crack, and for location M, from the hub. The replicas taken from these locations indicated the fracture face to be either highly oxidized, or badly rubbed after the fracture event. This is shown in Figures 15a and 15b, respectively taken from

locations A and M. The parts of these surfaces that do seem to represent actual fracture surface may even have been disturbed by oxidation or abrasion. Nevertheless these parts are very smooth in appearance, similar to a cleavage failure mode.

Figure 15. SEM Fractographs Taken from the Thermal Crack Region (15a) and from the Hub Region (15b), Showing Oxide Formations, Abraded Parts, and Flat Fracture.
