NBSIR 74-594

Examination of Failed Four Inch Cast Iron Pipe Natural Gas Main, Philadelphia Gas Works, Philadelphia, Pennsylvania

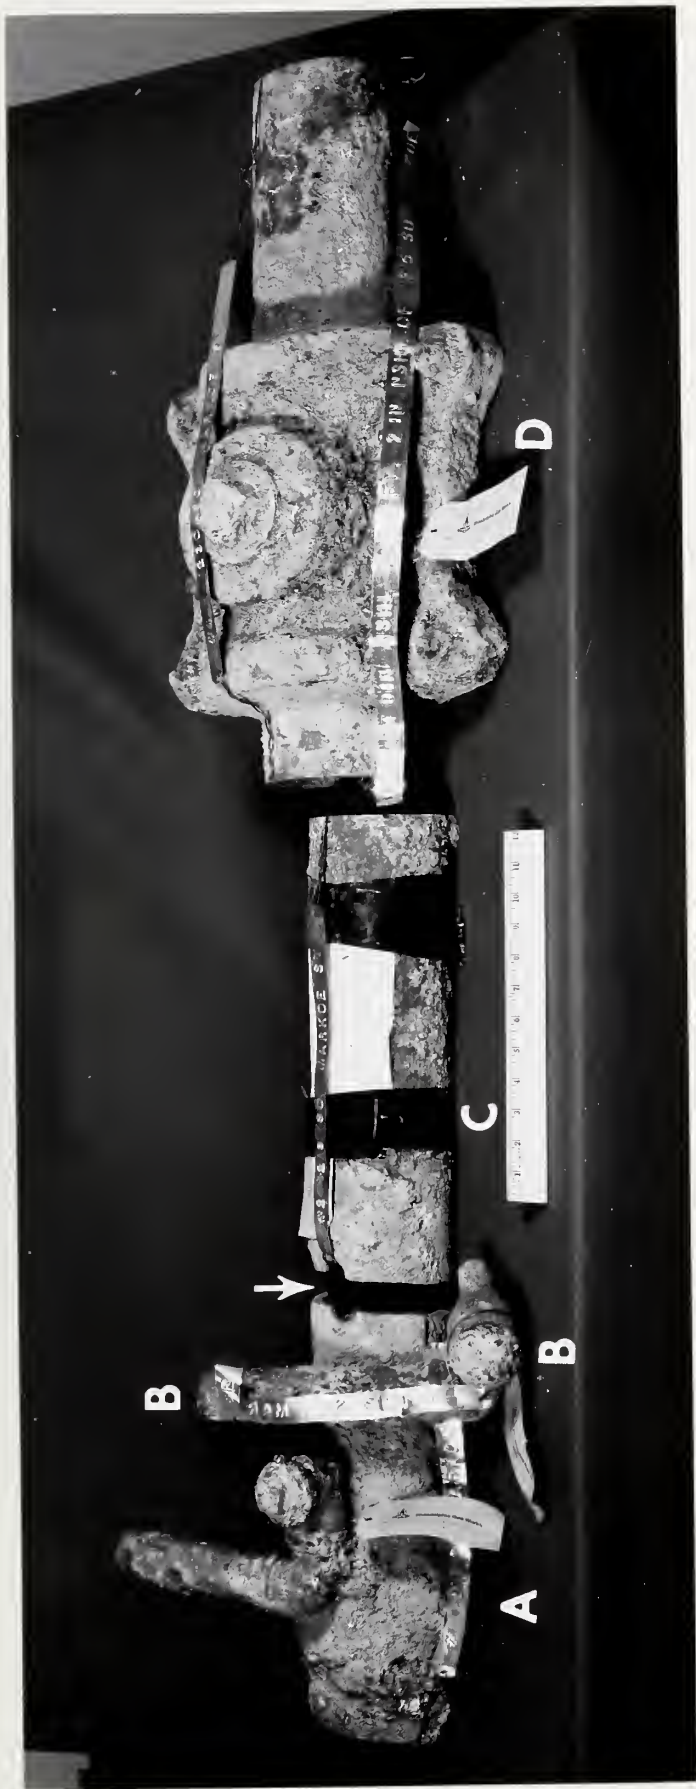
Figure 1. Lengths of the gas main pipe and service taps from the natural gas pipeline from South Markoe Street in Philadelphia, Pennsylvania as received at NBS after being removed from the shipping crates. North is to the left. X 1/6

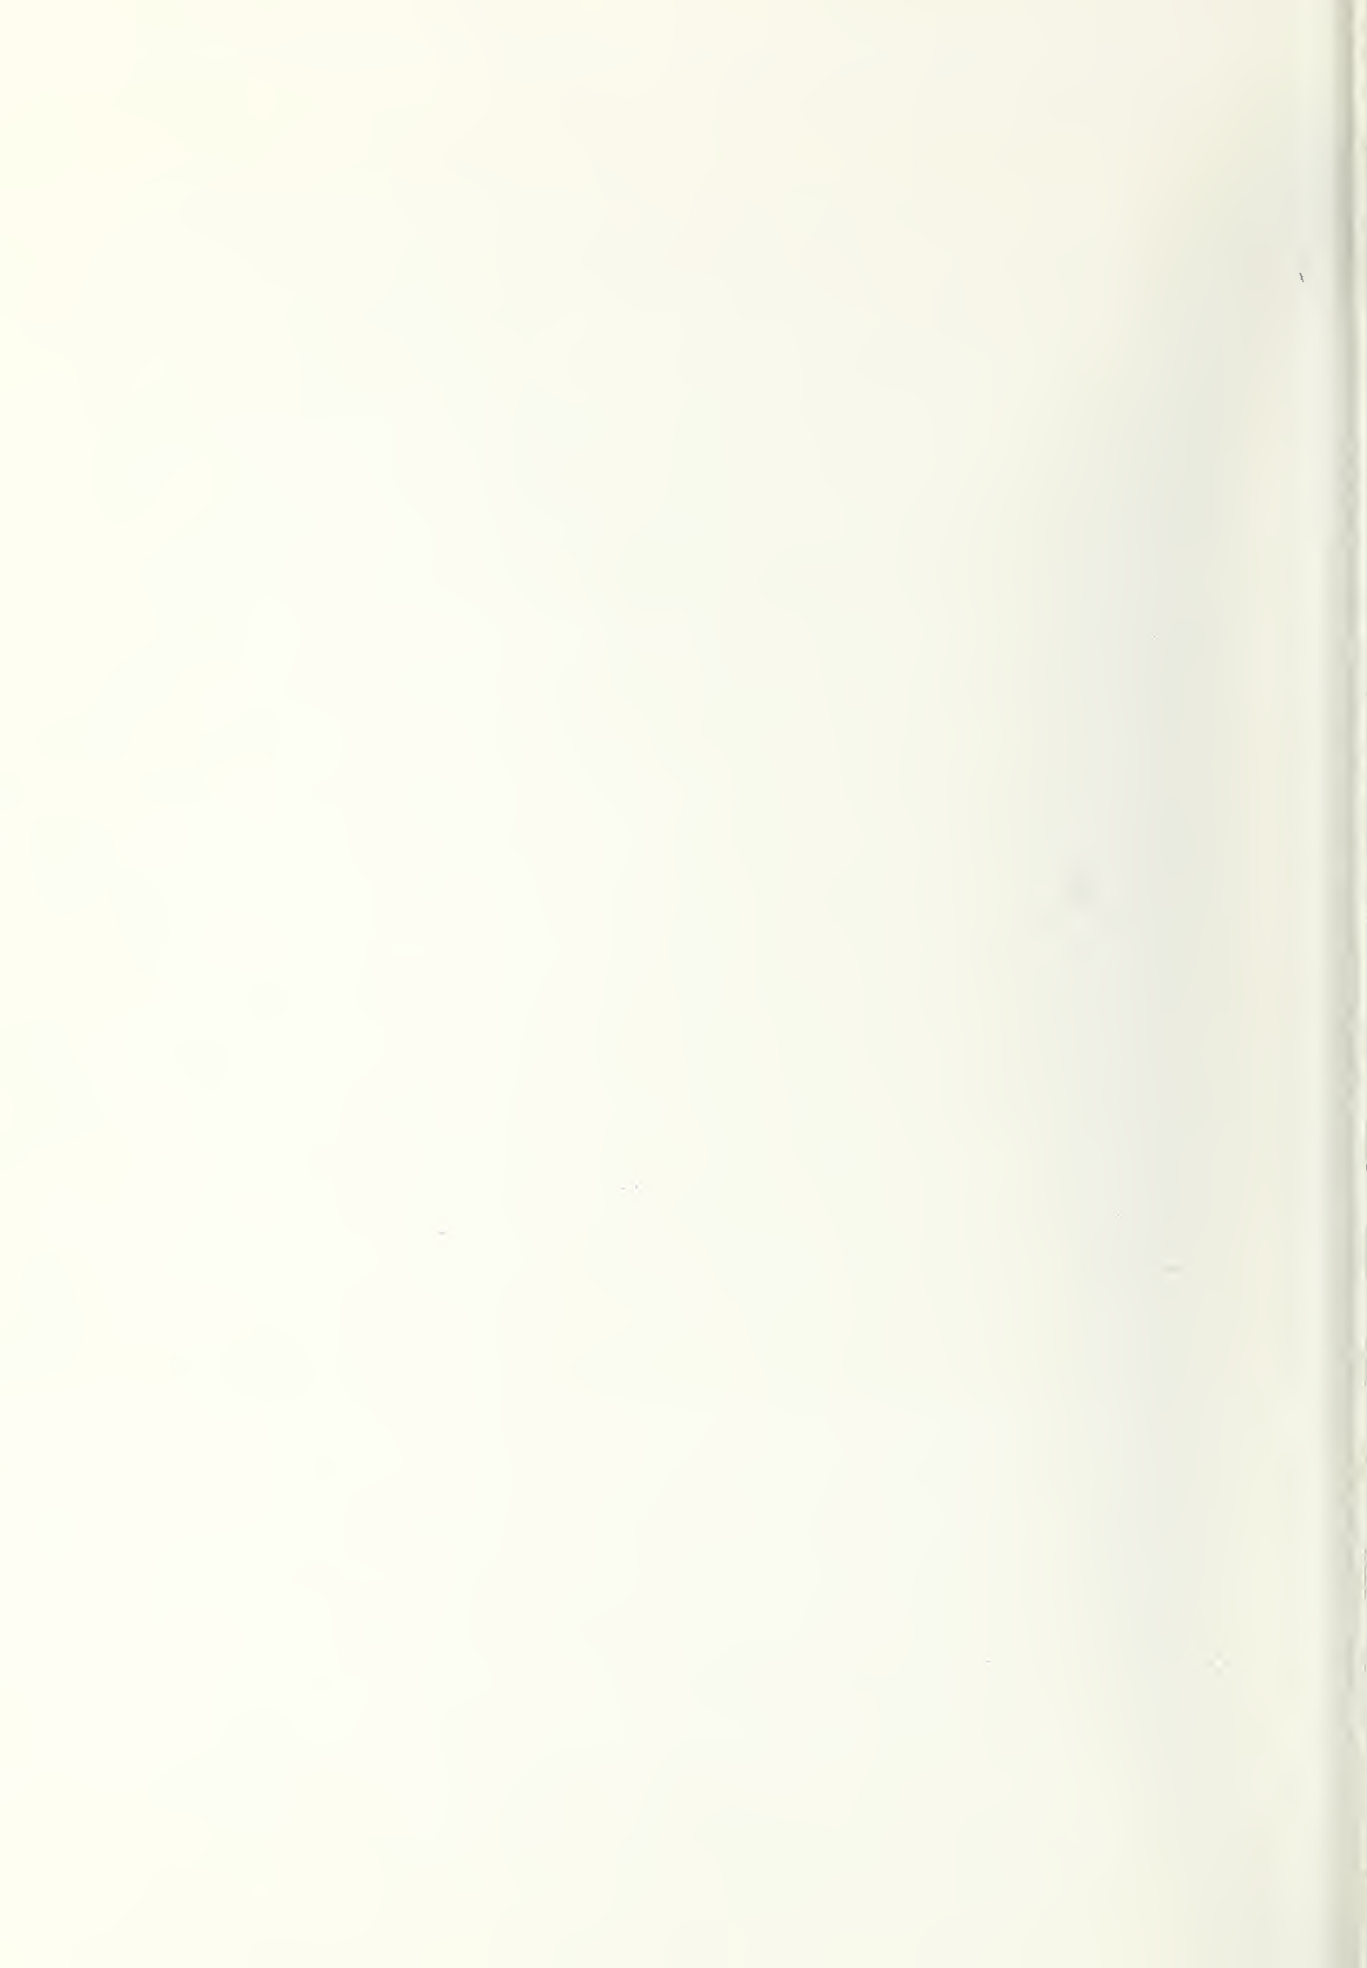
- A. "1' - 3" removed from front of 1211. Service to 1211."
 - B. "Service connection to 1213 Markoe."
 - C. "1' - 4 1/2" removed from front of 1213. Break at tap to 1213."
 - D. "26" length 4" C.I. removed from 5' - 0" to 7' - 2" N.S.H.L. 1216 Markoe."
- Arrow indicates location of the service connection to 1213 South Markoe Street and also the location of the fracture.

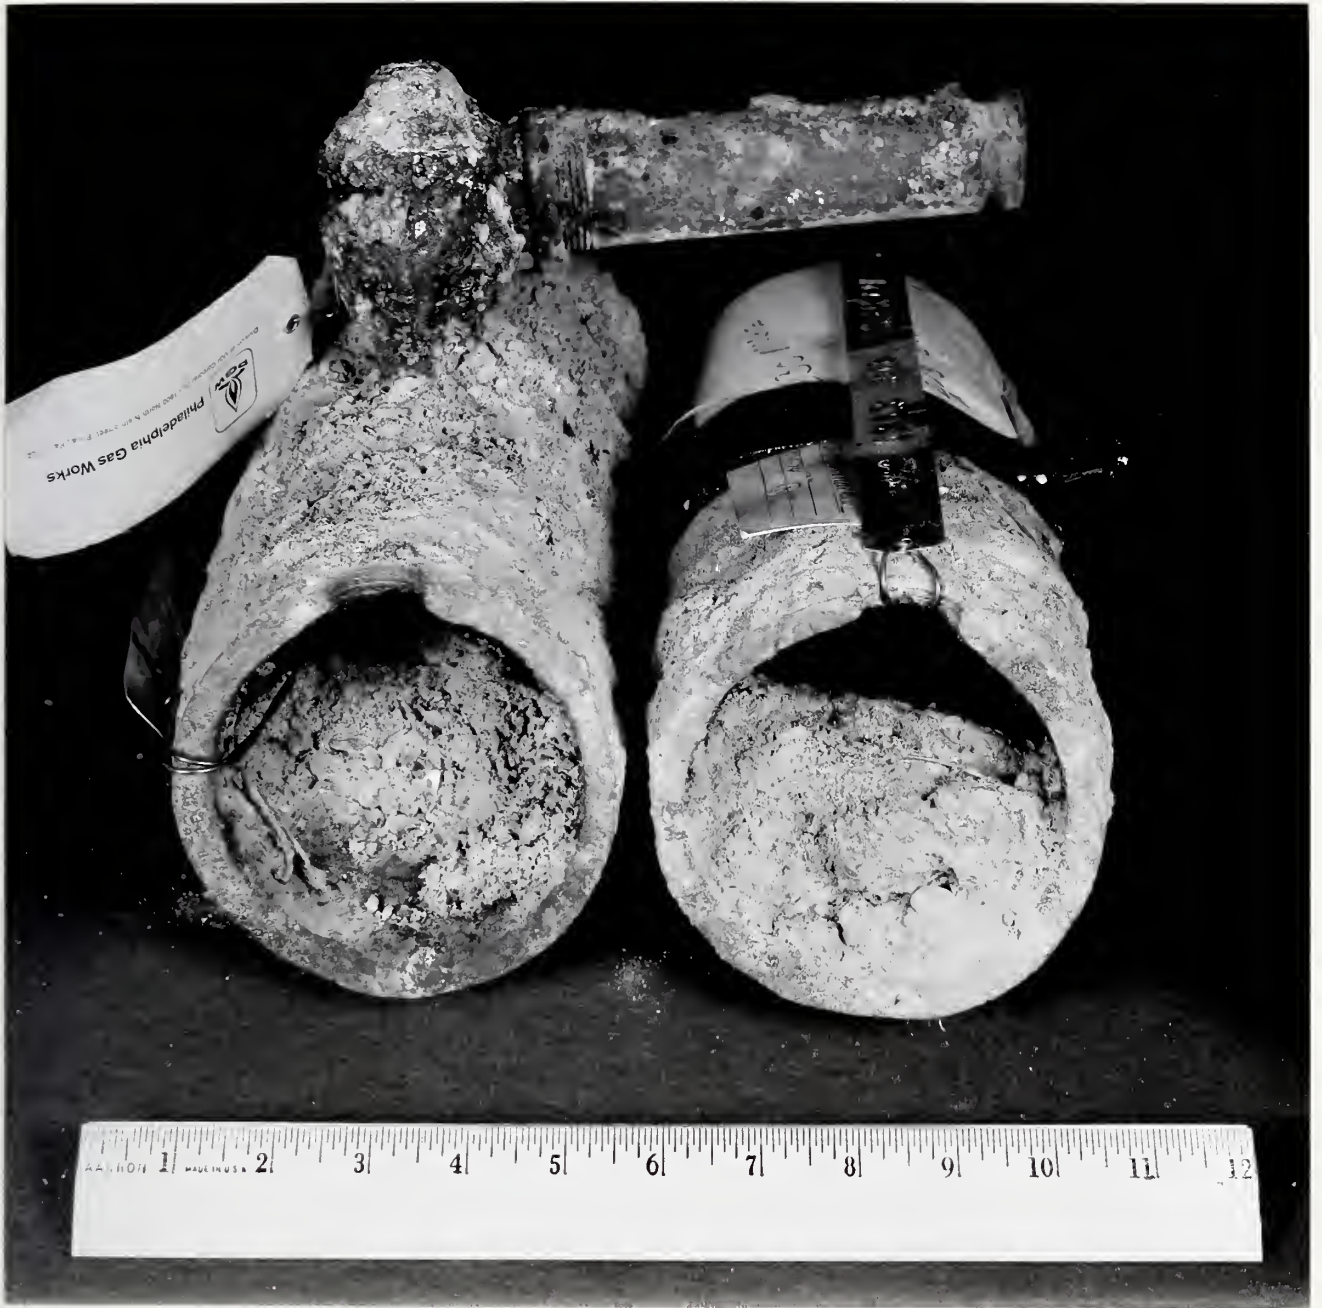
Figure 2. Opposing fracture surfaces as received. The north fracture surface is at the left and the south fracture surface is at the right. Large deposits of soil can be seen inside the pieces of pipe, along with some soil on the fracture surfaces and what appears to be soil adhering to the outside of the pipe. The top of the pipe as installed in the soil is at the top in the photograph. X 1/2

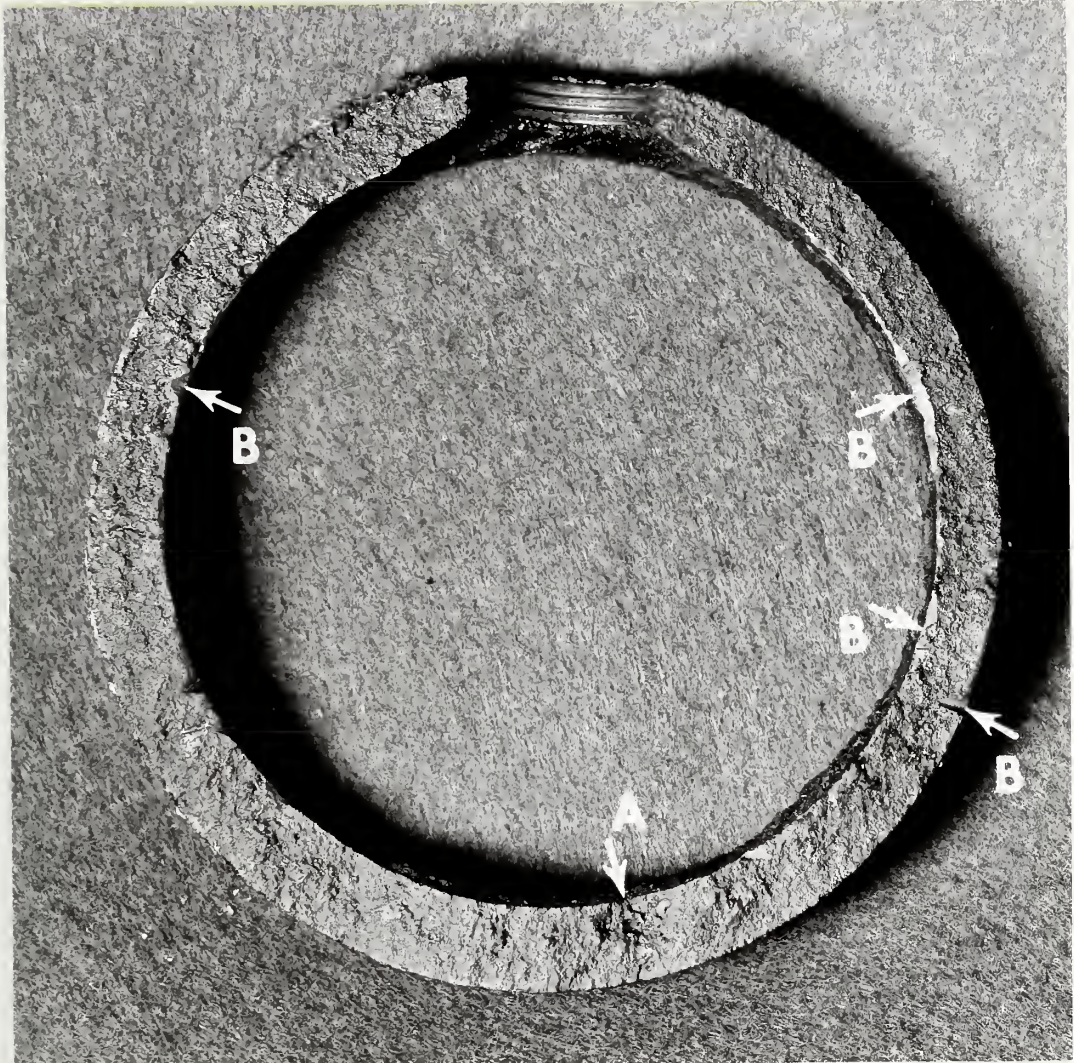
Figure 3. North fracture surface after ultrasonic cleaning. The top of the pipe as installed in the ditch is at the top of the photograph. The threaded region is in the tap hole for the service line to 1213 South Markoe Street. Arrow A indicates an area of the fracture surface shown in figure 4. Arrows B indicate examples of mechanical damage. X 1

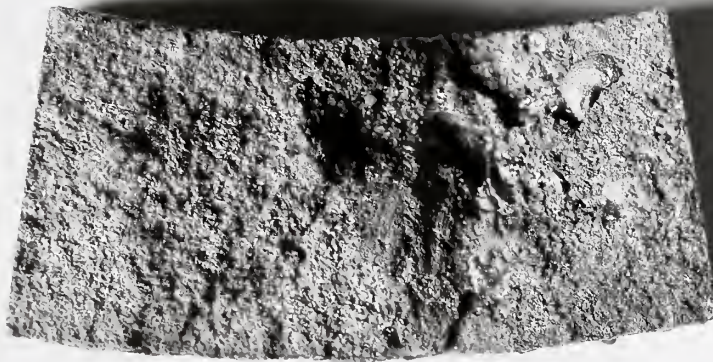
Figure 4. Area A of the fracture surface shown in figure 3. This is a region of apparent gas porosity. X 4

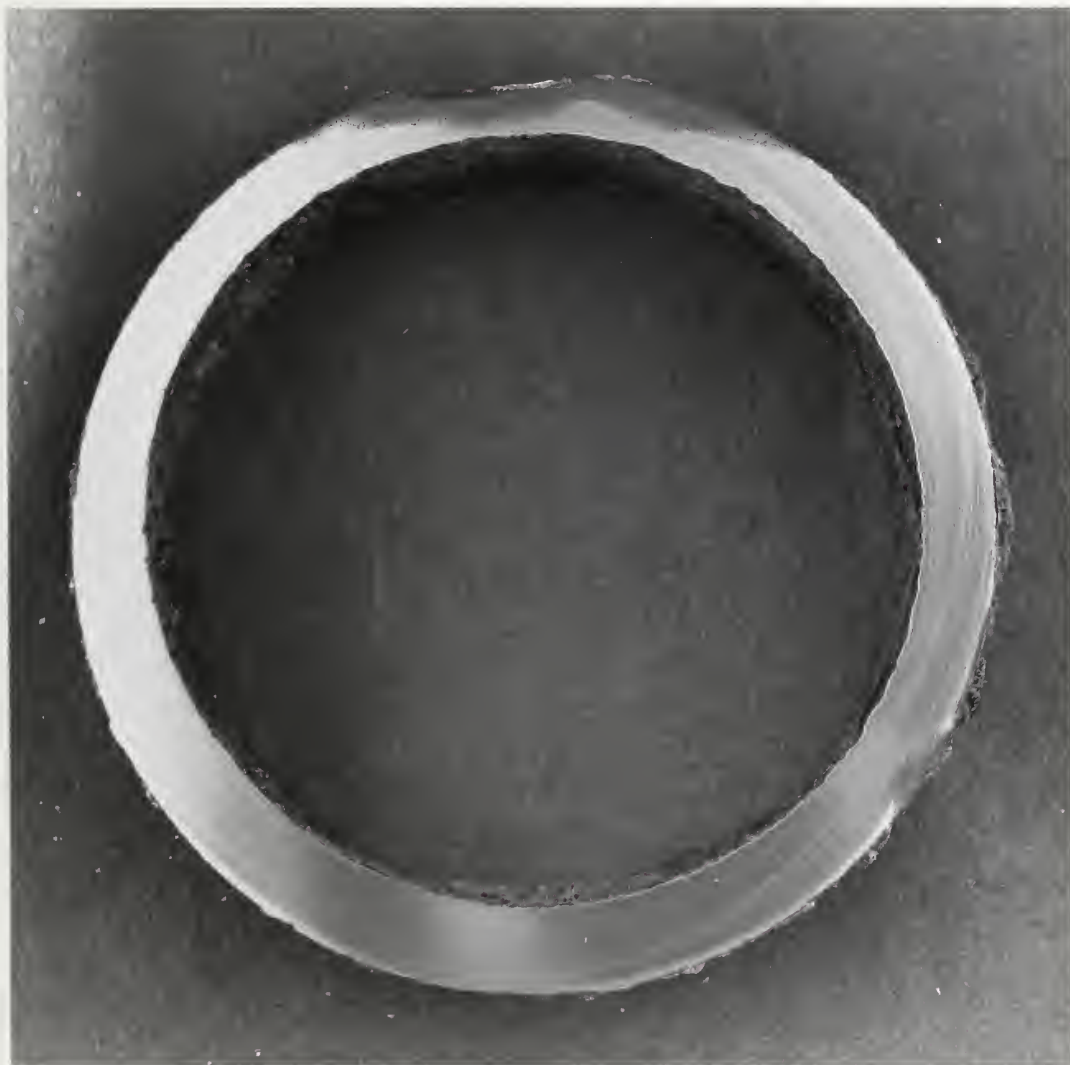
Figure 5. Transverse cross section through the pipe two inches north of the fracture. The dark areas at the top and at about 4 o'clock are regions of graphitic corrosion. Top of pipe as installed in the soil is at top of photograph. X 1

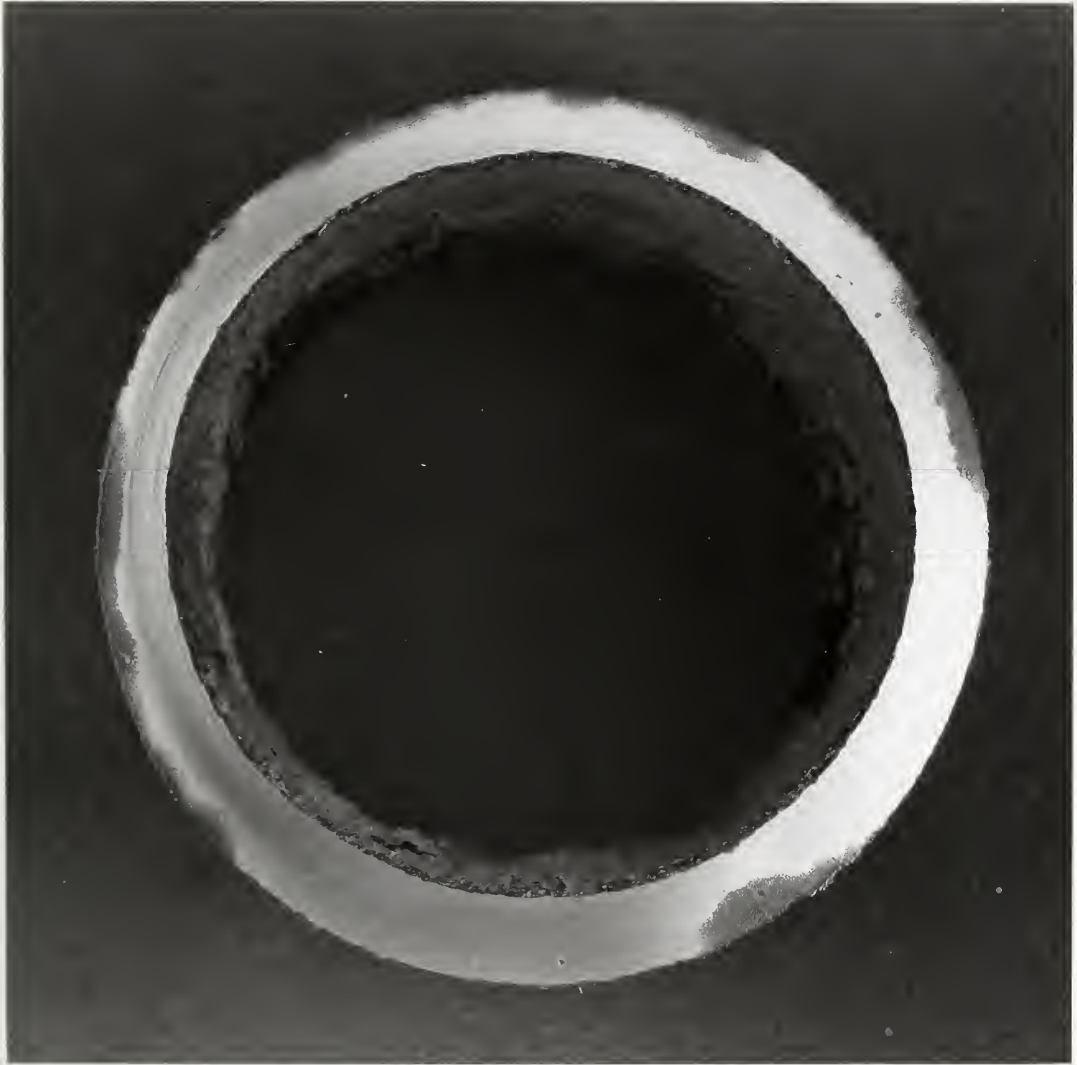
Figure 6. Transverse cross section through the pipe nine inches south of the fracture. Regions that have suffered graphitic corrosion can be seen around much of the circumference. The top of the pipe as installed in the soil is at the top of the photograph. X 1

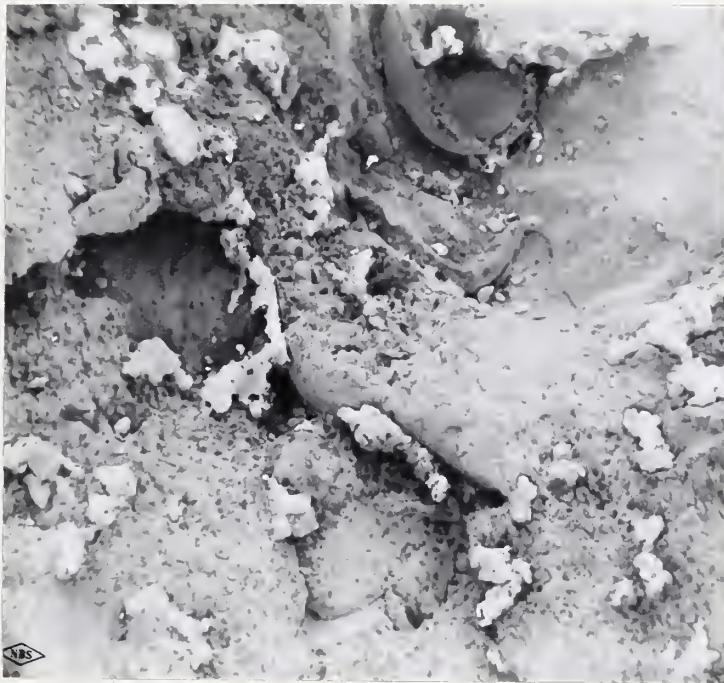
Figure 7. SEM fractograph showing the region of apparent gas porosity (arrow A, figure 3). The patches of very light colored matter are foreign material. X 20

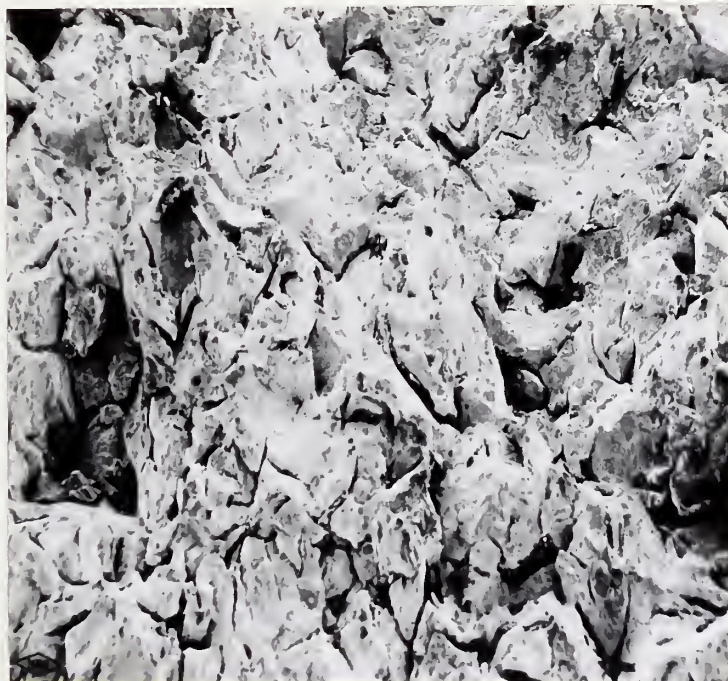
Figure 8, SEM fractograph exhibiting features typical of the pipe fracture surface. In most cases, the narrow dark phase is graphite. X 89

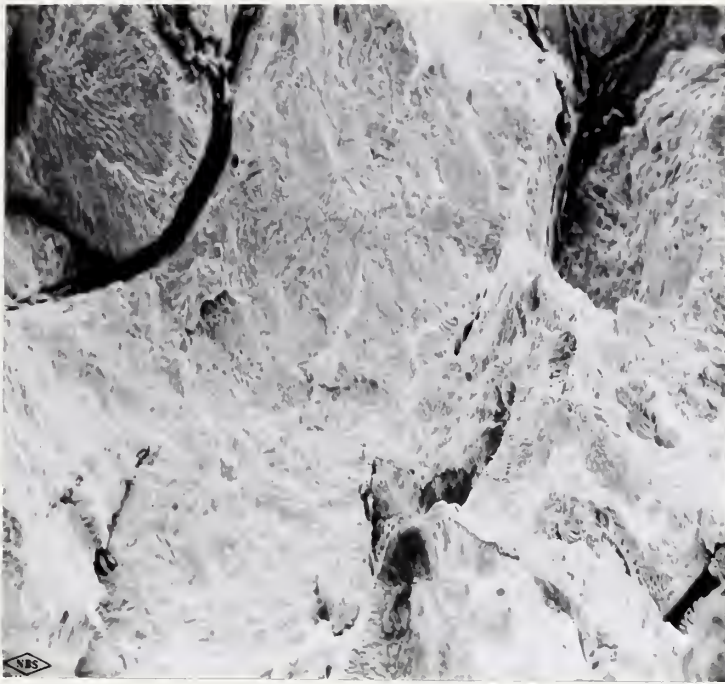
Figure 9. SEM fractograph exhibiting features typical of the pipe fracture surface. This figure is at a higher magnification than that of figure 8. The dark phase is graphite. X 460

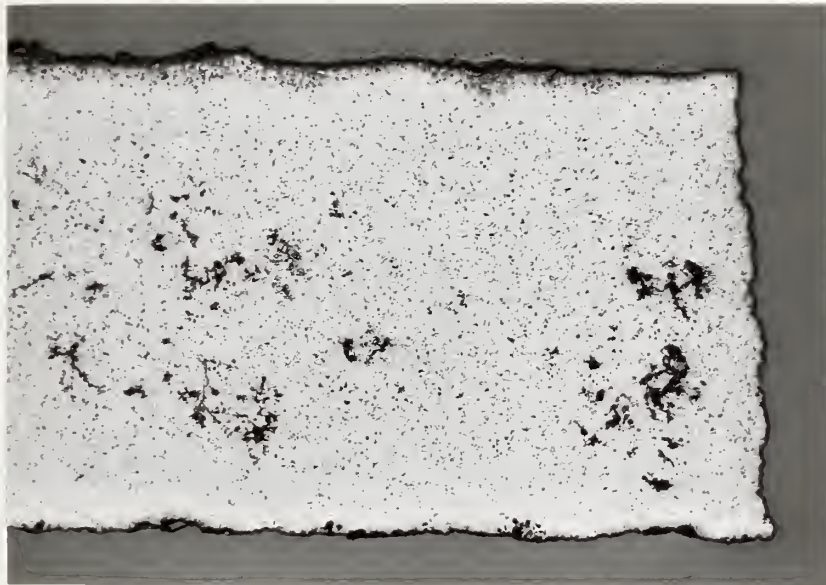
Figure 10. Longitudinal section through the top of the pipe showing the fracture profile at the right. The outside wall surface of the pipe is at the top and the inside wall surface of the pipe is at the bottom. The dark patches are regions of apparent gas porosity. Unetched. X 7.5

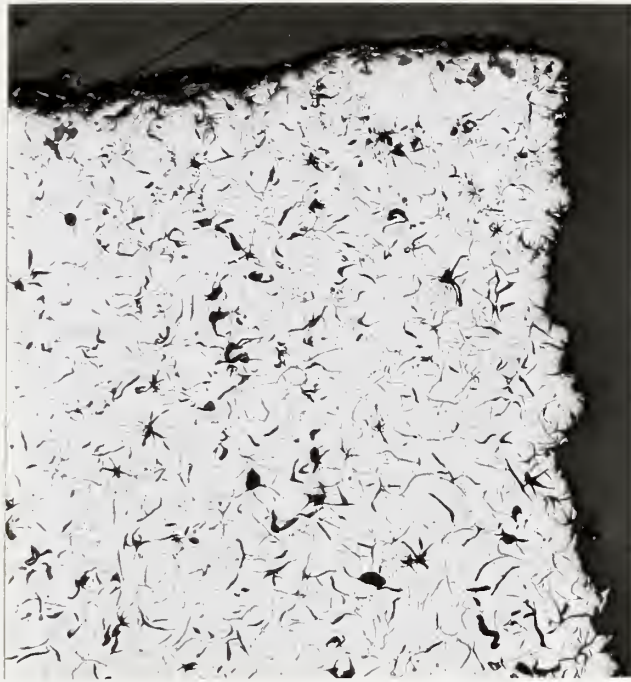
Figure 11. Area of figure 10 where the outside wall surface of the pipe intersects the fracture (vertically at the right). Some general surface corrosion can be seen on the outside wall surface. Most of the dark areas are graphite flakes. Unetched. X 50

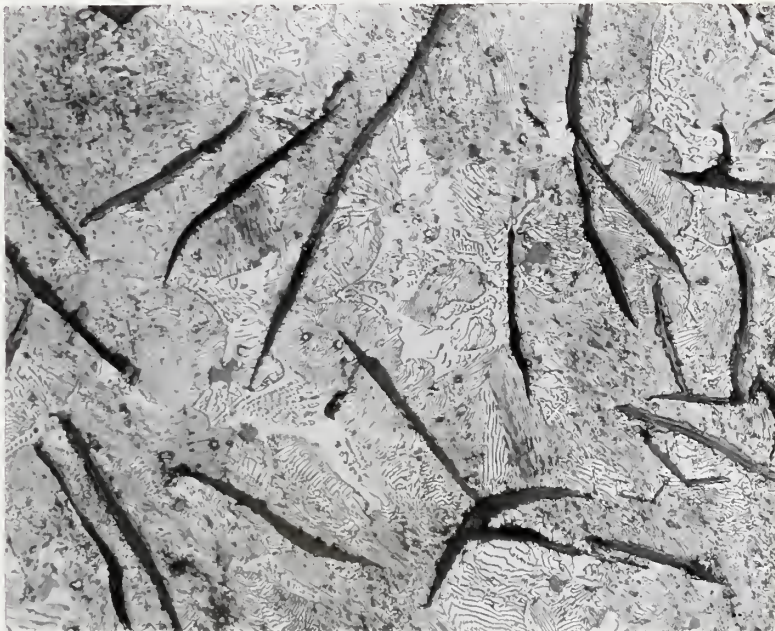
Figure 12. Typical field showing the microstructure of the pipe material. The microstructure consists of graphite flakes (long, thin, dark particles), pearlite (fingerprint pattern), ferrite (white), and steadite (small rounded particles). Etchant: 1% nital. X 500

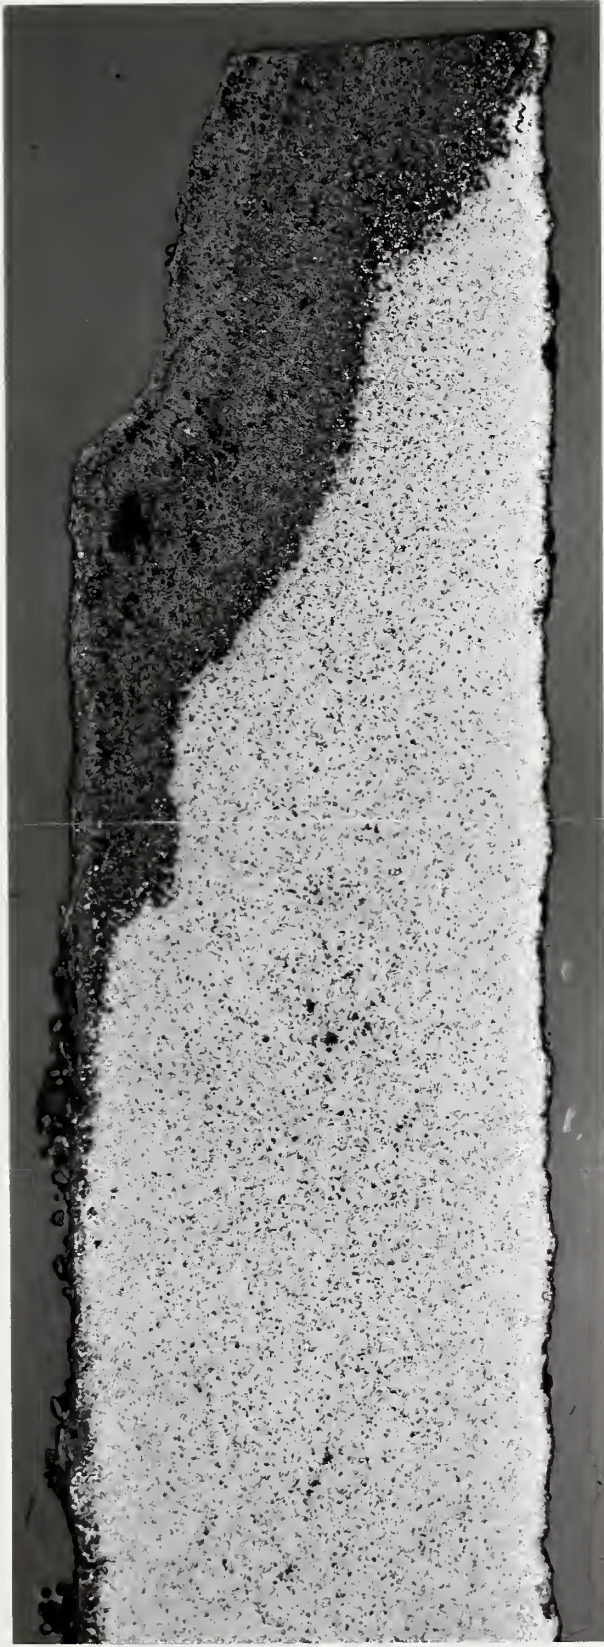
Figure 13. Longitudinal section through the top of the pipe. Right side of the section is two inches north of the fracture. The dark area represents graphitic corrosion, which has penetrated nearly the entire wall thickness of the pipe at the right of the section. Etchant: 1% nital. X 7 1/2
