NBSIR 74-625

# Examination of Failed Two Inch Steel Pipe Natural Gas Main, Columbia Gas Company, Spring Garden Township, York County, Pennsylvania

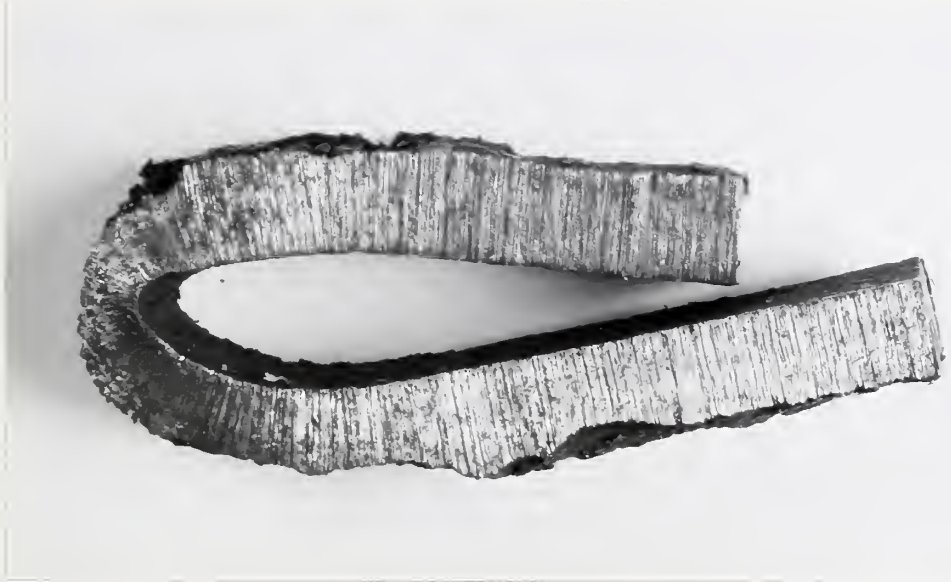
Figure 2. Longitudinal piece cut from the pipe length about 24 inches south of the fracture. This piece exhibited good ductility since it was bent through a sharp angle and exhibited only slight cracking. X 4

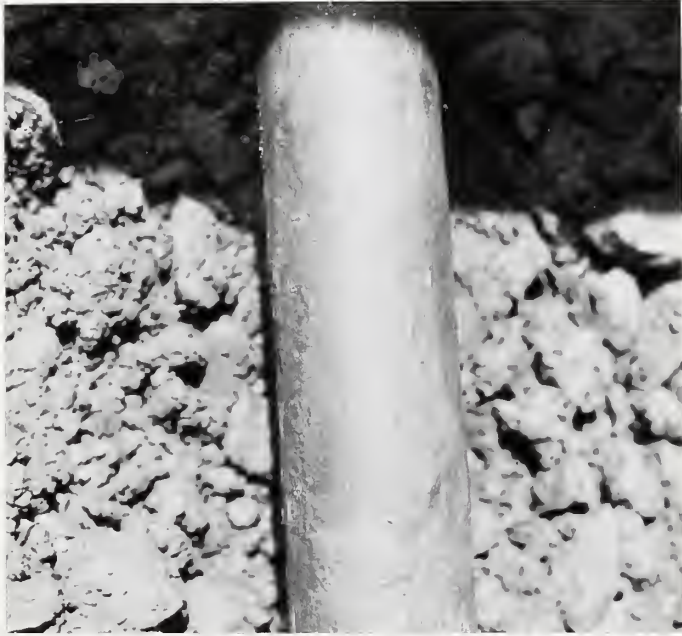
Figure 6. Top view of part of the pipeline excavated at site 2.  
X ~ 1/2

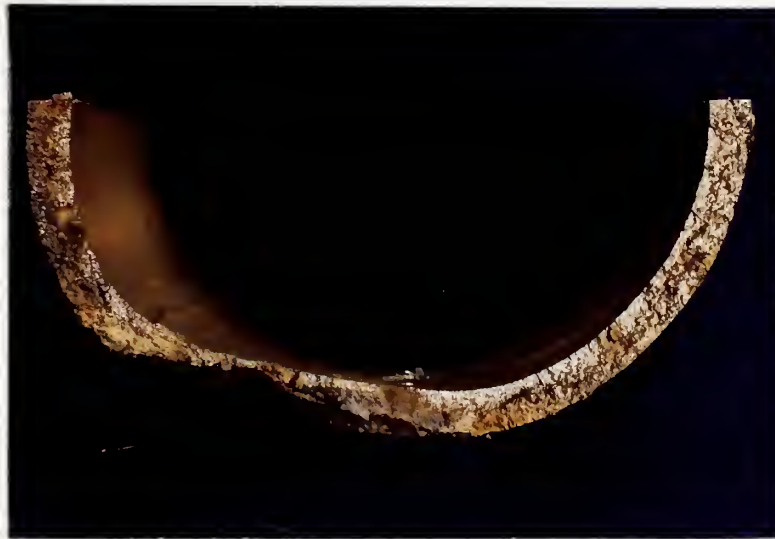
Figure 7. Bottom half (as the pipe was positioned in service) of the south side of the fracture. Thin area at about 7 o'clock is where the crack passed through a gouge. Note lighter color of the fracture near the inside wall surface of the pipe. This region is the recent part of the fracture. X 1 1/2

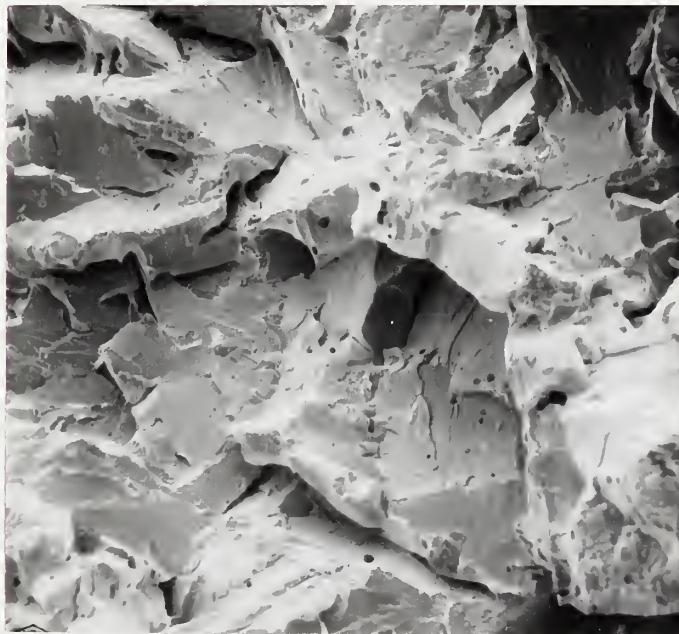
Figure 8. Scanning electron fractograph taken in region of "fresh" fracture showing essentially all quasi-cleavage. X 260

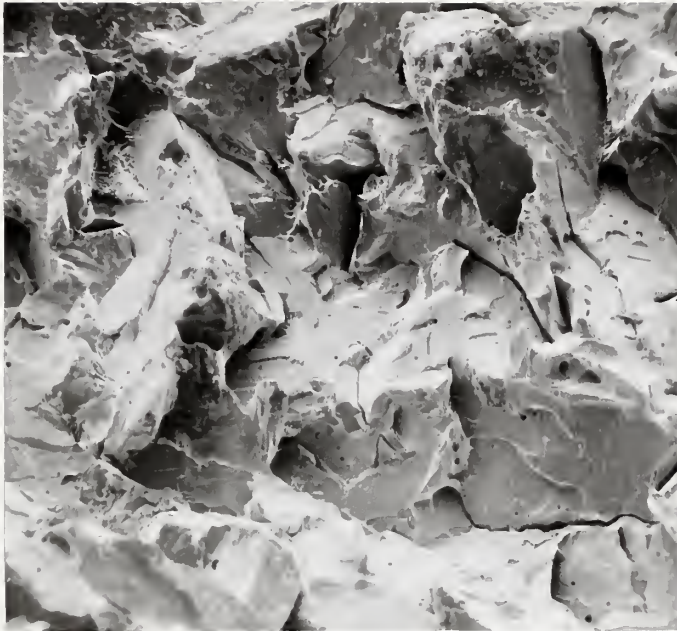
Figure 9. Scanning electron fractograph taken in region of "fresh" fracture showing essentially all quasi-cleavage. X 260

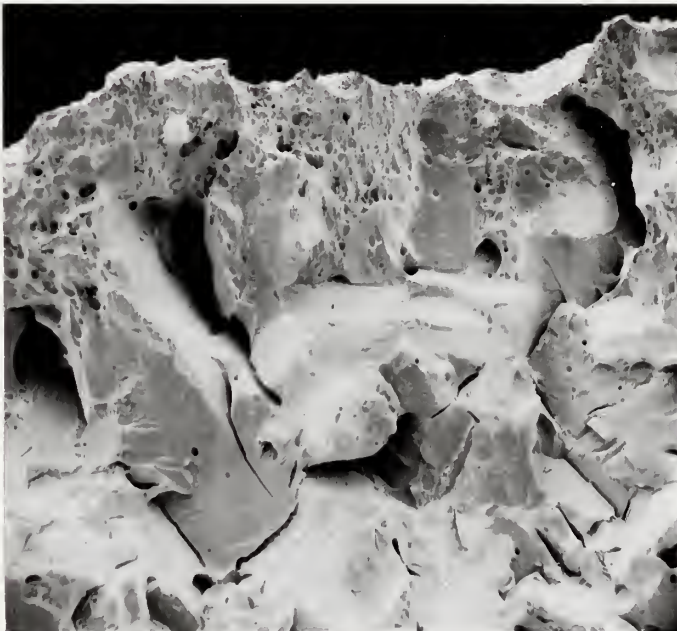
Figure 10. Scanning electron fractograph taken in region of "fresh" fracture adjacent to the inner wall surface. The primary fracture feature is quasi-cleavage. Some dimpled rupture is evident. X 260

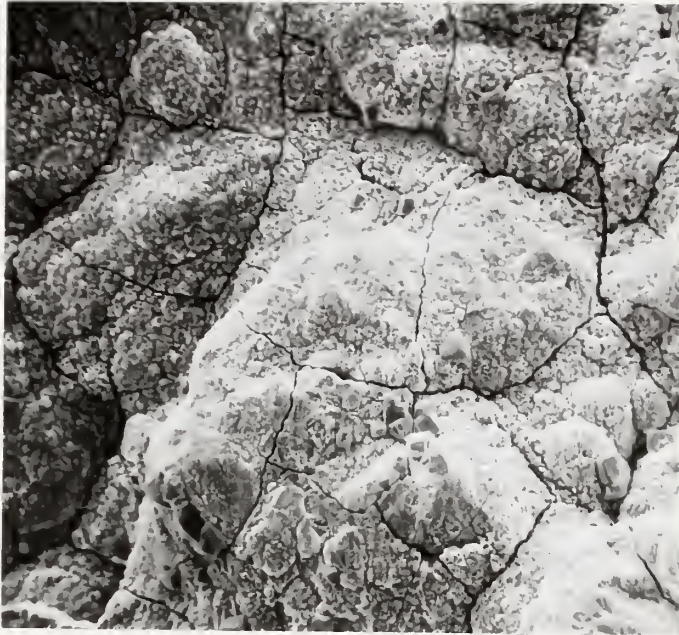
Figure 11. Scanning electron fractograph taken in the older appearing part of the fracture before ultrasonic cleaning. The film of corrosion product is evident. X 690

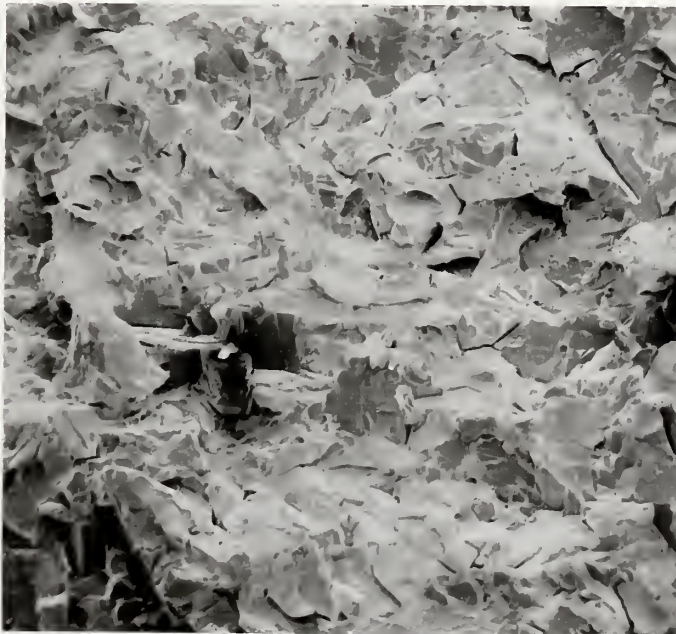
Figure 12. Scanning electron fractograph taken in the older part of the fracture after ultrasonic cleaning. Quasi-cleavage is the primary fracture feature. X 95

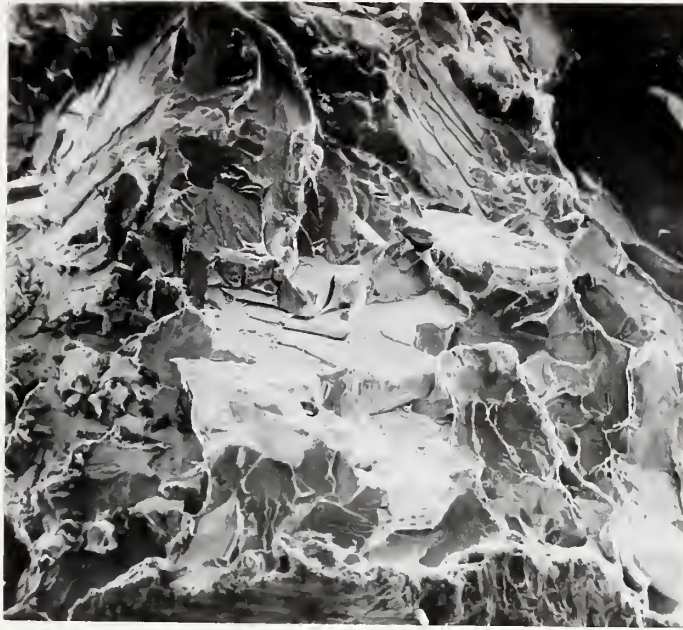
Figure 13. Scanning electron fractograph taken in the older appearing part of the fracture. The primary feature exhibited is quasi-cleavage. X 137

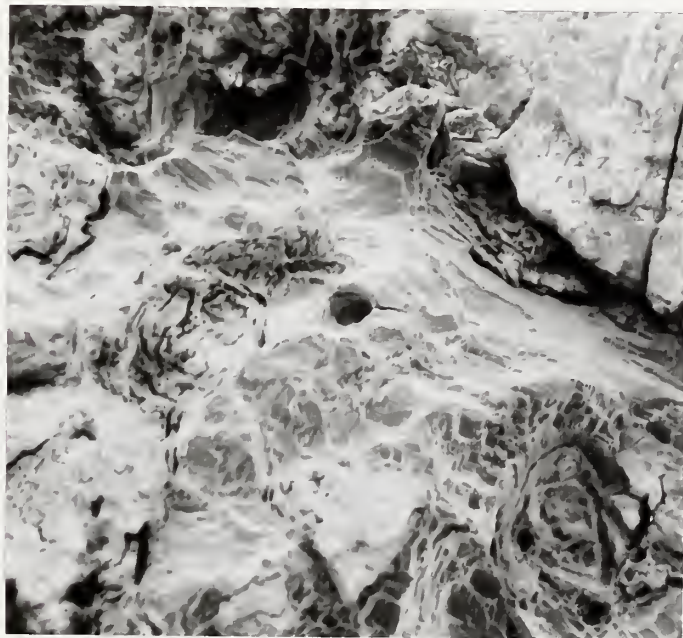
Figure 14. Scanning electron fractograph taken in the older appearing part of the fracture near the apparent fracture origin. There is a small amount of dimpled rupture. X 670

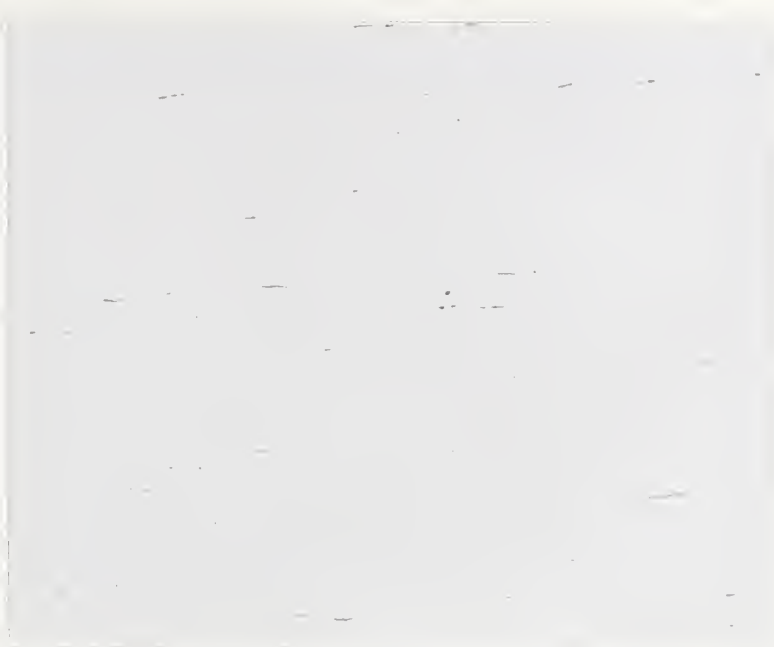
Figure 15. Longitudinal section through the pipe near the south fracture surface showing an average inclusion content for the areas examined. As polished. X 100

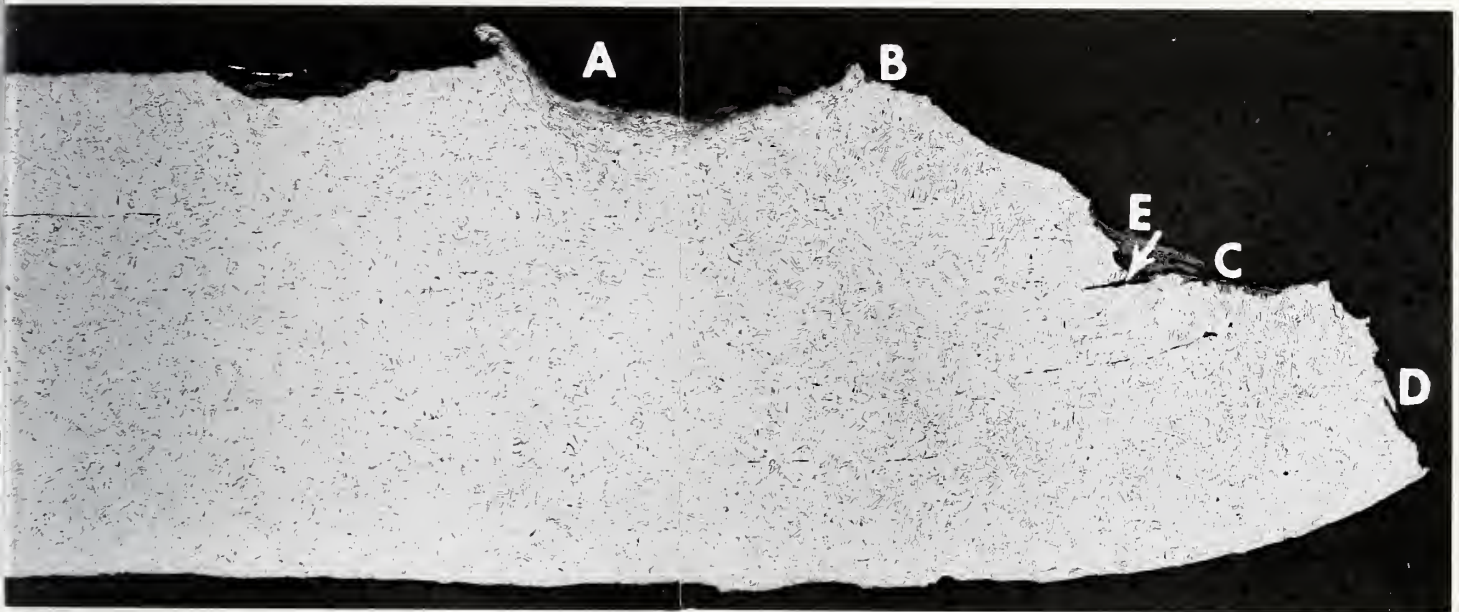
Figure 16. Longitudinal section intersecting the south fracture surface near the apparent crack origin. The outside wall surface of the pipe is at the top. The fracture profile is at the right (D). Macroscopic deformation is evident near the fracture. Deformation on a finer scale can be seen at A. E indicates a secondary crack. Areas B, C, and D are shown at higher magnification in figure 17.  
Etchant: 1% nital X16

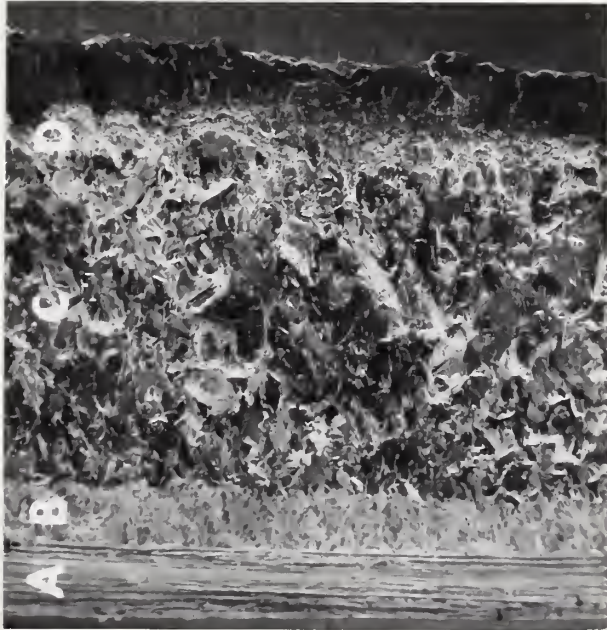
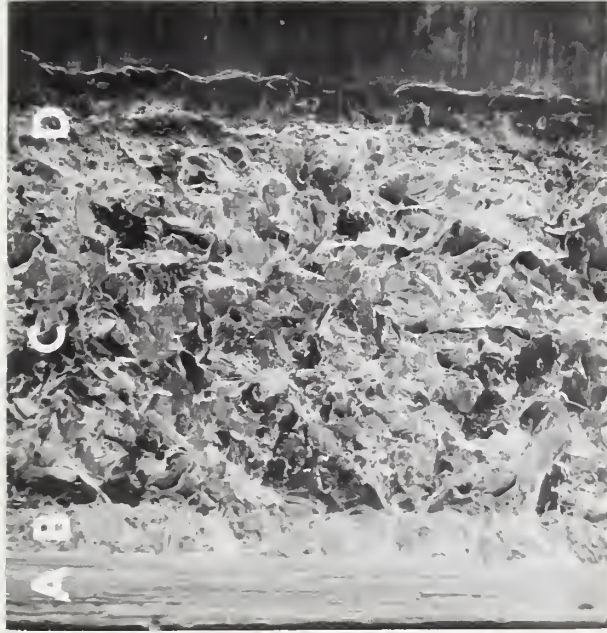
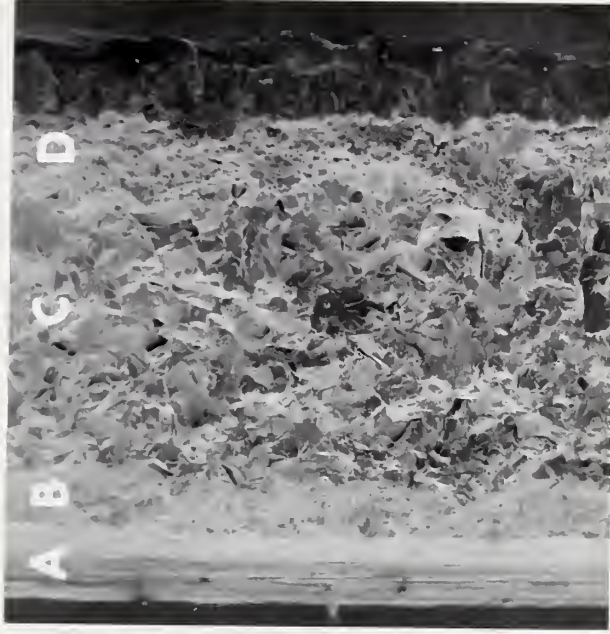
- a. Outside wall surface of the pipe is at the top. There is evidence of mechanical damage and subsequent corrosive attack.
- b. Gouged region showing evidence of corrosive attack and corrosion product.
- c. Fracture profile (vertically at the right). Fracture appears to be primarily intergranular.

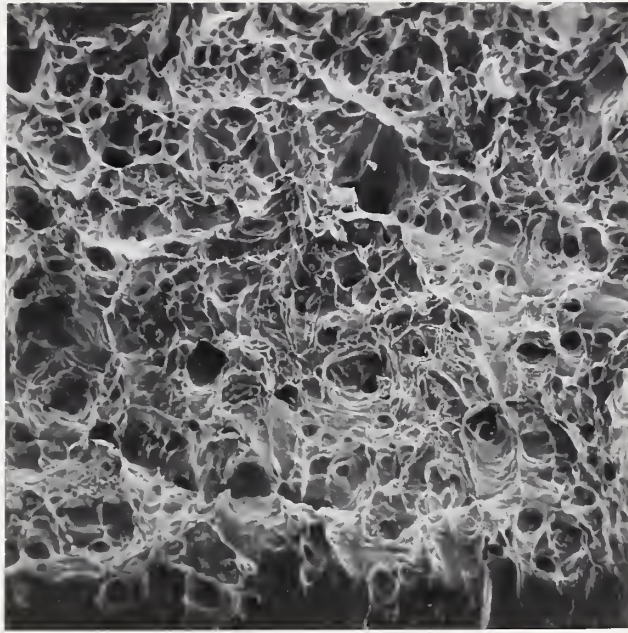
Figure 20. Scanning electron fractograph from the specimen tested in impact at 45°F. This area is in the ductile part of the fracture. The primary feature exhibited is dimpled rupture. X 425

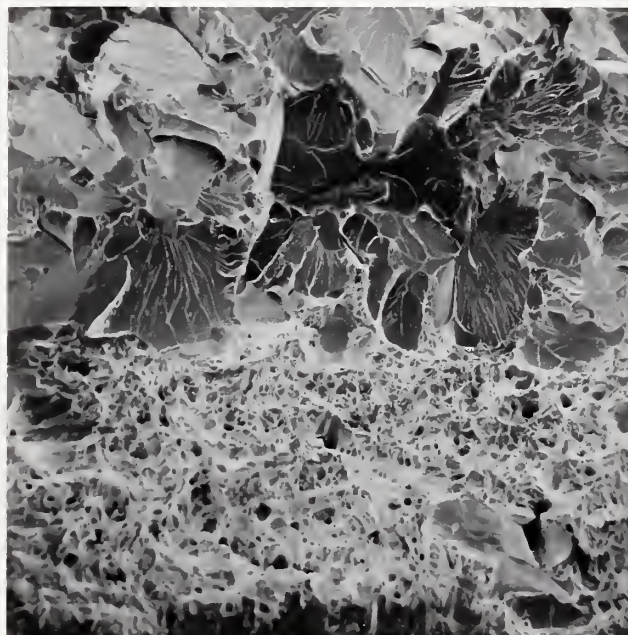
Figure 21. Scanning electron fractograph showing the transition from essentially brittle fracture (top) to ductile fracture (bottom). There is a small area of quasi-cleavage in the predominantly ductile region. X 165
