NBSIR 75-657 (R)

# Report No. 7

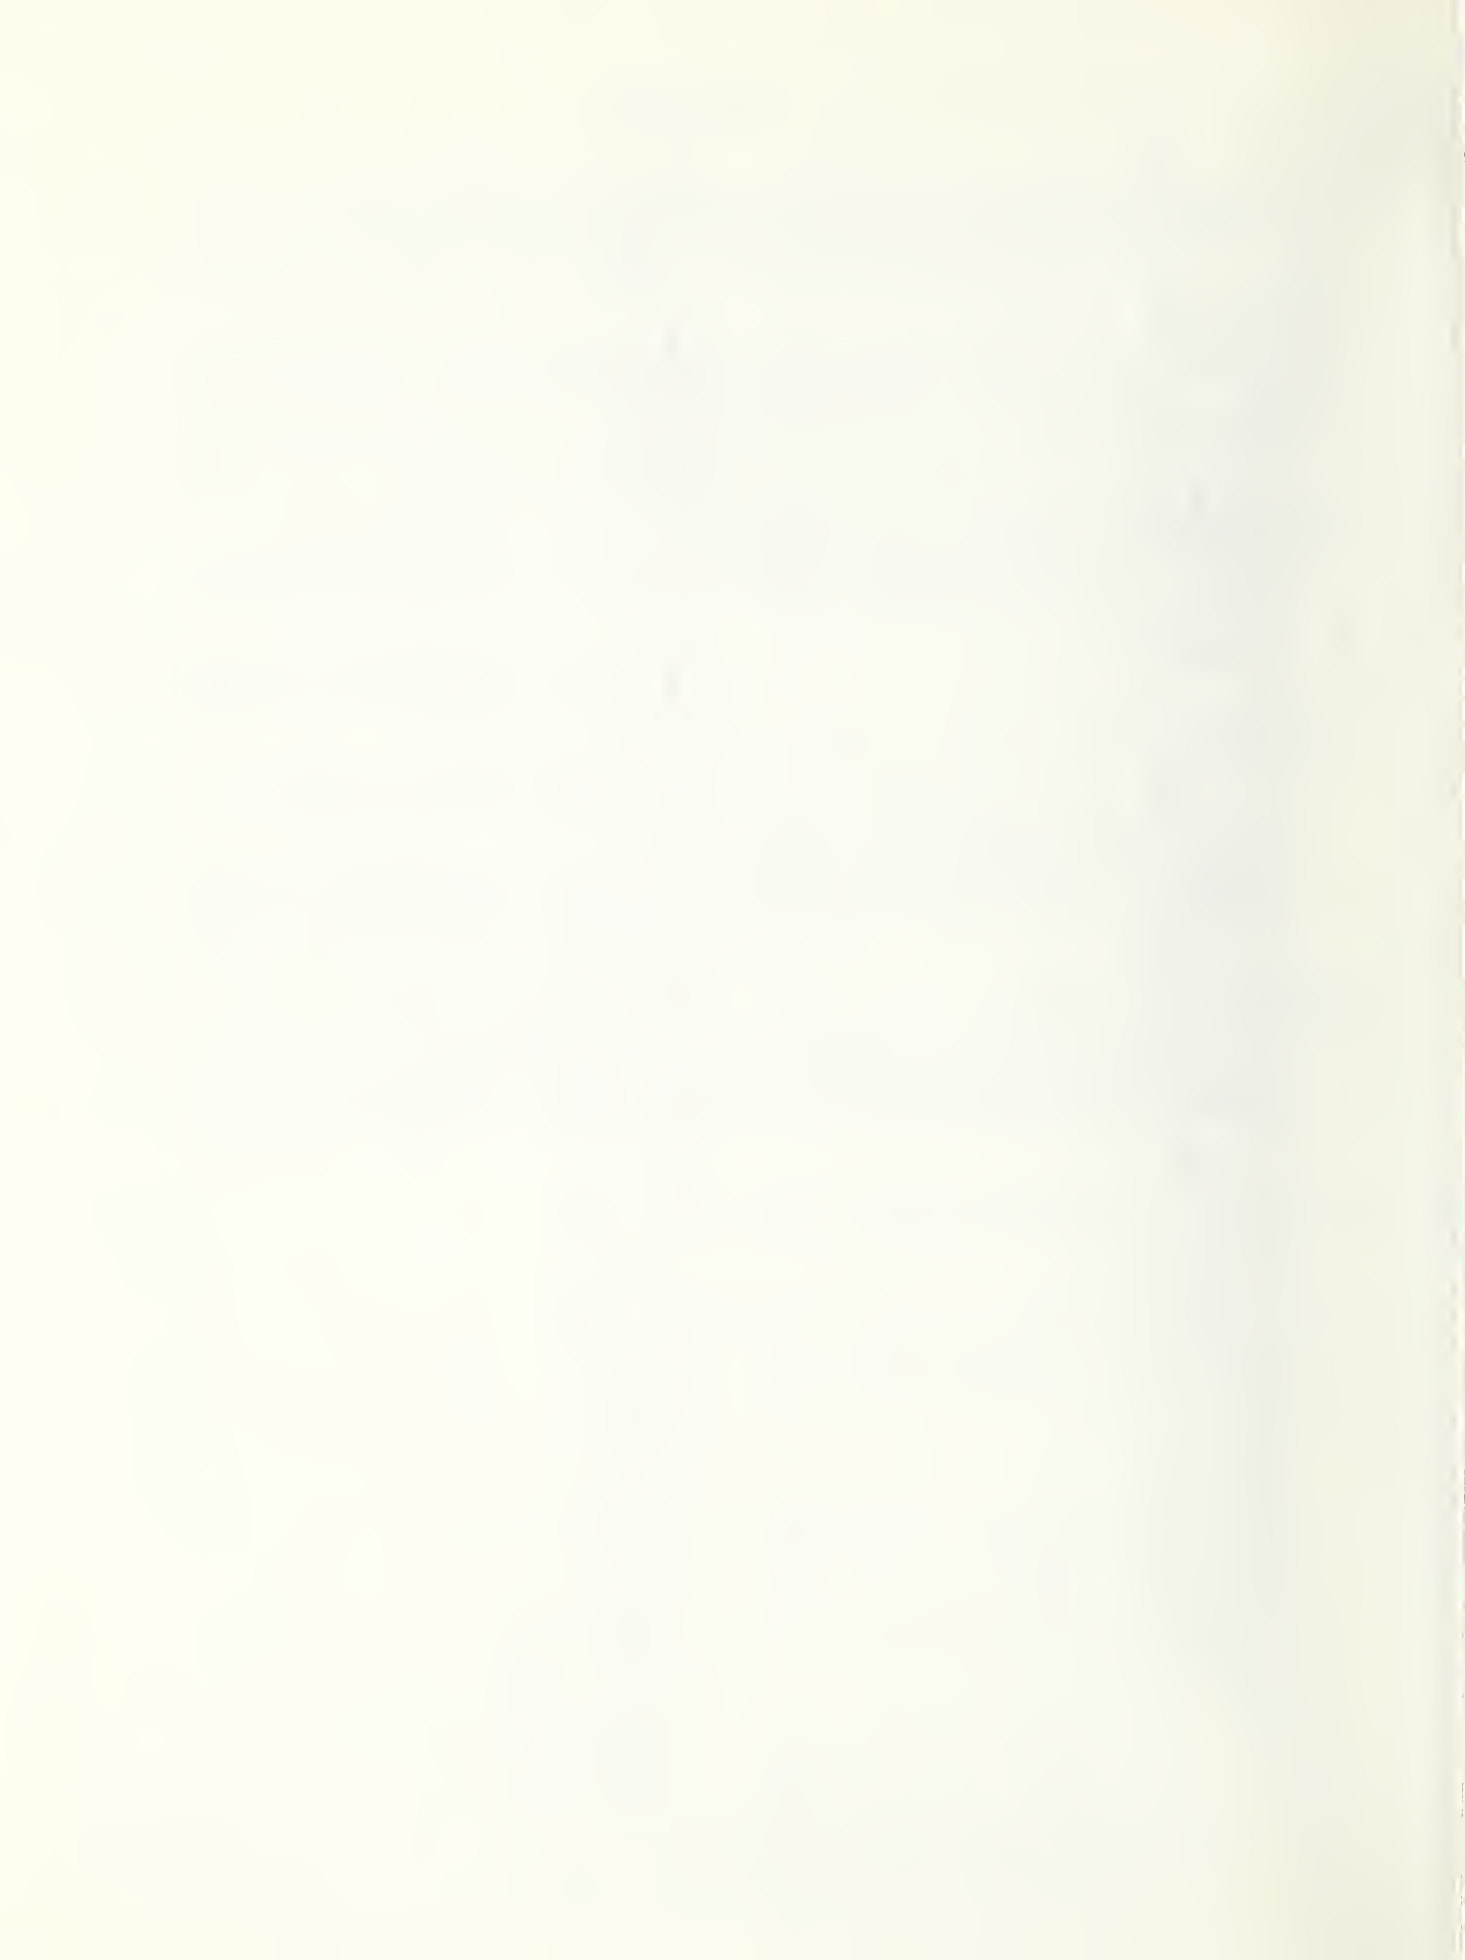
Table II. Macroscopic Observations of Plate Samples TC2-(1) and TC2-(3) From Shell Course 3

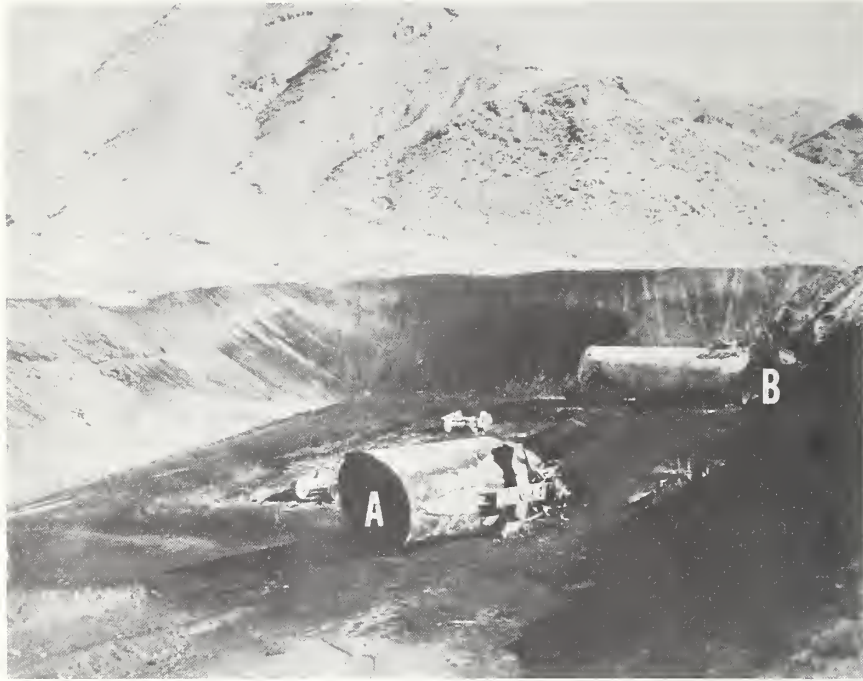
The additional manway, shown at A, and the instrumentation cable ports, shown at B, are modifications of this standard 33,000 gallon tank car. The JP-4 fuel dike is shown at C. Mag. X 1/84

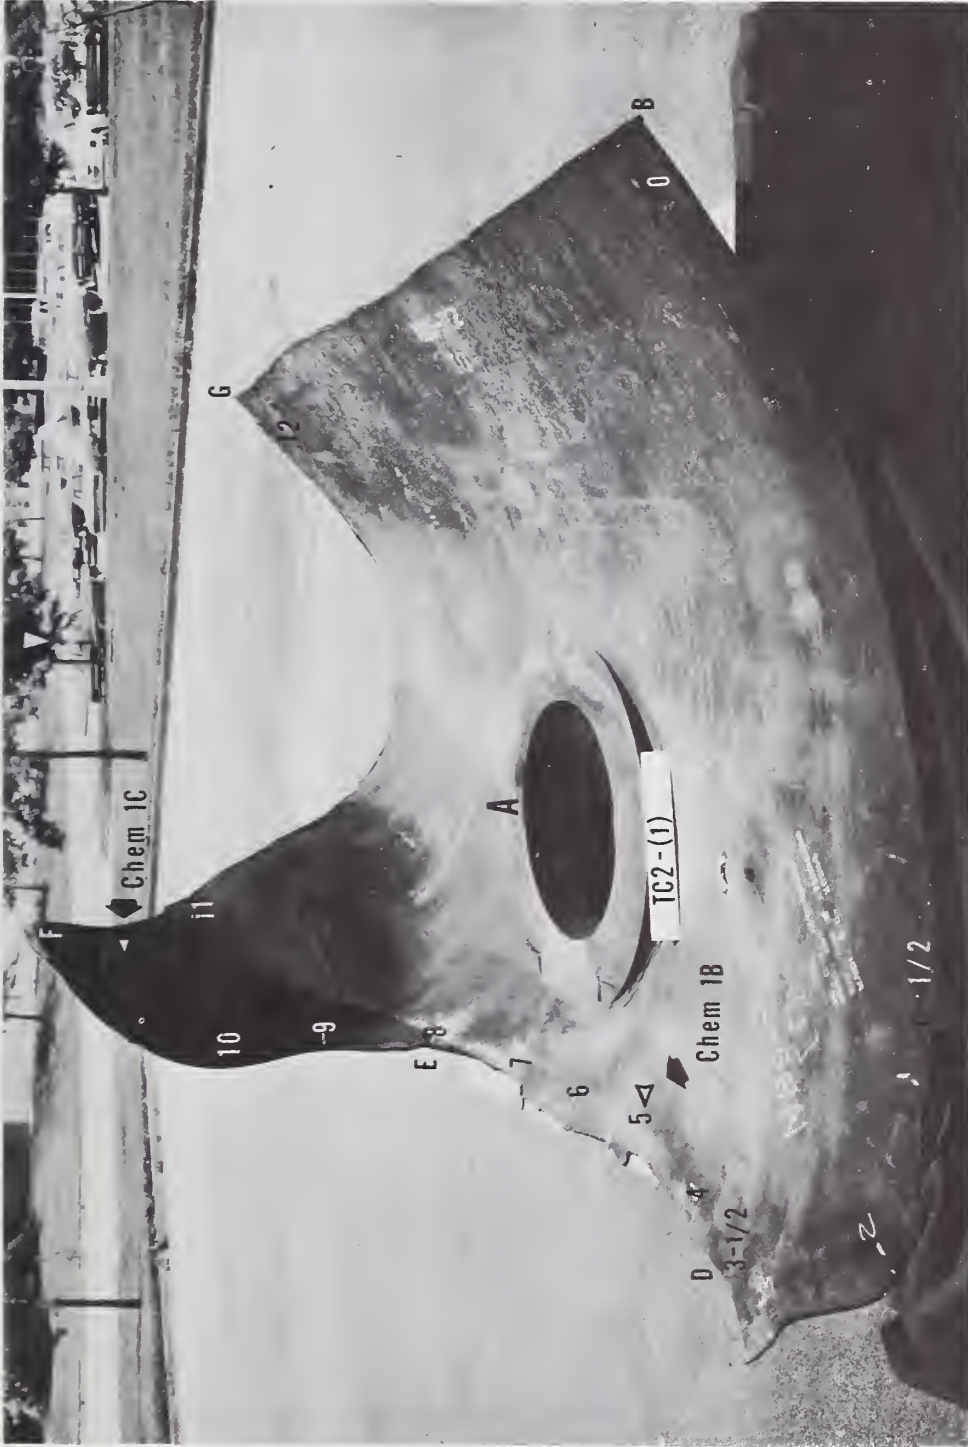
Figure 3. Plate Sample TC2-(1), Shell Course 3, Taken from Fragment C.

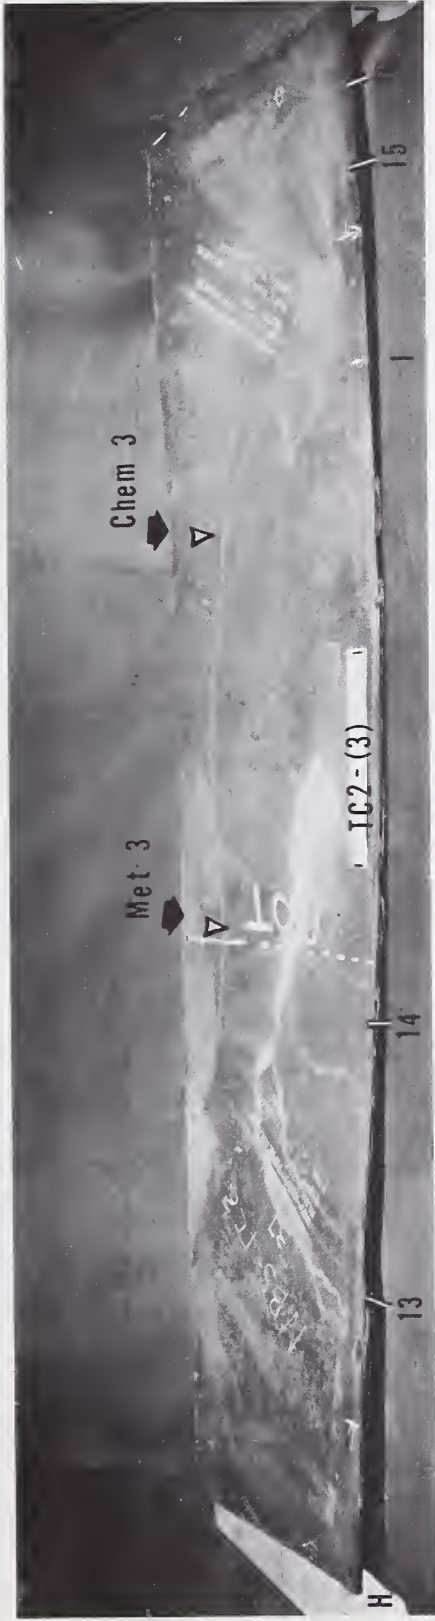
Figure 4. Plate Sample TC2-(3), Shell Course 3, Taken from Fragment C.

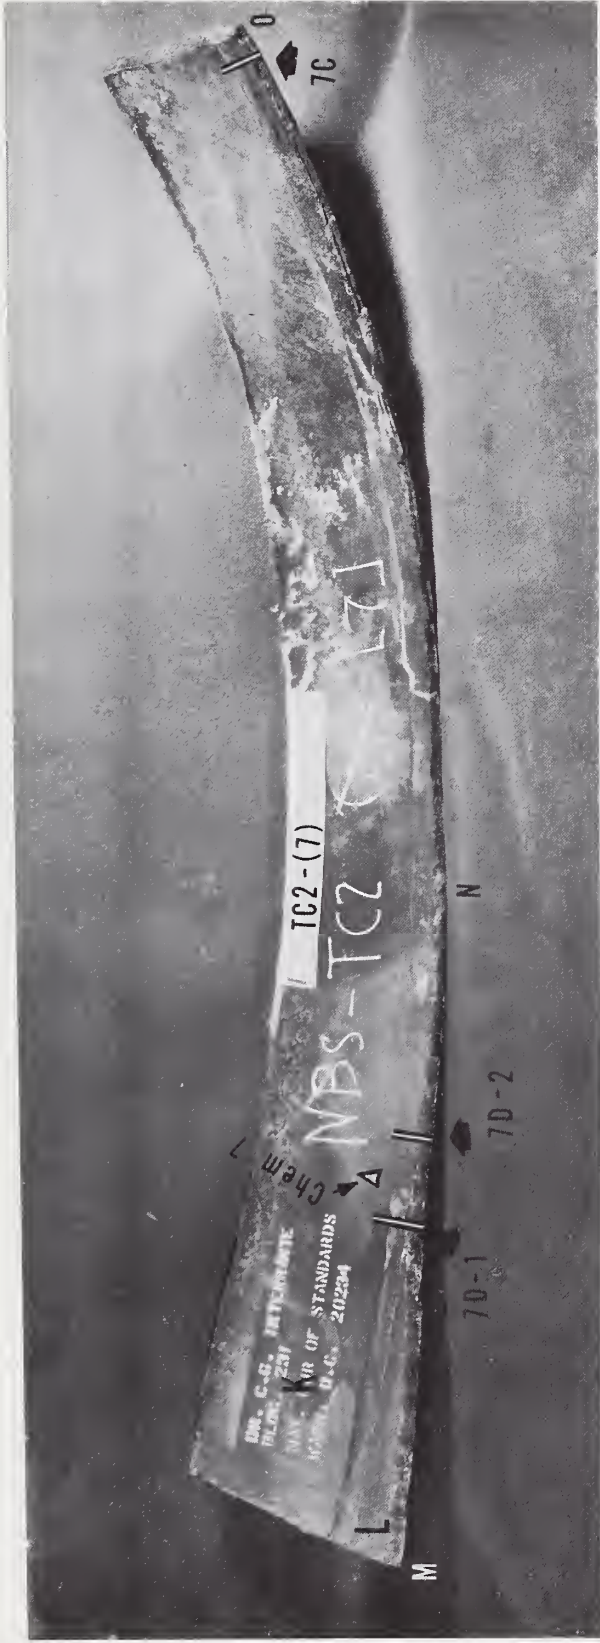
Figure 5. Plate Sample TC2-(7), Shell Course 4, Taken from Fragment B.

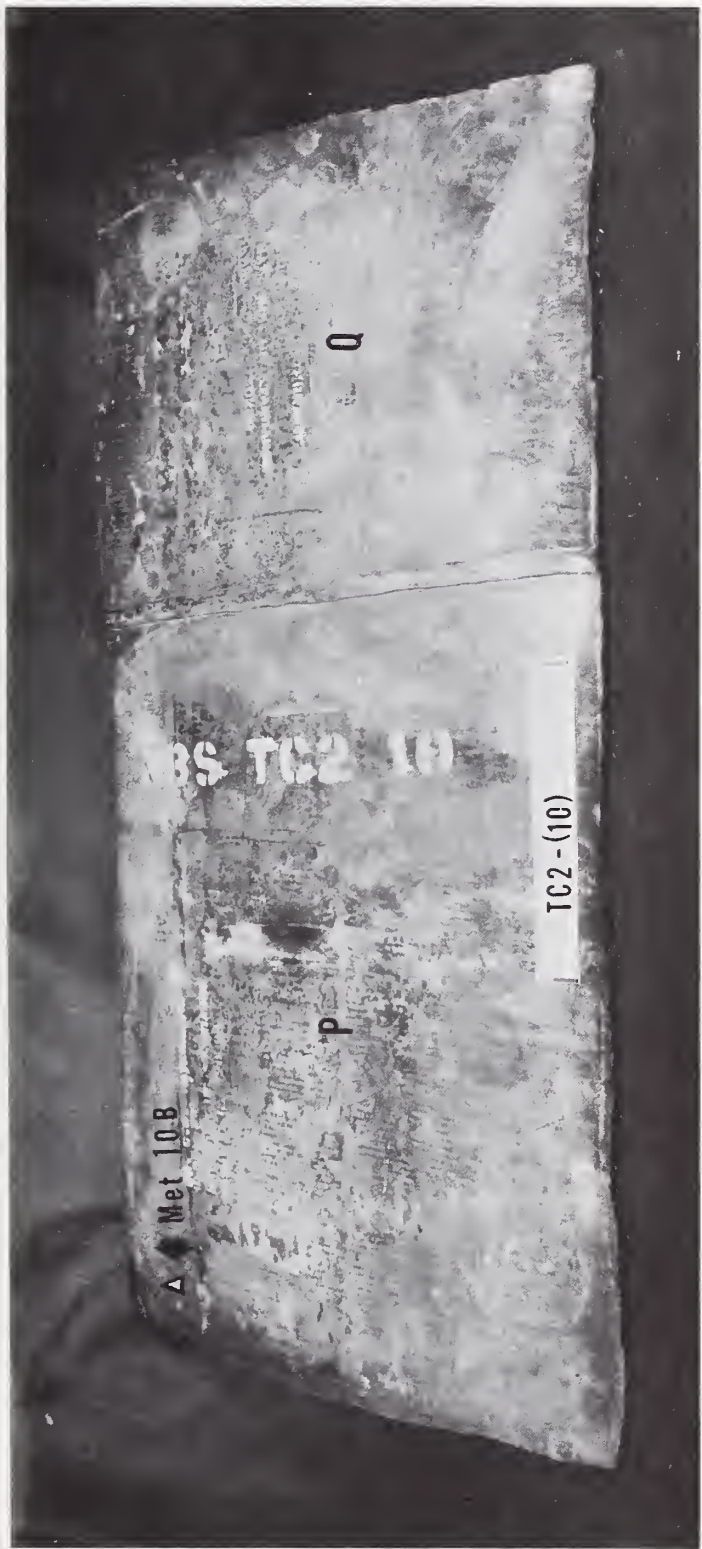
Figure 6. Plate Sample TC2-(10) Taken from Shell Courses 1 and 2 of Fragment A at the Top of the Tank Car. Photograph shows the outside plate surface of shell course 1 (TC2-(10B)), marked P, and shell course 2 (TC2-(10A)), marked Q. Specimen for metallographic examination was taken from the area marked Met. 10B. Mag. X 1/7

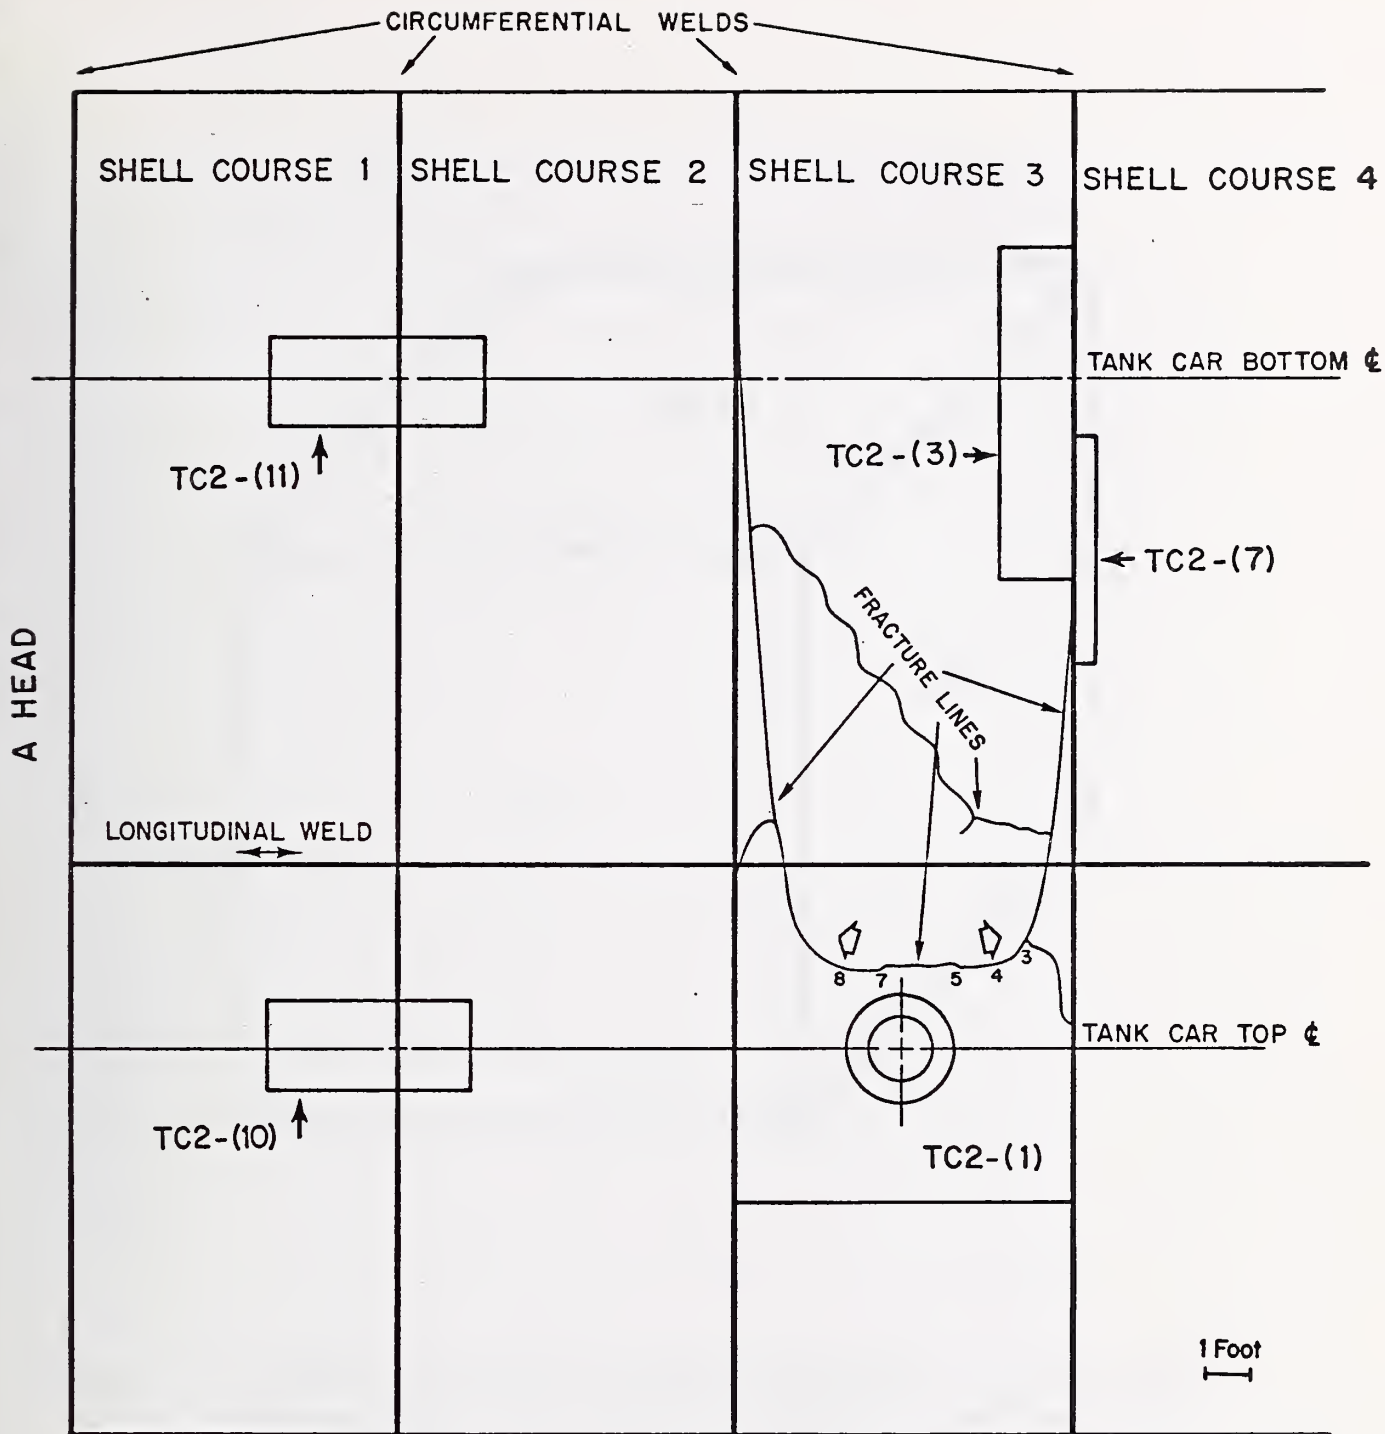
Figure 8. Schematic Diagram Showing the Location of NBS Samples in Tank Car RAX 202, Viewed from the Outside of the Tank Car. The direction of crack propagation is indicated by the open arrows  $\diamond$ .

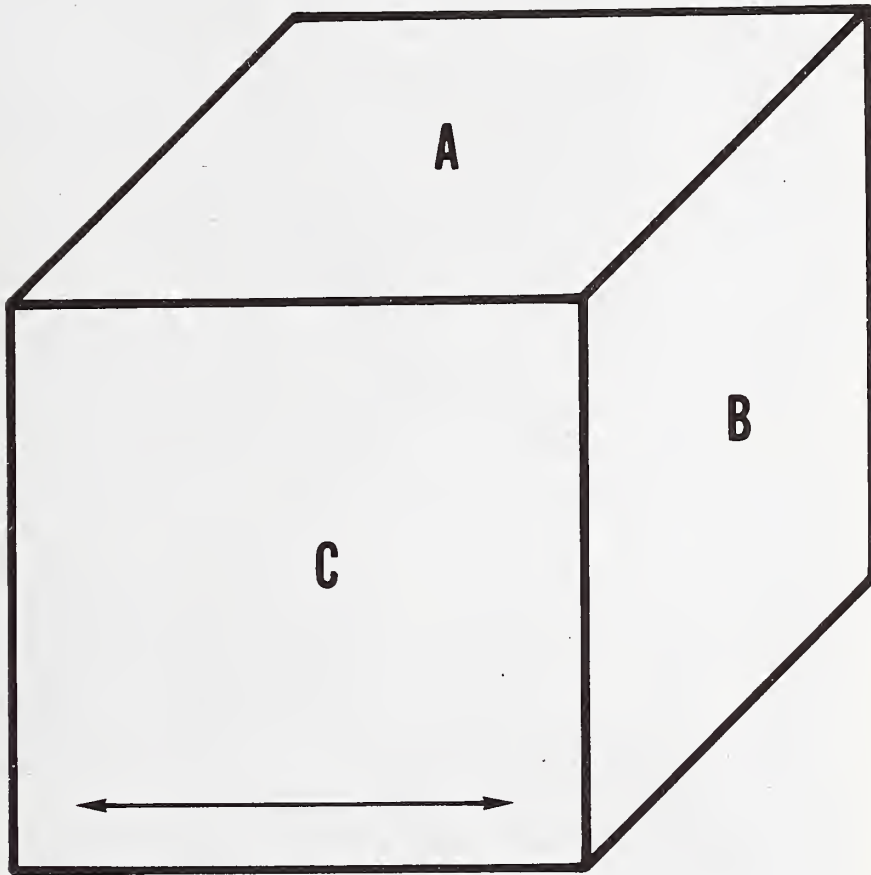
Figure 9. Schematic Showing the Three Mutually Perpendicular Planes Associated with the Rolling Direction in a Steel Plate.

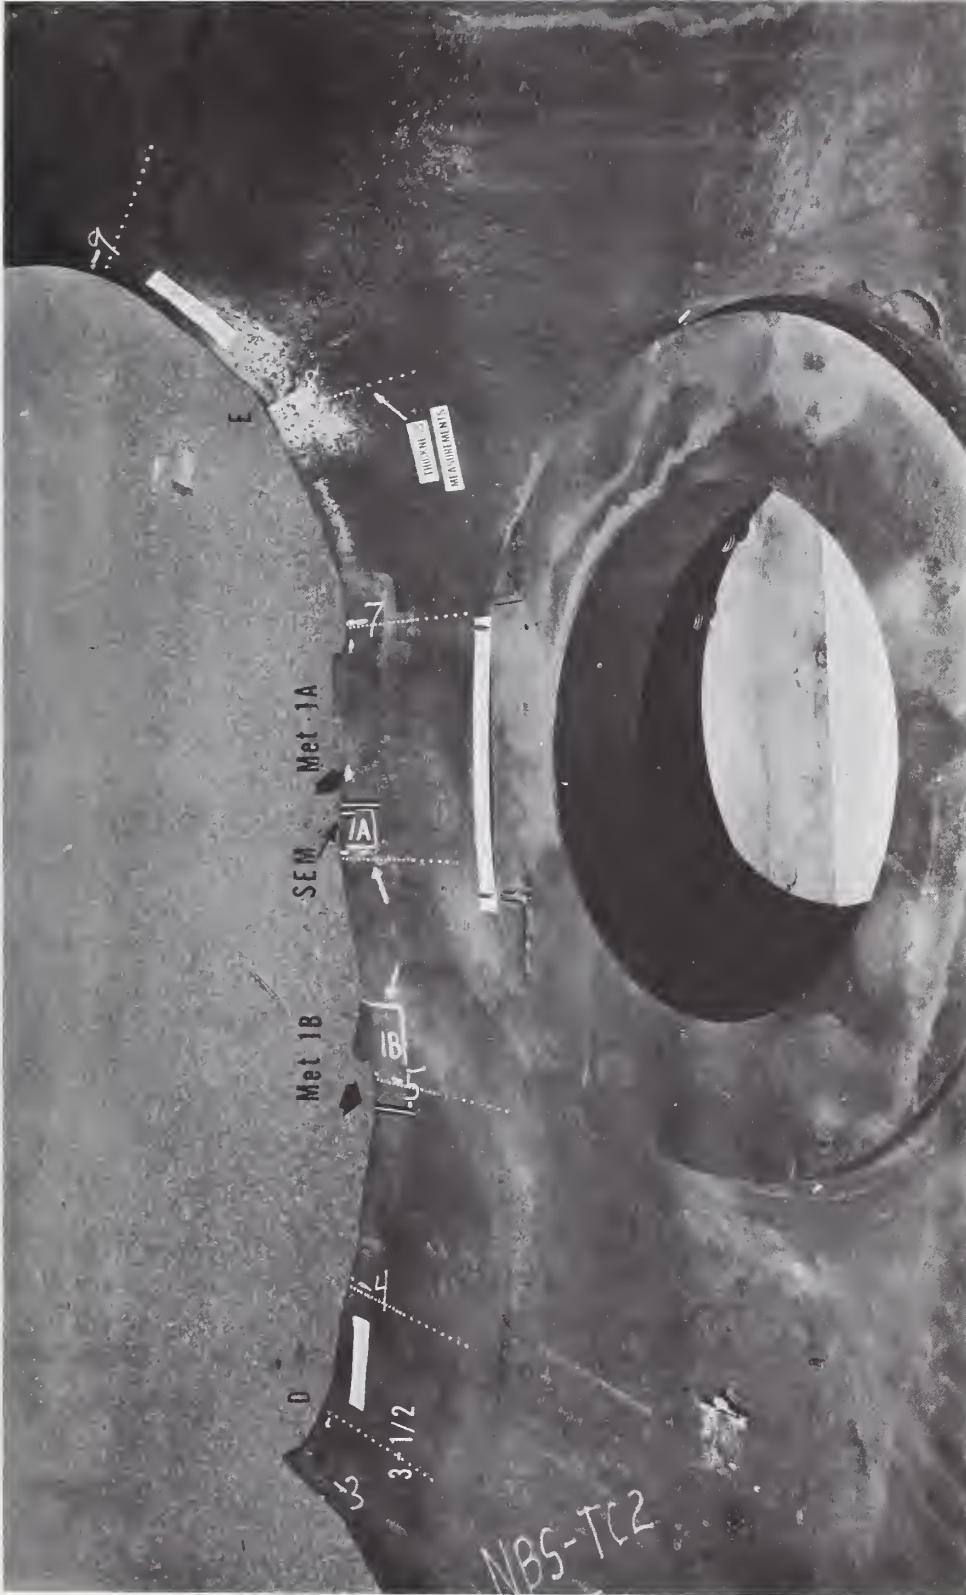
Figure 10. Close-up of a Portion of the Inside Surface of Plate Sample TC2-(1).

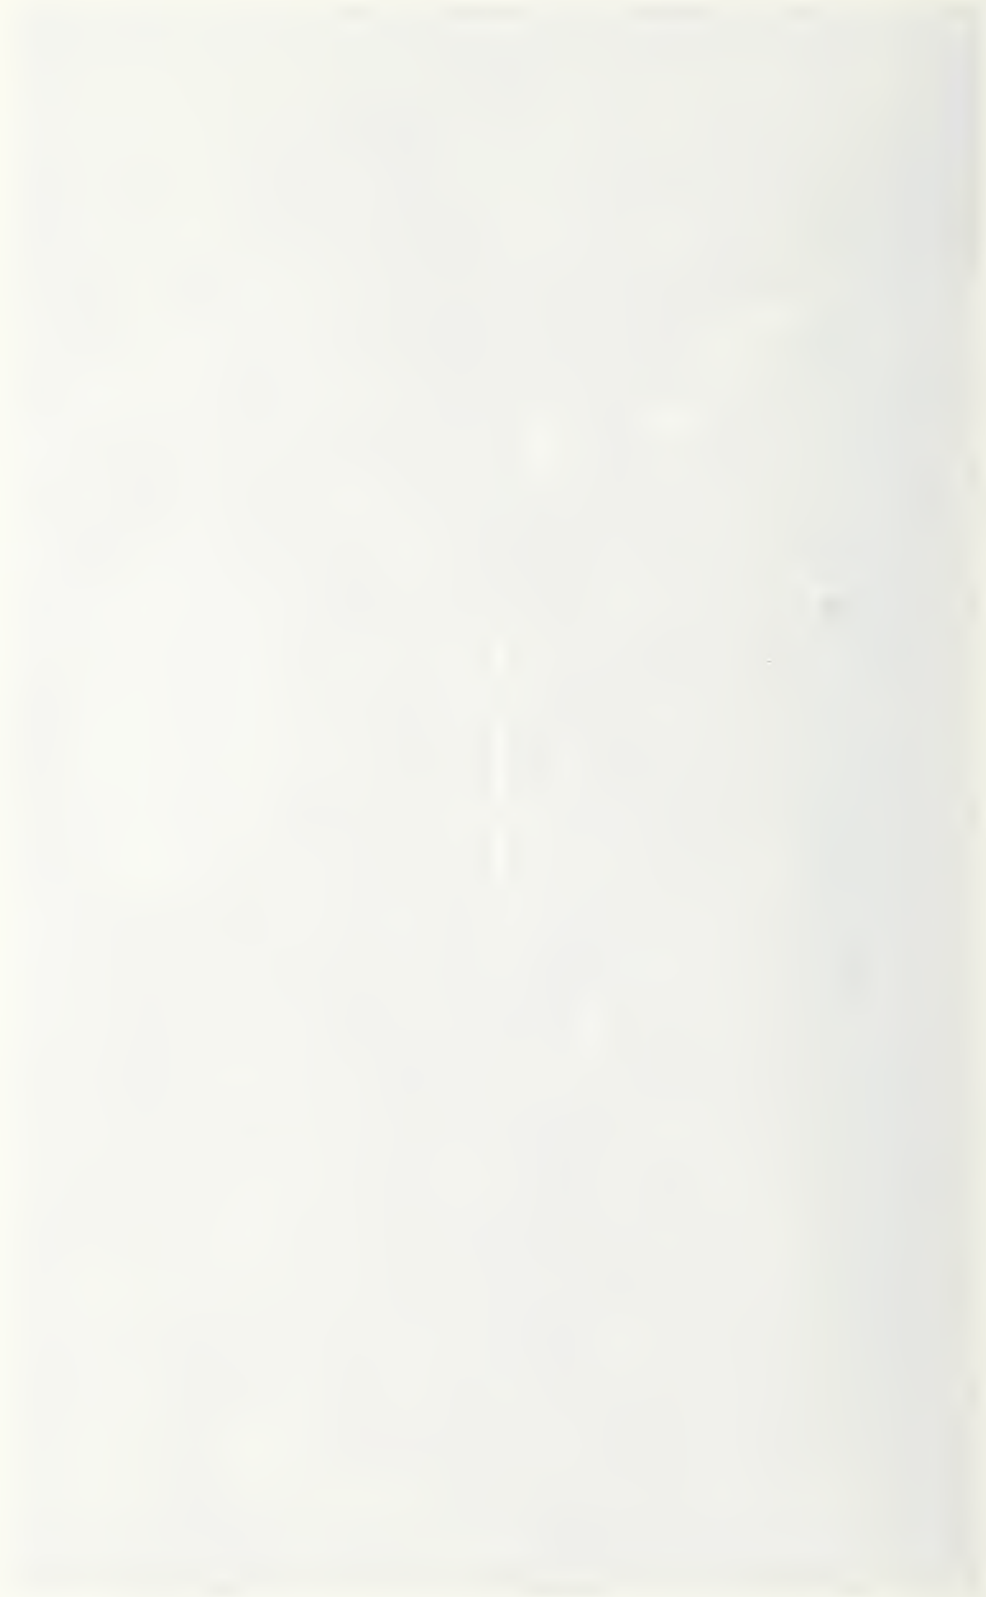
Line DE is the location along which the fracture was initiated. Specimens for metallographic examination were taken from areas marked Met. 1A and Met. 1B. A portion of the fracture surface, marked SEM, was removed for examination by scanning electron microscopy. Mag. X 1/7

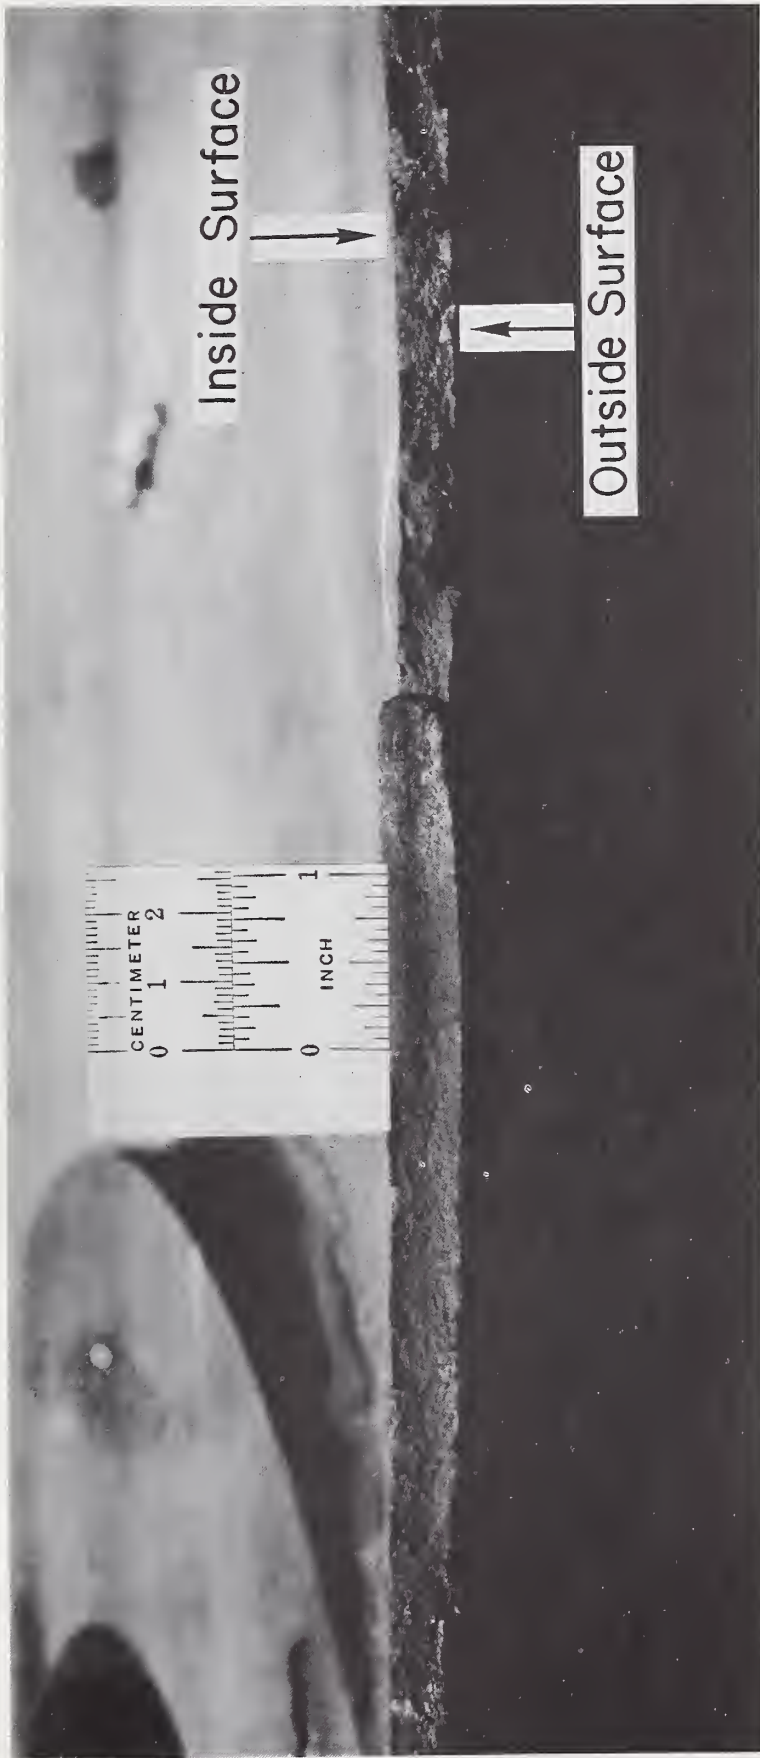
Figure 11. Macrograph of Fracture Face of TC2-(1) Between Locations 5 and 6. The fracture face is nearly perpendicular to the plate surface with evidence of very small shear lips at both the inside and outside plate surface. Mag. X 0.9

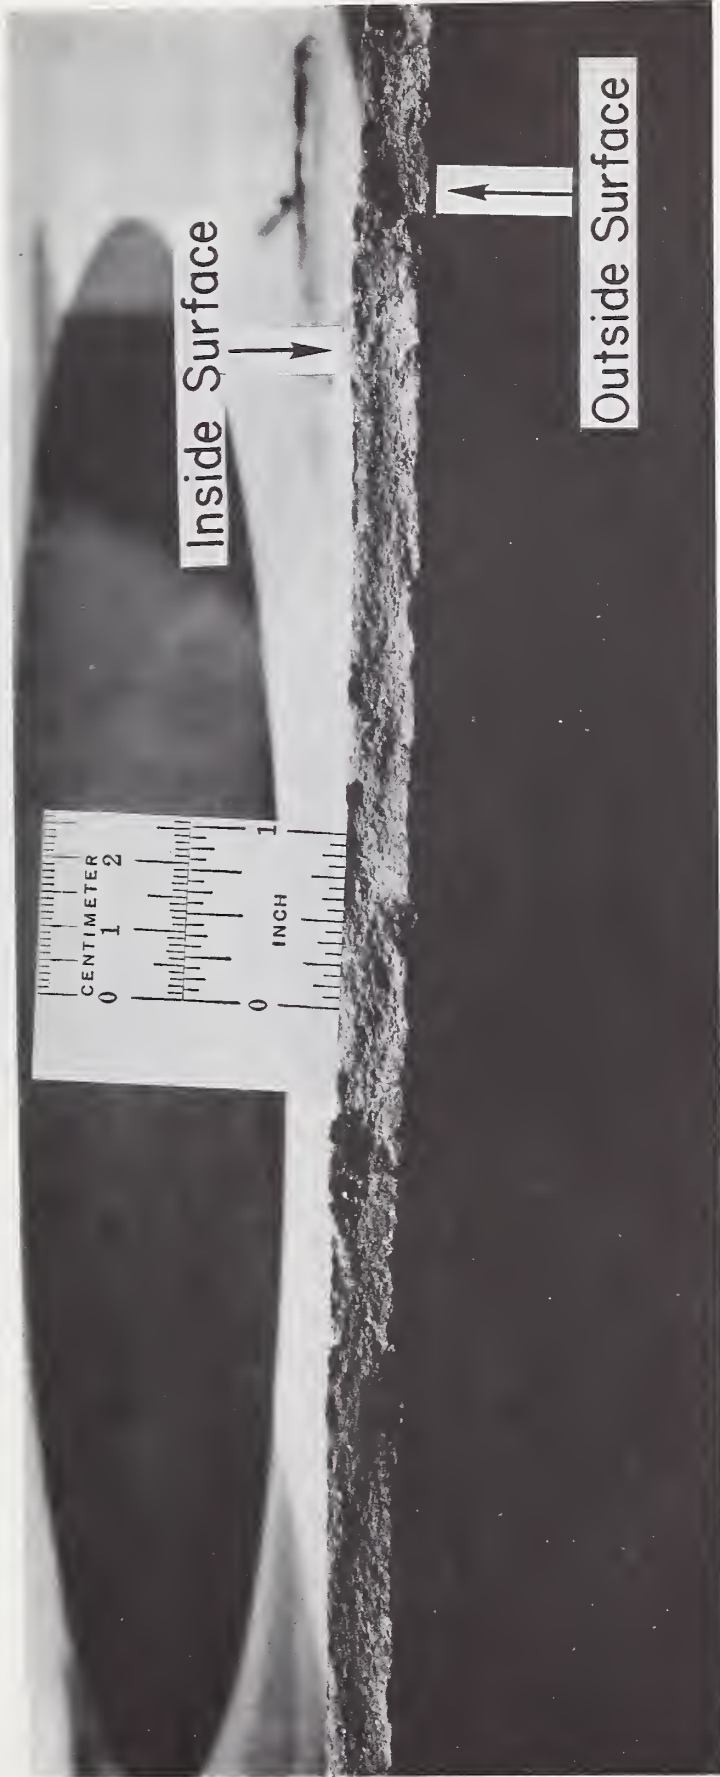
Figure 12. Macrograph of Fracture Face of TC2-(1) Between Locations 6 and 7.

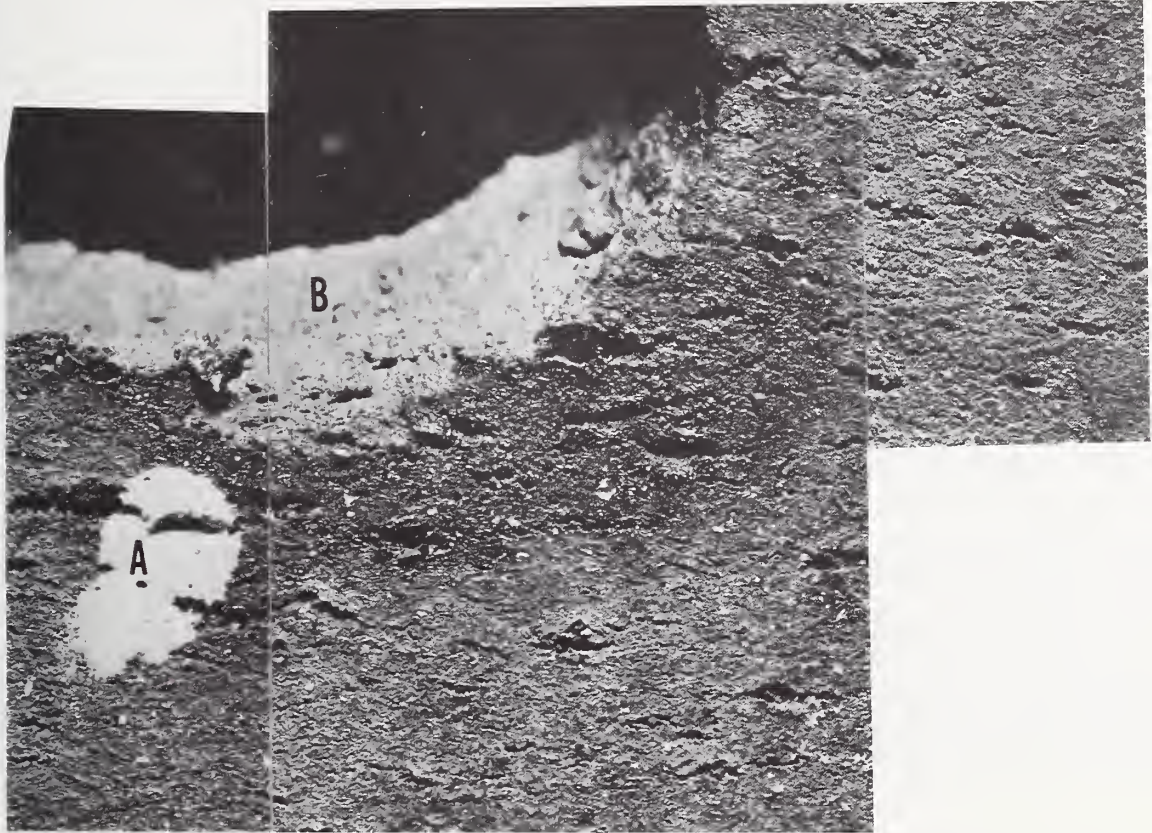
Figure 13. Macrograph of Inside Plate Surface of TC2-(1) at the Fracture Surface.

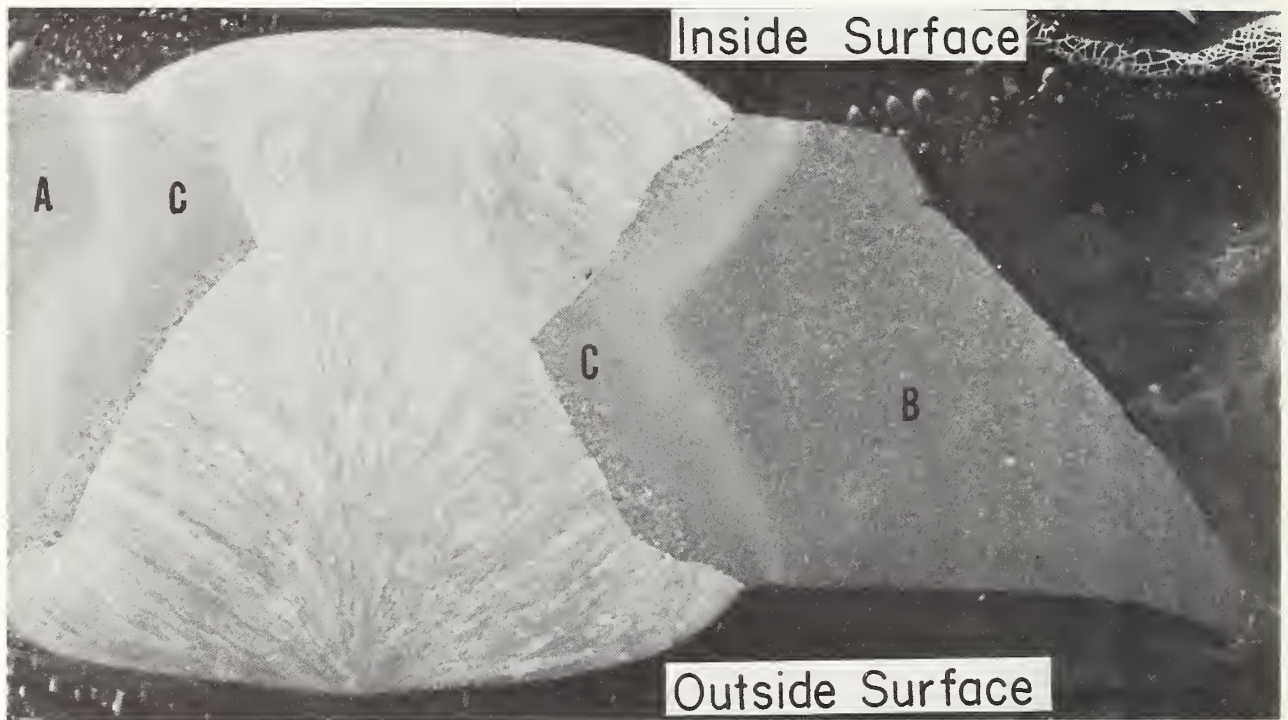
Photograph was taken near location 5 and shows numerous secondary surface cracks. A spot of white marking paint is shown at A and a portion of the fracture surface is shown at B. Mag. X 5

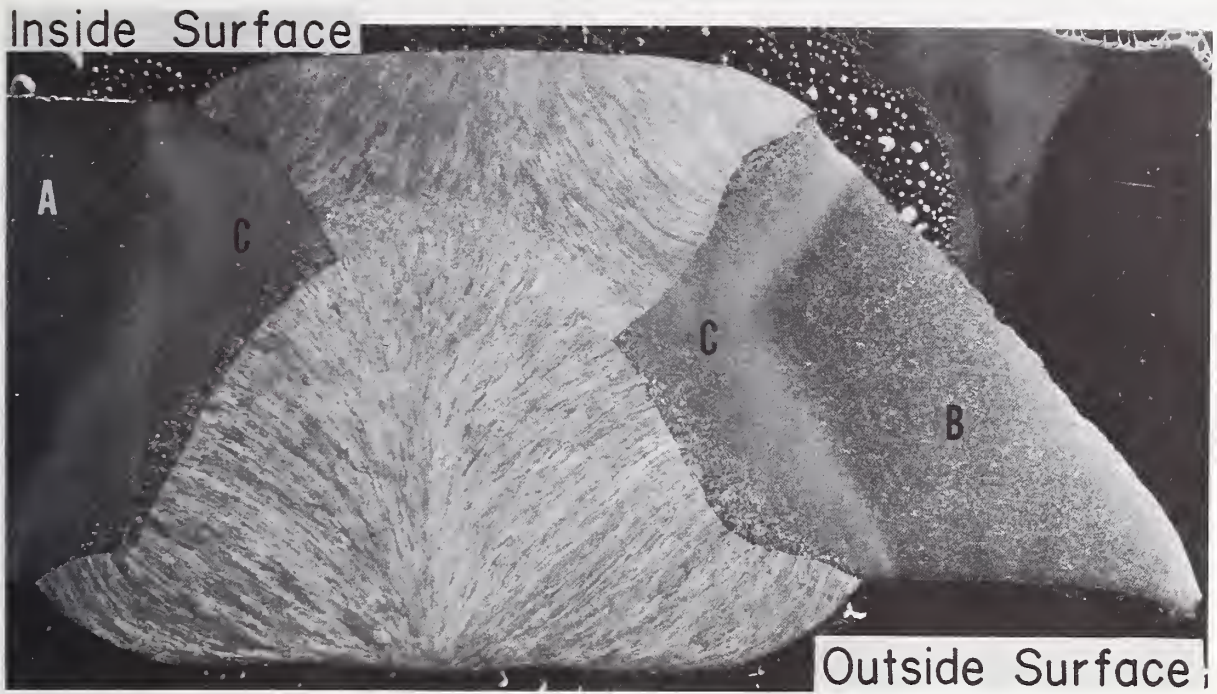
Etch: 5% Nital. Mag. X 4

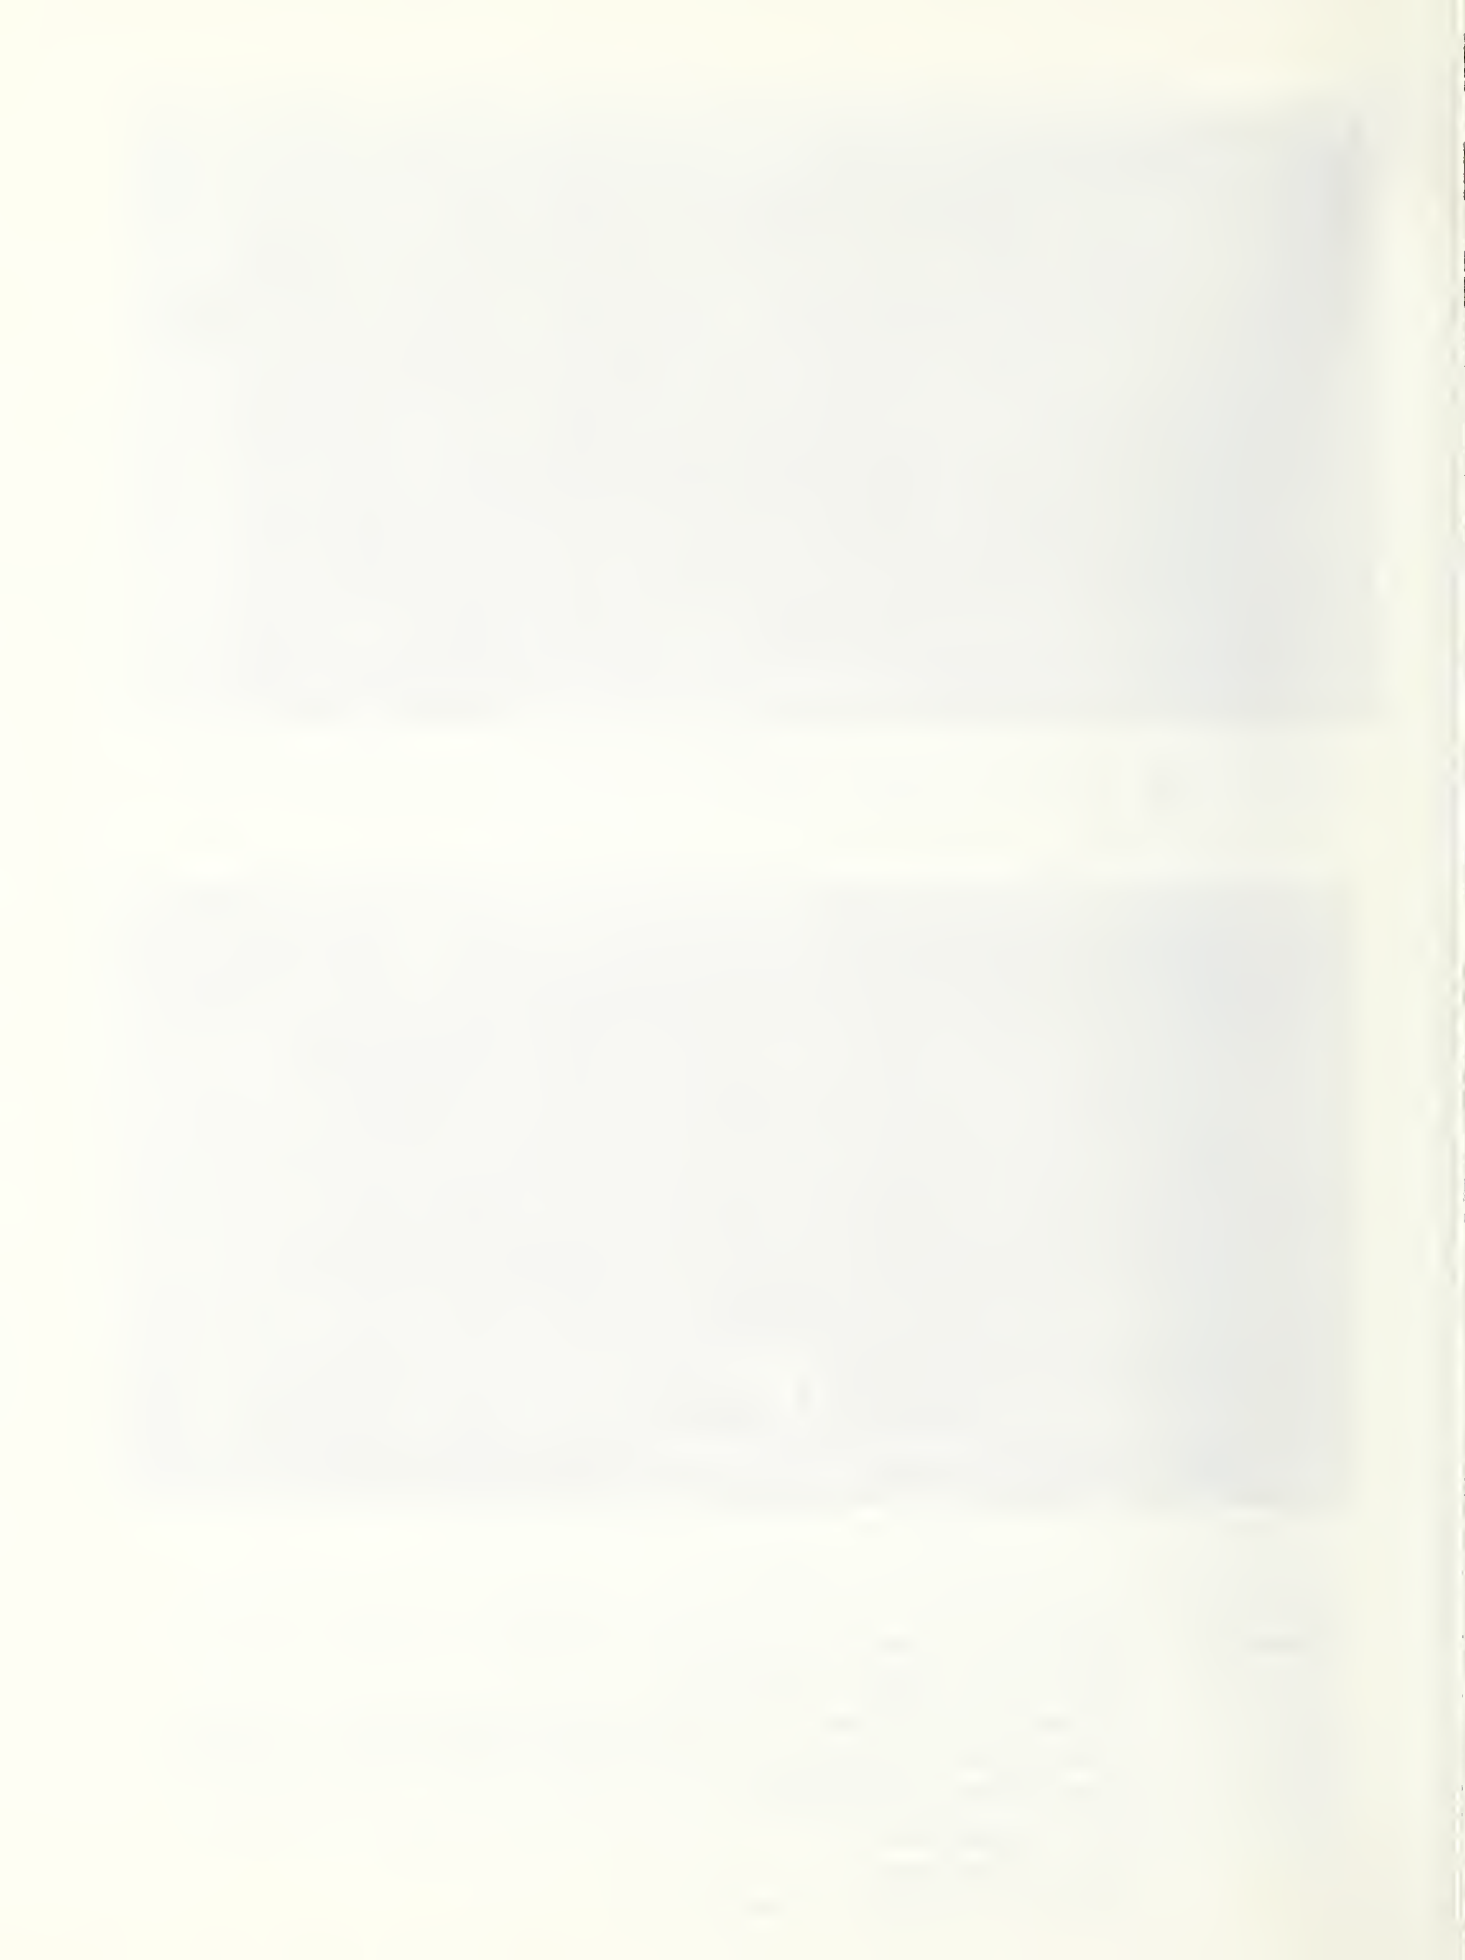
Figure 16. Representative Microstructures of Plate Sample TC2-(1) Away from Fracture Face. AAR TC128-B-69 Steel.
