NBSIR 75-657 (R)

# Report No. 7

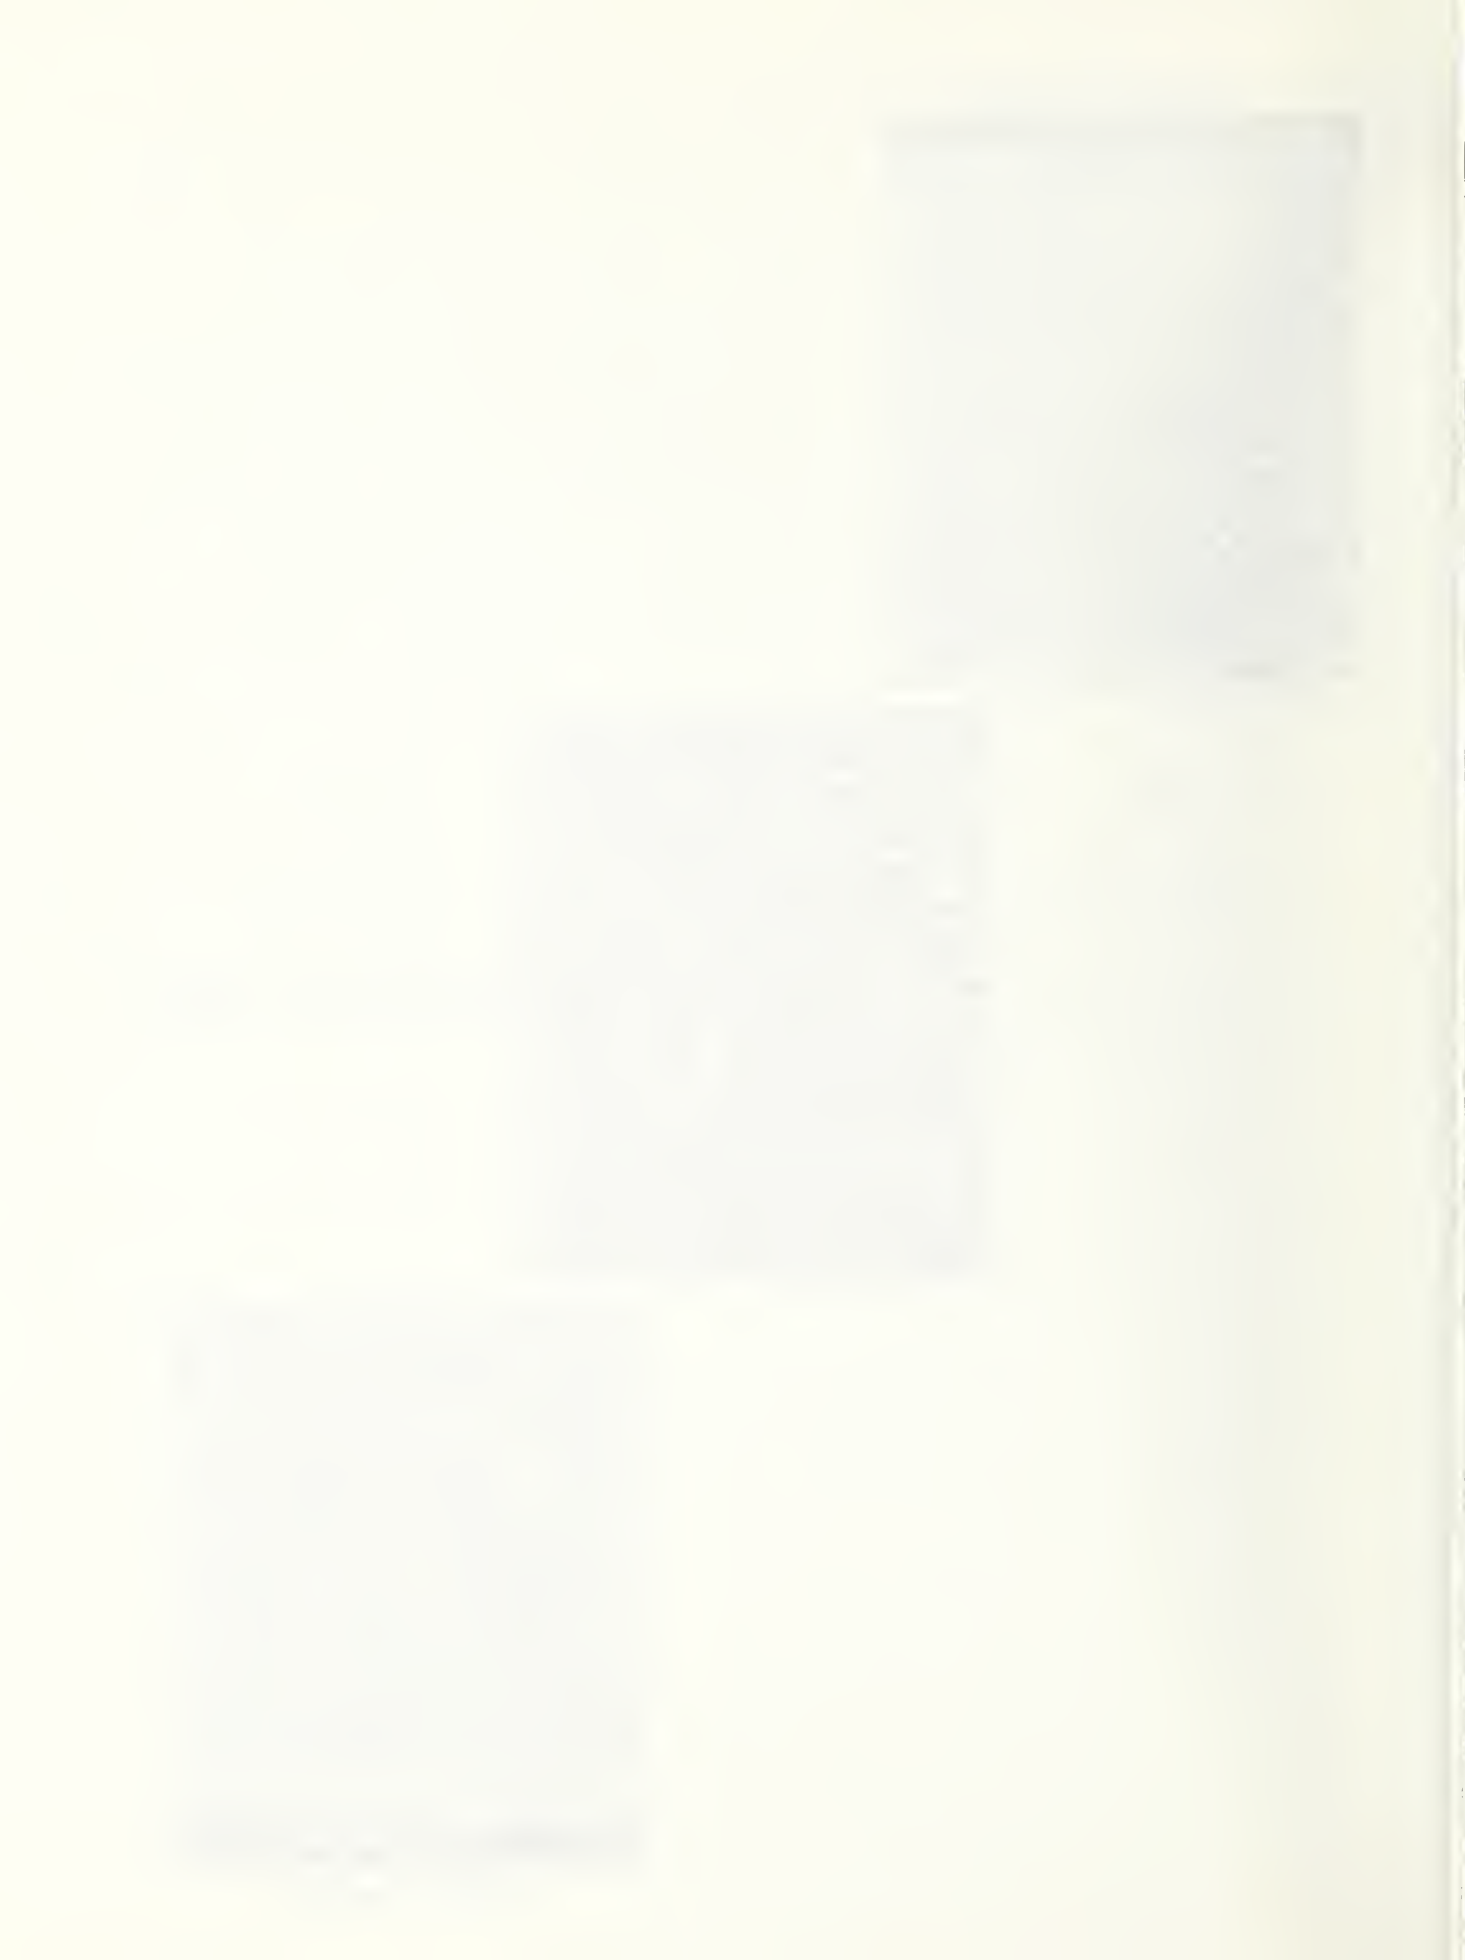
Figure 17. Representative Microstructures of Plate  
Sample TC2-(3). AAR TC128-B-69 steel.

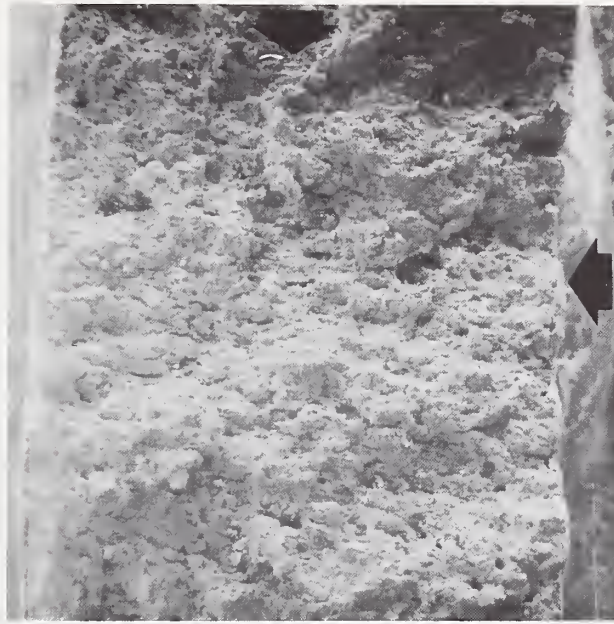
- a. Outside plate surface at the top of the photograph, near location 6. Mag. X 14
- b. Higher magnification photograph of the region indicated by the arrows in (a). Mag. X 190

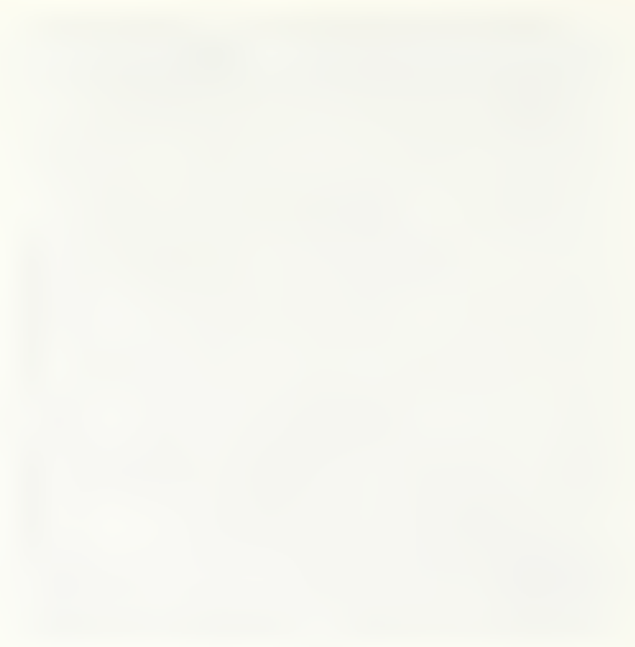
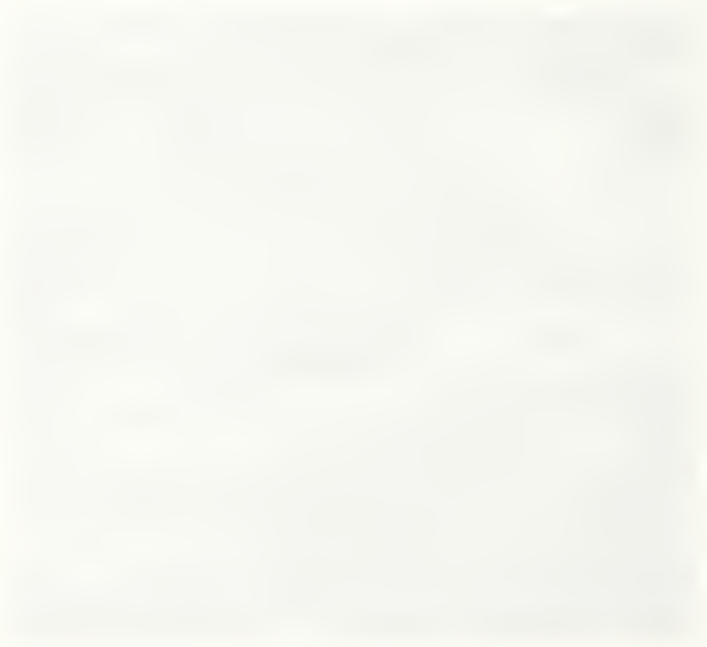
- a. Near location 6. Mag. X 13
- b. Higher magnification photograph of the region indicated by the arrows in (a). Mag. X 190

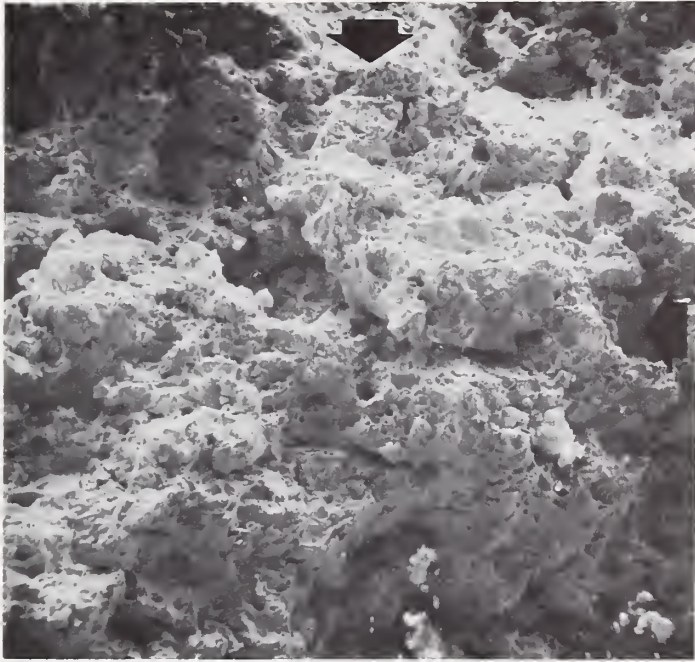
- a. Inside plate surface at the bottom of the photograph, near location 6. Mag. X 13
- b. Higher magnification photograph of the region indicated by arrows in (a). Mag. X 100
- c. Higher magnification photograph of the region indicated by arrows in (b). Mag. X 190

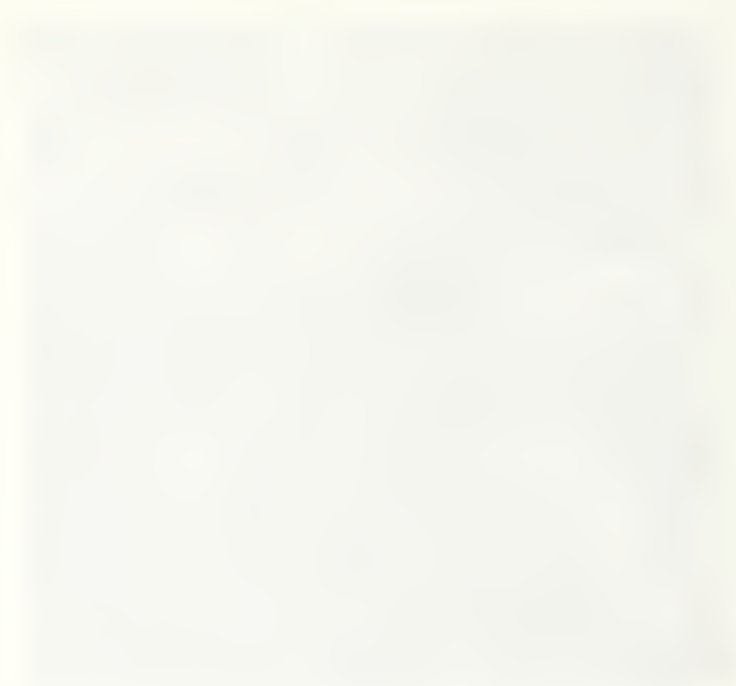
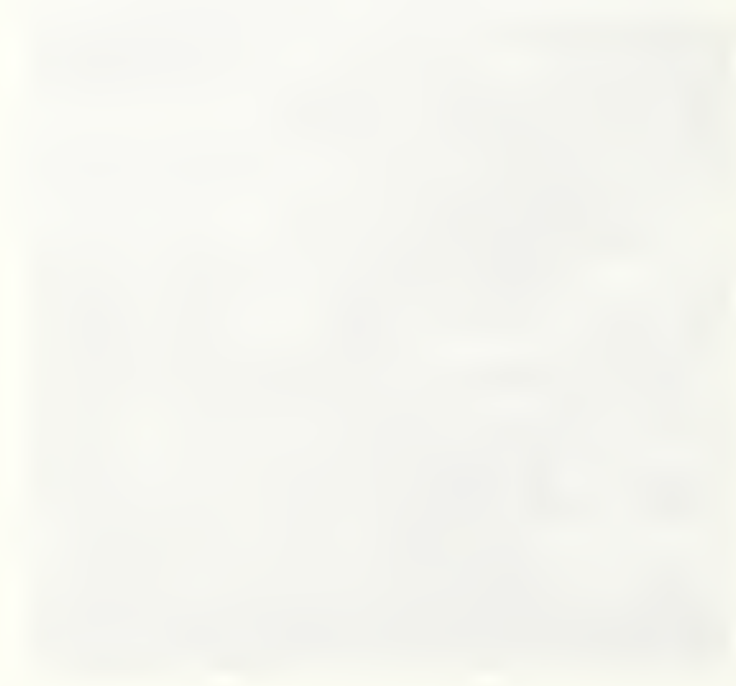
Figure 27. Representative Microstructures of Plate  
Sample TC2-(10B). AAR TC128-B-69 Steel.

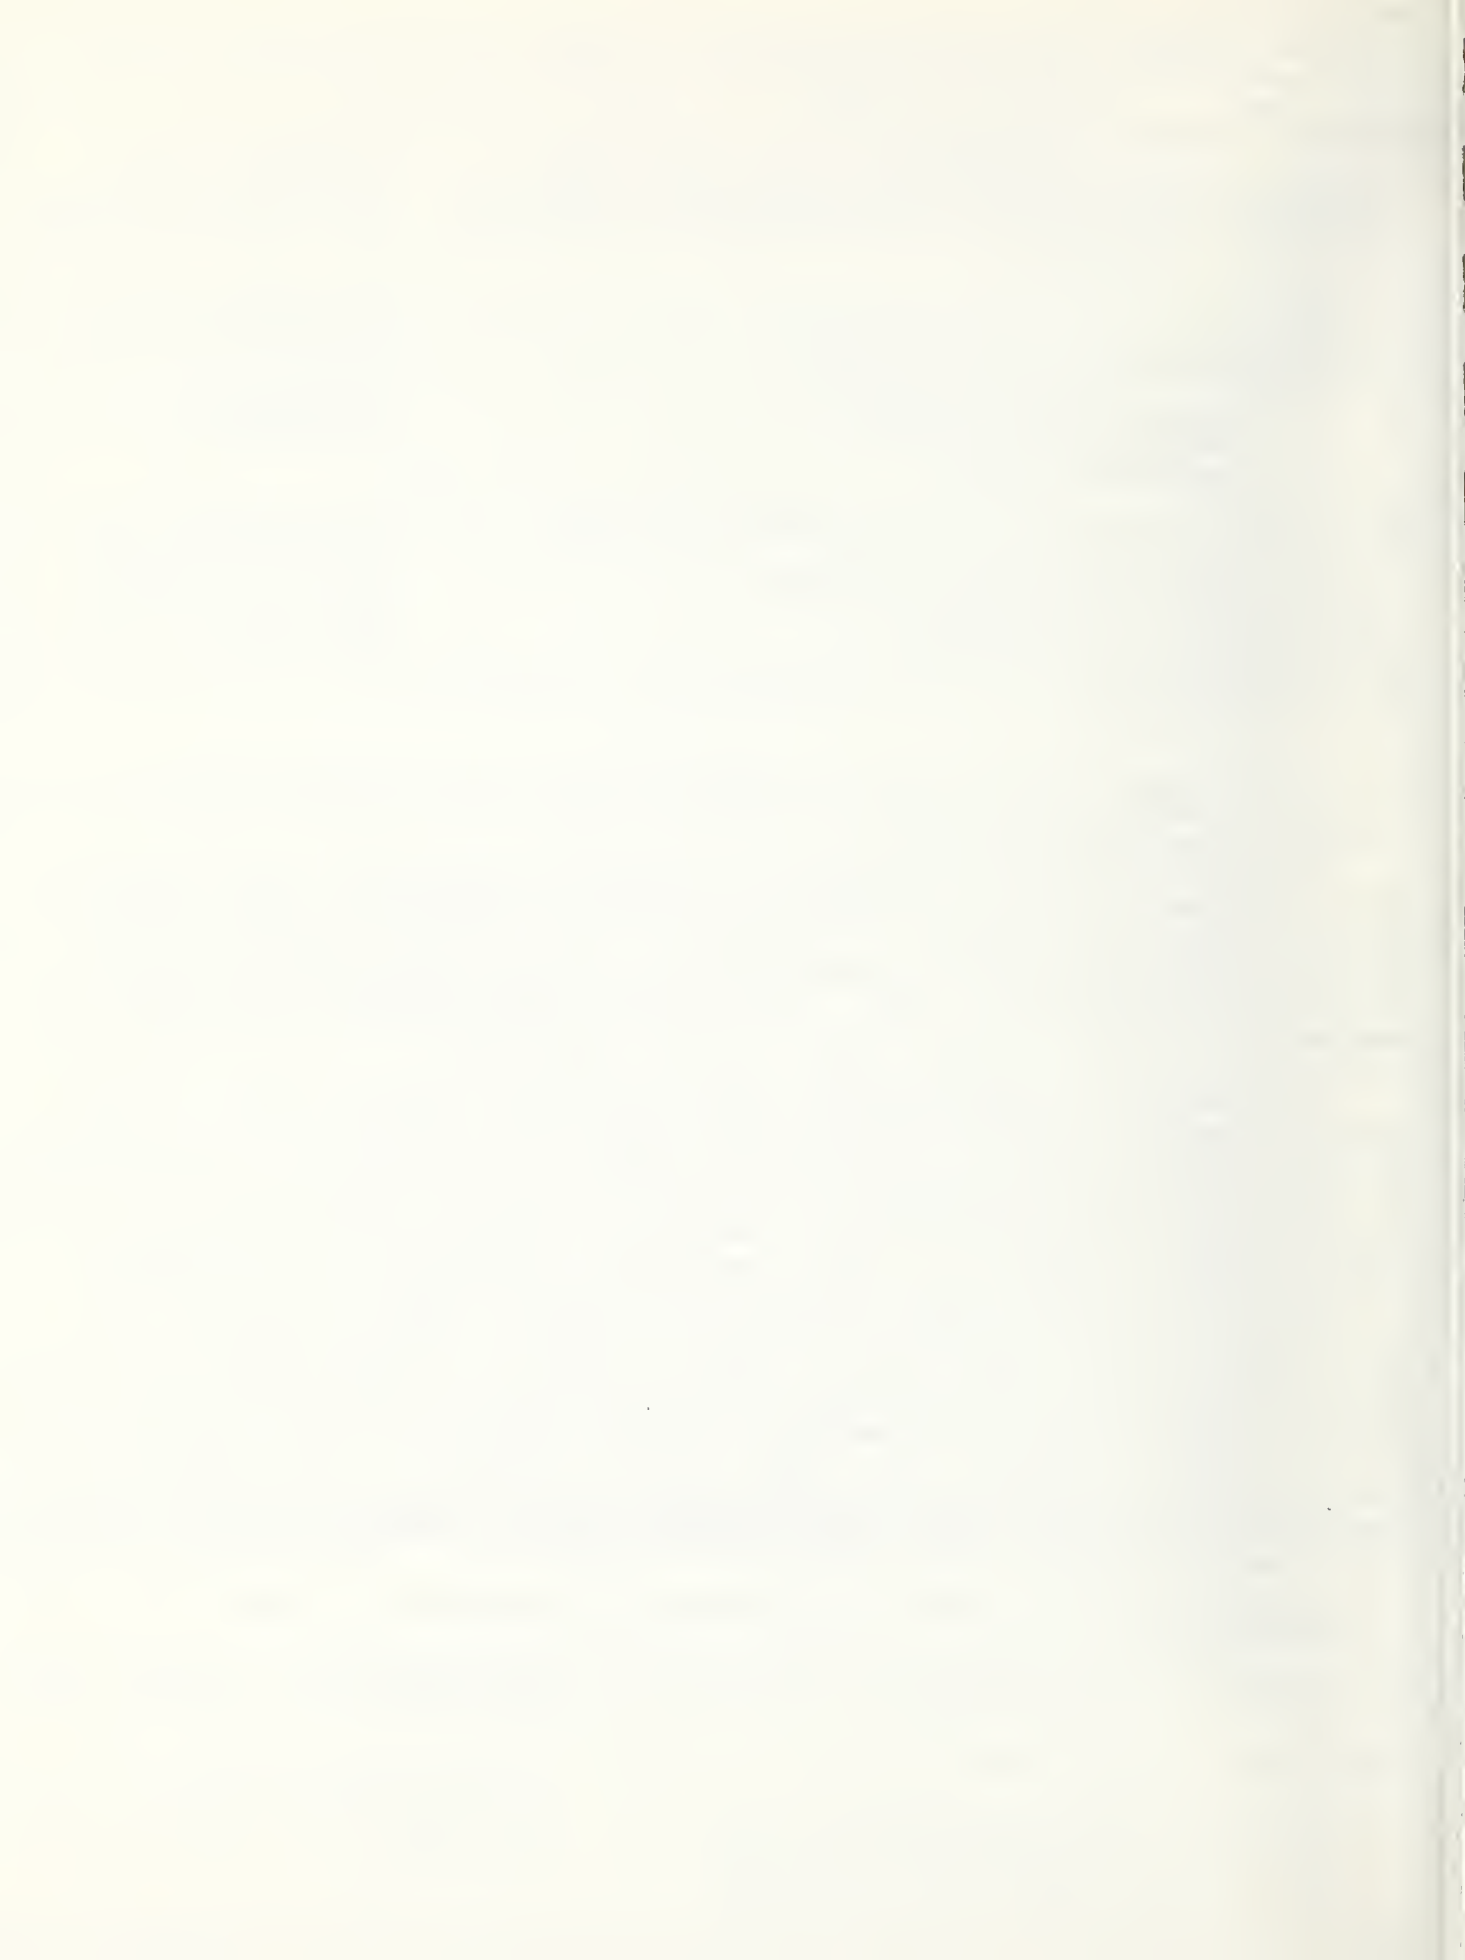
18. AVAILABILITY <input type="checkbox"/> Unlimited  <b>XX</b> For Official Distribution. Do Not Release to NTIS  <input type="checkbox"/> Order From Sup. of Doc., U.S. Government Printing Office Washington, D.C. 20402, <u>SD Cat. No. C13</u>  <input type="checkbox"/> Order From National Technical Information Service (NTIS) Springfield, Virginia 22151		19. SECURITY CLASS (THIS REPORT)  UNCLASSIFIED  20. SECURITY CLASS (THIS PAGE)  UNCLASSIFIED	21. NO. OF PAGES  63  22. Price
