NBSIR 75-686 (R)

Examination of Failed Pylon Components

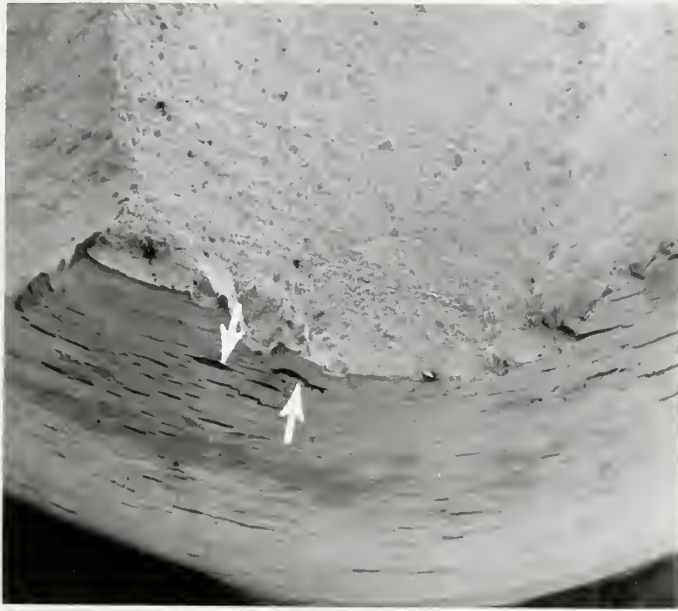
Figure 5. Scanning electron photomicrograph of bolt appearing in figure 4b. Several secondary cracks (arrows) appear in the shank surface, which is in the lower portion of the figure. Part of the fracture surface is shown in the upper portion of the figure. X 19

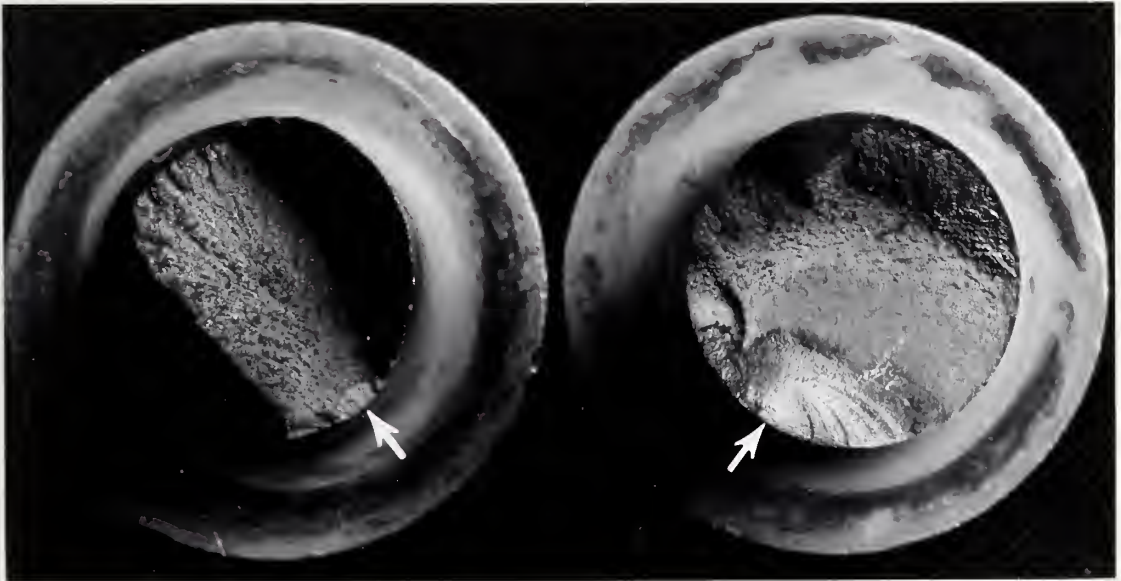
Figure 6. Fracture surfaces of the bolts shown in figure 4. The fracture surface on the left corresponds to the bolt shown in figure 4a. Arrows indicate the approximate locations of the crack origins. X 4

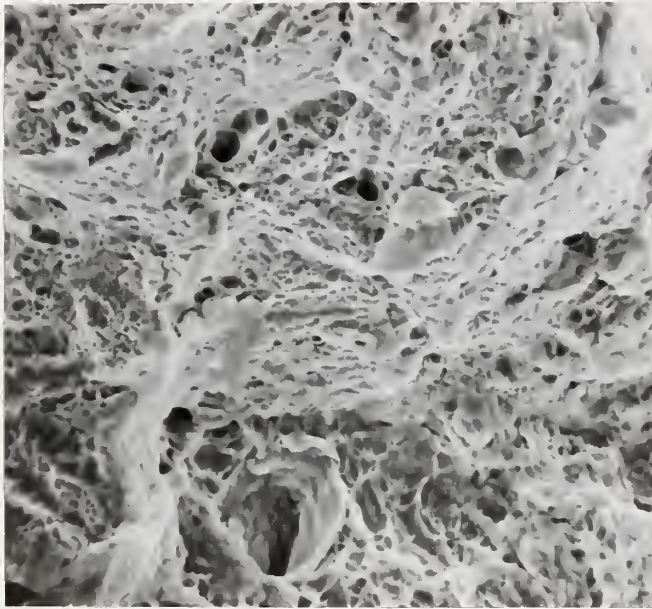
Figure 8. Scanning electron fractograph from the overload portion of the fracture of the bolt shown in figure 4b. The primary fracture mode is dimpled rupture. X 2000

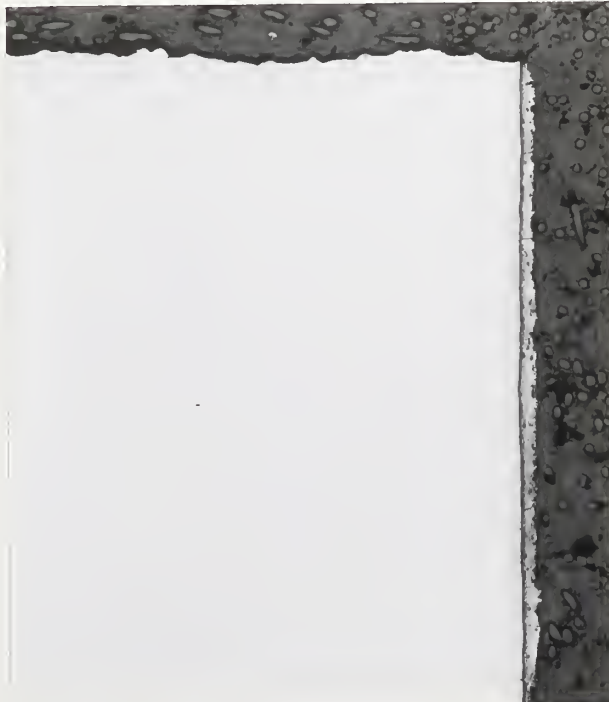
Figure 9. As-polished longitudinal section from the bolt shown in figure 4b. The fracture profile in the fatigue portion of the fracture is horizontal at the top. The cadmium plating can be seen along the surface of the bolt shank vertically at the right. X 100

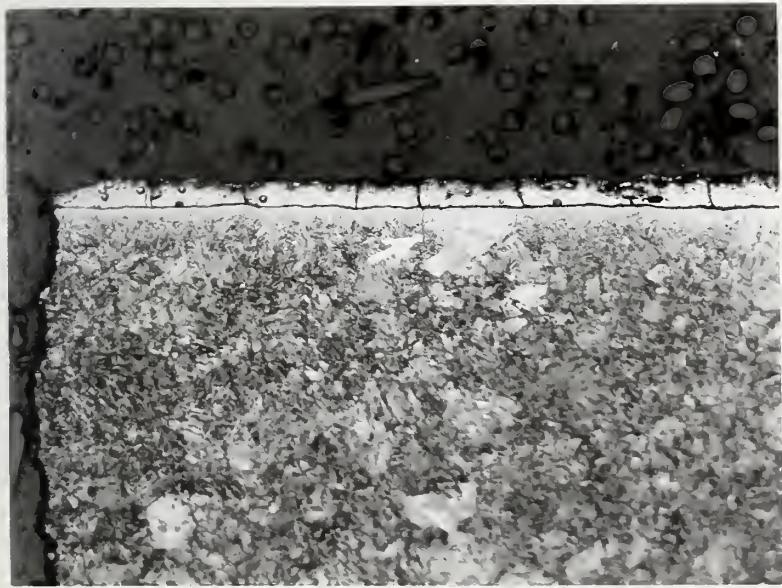
Figure 10. Part of the area shown in figure 9. The microstructure consists primarily of tempered martensite. The crack in the steel (arrow) is thought not to be associated with the crack in the cadmium plating. Several other cracks can be seen in the plating.
Etchant: 4% picral X 200

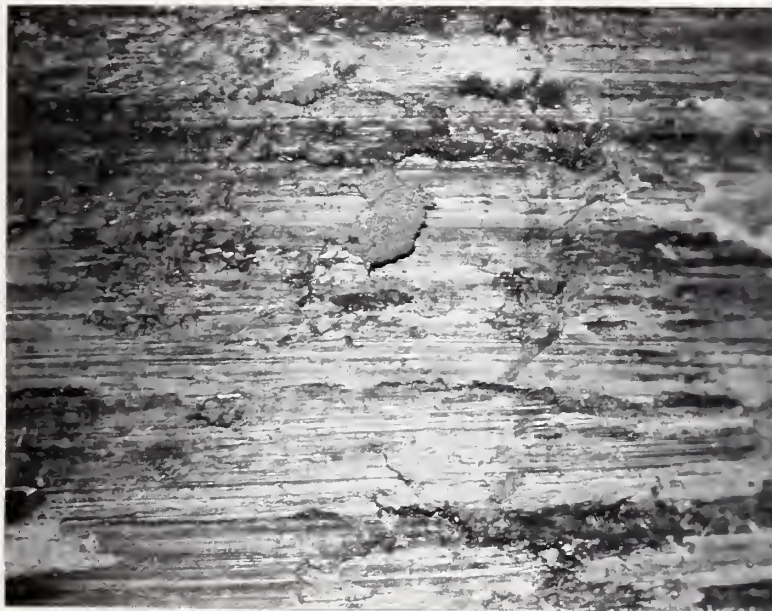
Figure 13. Part of the shank of one of the unbroken bolts from the LQ-2 group showing the mechanical damage and an area where the cadmium plating is missing. X 16

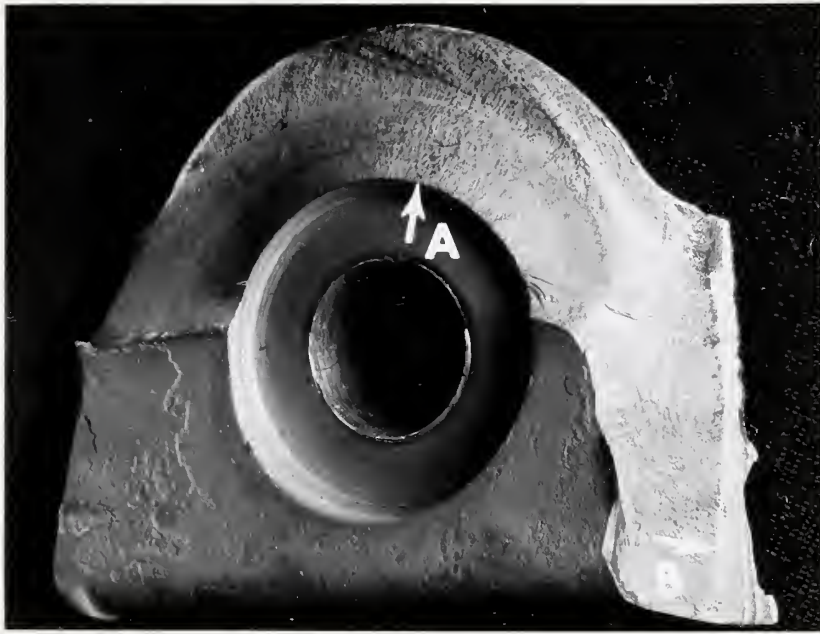
Figure 14. Separated piece from the aft spar subassembly lug from pylon no. 3 showing the fracture surface. Arrow A indicates the approximate location of the crack origin. Arrow B indicates a secondary fatigue crack. X 2

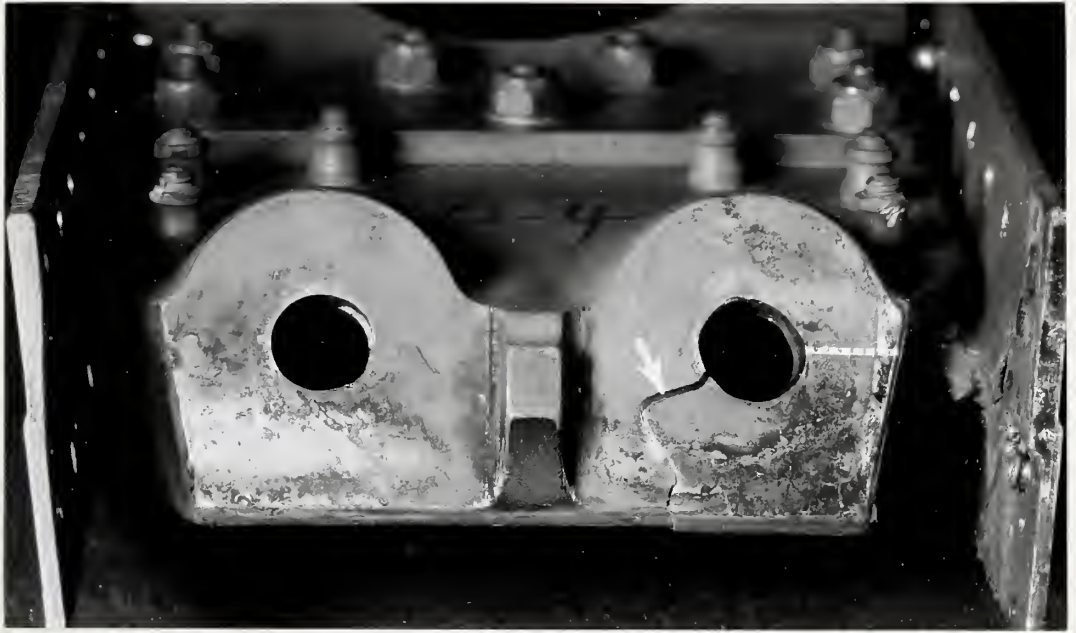
Figure 16. Forward spar subassembly lug from pylon no. 4. Arrow indicates crack. A saw-cut was made at the approximate location of the dotted line in order to expose the fracture surface. X 1

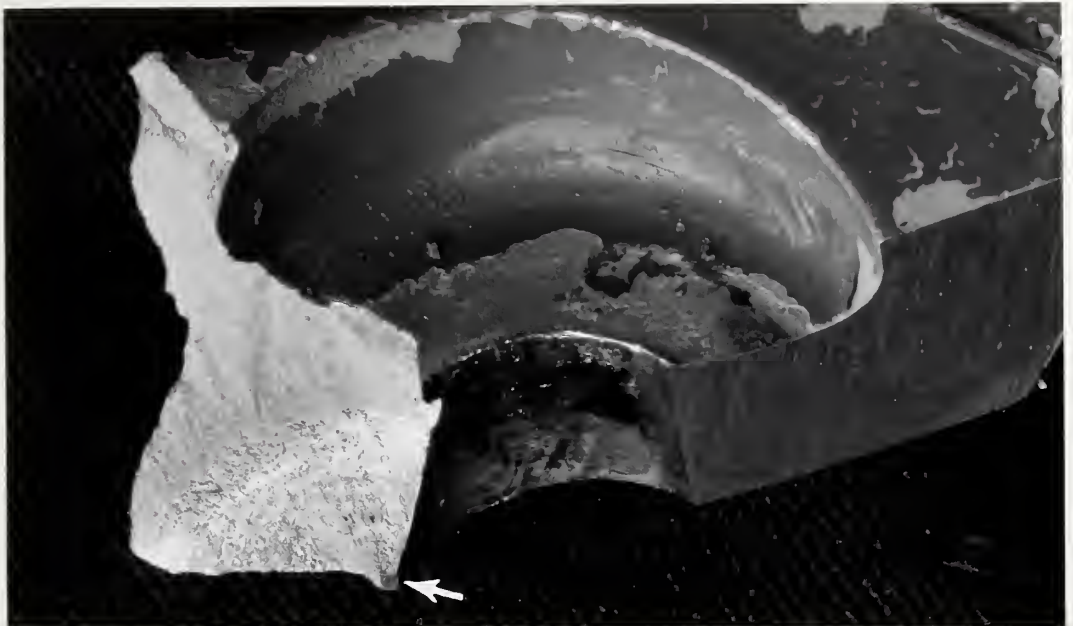
Figure 17. Part of the lug shown in figure 16 after being cut out. The fracture surface is at the left. The arrow indicates the approximate location of the point of crack initiation. X 4

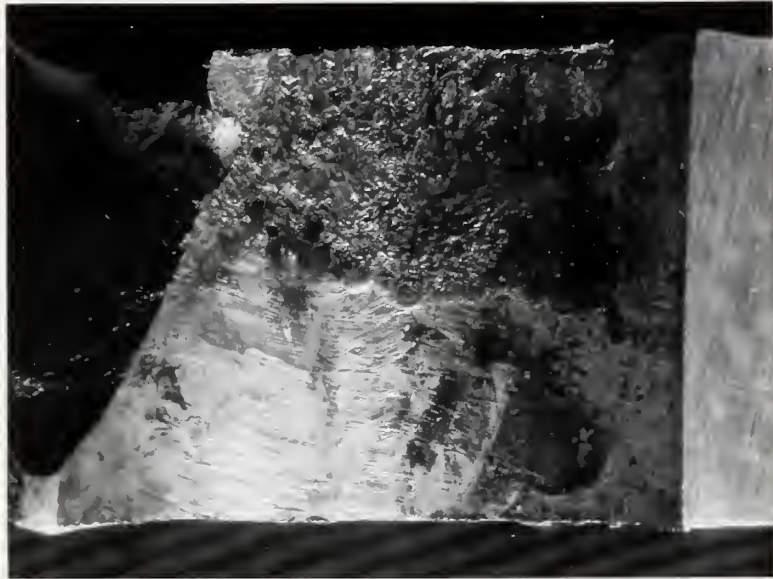
Figure 18. The bolt hole surface of the part of the lug shown in figure 17 is in the center of the photograph. The fretted and mechanically damaged surface can be seen. Part of the fracture surface is at the far left. A saw-cut surface is at the right. X 8

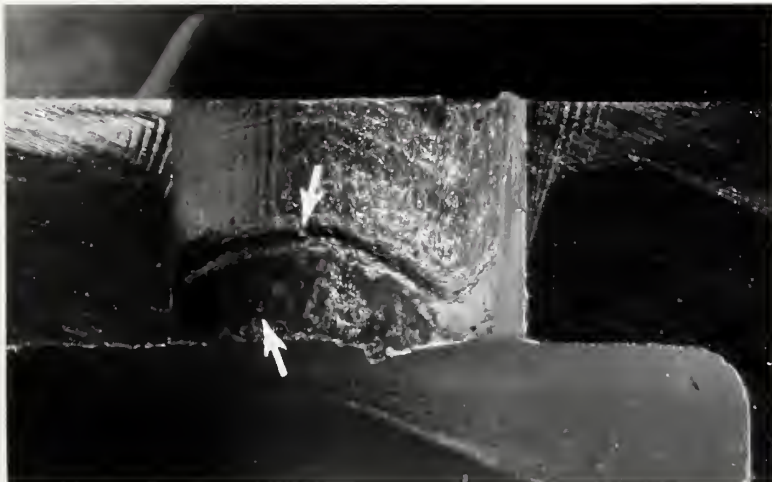
Figure 19. Part of the surface of the other bolt hole from the forward lug from pylon no. 4. This is the left bolt hole in figure 16. The damaged surface can be seen. Arrows indicate two apparent cracks. X 4

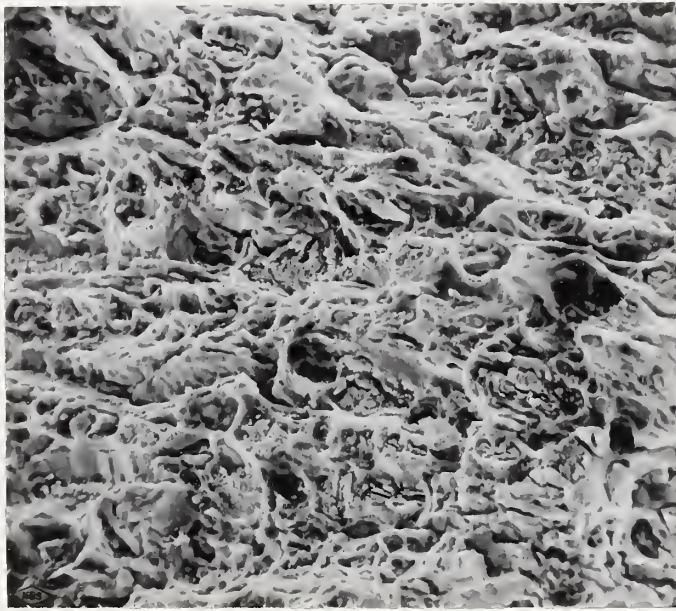
Figure 22. Scanning electron fractograph from the overload portion of the fracture through the forward spar subassembly lug from pylon no. 4. X 440

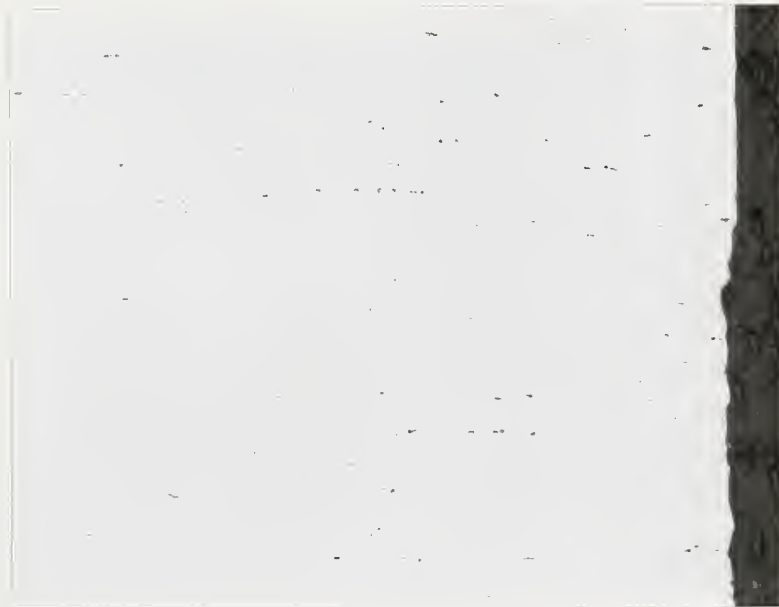
Figure 23. An as-polished section through the aft spar subassembly lug from pylon no. 3 intersecting the fatigue portion of the fracture. The fracture profile is vertical at the right. Second phase particles and inclusions can be seen. X 100

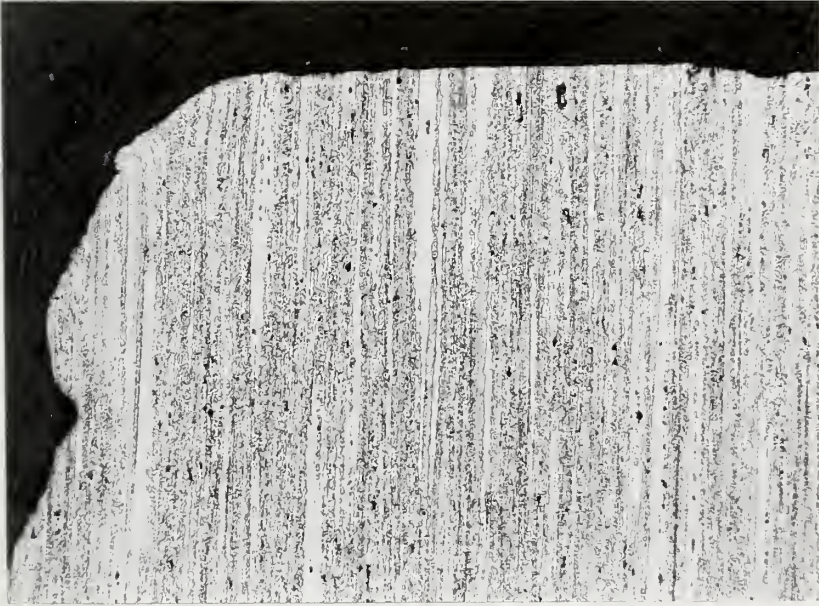
Figure 24. Etched section through the aft spar subassembly lug from pylon no. 3 showing the fatigue portion of the fracture. The fracture profile is vertical at the right.
Etchant: 10% NaOH X 100

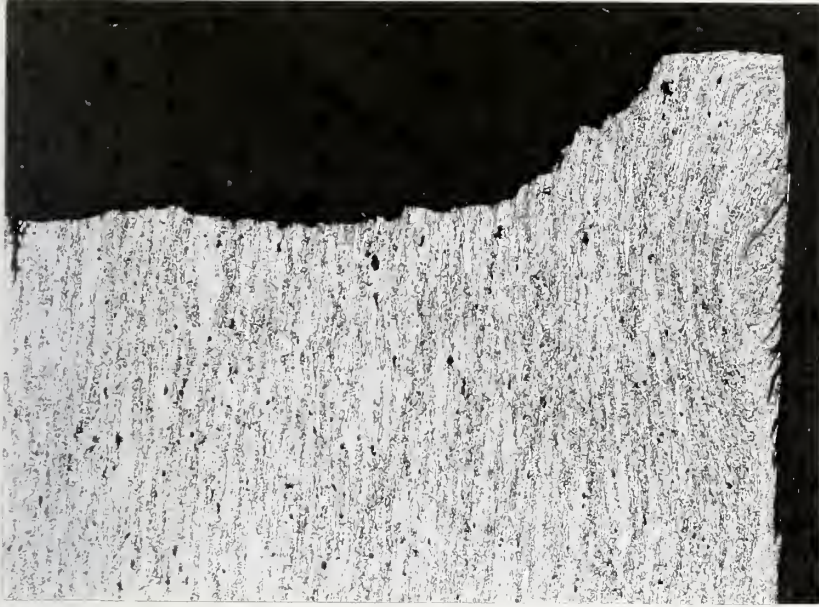
Figure 25. Etched section through the aft spar subassembly lug from pylon no. 3 showing the fracture profile in the overload portion of the fracture. The fracture profile is vertical at the right.
Etchant: 10% NaOH X 100

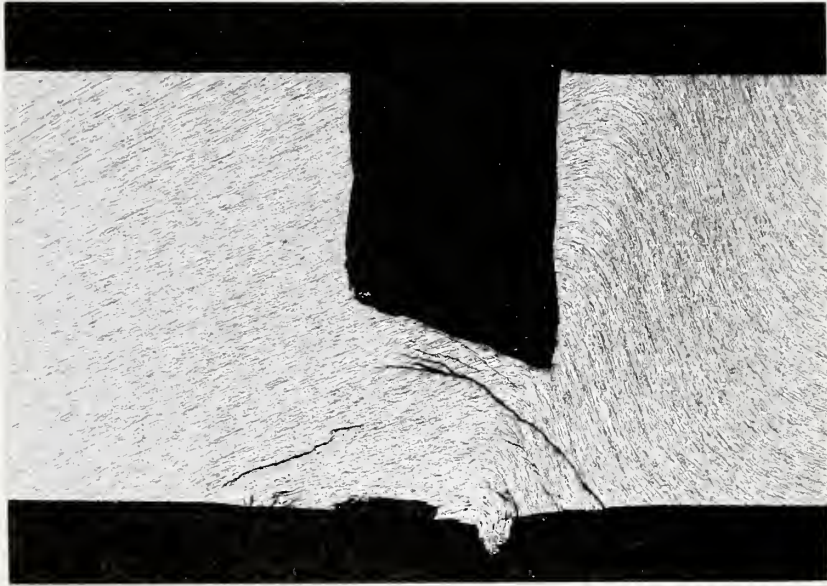
Figure 26. Etched section through the intact hole in the forward spar subassembly lug from pylon no. 4 revealing several cracks.
Etchant: 10% NaOH
