# Investigation of a 1-Ton Tank-Car Tank That Leaked Phosgene in Easton, Pennsylvania on April 24, 1973

C. G. Interrante

Failure Analysis Report

Prepared for  
**Federal Railroad Administration**  
**Department of Transportation**  
Washington, D. C. 20590

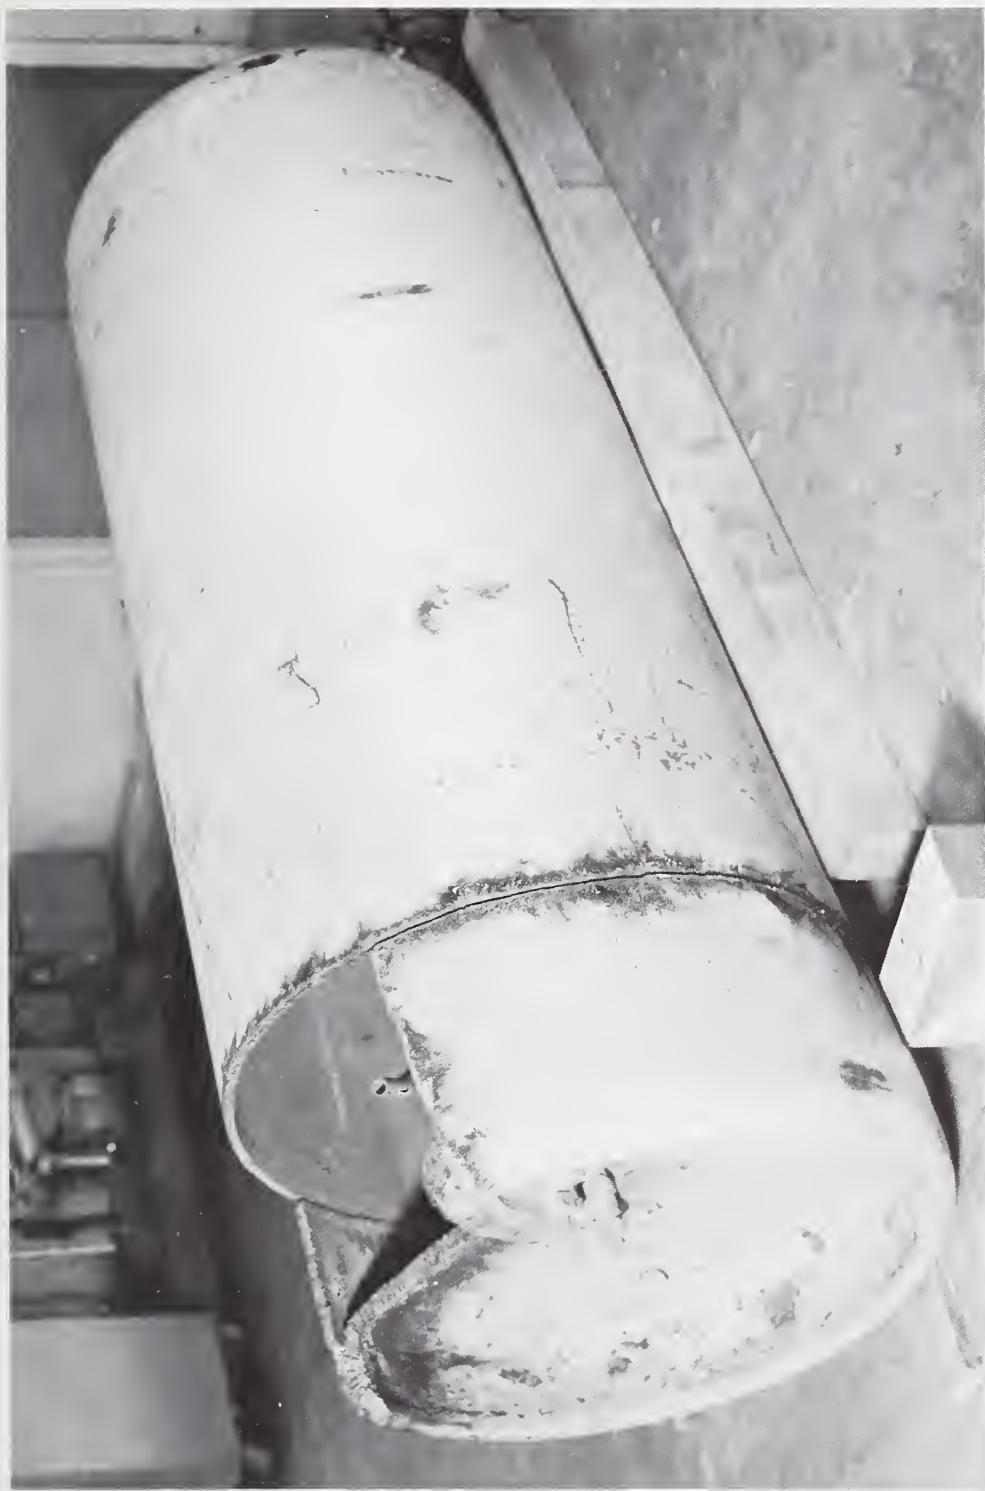
Figure 1. The tank after flame cutting to remove the end that leaked and the section that contained the leak.

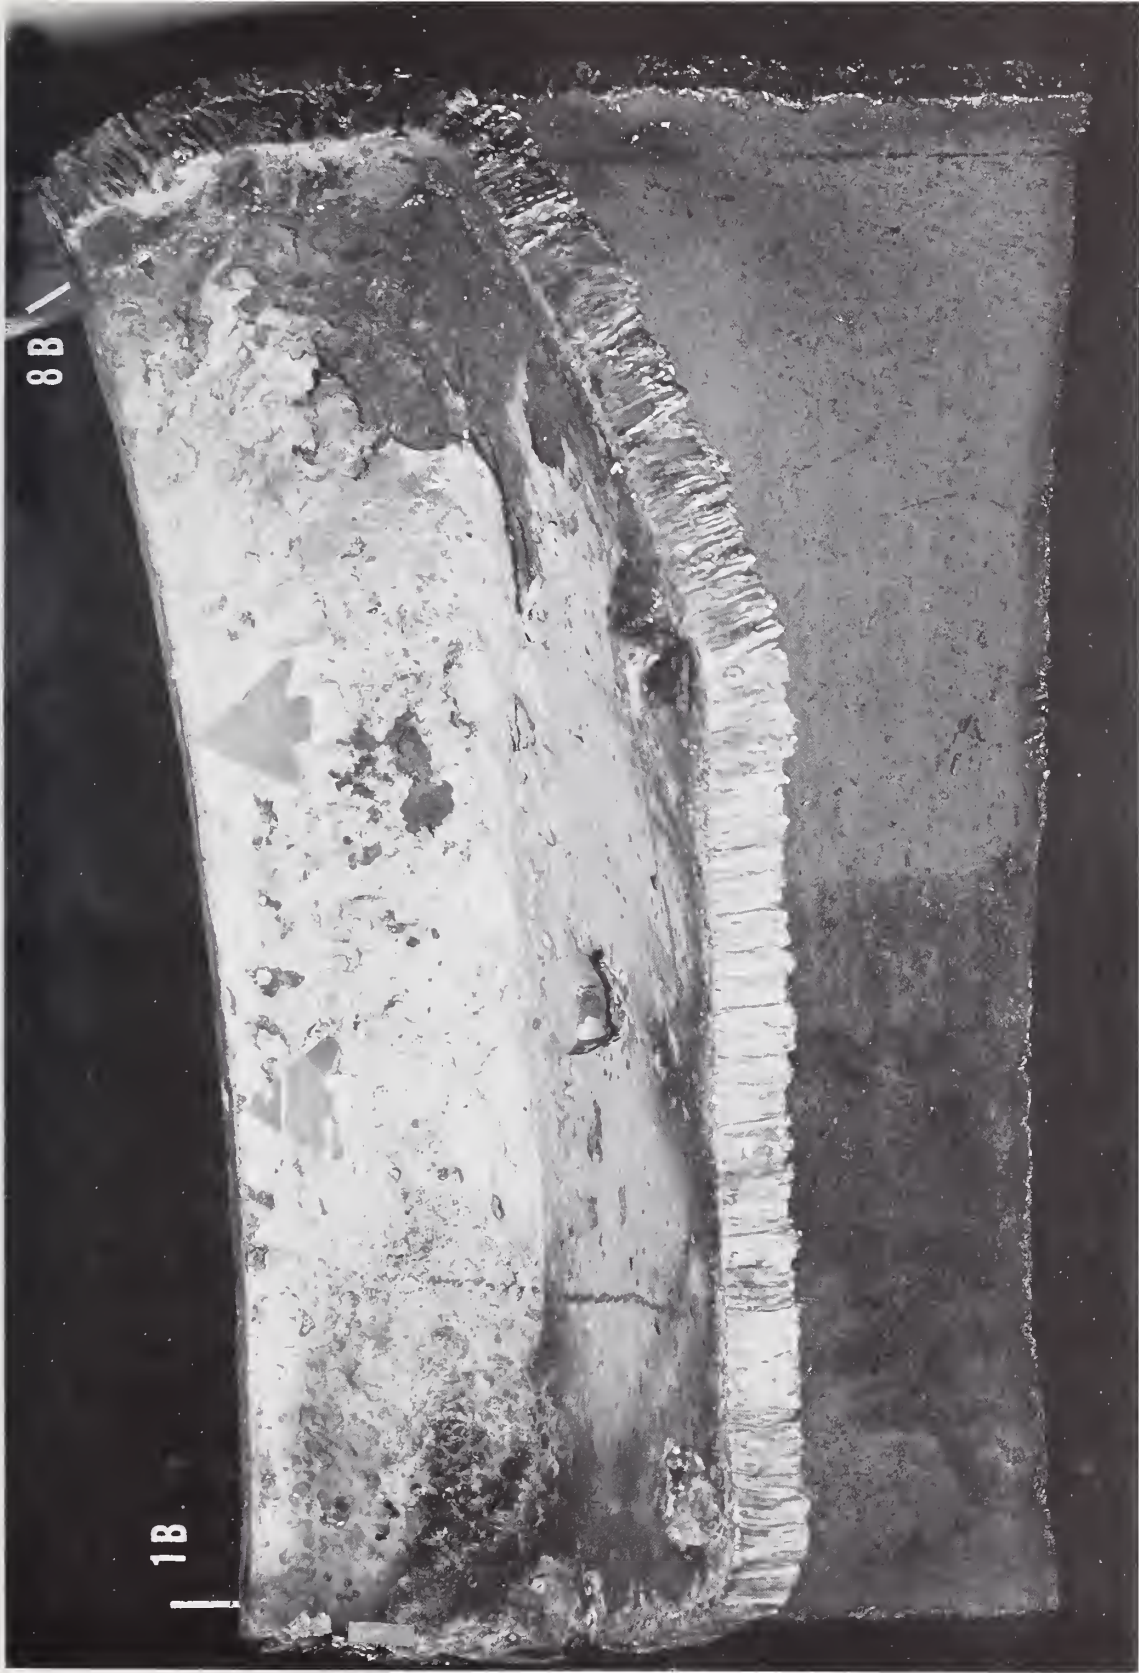
Figure 2. The section that contained the leak, as flame-cut from the tank. The leak occurred on the end of the tank between the two arrows.

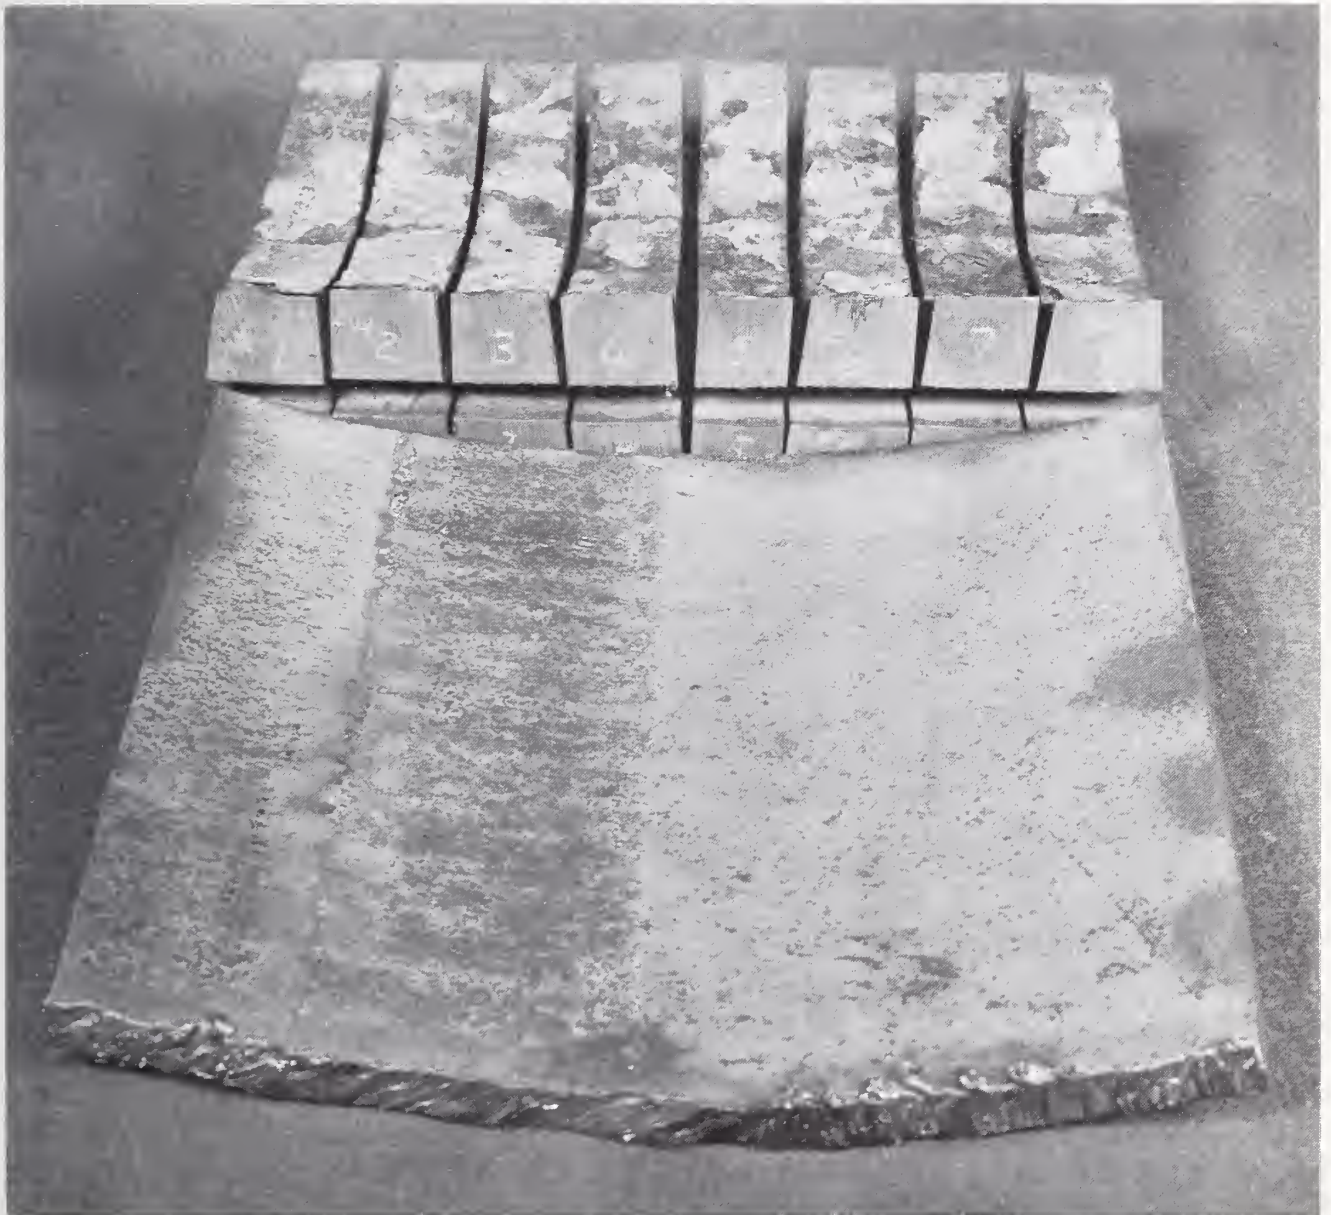
Midway between segments 4 and 5 inside the tank, a corrosion line was observed. This line can be seen in Figure 3 on the plate in front of these segments, and it can be seen in Figure 6, which shows the inside of the

Figure 3. Eight 1-inch segments as saw-cut from the section that contained the leak. Part of the shell plate that adjoined these segments is also shown.

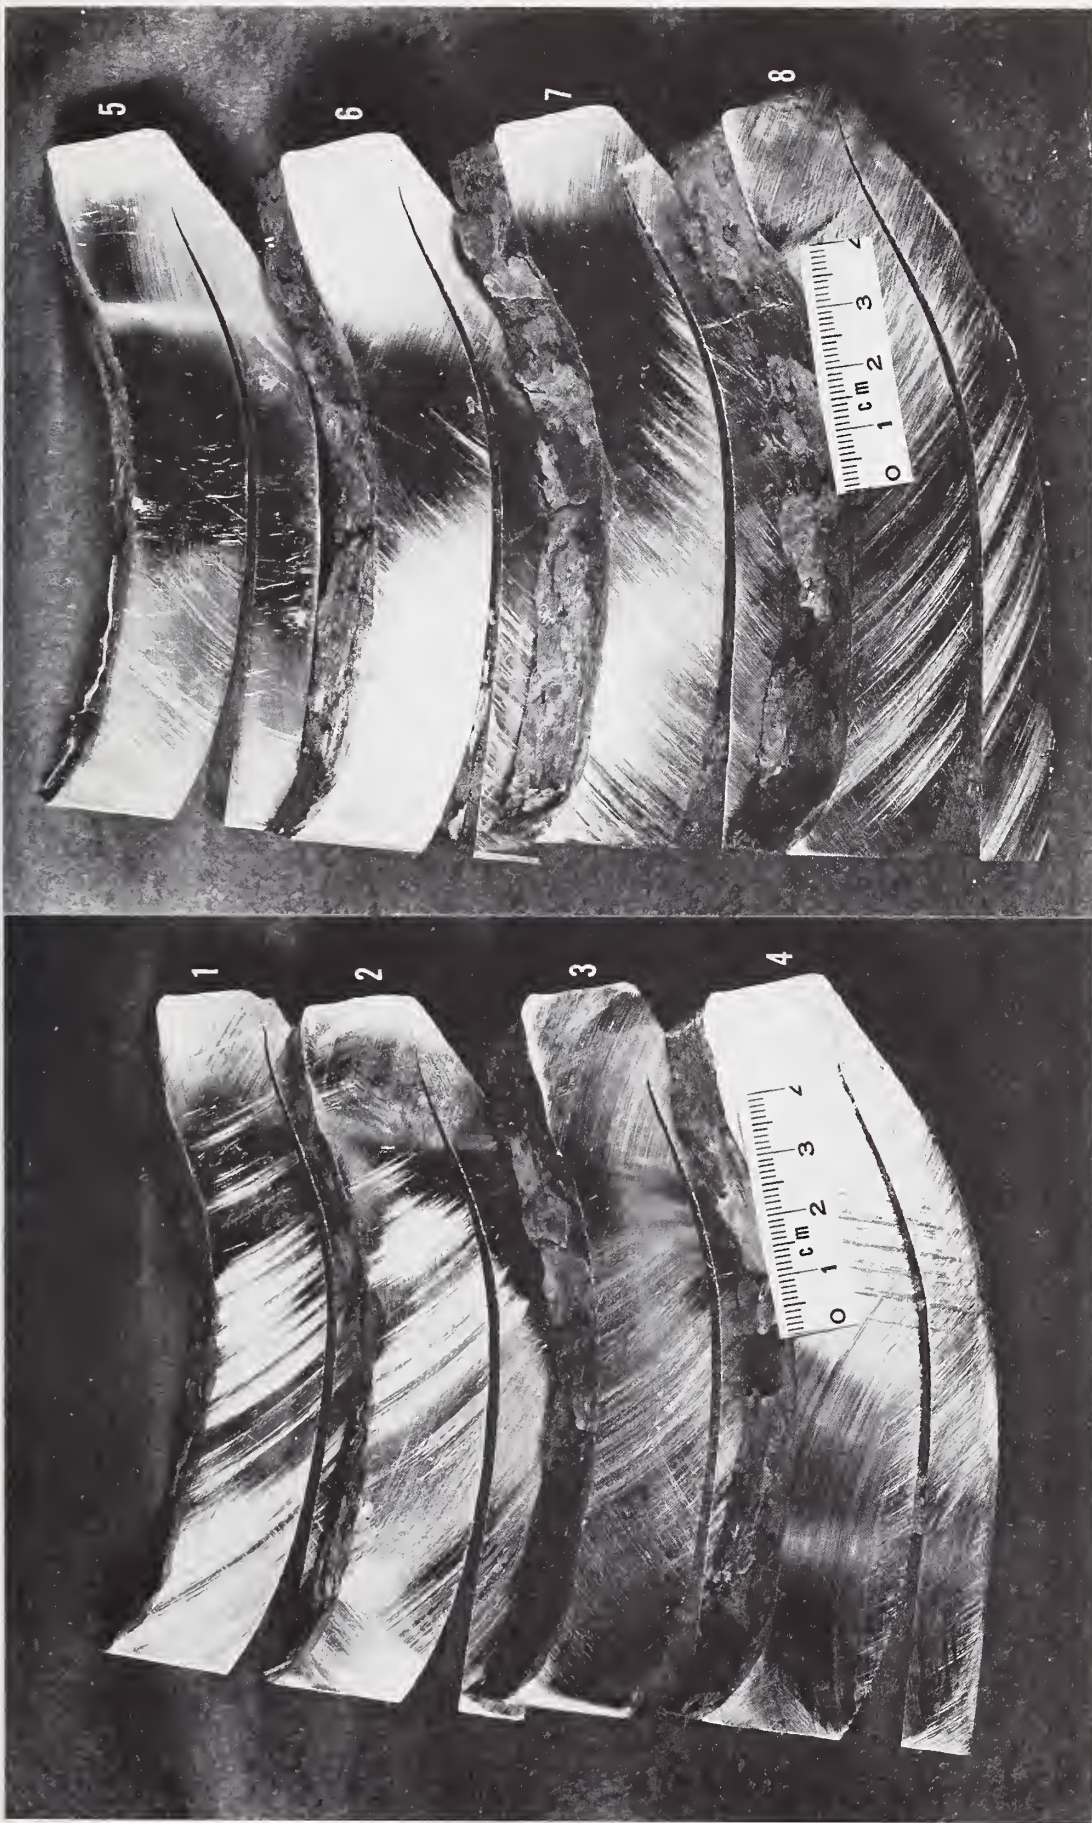
Both the rough-ground segments of Figure 4 and the polished segments of Figure 5 show that the bonded region extends for less than 0.4 inches (1.0 cm), in segments numbered 1 through 7, and for about 0.6 inches (1.5 cm), in segment number 8. The shortness of these lengths of the bond line are somewhat surprising, especially for segments 2, 4, and 5 which have bond line lengths of less than 0.2 inches (0.5 cm).

Figure 4. Eight 1-inch segments in the rough-ground condition.

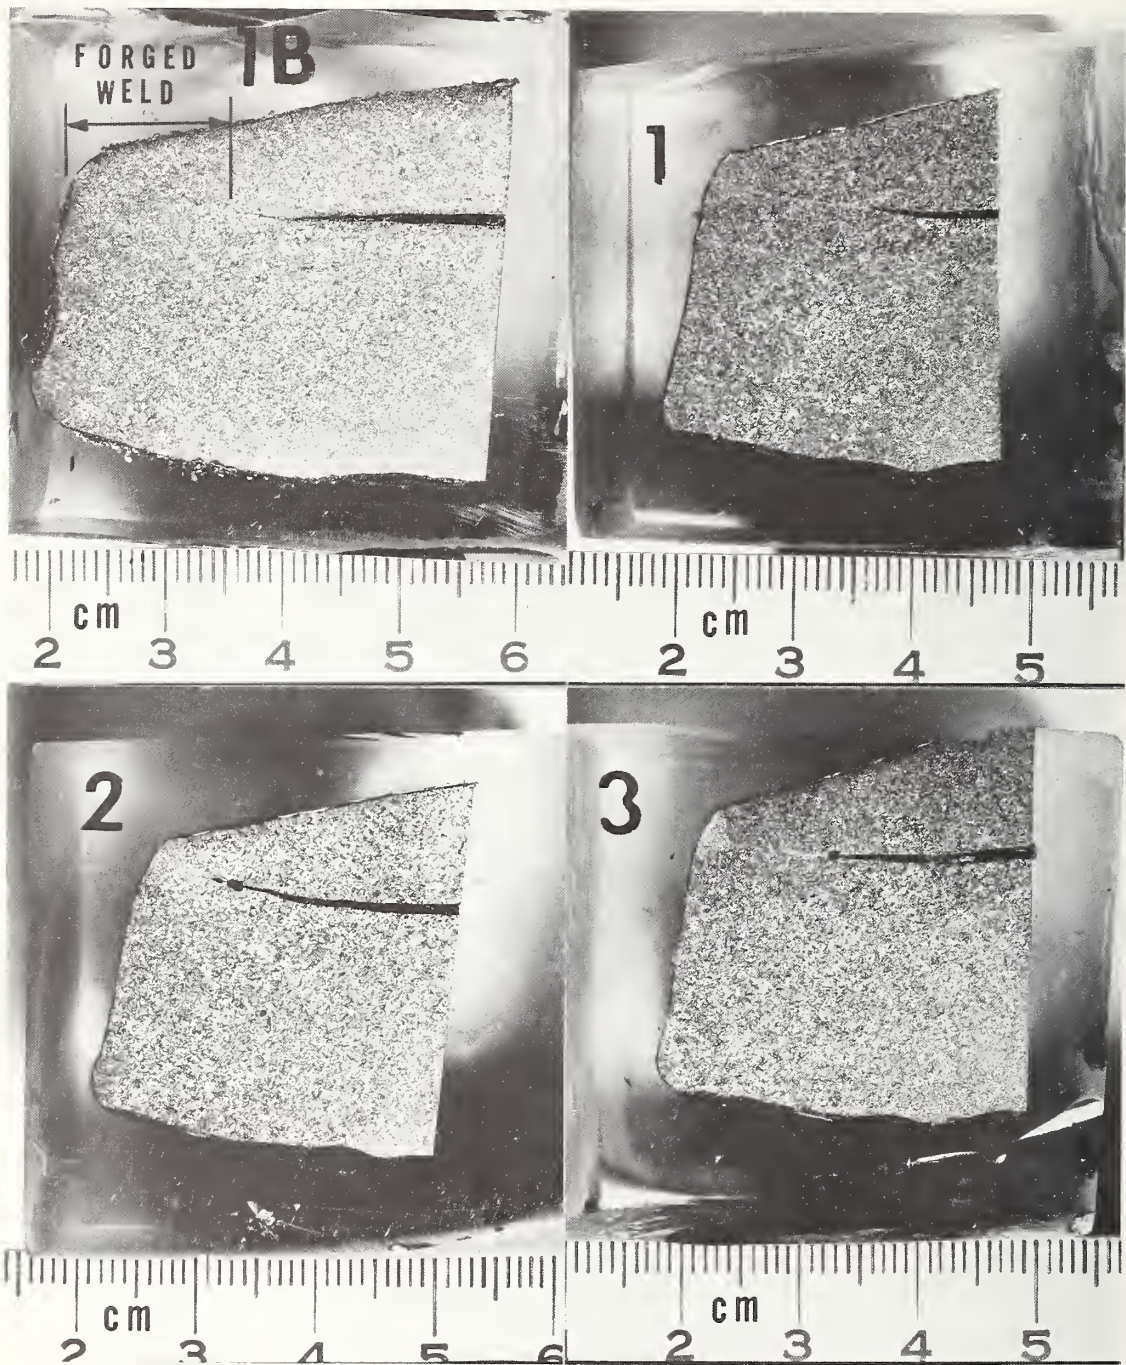
In the polished and etched condition (Figure 5), segments numbered 2, 4, and 5 were observed to have no fusion from lap welding, i.e. no forged weld region. The bonded metal shown here for these three segments is that of a tac weld at the end of the vessel. The other segments examined had at least some small length of forged weld metal along their bond lines. Segments 1B and 8B were taken from the ends of the original flame-cut section at distances somewhat remote from the leak, as marked on the photograph of Figure 2. In Figure 5, the polished and etched faces of these two segments clearly show forged weld metal in lengths of 1.3 inches (3.3 cm) for 8B and 0.6 inches (1.5 cm) for 1B. Segment 8B is more distant from the tac weld than any of the other segments examined, and 8B has the longest forged weld region.

Figure 5. Eight 1-inch segments from near the leak and two end segments taken from the section that contained the leak, in the cropped, polished, and etched condition.

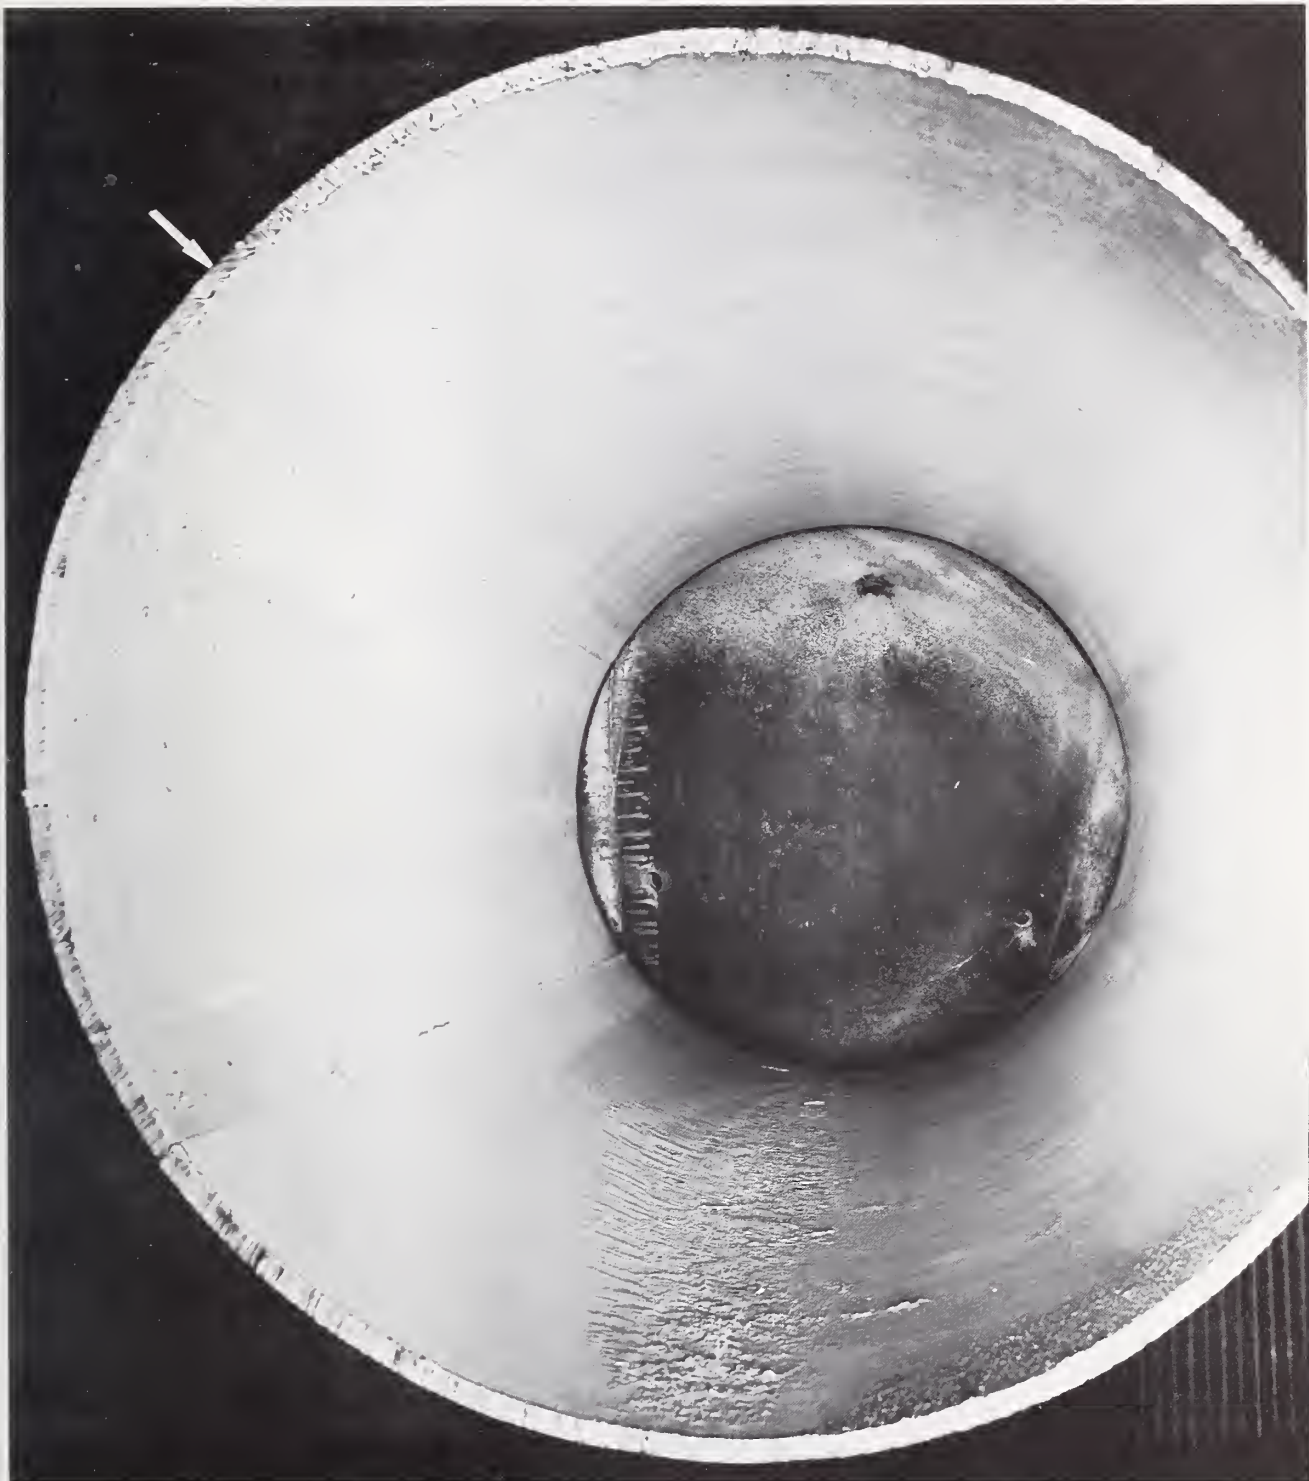
remainder of the tank after removal of the end that leaked. In Figure 6, this line is marked by an arrow. The line is bounded by two circles--one is the flame-cut shell plate and one is the head plate at the far end of the vessel--and the line is approximately midway between the 10 and the 11 o'clock positions on the circles.

Several cycles of corrosion are apparent in Figure 6 on the inside of the tank. Each cycle is believed to represent corrosion that occurred while the tank was partially filled while being stored flat along the long axis of the tank, and it appears that with each cycle, corrosion products were formed over a segment of the inside surfaces of a partially filled cylinder. Thus, at a previous boundary between the filled and unfilled parts, there exists a line, which is visible evidence of a difference in the corrosion experiences of the metal on the two sides of the line.

Figure 6. Inside of tank after removal of the end that leaked. The arrow marks a faint corrosion line located at saw-cut boundary of segments 4 and 5, which were taken from the flame-cut section of the tank. This arrow is also approximately centered on 2 white marks at 9 o'clock and 12 o'clock. These marks show the limits of the flame-cut section.

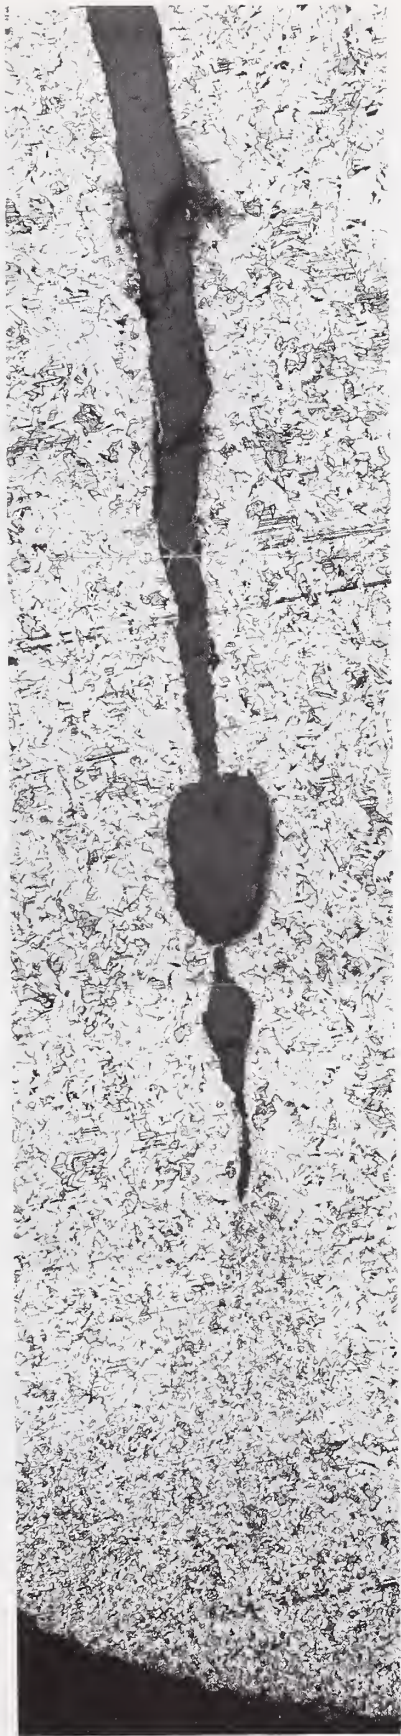
A montage of photomicrographs was taken on face 1 of segments 2, 4, and 5, each of which were bonded only by a tac weld with no lap weld being present. These montages are presented, respectively as Figure 7, 8, and 9. They show that the unbonded region extends (from inside the tank) to the root of the tac weld of segment 4 face 1, and that the unbonded region extends beyond the root of the weld for a short distance along the fusion line of the tac weld in the other two segments. They also show, in the corroded forged weld regions near the tip of the unbonded part, that somewhat enlarged cavities have formed, presumably by corrosion that occurred in these regions at a rate greater than the rate at which it occurred at other nearby locations. These local regions, such as is shown near the tip of the crack of Figure 7, have a geometry that restricts the access to the bulk of the interior space of the tank. The formation of cavities such as those shown in Figure 7 is not unlike that observed in crevice corrosion.<sup>1,2)</sup> It is well known that mild steels are susceptible to crevice corrosion.<sup>3)</sup>

Figure 7. Montage of bond region on segment number 2, face 1.  
X 40

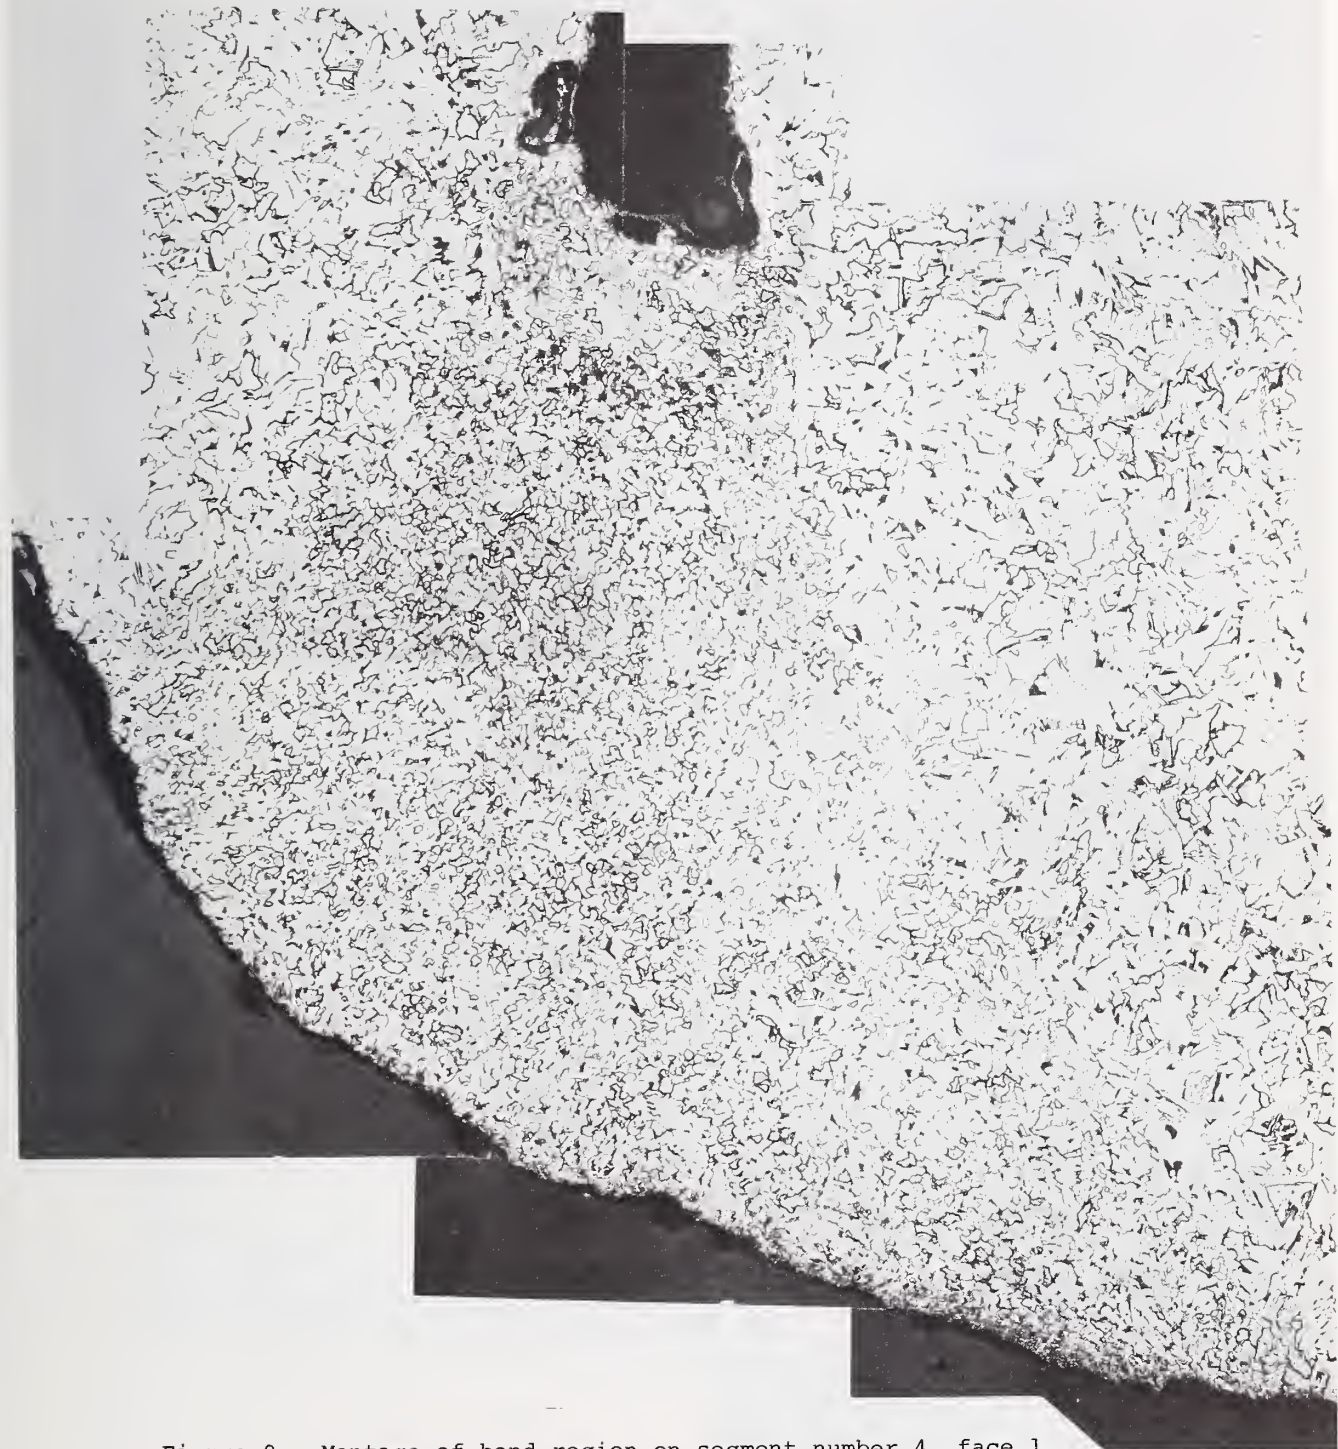
Figure 8. Montage of bond region on segment number 4, face 1.  
X 40

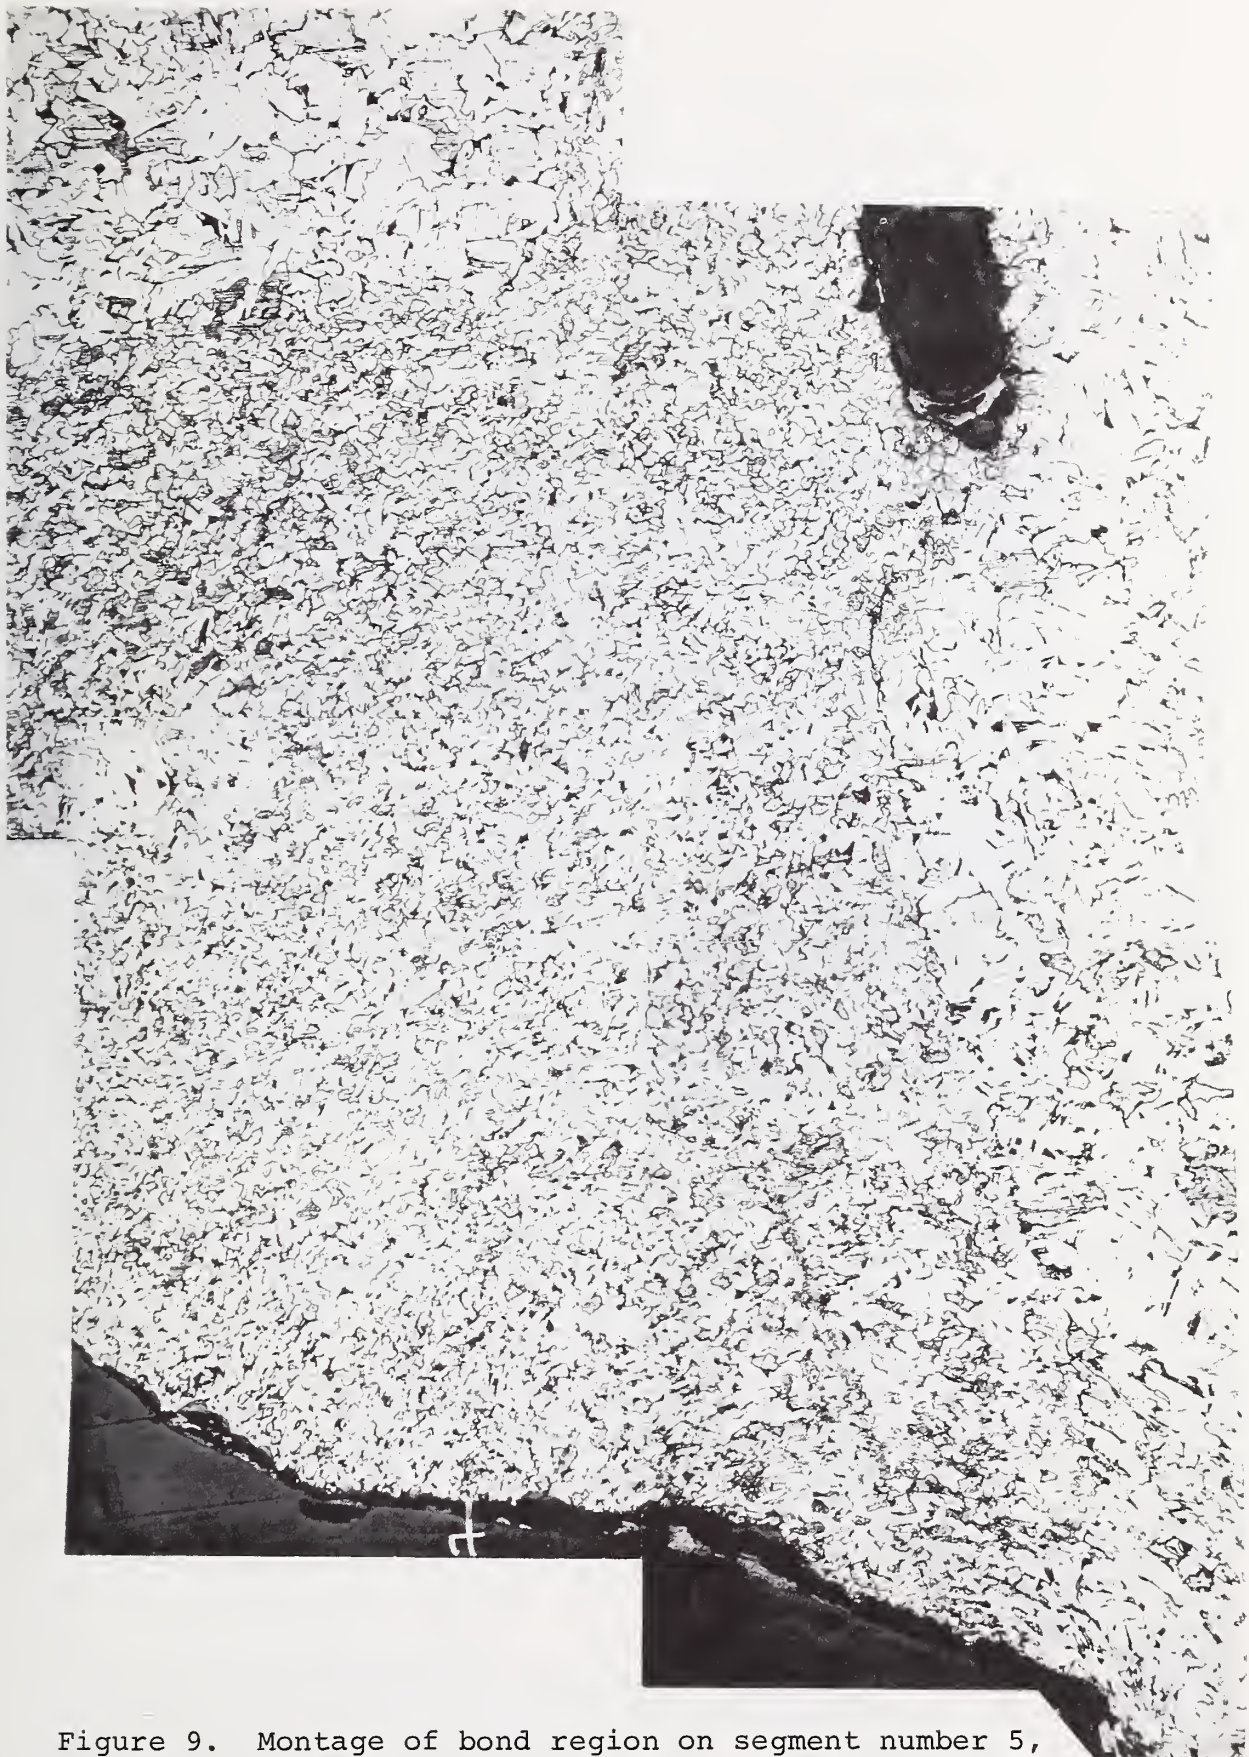
Figure 9. Montage of bond region on segment number 5,  
face 1. X 40

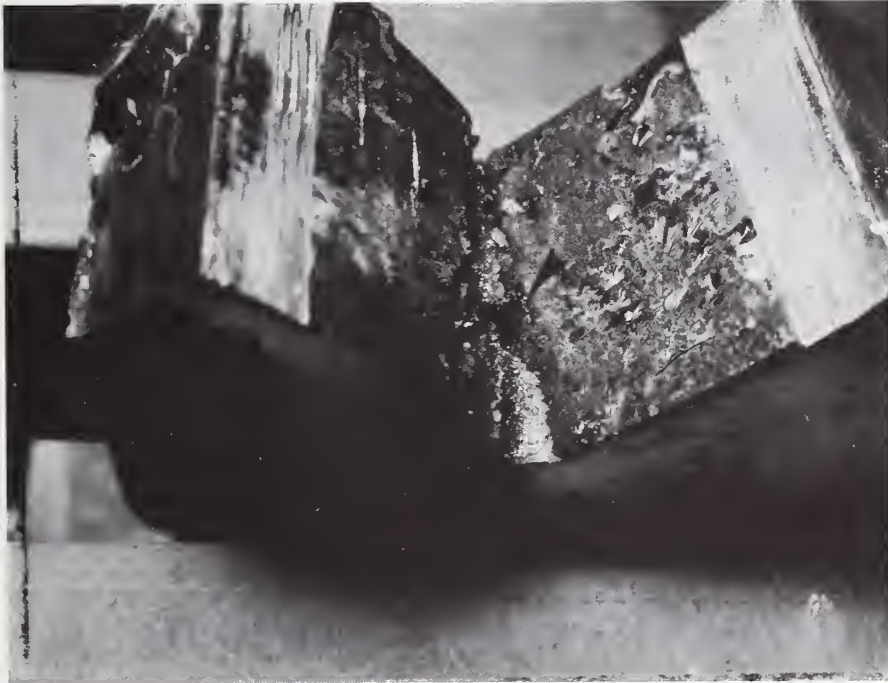
Segment 5 in the partially fractured condition is shown in Figure 10, in which the piece of the head is shown on the right and the shell on the left. The arrow in between the head and shell pieces points to a dark region along the bond line. This dark region is a void region in the partially fractured surface of weld metal, and it is believed to have existed prior to this separation. After the pieces were completely separated, the appearance of the fracture in the region just below this dark region was dull in comparison to that of the adjacent regions on the balance of the fracture faces. The balance of the fracture was bright and crystalline in appearance. The fracture face of the piece of the shell was observed in detail using the scanning electron microscope. The head piece of this fracture was used for metallographic studies.

Figure 10. Segment number 5 after being wedged open to examine for cracks, showing the location of a dark region (at the arrow) which represents a possible pre-existing path through the tac weld.

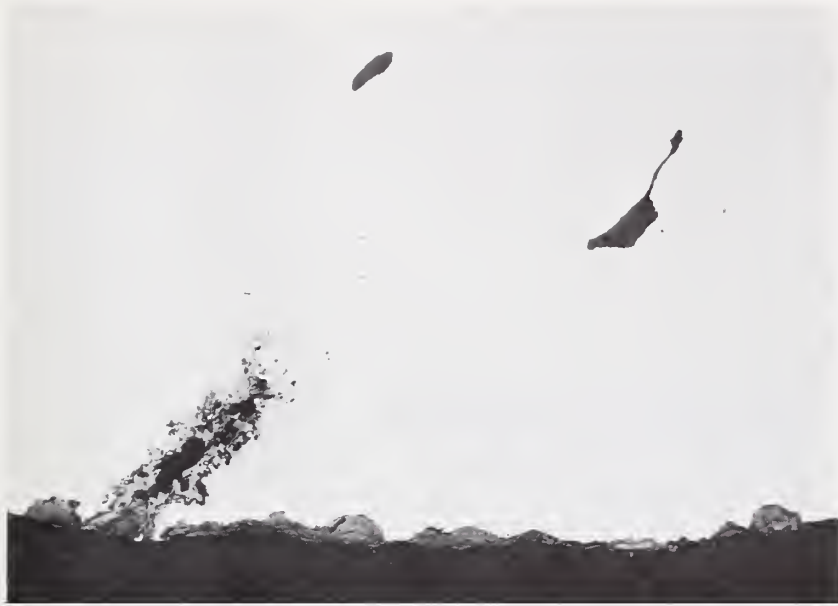
Fig. 11A

layers beneath the level of the fracture face of the weld metal. In several of these layers there existed weld-metal with gross porosity and oxidation which extended from outside of the tank on the face of the weld to within the tac weld metal. After successive weld-metal layers were removed microporosity only was present. Figure 11A shows the region of porosity at one level at which it extended to the outside of the tank and Figure 11B shows the region at another level at which it was essentially contained within the weld metal. Surrounding the pores there is evidence of corrosion. While this corrosion could have been the result of some externally prompted corrosive action, we suspect that it may be a result of internally prompted corrosion, and that it may be the actual site of the leak. However, the micropores observed at the internal weld metal site were not successfully traced all the way to the root of the tac weld inside the vessel.

Figure 11. Two sections taken in the weld metal on the head-plate portion of fractured segment 5, showing surface (11A) and sub-surface (11B) defects and oxides that surround them.

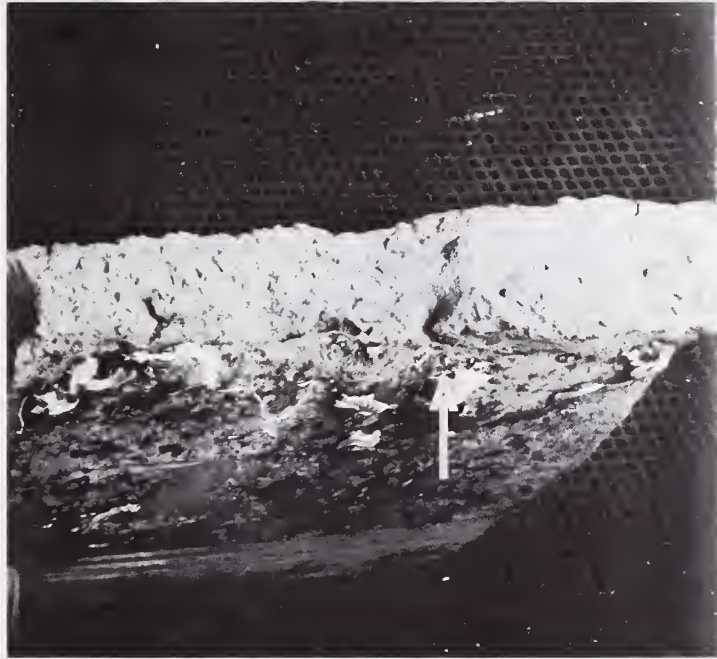
Figure 12 shows the fracture face on the shell portion of segment 5 at a magnification of X5. The arrow on the figure points in the direction of crack propagation (during separation from the inside to the outside of the tank) and it is located at the dark part shown at the arrow on Figure 7. At higher magnifications, Figure 13 shows that this dull region is non-crystalline whereas other parts of the fracture are crystallographic. Microporosity is much more prevalent in the dull region. This microporosity and the dimpled appearance of the dull region is shown at X1300 in Figure 14A, and the crystalline appearance of the balance of the fracture is represented at X1300 in Figure 14B.

Figure 12. SEM fractograph of fracture face of segment 5 taken at X5 magnification. The arrow points in the direction of crack propagation and it is located at the "dark part."

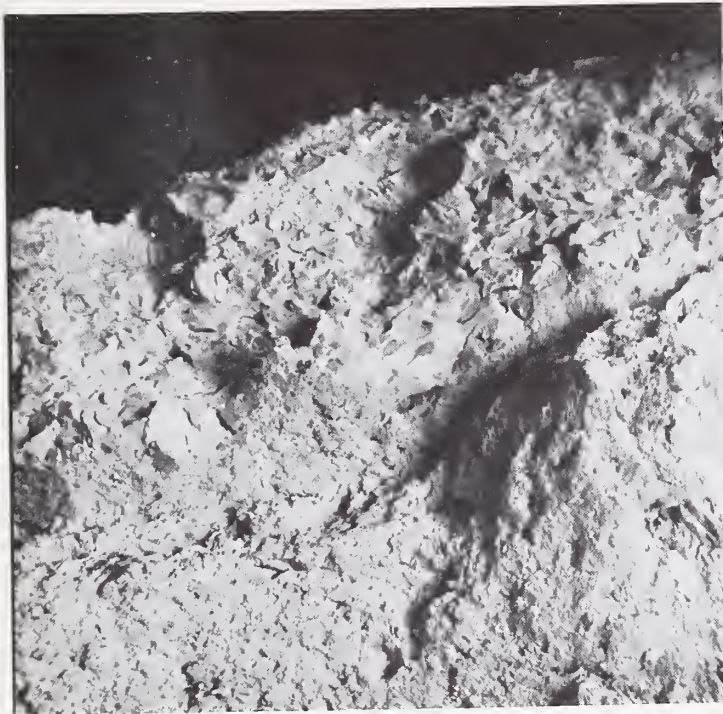
Fig. 13A  
X48

Figure 13. SEM fractographs taken at X48 (Fig. 13A.) and X240 (Fig. 14B.) showing microporosity in the dull region and crystalline fracture in the adjacent parts of the fracture.

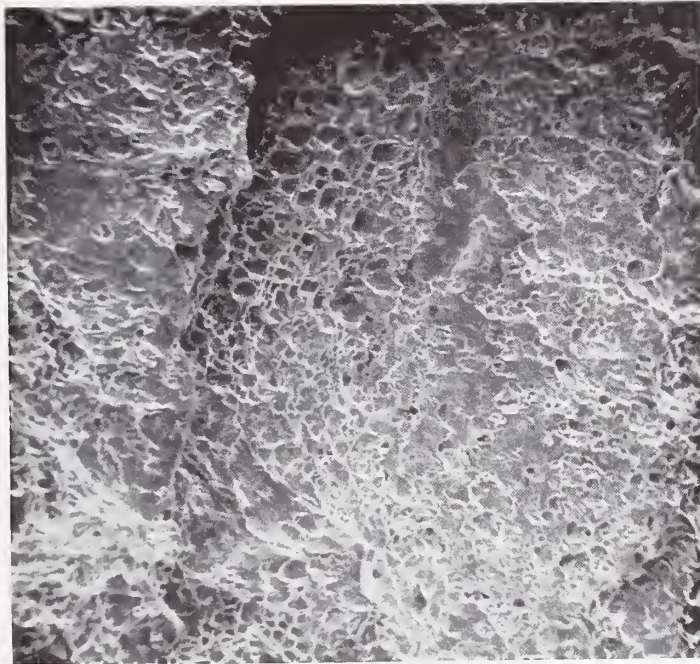
Fig. 14A

It is believed that the dull region failed in a more ductile manner than did the balance of the fracture because constraint was locally decreased in this region due to the presence of the micropores that existed before the two pieces were separated to form the fracture faces. This microporosity

Figure 14. SEM fractographs of the dull region (Figure 14A), showing microporosity and dimpled rupture, and of a region representative of the balance of the fracture (Figure 14B), showing a crystalline appearance.
