# **Safety Evaluation of Soda-Acid Fire Extinguishers**

**Bruce W. Christ and John H. Smith**

**Failure Analysis Report**

**Prepared for  
Bureau of Engineering Safety  
Consumer Product Safety Commission  
Washington, D. C. 20207**

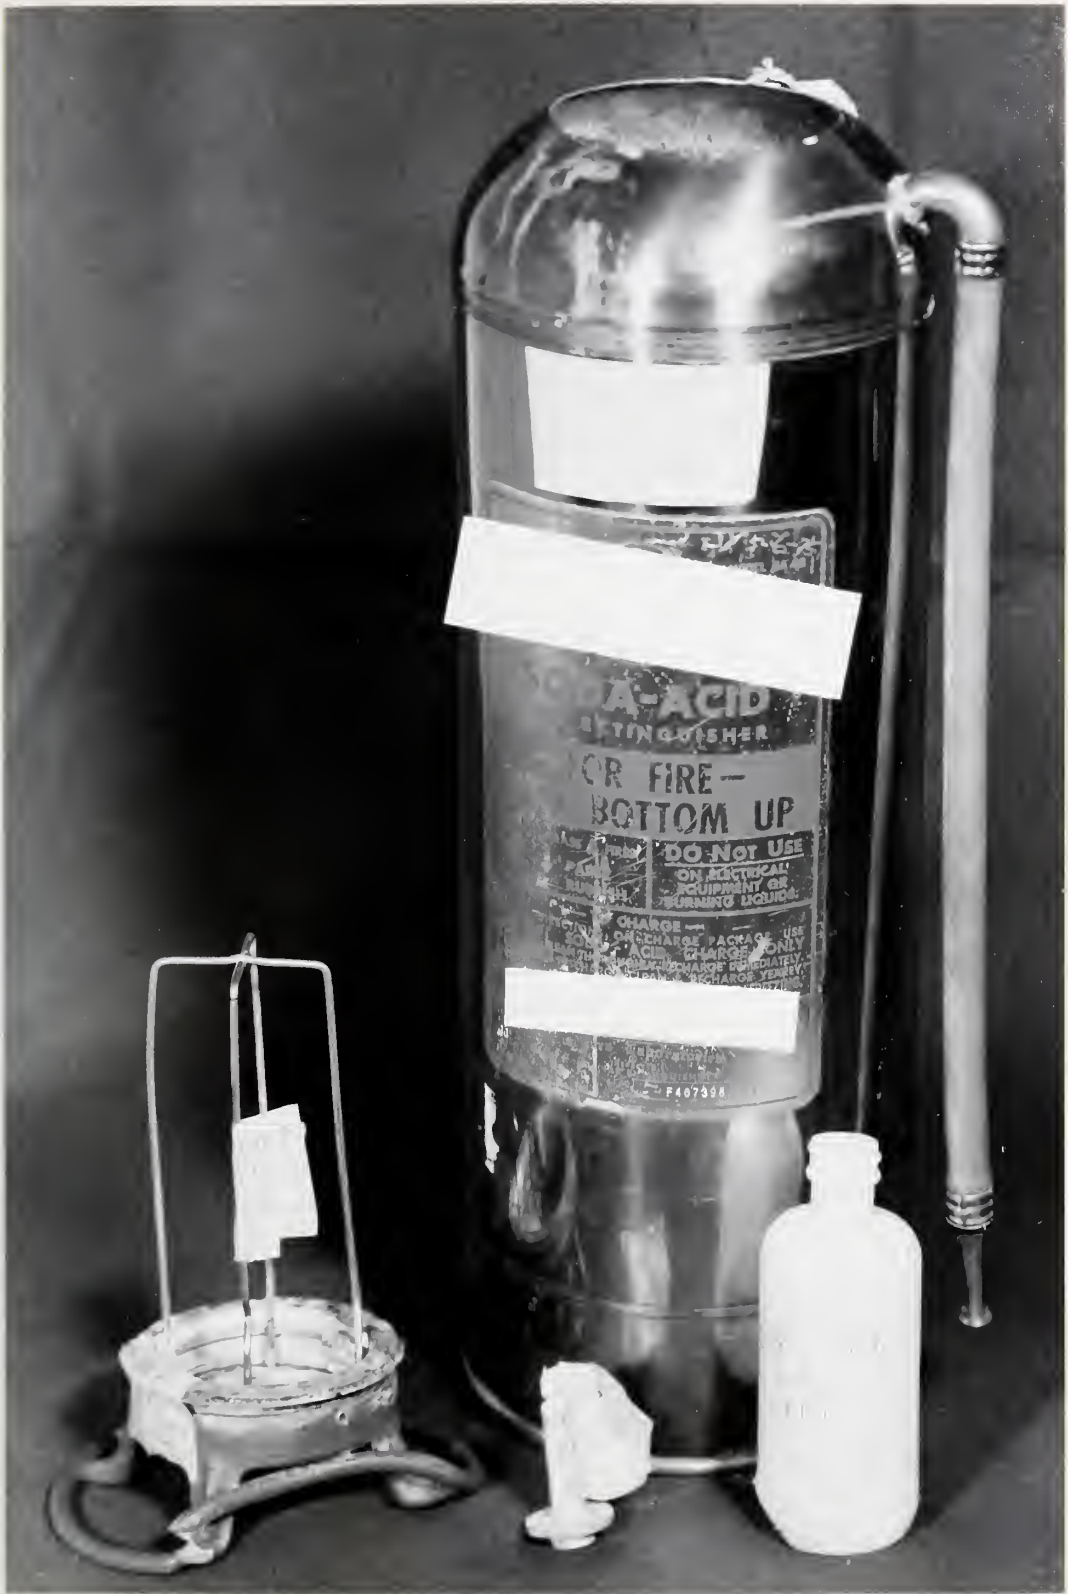
Figure 1. View of the fire extinguisher which exploded. The cap and collar assembly at lower left separated from the dome via a circumferential tear. The acid bottle is positioned with the stopple-end up in the wire cage attached to the cap-collar assembly when the extinguisher is ready for service. Note the identifying number stamped on the lower part of the label. X 1/3

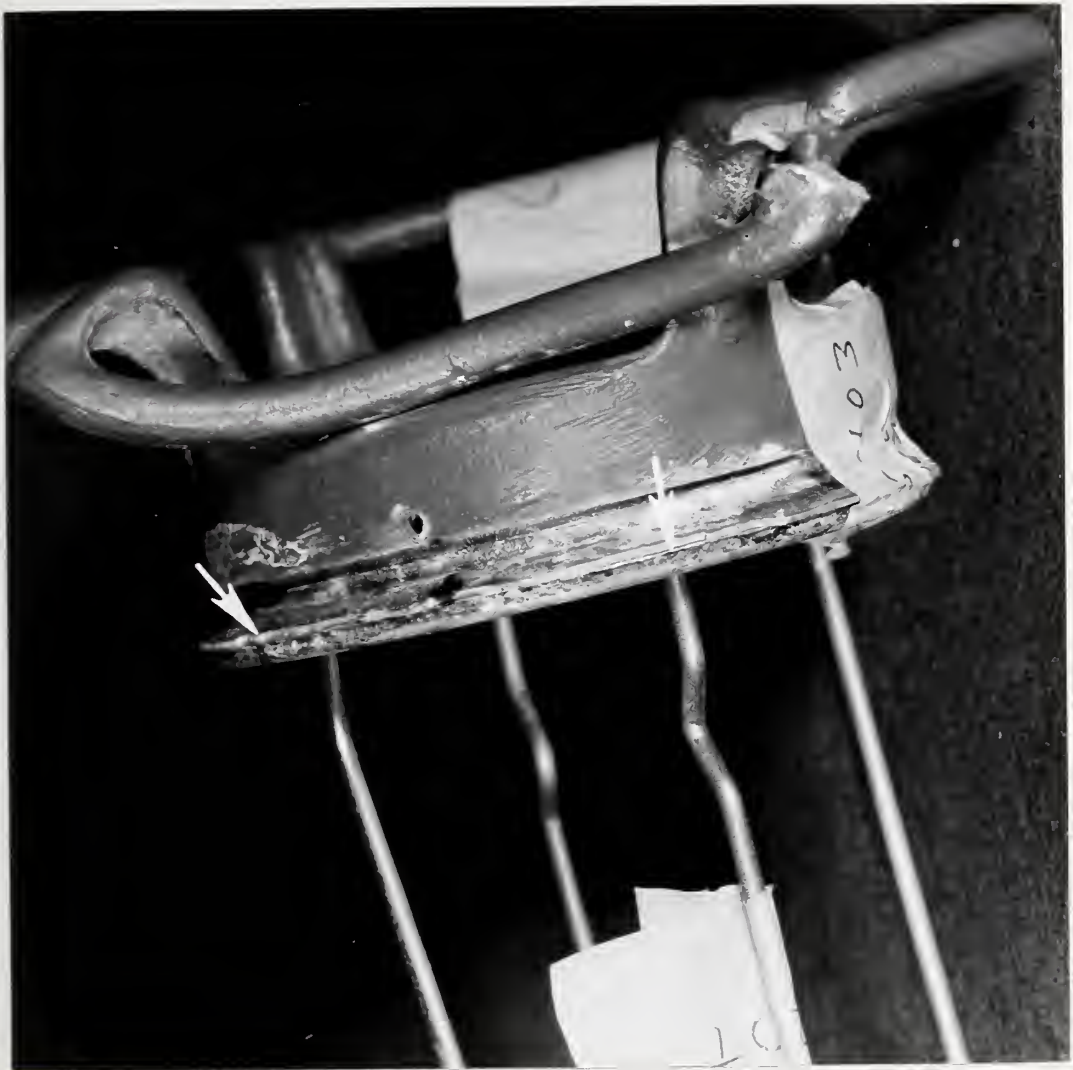
Figure 2a. Cap-collar assembly showing the ring of dome metal which remained attached to the collar - arrow at left. A fin-like projection of what is believed to be joining metal appears at the arrow - right center.

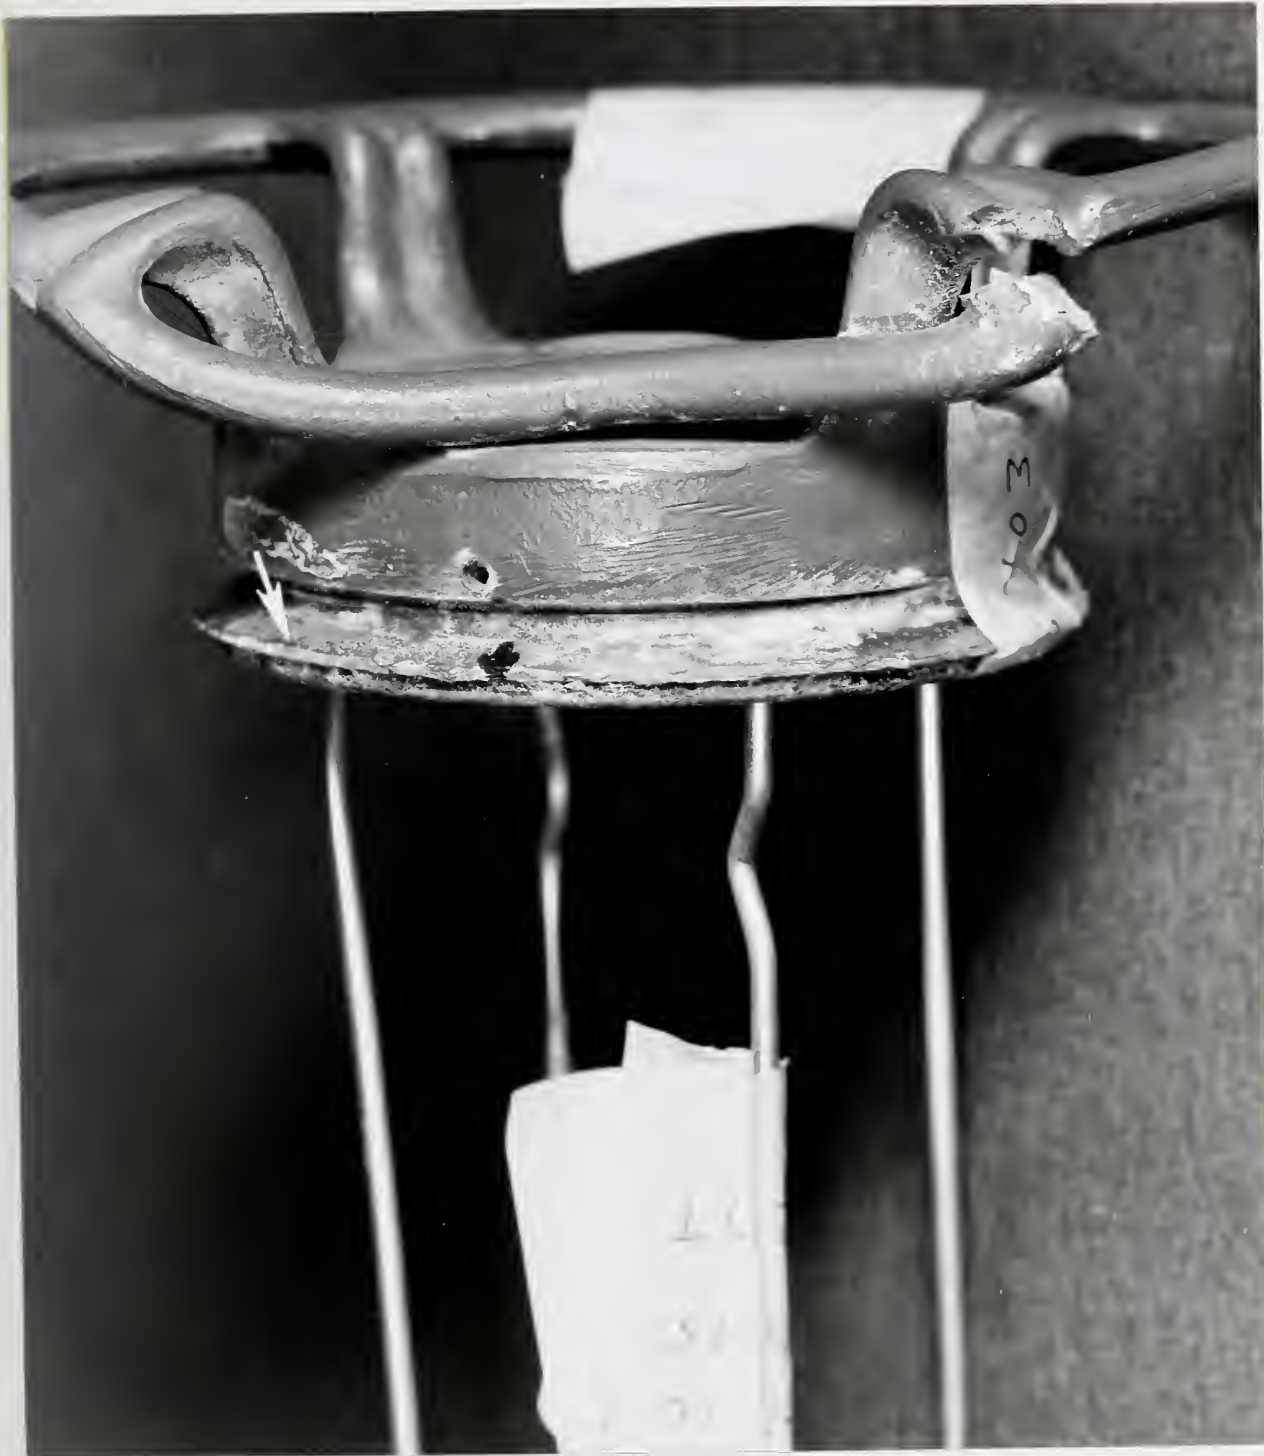
Figure 2b. Close up of the view in Figure 2a. The hole in the cap facilitates venting during filling for hydrotesting. X 1 1/4

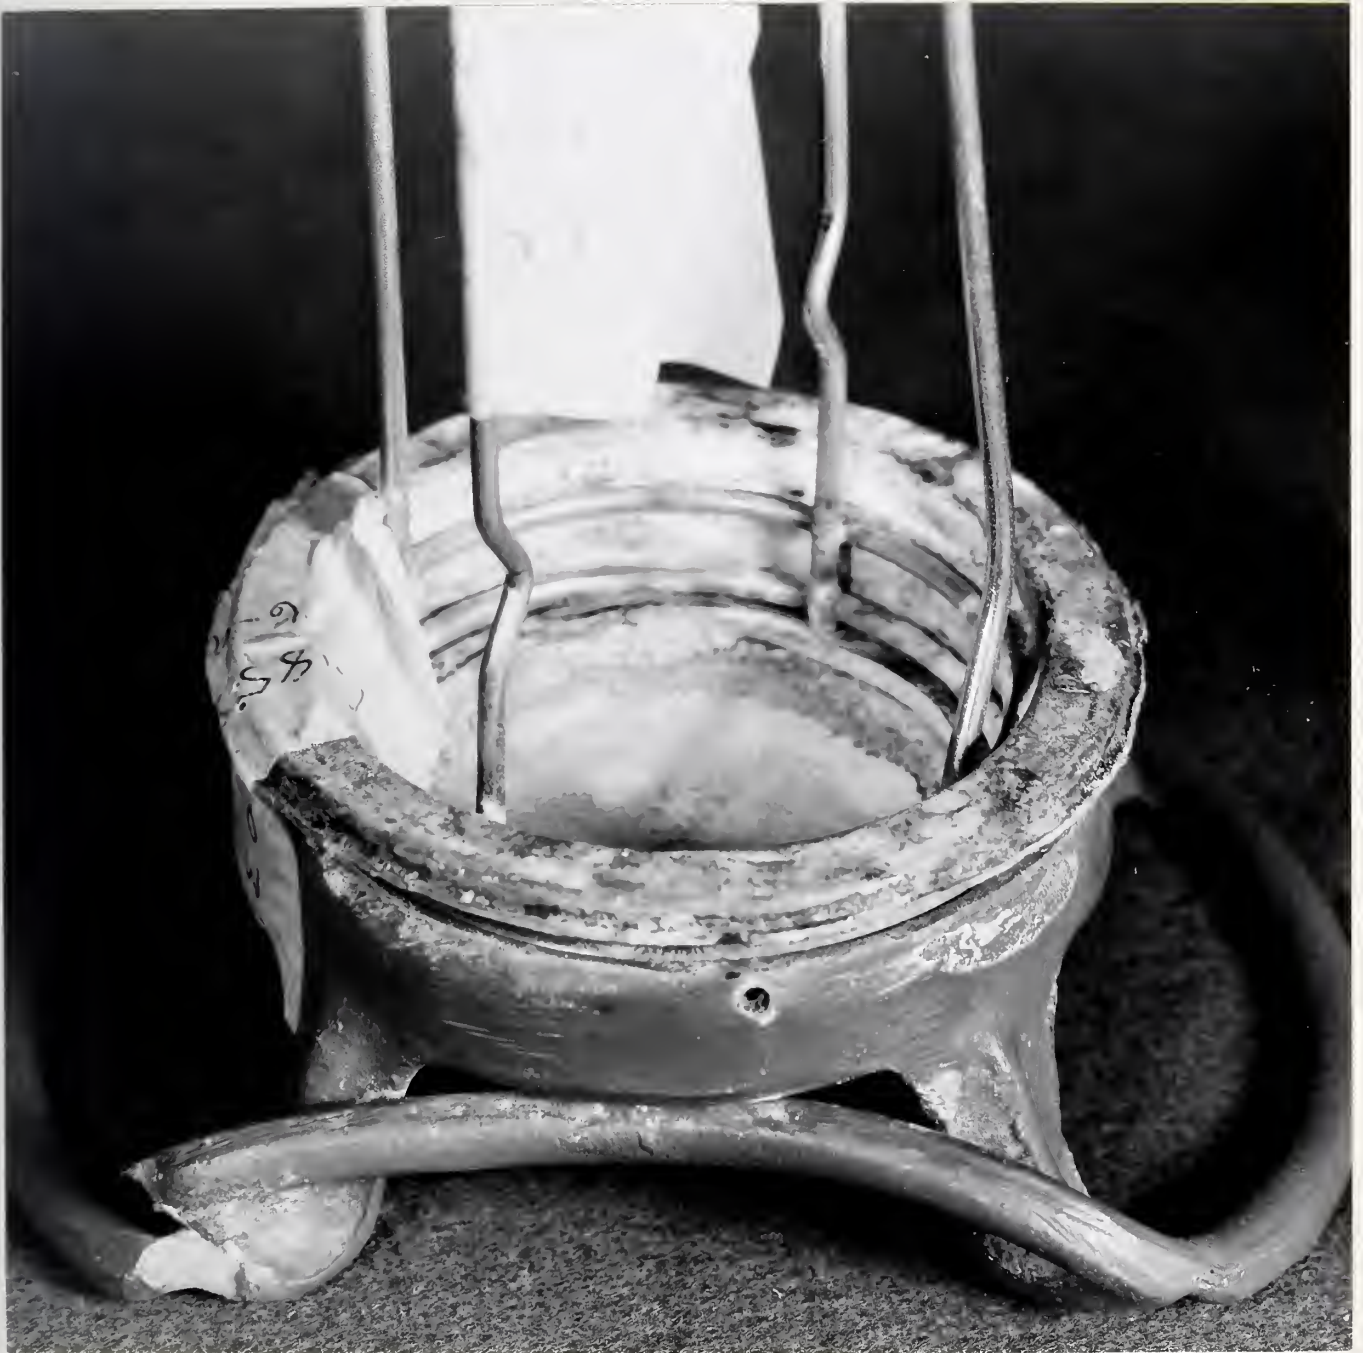
Figure 2c. Inside view of the cap-collar assembly, showing the collar and some of the fracture surface of the dome metal. Note the white substance, which is probably sodium bicarbonate. X 1 1/4

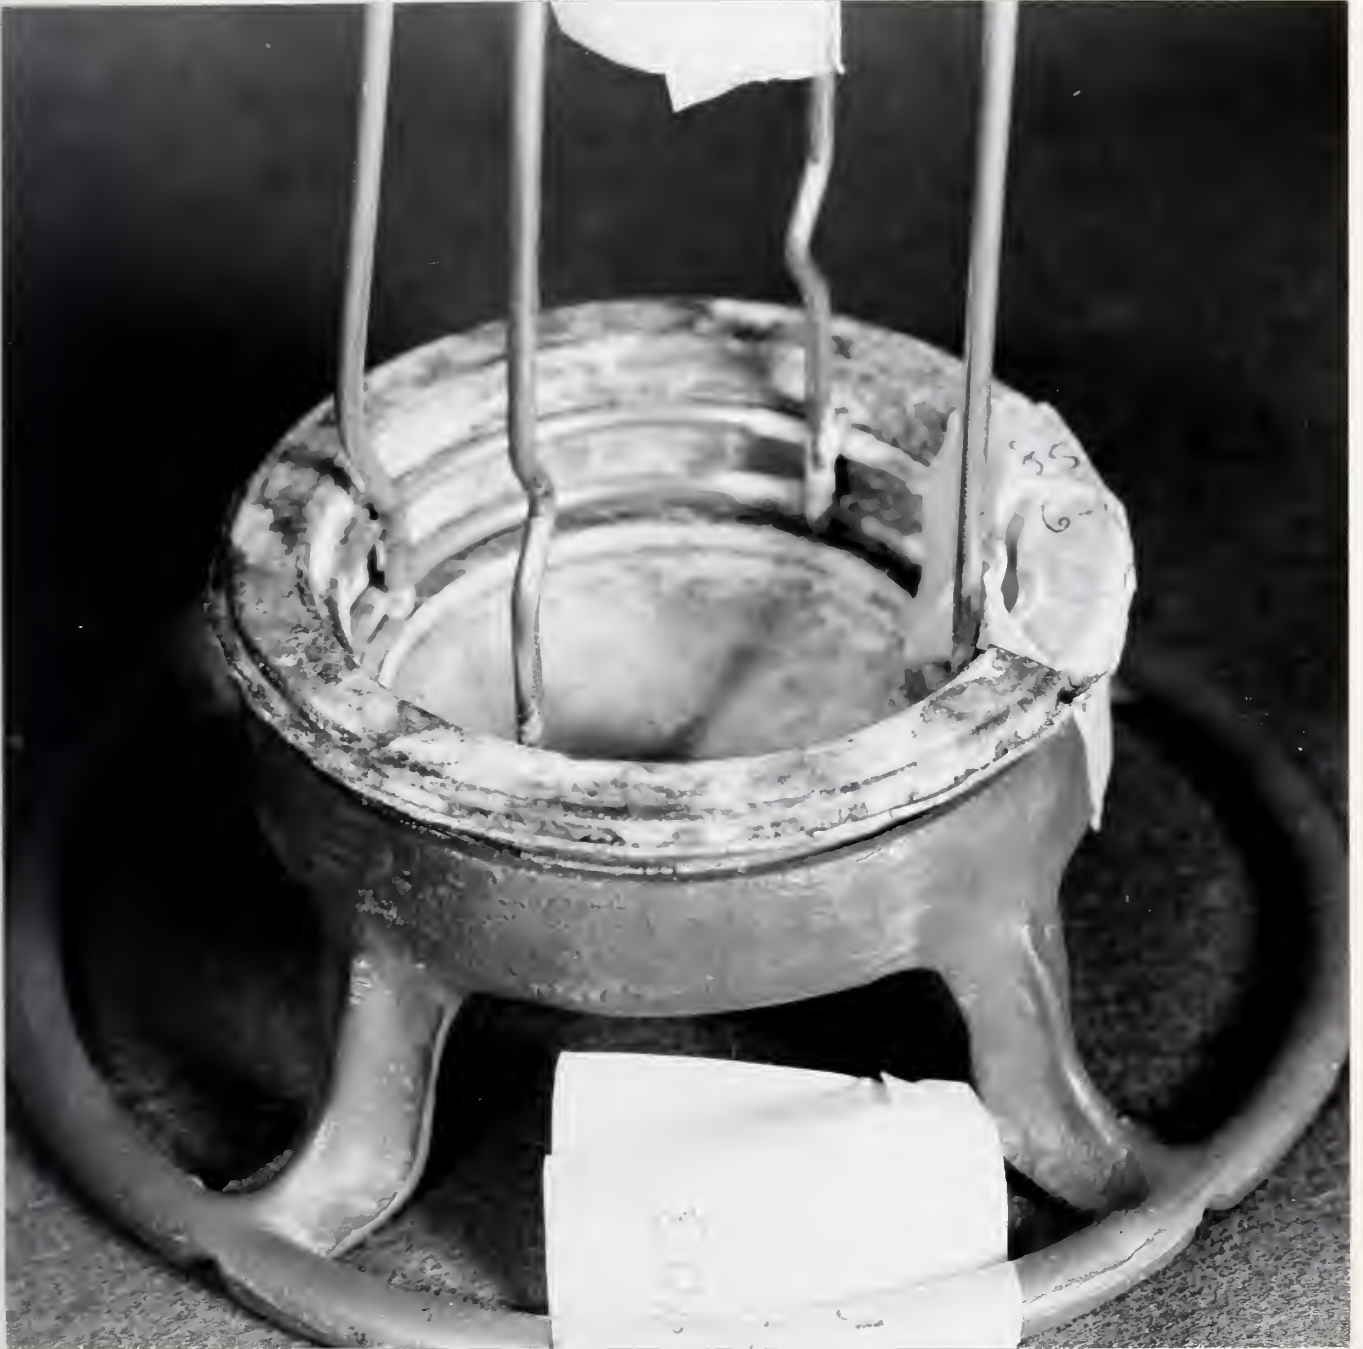
Figure 2d. View of the cap-collar assembly almost opposite that shown in Figure 2c, showing more of the fracture of the dome metal. X 1 1/4

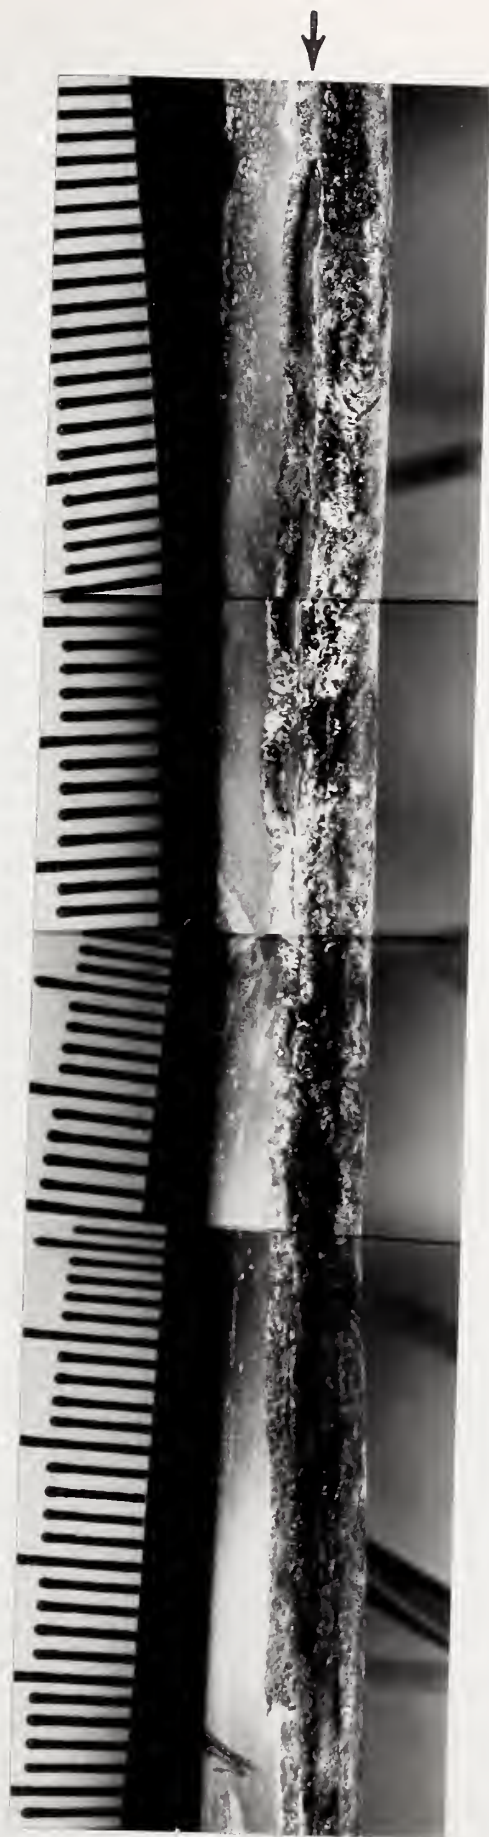
A view of the cap-collar assembly which includes some of the fracture surface of the dome metal along an arbitrarily-selected portion of the circumference appears the composite picture, Figure 3. In this picture, which has a three-dimensional character to it, the dome metal as seen at the outside top of an upright extinguisher appears above the side arrows, and the edge of the flange of the collar --- which would normally be inside the extinguisher --- appears in elevation below the side arrows. Appearing as a layer upon the flange is the dome metal --- which disappears towards the top horizon. The fracture through the thickness of the dome metal is shown in elevation, running between the side arrows. The fracture path does not run in a straight line, but follows a rather wavy path. In fact, scallops in the fracture path through the dome metal --- which show up especially well at the right of Figure 3 --- reveal some of the surface of the collar flange which was joined to the dome metal. Terrace-like features which may be ruptured metal or corrosion product show up at the right-most scallop and also at the third scallop from the right. A feature which may be a delamination between the dome metal and the collar metal appears just to the left of center in Figure 3. A smaller possible delamination appears somewhat further to the left. The white regions in Figure 3 may be areas where sodium bicarbonate has deposited. Conditions of photographing made it rather difficult to show up joining metal at the interface between the dome metal and the collar metal.

Figure 3. Close-up view of the cap-collar assembly showing dome metal and collar metal. The dome metal disappears toward the top horizon. Part of the fracture path through the dome metal is shown in elevation and runs horizontally from arrow to arrow. The collar metal is shown in elevation and runs horizontally across the lowermost portion of the picture. (One small scale division equals one millimeter.)

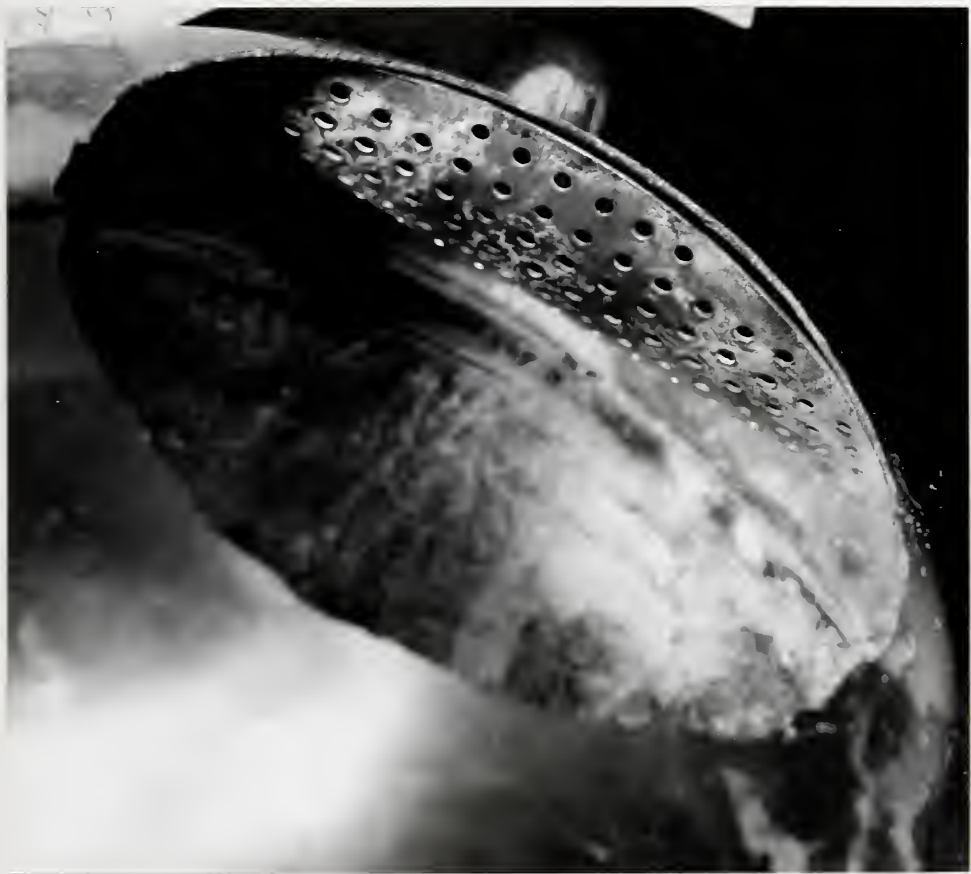
The circumferential tear which is clearly evident at the top of the dome in Figure 1 is shown in some close-up views which appear in Figures 4a, 4b, and 4c. Conspicuous bulging does not show up anywhere along the circumference. Indeed, the separation seems to have occurred in a uniform fashion along the entire circumference. The wavy path followed by the fracture is clearly seen in Figure 4c. All three figures seem to indicate that the fracture occurred entirely in the dome metal. It is likely that the dome metal is a stainless steel, as suggested by its surface luster, its inability to attract a small, hand-held magnet and the wording of the specification, Paragraph 20 of Reference 5. However, conclusive identification of the dome metal via chemical analysis was not obtained at this stage of the examination.

Figure 4a. Close-up view of the circumferential tear. X 1 1/4

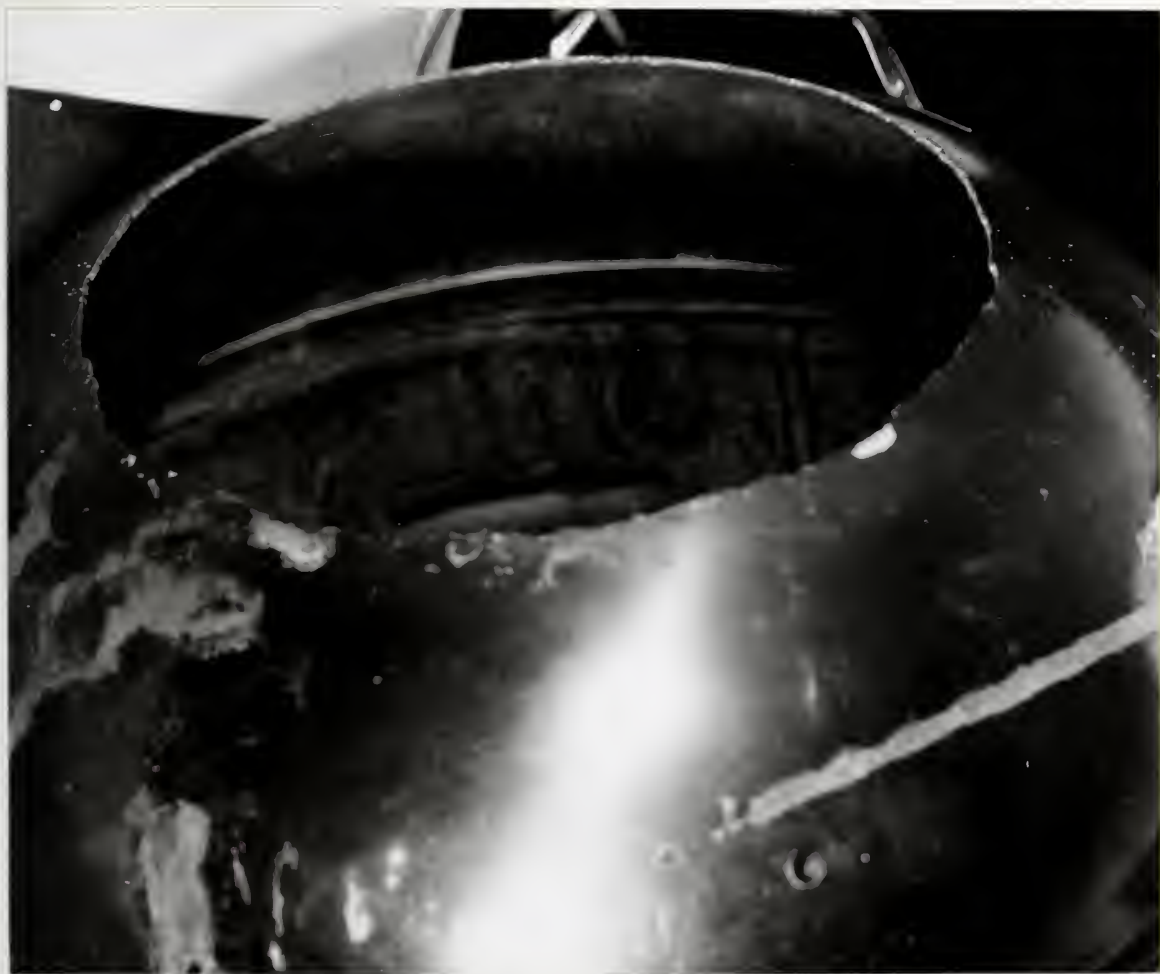
Figure 4b. Close-up view of the circumferential tear. X 1 1/4

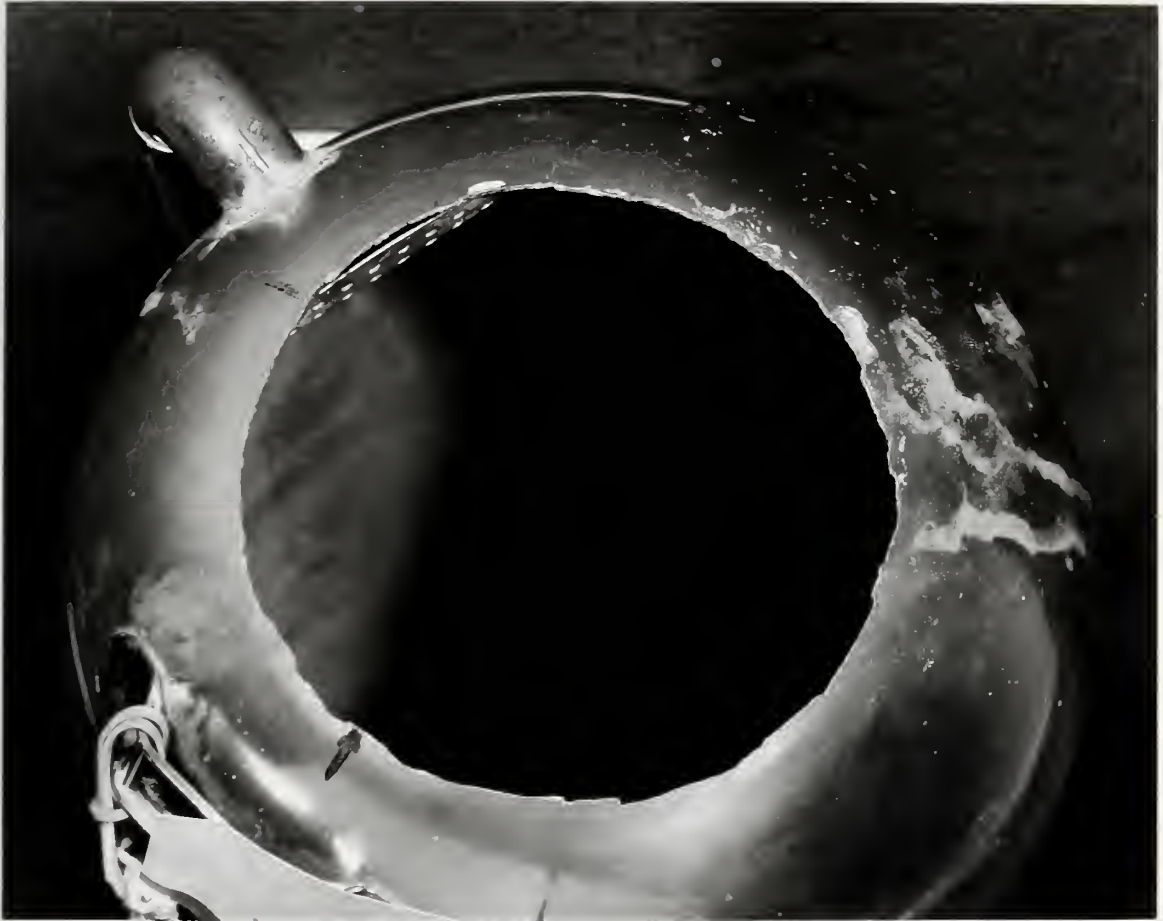
Figure 4c. Close-up view of the circumferential tear. X 3/4

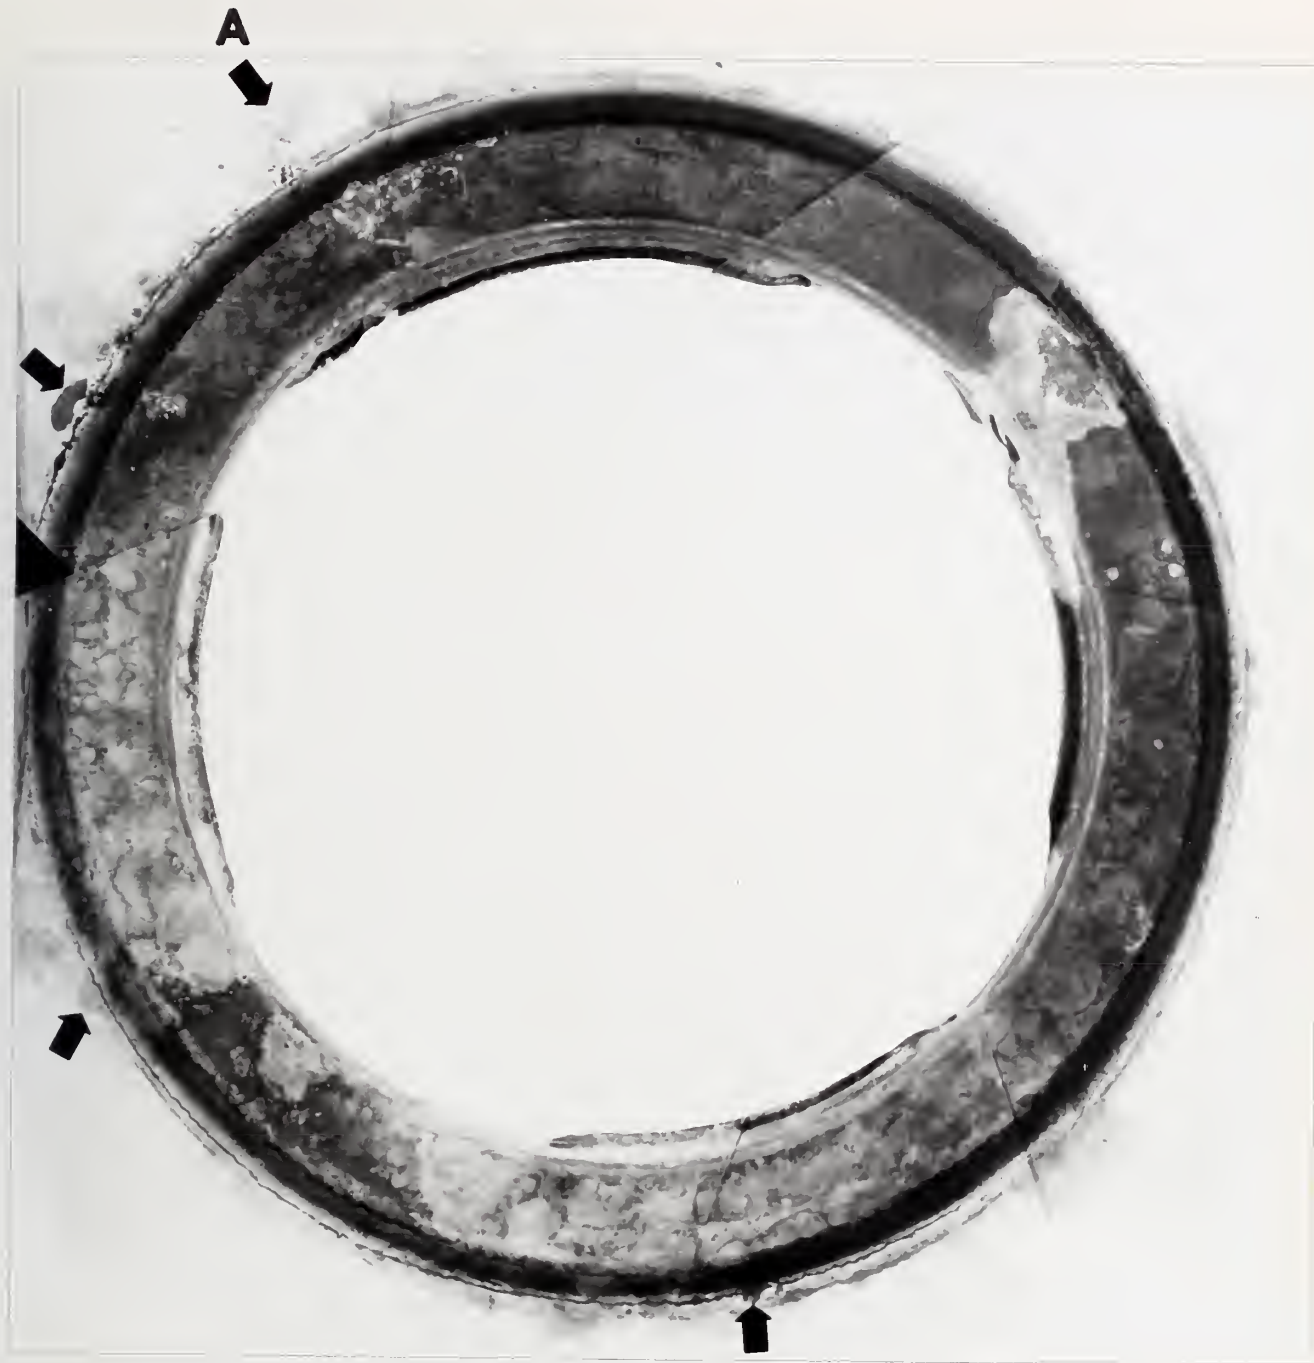
A notable feature in Figure 7a is the circumferential step or crack which shows up between the joining metal and the dome metal. The vicinity of this crack is stained with corrosion product around the entire circumference. Drip-shaped stains appear at the arrows in Figure 7a and 7b. These stains have a reddish-orange-brown color, as is evident in Figure 7c.

Figure 7a. Full circumferential view of inside of dome.  
Note the circumferential step or crack which  
shows up between the joining metal and the  
dome metal. X 1 1/4

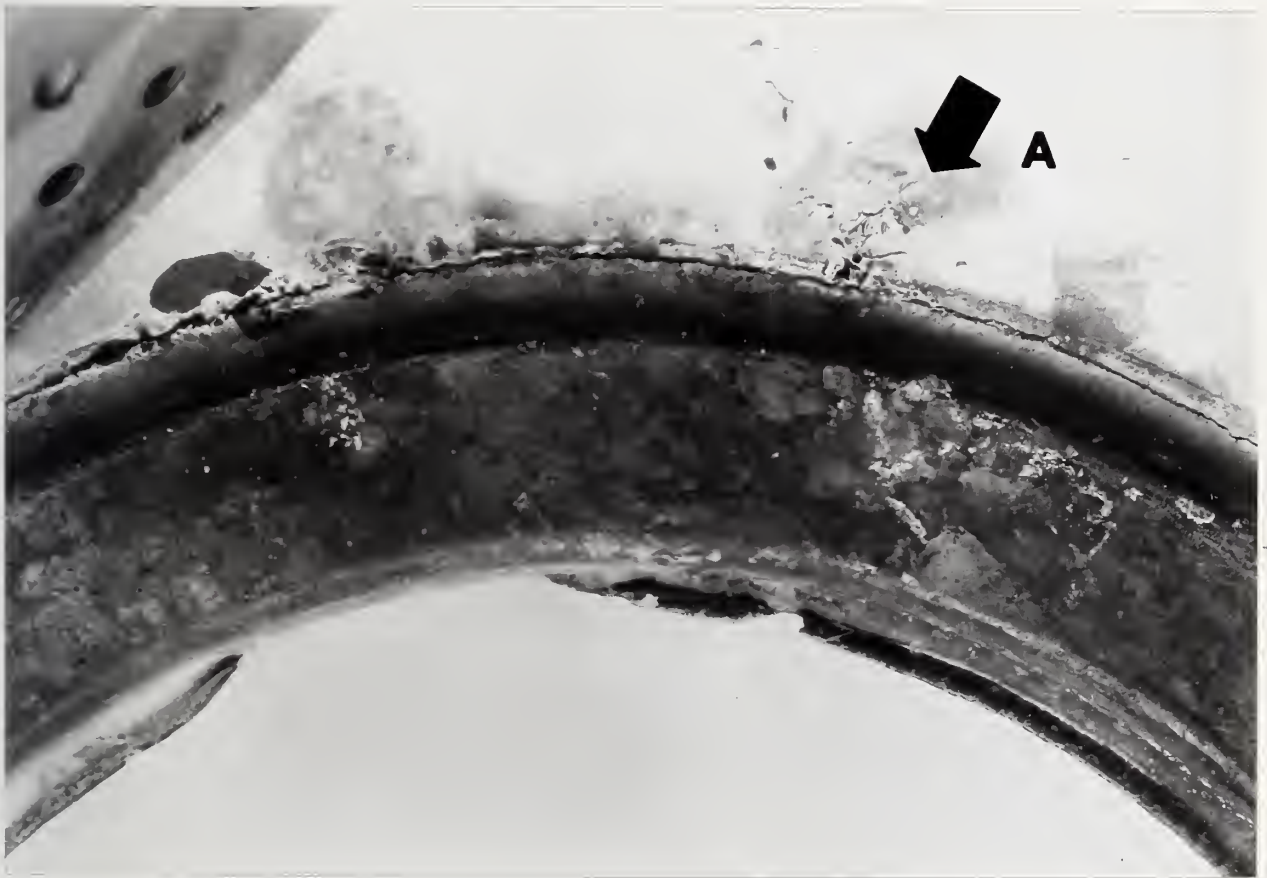
Figure 7b shows a close-up view of the stain at A in Figure 7a. The longitudinal section cut from the dome, Figure 5b, was obtained by cutting as closely as possible through this stain. Close-up views of the joining metal, the collar and the dome wall appear in Figures 8a (as polished) and 8b (polished and lightly etched).

Figure 7b. Close-up of a section from Figure 7a  
near the strainer. X 2 1/2

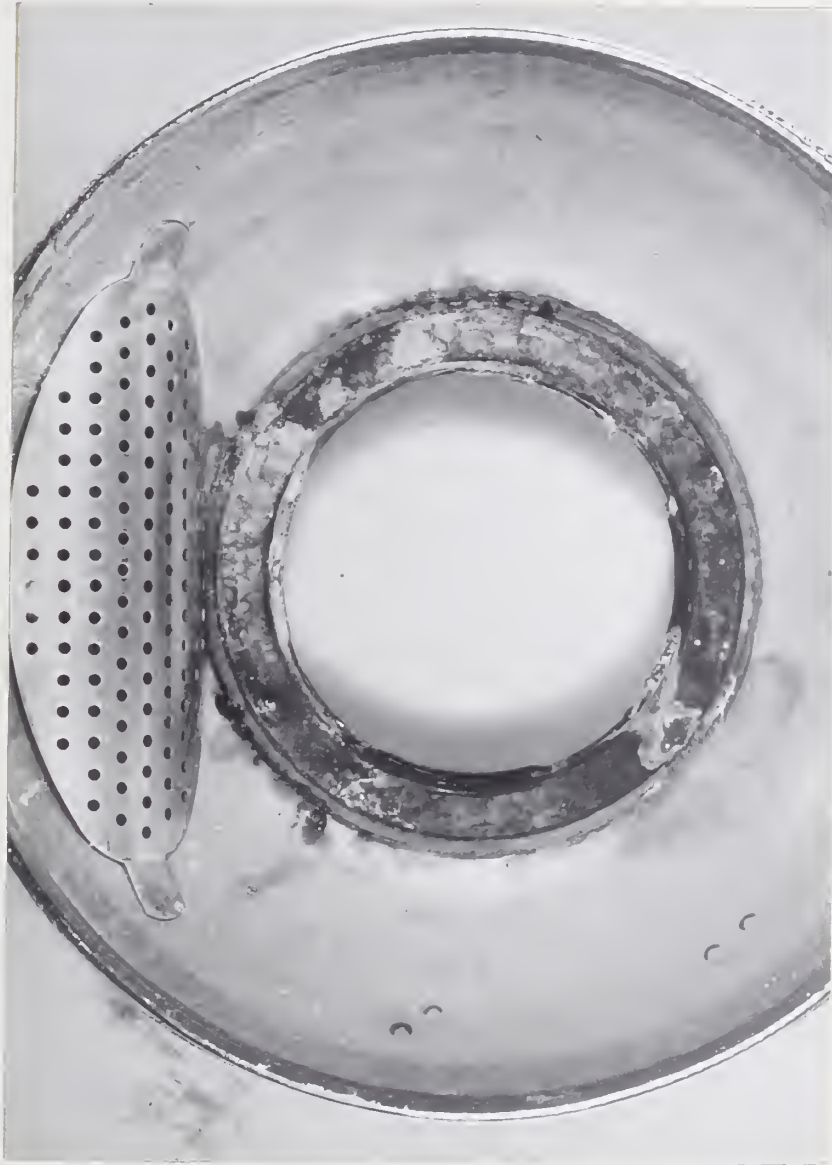
Figure 7c. Full circumferential view of inside of dome, showing the reddish-orange-brown coloring of stains near the circumferential step or crack shown in Figures 7a and 7b. X 3/4

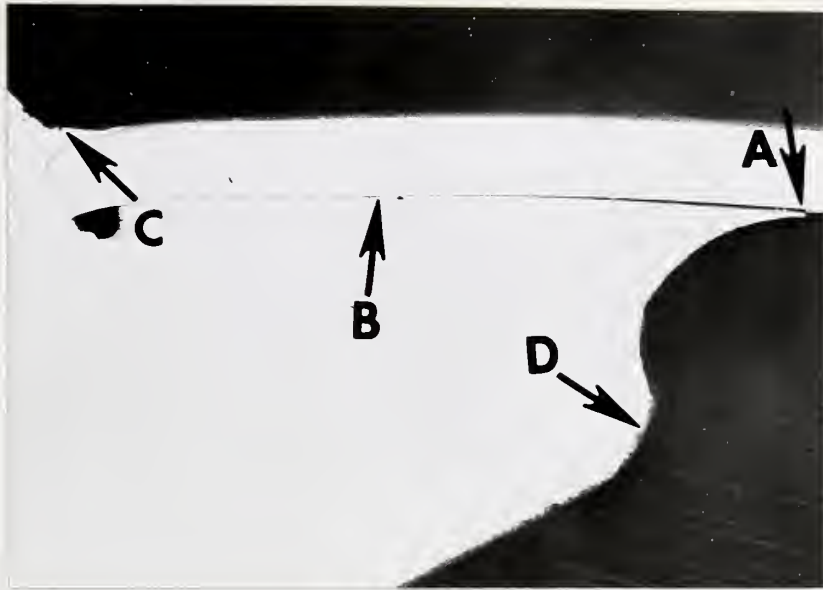
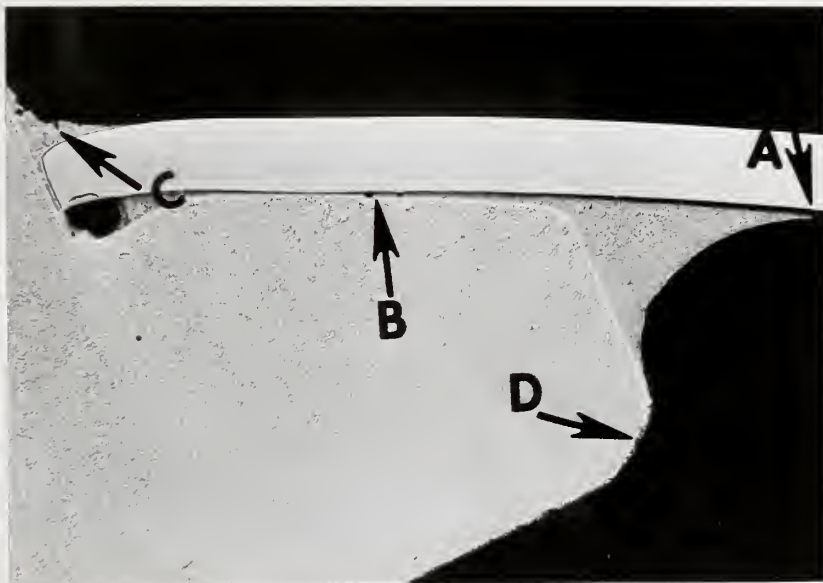
It is of interest to note that the outside fillet of joining metal shows a rather irregular profile, suggesting that some corrosion took place. Indeed, it was in this region that the three used-but-undamaged extinguishers showed a bluish-green deposit, which was probably a corrosion product. The outside fillet of joining metal is about 0.35 inches away from the region where the dome metal of fire extinguisher number F 407396 ruptured --- it appears unlikely that the corrosion of the outside joining metal might lead to the type of rupture observed in the dome metal of fire extinguisher number F 407396.

A less conspicuous feature in Figure 8 than the pore is the rupture of the joining metal in the region where the inside fillet runs along the dome wall --- this region is labeled A. This rupture leads into a crevice between the joining metal and the dome metal --- and the crevice tip seems to be in the vicinity of the region labeled B in Figure 8b. The overall length of the crevice seems to be about 0.20 inches, as compared to an overall length of 0.35 inches between the tip of the fillet and the end of the dome wall. This crevice is of potential importance in understanding the malfunctioning of fire extinguisher number F 407396, since this crevice is near the observed rupture path in the dome metal.

Figure 8a. Close-up view of the region where the dome metal joins the collar metal. The interface between the wall of dome metal and the collar metal shows up as the horizontal line running left from A.

Figure 8b. Close-up view of the region where the dome metal joins the collar metal. The joining metal shows up clearly between the dome metal and the collar metal due to etching. The outside fillet of joining metal is in the region labeled C, and the inside fillet curves between A and D.

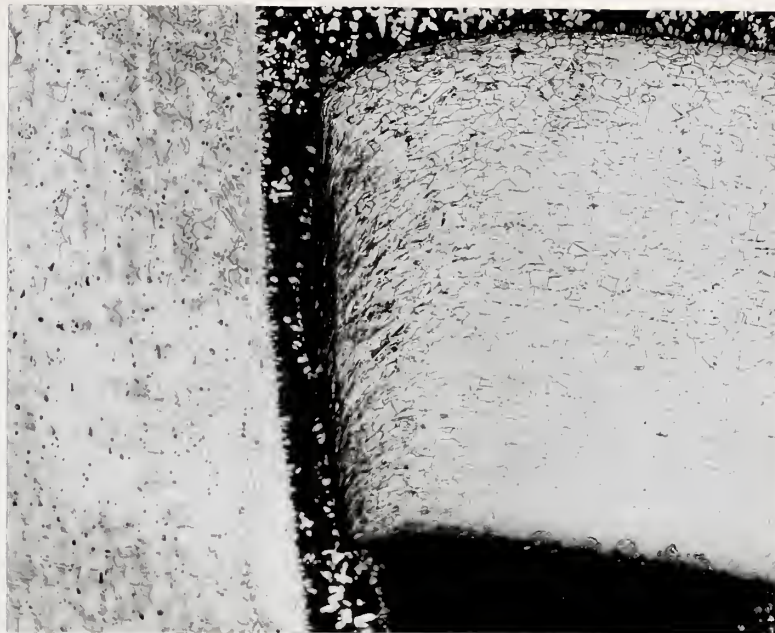
Another region of some interest is the end of the dome metal under the outside fillet of joining metal --- this region is near the label "C" in Figure 8. A close-up of this region after etching --- Figure 9 --- reveals evidence of severe plastic deformation, especially at the tip. The explanation of this deformation is not definite. It may be due to punching forces, assuming that the dome was annealed after forming as prescribed in Paragraph 20 of Reference 5 --- then punched to accommodate the collar. Regardless of the cause of this deformation, it seems unlikely that it --- or the cause of it --- might lead to the type of rupture observed in the dome metal of fire extinguisher number F 407396.

Figure 9a. End of the dome metal under the outside fillet of joining metal. Note severely distorted grains at end indicating localized distortion.

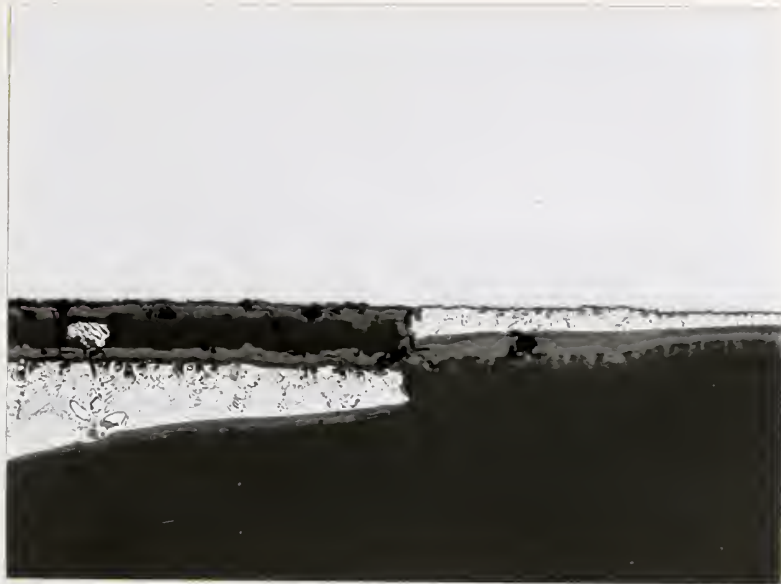
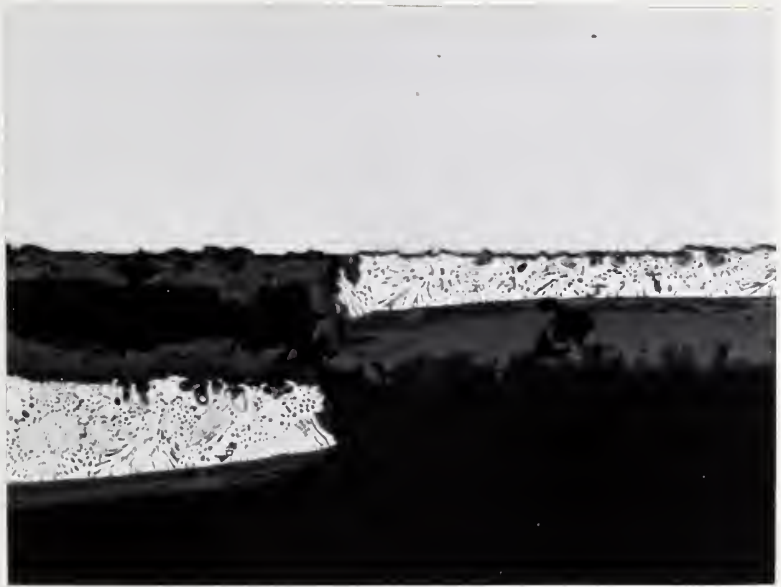
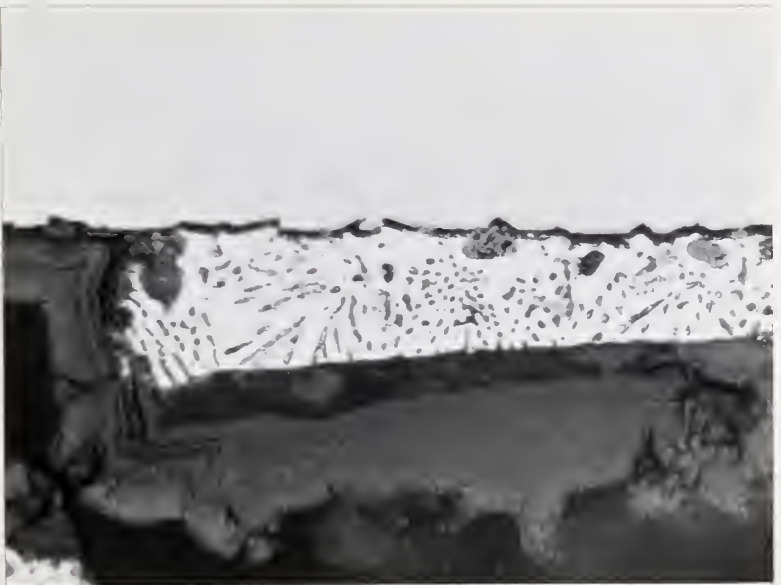
Returning to the joining metal noted at A in Figure 8, it is evident from the close-up views in Figure 10 that the joining metal at the tip of the inside fillet has ruptured and separated from the dome wall. The step due to separation is probably what leads to the appearance of the circumferential step or crack which was pointed out in Figure 7. The layer of corrosion product --- which appears as a grey-black layer on both the joining metal and the dome metal --- suggests that the rupture of the joining metal occurred before the longitudinal section was cut from the dome. Indeed, the layer of corrosion product is apparently quite adherent, since the layer did not flake away significantly during the cutting process.

Corrosion product growing on the ruptured joining metal seems to have almost closed up the rupture in Figure 10c --- however, despite the apparent impingement of these corrosion products, it is likely that the crevice is still open to the interior of the fire extinguisher. In fact, one plausible explanation of the stains labeled A in Figure 7 is that these stains arise from the gradual seepage of corrosive fluid out of the crevice. Corrosive fluid such as the mixture of sulfuric acid and water containing sodium bicarbonate may be driven into the crevice under pressure when the fire extinguisher is used, then may seep out gradually while the re-charged extinguisher is in an upright position awaiting its next use. It is unlikely that even thorough cleaning could remove all corrosive fluid driven into the crevice by pressurization during use because of surface tension effects as well as the near impingement of corrosion product which is evident in Figure 10c.

- Figure 10.
- a. Rupture of the inside fillet of joining metal noted at A in Figure 8. Dome metal appears across the top. X 100
  - b. Close-up of the ruptured joining metal shown in Figure 10a. Note corrosion product coating the surface of the dome metal and the surfaces of the joining metal. X 200
  - c. Rupture of the joining metal shown in Figure 10a. Note the film of corrosion product and the incomplete closure of the rupture. X 500

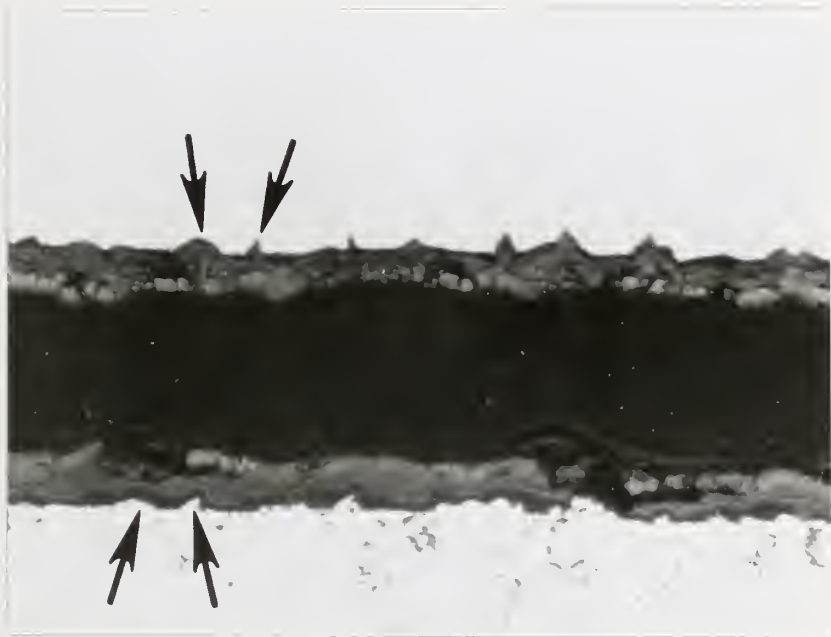
The crevice evident in Figure 8 --- referred to earlier --- shows a significant amount of corrosion product on the dome metal as well as on the collar metal. Figure 11 is a close-up of the crevice at some point between the regions labeled A and B in Figure 8. In addition to the corrosion product evident in Figure 11, there also seems to be an occasional good matching of the profile of the joining metal and the dome metal --- two examples are indicated by the pairs of arrows. This matching suggests the following sequence of events --- first, the interface between the dome metal and joining metal was ruptured, then corrosive fluid entered the crevice and helped to form the tightly adherent corrosion product.

Figure 11. Close-up of the crevice between dome metal (top) and joining metal (bottom) at some point between A and B in Figure 8. Note the good matching of the profiles of the dome metal and the joining metal at the arrows.
