# **Safety Evaluation of Soda-Acid Fire Extinguishers**

**Bruce W. Christ and John H. Smith**

**Failure Analysis Report**

**Prepared for  
Bureau of Engineering Safety  
Consumer Product Safety Commission  
Washington, D. C. 20207**

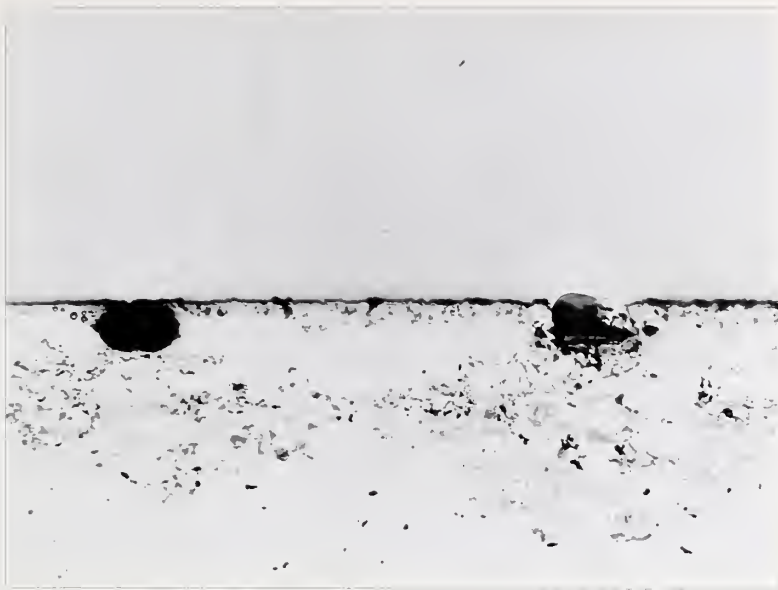
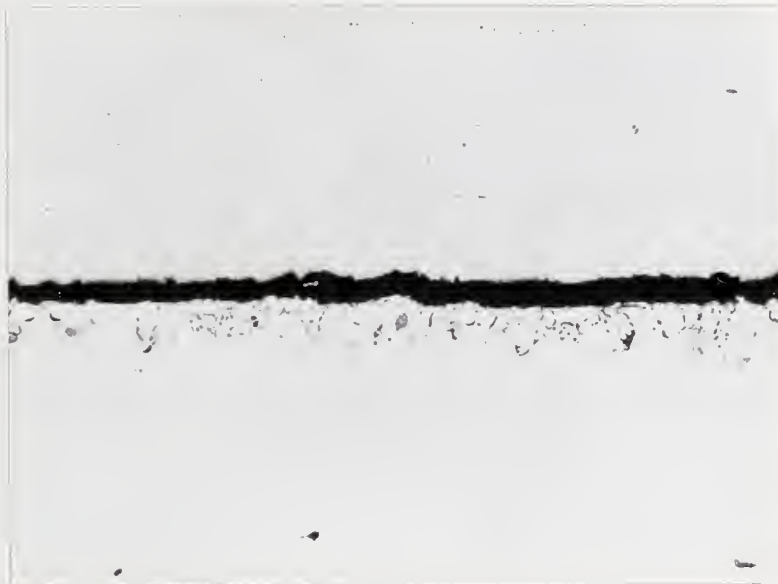
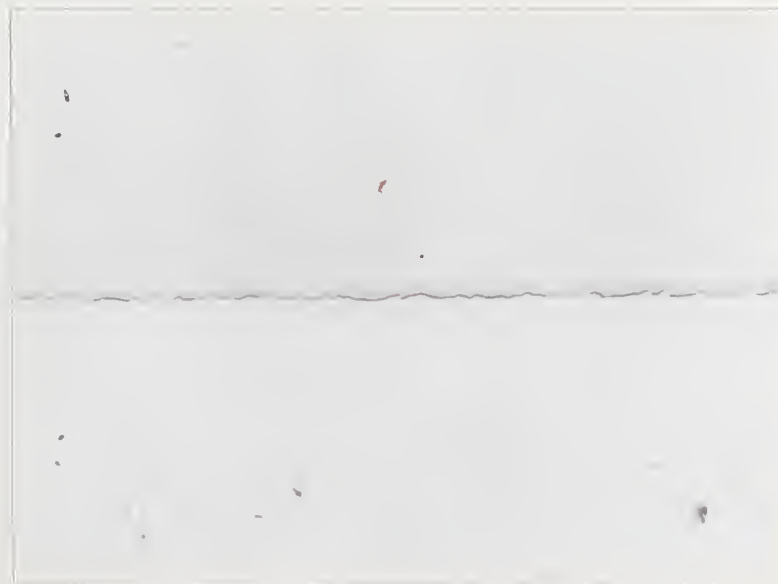
- Figure 12. a. Close-up of the two pits at B in Figure 8. Dome metal is at the top and joining metal is at the bottom. X 100
- b. Appearance of the crevice between dome metal (top) and joining metal (bottom) to the right of the pits in Figure 12a. X 200
- c. Region to the left of the pits in Figure 12a, showing tightly bonded interface between the dome metal (top) and joining metal (bottom). X200

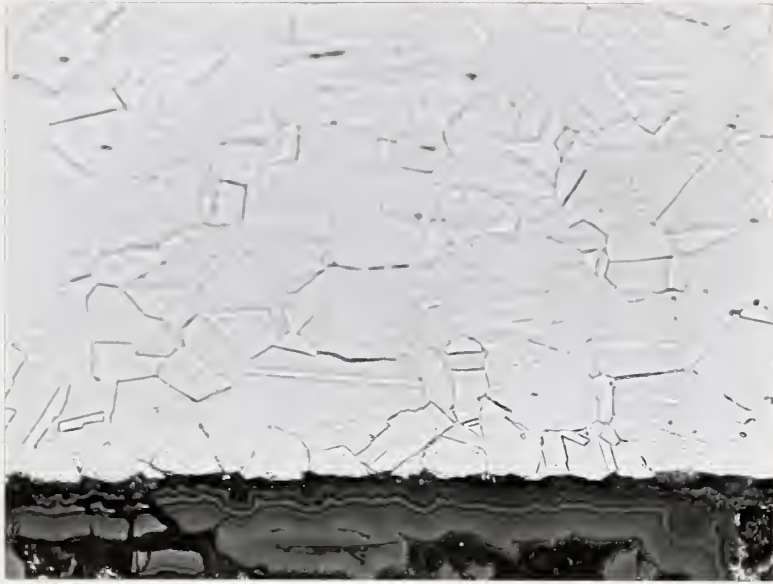
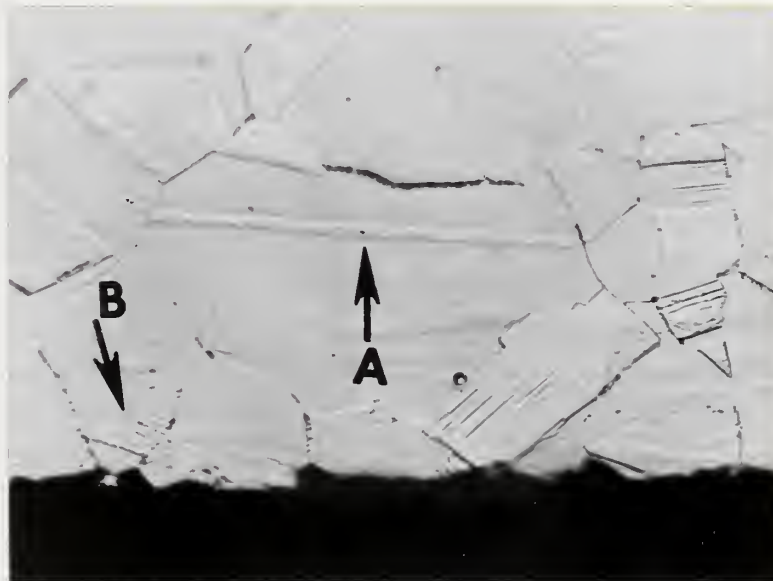
A few final features of the dome metal in the region between the labels A and C in Figure 8 are noteworthy, namely, slip lines in isolated grains and grain boundary precipitates. The grain structure of the dome metal appears in Figure 13a --- the crevice and the corrosion product coating the dome metal are at the bottom. The narrow bands traversing entire grains are probably annealing twins (A in Fig. 13b). On the other hand, wavy lines within individual grains are probably slip lines (B in Fig. 13b). These lines show up especially well in certain grains in Figure 13b. Slip lines form when metals are stressed above their yield point. An example of a profusion of slip lines appears in Figure 9. The slip lines of Figure 13b suggest that individual grains in the dome metal were stressed above their yield point, whereas the bulk of the dome metal itself was not. It may be that these slip lines formed when the interface between the joining metal and the dome metal was ruptured. Consistent with this suggestion is the observation that no evidence of slip lines in isolated grains was found in regions of the dome metal remote from the collar and joining metal. Precautions were taken to assure that these slip lines were not artifacts introduced during polishing of the specimens.

Figure 13a. Grain structure of the dome metal near the crevice at some point between A and B in Figure 8.

Figure 13b. Close-up of some grains appearing just below the center of Figure 13a. The feature at A traversing an entire grain is probably an annealing twin, and the features at B --- which appear in several grains --- are probably slip lines.

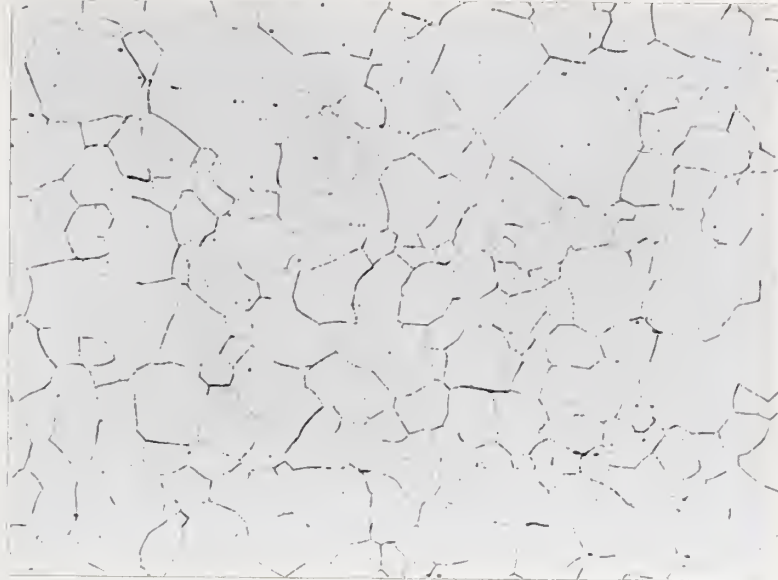
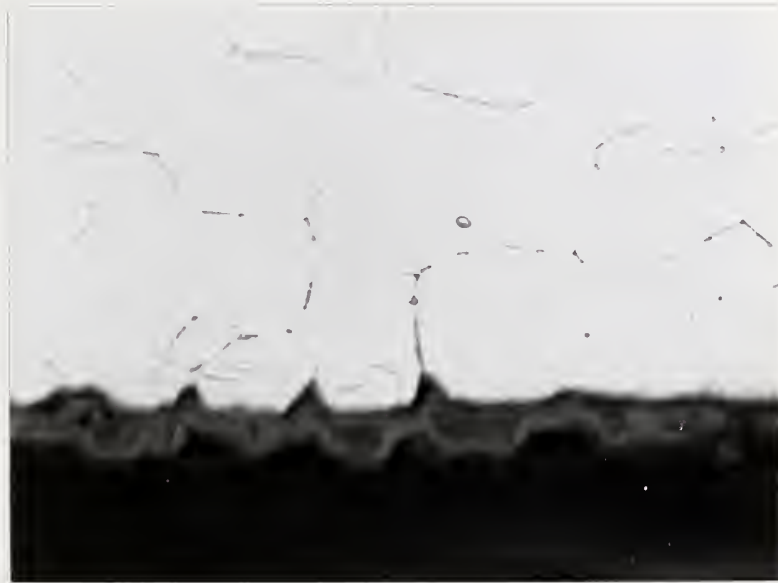
An abundance of the grain boundary precipitates mentioned above appears in Figure 14a. Were a Type 304 stainless steel --- which the dome metal might be made of (Reference 5, Paragraph 20) --- to exhibit such a microstructure, it would be described as "sensitized." Such a microstructure --- which frequently forms in Type 304 stainless steel during welding and brazing operations --- is highly susceptible to intergranular corrosion. A close-up of a few grain boundaries is shown in Figure 14b, where the corrosion product at the dome metal-crevice interface appears at the bottom. A suggestion of a slight penetration of grain boundaries by a corrosion process shows up in Figure 14b, but for the most part, it appears that the tightly adherent corrosion product serves as a protective film to shield the dome metal from further penetration by a corrosion process.

Figure 14a. Grain structure of the dome metal at some point between A and B in Figure 8. An abundance of grain boundary precipitates lead to the darkened and dotted appearance of grain boundaries.

Figure 14b. Close-up of grain boundaries in the dome metal near the crevice, showing evidence of grain boundary precipitates. Note that the film of corrosion product exhibits a slight tendency to penetrate some of the grain boundaries.

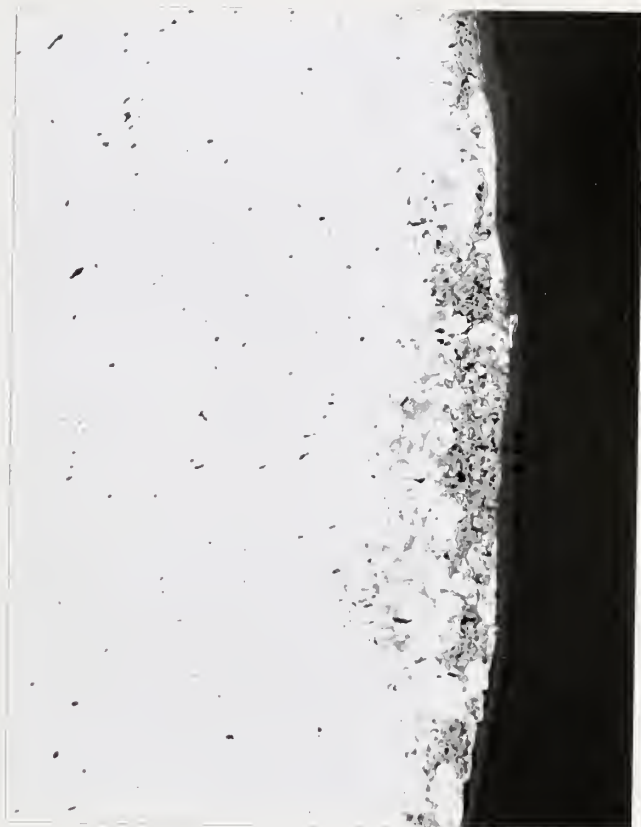
The materials at the dome end of the used-but-undamaged fire extinguisher which was cut up --- number F 700745 --- seemed to exhibit tendencies toward corrosion. For example, Figure 15 shows a section of the collar metal near the region labeled D in Figure 8. The surface film of corrosion product is clearly evident. Susceptibility of the joining metal and dome metal to corrosion is evident along the crevice in Figures 10, 11, 13a and 14b. The tendency of the joining metal at the top outside fillet --- C in Figure 8 --- was already pointed out. A close-up of a region near C in Figure 8, Figure 16, shows corrosion product adhering to the surface of the joining metal. The region labeled E in Figure 5b --- where the dome metal overlaps the shell metal --- was examined for evidence of corrosion. Indeed, as shown in Figure 17, some evidence of corrosion appears in the form of the irregular surfaces. Adhering corrosion product was not conspicuous on either the dome metal or the shell metal.

Figure 15. A section of the collar metal near D in Figure 8, showing surface film of corrosion product.

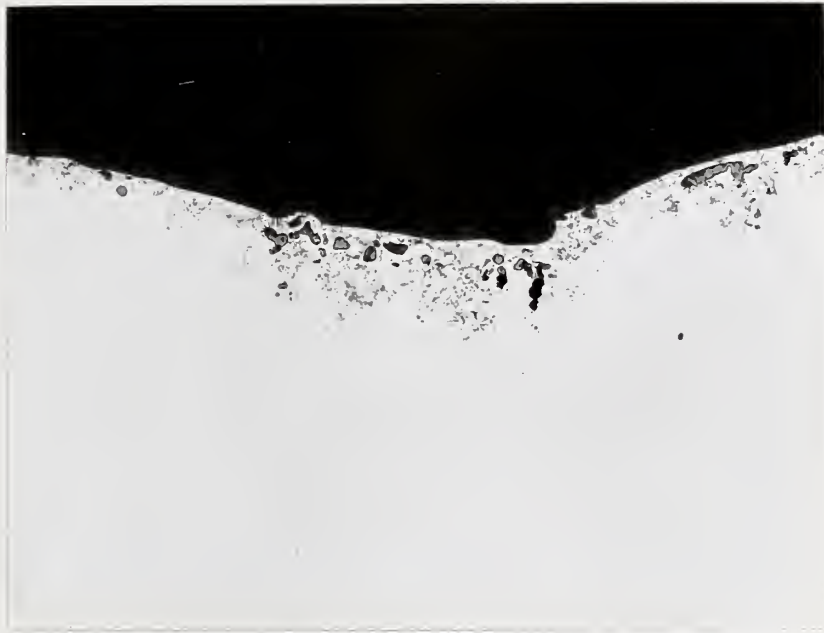
Figure 16. A section of the joining metal near C in Figure 8, showing film of corrosion product.

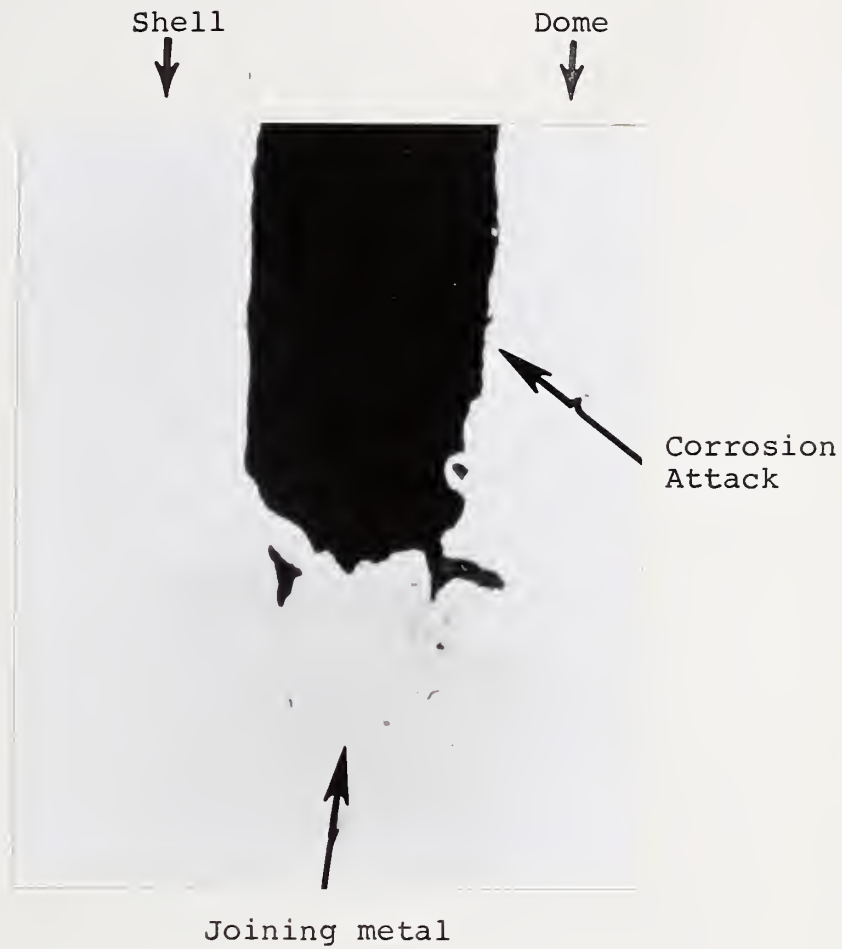
Figure 17. Upper region of lap joint between dome metal and shell metal shown at E in Figure 5b. Irregular surfaces suggest corrosive attack, possibly from corrosive fluid retained in the crevice formed by the lap joint.

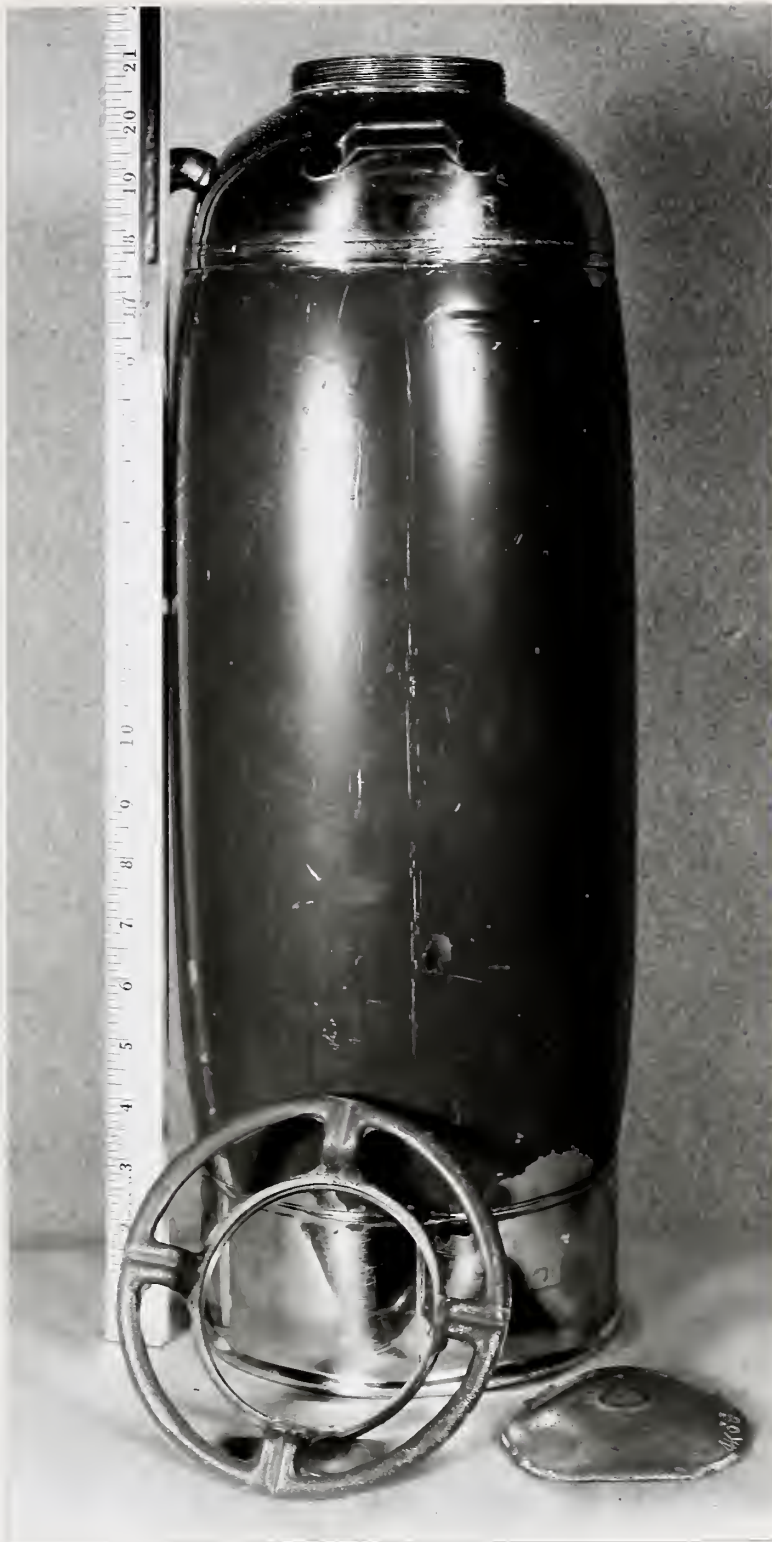
Figure 18. Fire extinguisher number F 701019 pressurized to burst. The extinguisher bulged significantly, but remained structurally intact. Failure occurred at 850 psig when the center section of the cap blew out.
