# **Analysis of Failure of a Polyethylene (PE) Gas Service Pipe (Lenoir County, NC)**

June 1976

Final Report

Report for  
**North Carolina Utilities Commission**  
Raleigh, North Carolina

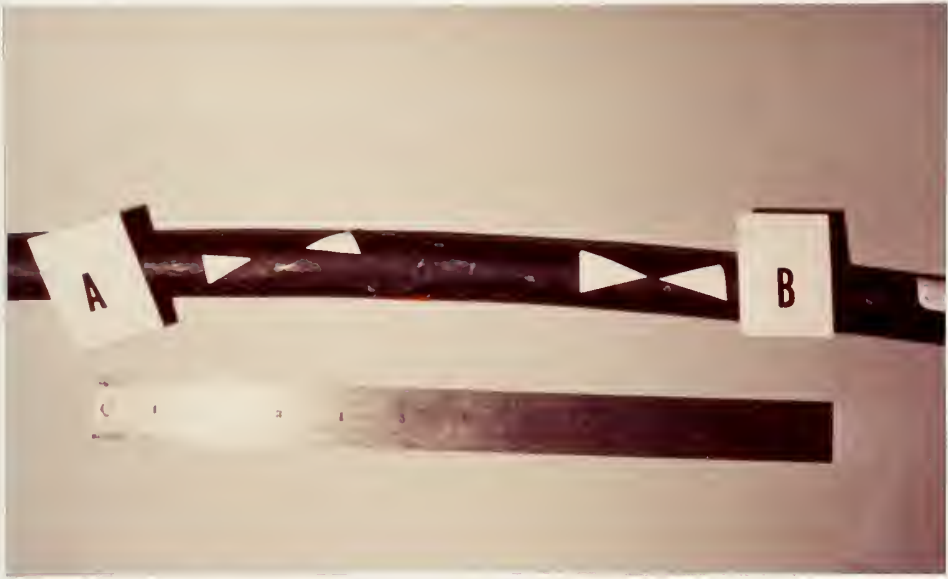
Figure 1

The two marked areas of leakage were designated as A and B. These two areas were, respectively, 80 and 65 cm from the nearest end of the overall sample, figure 1. A portion of crack A was visible on the outer wall of the pipe. A crack somewhat transverse to the longitudinal direction of the pipe was visible. This crack was approximately 2 cm in length but curved into a longitudinal groove, apparently the result of abrasion, which extended for about 11.5 cm along the outer pipe wall, consequently, the actual length of the crack could not be determined initially. Microscopic examination of area B did not reveal the presence of a crack, although numerous pits, scratches and embedded particles were observed. The pipe was then pressurized to 4 psi gauge (psig) air pressure. The leak at A was obvious, but no leak was detected at B. Subsequently, a liquid leak detector was applied over area B and the approximate location of two small leaks was determined. The pipe was then placed under the microscope, again pressurized and the leak detector applied to this area. The two leaks were located and found to be about 3 millimeters (mm) apart in the longitudinal direction and 5 mm apart in the transverse direction of the pipe. No holes were actually observed under magnification, but one leak appeared to be at or adjacent to a small piece of embedded debris. The latter leak was located in a shallow furrow in the pipe wall that appeared to have resulted from external abrasive damage.

A section of pipe, containing the two cracks, was cut from the sample. This section was about 45 cm in length with the two cuts being made approximately 15 cm to the left of crack A and to the right of crack B (see figure 1). Examination of the inside of this section showed the presence of two cracks on the inner wall at the approximate location

Examination of crack A revealed the presence of two particles, which looked like sand, embedded in the crack near the mid wall (the cylindrical surface parallel with and halfway between the inner and outer walls of the pipe) of the pipe. These particles were located about 4 mm from the end of the crack on the inner wall and were near the right end of the visible crack on the outer wall as illustrated in figure 1. The crack in the 2.7 cm section appeared to be a stress crack.

In the section of pipe between the two sections containing cracks A and B, a severely abraded area was noted on the same side of the pipe as crack A. This area is located on the outer pipe wall just to the right of the two arrows showing the location of crack A (figure 1). This area was approximately 2.5 by 2.5 cm and its center was located about 4 cm from the nearest end of the visible part of crack A. The outer wall of the pipe at this point was concave. It was also noted that three similar abraded areas exhibiting less severe damage occurred a distance of 15, 30 and 45 cm to the left of the above area as viewed in figure 1. The outer wall of the pipe was visibly deformed and concave in these areas. This concavity is typical of compressive deformation.

Examination of the pipe revealed a series of abrasion marks associated with shallower deformations of the outer pipe wall at intervals of approximately 7.5 cm, including those previously observed. That is, starting at the abrasion mark indicated in figure 1 there was evidence of a similar mark 7.5 cm to the right, located at the suspected origin of stress crack B, while to the left there was a mark 7.5 cm away located at the suspected origin of crack A. The next mark to the left was the one observed at crack C, while further to the left there were five additional marks located at 7.5 cm intervals, including the two previously noted marks at the 30 cm and 45 cm intervals from the one in figure 1. There was also some evidence, though not conclusive, of three or four additional abrasion marks to the right of crack B in figure 1. These marks appeared to be associated with the rib-like projections previously noted on the inner wall of the pipe. As a point of verification, wall thickness measurements made adjacent to the cracks and parallel to the longitudinal direction of the pipe across these areas indicated that thickness did not vary by more than about 0.0004 - 0.0005 in (0.010 - 0.013 mm), over a distance of 1 to 1.5 cm. This compares to wall thickness variations of .007 - .010 in (0.18 - 0.25 mm) when a cross section of pipe was measured circumferentially.

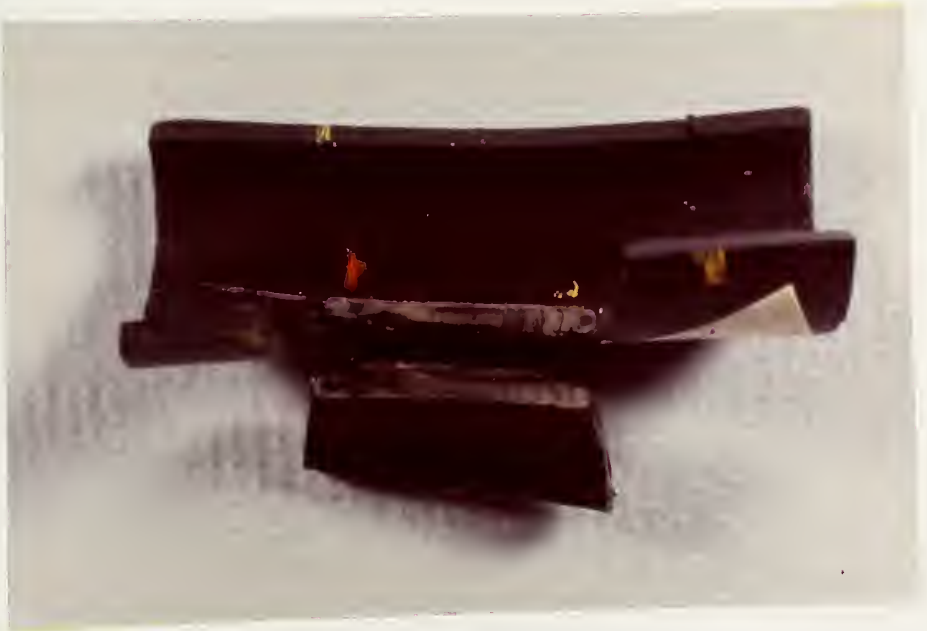
Figure 2

That portion of crack A which completely penetrated the outer wall was found to be about 2.3 cm in length. When the pipe was cut at each end of this crack, the two sections readily separated as illustrated in figure 2. The red mark on the inner pipe wall near the left end of the crack marks the location of the apparent origin of the stress crack. There was a small, raised irregularity in the crack surface of the smaller piece located about 0.25 mm from the inner wall. It was somewhat less than 0.25 mm in length in the longitudinal direction of the pipe, and was estimated to be on the order of 0.04 to 0.05 mm in width. A corresponding matching cavity was observed on the opposite crack surface on the larger piece of pipe. The yellow mark on the inner pipe wall near the right end of the crack in figure 2 indicates the locations of the two particles previously noted. These two particles fell out when the crack was separated. Examination of the crack surfaces in this area showed the presence of three very small voids and a small pit near the mid wall. It could not be determined whether the pit had been caused by the presence of one of the particles. Two small reddish spots were also observed in this area, but it could not be determined whether they were due to occlusions or to debris.

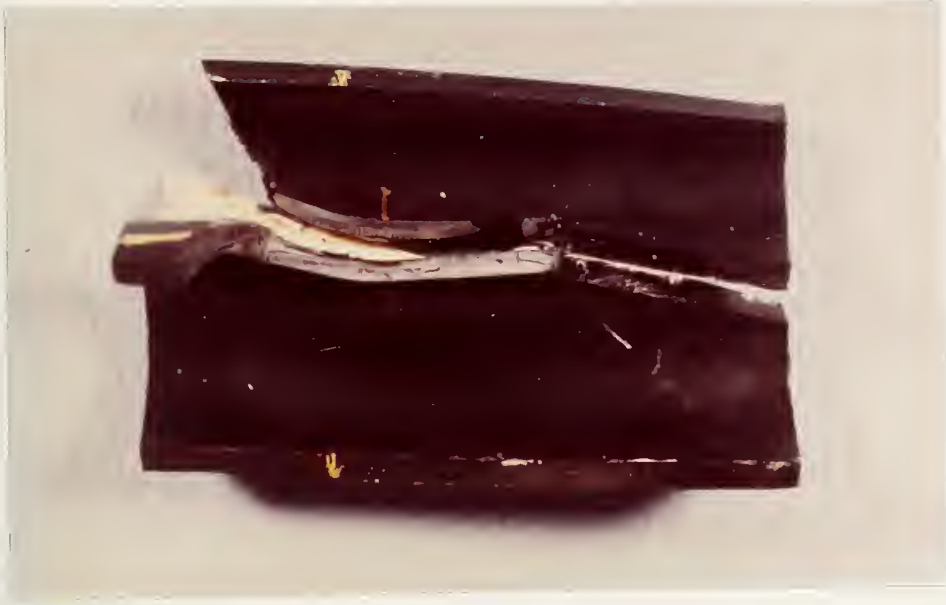
Figure 3

Crack B is illustrated in figure 3. The two portions of this crack did not separate when the pipe was cut. Examination of the surfaces of the crack in the area of the two leaks observed on the outer wall did not indicate any obvious defects in the pipe. The two sections were then bent and broken apart. There was some visual evidence that the crack had penetrated the outer wall for a distance of about 6 mm at the right end of the crack in the area of the two leaks. The red mark on the inner wall is the location of the probable point of initiation of the stress crack. The larger piece of pipe had a very small irregularly shaped pit, located about 0.25 mm from the inner wall, and approximately 0.25 mm in diameter, at the apparent initiation point. A similar, but much shallower pit was observed on the opposite crack surface. It could not be determined whether this pit was a void or had been caused by the presence of an occluded particle. Two small voids were found near the mid wall of the pipe, in the crack surface, but neither appeared to have been a crack initiation point.

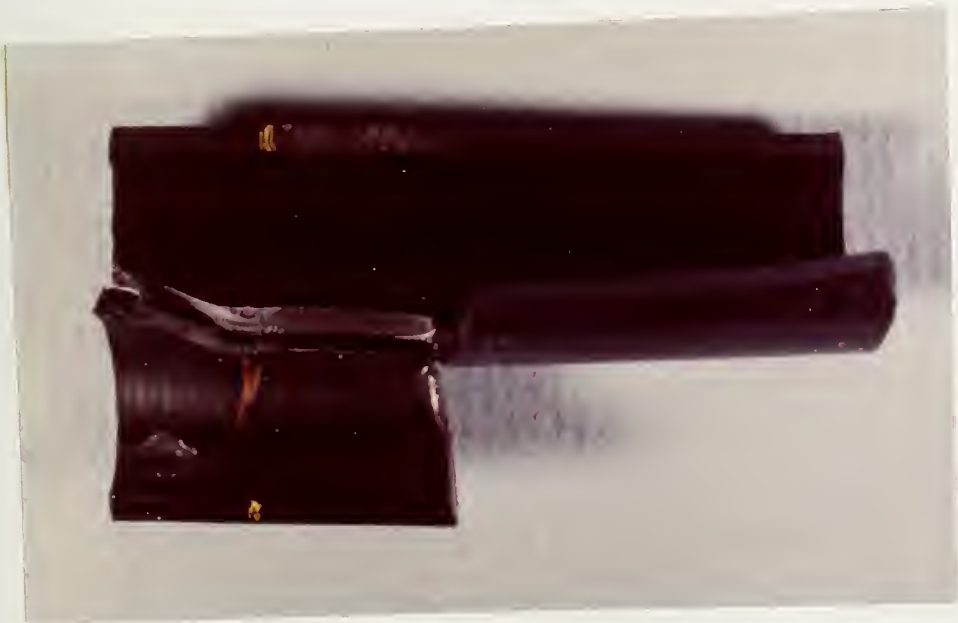
Figure 4

Attempts to separate crack C indicated that this crack did not extend much beyond the mid wall of the pipe. The crack was forced open, resulting in some tensile failure, in order to examine the crack surfaces. Although the point of origin of the crack seemed quite obvious, there were no indications of any artifacts, voids, or occlusions to enhance crack formation. The apparent origin of the crack was near the point of directional change in the crack, as illustrated in figure 4.

It was noted that the abraded area located 15 cm from the one between cracks A and B, was in the area of crack C at the point of the directional change in the crack configuration. This was also the location of the suspected point of initiation of this stress crack.
