NBSIR 76-1118 (R)

Examination of Ruptured Tubing from a Hot Water Generator at Bolling Air Force Base

Failure Analysis Report

Prepared for
Naval Facility Engineering Command
Department of the Navy
Washington Navy Yard
Washington, D. C. 20374

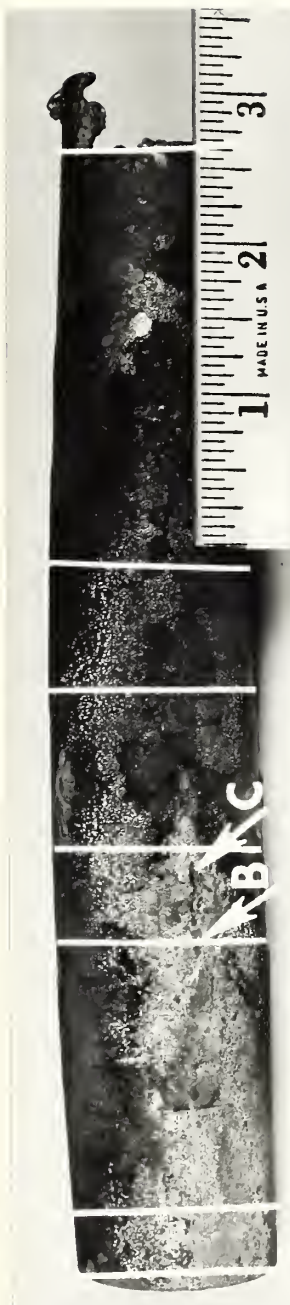
Macroscopic examination of the tube sample revealed a tight longitudinal rupture, approximately 0.75 inch long that is shown between arrows B and C in Figure 1. The rupture was in the heated fire-side wall (side on which the flame impinged). The diameter of the tube sample adjacent to the rupture was approximately 1.4 inch. The sample was slightly bowed. An adherent scale was present on the heated-fire-side surface of the tube sample adjacent to the rupture. The sample was flame-cut from the parent tube, which is evident from the irregular contour of the sample end at F, Figure 1. Adherent scale which was found on the water-side of the tube sample is shown in Figures 2a and 2b. Thinning of the tube wall that occurred is shown in Figures 3a and 3b.

Figure 1. Ruptured Tube Sample Submitted for Examination. Arrows point to rupture. Viewing faces at X 0.8

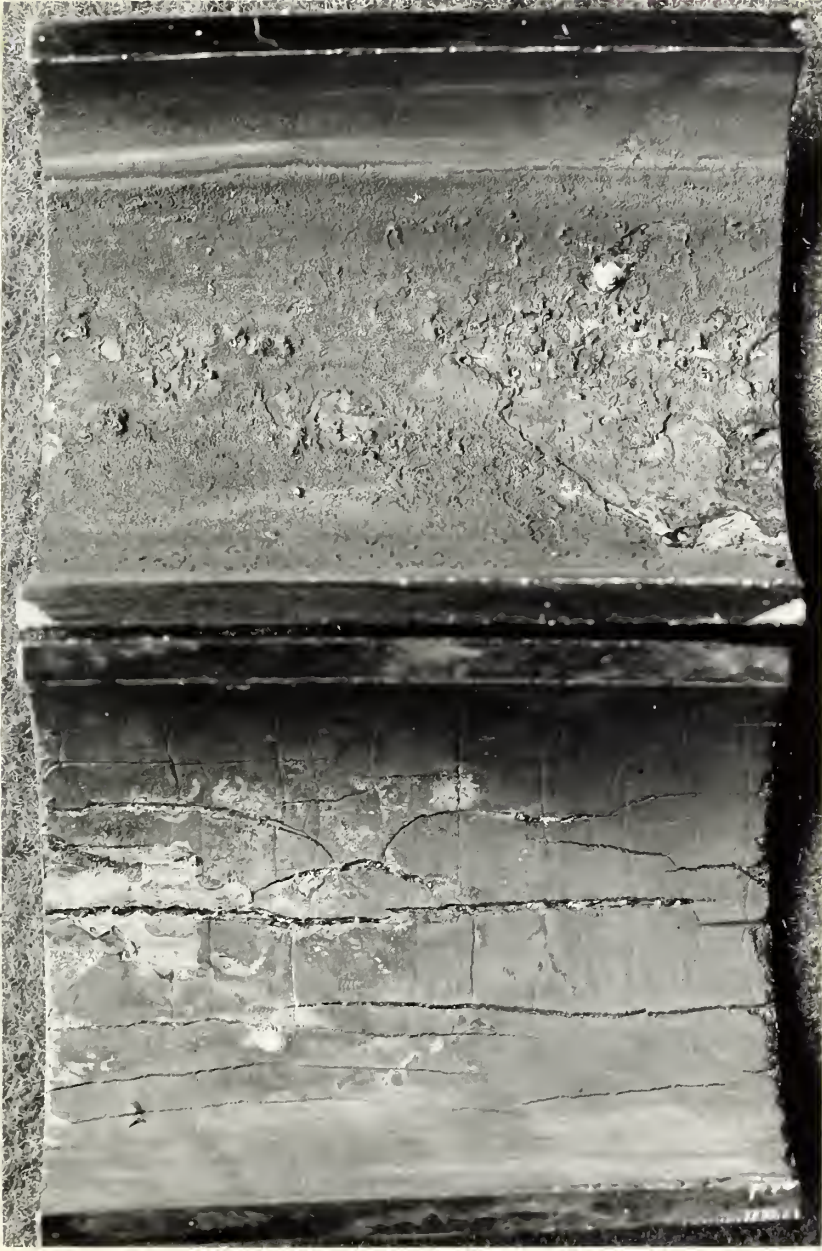
Crevice corrosion and pitting corrosion which were observed both proceed by the same mechanism - galvanic corrosion. Scale or deposits frequently lead to crevice corrosion in boiler tubing by creating anodic and cathodic areas. The anodic areas are subject to relatively rapid attack, mainly because they are small in relation to surrounding cathode areas. The general thinning of the tube wall in the water-side adjacent to the rupture, as shown in Figures 3a and 3b, resulted from crevice corrosion. In pitting corrosion, a small area is attacked because it becomes anodic to the rest of the surface, or because of a highly localized concentration of a corrosive contaminant in the water. Pitting that occurs at relatively few and scattered sites can result in rapid perforation because of the large ratio of cathode-to-anode area. Cracking of the scale, as shown in Figure 2a, is considered to have been conducive to pitting attack of the tube water-side.

Figure 2. Views of Section A-B After Splitting. Shows adherent scale on water-side wall of tube X 2.5
a. Heated water-side
b. Shadow water-side
Note the longitudinal cracks in the scale in 2a. Arrow points to terminus of rupture in tube wall.

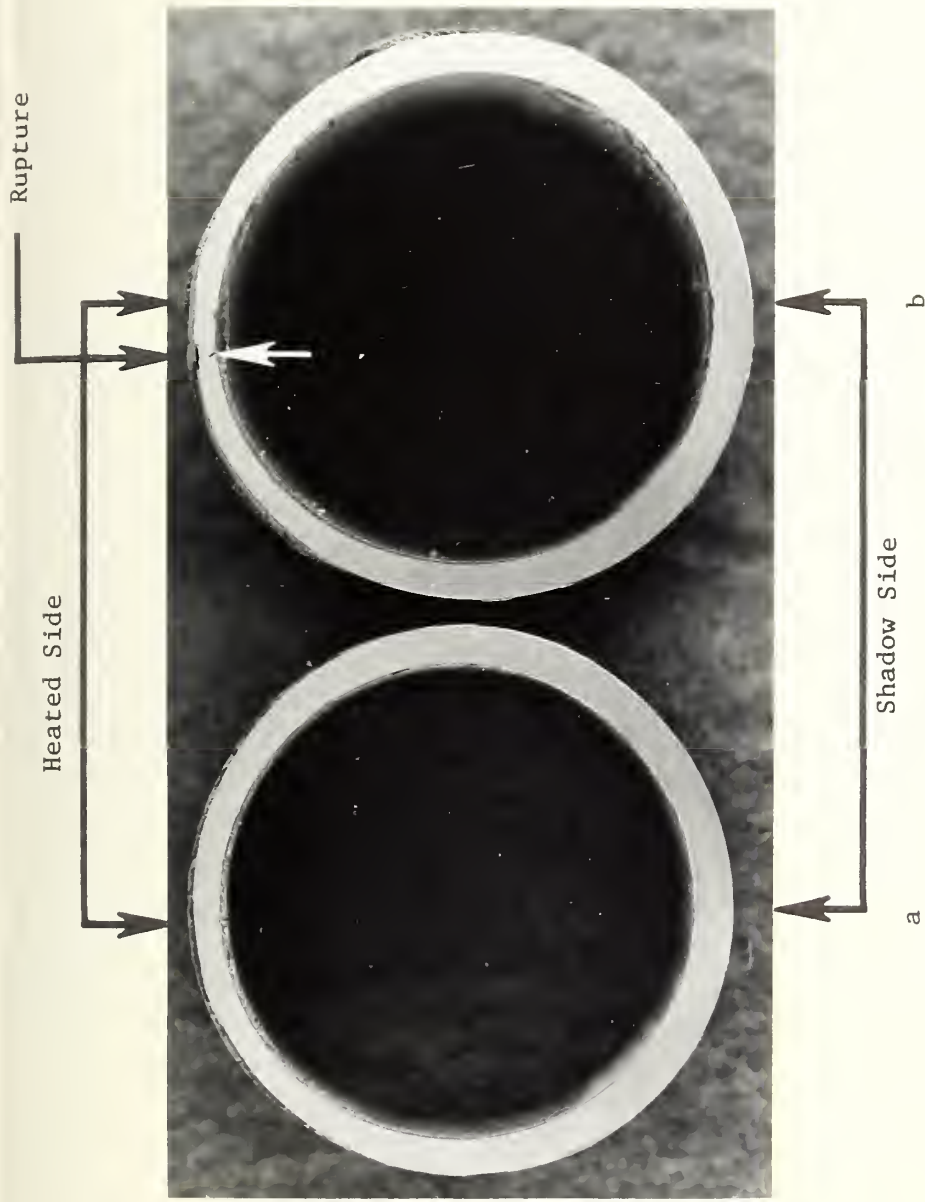
From microscopic observations it is evident that crevice corrosion on the water-side greatly reduced tube wall thickness. In addition, pitting attack further reduced tube wall thickness in localized areas and created stress-raising notches.

Figure 3. Viewing Faces of Tube Wall Showing Thinning, Bulging and Scale.
 a. Face S of Section S-A
 b. Face C of Section B-C
 Greatest reduction in wall thickness was observed adjacent to rupture, at arrow, Figure 3b. Bulging - heated side to shadow side axis - was observed to be slightly greater in section B-C than in Section S-A. Note also scale present in both views at heated fire-side and heated water-side areas.

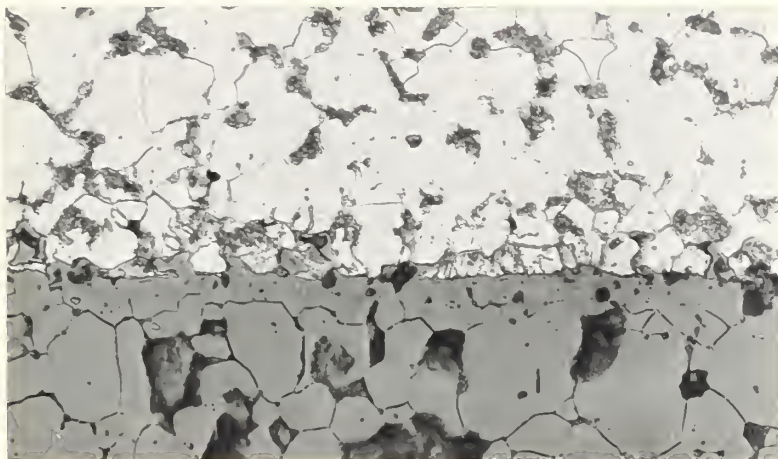
The original microstructure of the tube wall, as observed in unaffected areas, consisted of pearlite in a ferrite matrix. Some decomposition of the pearlite was found at a metal-scale interface on the tube water-side (see Figure 4a). Crevice corrosion and pitting attack were both revealed in microscopic examination [1]* Crevice corrosion of the water-side of the tube wall is shown in Figure 5a. Pitting attack of the water-side adjacent to the rupture is shown in Figures 5b, 5c and 8.

The original microstructure, pearlite in a ferrite matrix, is a normal boiler tube steel microstructure. Decomposition of the pearlite observed at a metal-scale interface adjacent to the rupture is the result of a deterioration of heat transfer characteristics because of scale accumulation. Excessive scaling will create a localized hot spot.

- a. Microstructures adjacent to water-side. Upper half shows unaffected structure consisting of pearlite (black) in a ferrite (white) matrix. Some decomposition of the pearlite occurred at the metal-scale interface.
- b. Microstructures adjacent to fire-side. Shows a penetration of oxides (grey) and decomposed pearlite (black) in metal adjacent to metal-scale interface. Steel has also been decarburized.

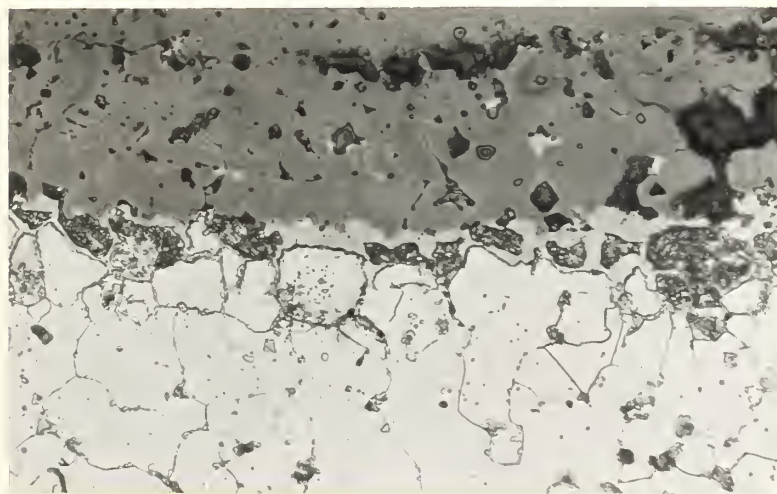
b

In examination of a fire-side area a penetration of oxides and decomposed pearlite were found adjacent to a metal-scale interface. Decarburization was also observed in this area (see Figure 4b). Corrosive attack penetrated into the heated fire-side of the tube wall adjacent to the rupture and decarburization also occurred in this zone (see Figure 6).

Decarburization observed on the fire-side of the tube indicates that the tube was at some time exposed to an oxidizing atmosphere (flame). This atmosphere reacted with and removed carbon from the pearlite constituent in the steel resulting in a localized weakening of the metal structure. Corrosive attack on the fire-side also reduced tube wall thickness in the rupture zone.

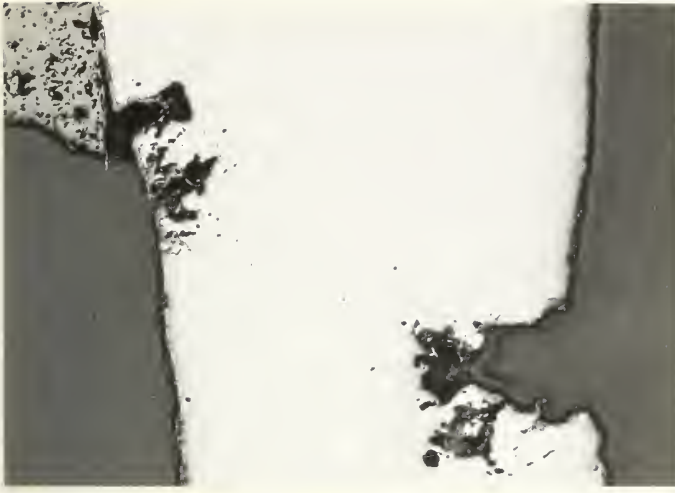
c

c. Crevice corrosion and pitting adjacent to rupture. Transverse. Unetched. X 50
 Penetration of pits on fire-side (adjacent to grey scale) and on water-side (large pit) are shown. Crevice corrosion and pitting reduced the tube wall thickness to approximately 0.024 inch from 0.094 inch, the approximate installation thickness.

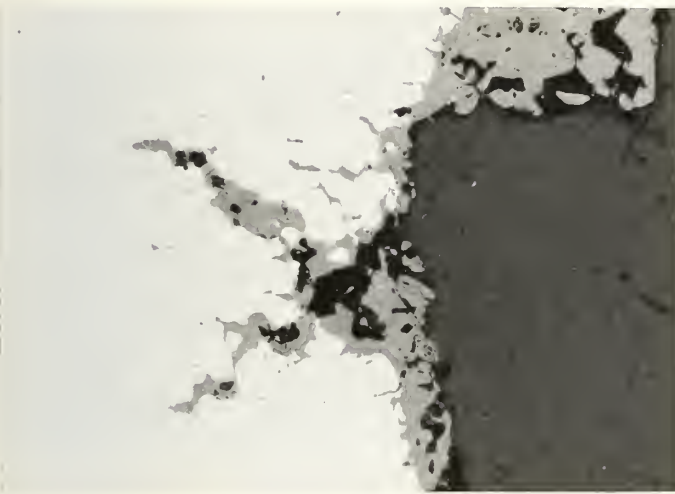
b

b. Pitting attack of water-side adjacent to Rupture. Longitudinal. Unetched. X 200
 Penetration into tube wall from break in scale is shown.

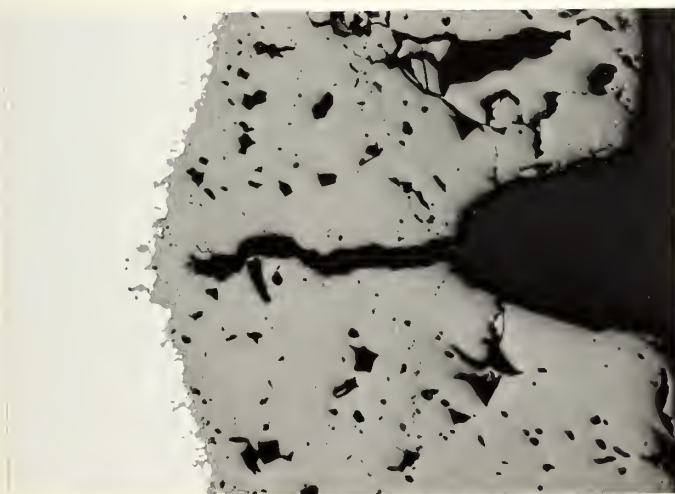
a

a. Crevice corrosion of water-side. Transverse. Unetched. X 100
 Corrosion is shown advancing from tip of crack in scale (grey).

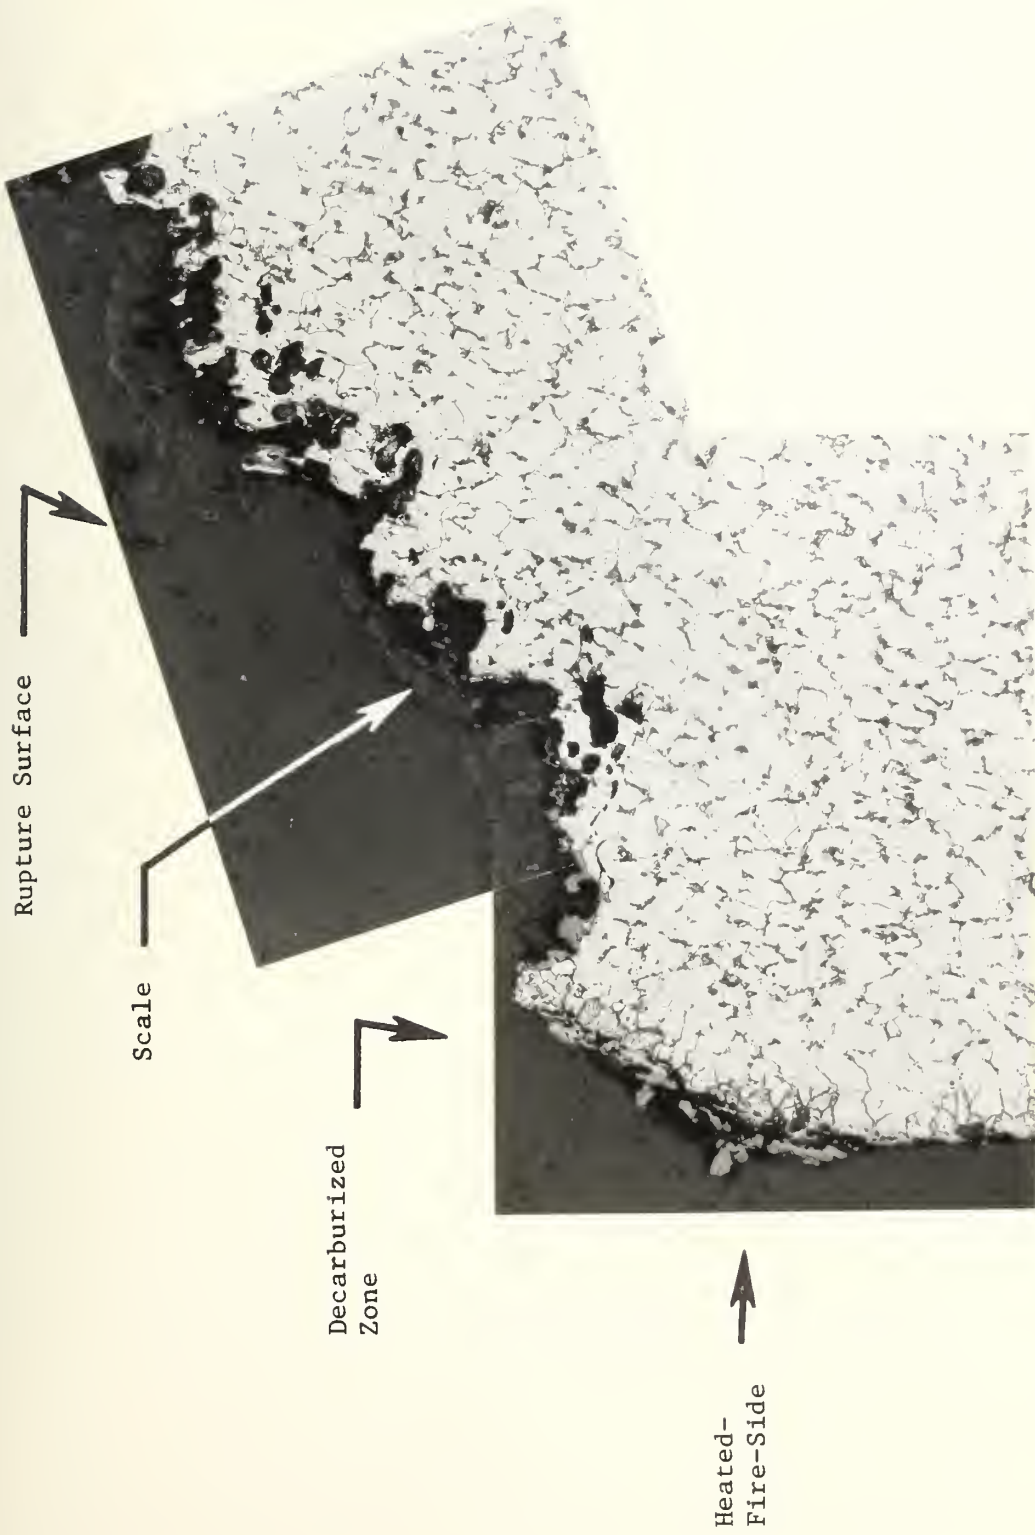
The chemical composition of the steel in the tube was found to comply with the requirements for ASME SA 178A, Grade A, as reported to be specified by the Naval Facility Engineering Command for this installation. The carbon content of the exterior scale points to an unfavorable operating condition. The high carbon content (about 70%) is indicative of uncombusted fuel. This condition resulted in the accumulation of the fire-side scale that is shown in Figures 4b, 5c and 6. An accumulation of exterior scale on boiler tubes detrimentally affects heat transfer characteristics and can result in localized hot spots. Sulfur, sodium and vanadium found in the exterior scale were apparently derived from the fuel oil in which they are frequently found. These elements are present in complex compounds formed during the combustion of fuel oil. These compounds may have contributed to the corrosive attack shown in Figure 6 [2].

Figure 6. Profile of Rupture in Tube Wall Adjacent to Heated Fire-Side Longitudinal. Etched with 1% Nital. Shows decarburization adjacent to rupture surface on heated fire-side. Irregularity of rupture surface resulted from corrosive attack penetrating from heated fire-side.

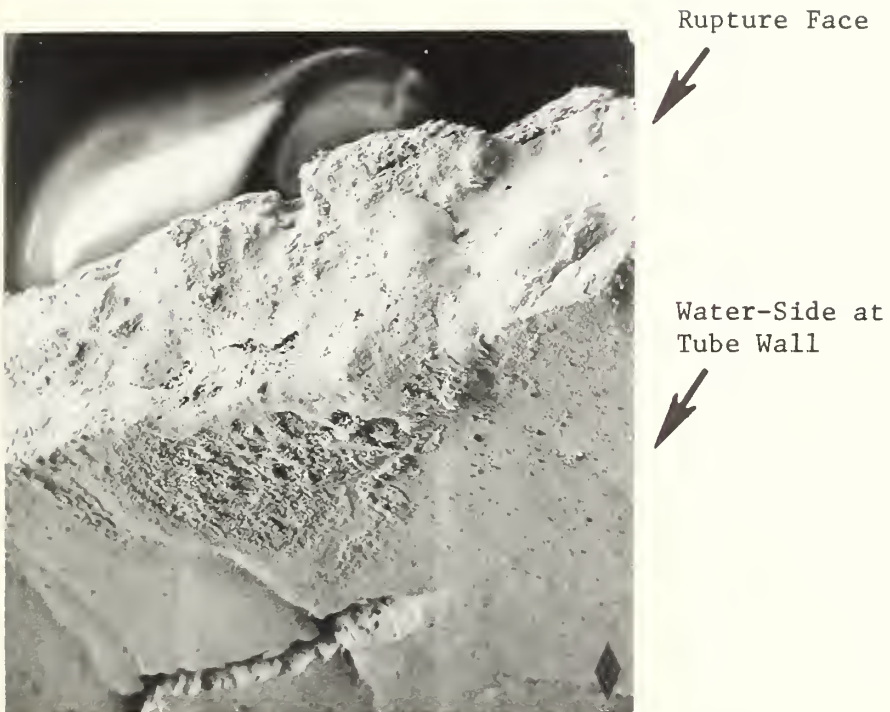
An oxide deposit was present over the entire length of the rupture surface. An SEM micrograph, Figure 7, shows the deposit midway along the rupture face.

The oxide deposit observed on the fracture surface resulted from the seepage of detritus from within the tube. An S.E.M. fractographic examination of the rupture surface could not be made because of the deposit.

Figure 7. Oxide Deposit Observed Midway Along Rupture Face. SEM X 18.5
Scale on adjacent water-side of tube wall is also shown.

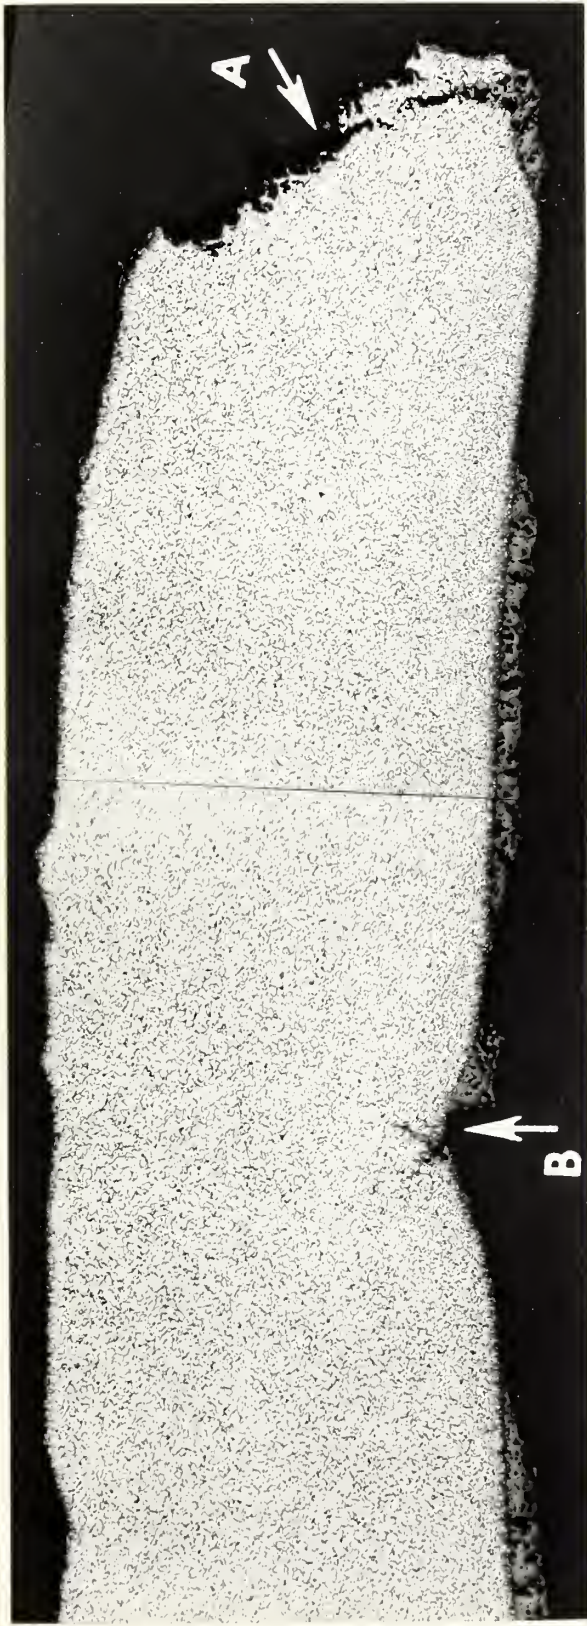
Figure 8. View of Entire Rupture Profile in Tube Wall.
Longitudinal. Etchant: 1% Nital

Arrow A. Rupture surface. Note penetration of scale (grey) on water-side adjacent to rupture.

Arrow B. Corrosion pit on water-side.
