NBSIR 76-1153

Microstructural Aspects of Deformation and Oxidation of Magnesia-Doped Silicon Nitride

N. J. Tighe

Interim Report for Period 1 July, 1976 to September 30, 1976

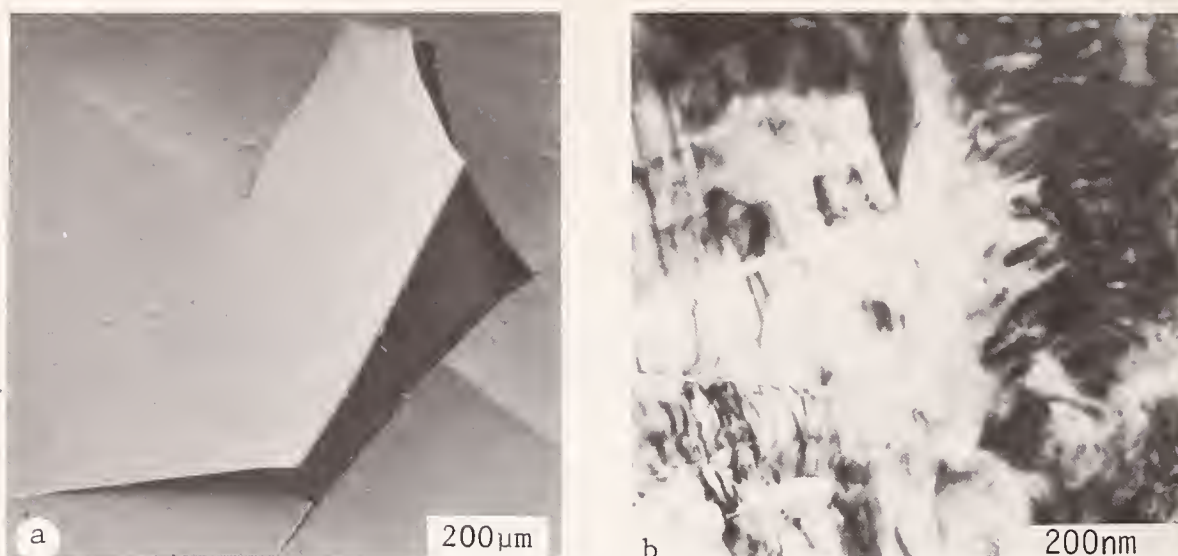
Fig. 1 Grinding damage (a) scanning electron micrograph of a thin foil specimen which curled-up as a result of strain on one ground side. (b) TEM showing sub-surface damage.

The damage found near a ground surface is shown in Fig. 1b. The dislocation density is high and the strain contrast in the image reduced the resolution. The micrograph shows, however, the dislocations and cracks that constitute some of the near surface grinding damage.

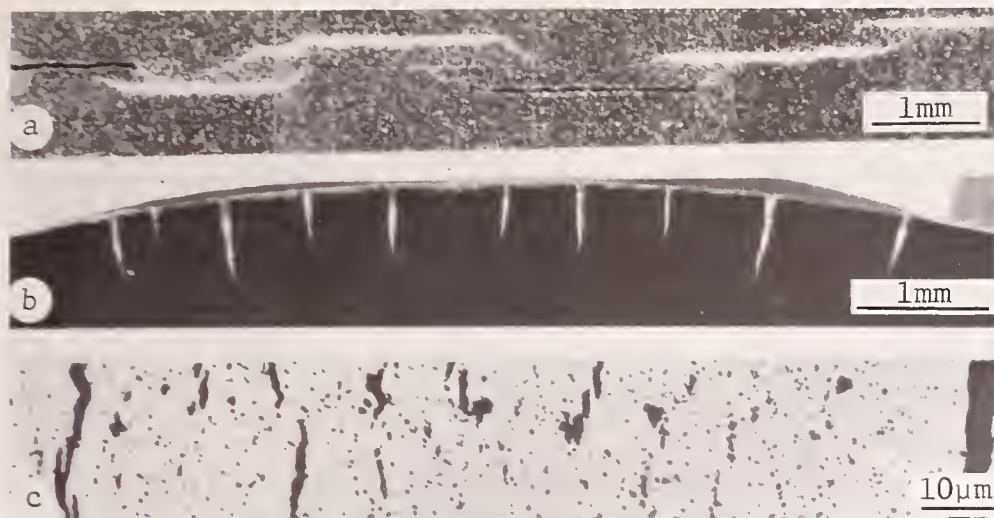
Fig. 2 Light micrographs of cracks in specimens deformed at 1400°C (a) tension surface of double-torsion specimen, (b) tension side of 4-pt. bend bar, (c) area between edge cracks in (b).

Specimens which exhibited slow crack growth during crack propagation experiments of 1400°C were examined by light and electron microscopy. Cracks which had formed in the tension side of specimens were filled partially with oxide; and, therefore were easily visible. The segmented primary crack shown in Fig. 2a demonstrates the characteristic fracture pattern of slow crack growth in HPSN.

Cracks were produced along the tension side of a 4-pt. bend bar which was tested at 1400°C. When the surface oxide was polished away the deep cracks shown in Fig. 2b were seen along the specimen edge; however, near the center of the bar cracks penetrated only a few tenths of a mm. Short crack segments which occurred between the deep edge cracks are shown in Fig. 2c. These observations suggest that the crack growth was influenced by edge effects and by surface oxidation.

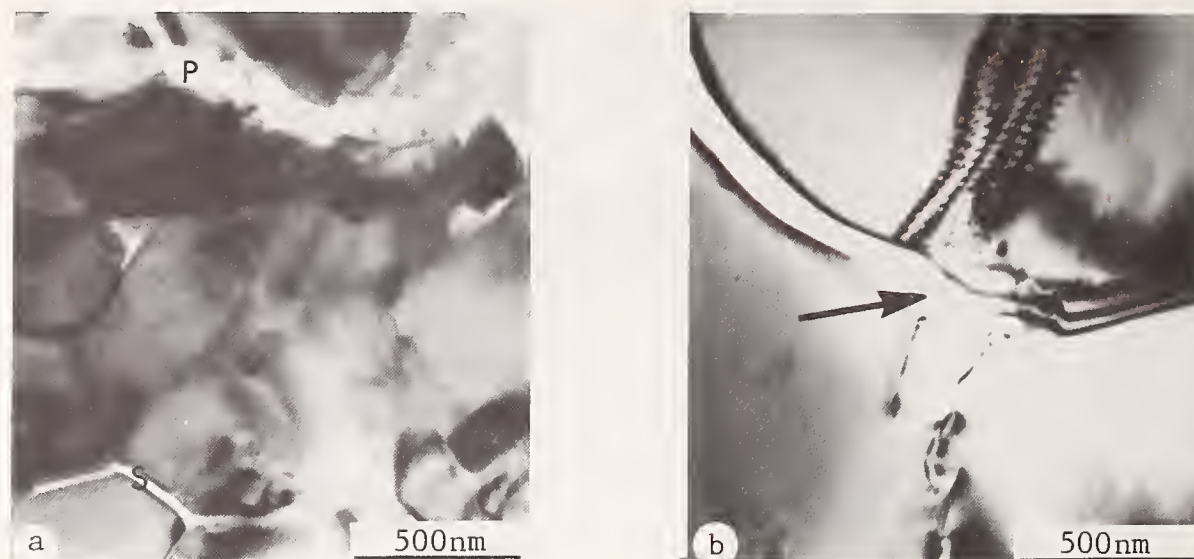
Fig. 3 Electron micrographs of cracks produced in double-torsion specimens tested at 1400°C, (a) primary (P) and secondary cracks (S), (b) dislocation arrays at the tip of a secondary crack.

In double-torsion specimens, electron microscopy showed that cracks occurred along grain boundaries. The primary crack and the secondary cracks were oriented approximately parallel to each other and were separated by one or more grains. An example of this configuration is shown in Fig. 3a. Figure 3b shows a crack tip which is several grain diameters away from the primary crack. The crack is several grains long and dislocations are seen emanating from the crack tip into the two adjacent grains.

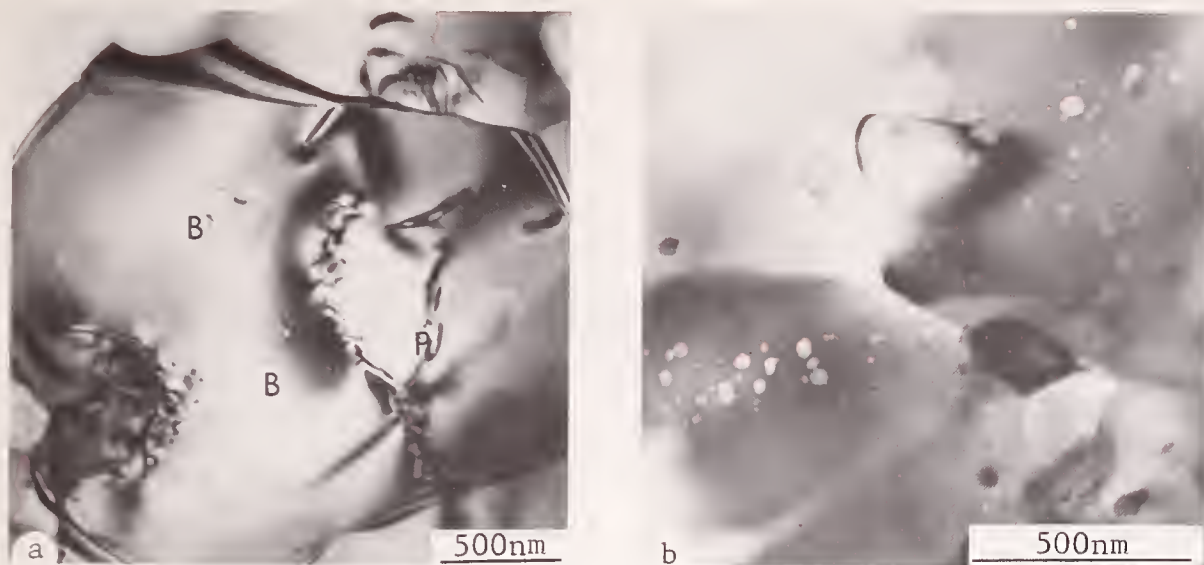
Grains on the compression side of the bent bars had extensive arrays of bubbles, (B), dislocation arrays, (P) associated with grain boundaries and in sub-grain boundaries. The pictures in Fig. 4a, b show typical areas in these samples.

Fig. 4 Compression side of a bent sample showing (a) Bubbles, and dislocation arrays within a grain, (b) Extensive array of voids.

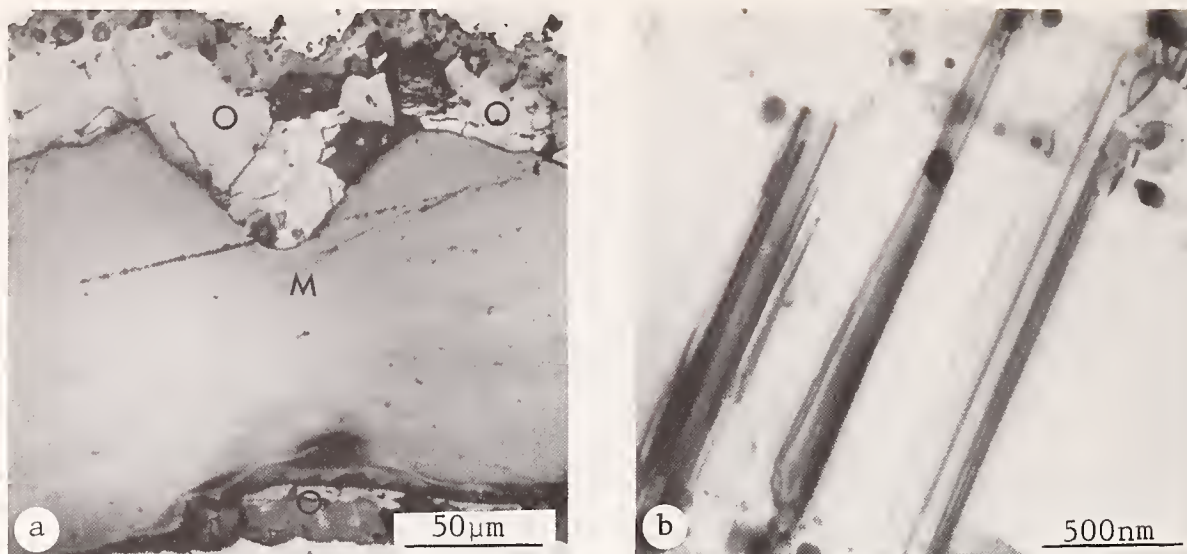
A cross section of the oxide formed on a specimen heated 96 hrs at 1400°C is shown in Fig. 5a. The oxide is polycrystalline and polyphase and has many pores and cracks. This specimen was heated cyclically and the oxide appeared to have melted during this heat treatment.

Electron microscopy on the sample in Fig. 5a showed that the oxide nearest the Si_3N_4 matrix was $\text{Si}_2\text{N}_2\text{O}$. This phase was distinguished also by light microscopy, and, from the light microscopy examination it appeared that the oxide formed nodules which grew to cover the surface. Large grains of silicon oxy-nitride were found in the thin sections, and these grains were heavily faulted as shown in Fig. 5b.

Fig. 5 Oxide produced at 1400°C, (a) light micrograph showing oxide (O) on both surfaces of Si_3N_4 specimen (M), (b) $\text{Si}_2\text{N}_2\text{O}$ grain.

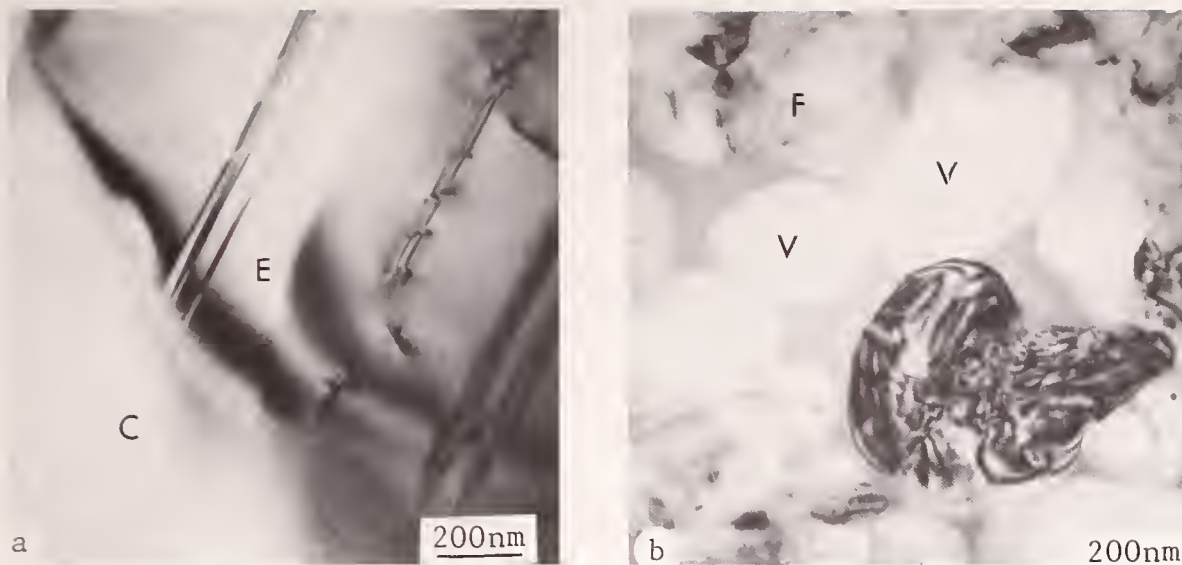
In the layer adjacent to the silicon oxynitride, enstatite and cristobalite were found. The electron micrograph in Fig. 6a shows an enstatite grain with its characteristic faulting and a partially vitrified cristobalite grain.

Cristobalite was found in all the oxidized specimens. In thin foils which were oxidized at 1000°C and at 1200°C, β -cristobalite occurred as grains within a glassy matrix. However, under the influence of the electron beam, the β -cristobalite decomposed first to α -cristobalite an amorphous phase. The grain shape did not change during this vitrification. The vitrification occurred in less than two minutes and Fig. 6b shows both transformed and nontransformed grains. The diffraction pattern taken from the vitrified β -cristobalite was used to differentiate the amorphous silica phase from the other amorphous phase. It is possible that the second amorphous phase is a magnesium silicate glass. Cristobalite and various pyroxene phases can occur by devitrification of a magnesium silicate glass at 1400°C as well as during cooling to room temperature.

Fig. 6 Phases found in oxide produced by heating at 1400°C (a) enstatite, $MgSiO_3$ (E) and β -cristobalite grains in the mid-oxide layer. (b) β -cristobalite formed on a thin foil oxidized 1 hr at 1200°C; area shows faulted grains and some vitrified grains.
